The floor level change along the 3 km SuperKEKB main ring tunnel has been surveyed using DNA03 and N3 periodically. The south arc section continues to sink with respect to the interaction point at an average speed of a few millimeters per year, resulting in a net sinkage of 35 mm. The floor level of the south arc section and around the interaction point have been monitored continuously with the BINP HLS system. The level is affected by the outside temperature, rainfall etc.

CONSTRUCTION OF THE NEW FACILITY BUILDINGS (3M-12M) AND NEW BT LINE AND EFFECTS ON THE TUNNEL

FLOOR VARIATION DUE TO WEATHER IN TSUKUBA EXP.

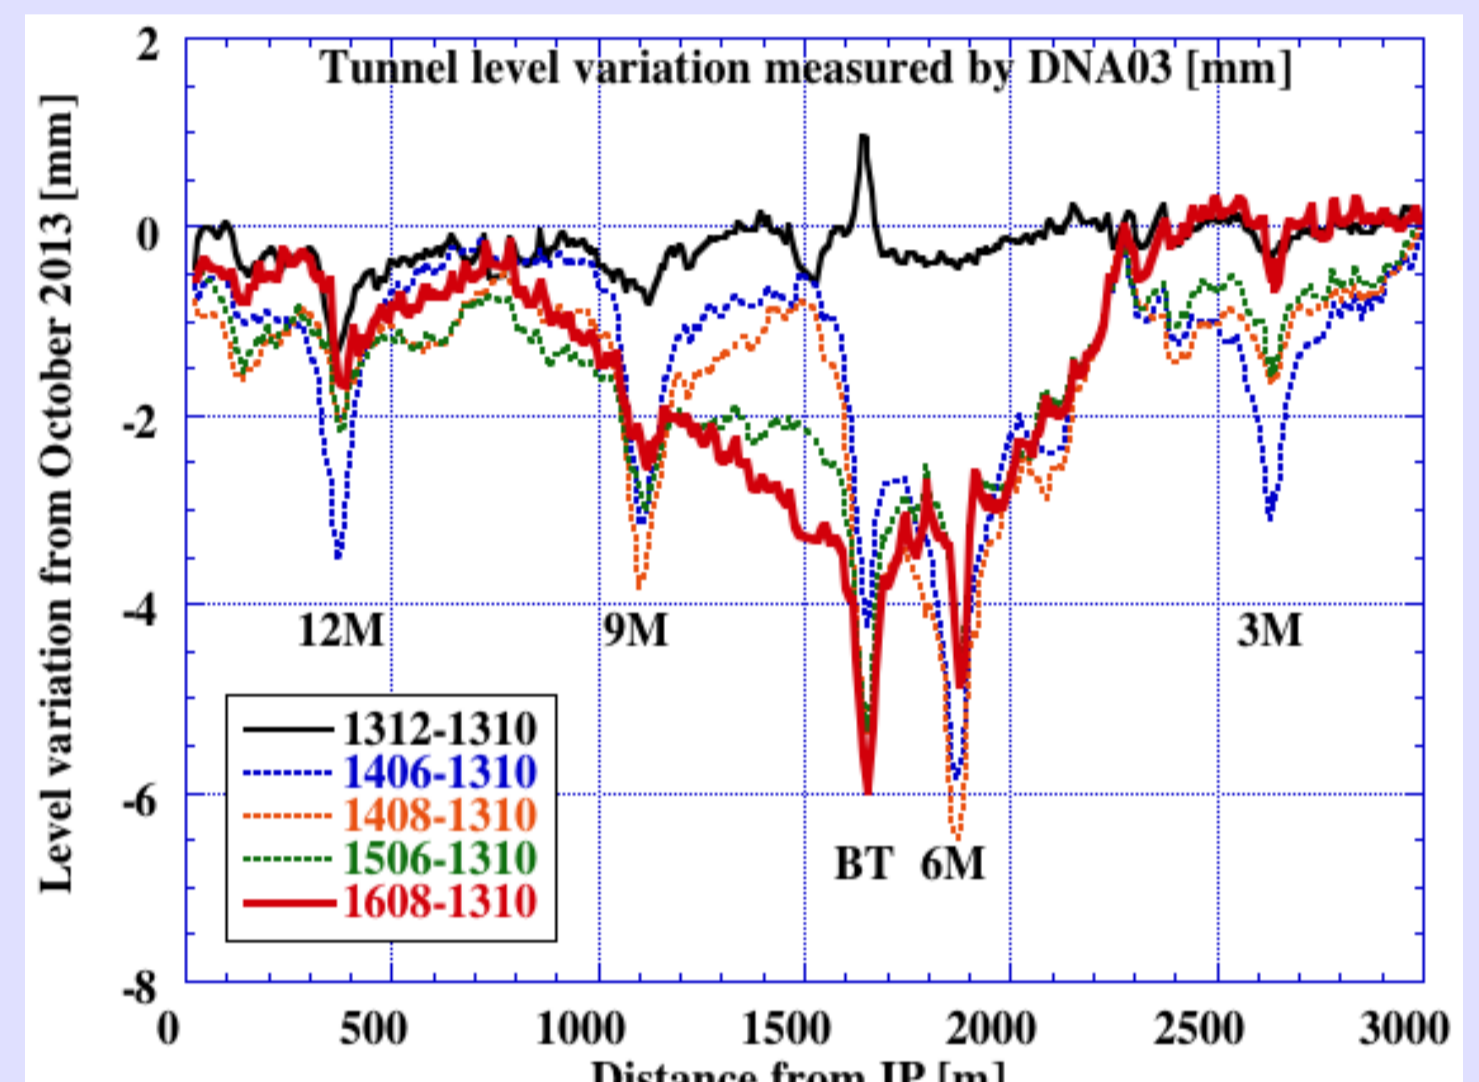
Relative level change measured by DNA03 is plotted against the distance from the IP. The effects of the construction is clearly seen.

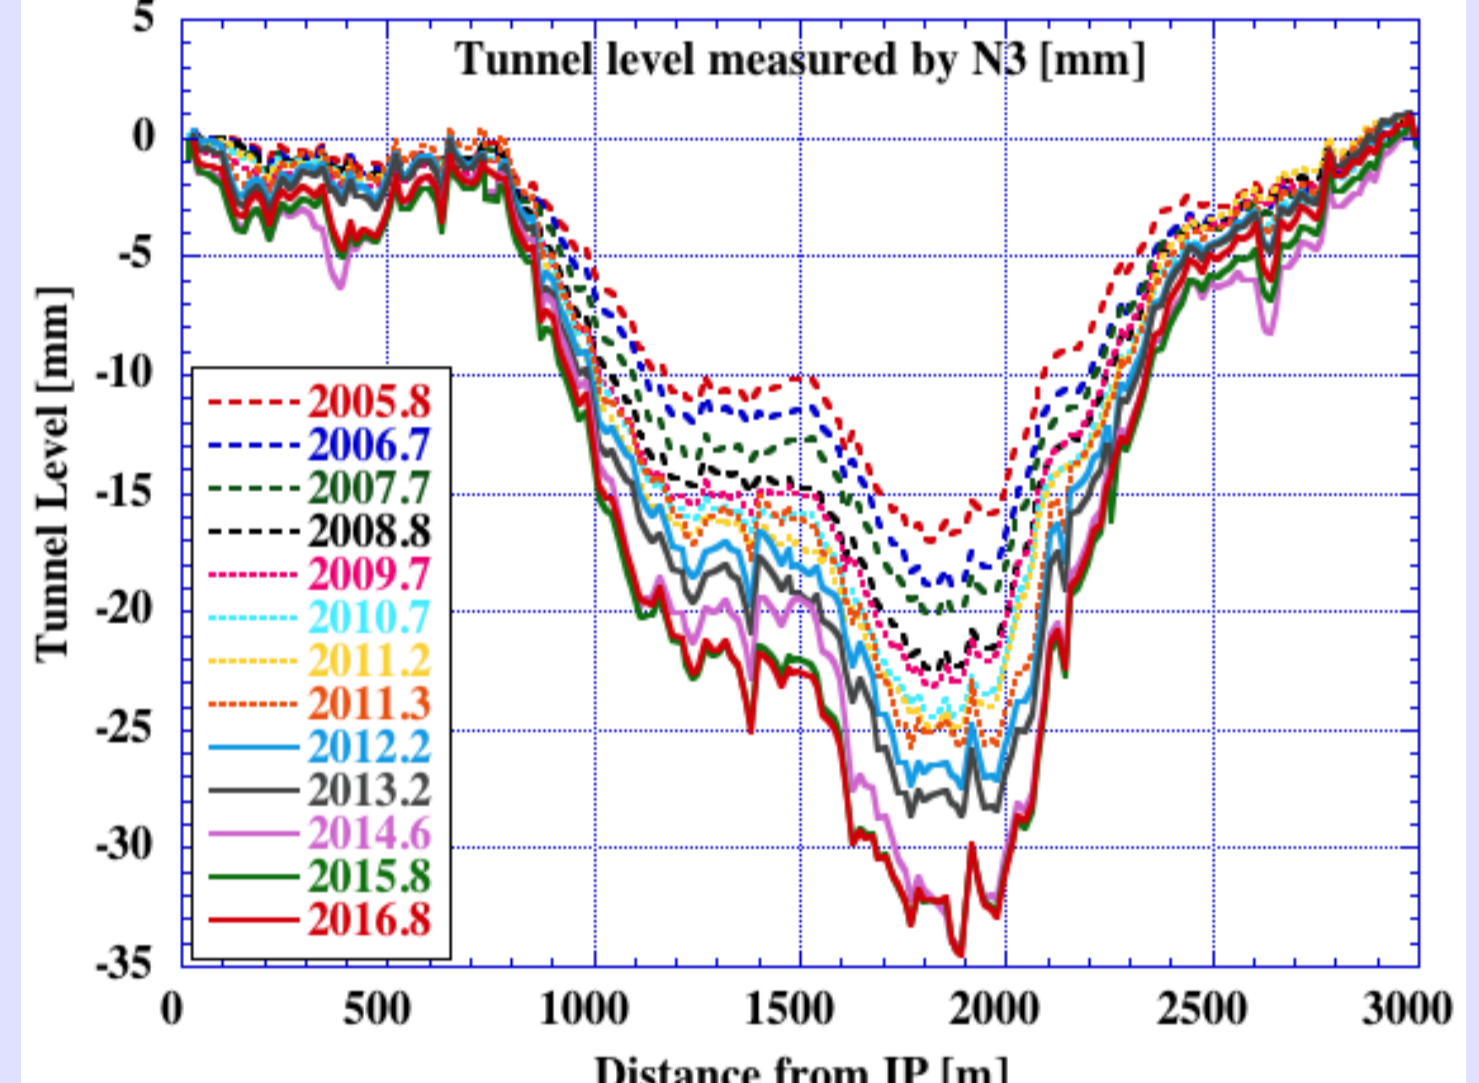
Tunnel level measured by N3 is plotted against the distance from the IP. Relative level with respect to the IP is shown.

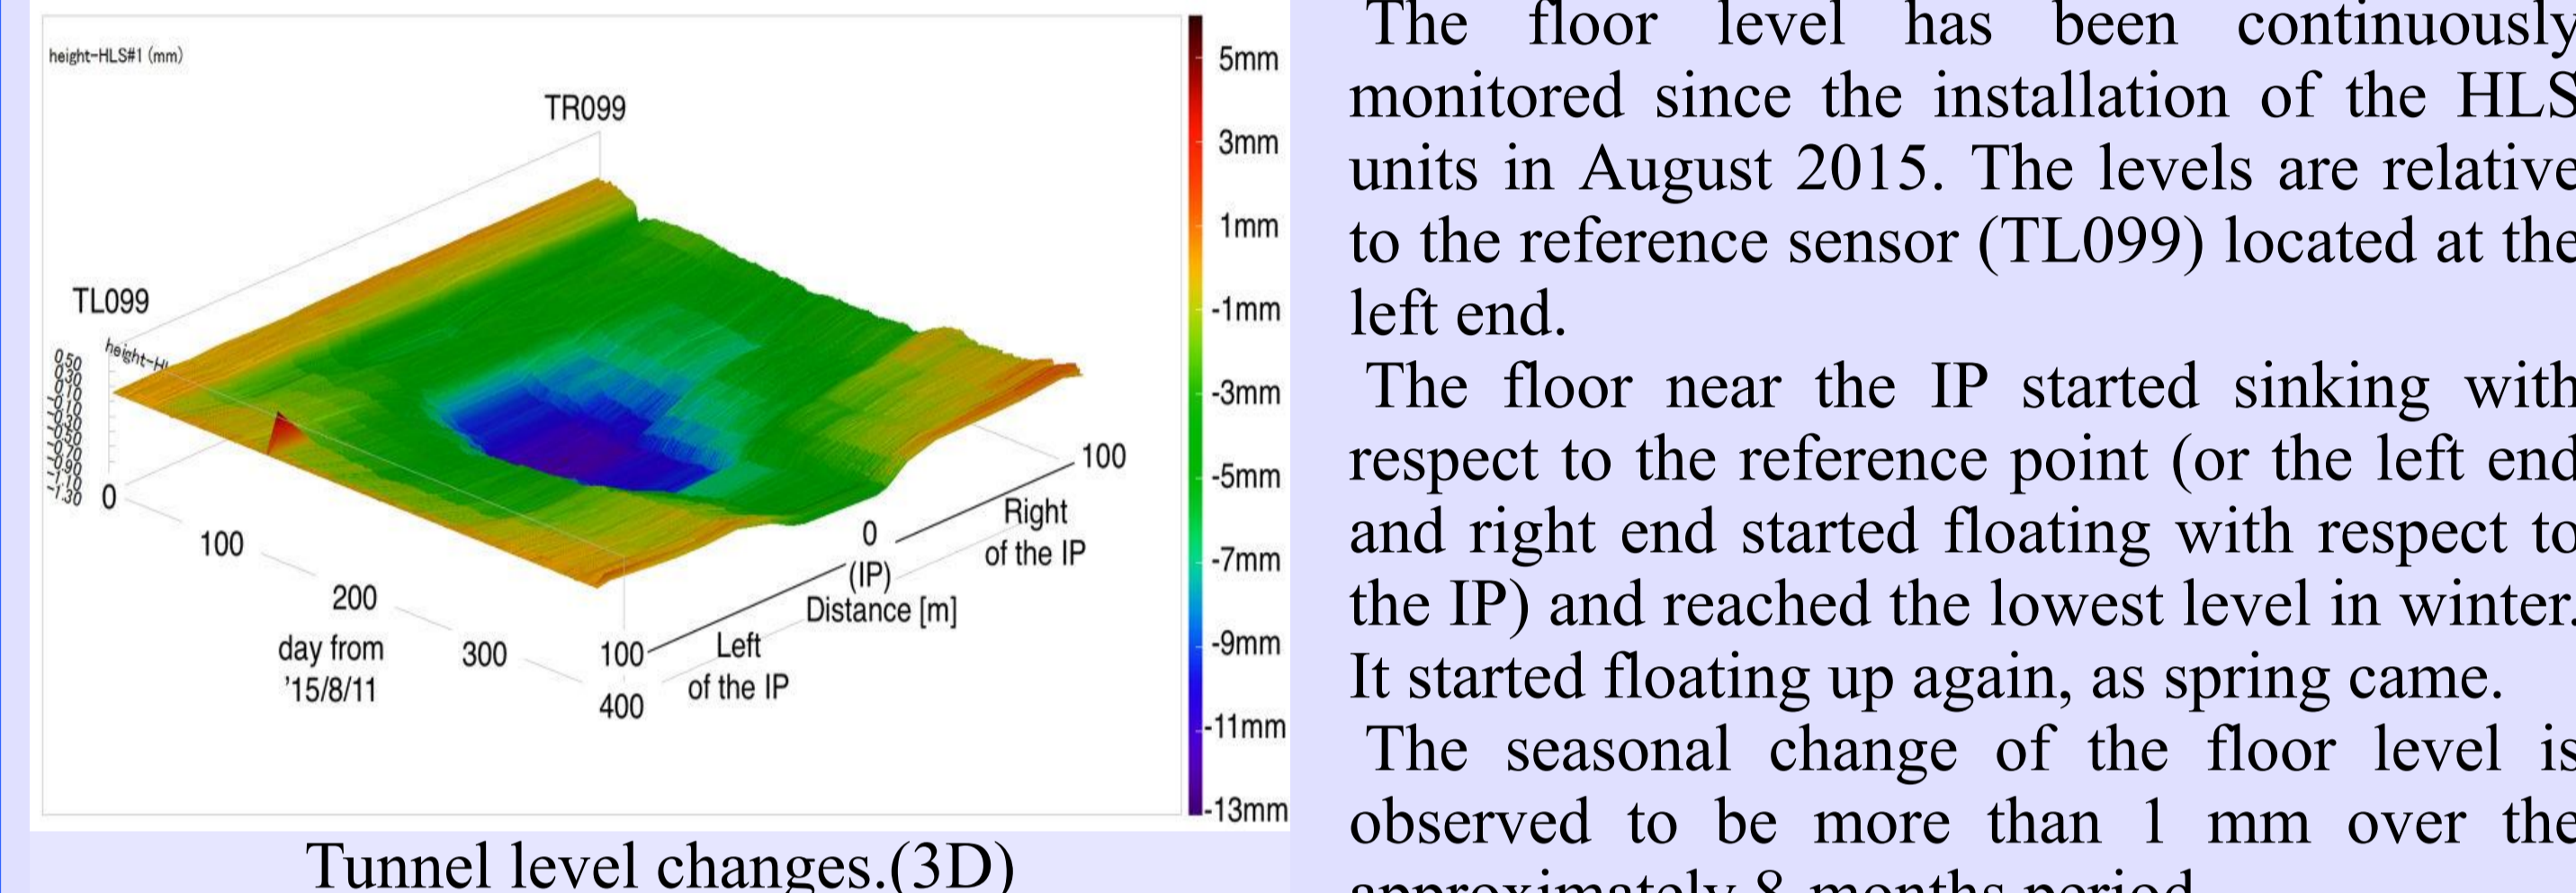
The floor level has been continuously monitored since the installation of the HLS units in August 2015. The levels are relative to the reference sensor (TL099) located at the left end. The floor near the IP started sinking with respect to the reference point (or the left end and right end started floating with respect to the IP) and reached the lowest level in winter. It started floating up again, as spring came. The seasonal change of the floor level is observed to be more than 1 mm over the approximately 8-months period.

The floor level variation appears to follow seasonal changes of the out-side air temperature. The daily variation following to the air temperature is seen, too.

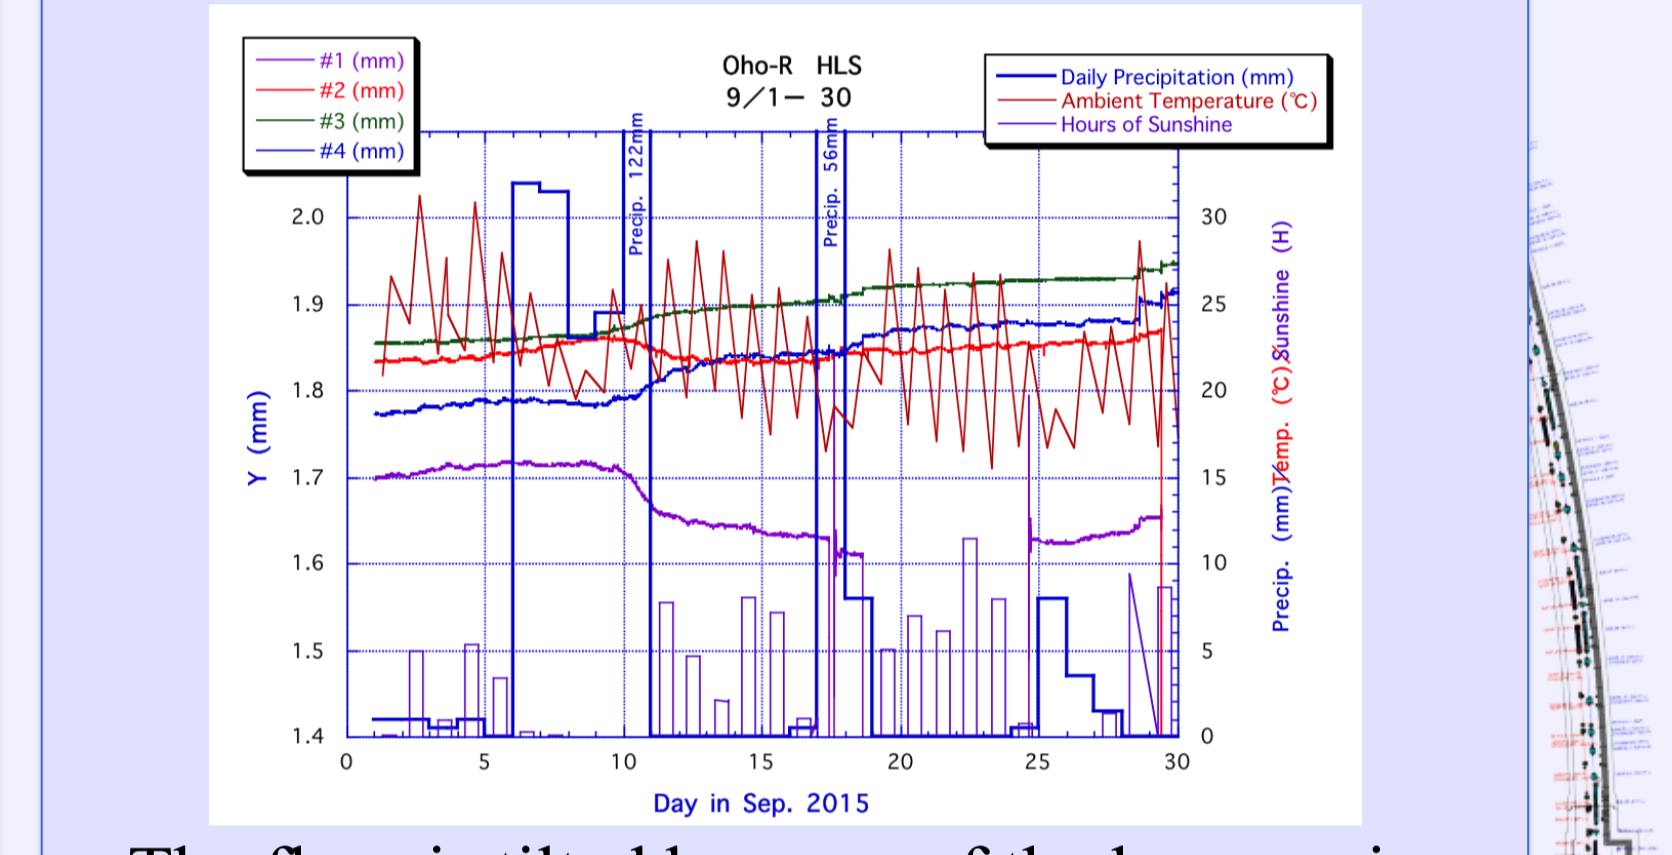
HLS #1-#4 (offered by DESY) OUTPUTS, WHICH WERE PLACED IN THE ARC SECTION OF OHO AREA

The floor is tilted because of the heavy rain.

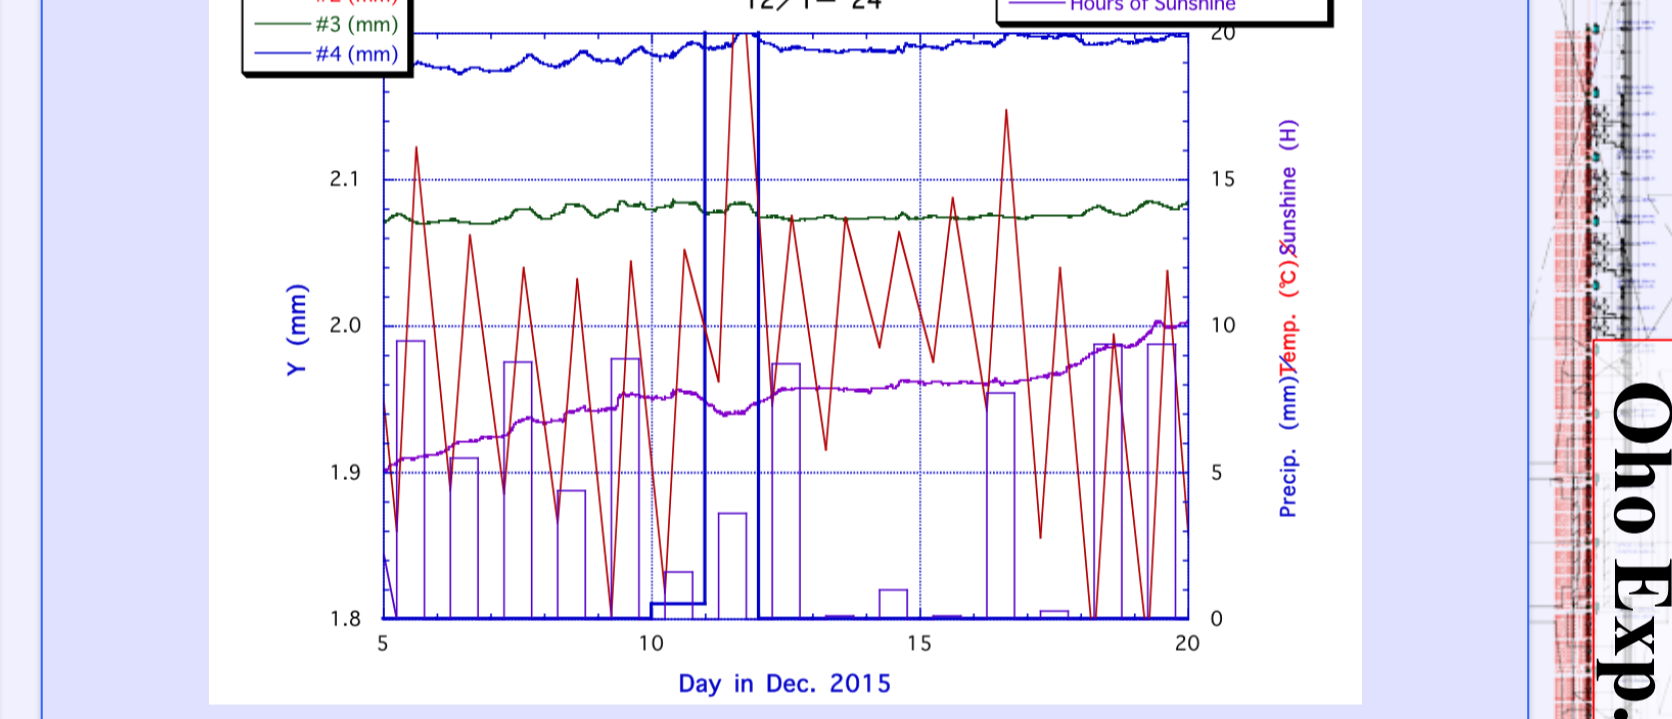
Daily variation of the tilt of the tunnel floor is as small as 20 $\mu\text{m} / 10 \text{ m}$, but it is noticeable when the daily variation of the ambient temperature is large or the time of the sunshine is long.
