# Medipix3 Irradiation Studies

## Irradiation Studies of a 130nm Large Area Pixel Chip

Richard Plackett – CERN Medipix Group  
TWEPP 2009, Paris, 22<sup>nd</sup> September

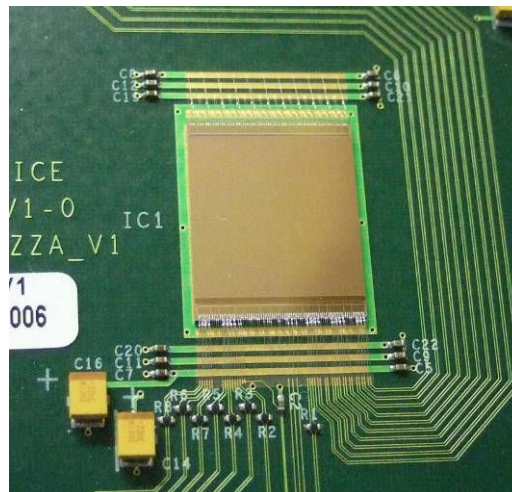
- **Medipix3 builds on the success of Medipix2 as a single photon counting imaging chip**
- **Added Features**
  - Analogue charge summing to keep all charge information
  - Spectroscopic mode with 8 threshold levels
  - Continuous readout mode (no dead time)
  - Increased counter depth increasing dynamic range
  - Increased readout speed
  - Increased radiation hardness from 130nm CMOS process

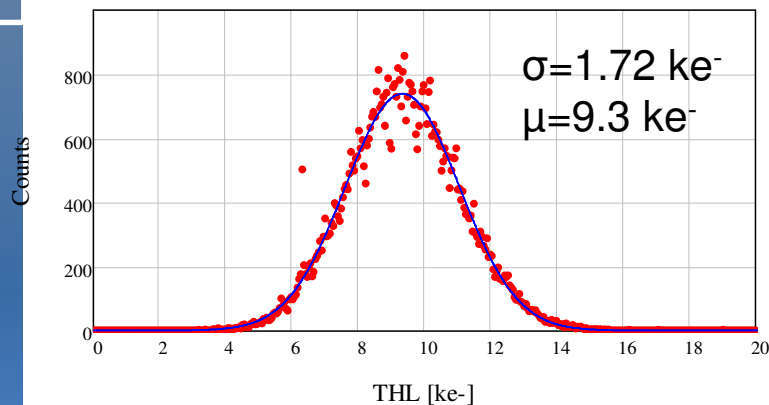
## Threshold

**Threshold can be re-tuned using 5 bit equalisation**

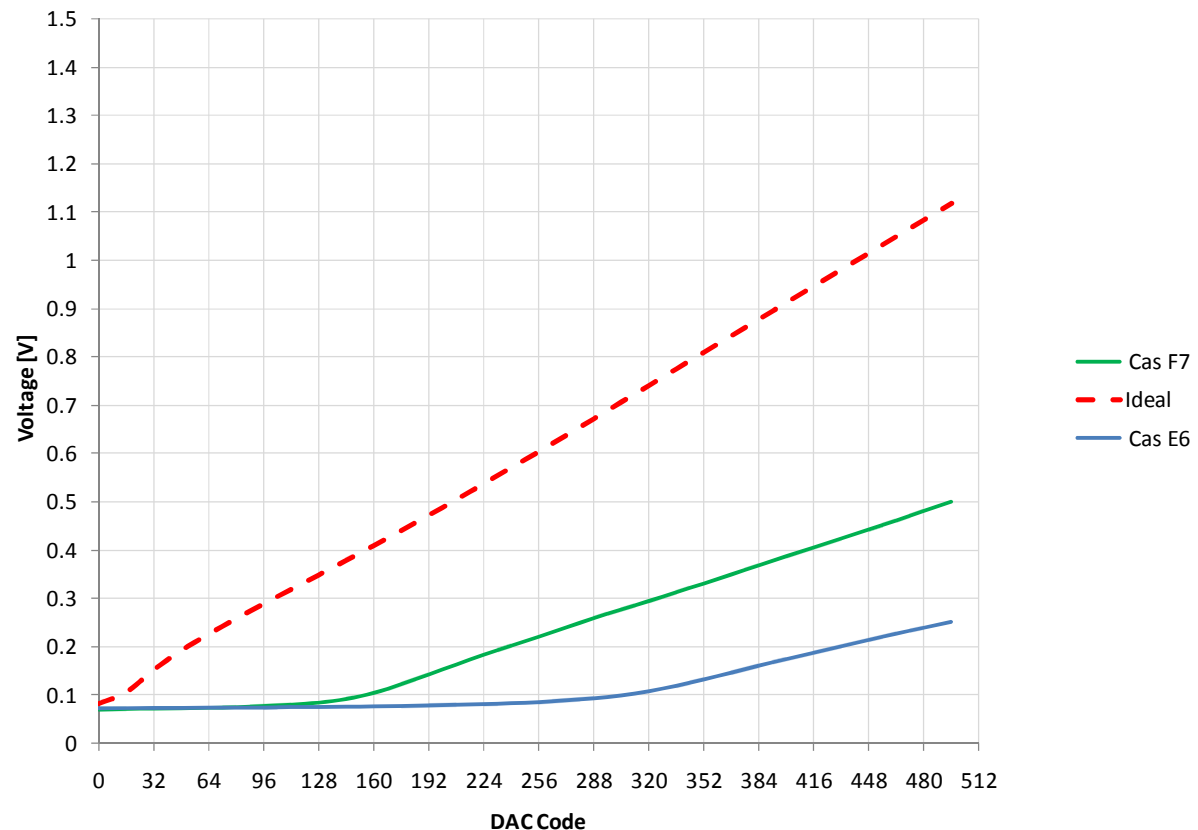
- Good chip (F7) shows CAS DAC dynamic range larger than other chips → Less *ids* transistor leakage in analog switches?
