# Summary of DC-DC Stave Core Measurements

- Profile Measurements
- Bend Tests
- Resonant Frequency Measurements
- Thermal Imaging

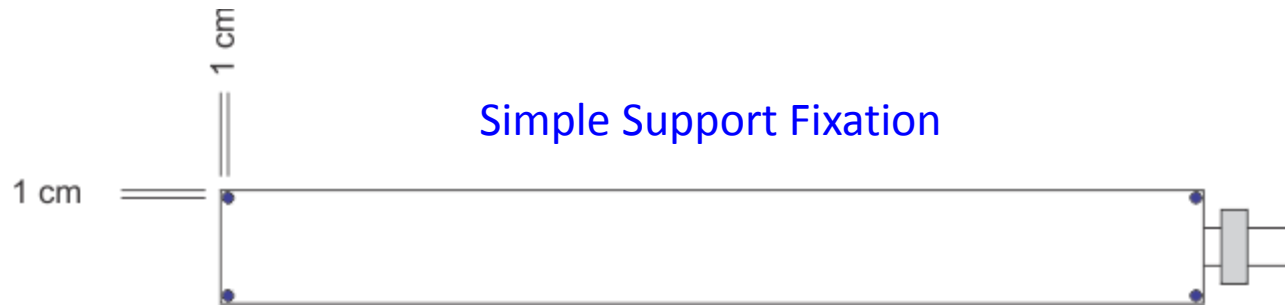
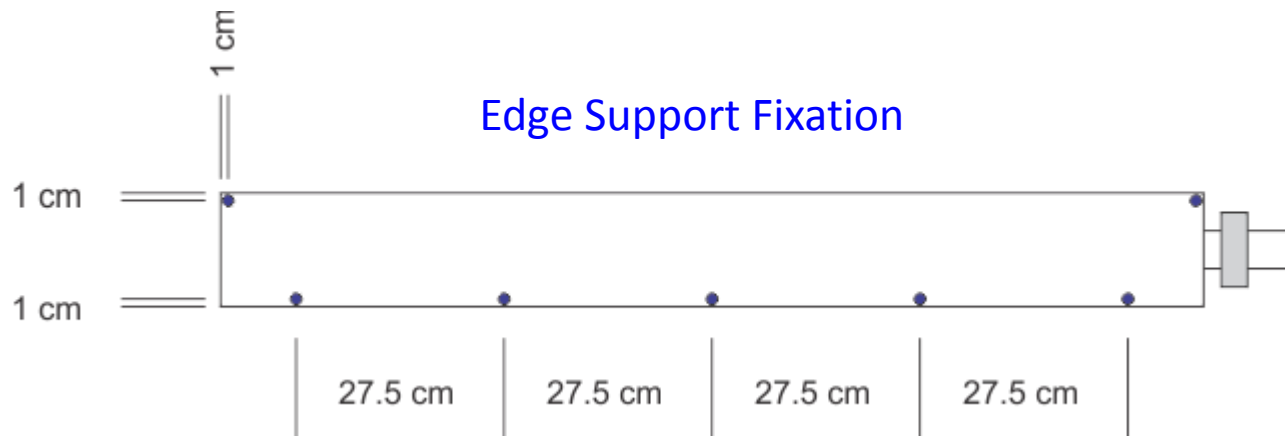
# Fixation Locations for Profile Measurements

*Stave Size 1300 mm x 151 mm*

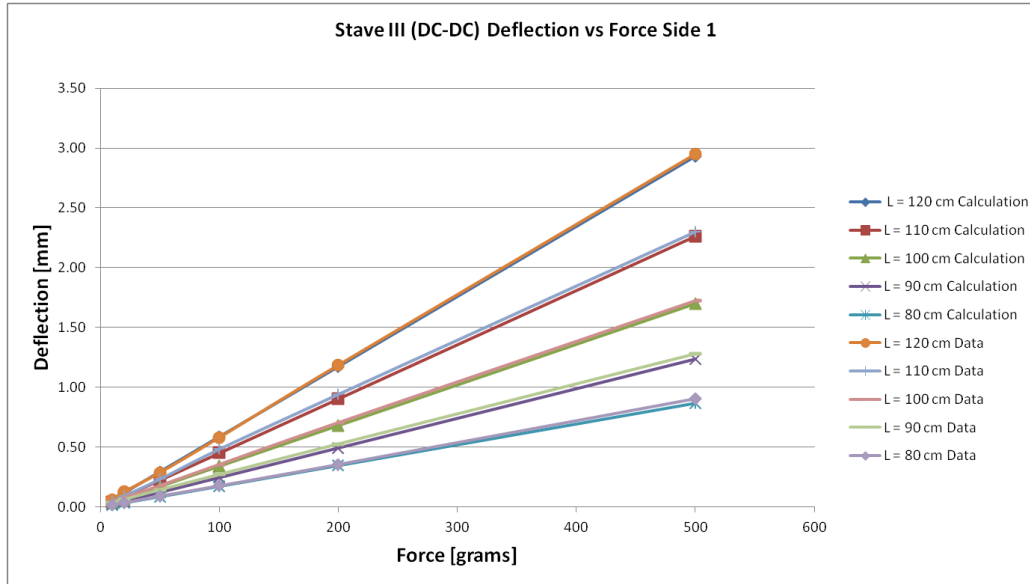
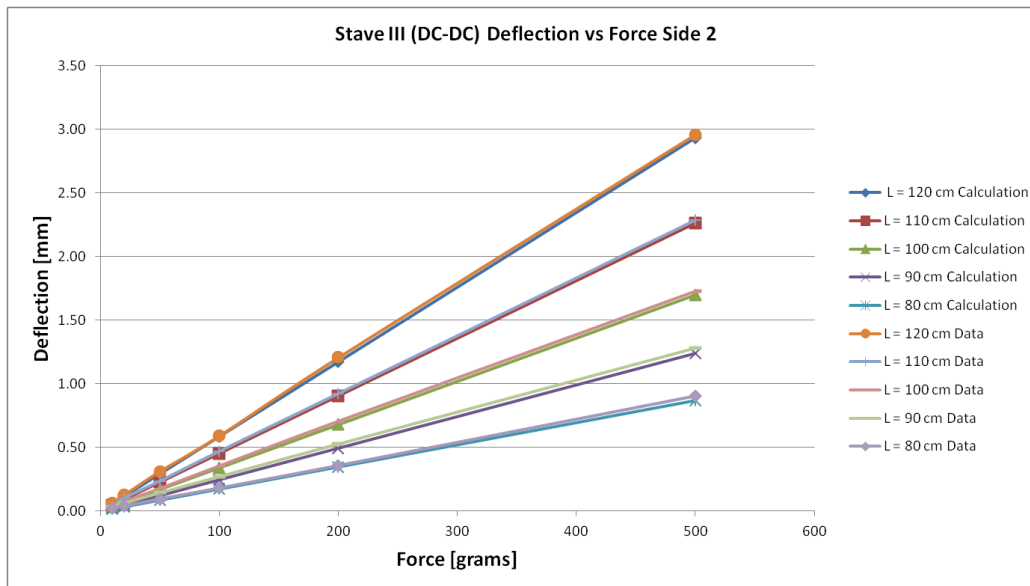
# Simply Supported Bend Tests with Variable Support Spacing

- Facing thickness measured pre-assembly to be  $\sim 430 \mu\text{m}$ .
- “Calculation” shown in both plots show results for a bending stiffness  $D = 60 \text{ Nm}^2$  and a effective facing modulus of  $95 \text{ GPa}$ .
- Side 1 and 2 give identical results as expected.

“L” = spacing between simple supports

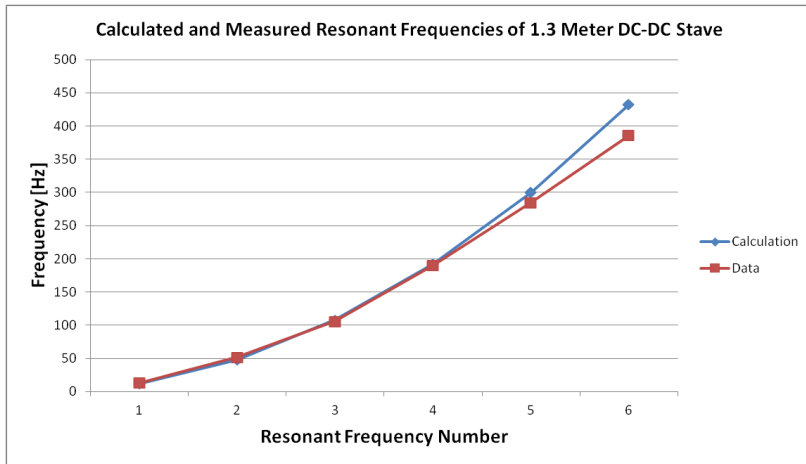
# Simply Supported Resonant Frequency Measurements

Resonant Frequencies [Hz]		
Mode #	Predicted	Measured
1	12	13
2	48	52
3	108	106
4	192	190
5	300	285
6	432	386

MEMs accelerometers used to measure stave resonant frequencies

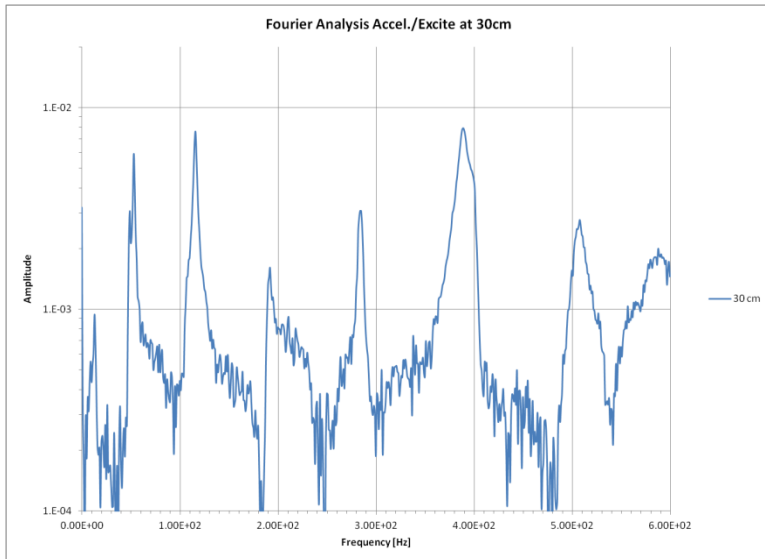
$$\delta = \frac{1}{48} \frac{P L^3}{D}, \quad D = \text{bending stiffness [Nm}^2\text{]}, P = \text{Load [N]}, L = \text{stave length [m]}, \delta = \text{deflection [m]}$$

Bend test to measure “D” permits calculation of stave resonant frequencies
