Stave Cooling Pipe Temperature

Stave QC discussion, Jan.25.2017

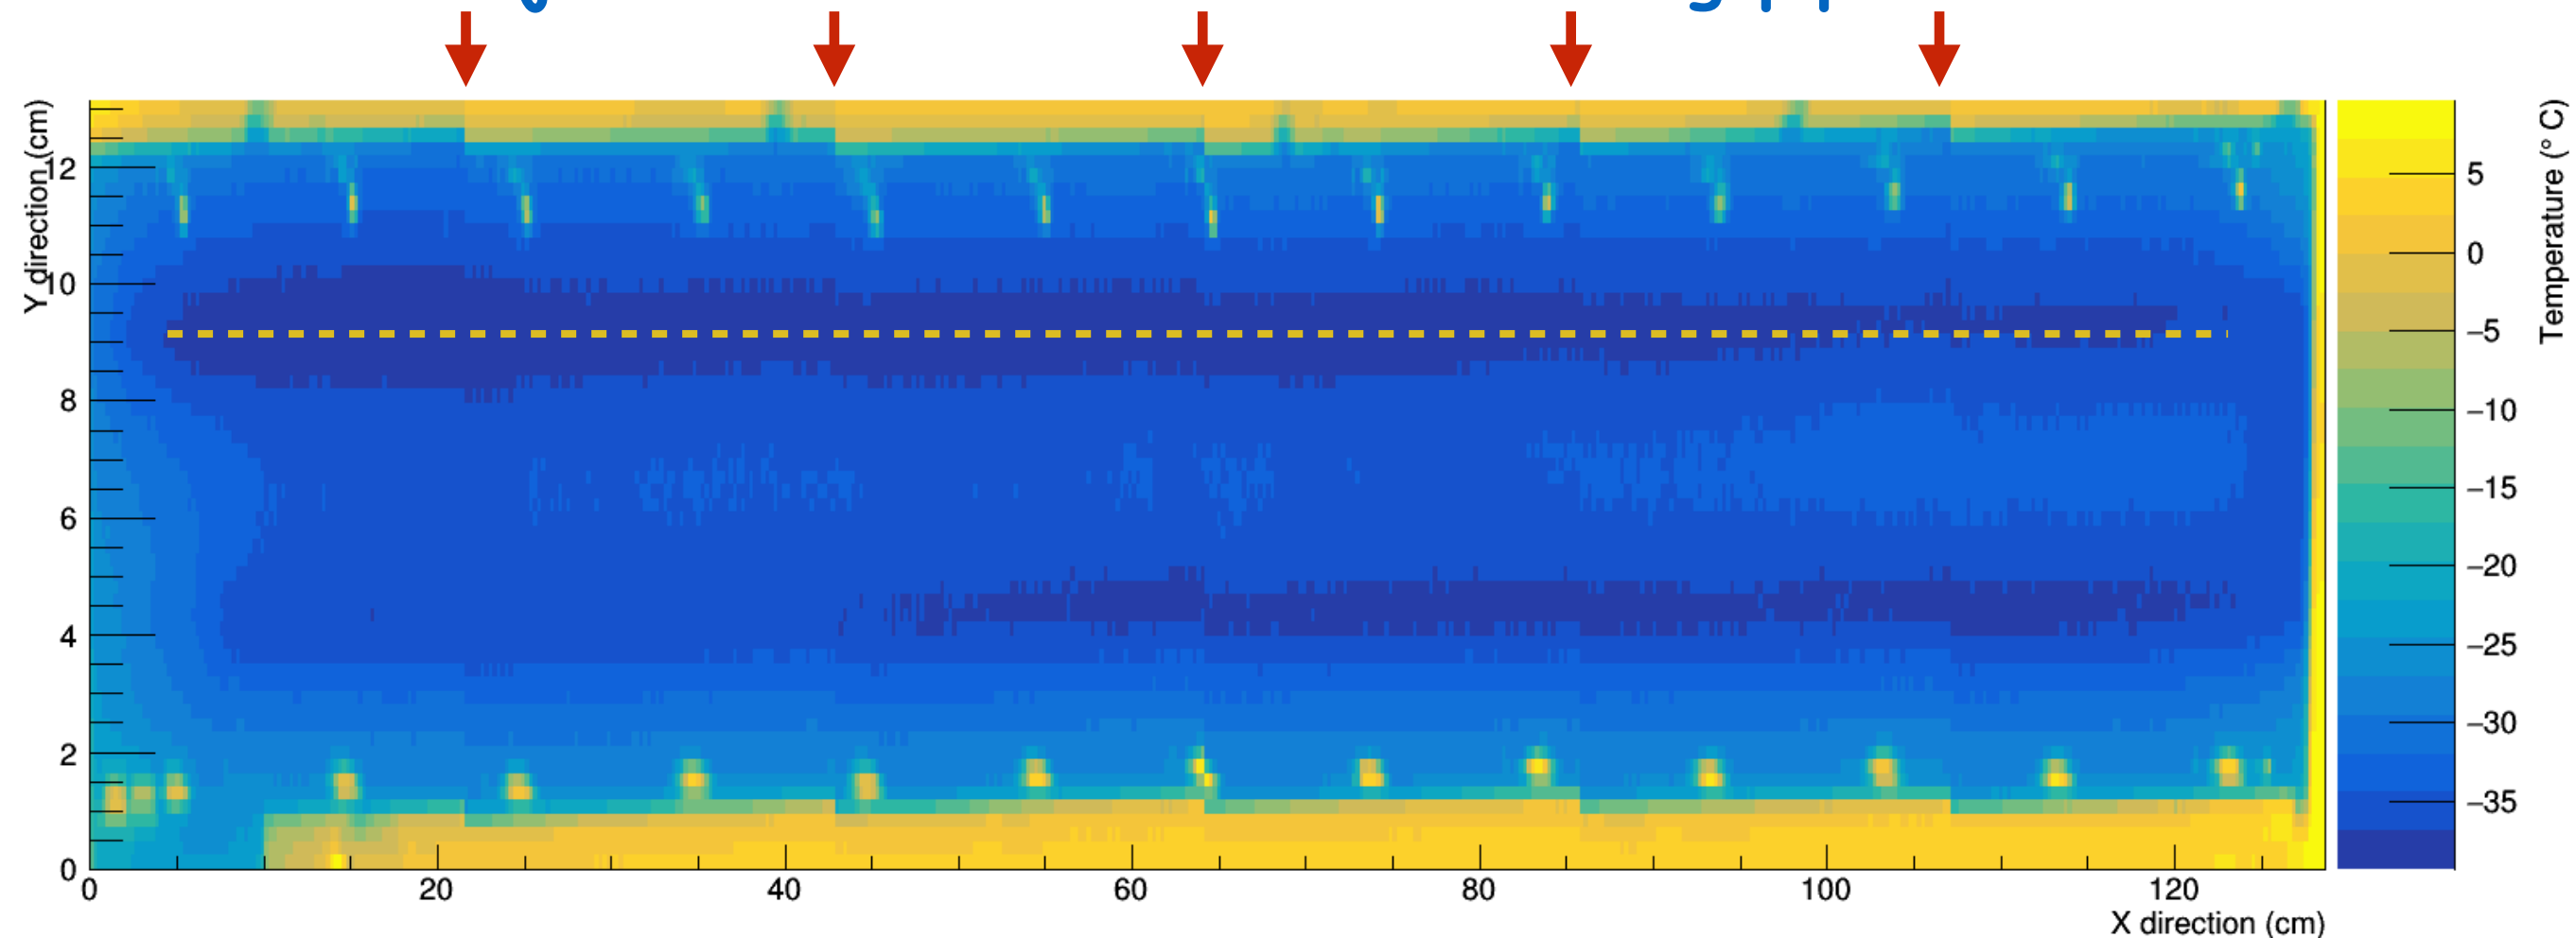
- ◉ Flawless stave.
 - ✦ Chiller at $-55\text{ C} - 50\text{ C}$, every 5 C
 - ✦ Emissivity = 0.9 after data taking.
- ◉ Found a mistake in the previous talk:
 - ✦ The stave image is upside down. Inlet \leftrightarrow outlet exchanged :(
 - ✦ With this fixed, inlet has lower temperature.
- ◉ Stave is adjusted to have a strait line cooling pipe.

- ◉ Mistake found for stave facing (Coordinate different in Flir software and ROOT).
- ◉ Fit method needs to be improved to be more stable:
 - ◆ Most of the times, it looks nice, but sometimes it fails.

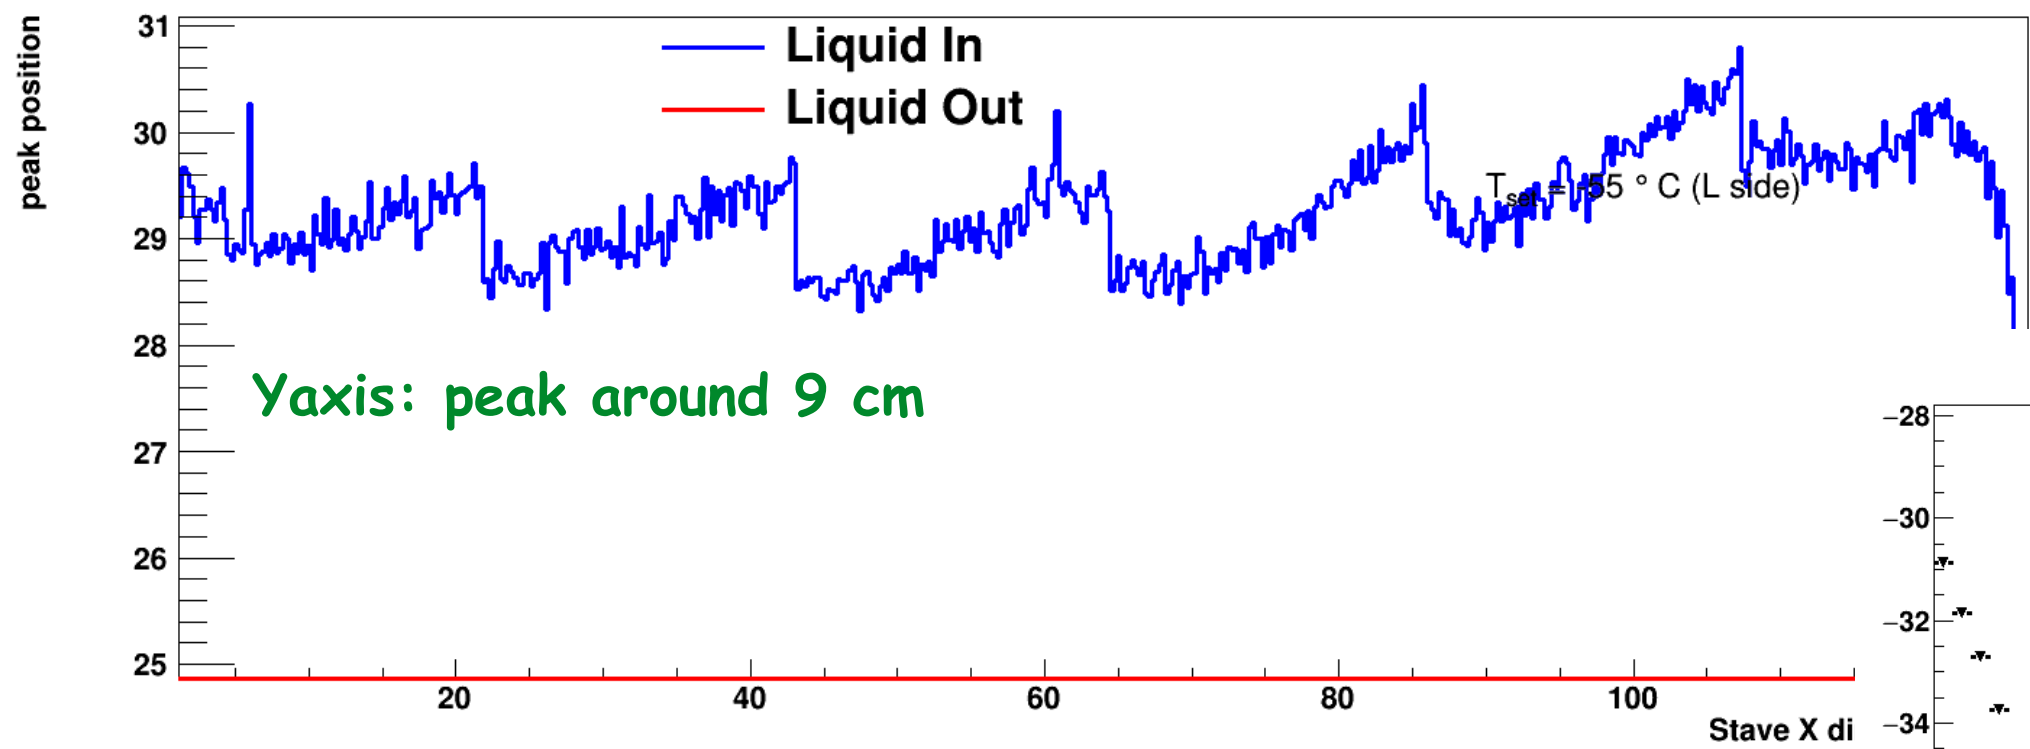
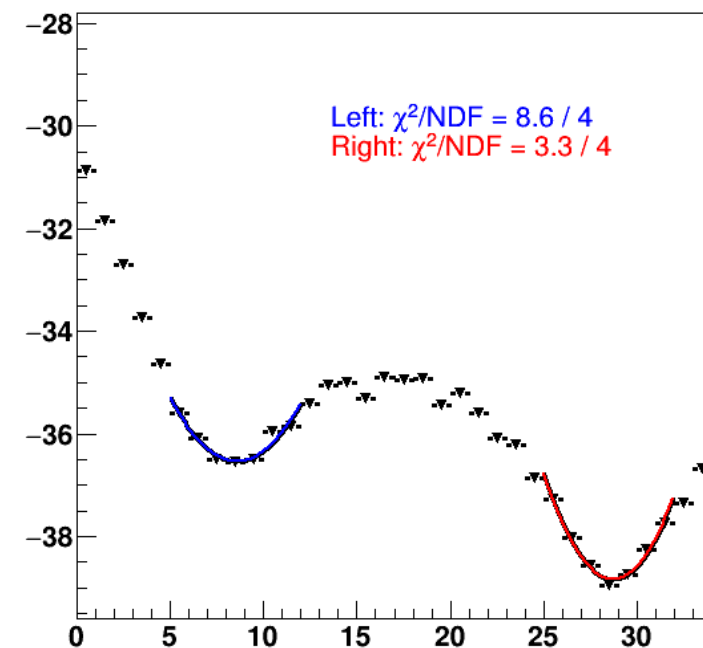
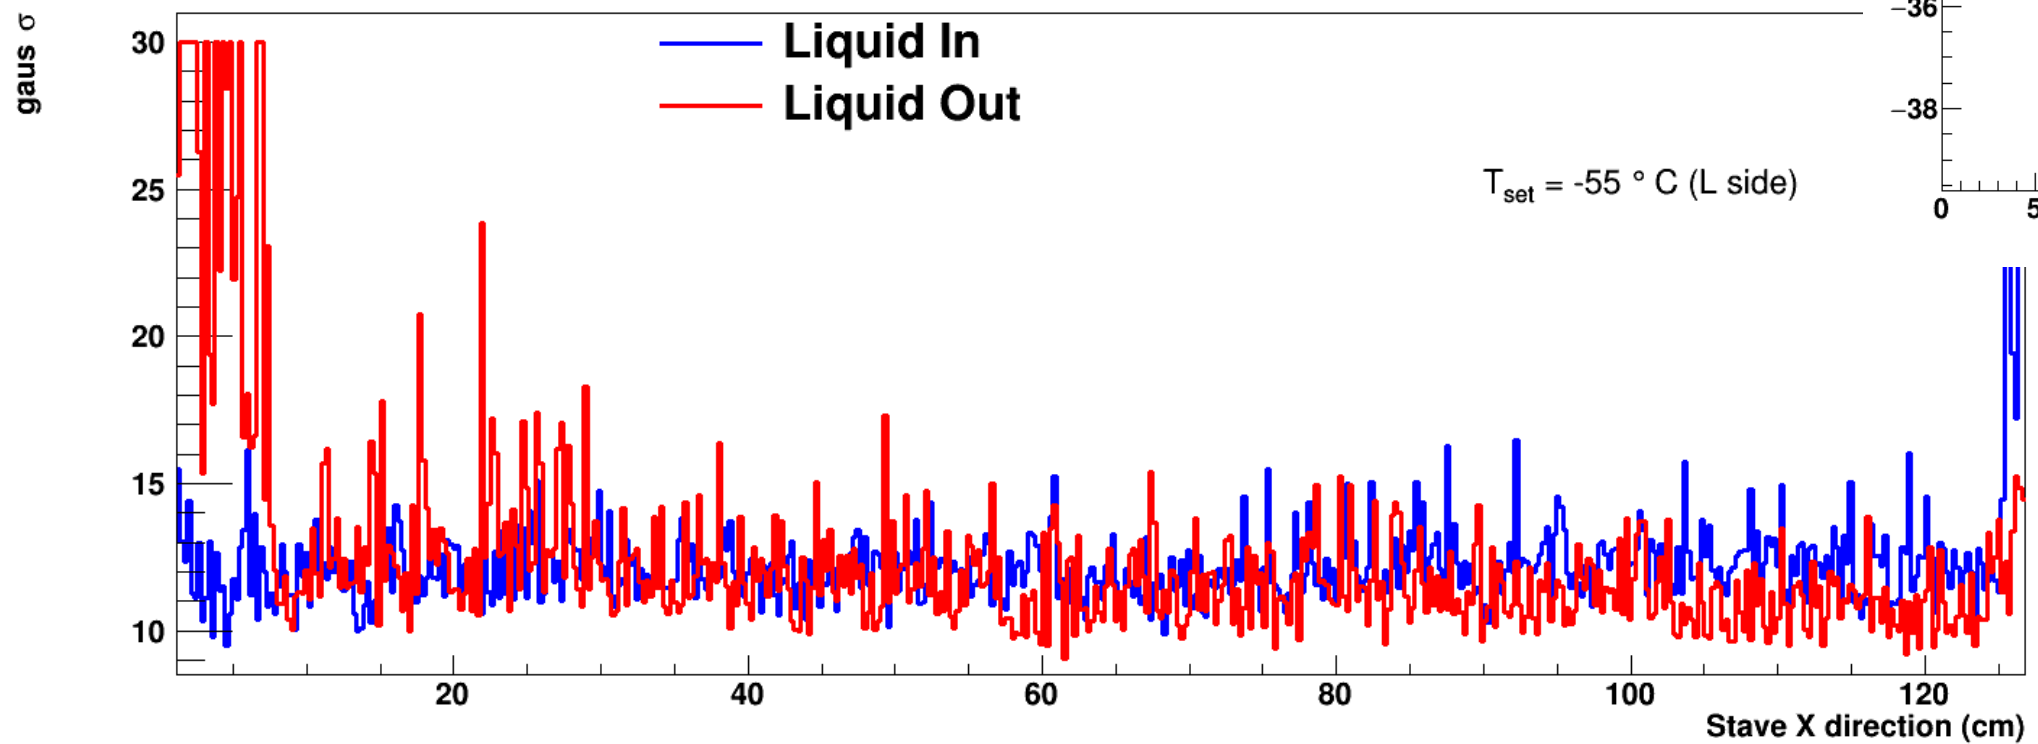
Peak Fit @ -55 C

Yaxis @ 23 cm

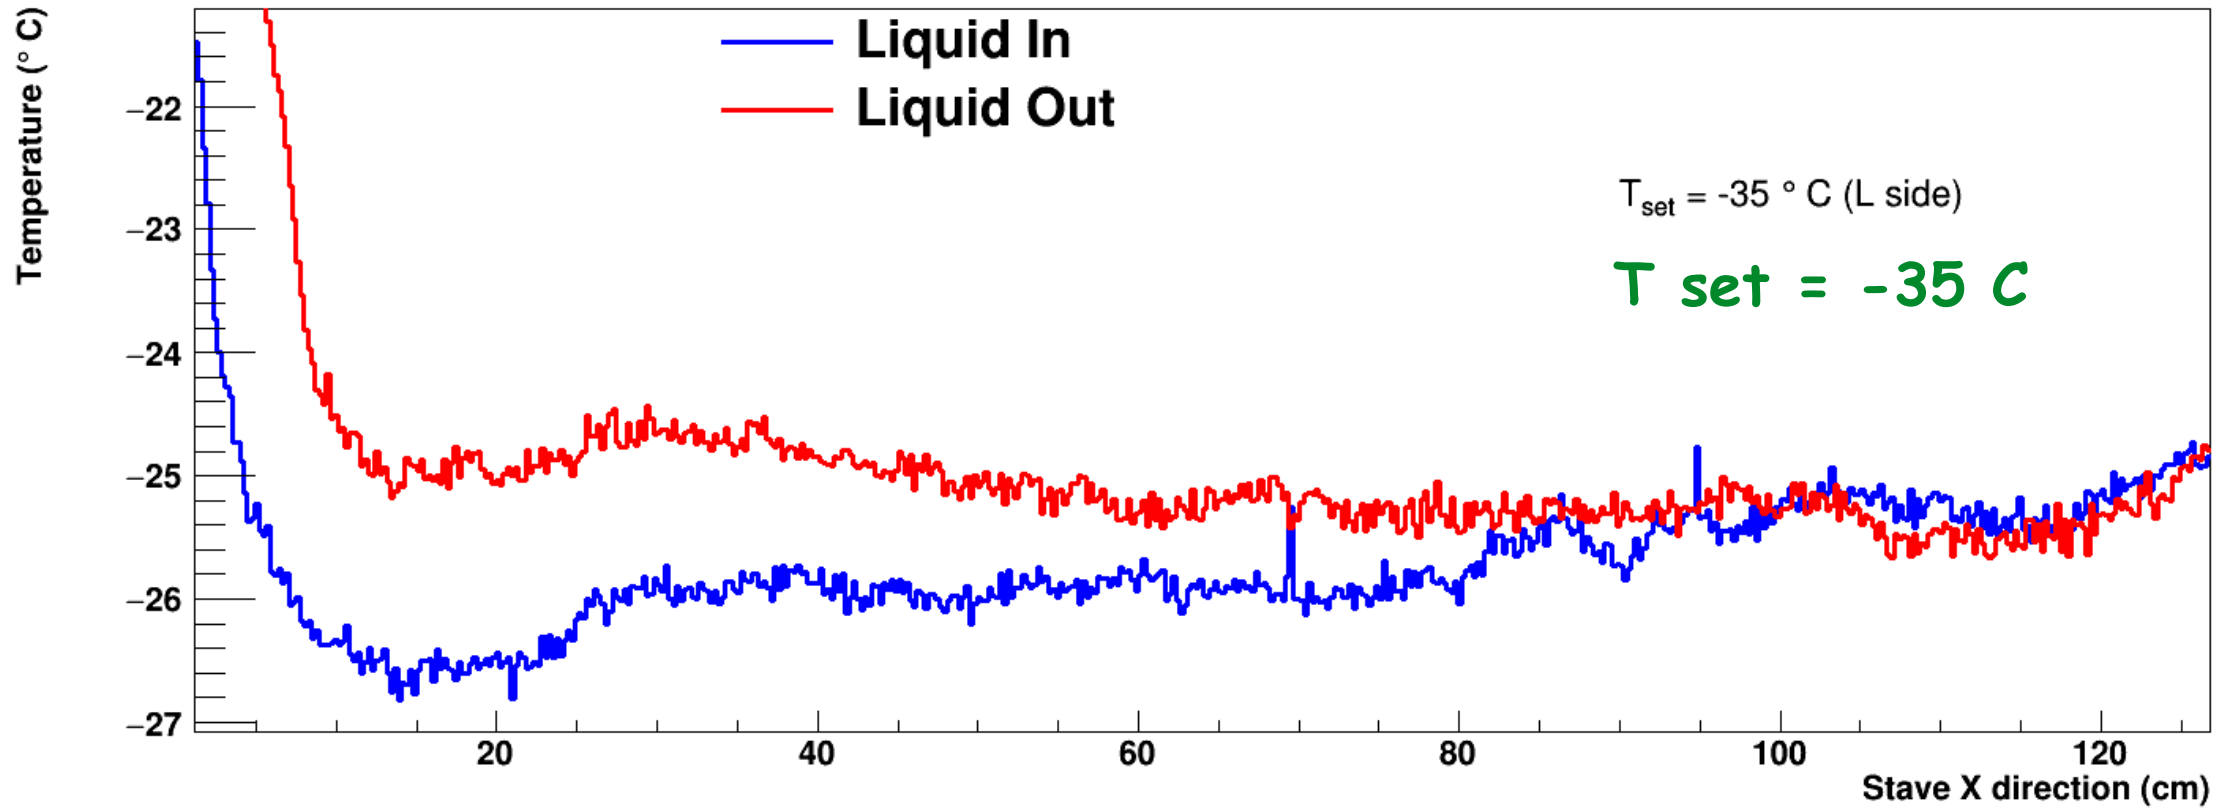
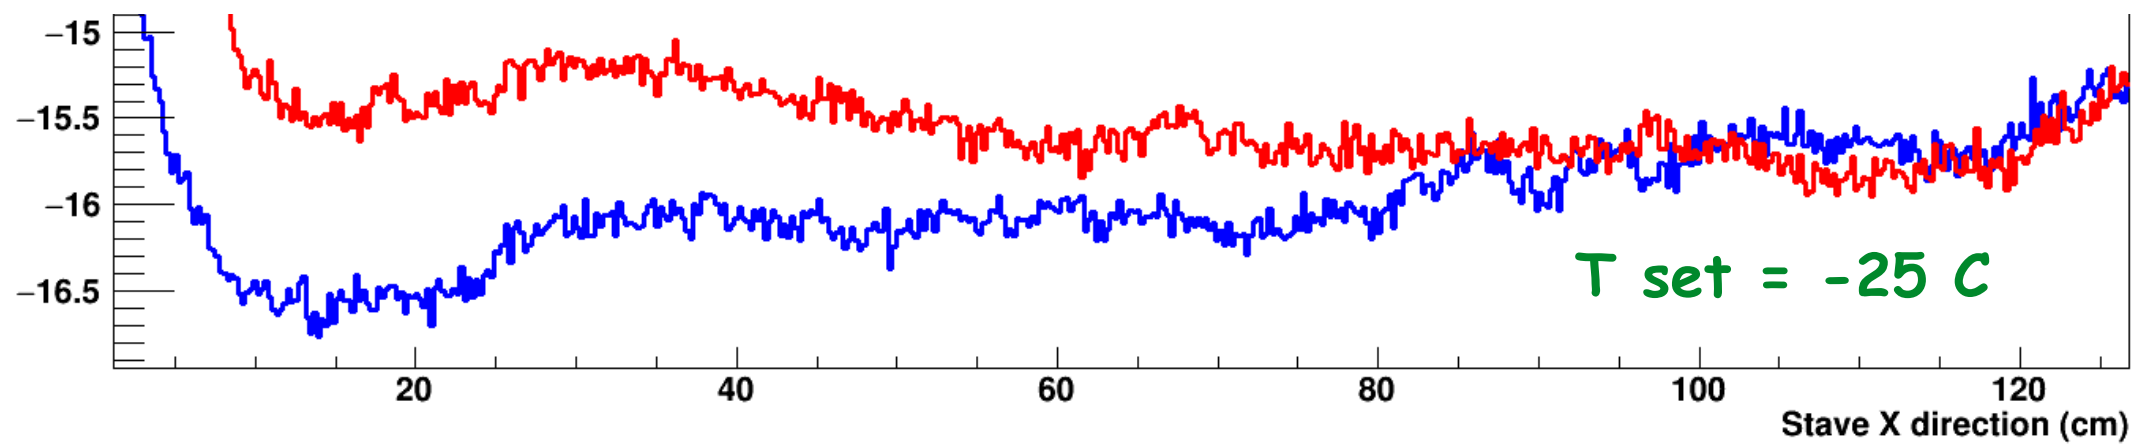
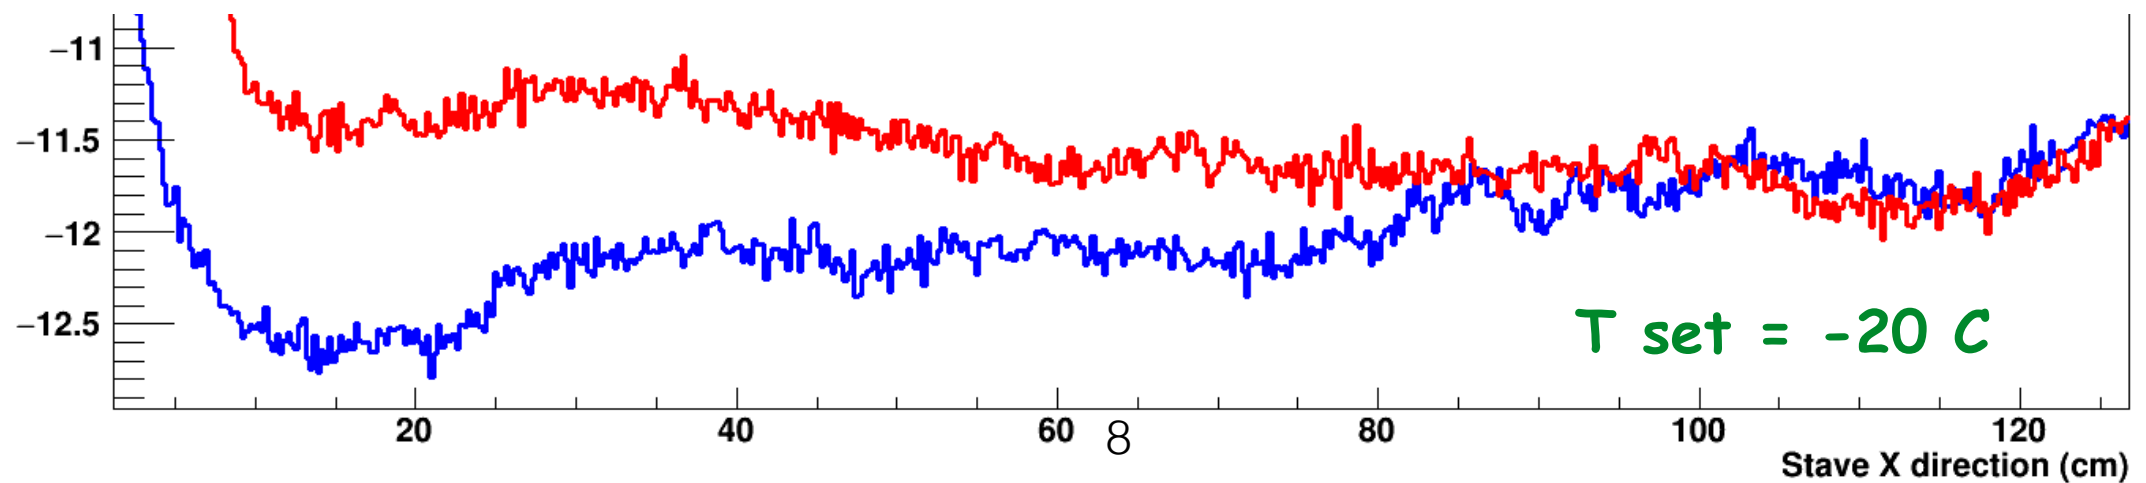
More Temperature profiles

Problem with $T_{\text{set}} = -30 \text{ C}$: see back up

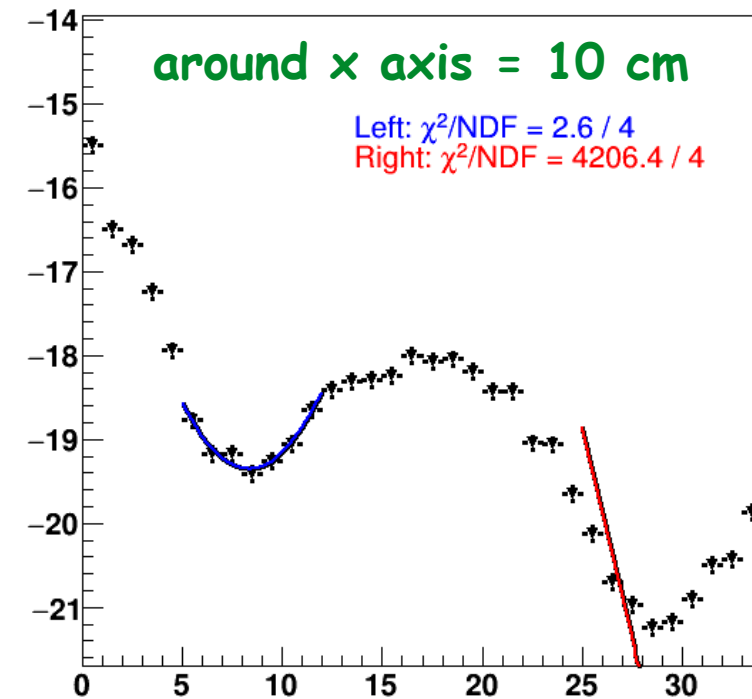
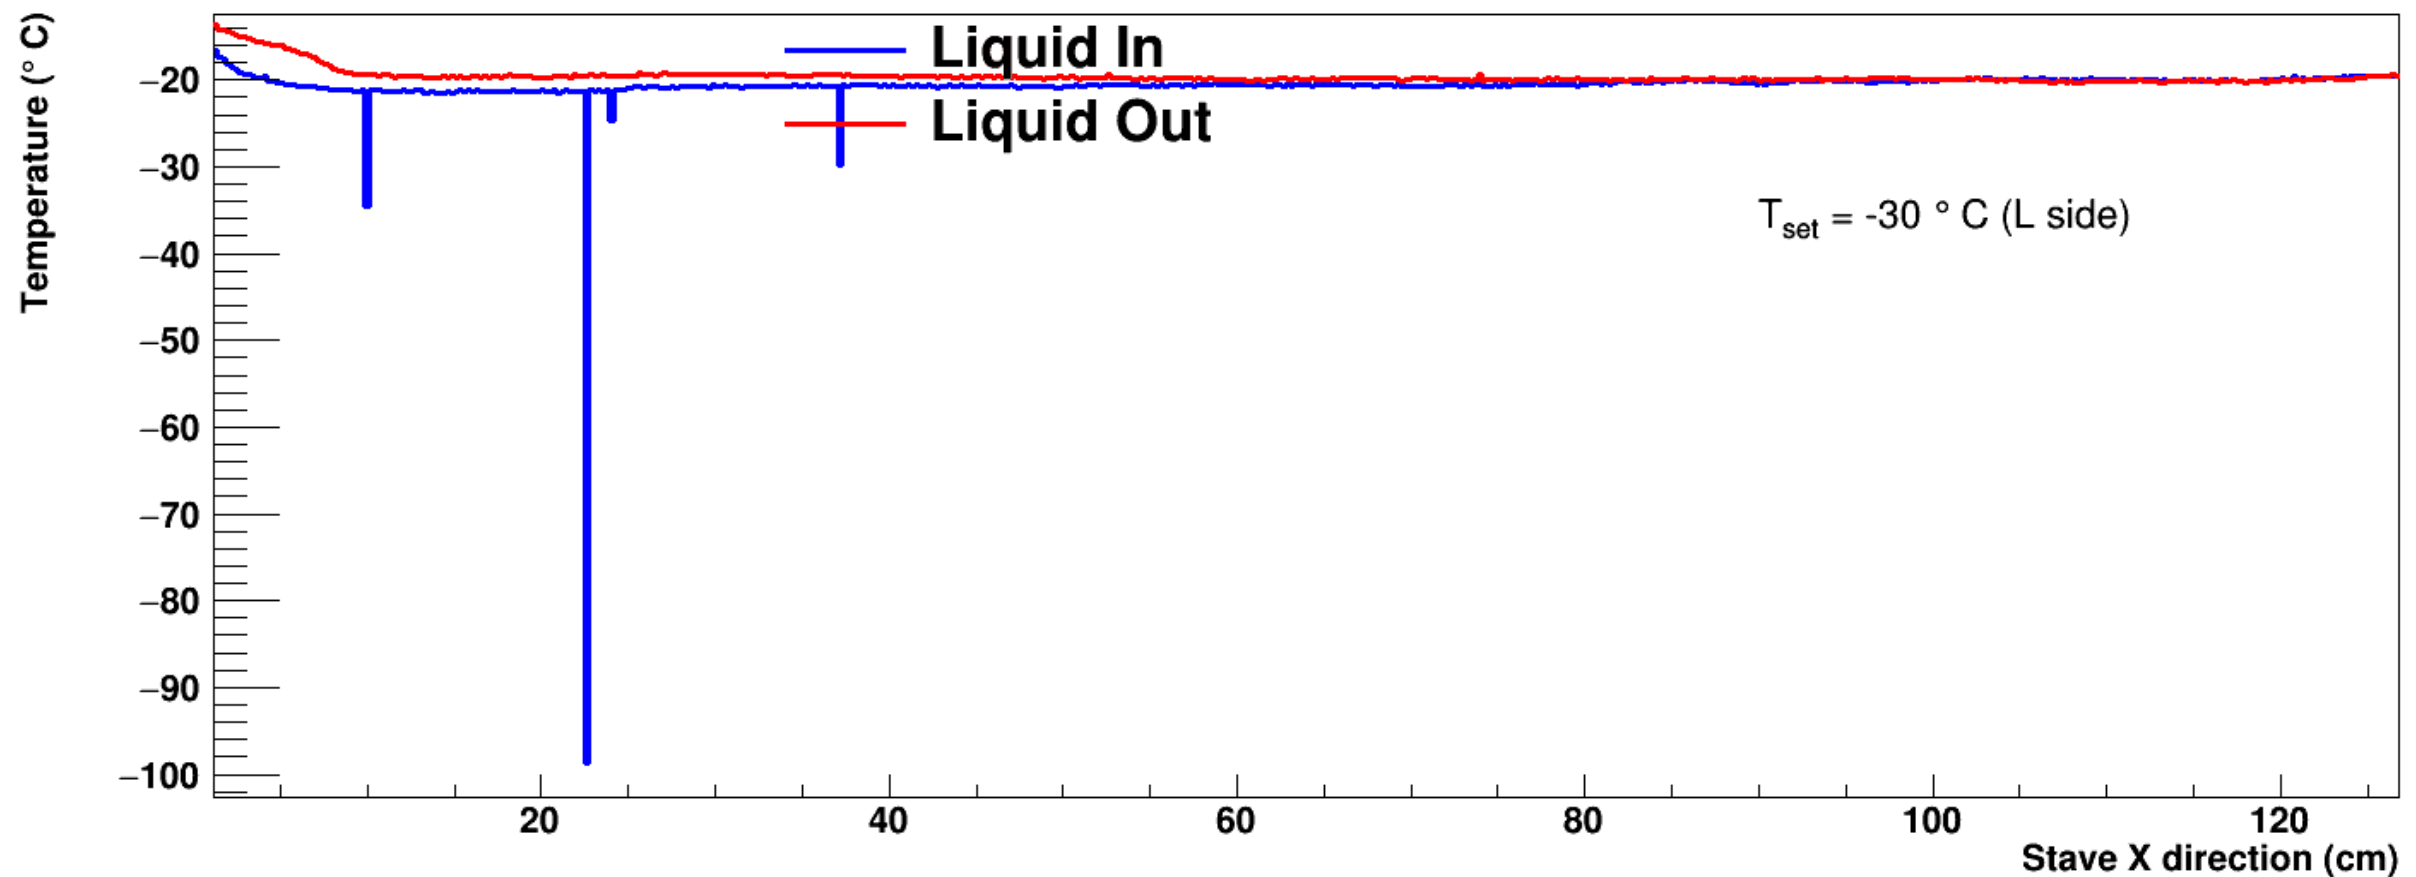
Problematic Temperature profiles

- ⦿ Not sure why the fit didn't work
- ⦿ Can be removed by chi2
