Stave Cooling Pipe Temperature Profile

William Heidorn, Jie Yu

Iowa State University

Stave QC discussion, Feb. 8. 2017

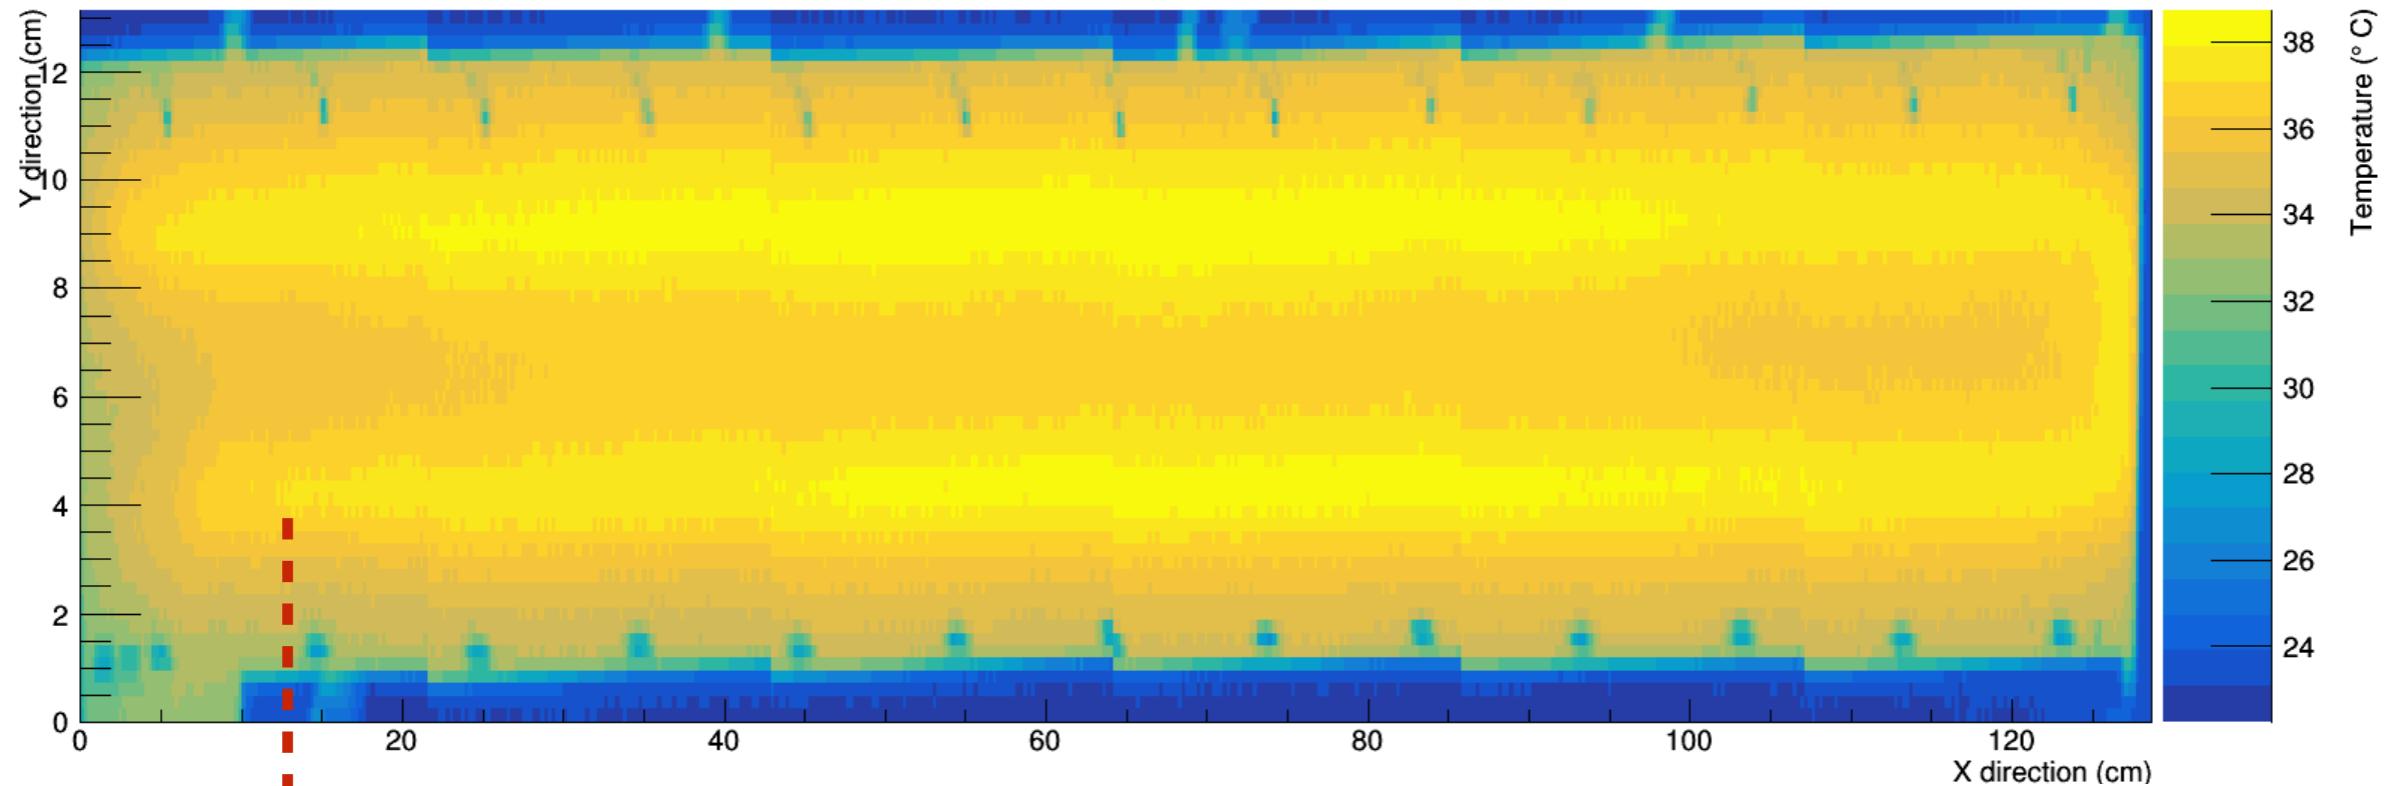
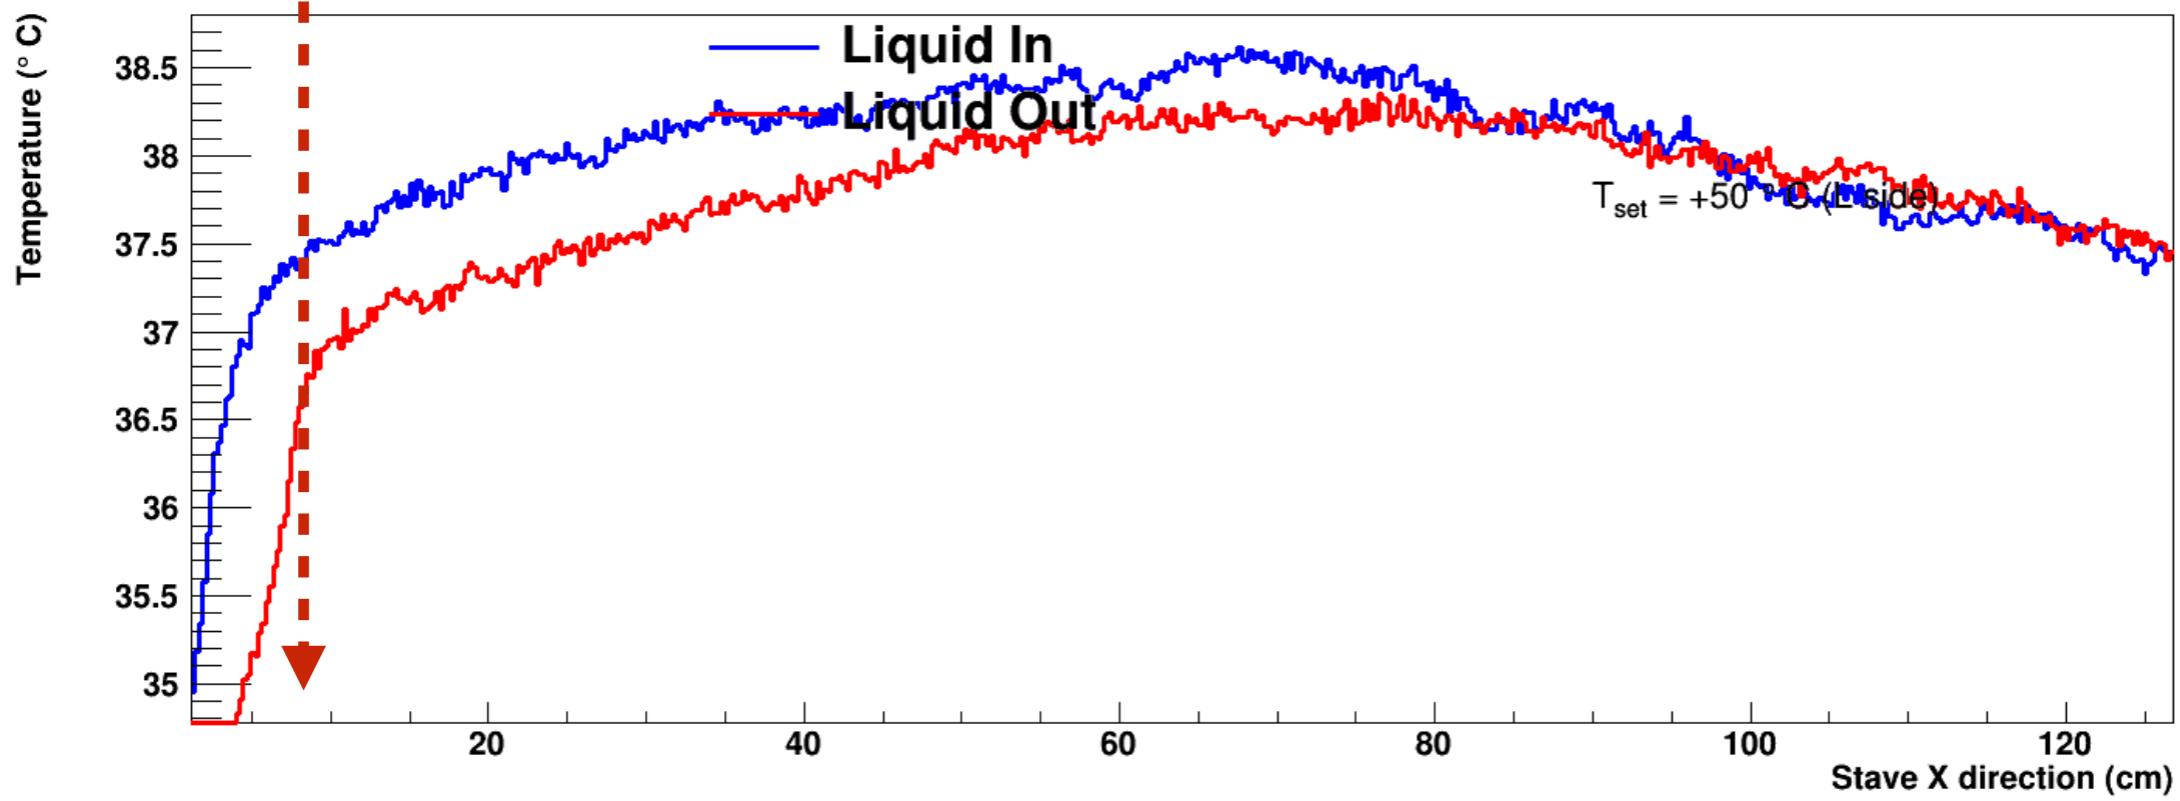
Stave #3: Temperature profile @ +50 C

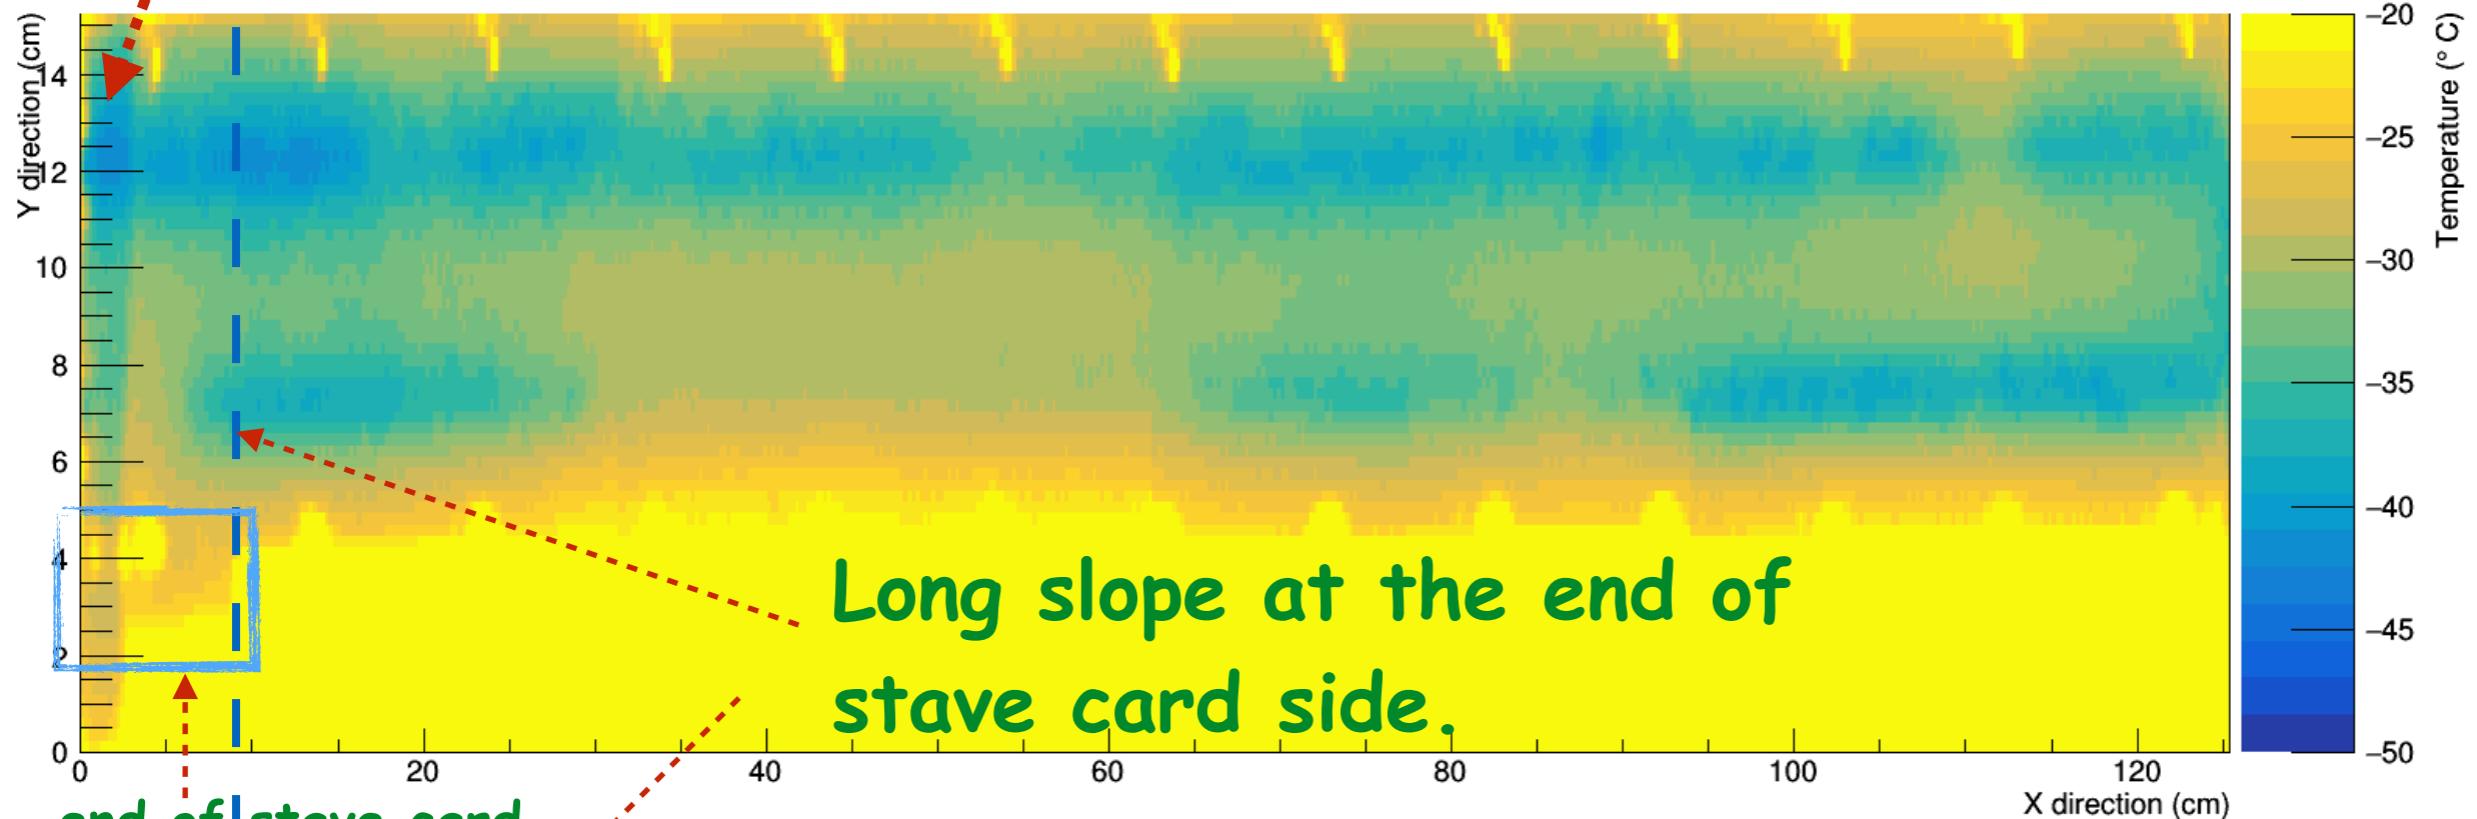
Stave #2: Temperature profile @ -50 (-55) C

With shelter, $T = -55C$

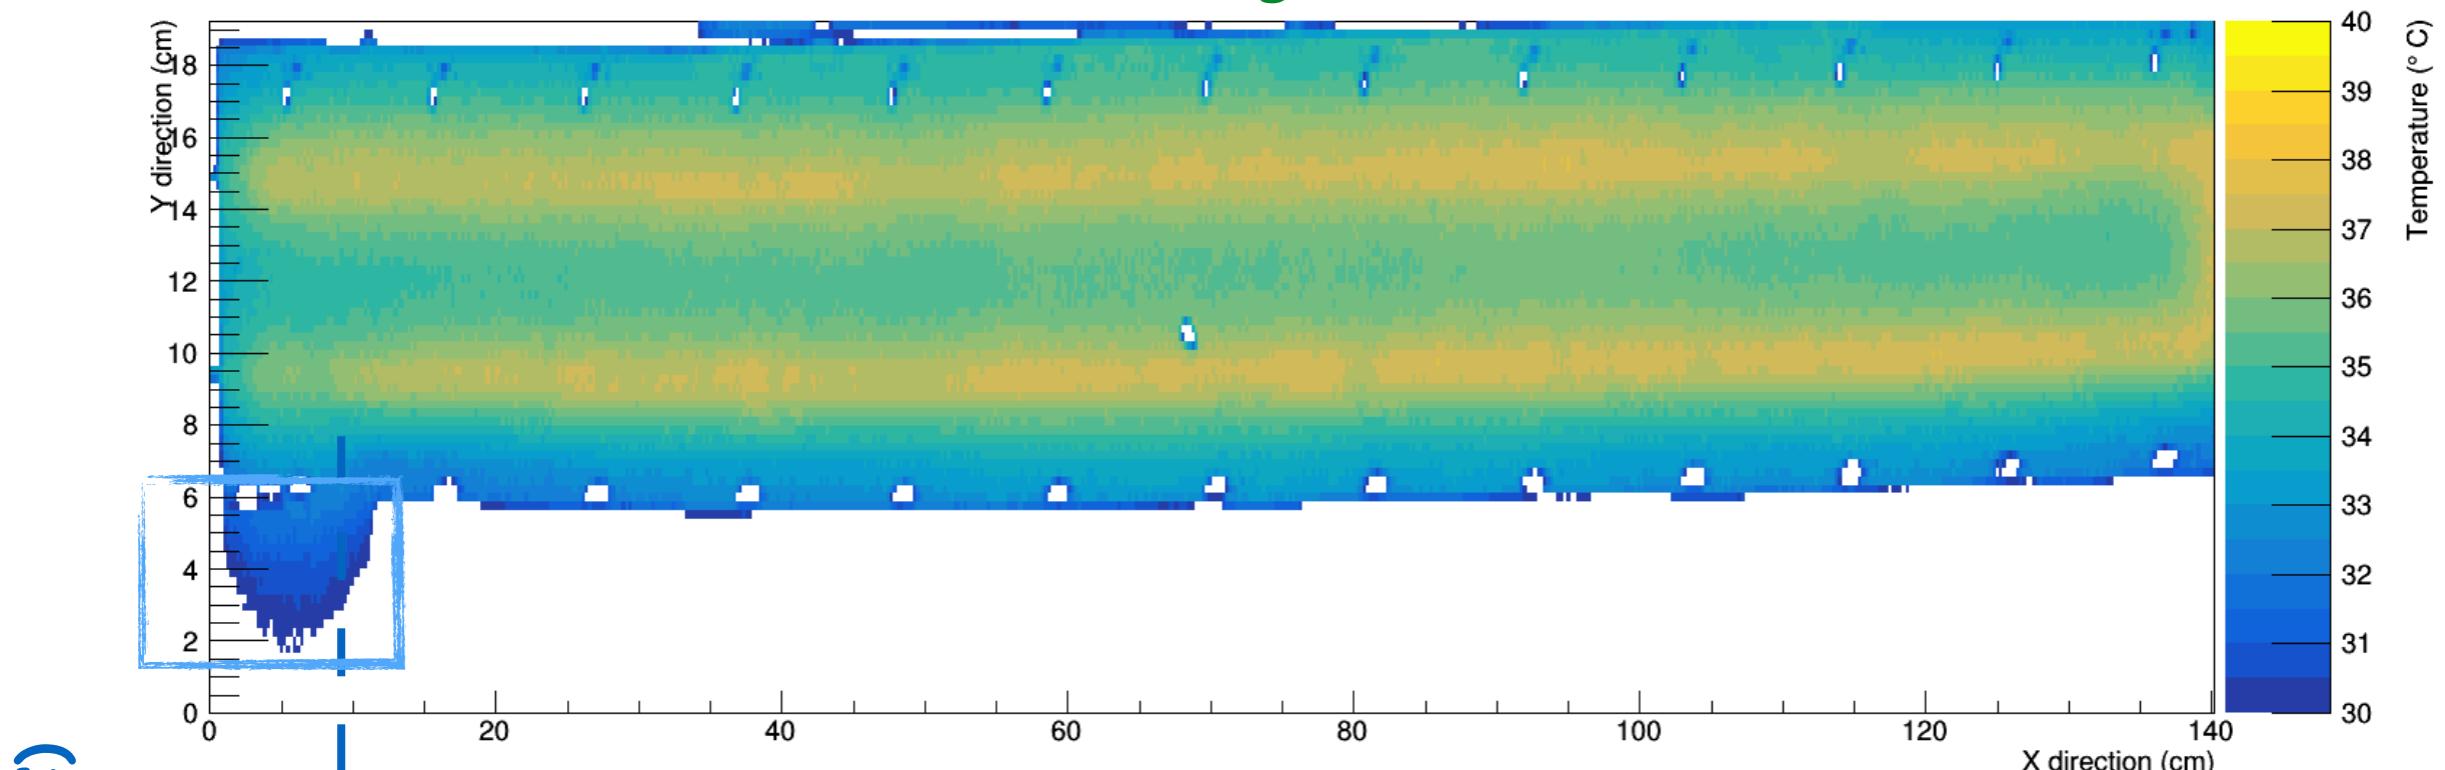
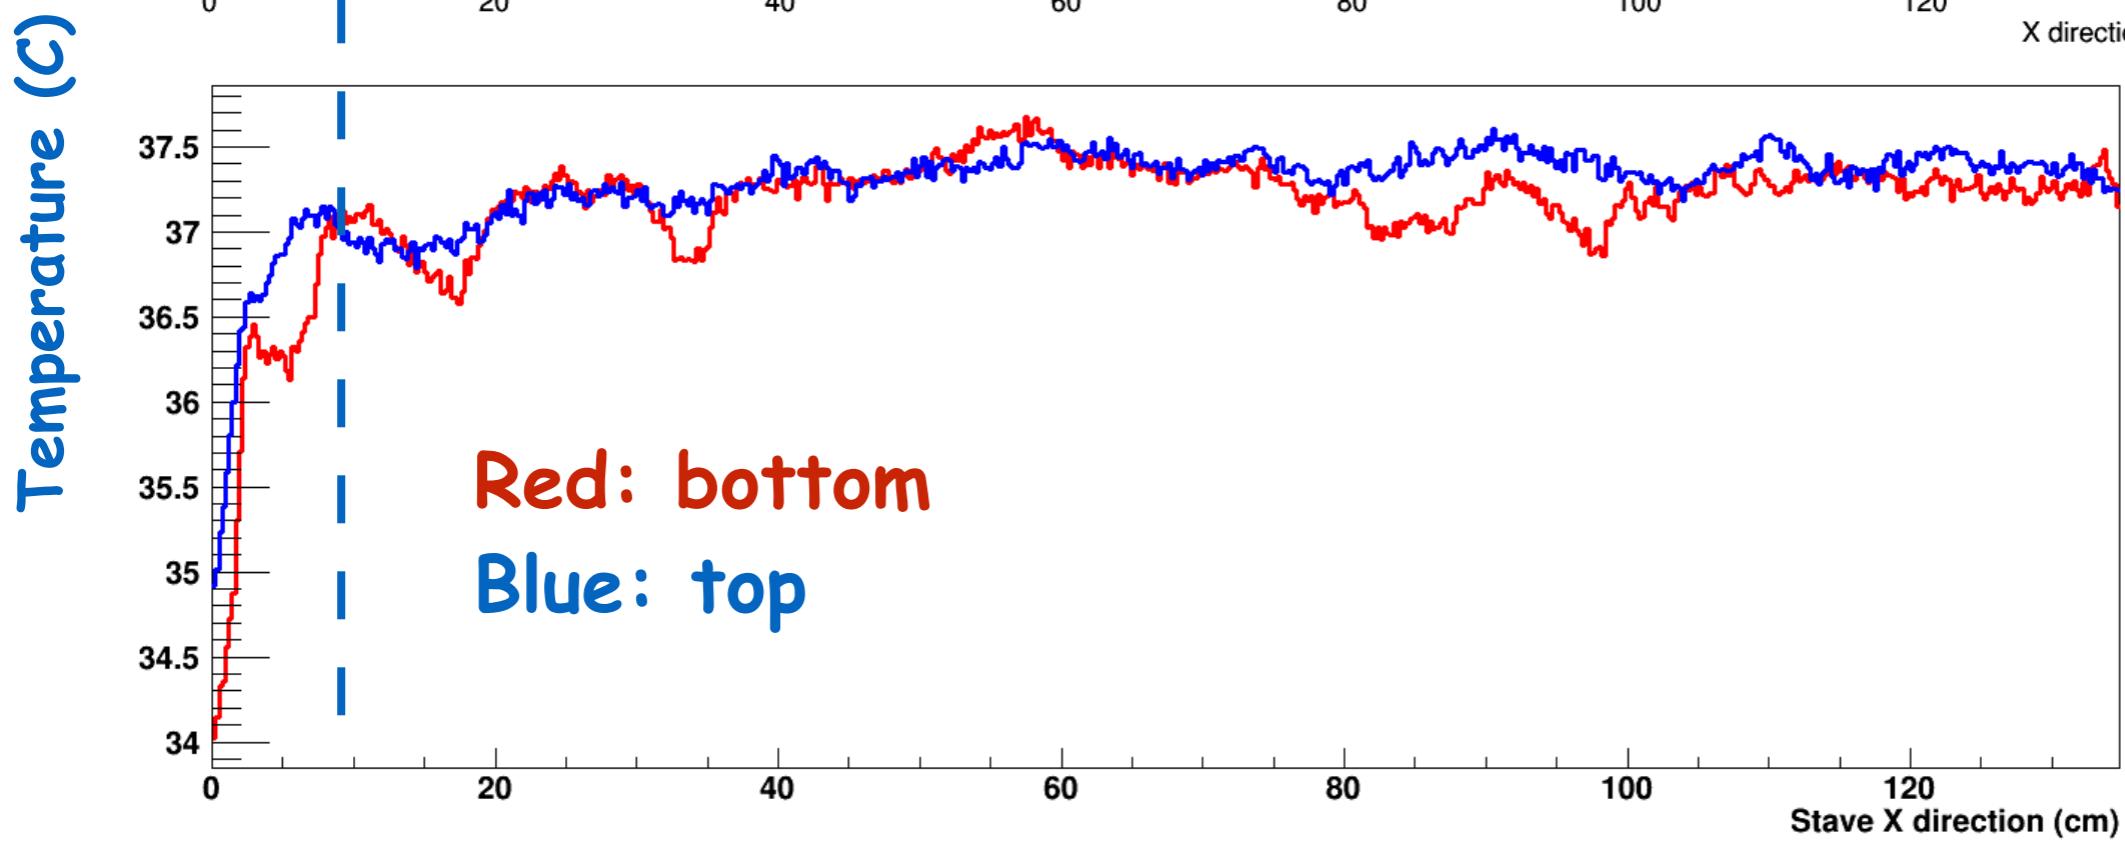
L-side

Stave QMUL: +40 C

QMUL's stave shows similar slop around cooling pipe inlet outlet edge.

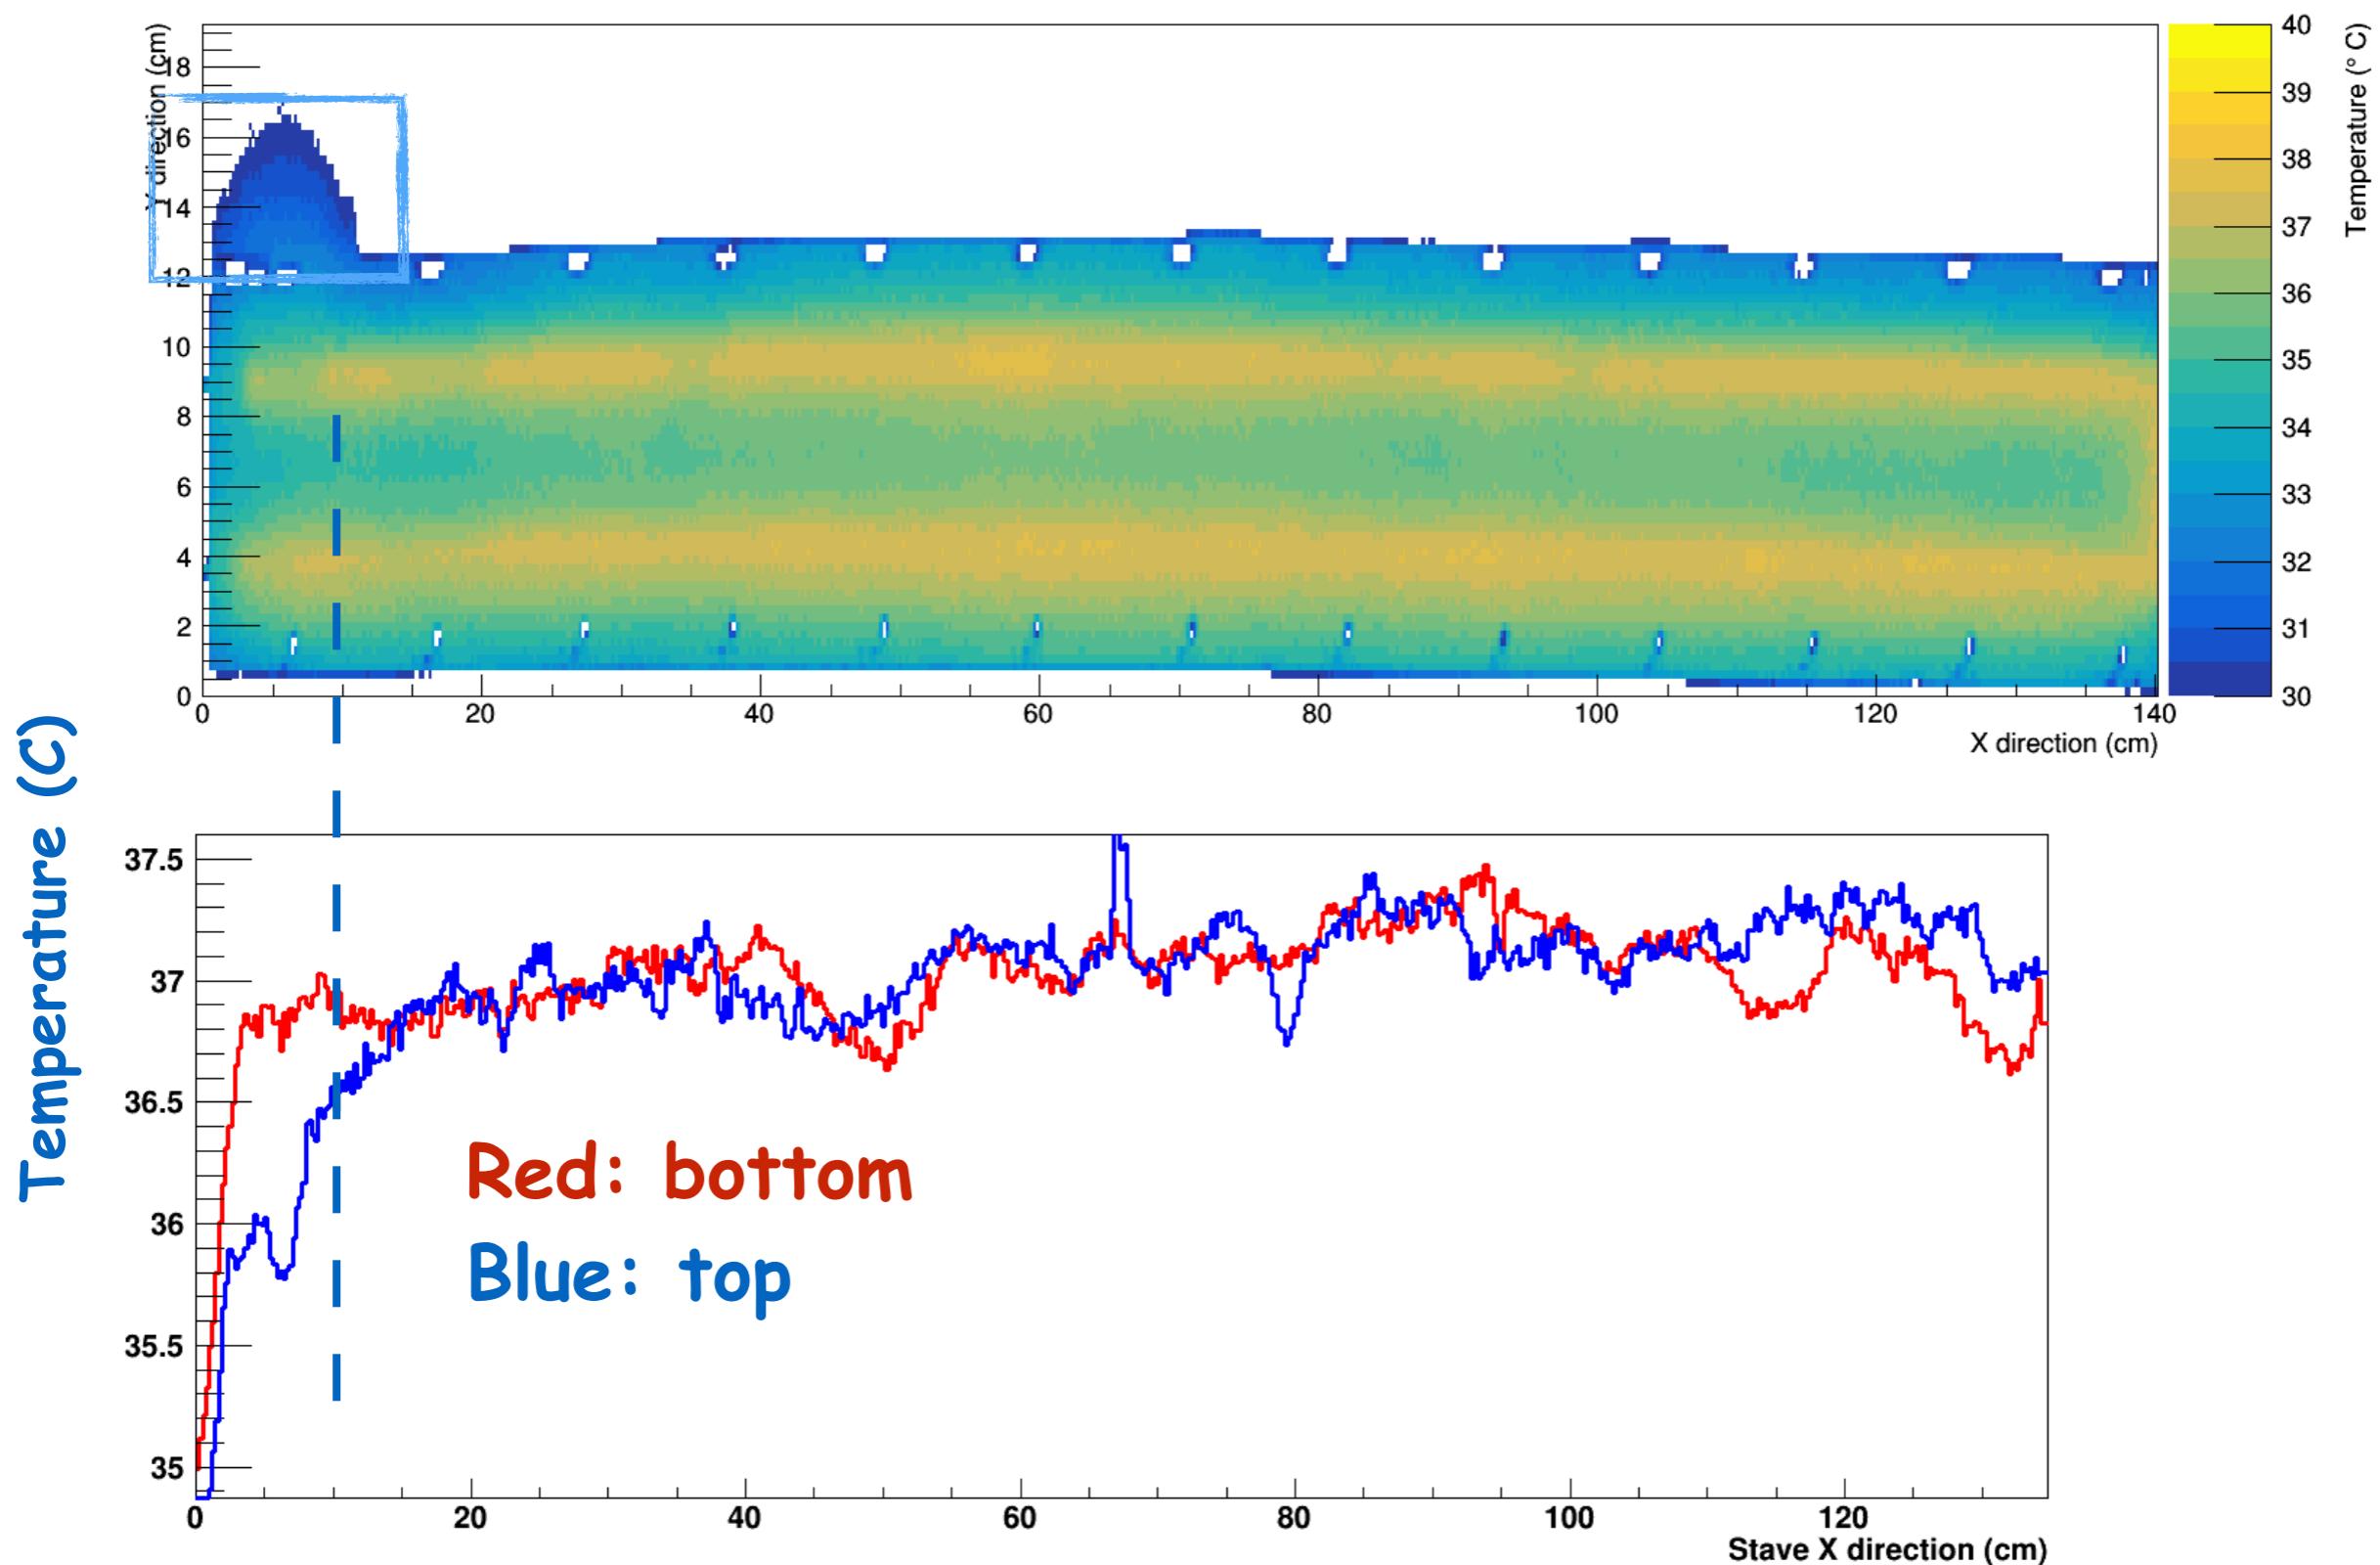
J-side

Stave QMUL: +40 C

QMUL's stave shows similar slop around cooling pipe inlet outlet edge.

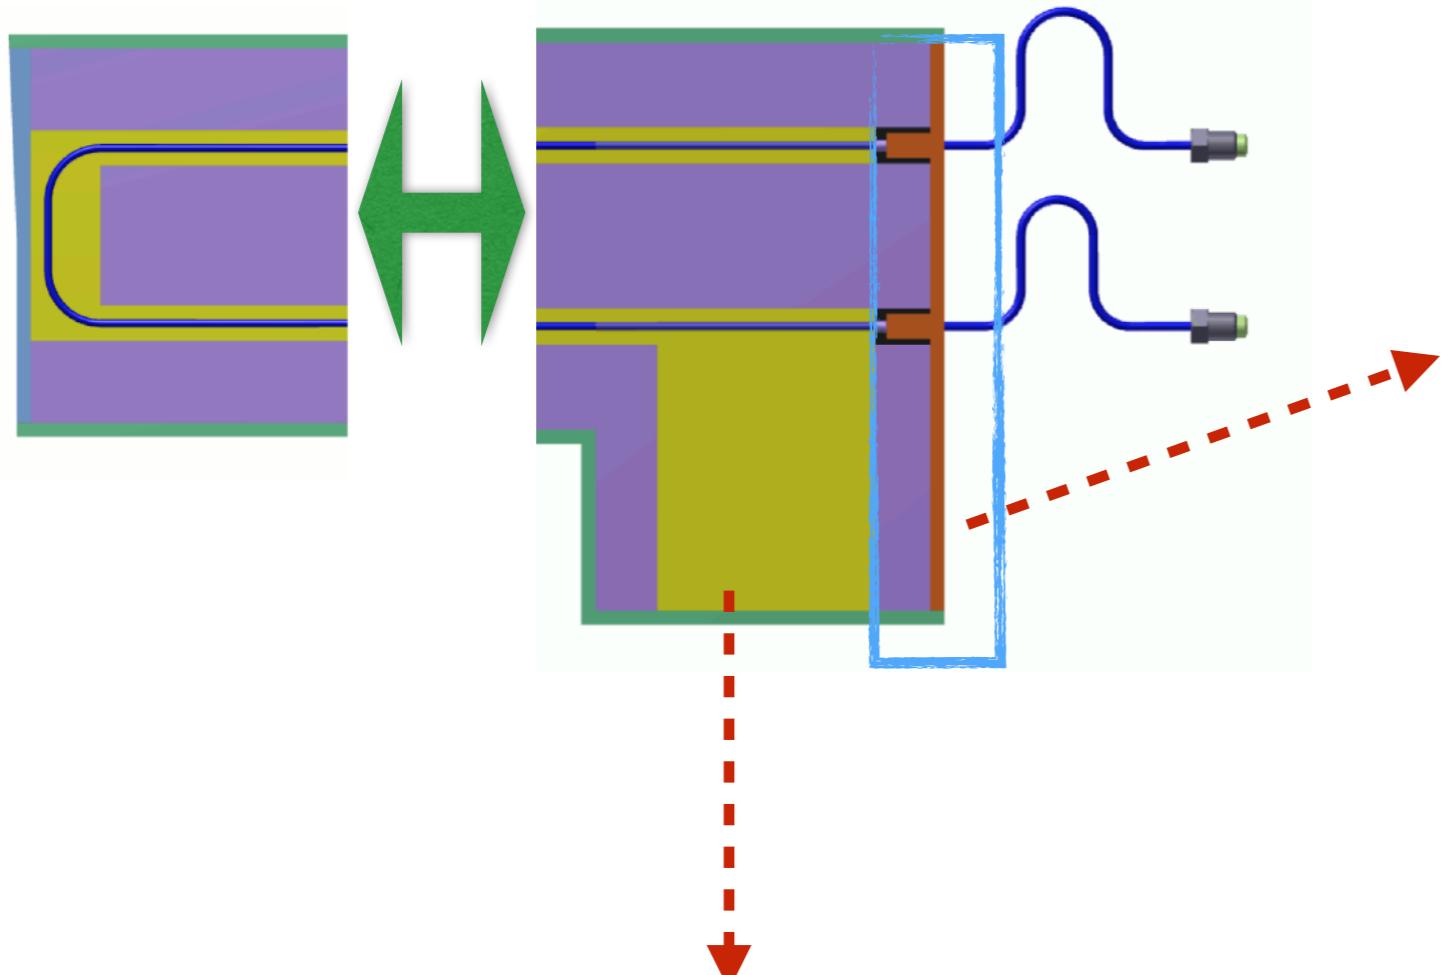
Possible explanation

- Heat transfer through the high thermal conductivity foam around the end of stave card.
- What is the material at the edge? Might have high thermal conductivity, as well?

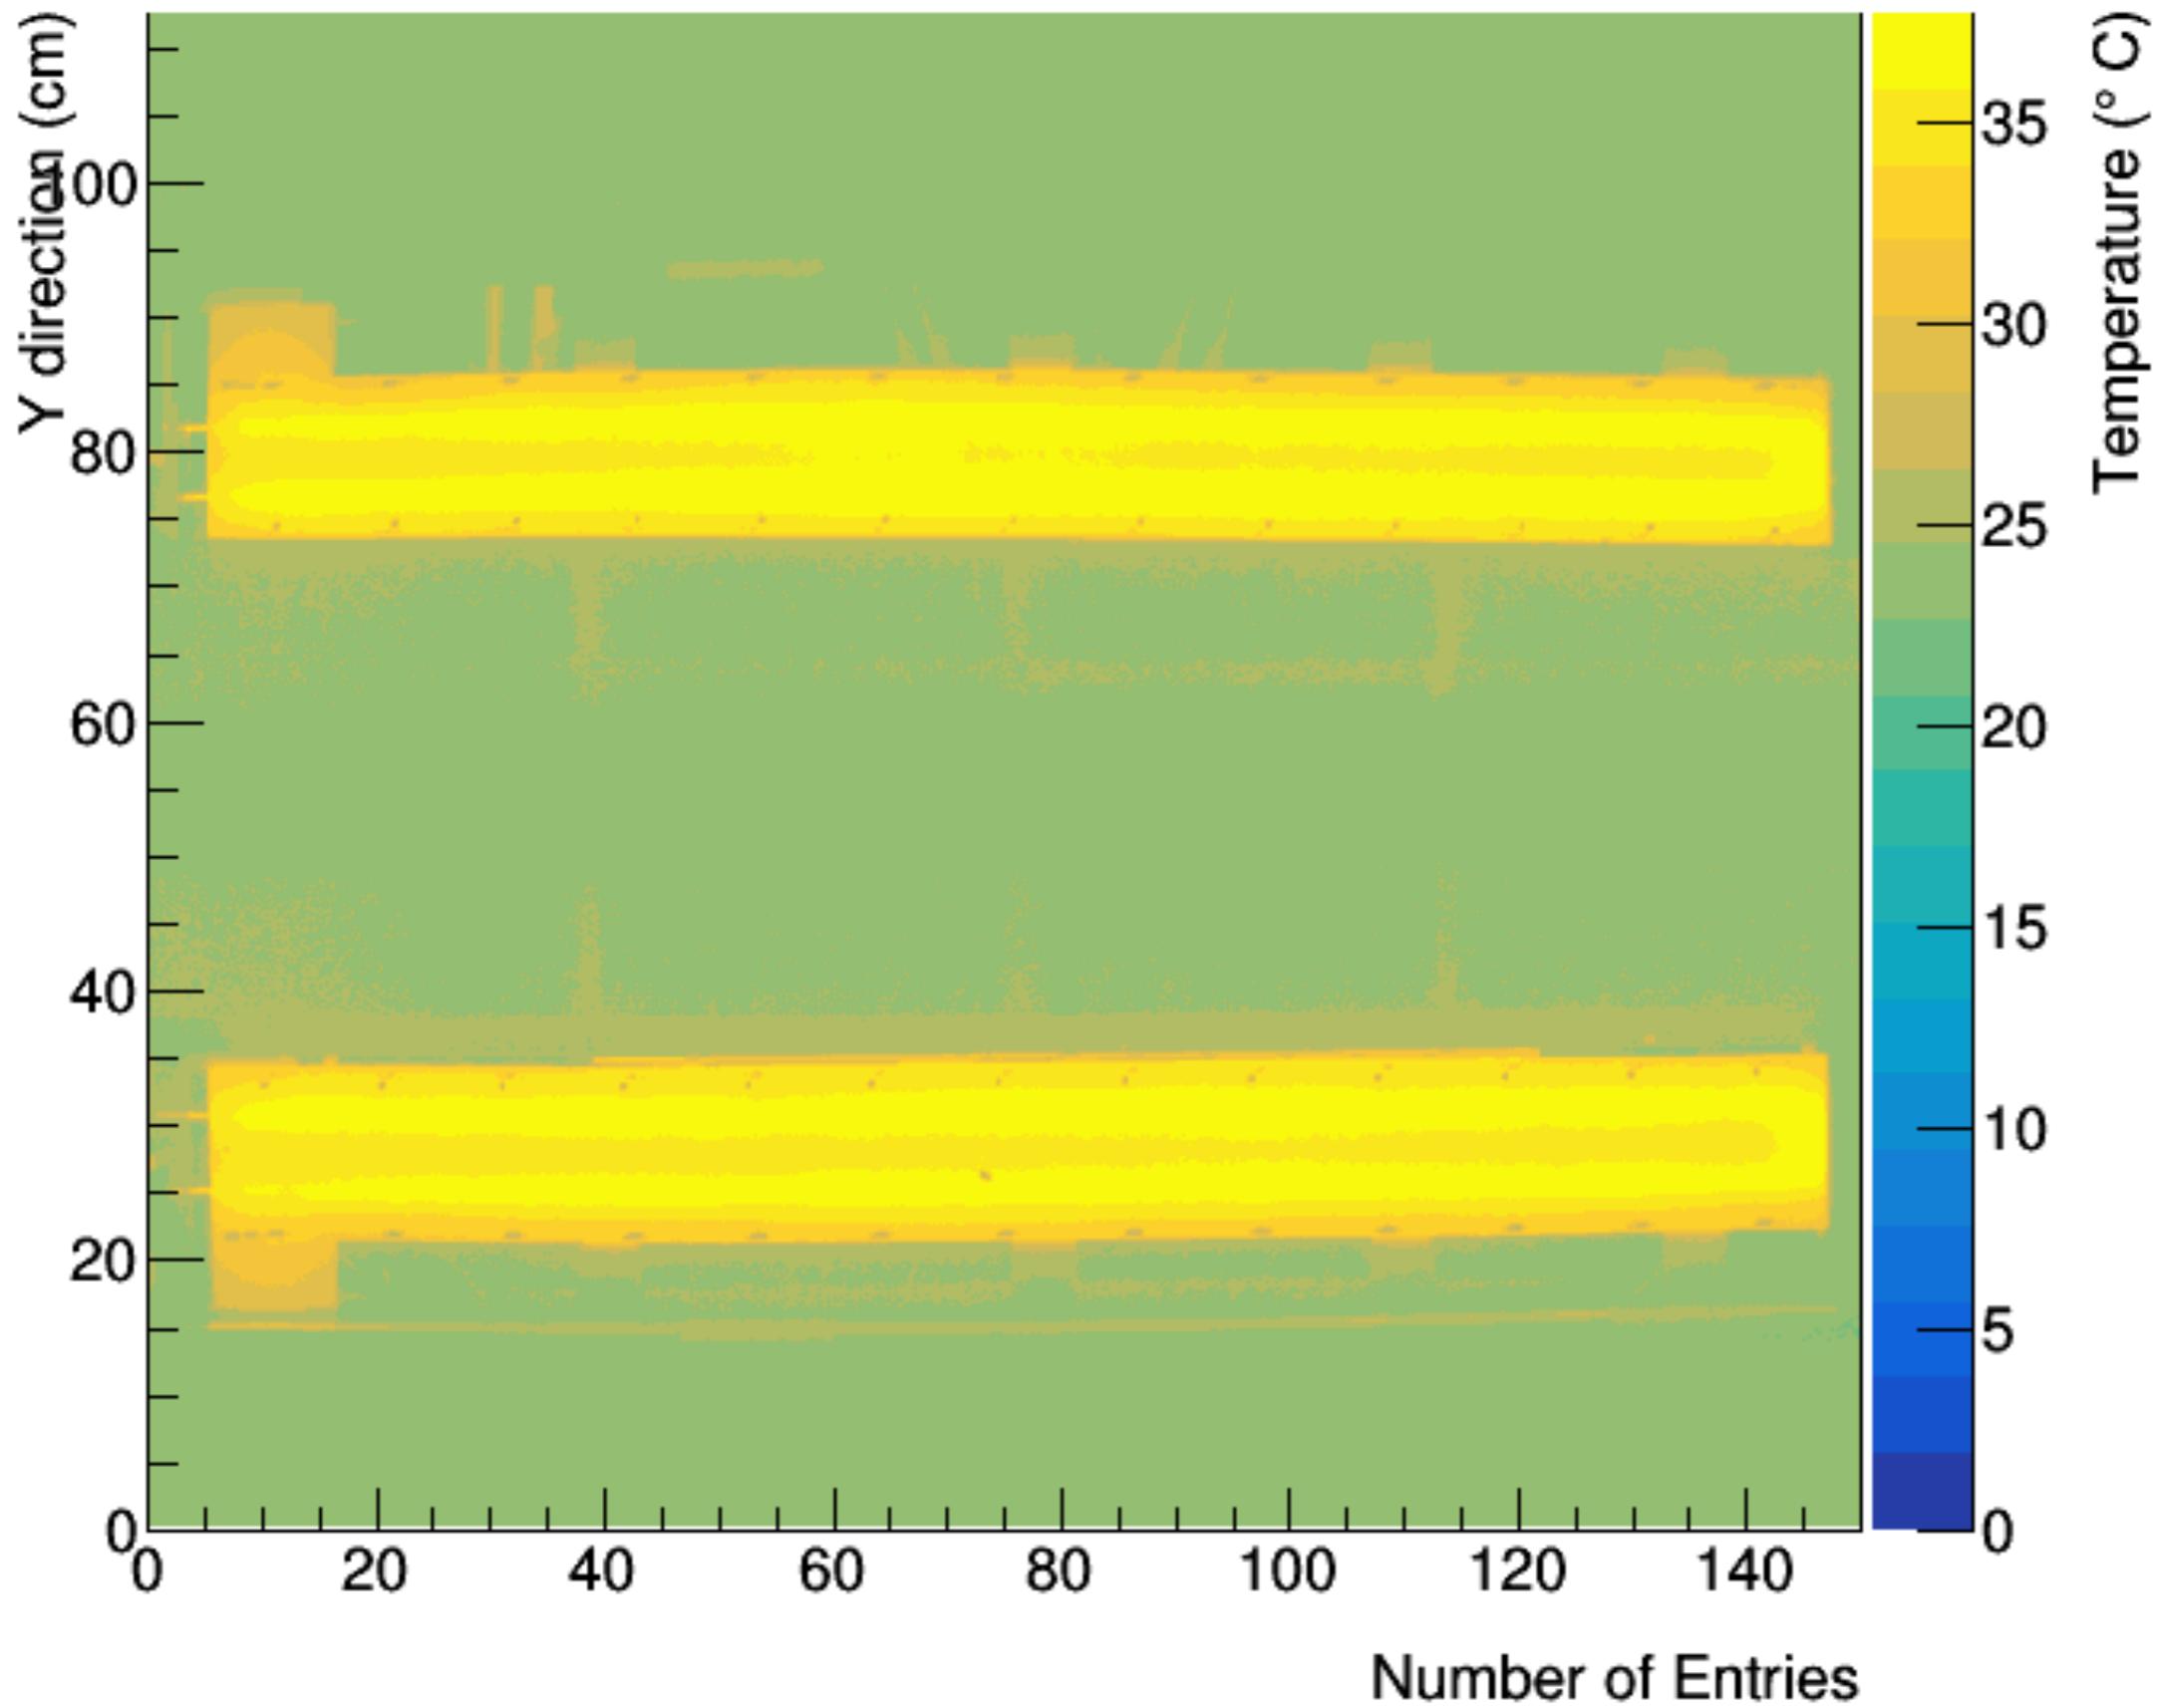
QMUL: +40 C
