# Temperature Profile and new Stave with Flaws

William Heidorn, Jie Yu

Iowa State University

Stave QC discussion, Feb.8.2017

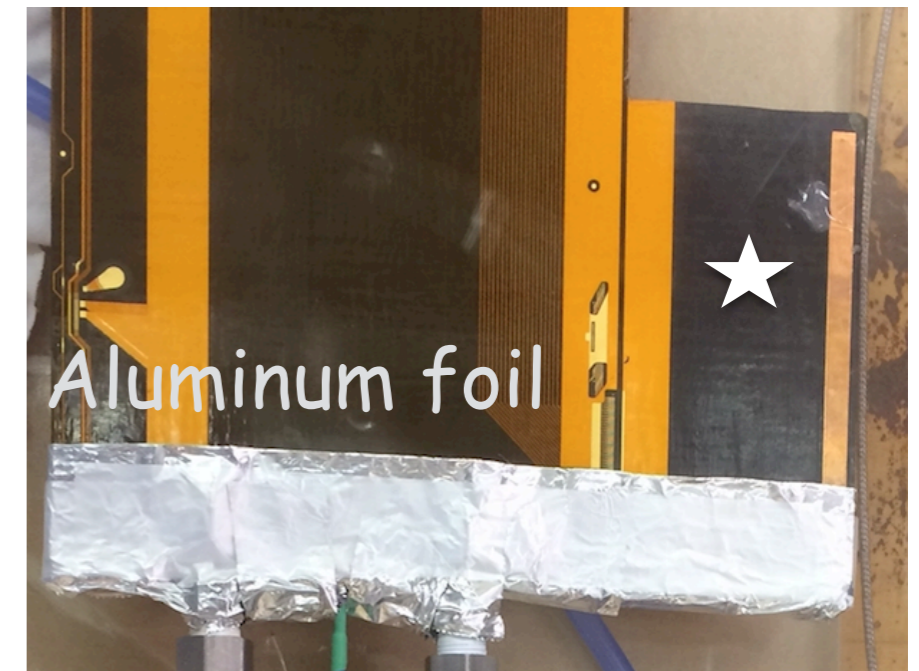
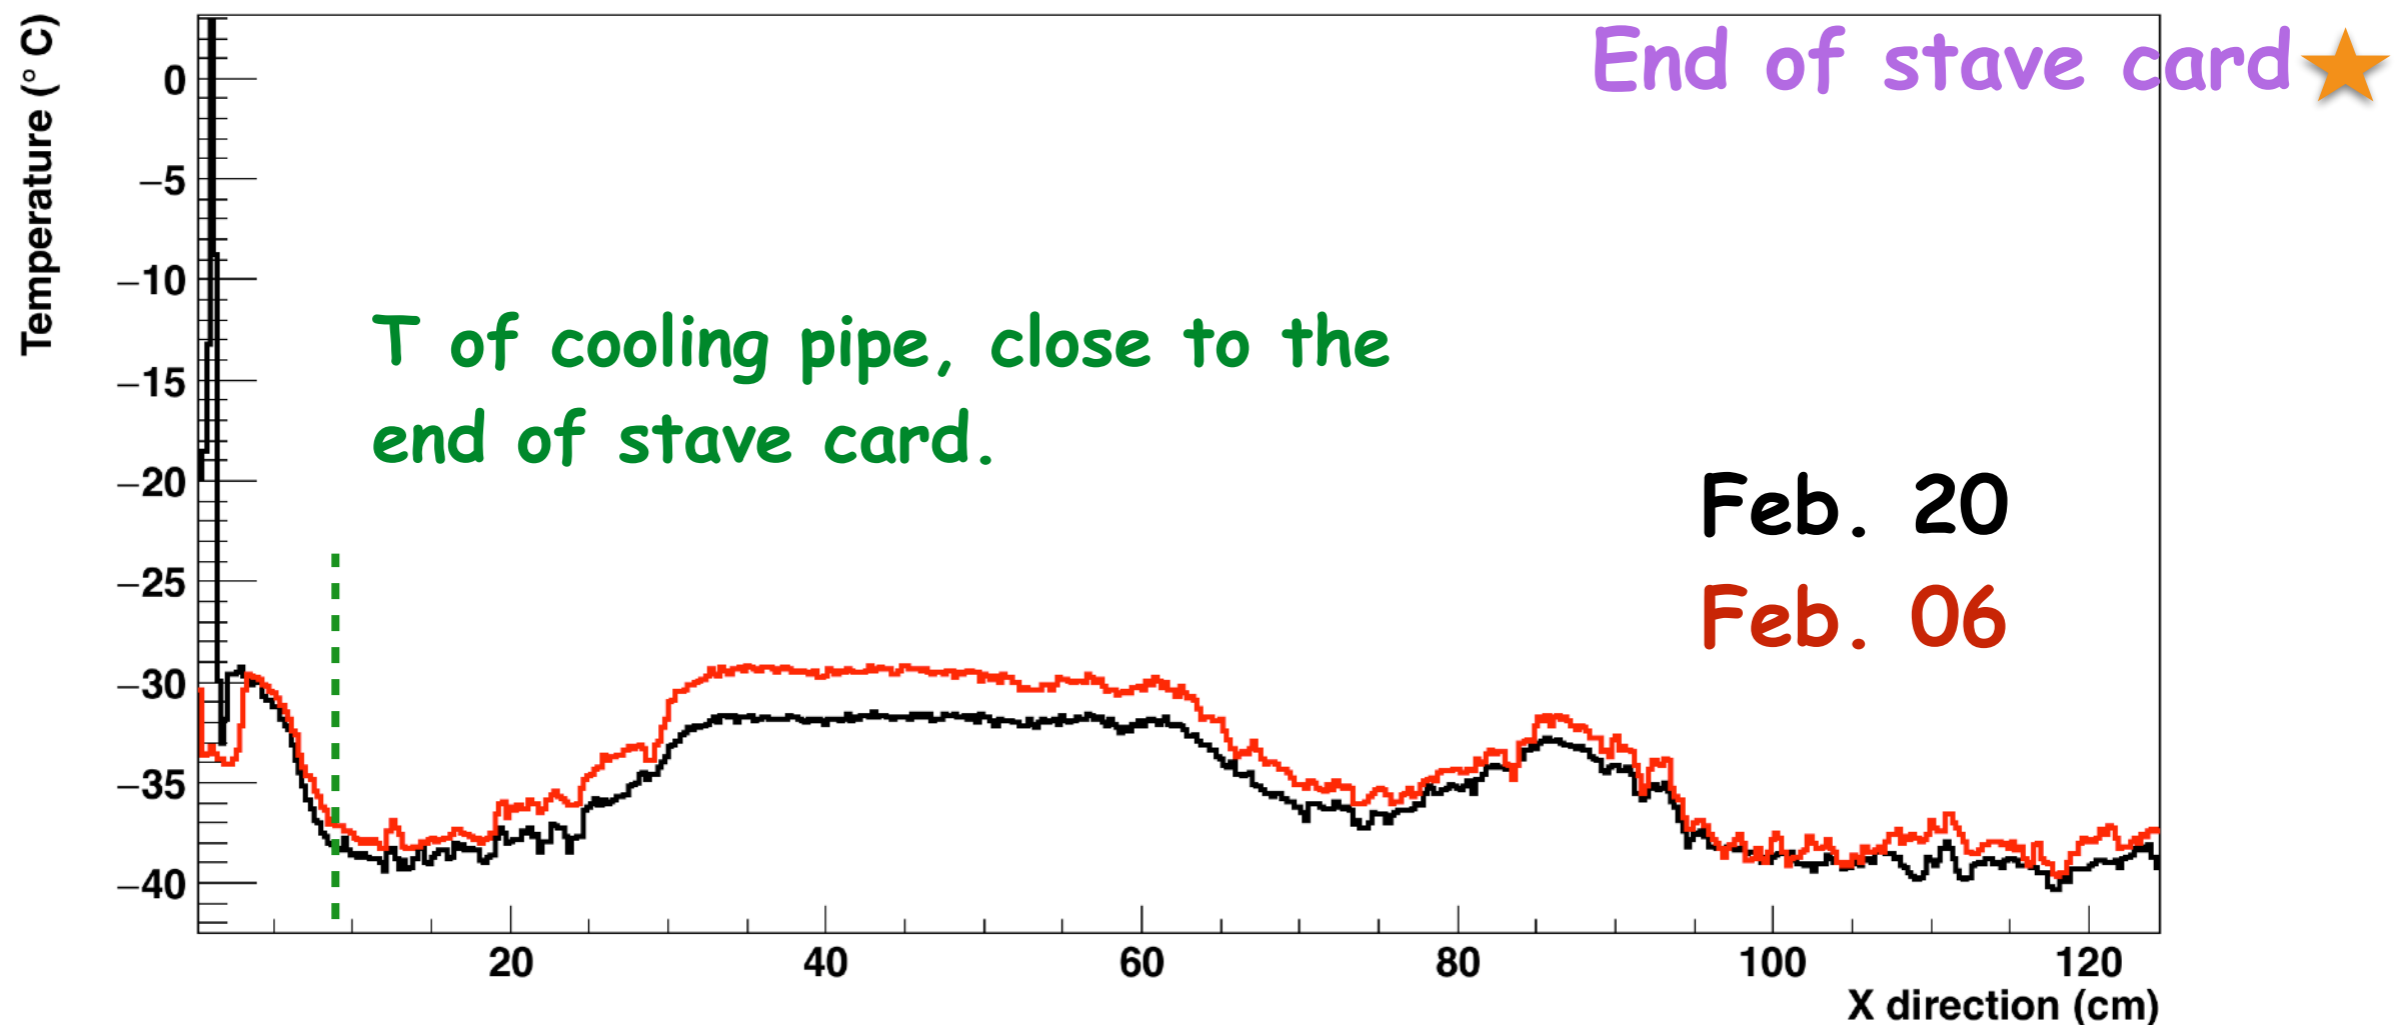
# Edge Temperature Profile

- Test with Stave #2.
  - ◆ Chiller at -55 C (Feb 06)
  - ◆ Chiller at -55 C (edge cover, Feb 20)
  - ◆ no obvious difference found!

- ◉ Temperature edge profile, coverage of aluminum foil:
  - ✦ Experiment using stave #2 with intended flaws → no difference found.
- ◉ New stave with intended flaws No.4:
  - ✦ Experiments on L side and J side at -55 C and +50 C.
  - ✦ L side: 5 clear intended flaws
  - ✦ J side: 4 clear intended flaws
  - ✦ One of them is huge and is found on both sides.
  - ✦ Temperature curve is smoother at +50 C, but small flaws are clearer at -55 C.
  - ✦ Effects from flaws on the other side of the stave can be seen (not clearly) at -55C.

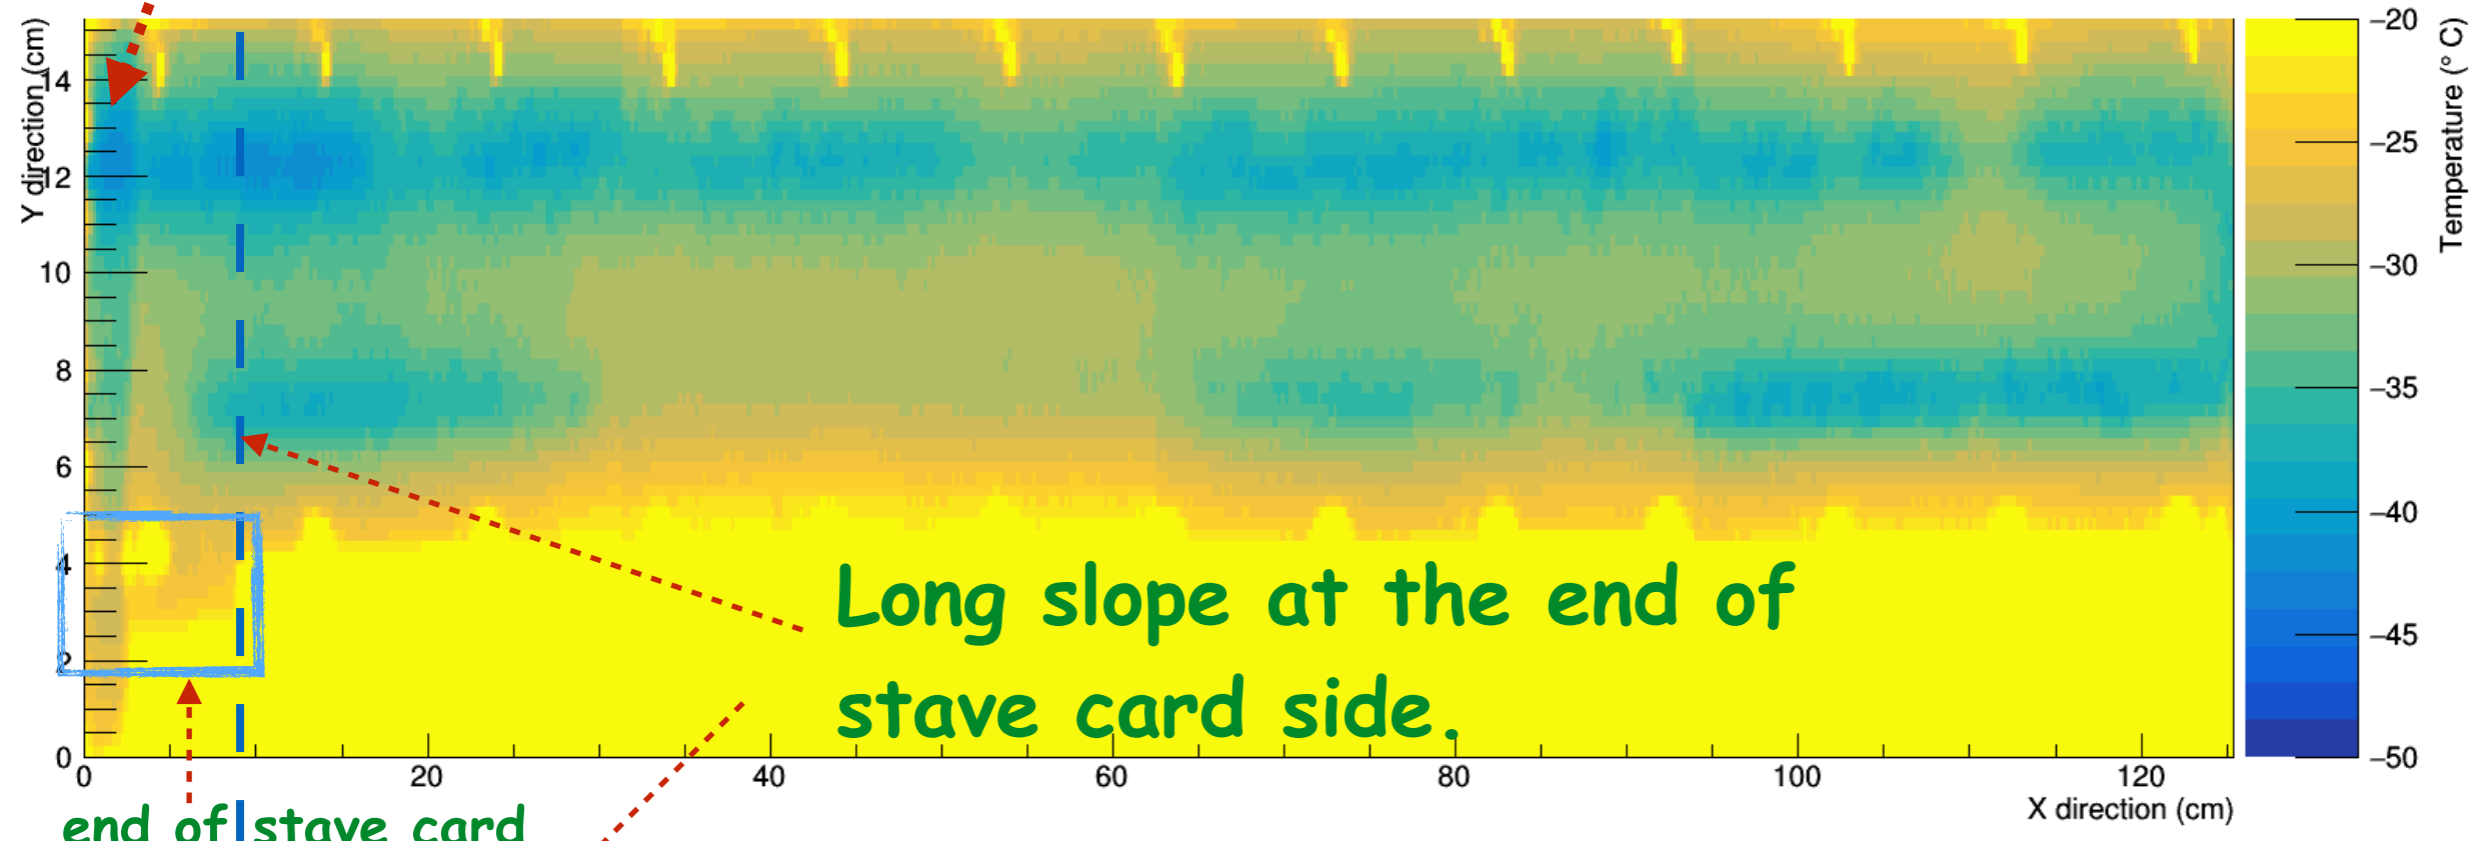
Feb 06, T = -55C

!!! Stave #2 with flaws

end of stave card

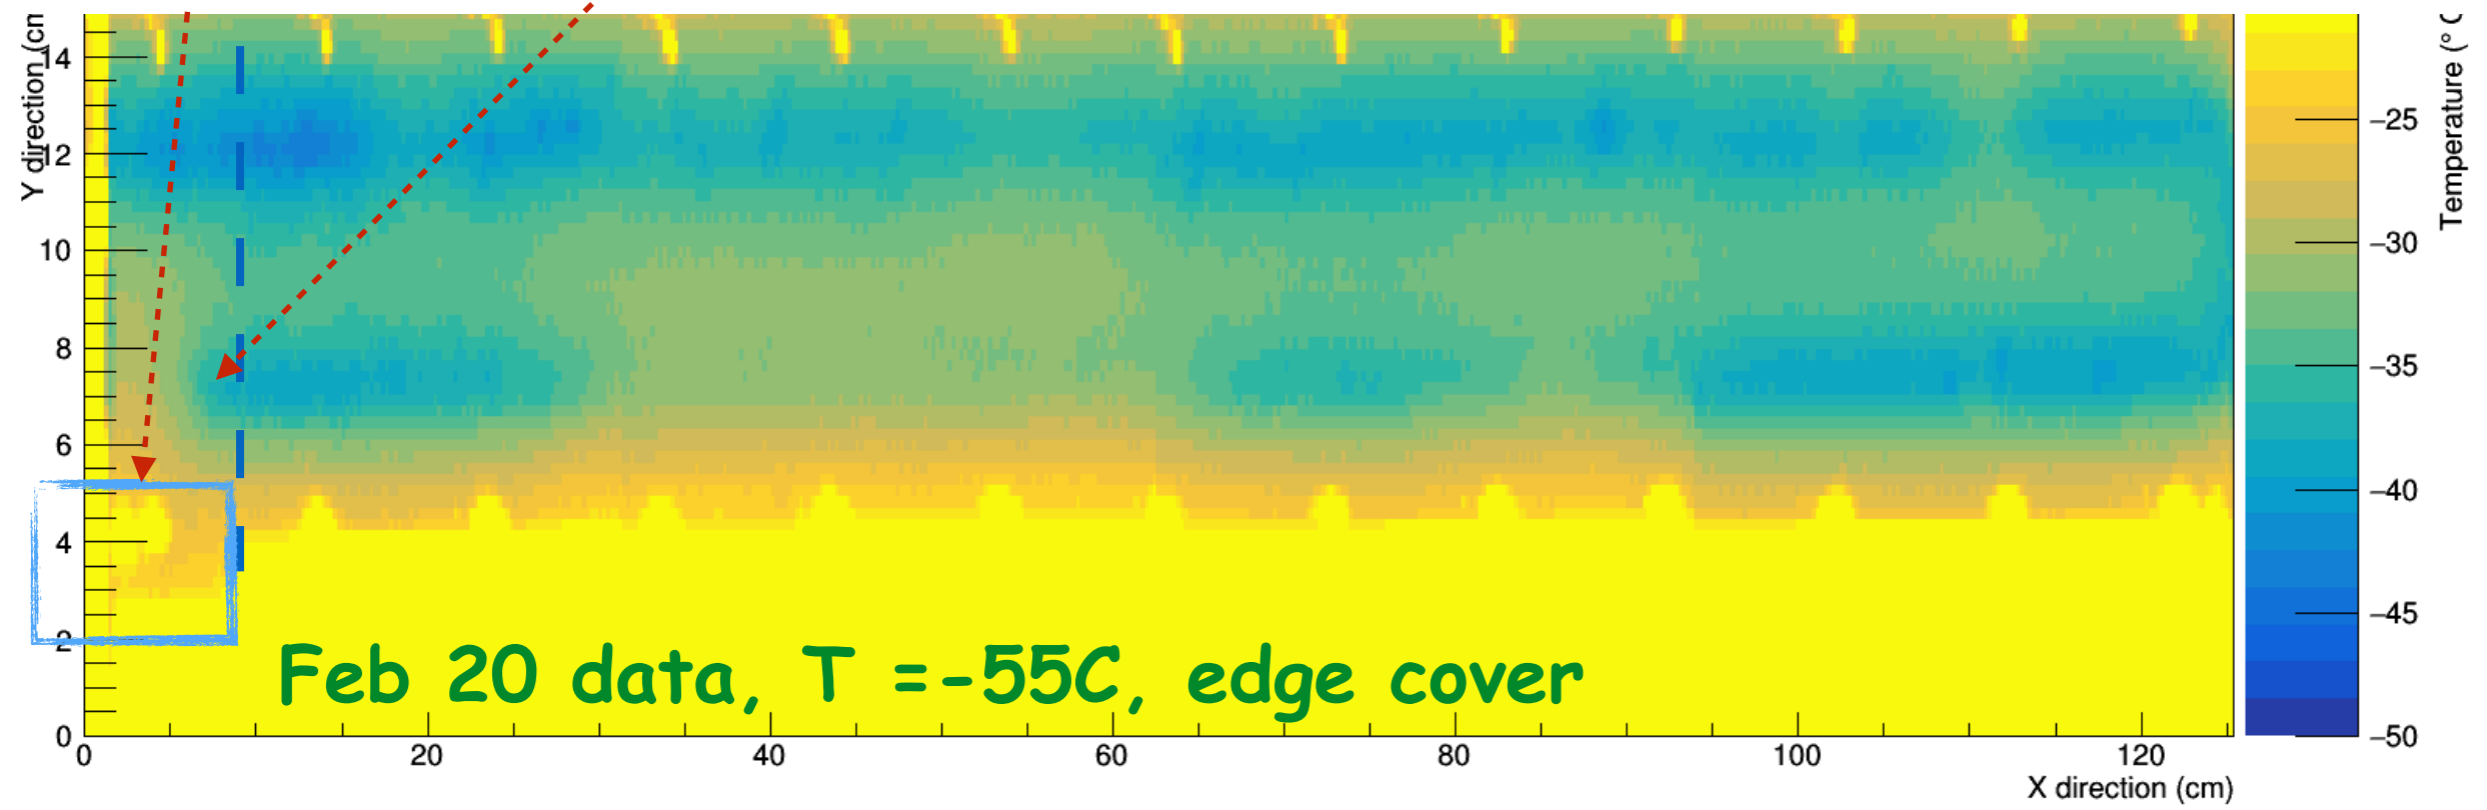
Feb 20 data, T = -55C, edge cover

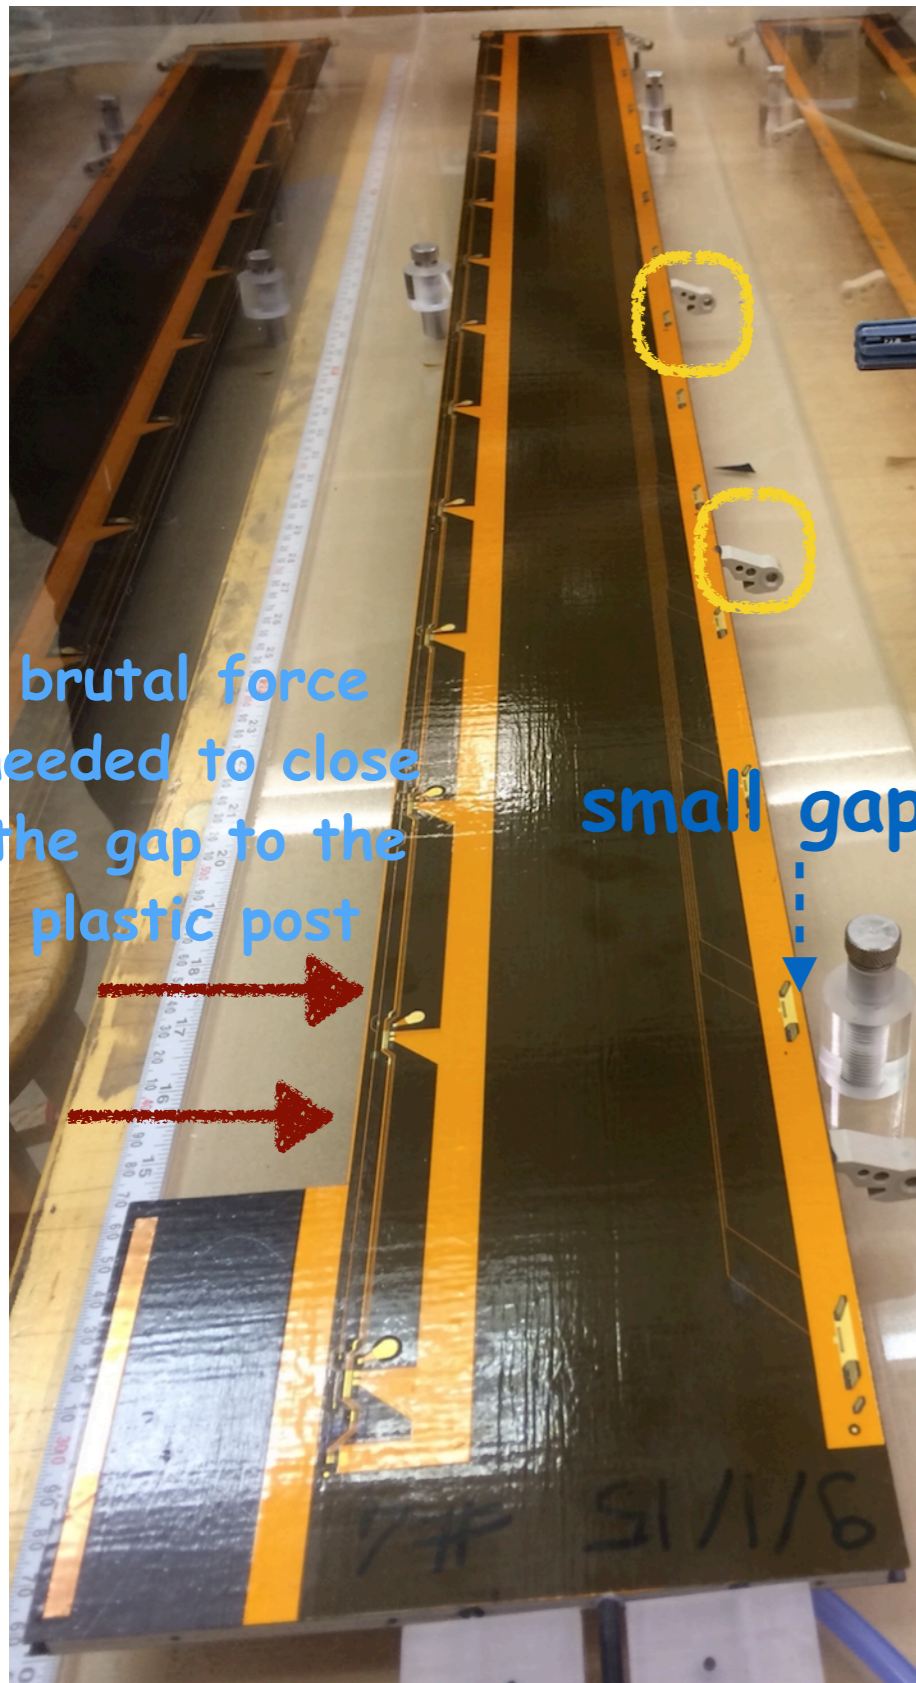
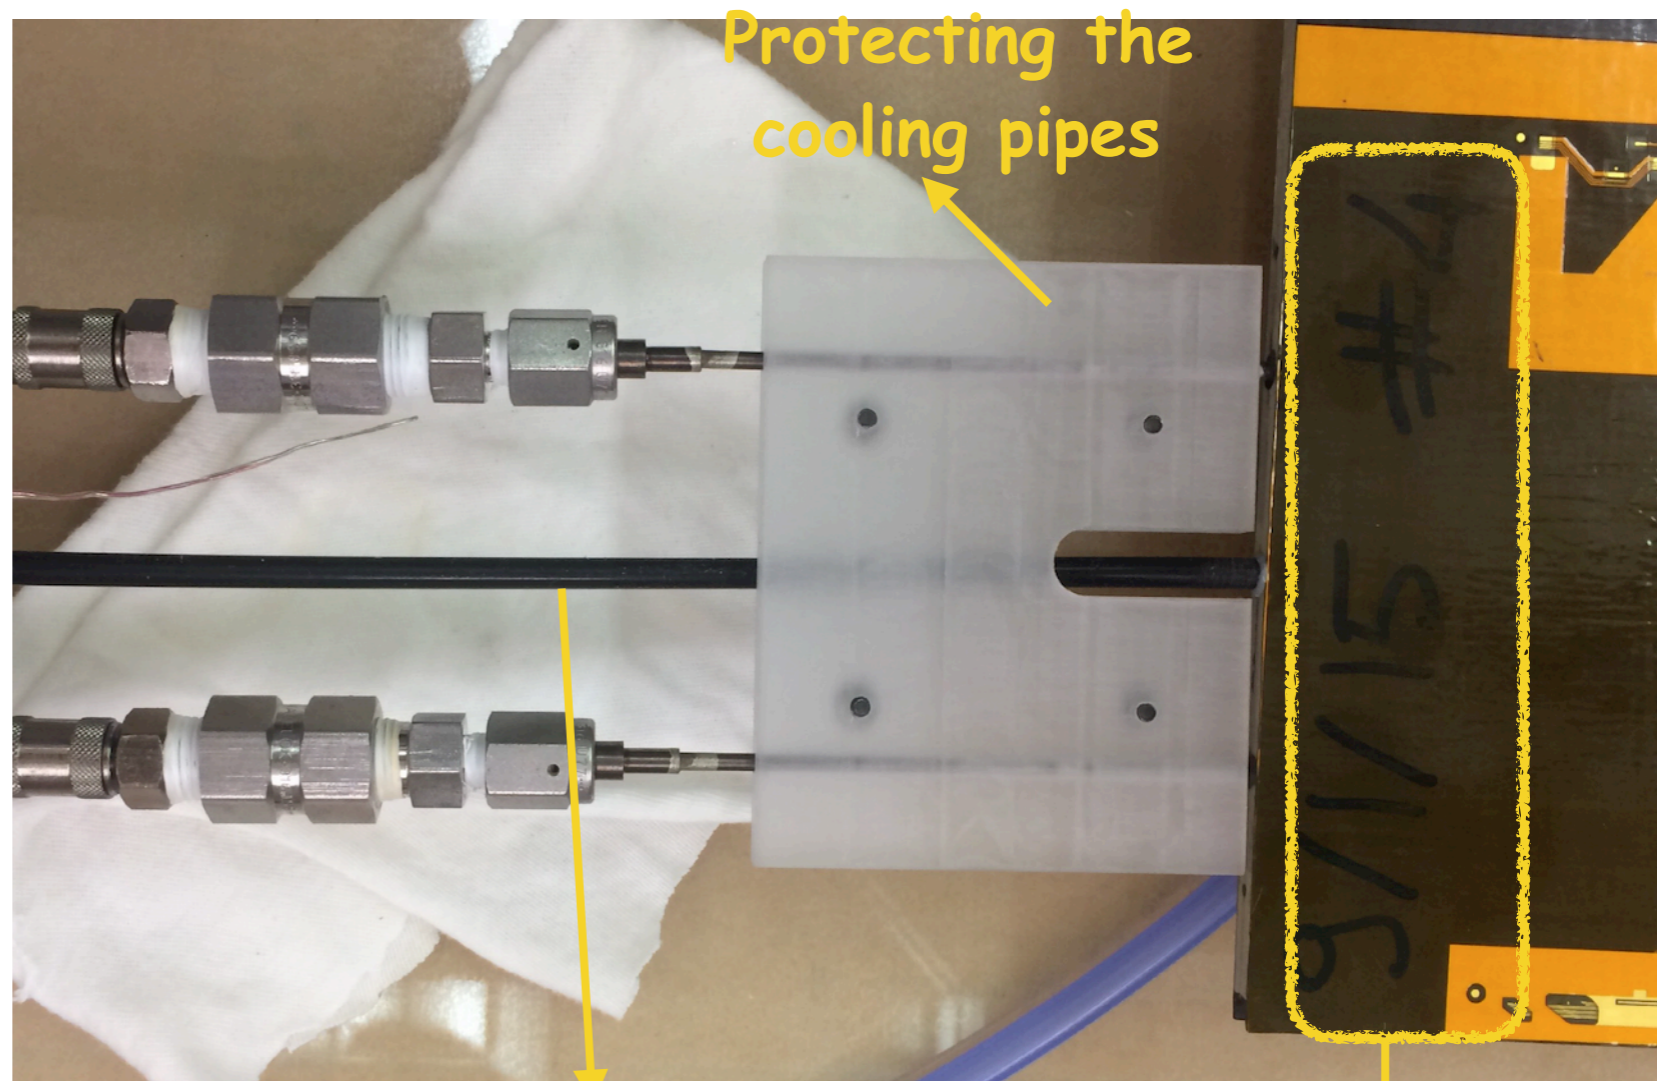
# New Stave (#2 revised = #4)

• Data taken in Feb 20 (Will, Jie).

• Chiller at -55 & 50 C

• J side and L side

• → to find the flaws (doing a blind analysis !!! )

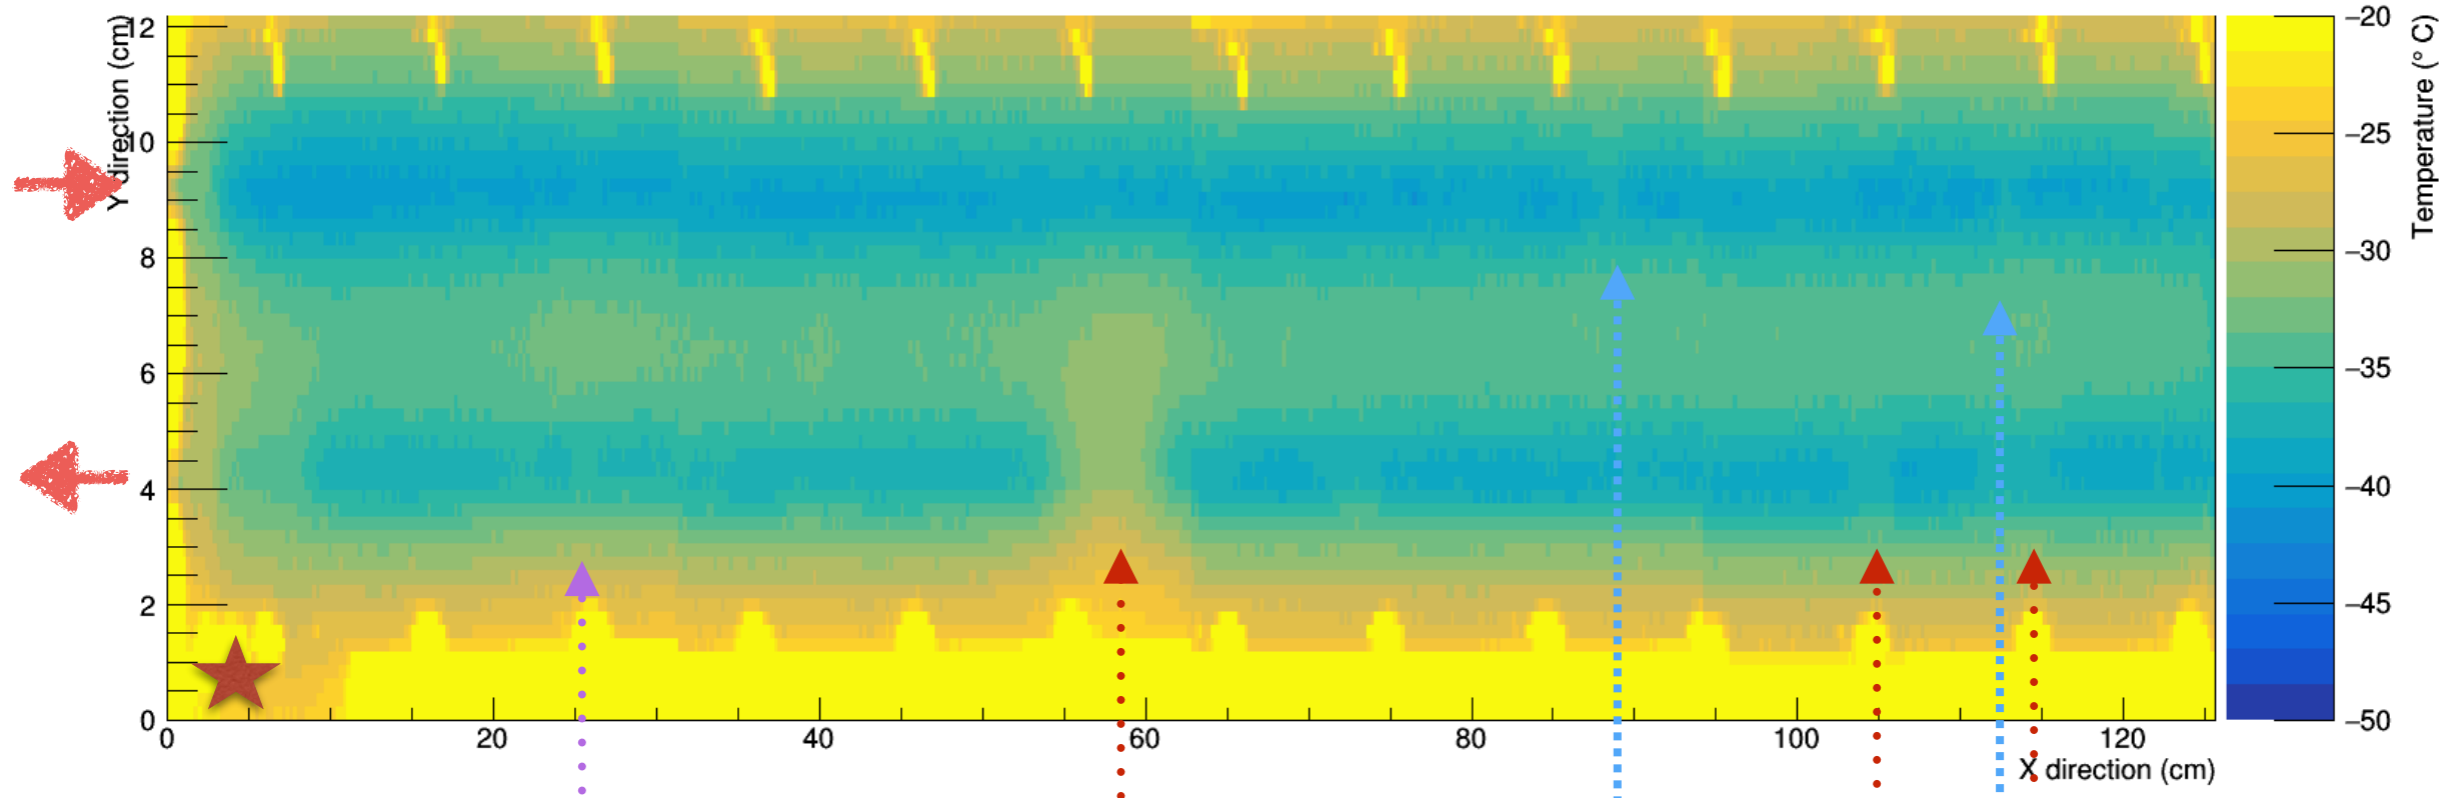
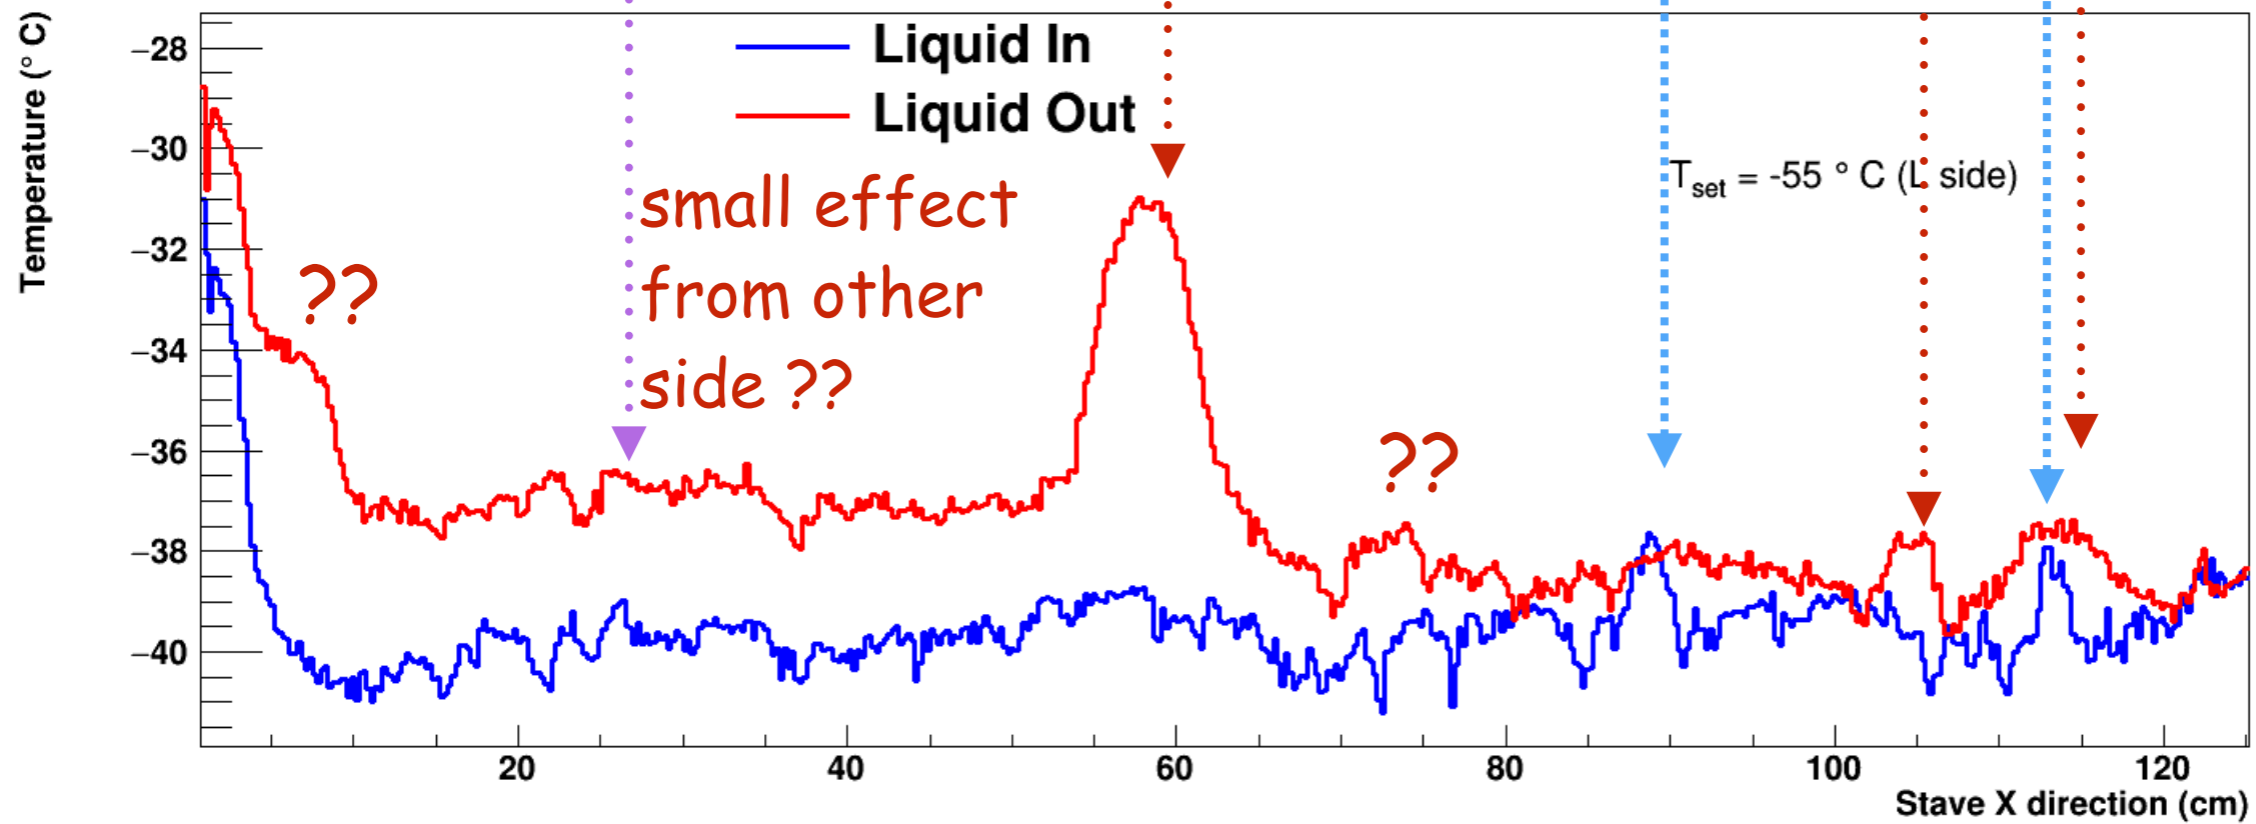
# L side, -55 C

Temperature: averaged over central line.

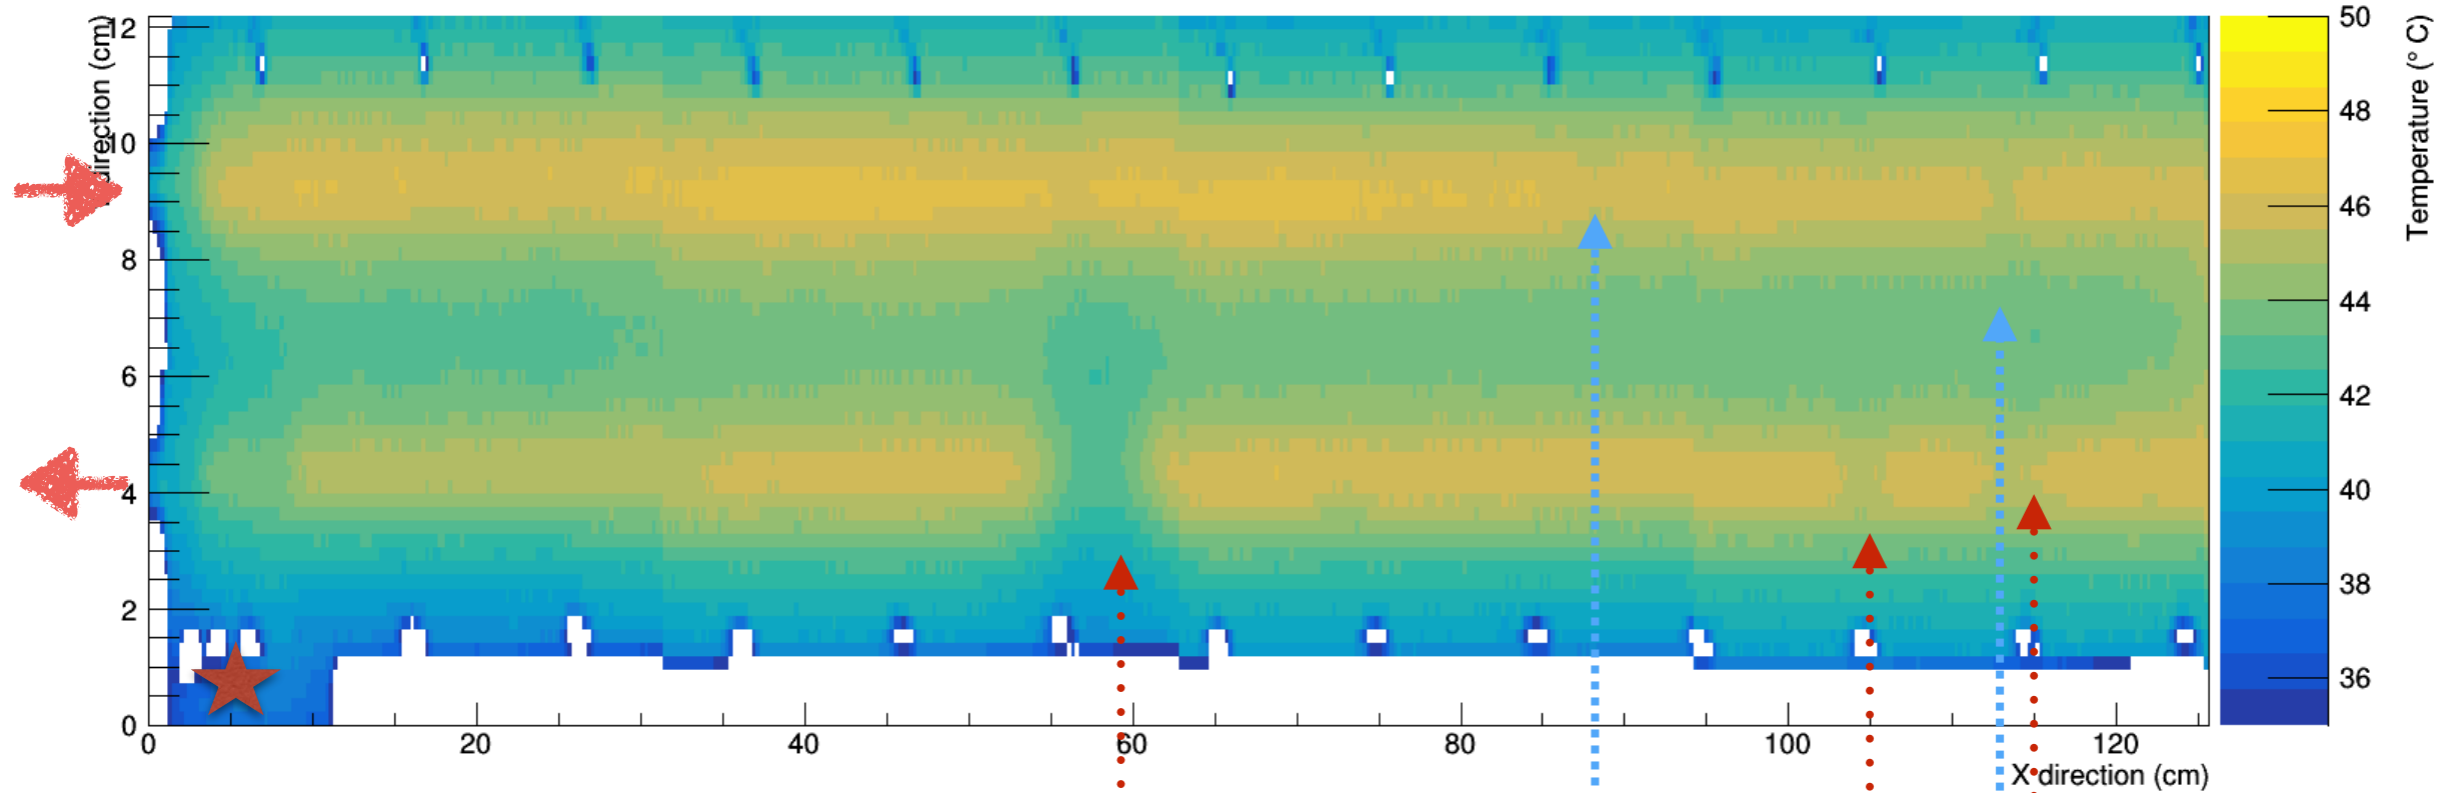
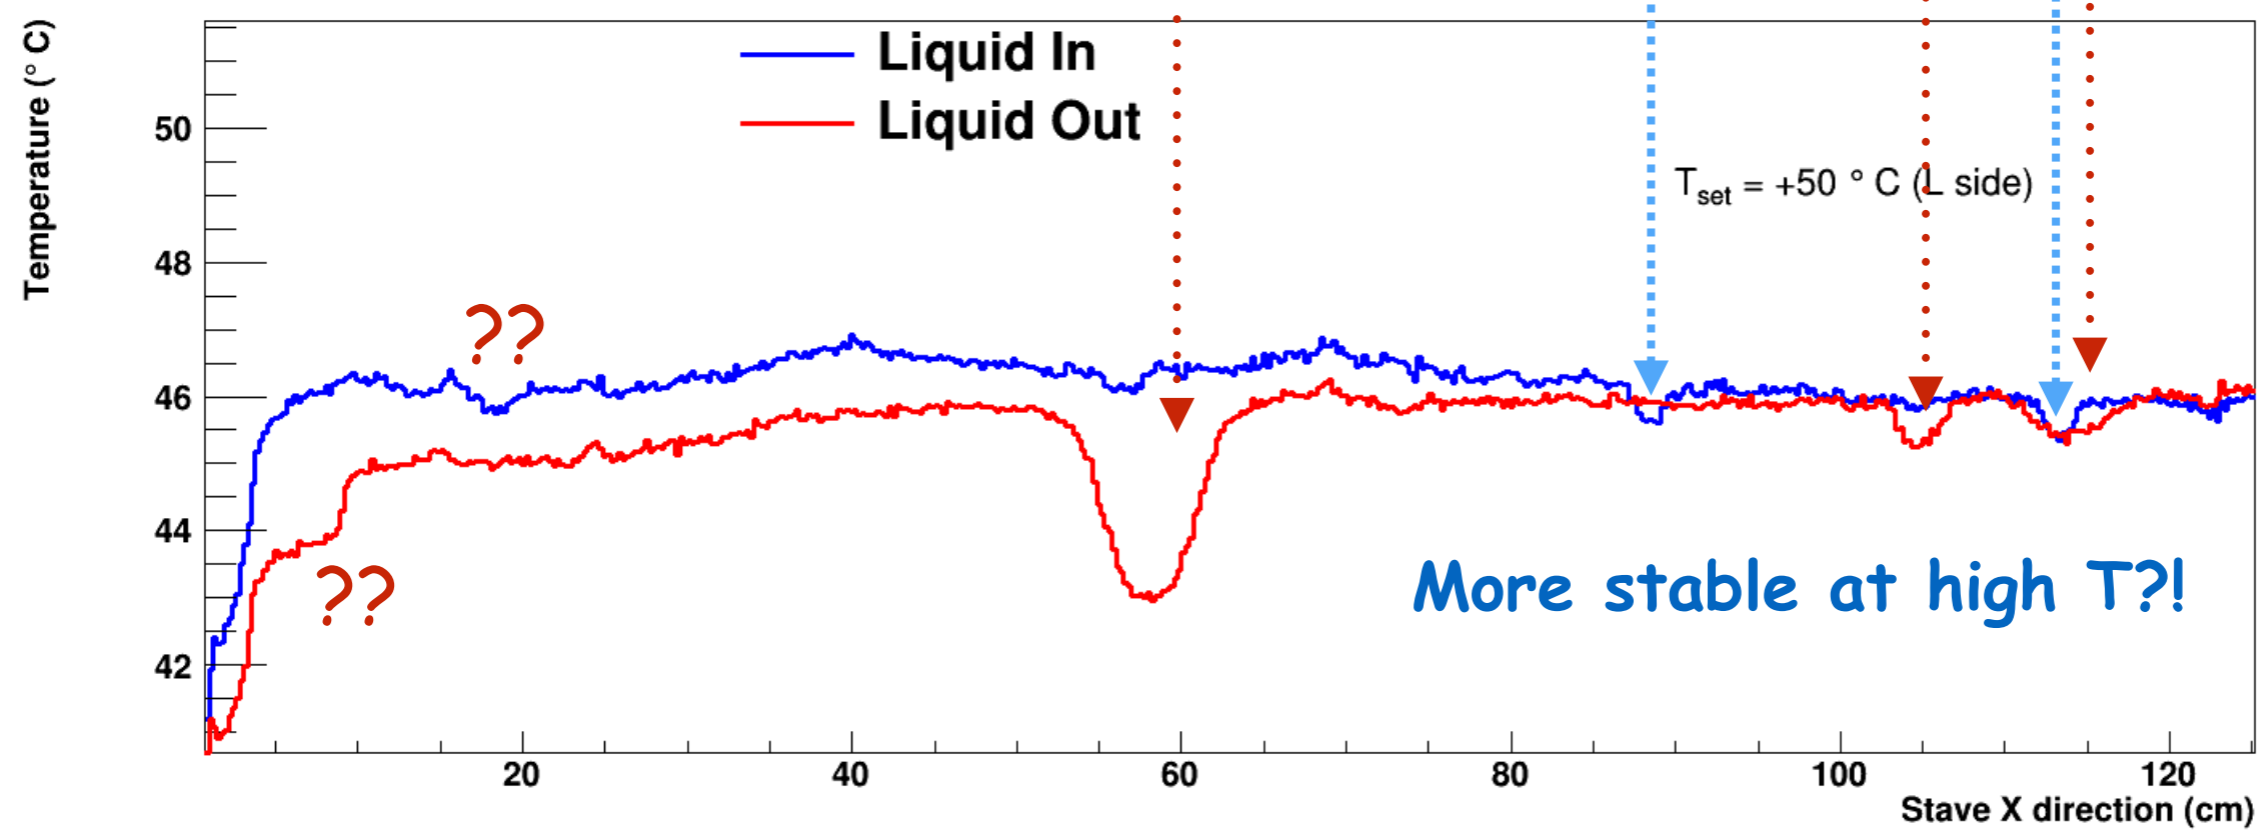
# L side, +50 C

Temperature: averaged over central line.

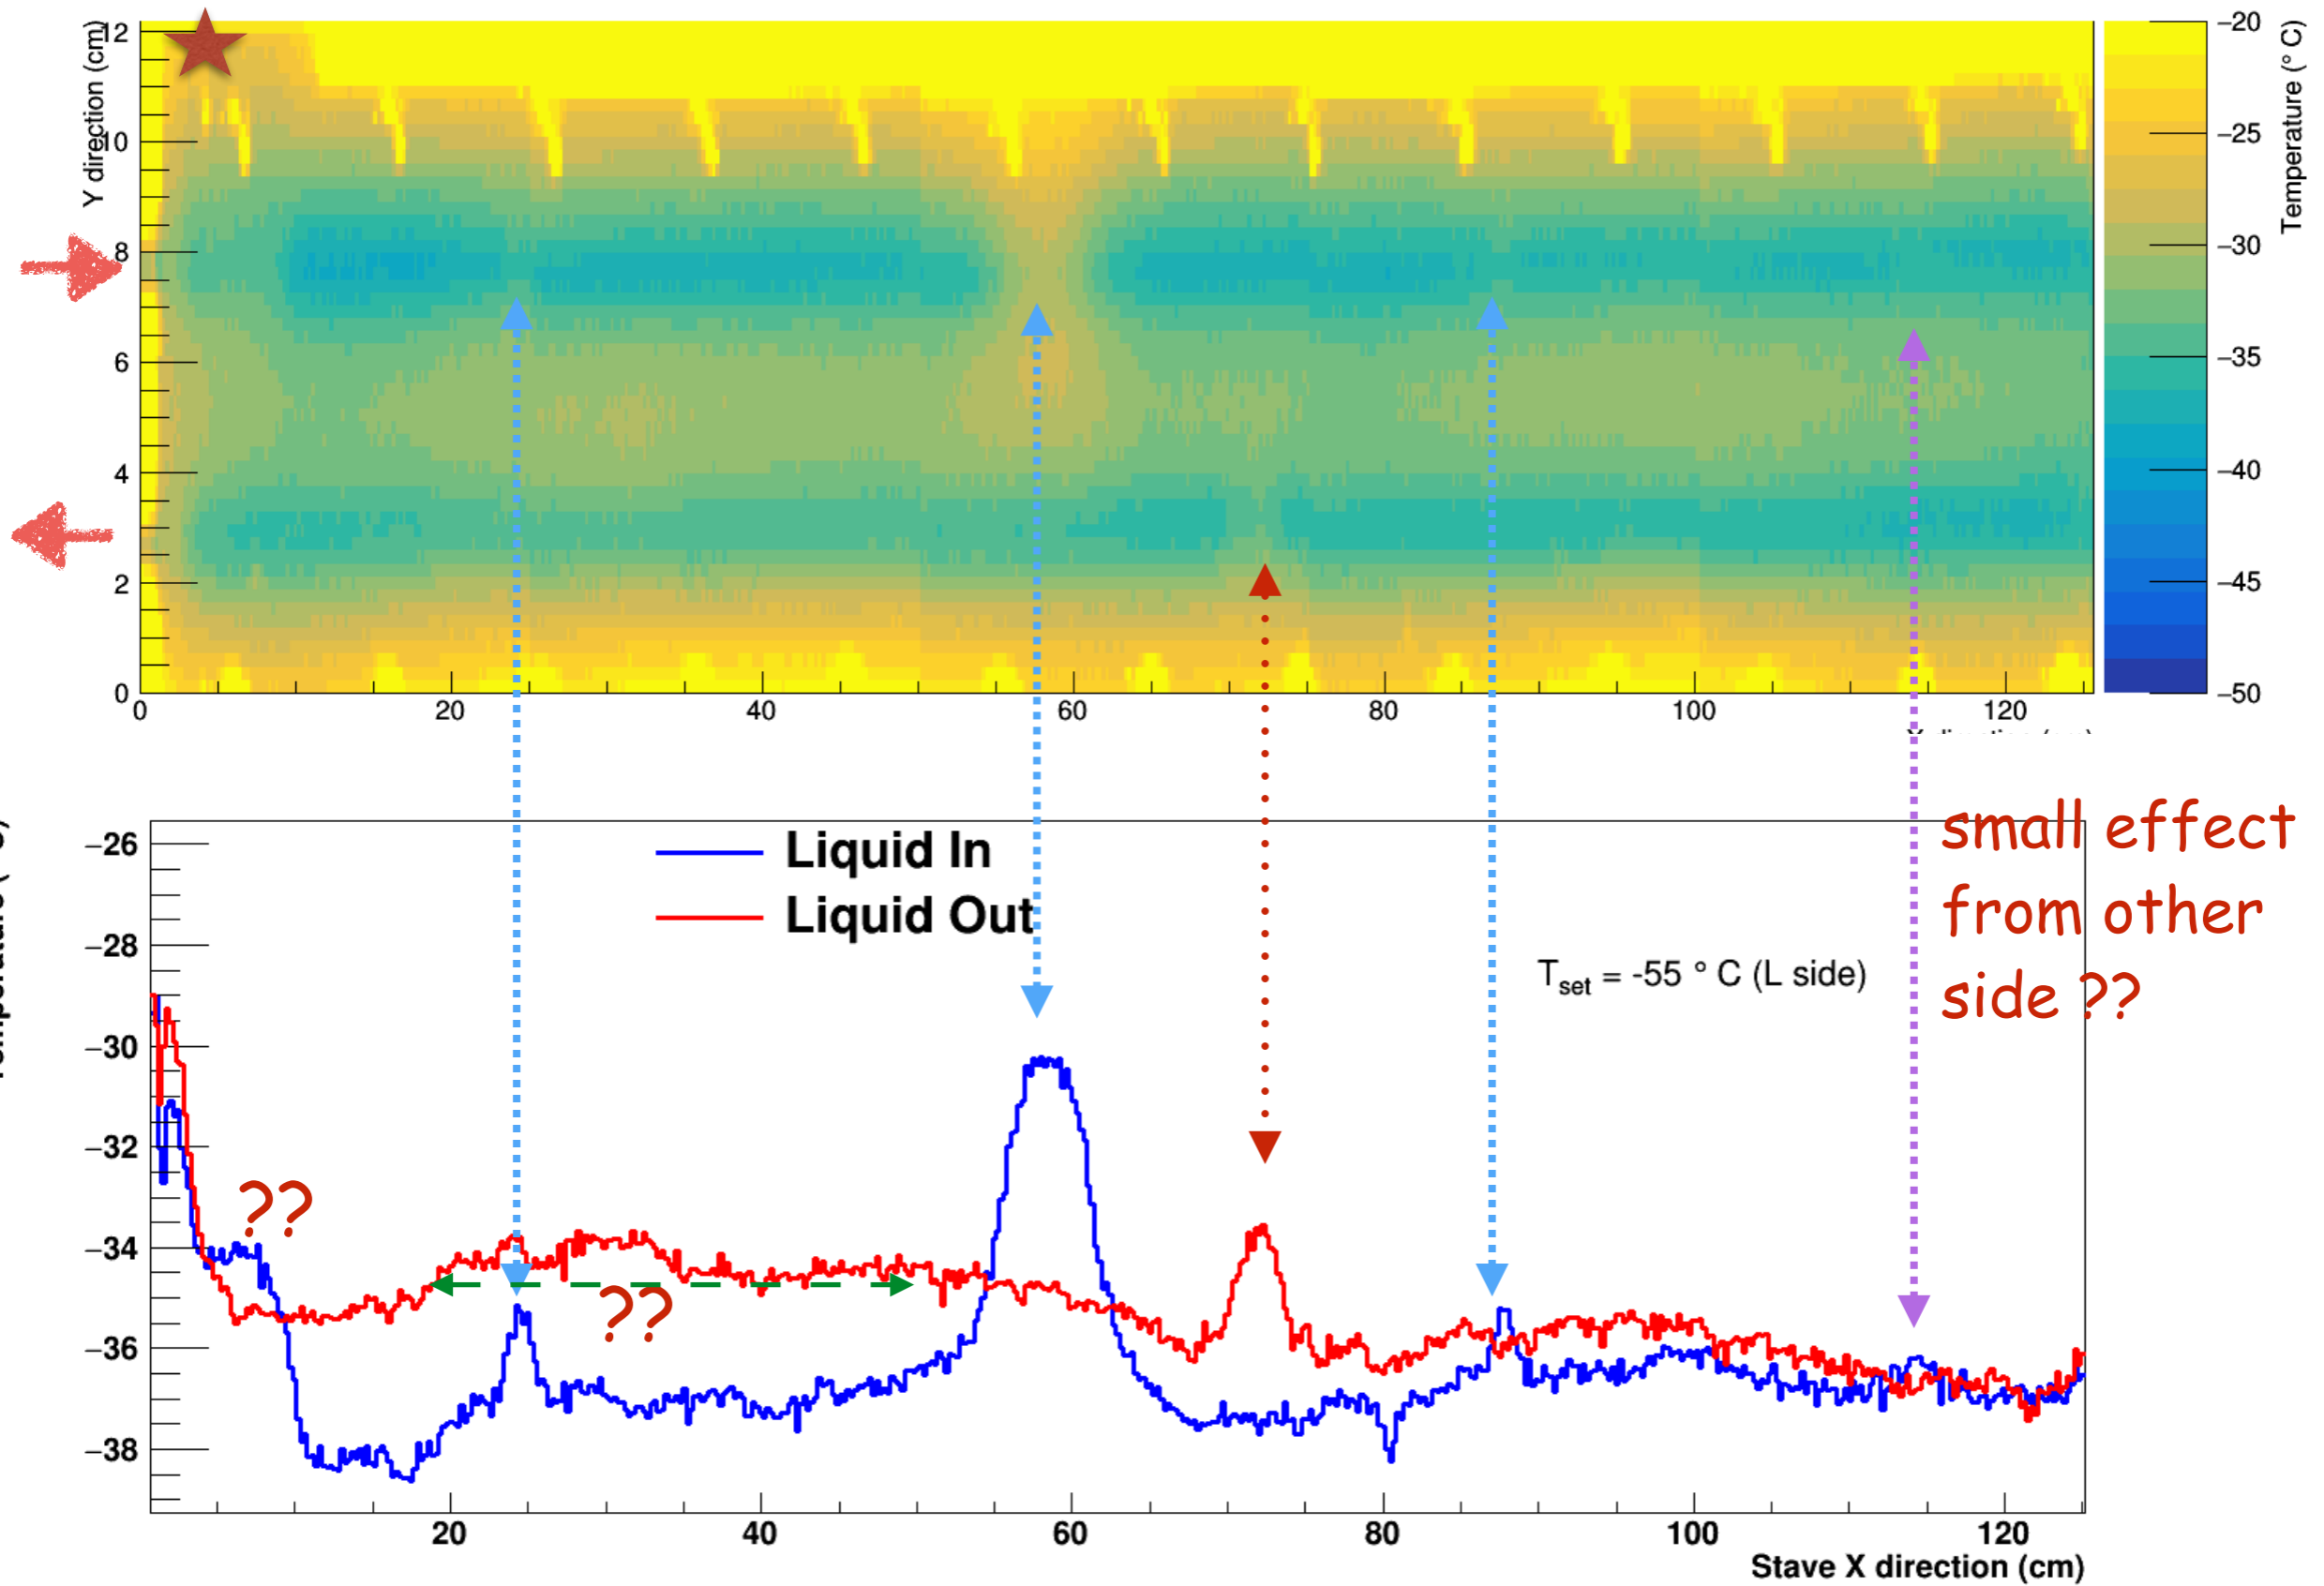
# J side, -55 C

Temperature: averaged over central line.
