# Temperature Profile and new Stave with Flaws

William Heidorn, Jie Yu

Iowa State University

Stave QC discussion, Feb.8.2017

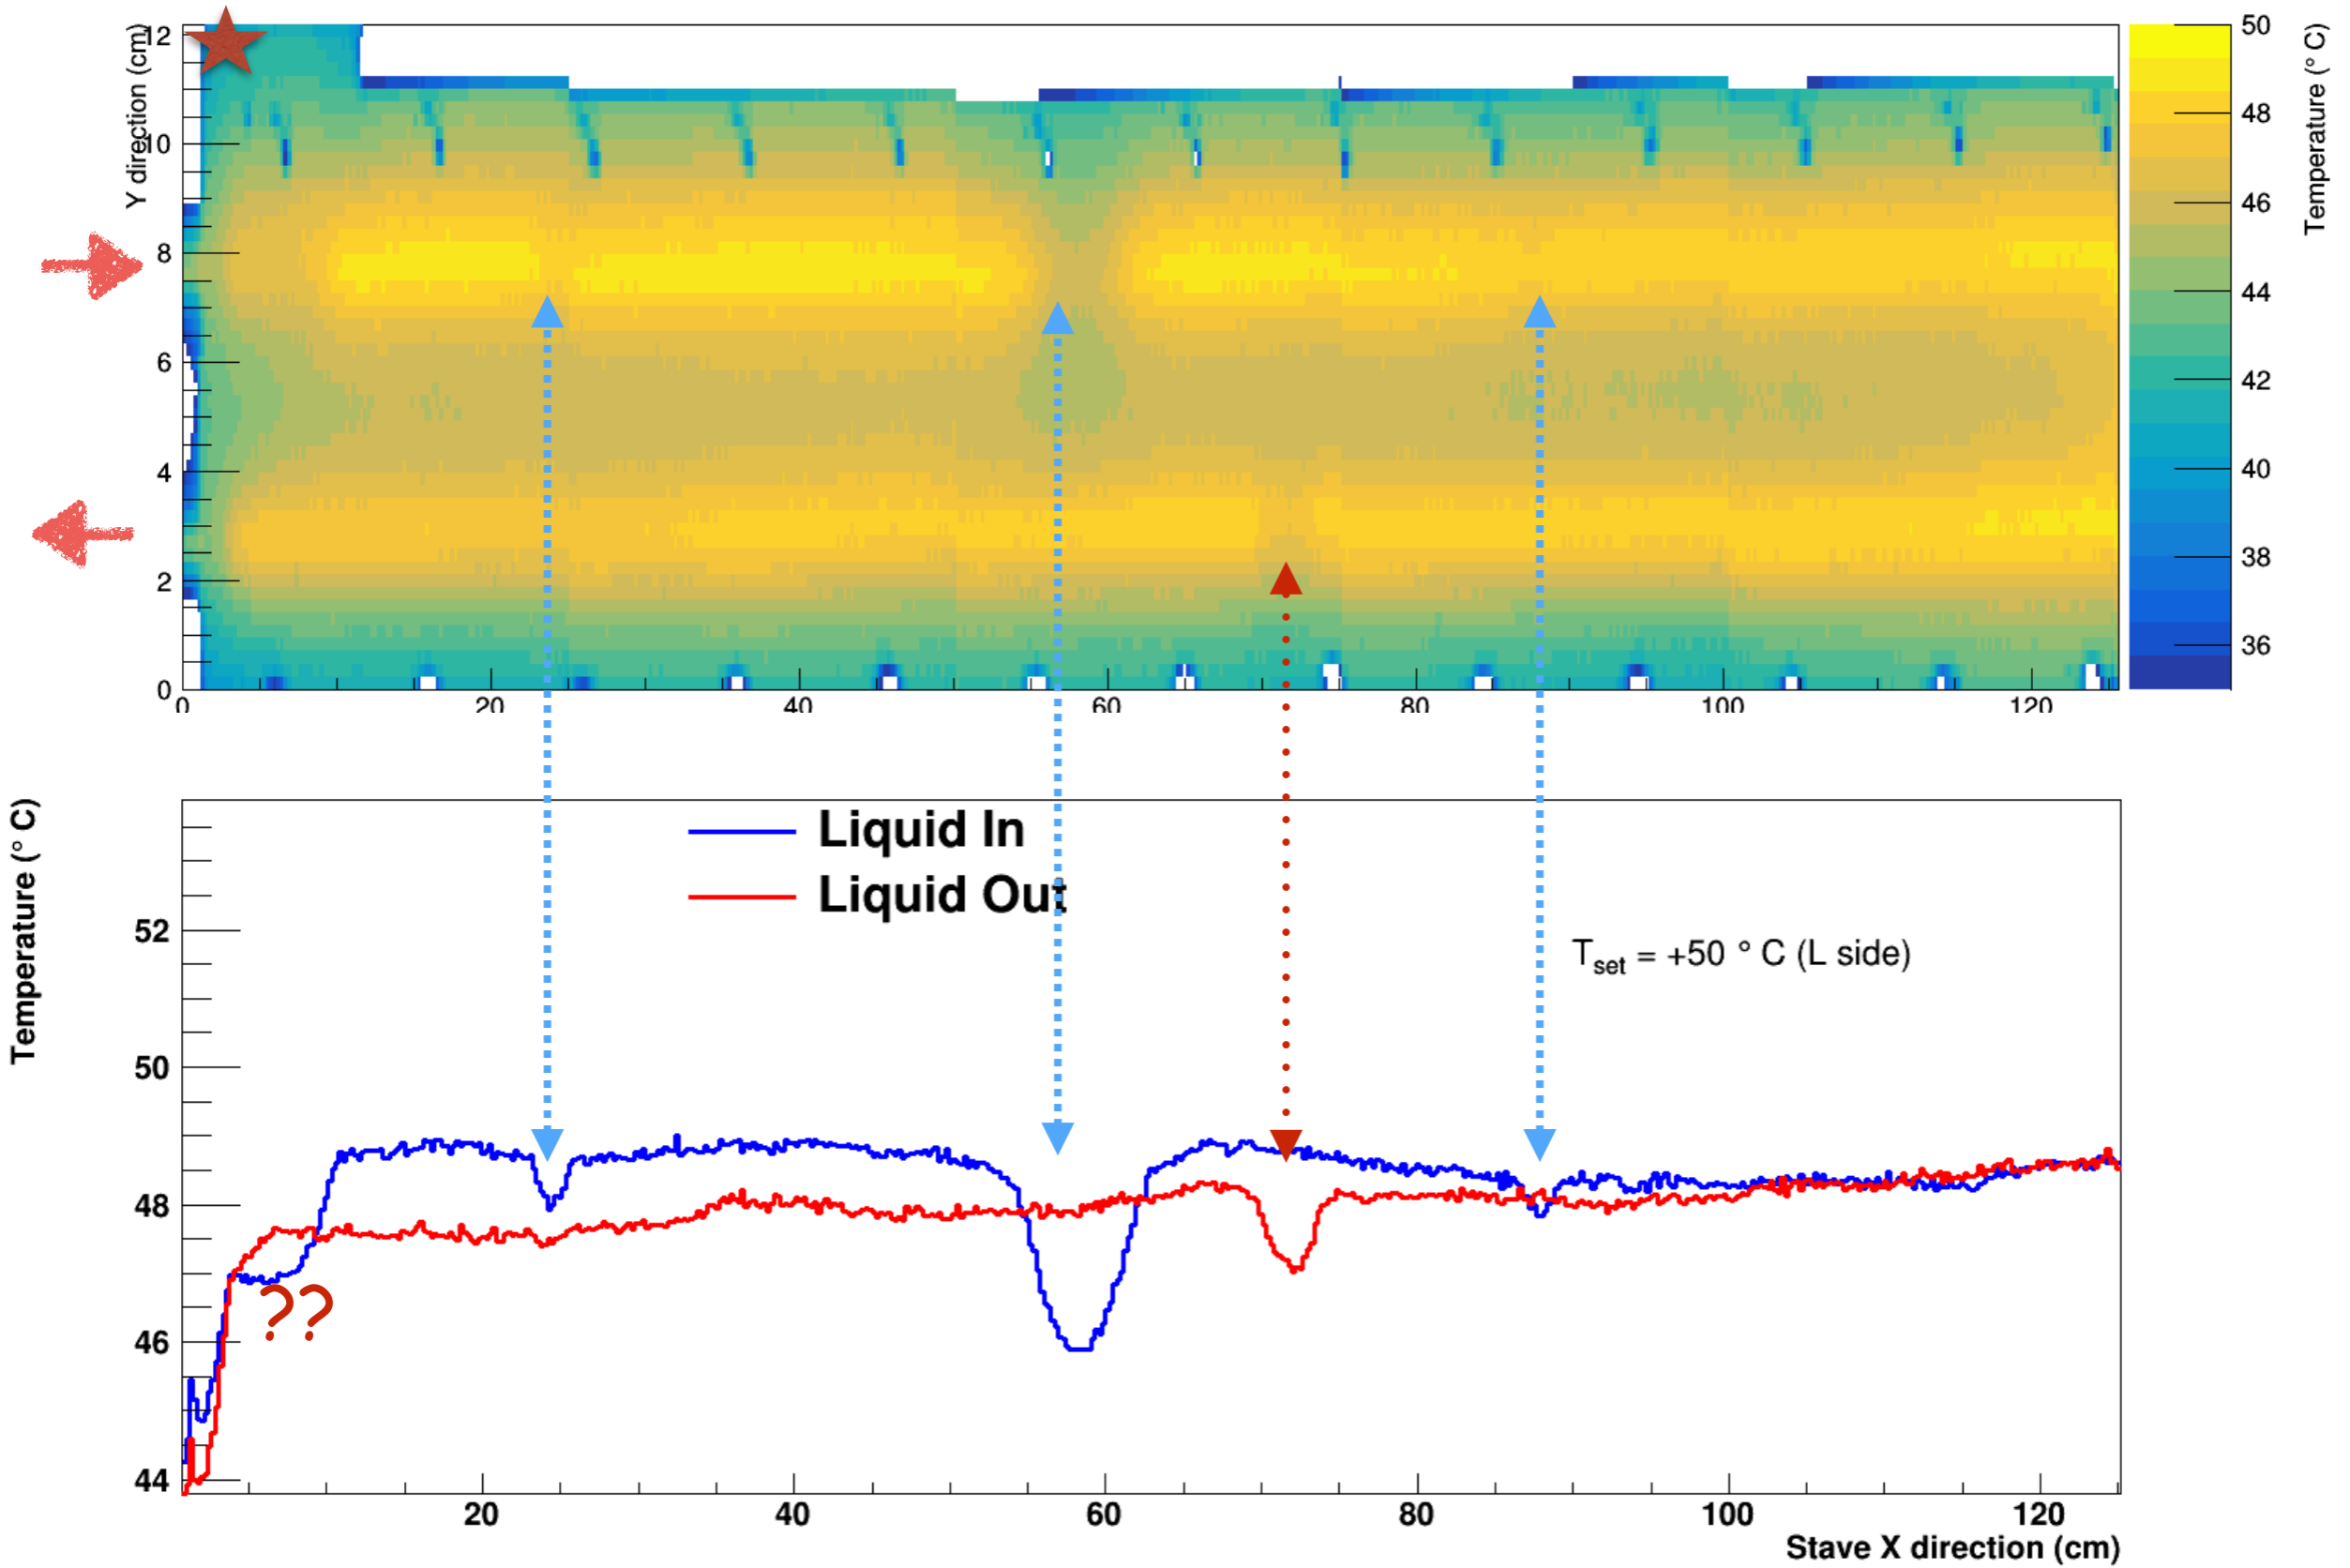
# J side, +50 C

Temperature: averaged over central line.

- ◉ Temperature edge profile, coverage of aluminum foil:
  - ✦ Experiment using stave #2 with intended flaws → no difference found.
- ◉ New stave with intended flaws No.4:
  - ✦ Experiments on L side and J side at -55 C and +50 C.
  - ✦ L side: 5 clear intended flaws
  - ✦ J side: 4 clear intended flaws
  - ✦ One of them is huge and is found on both sides.
  - ✦ Temperature curve is smoother at +50 C, but small flaws are clearer at -55 C.
  - ✦ Effects from flaws on the other side of the stave can be seen (not clearly) at -55C.
