YETS 2016

Vacuum Alignments

(LSS1 / LSS5)

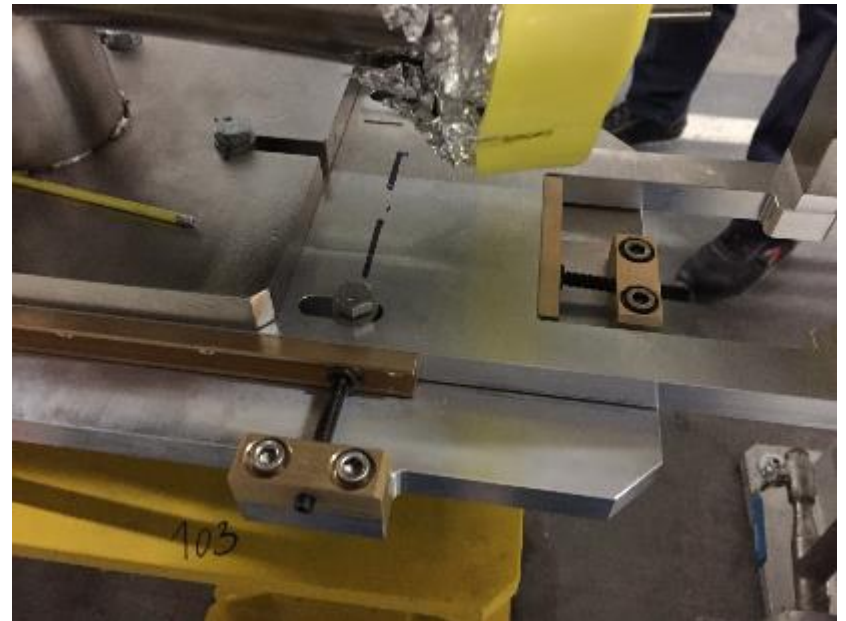
- Alignment system need to be optimized

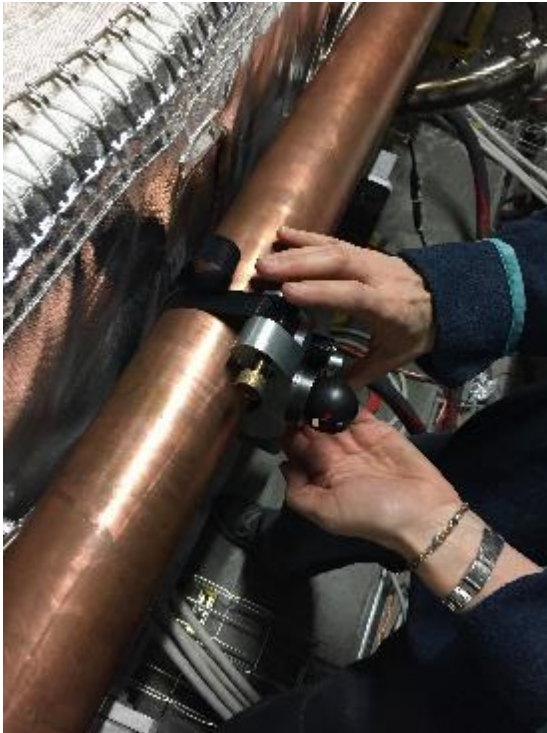
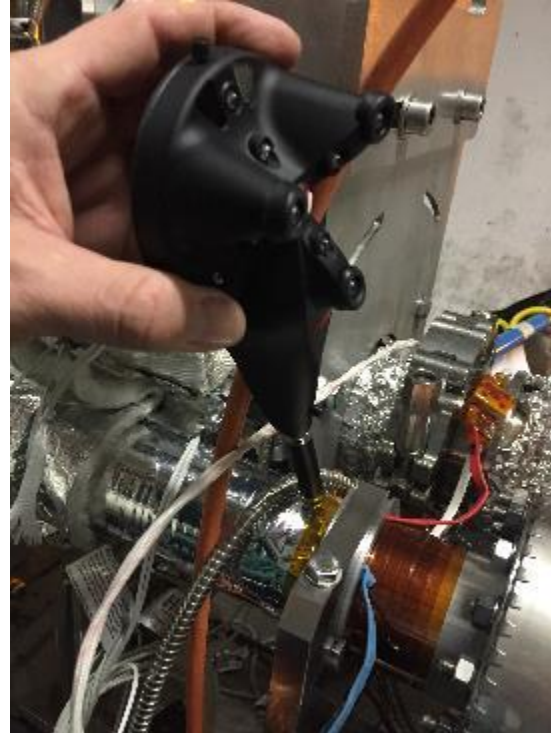
At the end SU measured the chamber axis

- Many obstacles
- Cannot be used for the alignment process
