The CMS Beam Condition Monitoring Leakage system at the LHC

Florian Kassel

PH-CMX-DS, CERN Institut für Experimentelle Kernphysik (IEKP), KIT

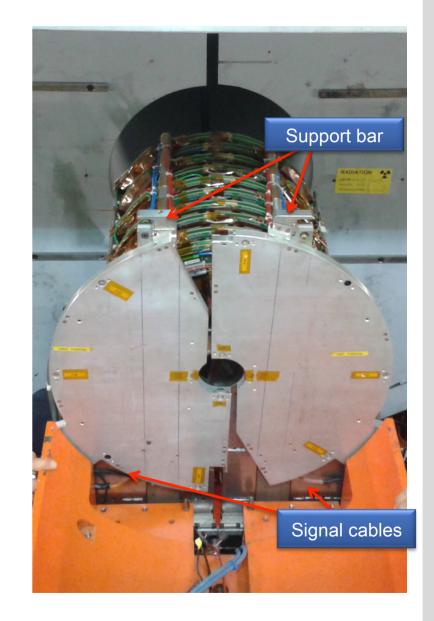
Upgrade of the BCML2 detector unit - Motivation

- Replacing or switching of diamonds sensors or of entire wheel should be possible with *minimum effort* and as fast as possible.
- 2. Regarding Phase 1: Mechanics have to be adjusted to increased beam pipe diameter
- 3. New design should allow the installation of sensors of different sizes:
 - Possible usage of 25x25 mm² sapphire sensors

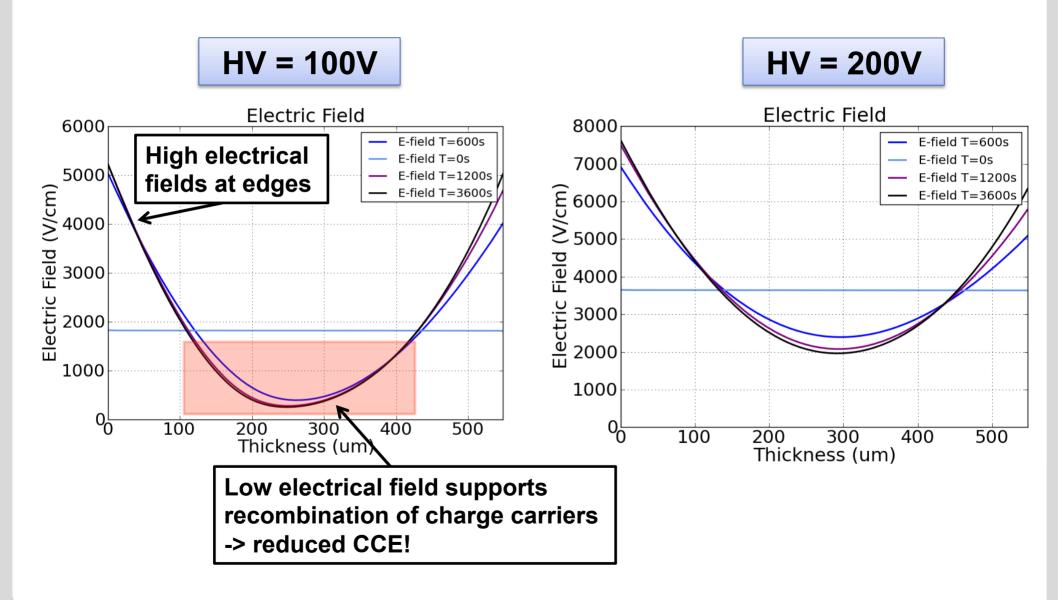
Backup:

Corresponding simulated electrical field
