FPCs Development at IHEP

RF Group (IHEP)

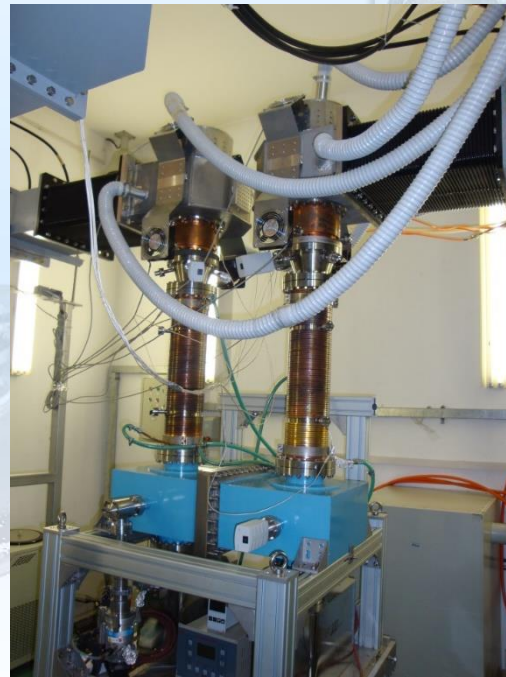
High power test stand
for 500MHz FPCs

CPL #	RT on stand test results
1#CPL_2008	270kW,CW,TW (Tested at KEK)
2#CPL_2010	300KW,CW,TW (Tested at KEK)
1#CPL_2010	420kW,CW,TW (Tested at KEK)
3#CPL_2008	180kW,CW,TW (Tested at IHEP, limited by the power source)

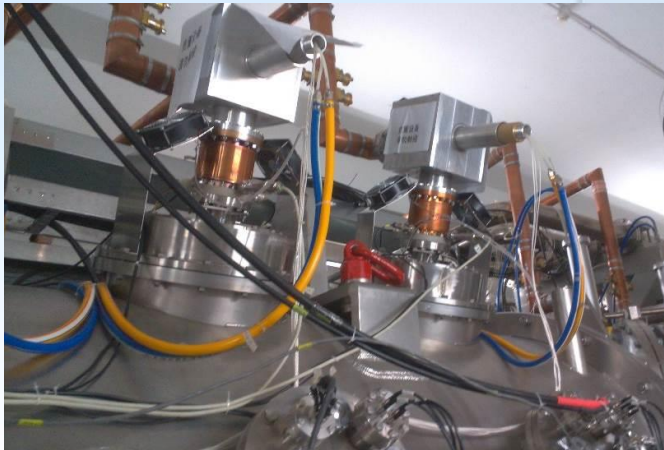
FPCs assembled with CM1 of Injector-I

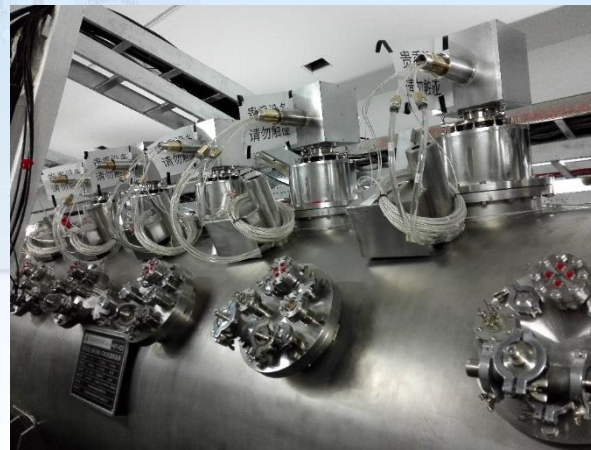
FPCs assembled with CM2 of Injector-I

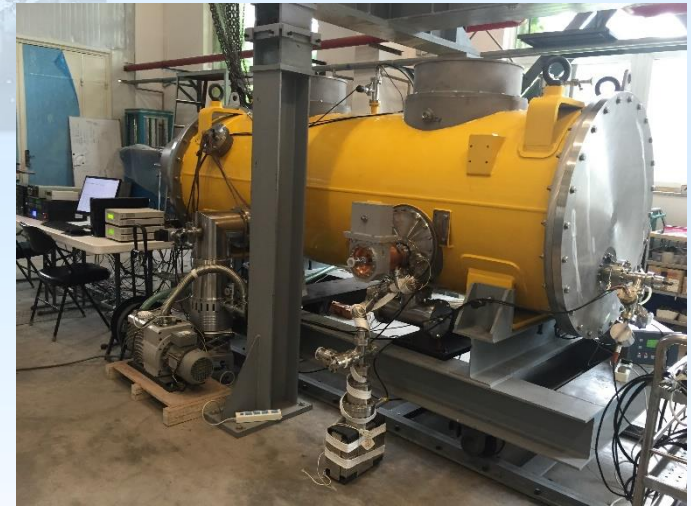
Integrated with cavity

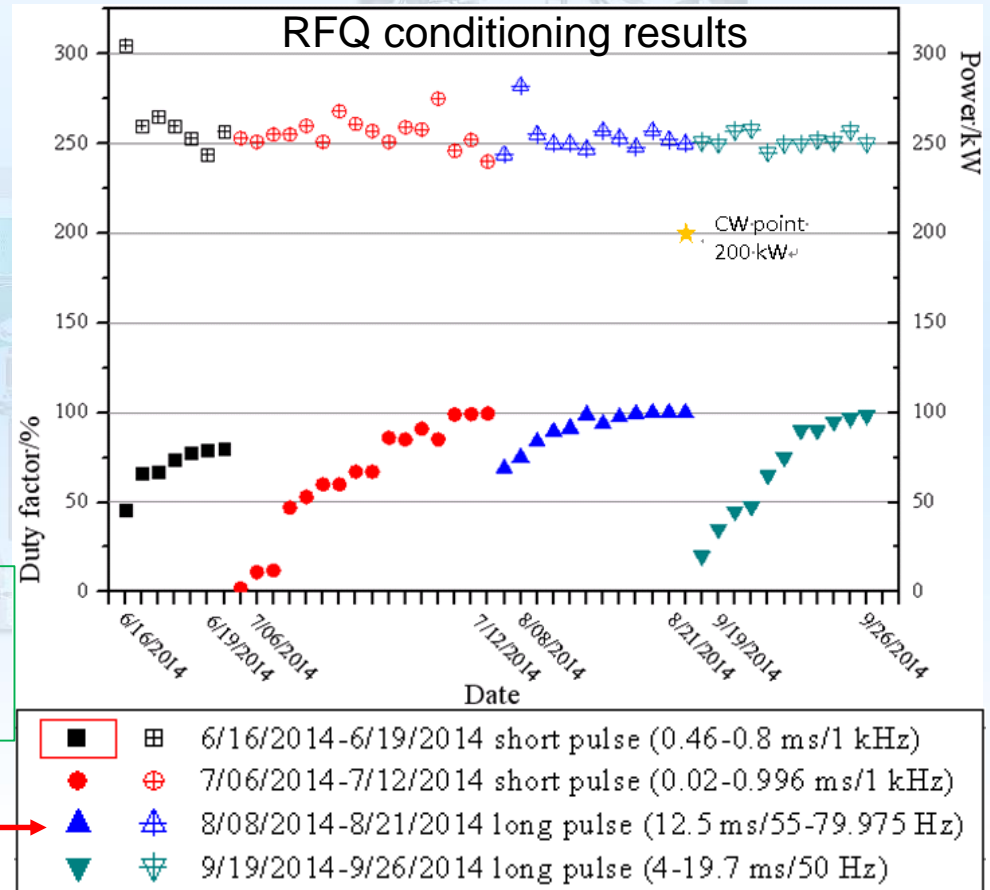
- Beam commissioning is still ongoing
- Reached: 11mA, 3.2MeV, DF: 90%
- Goal: 10mA, 3.2MeV, CW

99.97% duty →

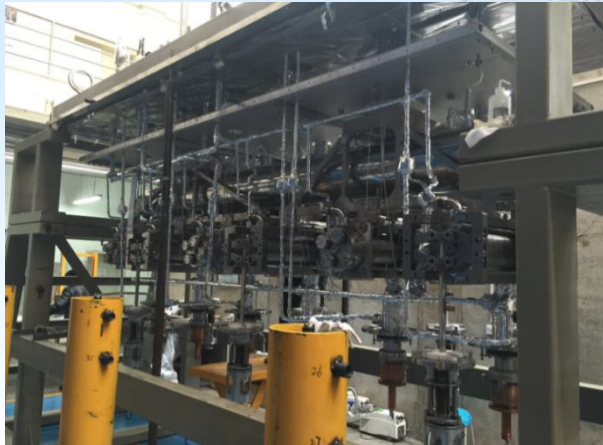
- We developed some new designs
 - Single warm window with short vacuum part, which can be assembled with cavity in class 10 clean room:
 - Special cryo-module design to assure the coupler can be assembled with cavity in class 10 clean room.
 - Two warm windows → improve the vacuum safety (Designed by Yongming Li, IMP)
- Any comments about above designs?

CM1 of Injector-II for C-ADS:
cuboid shape cryo-module

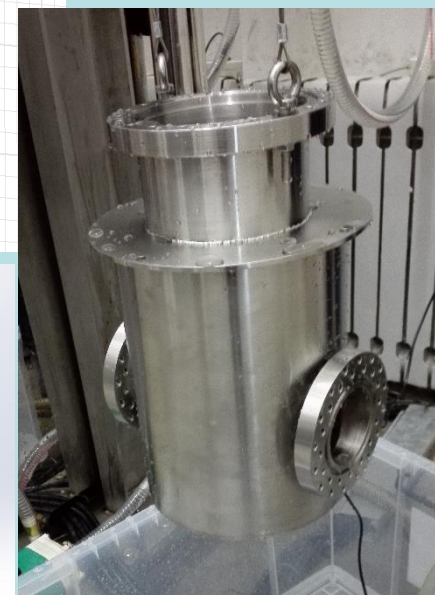
- Two test benches (162.5MHz & 325MHz) based on an approximate capacitor-loaded coaxial cavity has been developed.
- One new 325MHz test bench based on QWR cavity developed: more compact

325MHz Test benches based on QWR cavity

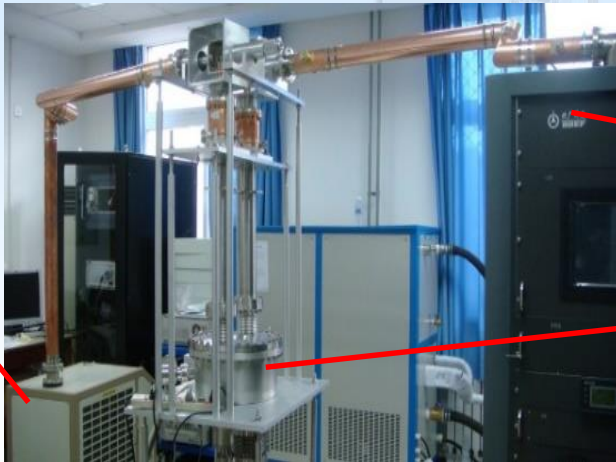
Dummy load

10 kW Solid amplifier

Test bench

325MHz Spoke012 CPL test system

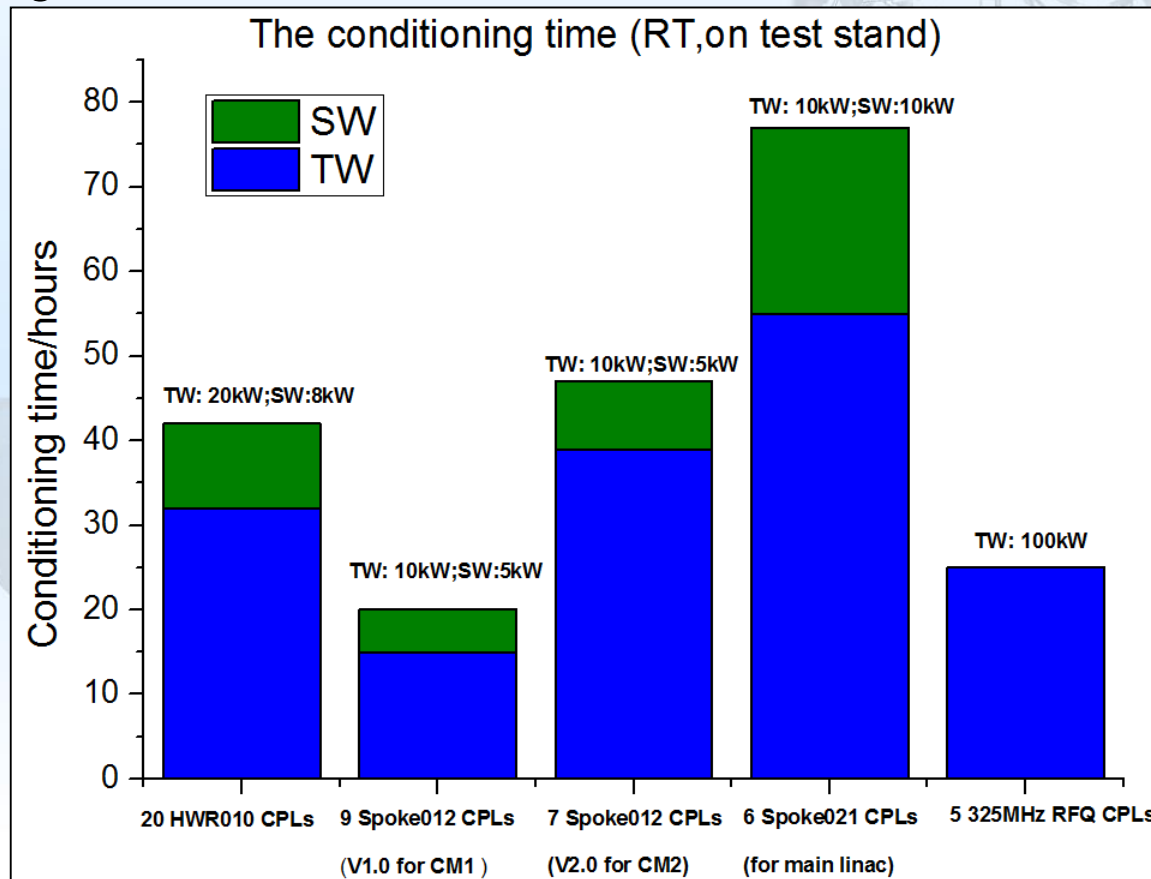
- More than 40 couplers has been high power tested up to the nominal power level since 2012.
- Both traveling and standing wave with removable short circuit conditioning are done in RT test stand.

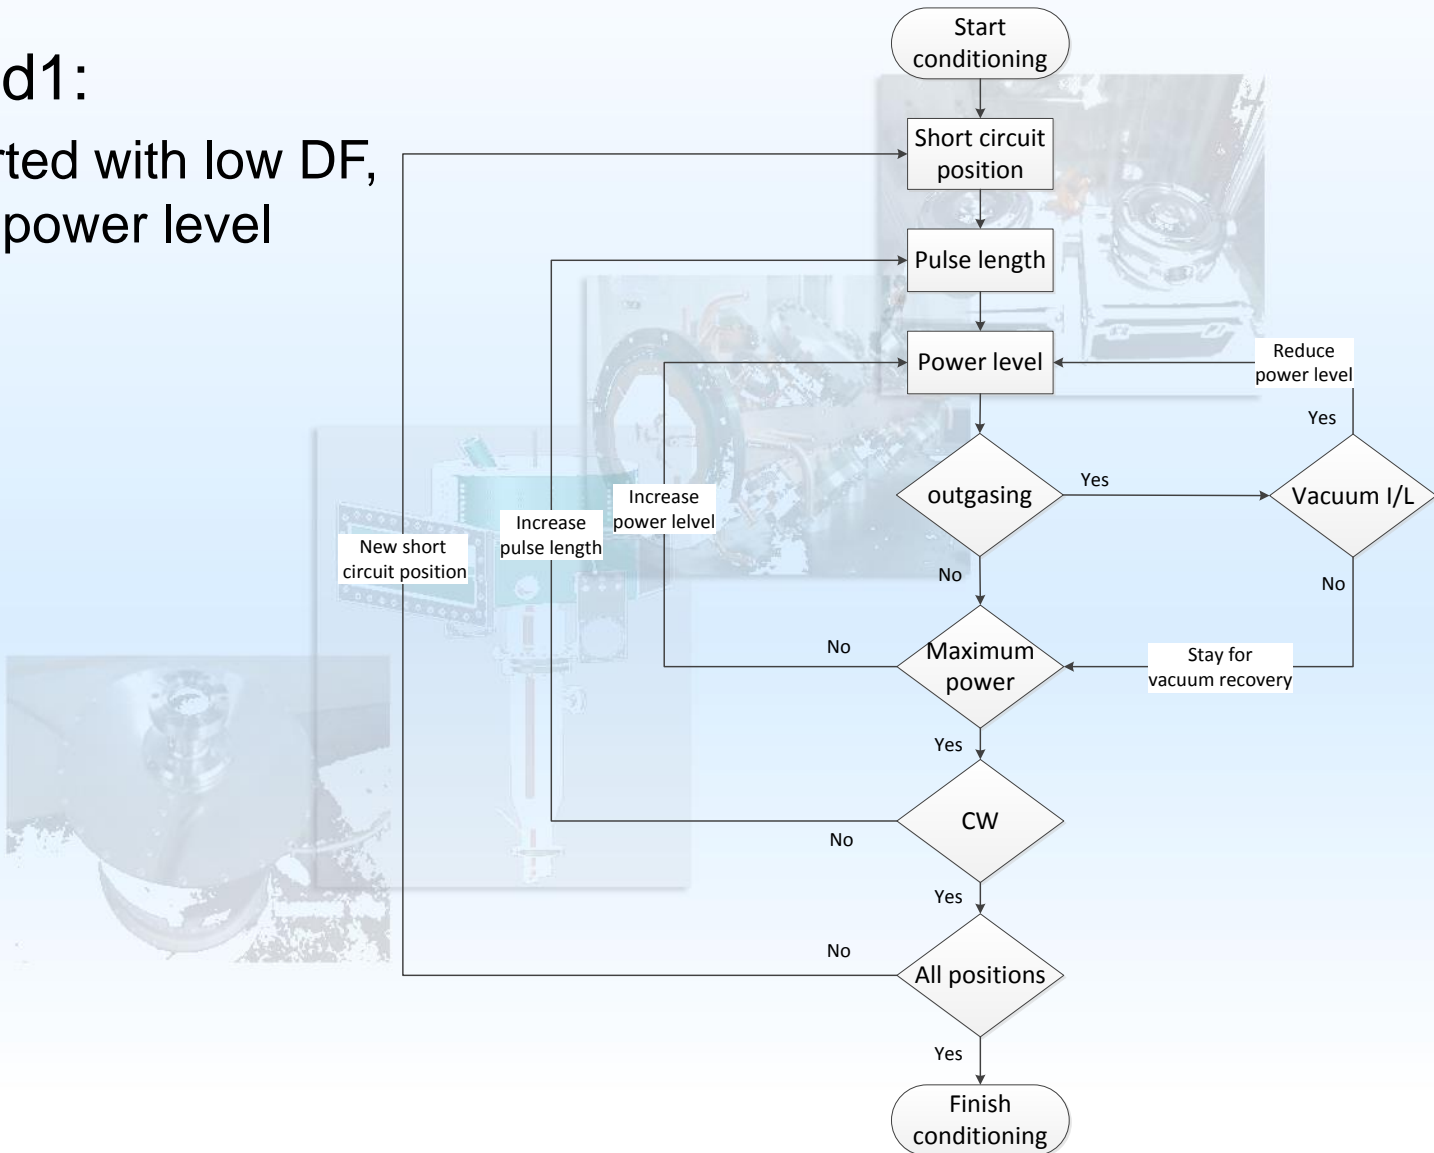
- Method1:
 - Started with low DF, low power level

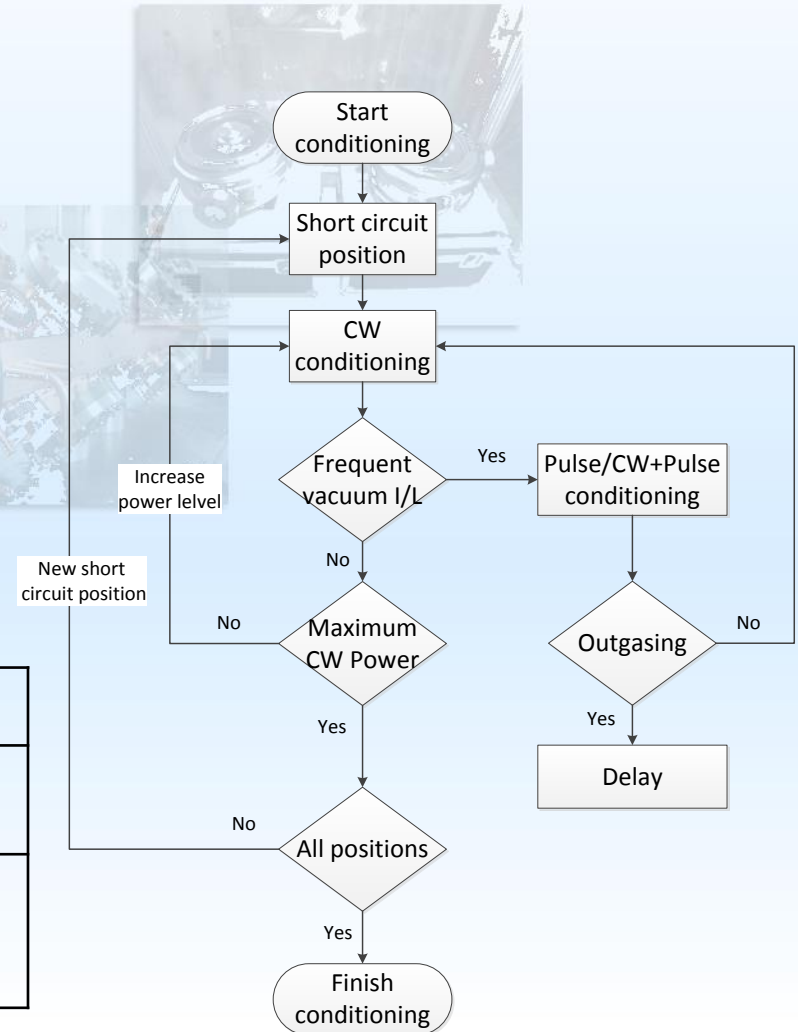
- Method2:
 - Started with CW, low power level
 - Change to pulse or 'CW + pulse' conditioning when vacuum interlock happened frequently
- **Question:**
 - Which method is better?

Pros.	Cons.
Method1	• More safe	• ?
Method2	• More efficient sometimes	• More dangerous if serious outgasing and arc happened

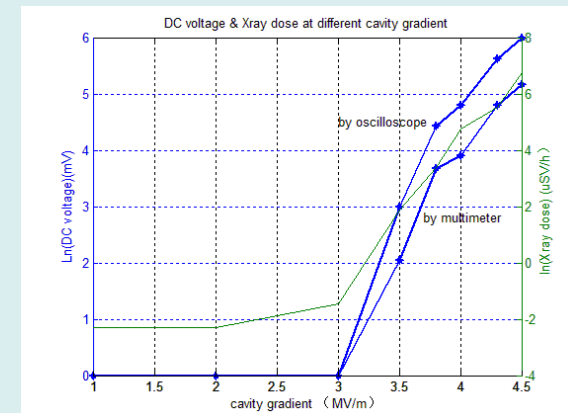
The expected DC voltage was detected accompanying the X-ray dose arising.

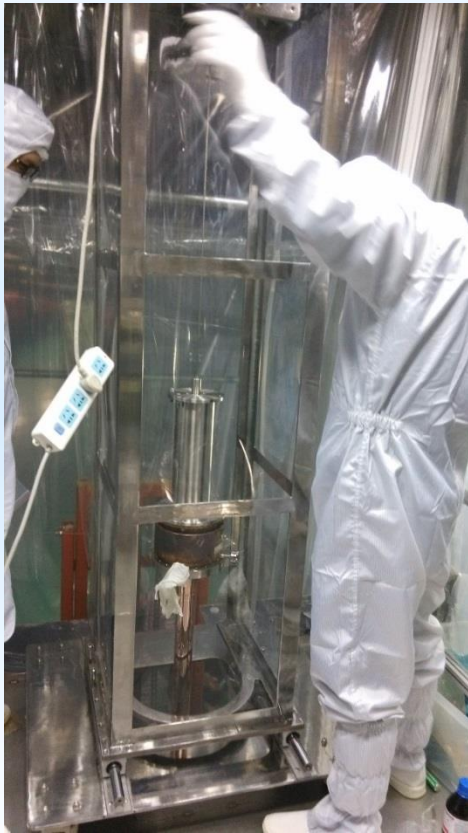
Old window taken out

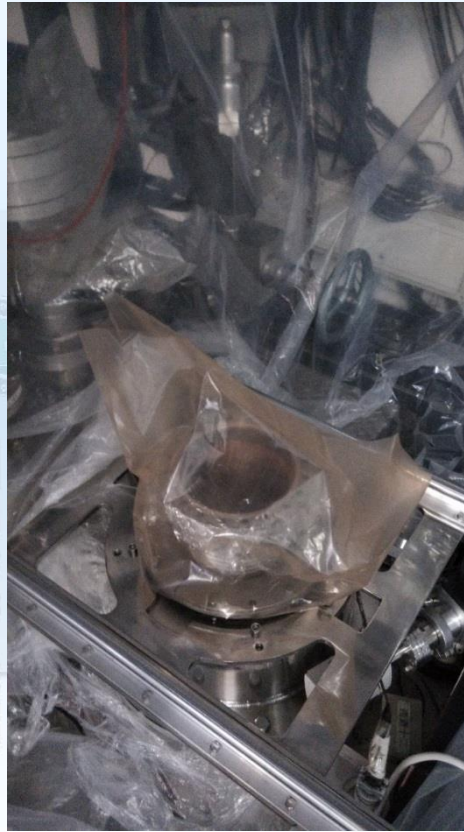
The coupler port covered with clean PVC plate (down) and plastic film (up)

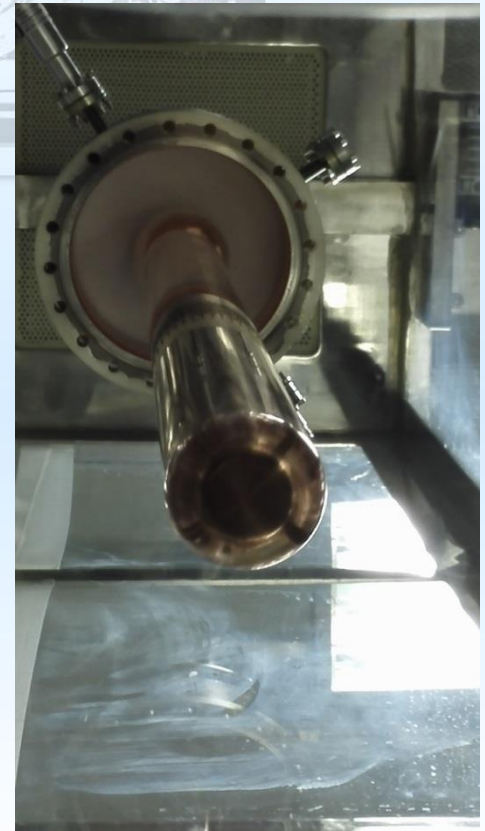
New window pick up from the container by clean booth

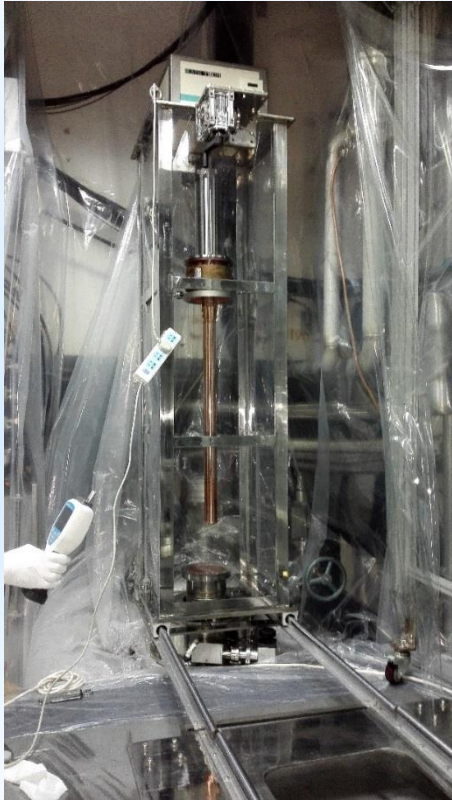
New window move into place

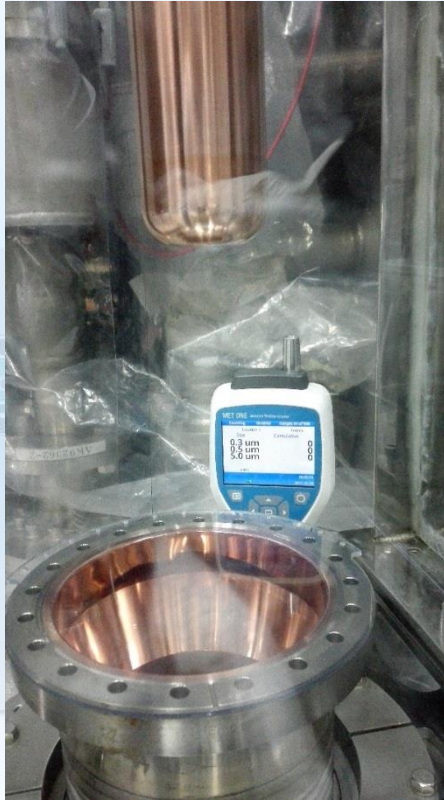
New window waiting for put down:
particle measuring
