352 MHz POWER COUPLER DEVELOPMENTS FOR THE ESS

PROTOTYPE COUPLERS

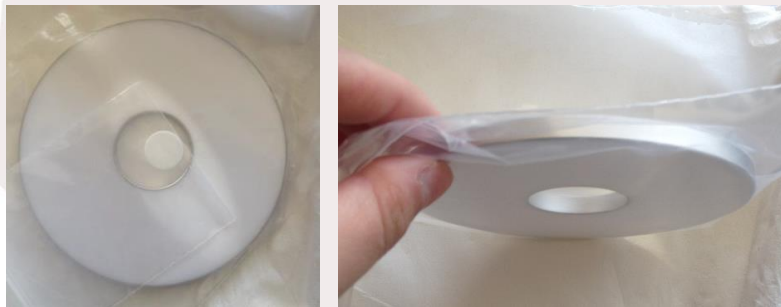
SCT

- Alumina ceramics manufacturer.
- Brazing facilities.
- TiN deposit achieved before the brazing step.

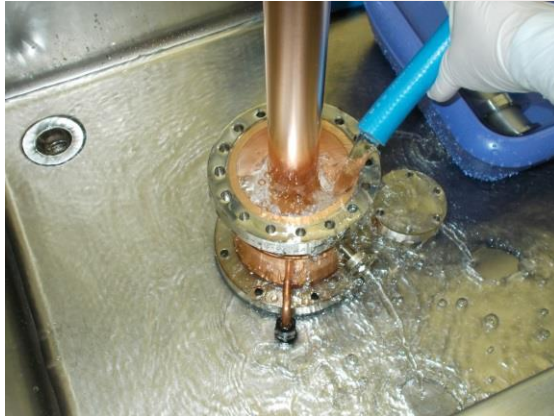
- ❑ Cleaning in clean room iso class 100
- ❑ Ultra Pure Water (UPW) rinsing
- ❑ Blowing with N2 in clean room iso class 10
- ❑ UV lamp to see dusts on metal parts
- ❑ Particle counting

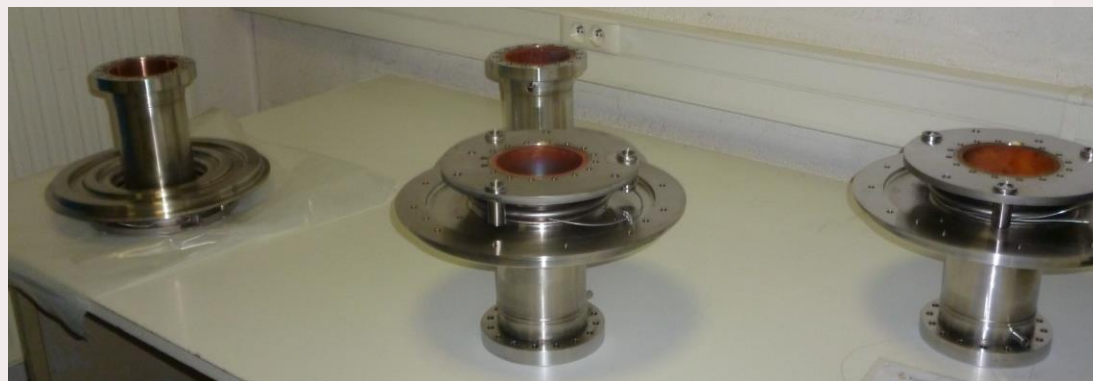
Four heat exchanger with Copper deposits have been manufactured

Copper deposit of three exchanger on four have a poor visual appearance

On one heat exchanger a part of the Cu deposit was torn under the pressure of the HPR (50 to 100 bars)

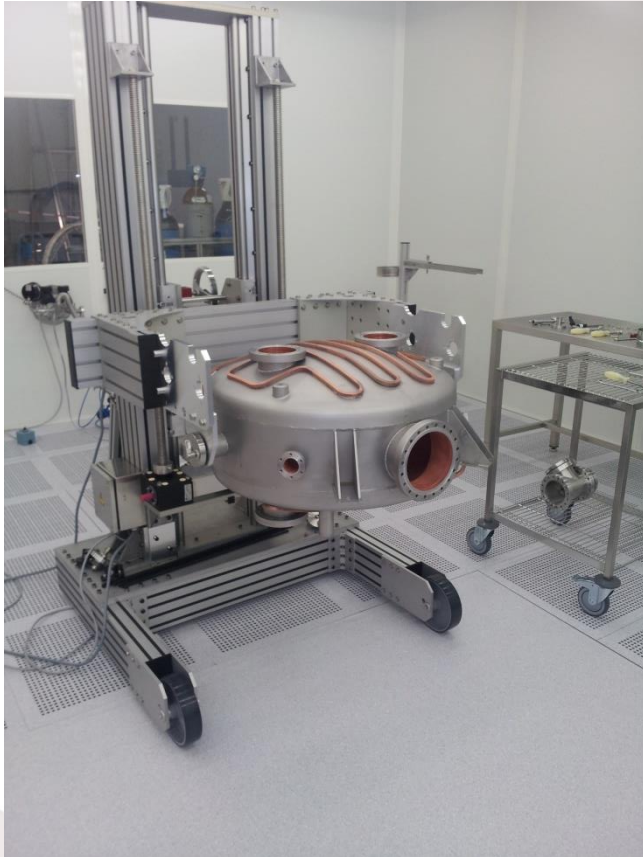
Handling truck

- ❑ Cleaning of the RF conditioning cavity with High Pressure Rising system (HPR)
- ❑ Use of handling truck to facilitate the cleaning and the assembly of vacuum components

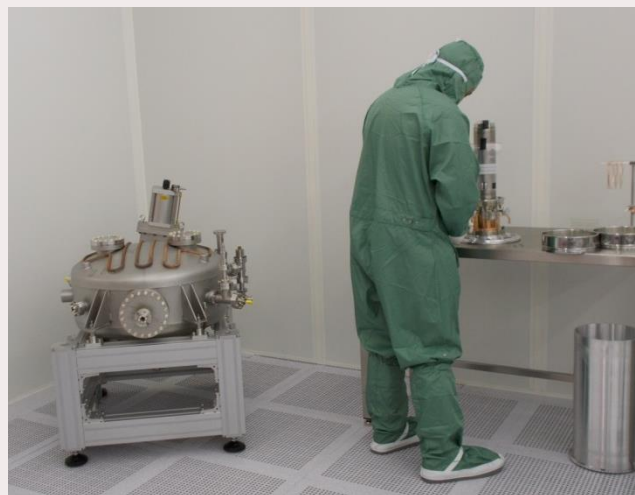
Checking the cleanliness

- ❑ Particle counting on each coupler with adapted accessories to lead the N₂ flow

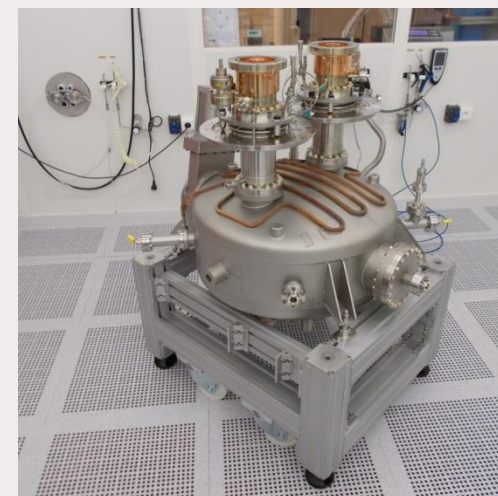
- ❑ Use of heating cables associated with thermocouples which are monitored by a temperature controller
- ❑ Cover with Aluminum foil to distribute the heat
- ❑ Monitor the baking by a LabView program

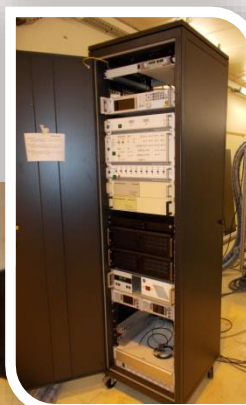
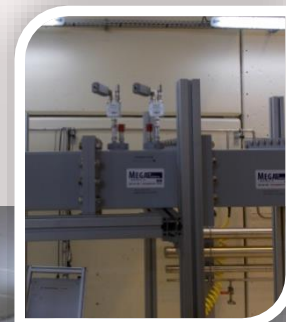
RF CONDITIONING TEST STAND

- ❑ Standing wave configuration
- ❑ Short circuit has been motorised by a step

by step engine

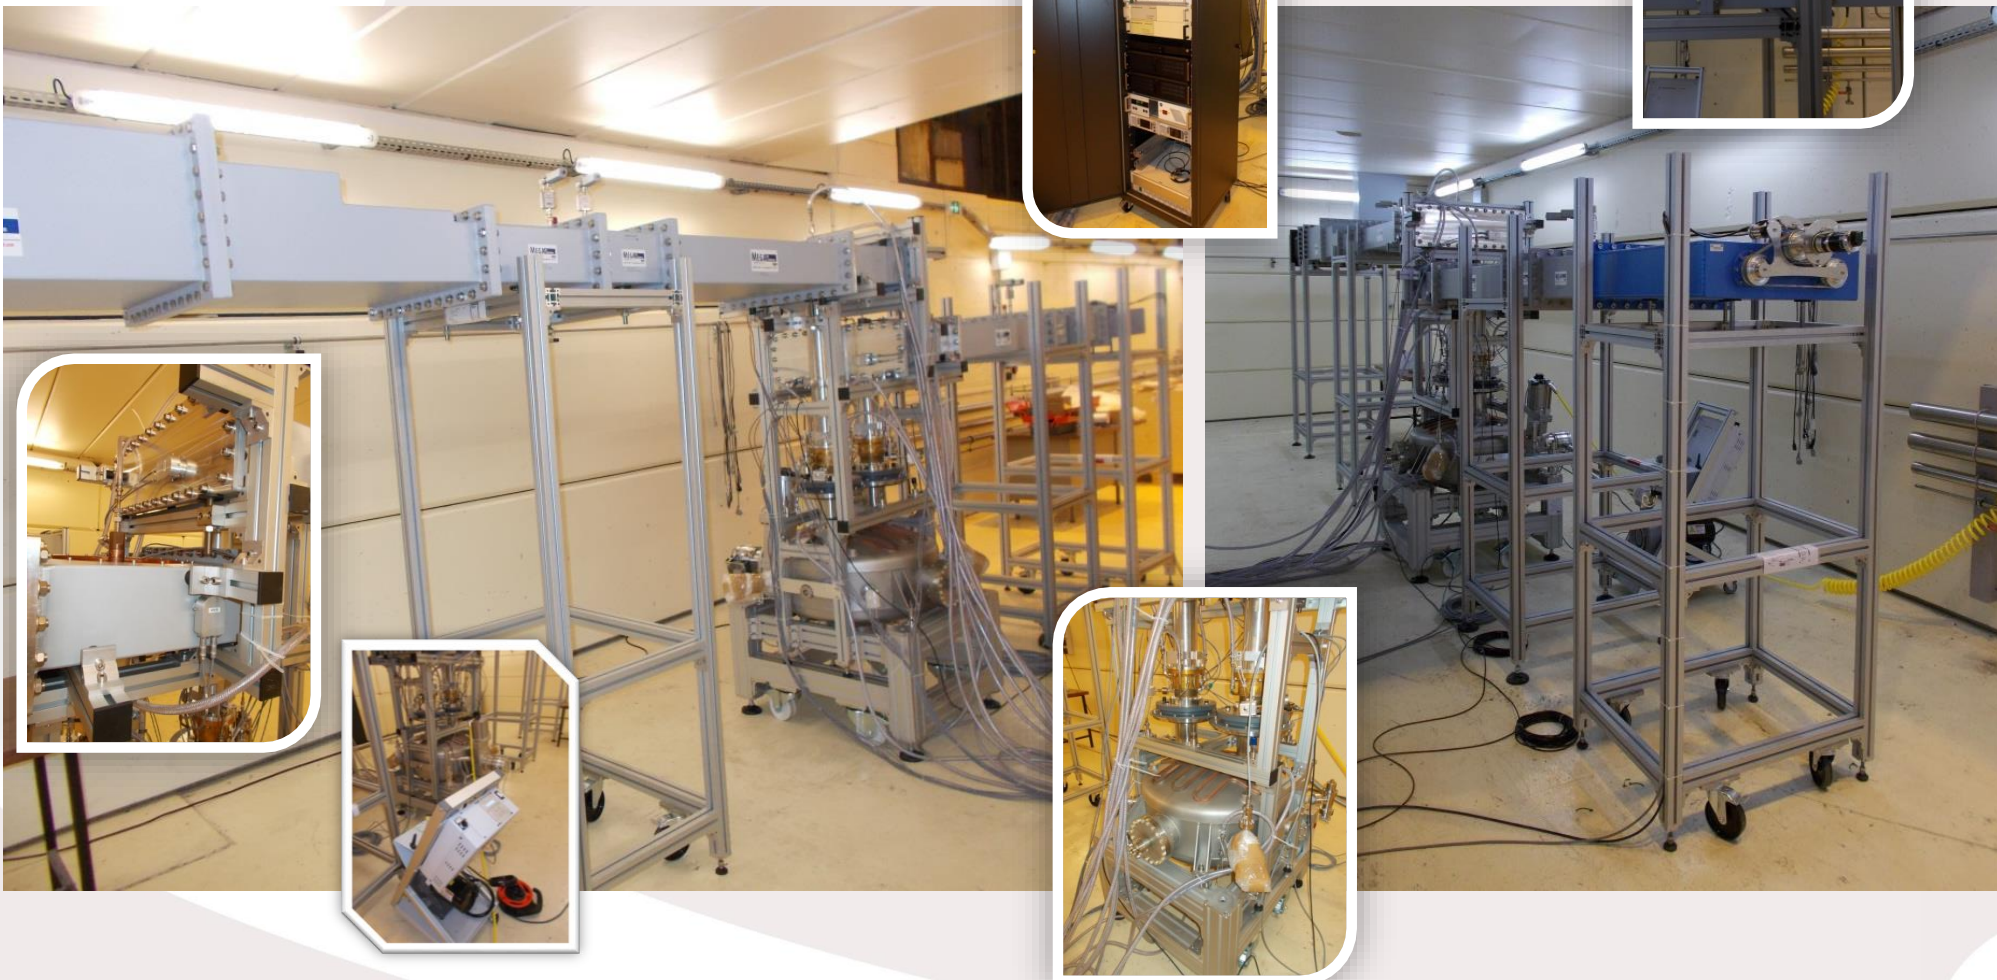
- ❑ RF conditioning of two SCT couplers
- ❑ Short circuit located to have RF peak power on the ceramic of the input coupler
- ❑ RF conditioning with four pulse widths : 20 μ s - 300 μ s - 1.5 ms 2.86 ms
- ❑ 400 kW RF on input coupler and 250 kW RF on output coupler
- ❑ All safeties have been take off inadvertently
- ❑ RF conditioning until a RF pulse of 2.86 ms and sudden rise of vacuum level \rightarrow 0.6 mbar
- ❑ Lead to the break-in of the Input power coupler

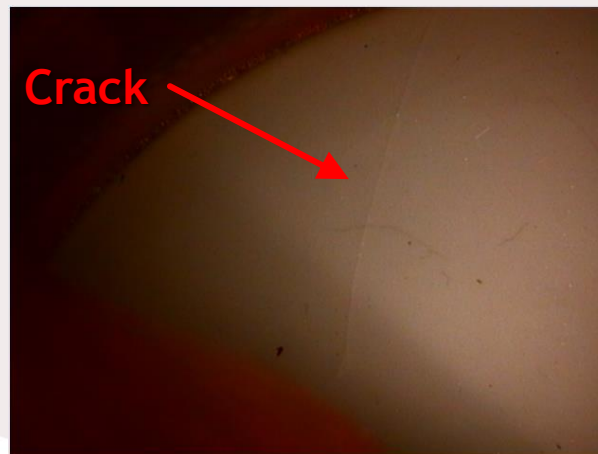
**Black draw
on the surface**

- SCT compagny

Input cavity coupler → ceramic broken

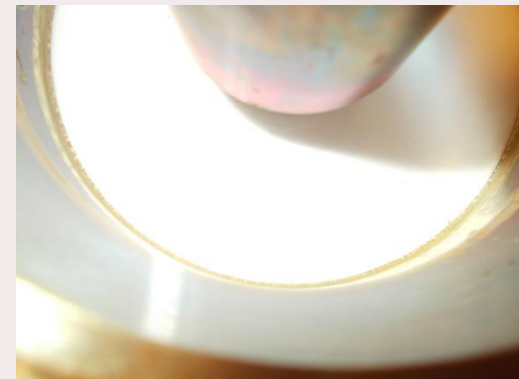
Antenna side

Output cavity coupler → sealed

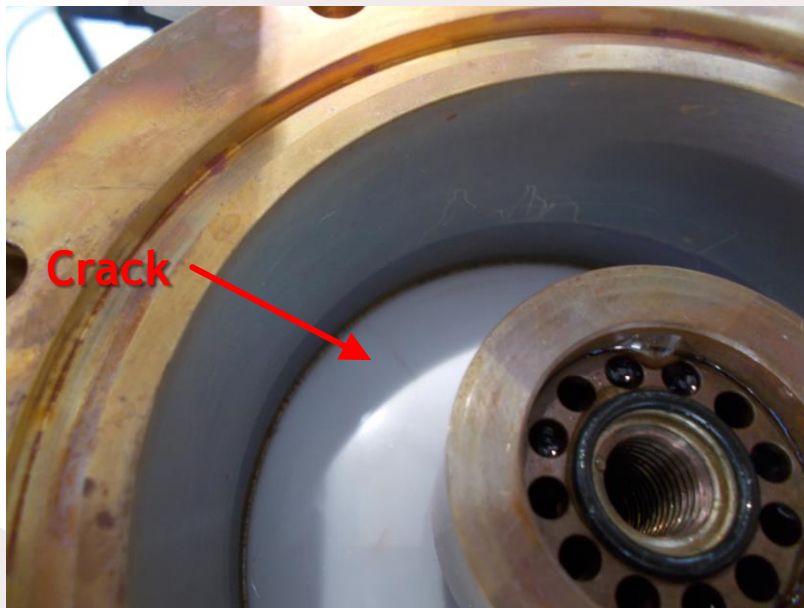
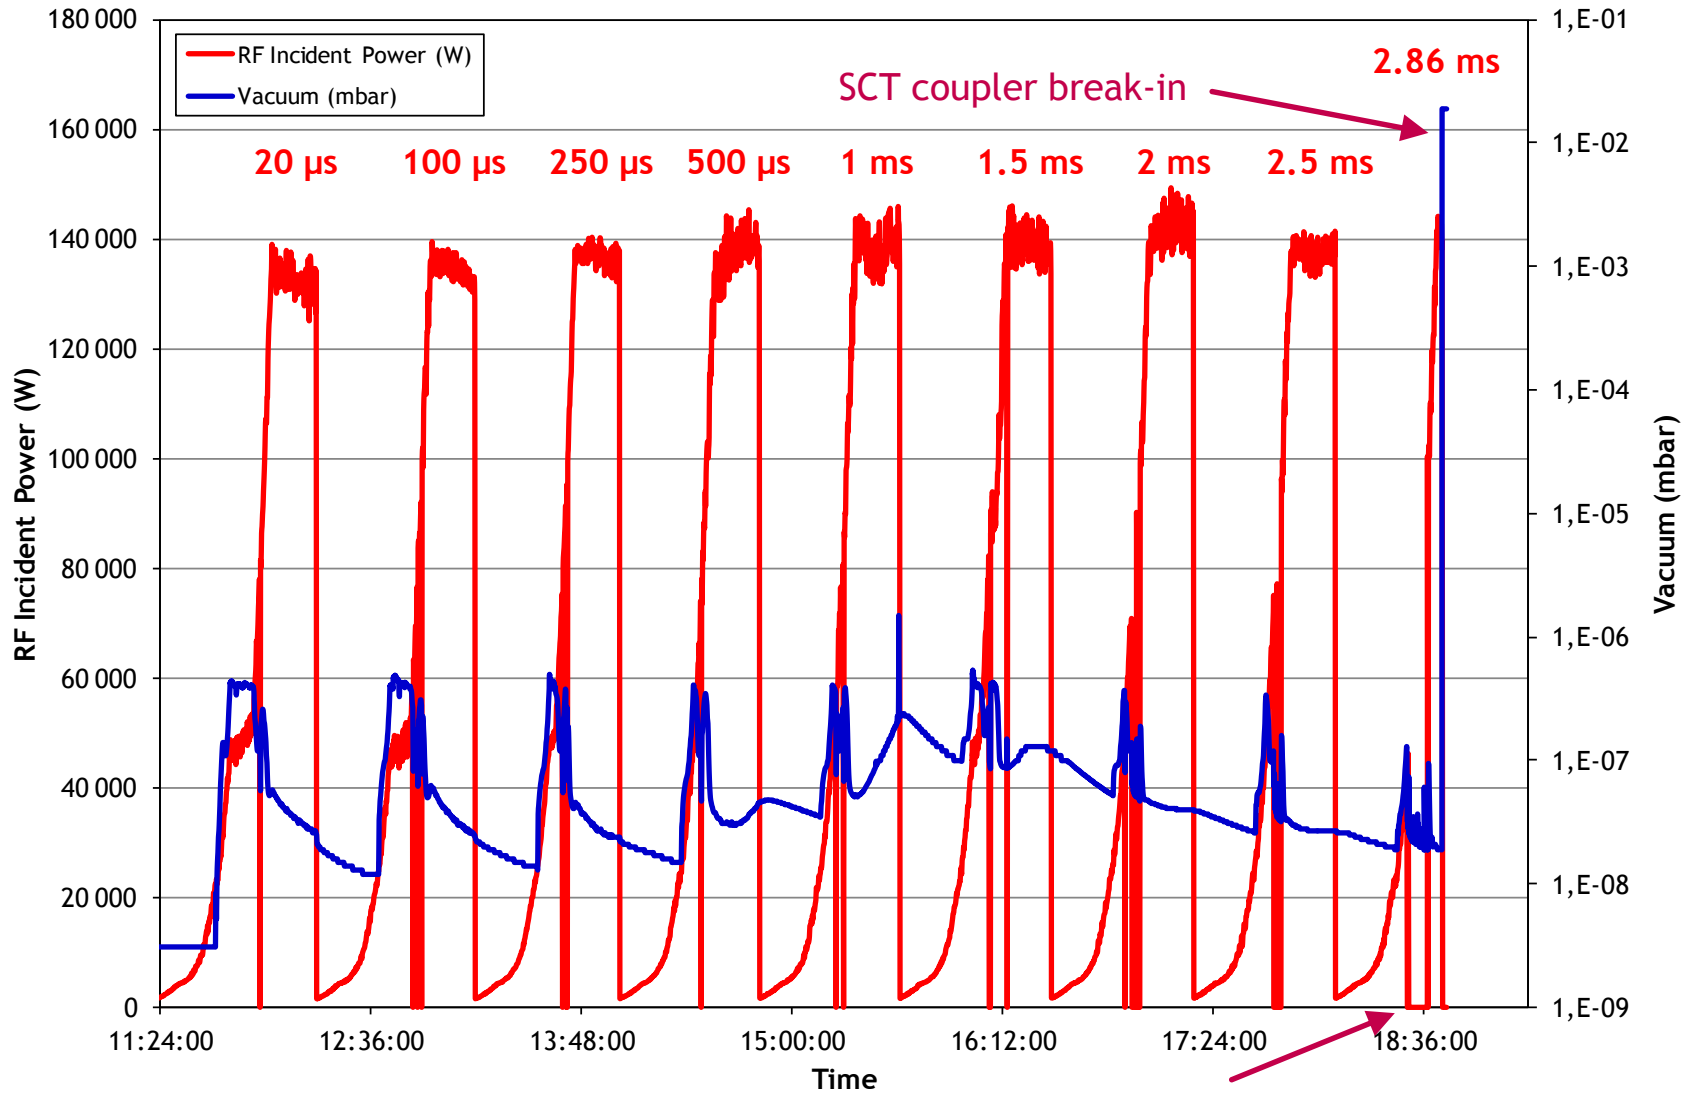
SECOND RF CONDITIONING (06/2016)

- ❑ RF conditioning of one PMB coupler (input) and one SCT coupler (output)
- ❑ Short circuit located to have RF peak power on the ceramic of the input coupler (PMB)
- ❑ 400 kW RF on input coupler (PMB) and 250 kW RF on output coupler (SCT)
- ❑ All safeties have been take on
- ❑ RF conditioning until a RF pulse of 2.86 ms and suden rise of vacuum level → 0.1 mbar
- ❑ Lead to the break-in of the Output power coupler (SCT)

- ❑ No particular event when the ceramic broke even before
- ❑ Short circuit located to have RF peak power on the ceramic of the input coupler (PMB)
- ❑ Conditioning at 400 kW RF on input coupler (PMB) and 250 kW RF on output coupler (SCT) with a 2.86 ms RF pulse width at the time of the break-in
- ❑ PMB coupler is intact visually - no trace of electron activity and/or heating
- ❑ Was the SCT coupler damaged further to the first RF conditioning ?
- ❑ Investigation:
 - Thickness of TiN deposit is in accordance with the IPNO specification (for all couplers)
 - SCT couplers solders are coarser than PMB
 - Perhaps SCT compagny must adapt their manufacturing process to more important thermomechanical stresses ?
