MQXFS-3 test result

6th HL-LHC Collaboration Meeting
Espace Saint Martin, Paris, 15th Nov. 2016

MQXFS-3 test report

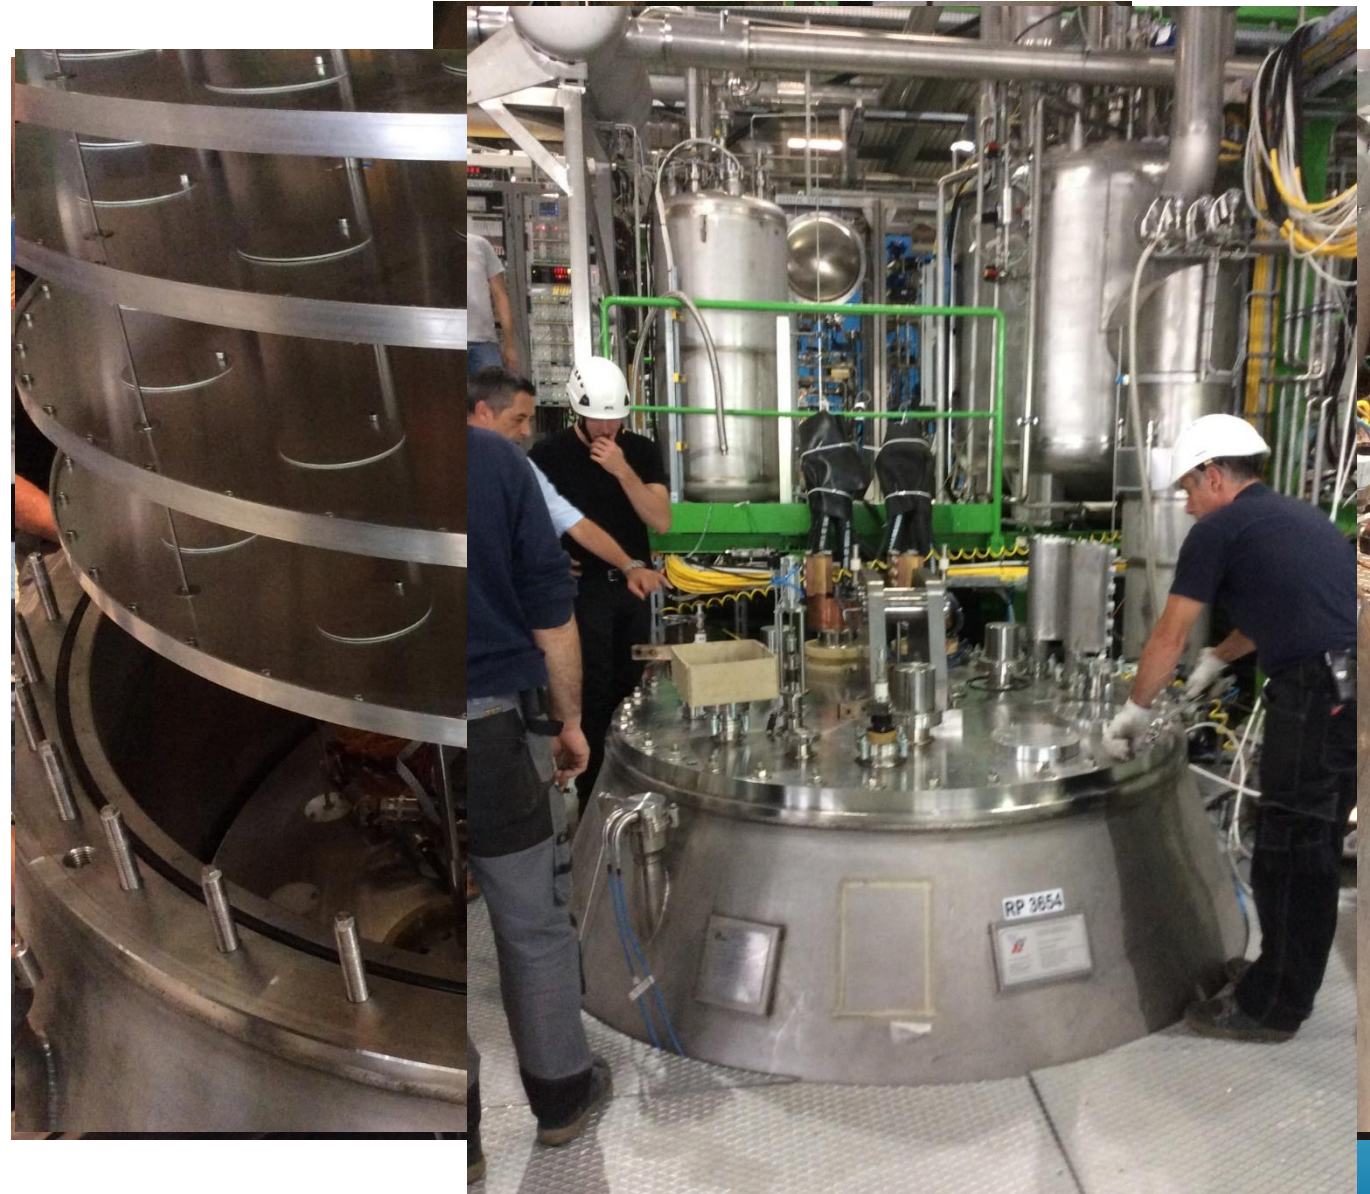
- High Field Magnet facility
 - Cluster D
 - Commissioning in Dec.
 - HFM
 - (FreSCa2)
 - Commissioning
 - Jun-August-October
 - 4.3 K OK
 - 1.9 K not reached in October
 - Limited to 2.1 K
 - Investigation on-going

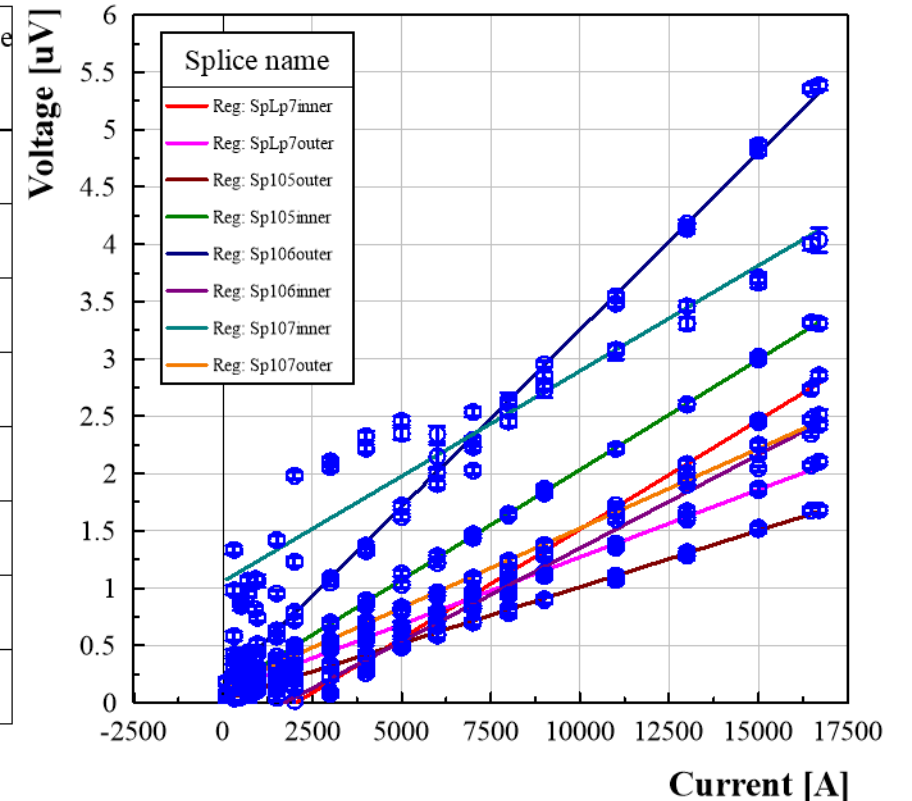
- Preliminary tests
 - RRR measurement
 - C105(140), C106(140), C107(140), Lp7(170)
 - Low current discharge
 - Splice resistances

Splice name	Splice resistance [nΩ]
SpLp7inner	0.190
SpLp7outer	0.117
Sp105outer	0.0984
Sp105inner	0.192
Sp106outer	0.309
Sp106inner	0.163
Sp107inner	0.184
Sp107outer	0.139

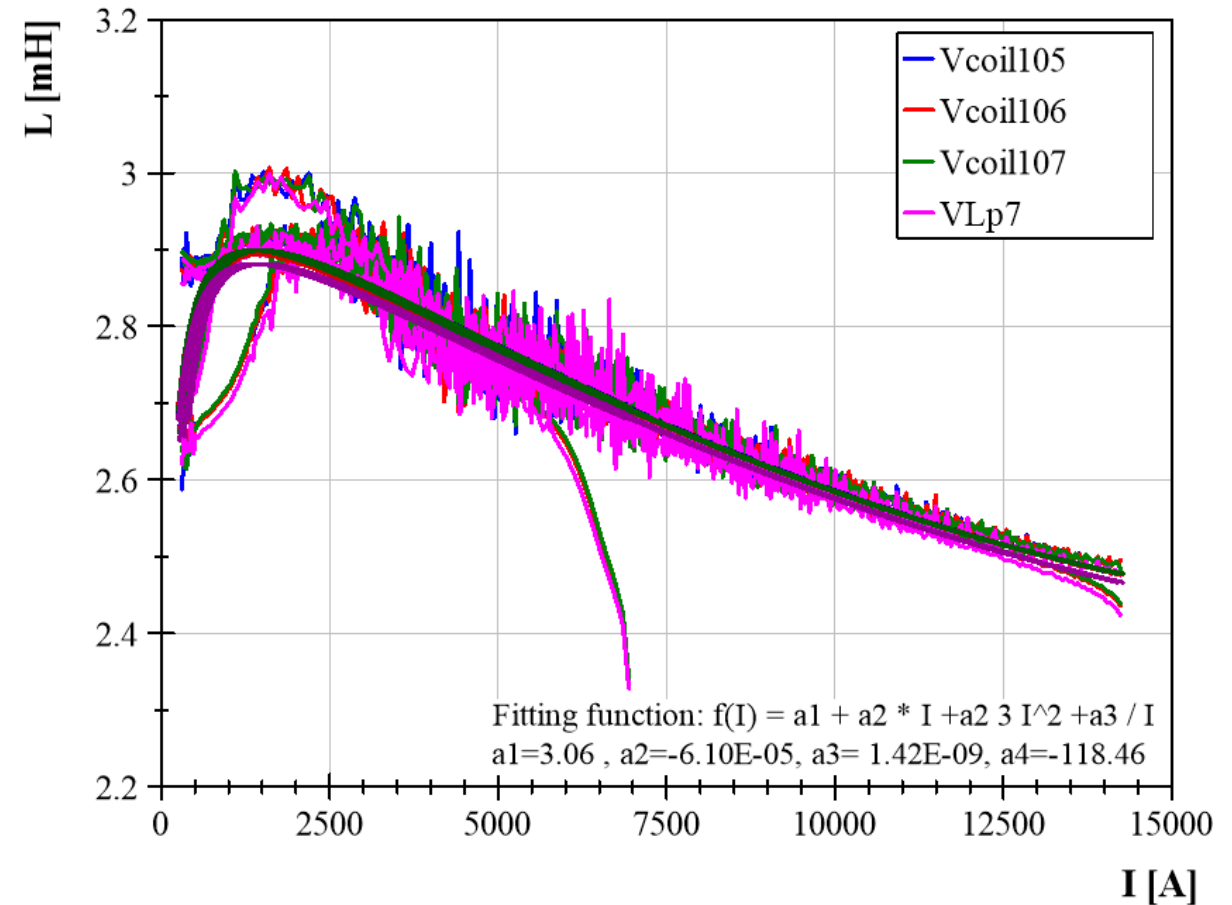
- Preliminary tests
 - RRR measurement
 - C105(140), C106(140), C107(140), Lp7(170)
 - Low current discharge
 - Splice resistances
 - Coils Inductances
 - Non-linear behavior
 - magnetisation < 2.5 kA
 - Iron saturation without stabilisation)

Quench file: MQXFS_Inductance_2016_10_14-11_23_27_dmm.csv

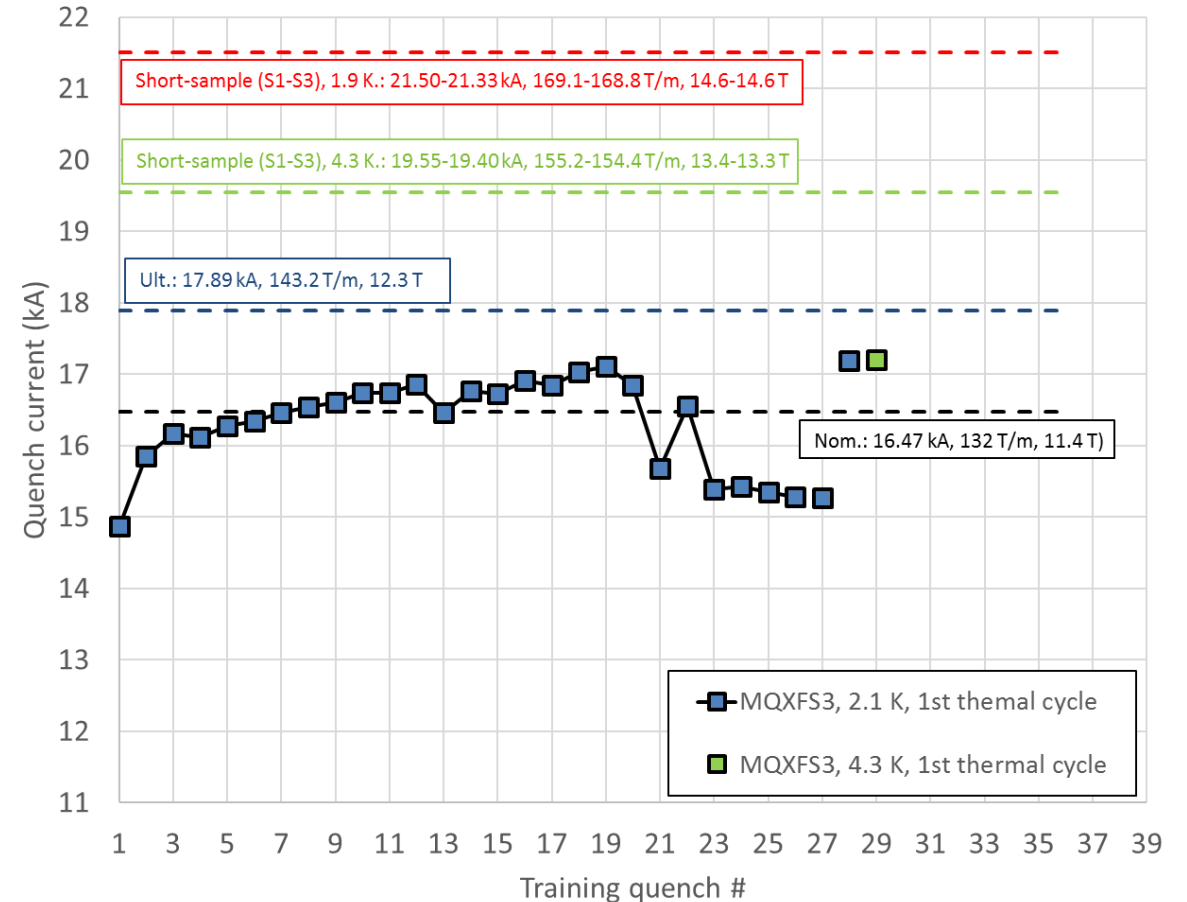
- Magnet performances
 - @ 2.1 K
 - 1st quench at 91% Inom
 - Highest quench
 - 104 % Inom, 96% Iult, 81% Iss

- Performance check @ 4.3 K
 - 89% Iss

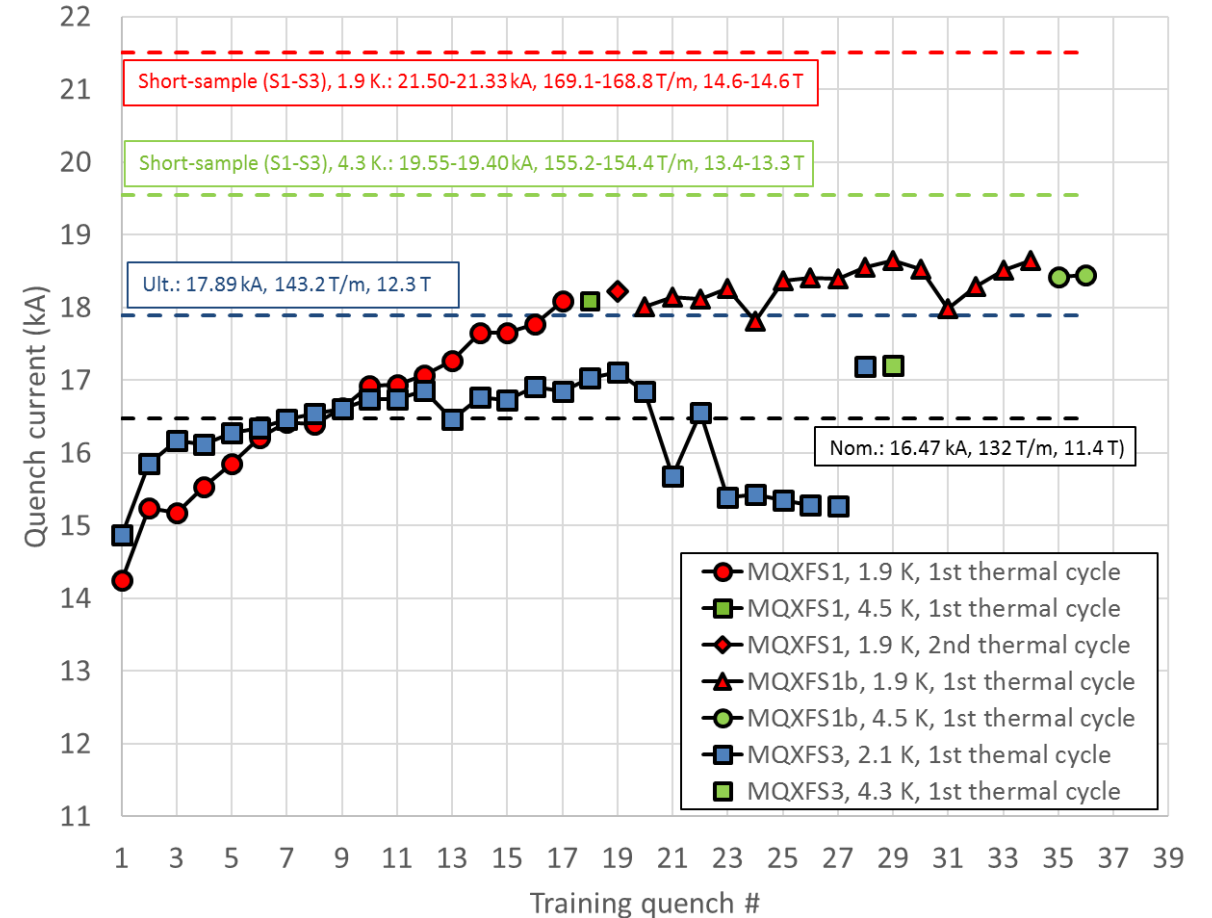
- Magnet performances
 - @ 2.1 K
 - 1st quench at 91% Inom
 - Highest quench
 - 104 % Inom, 96% Iult, 81% Iss

- Performance check @ 4.3 K
 - 89% Iss

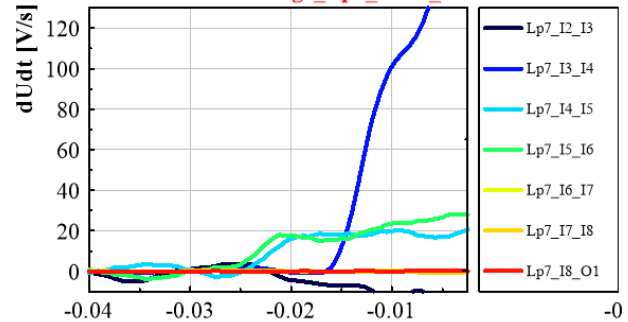
Quenches in the straight part with transverse propagation to first block (I3-I4)

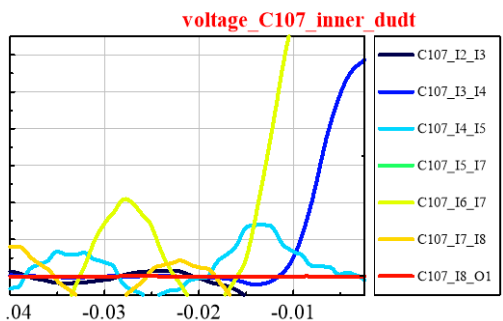
Quenches in pole head (1st turn or 1st block)

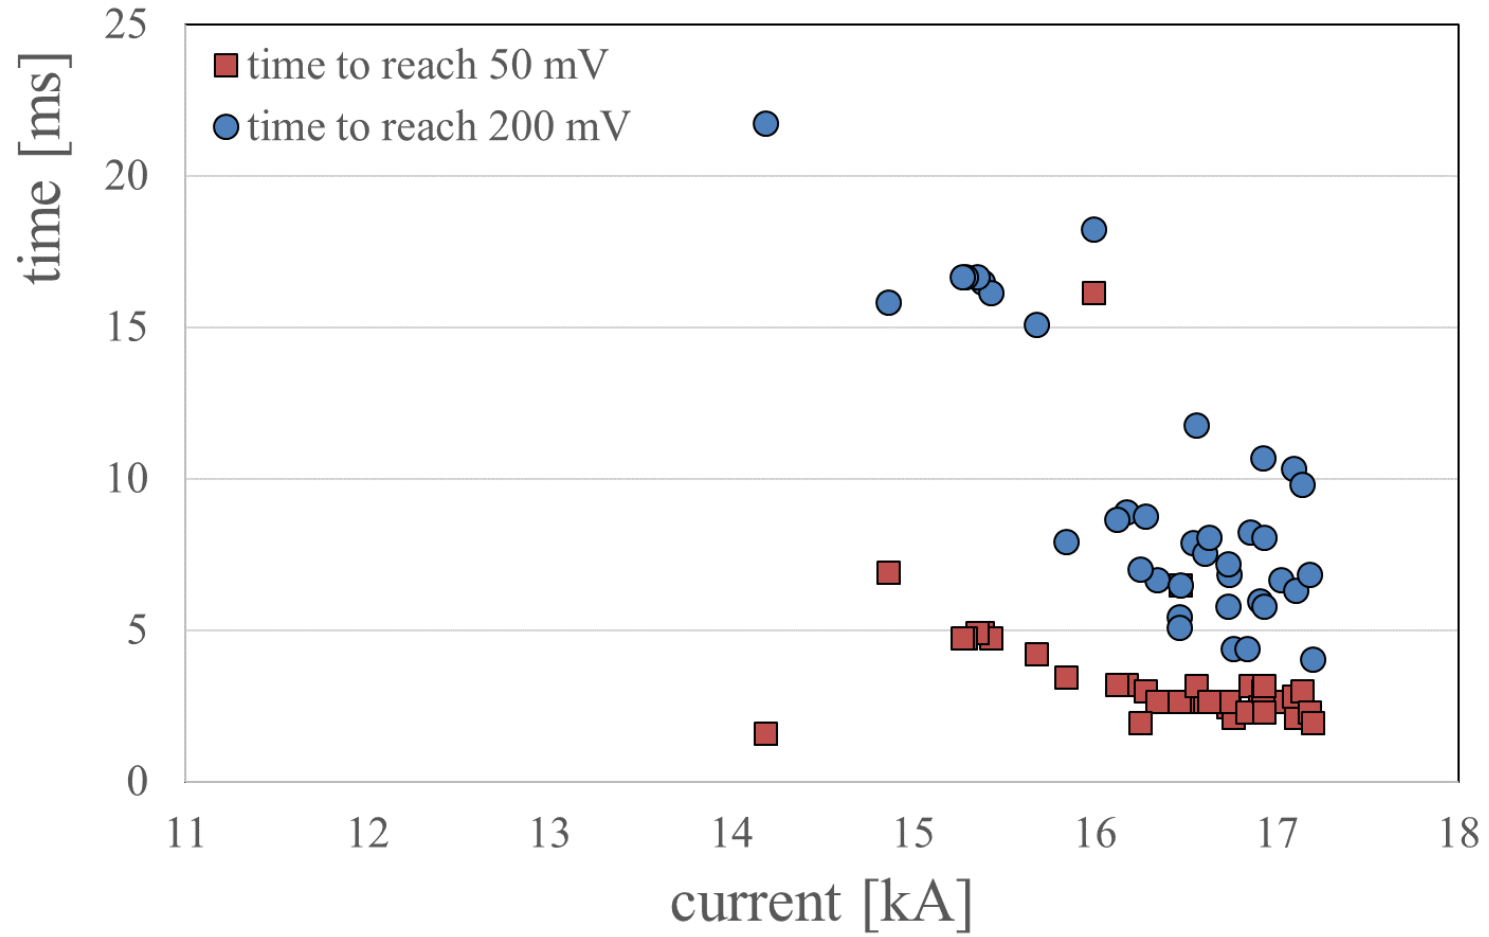
Detection time on differential signal

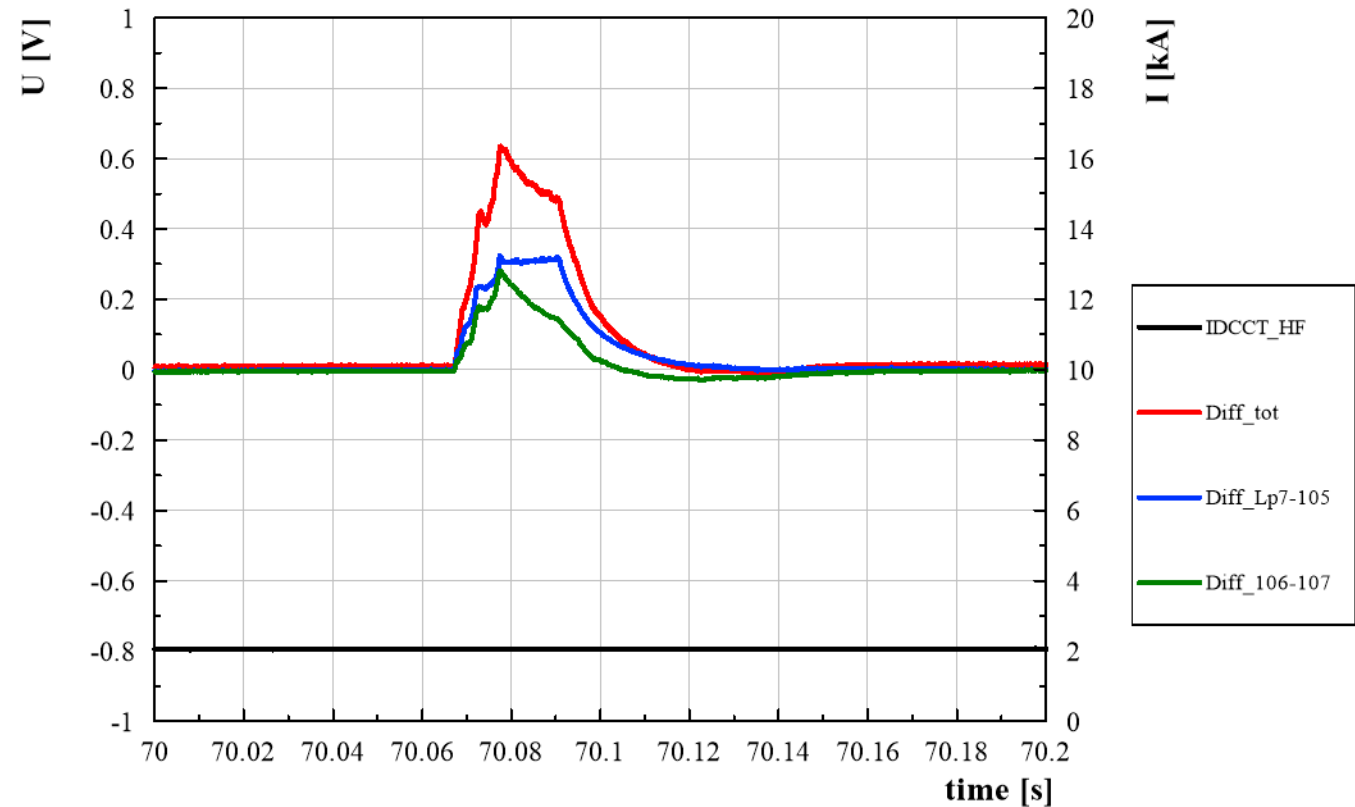
Zoom on the jump (~5-20 ms, 100-600 mV)
