# Cavity-Coupler Treatment & Testing

Preparation of crab cavities for KEKB

RF aging of input couplers.

17<sup>th</sup> September 2009 , LHC-CC09 at CERN

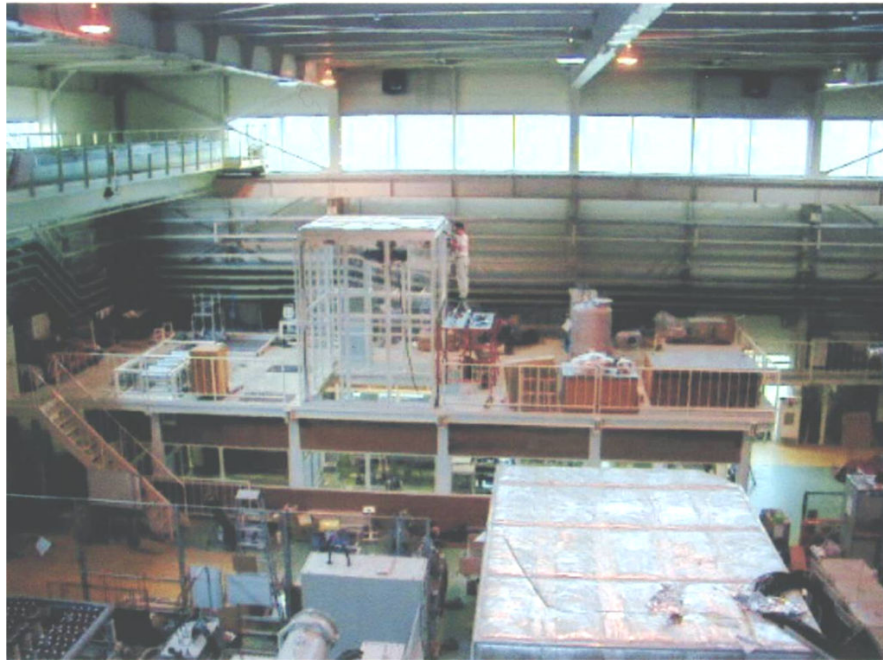
Fabrication Space

Clean room (class 100) for cavity assembling

Barrel Polishing

High pressure rinsing

Clean room for cryostat assembling

This area is shut down to expand ATF(2).

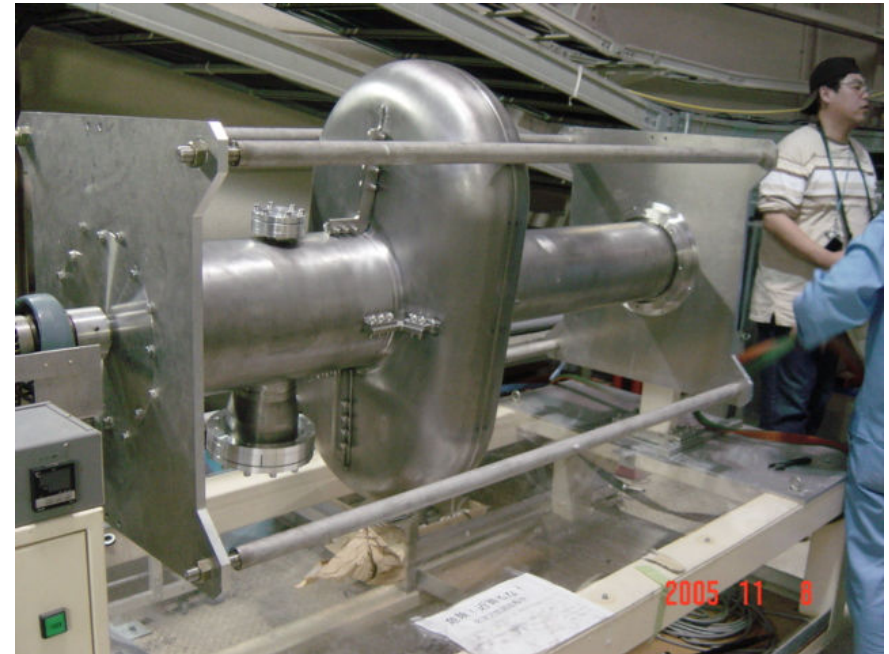
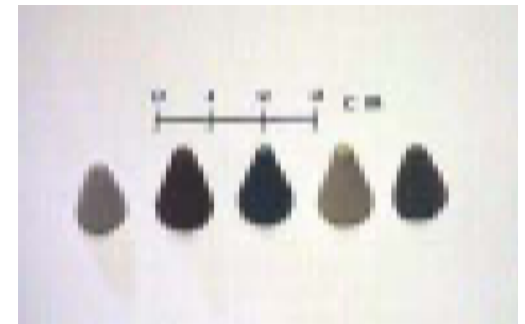
Barrel Polishing

Polishing Time 312 Hr

20RPM

media

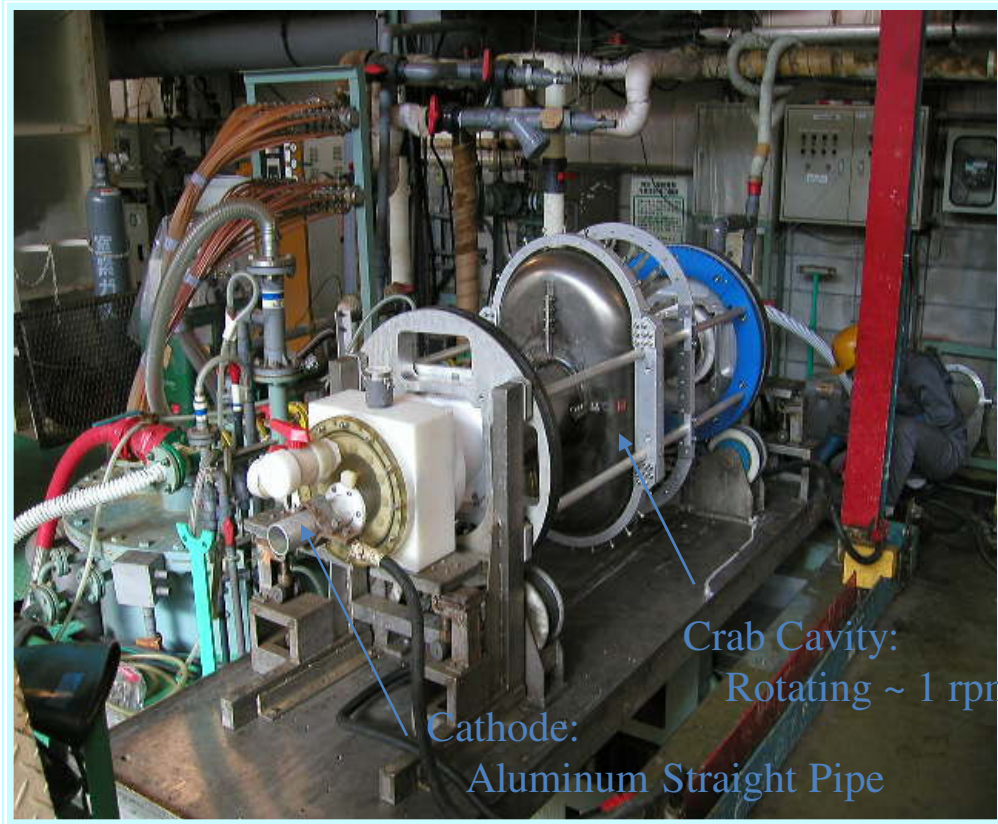
**Electro Polishing at Nomura Plating Ltd.**  
**This system was shut down.**  
**New EP system was established at STF in KEK**

EP 1 ~ 100  $\mu\text{m}$   
EP 2 ~ 5  $\mu\text{m}$

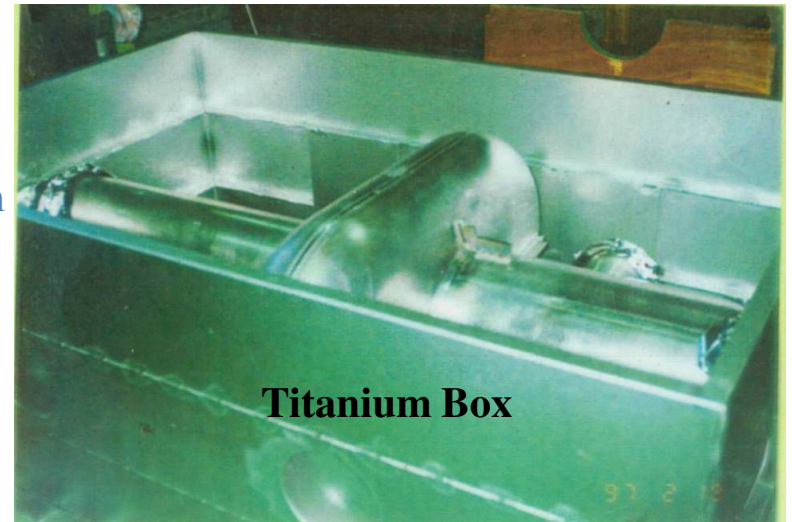
**Annealing at 700°C for 3 hours**  
**at Kinzoku Giken Ltd.**

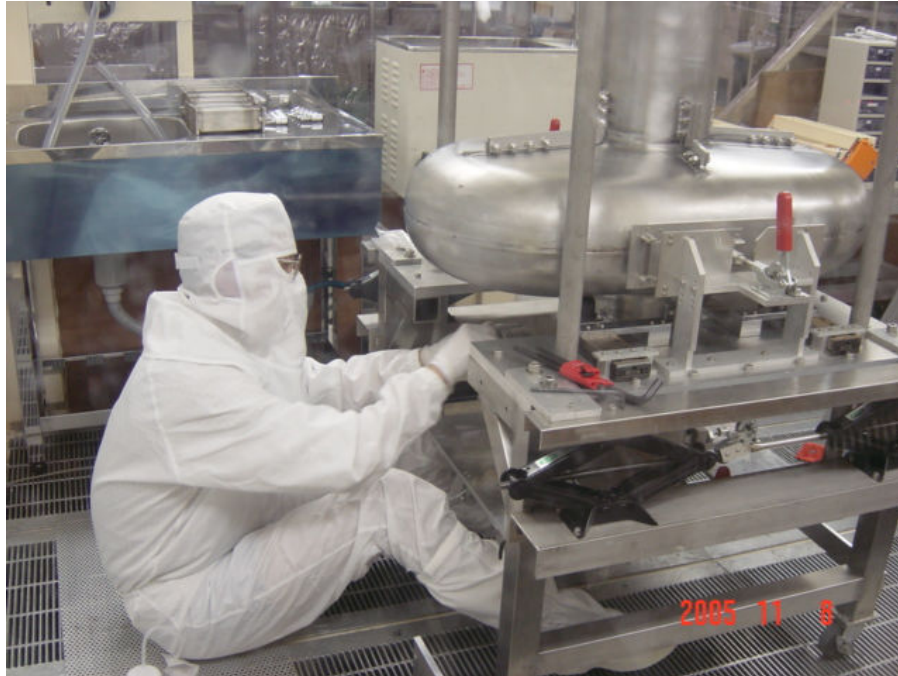
Set Flanges of Beam Pipes and Ports  
in Class 100 Clean Room

STF also has a clean room.

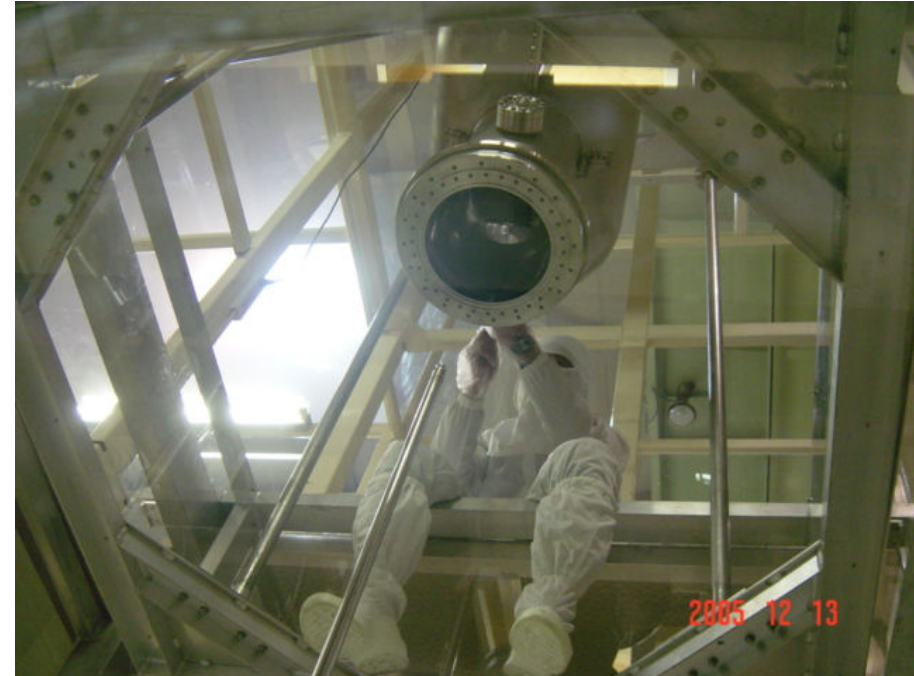
High Pressure Water Rinsing  
by 80 bar Ultra-Pure water

Rotation & Up-Down Motion

STF has other system.

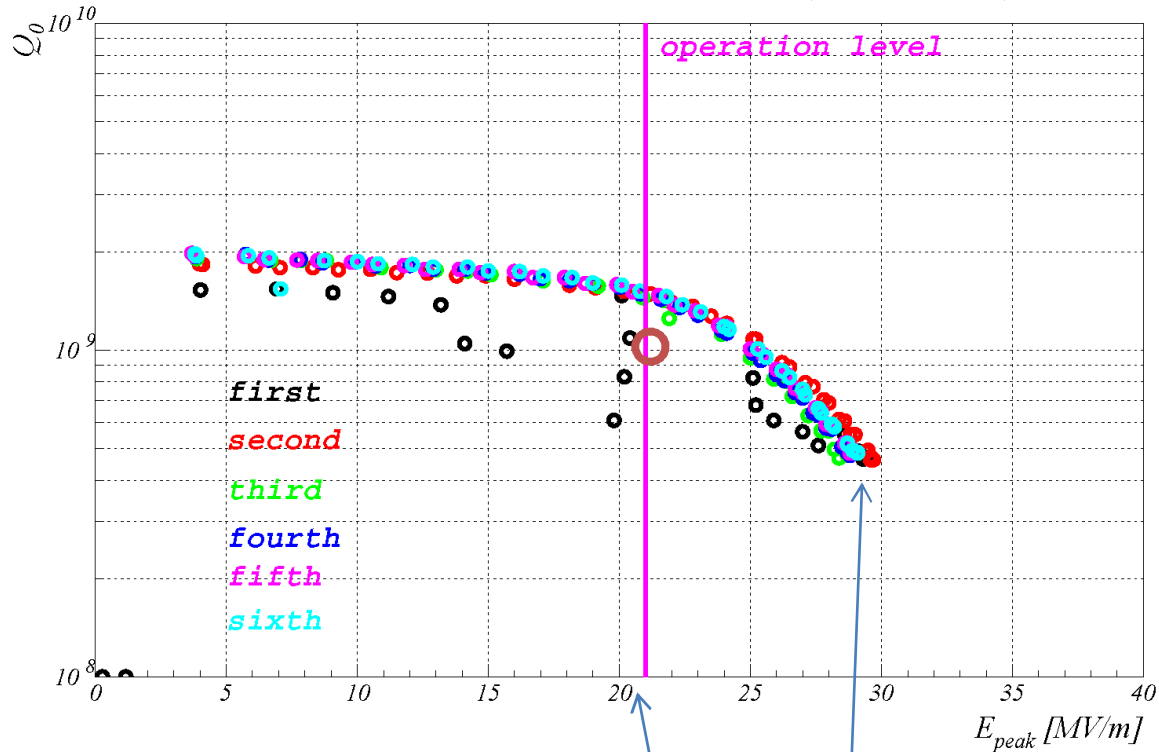
## HER Crab Cavity Vertical Test (2005/12/20)

1.44MV

It was limited by capacity of RF power supply.

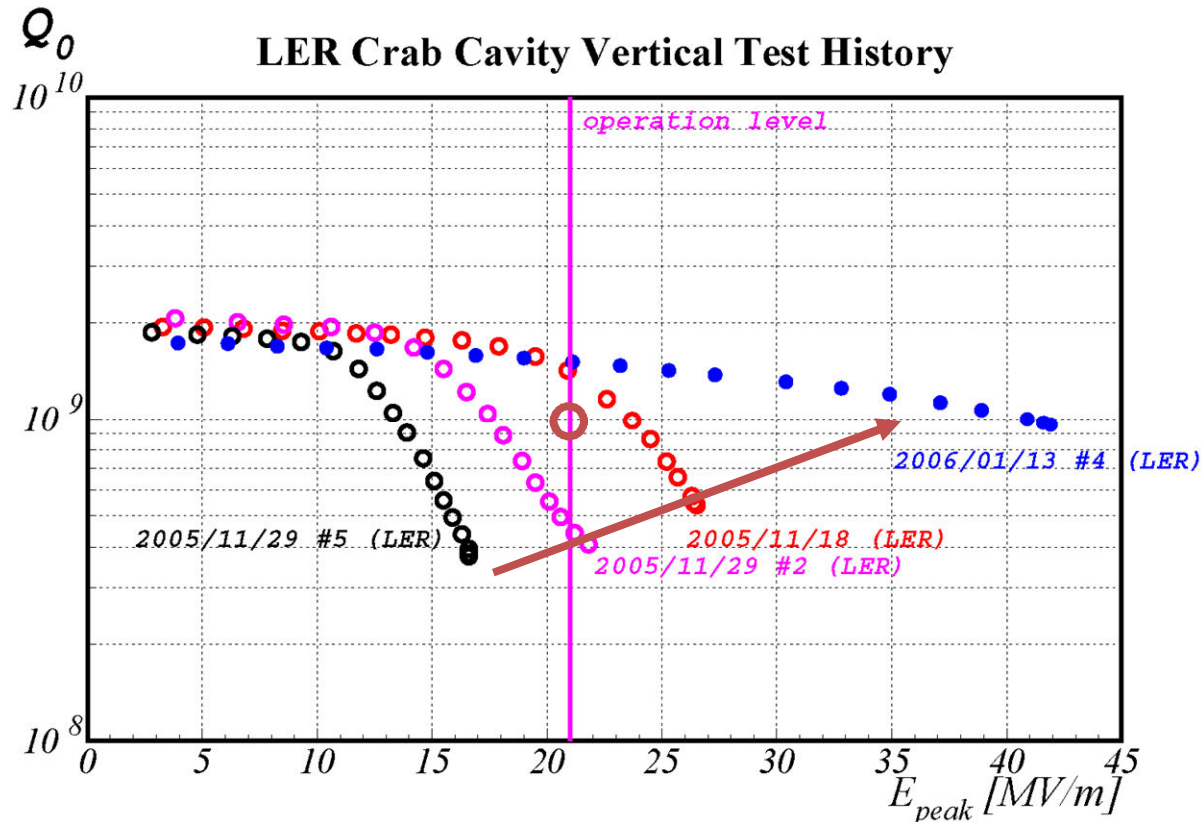
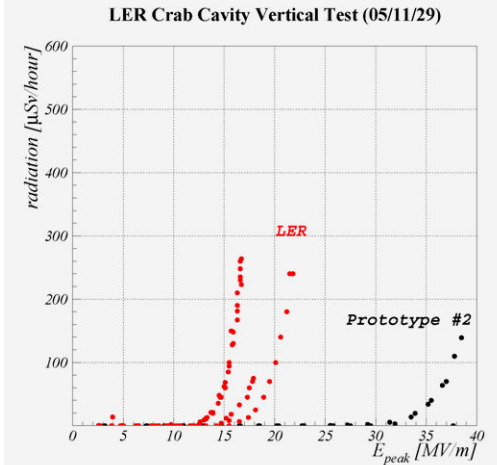
# Test Result Crab Cavity for LER

Nov. 18 1<sup>st</sup> Test

↓  
H.P.R.

Nov. 29 2<sup>nd</sup> Test

Re-processing

Field Emission

EP2

Jan. 13 Test

Recovered !

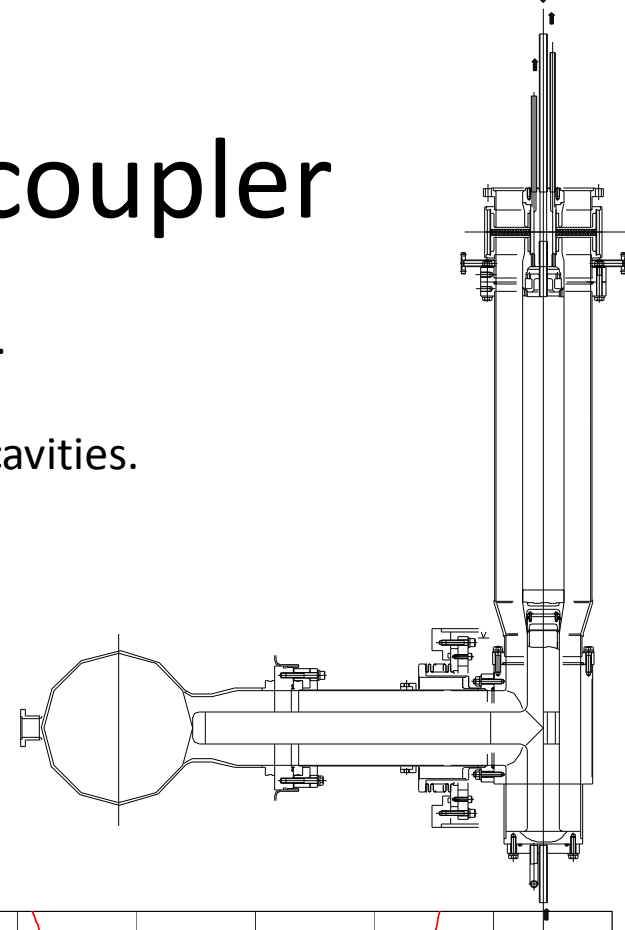
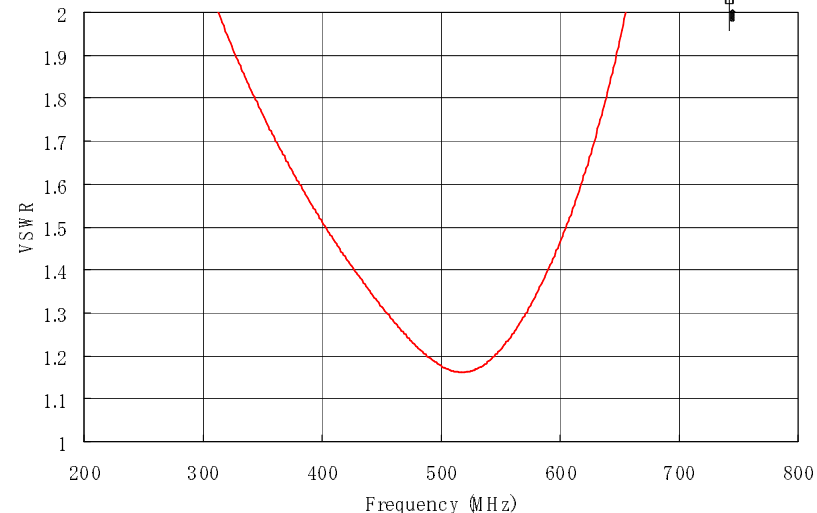
# Design of the input coupler

- The RF window is used that was designed for acceleration cavities.
- The maximum input power is 100kW.
- The input coupler has T-stub structure.
- The pass-band of T-stub is adjusted to operation frequency.

Item	Requirement	Reason
Diameter of outer conductor (vertical part)	151.9 mm	To use RF windows designed for acceleration cavities.
Diameter of inner conductor (vertical part)	66 mm	
Diameter of outer conductor (horizontal part)	120 mm	This size is same as acceleration cavity.
RF frequency	509 MHz	KEKB specification

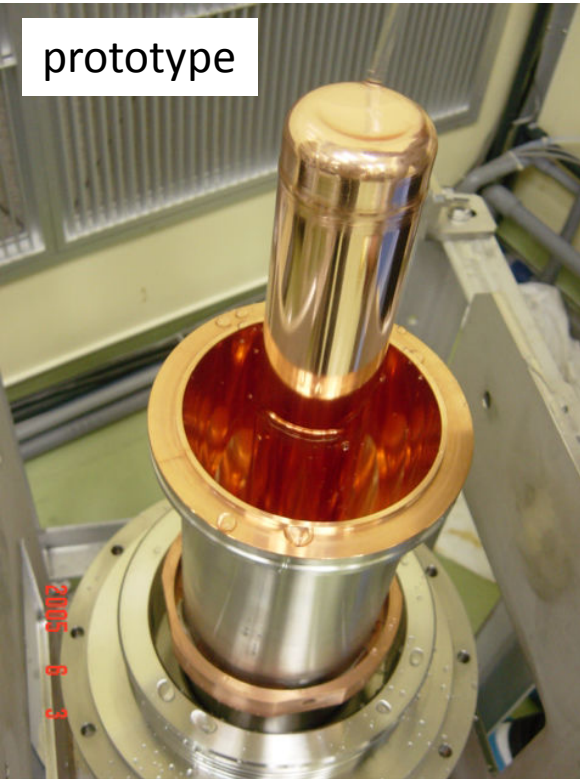
prototype

It looks good.

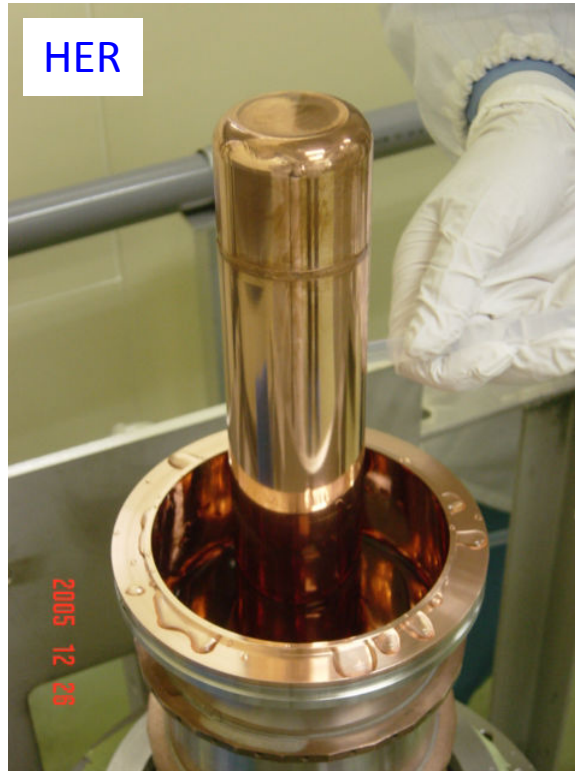
HER

It's not shiny.

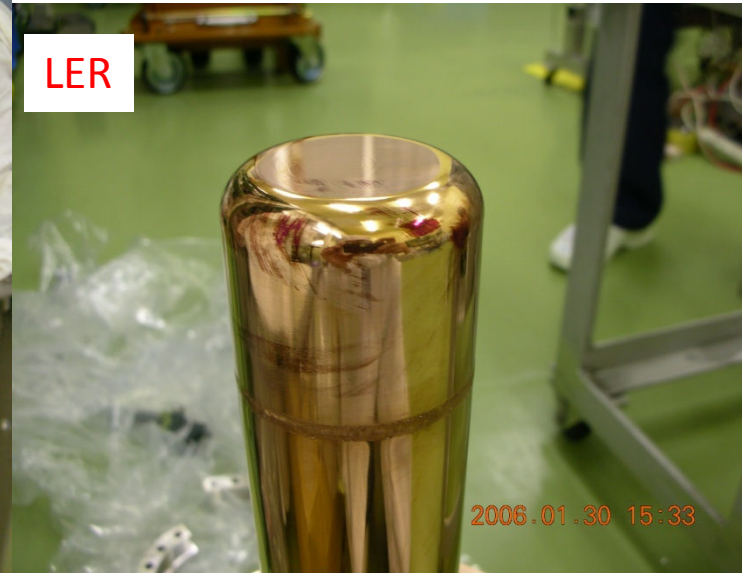
LER

Some of purple stains were found.

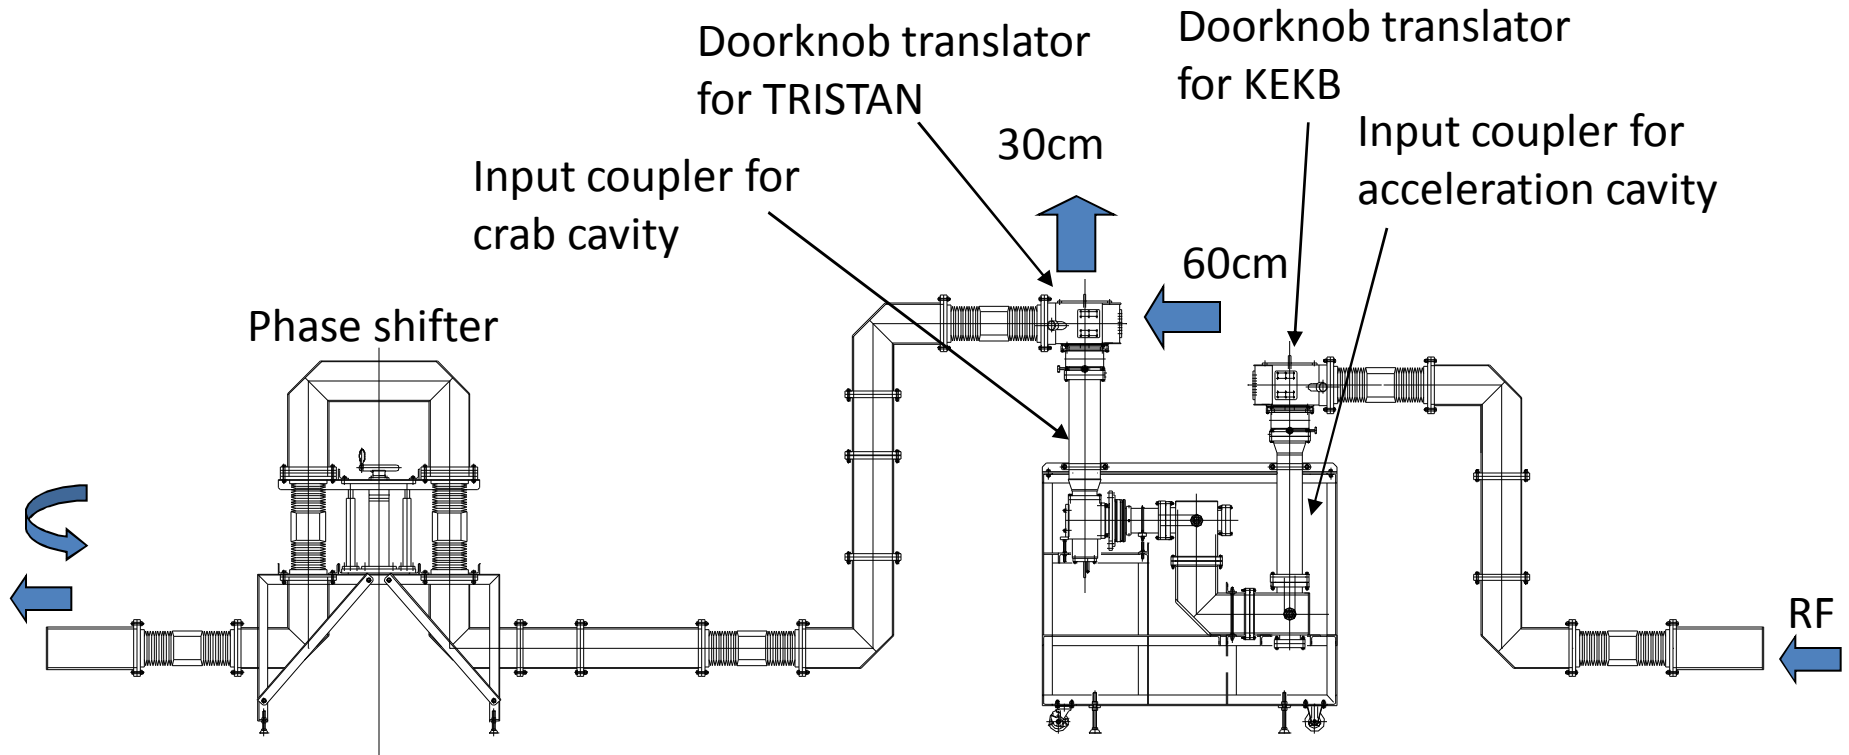
# Setup of the input coupler aging.

- Almost setups for acceleration cavities are available.
- The waveguide between two input couplers was made.
- An aging test will be started at the end of march.

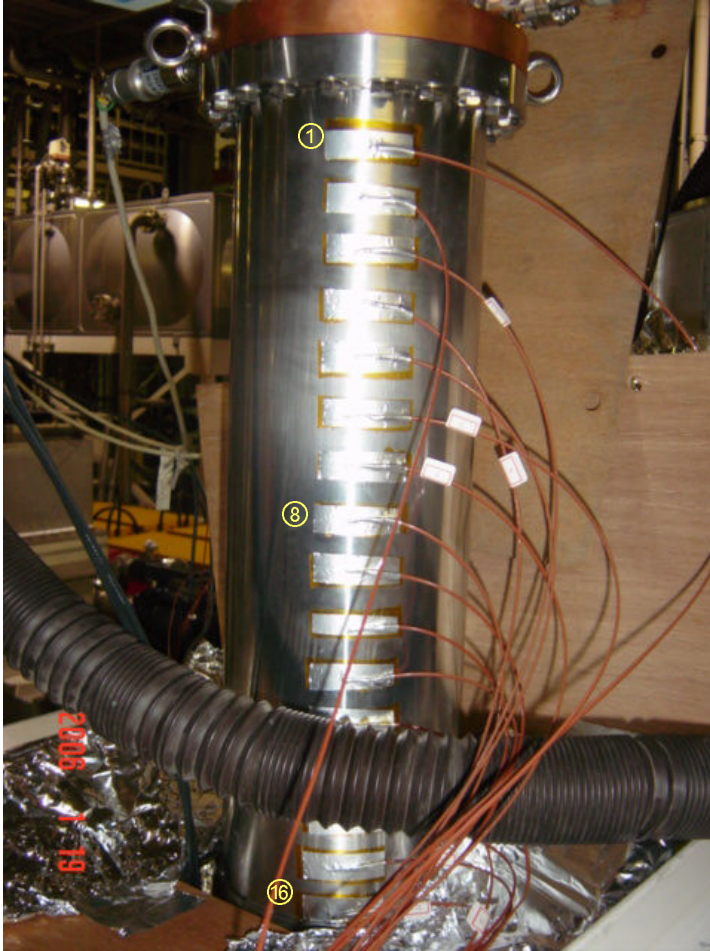
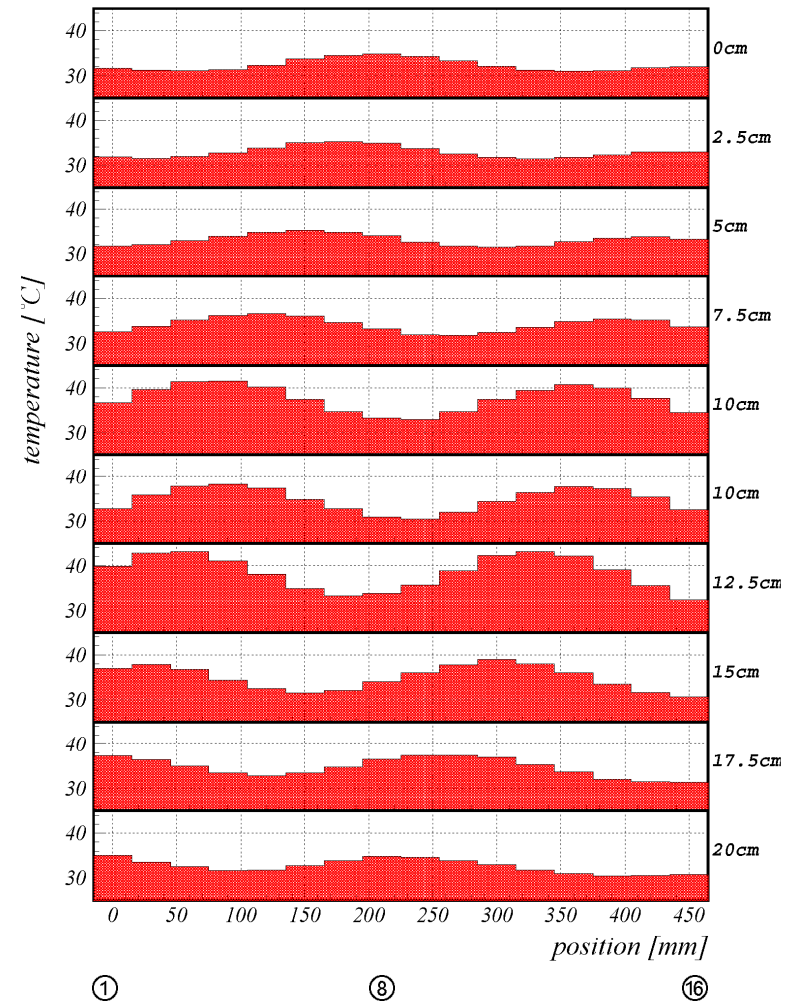
# Aging by tanding wave

16 thermo couples were attached every 3cm.

Crab HER Coupler for Standing Wave (06/01/19 ~ 06/01/20)

Offset	Aging effort [min]	Inter lock		
		arc ( crab)	arc(acc)	vacuum
0 cm	111	3	1	1
5 cm	5	0	0	0
10 cm	10	0	0	1
15 cm	84*	2	1	3
20 cm	31	0	0	3
25 cm	12	0	0	0
30 cm	12	0	0	0

We spend 4.5Hr to complete standing wave aging.

\*Peak of electric field hit the RF window.

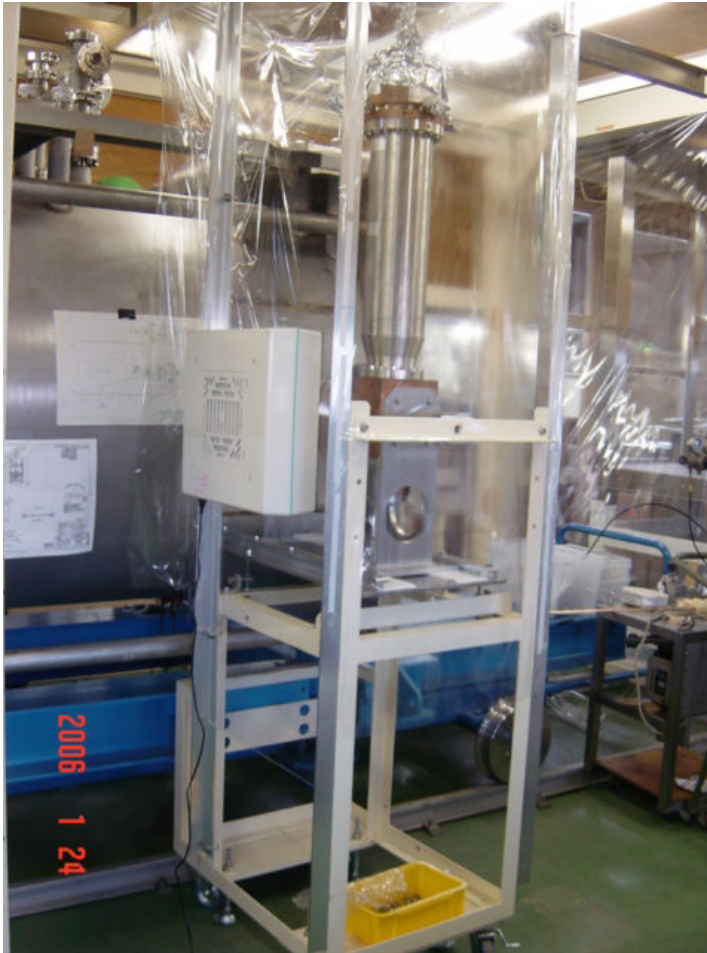
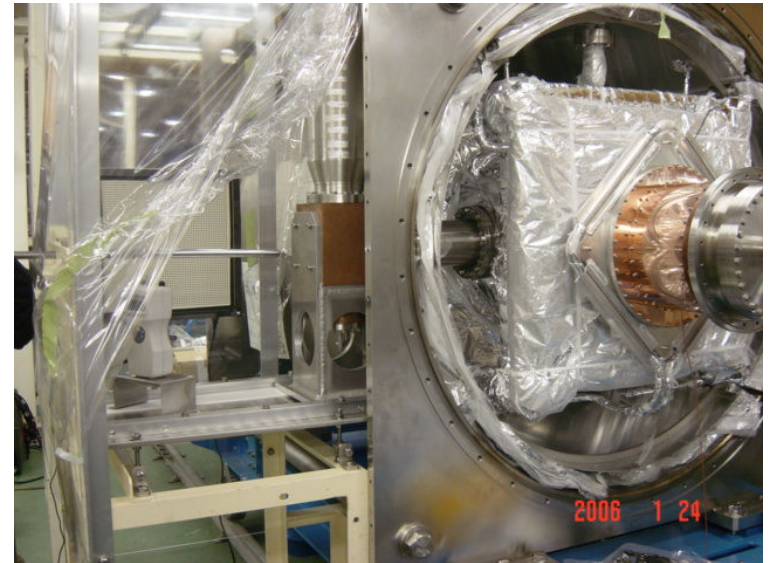
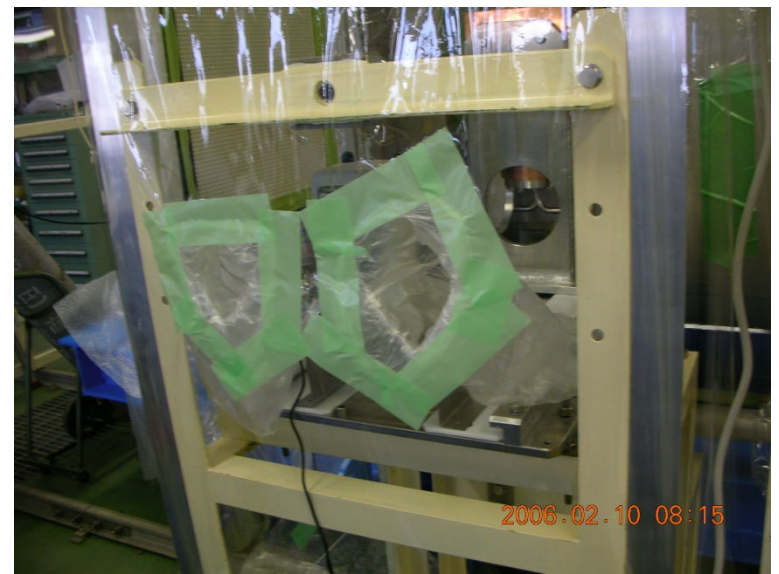
# Assembling

The couplers were installed in handmade clean booth (less than class 20).

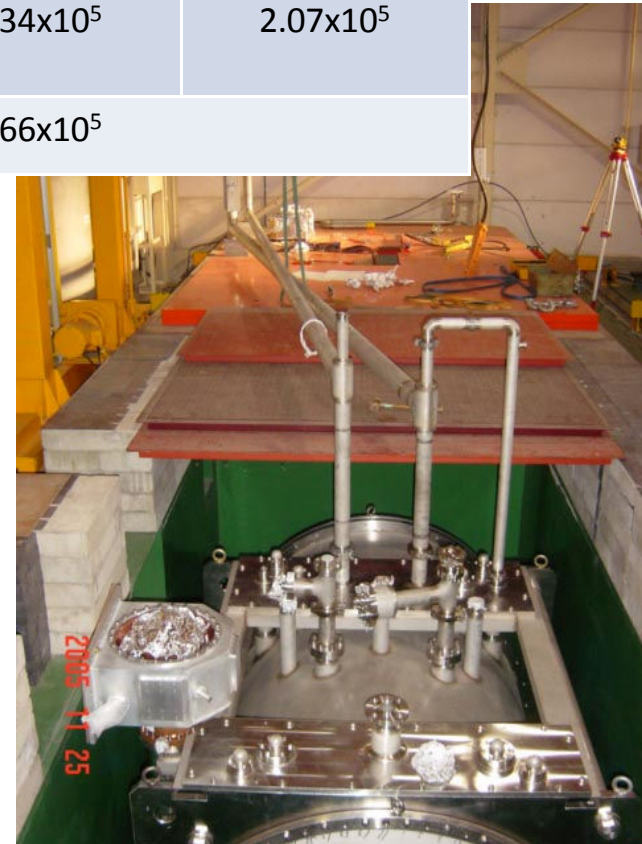
# Horizontal testing

$Q_L$		
	Input power	Observation	HER(Jun/2006)	HER(Nov/2006)	LER(Dec/2006)
RF power (1)	10kW	Band width	$1.59 \times 10^5$	$1.66 \times 10^5$	$1.86 \times 10^5$
RF power (2)	20kW	Decay time	$1.66 \times 10^5$	$1.34 \times 10^5$	$2.07 \times 10^5$
Simulation	(HFSS v9.2)		$1.66 \times 10^5$

Achieved $V_{kick}$	Applied RF Power
HER	1.8MV	120 kW
LER	1.93MV	55kW

$Q_0$  values at design kick voltage were higher than  $1 \times 10^9$ .

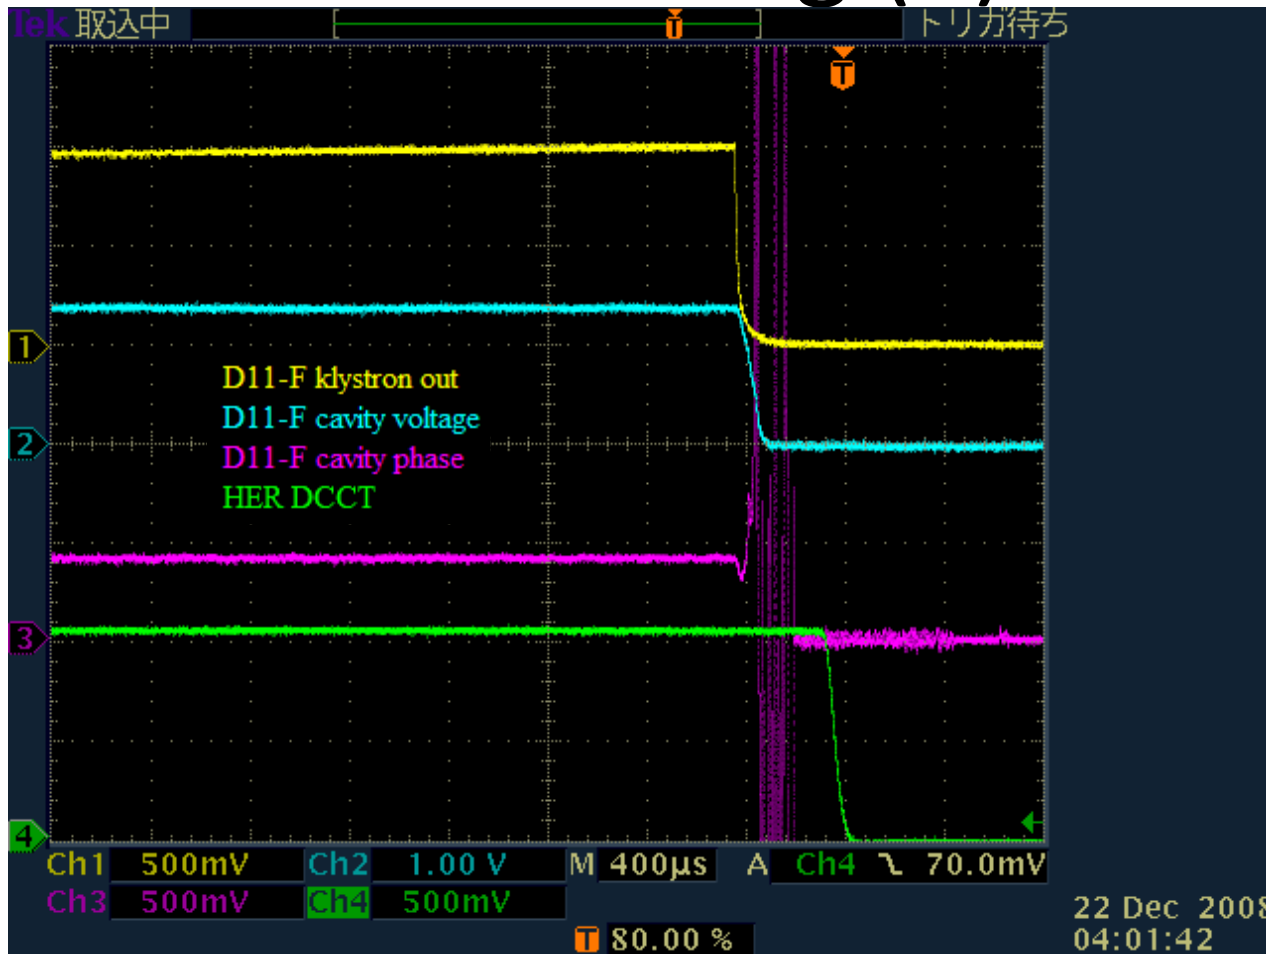
# RF abort log (1)

Break down detector was worked, because klystron output power was increased.

After RF turned off, beam phase looks unstable.

But beam was kept until beam abort.

RF switch status is one of the I/L items. Because cavity vacuum was deteriorated, when beam was injected with no RF power and without detuning.

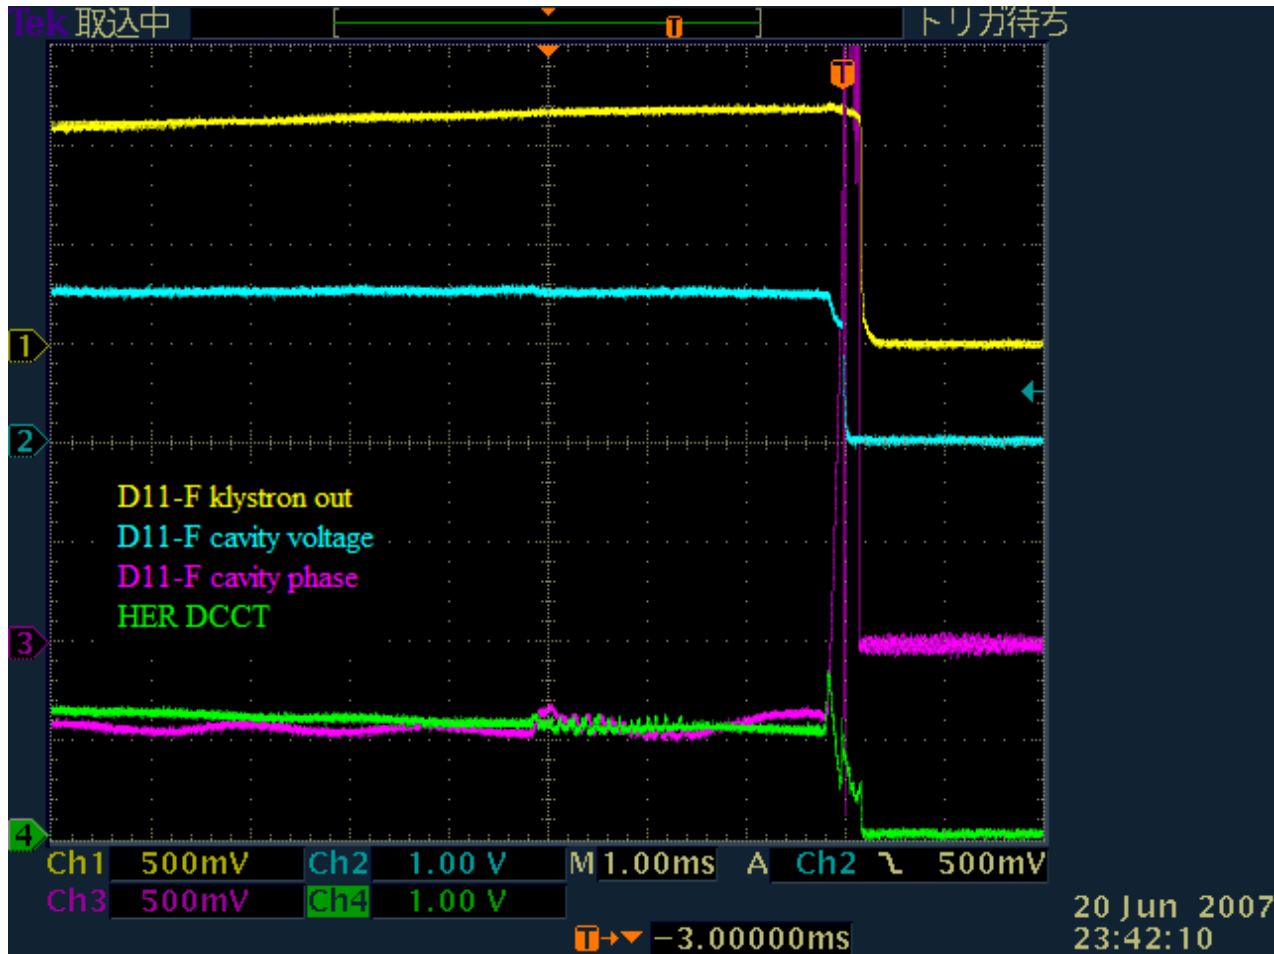
# RF abort log (2)

The cavity phase was unstable before RF turned off.  
Probably, discharge was occur near by input or pickup coupler.  
Finally, break down detector was worked.

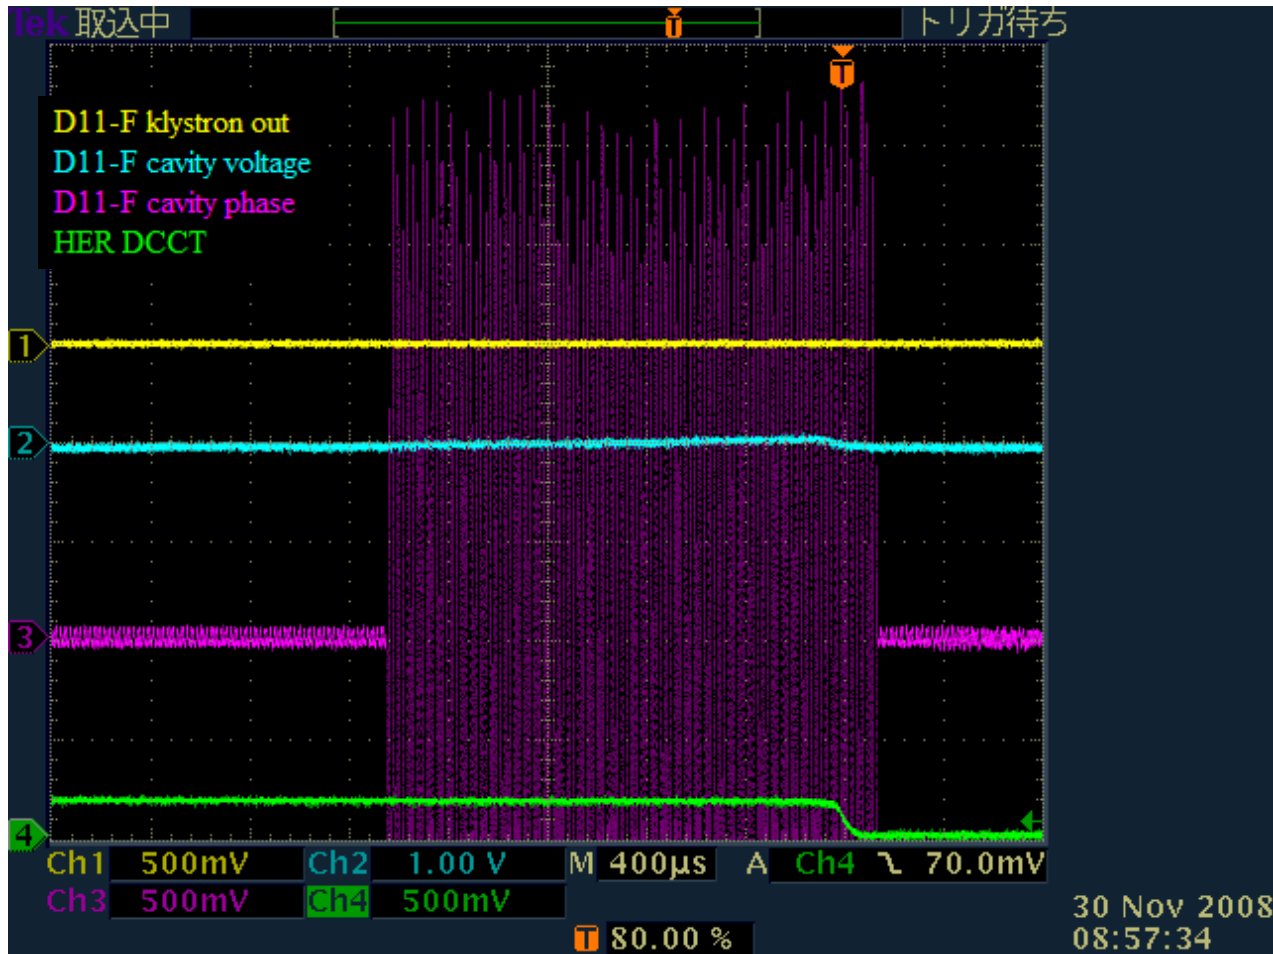
# RF abort log (3)

Phase detector lose cavity phase. But RF was not turned off.  
Uncontrolled high power RF is harmful for the beam.  
In this case, I/L system of crab cavity could not detect this disturbance. (it is improved.)
