A Long Term Reliability Challenge at the RHIC

Peter F. Ingrassia,
D. Bruno, A. Drees, G. Marr,
A. Marusic, J.N. Sandberg,
T. Shrey, V. Schoefer

Abstract

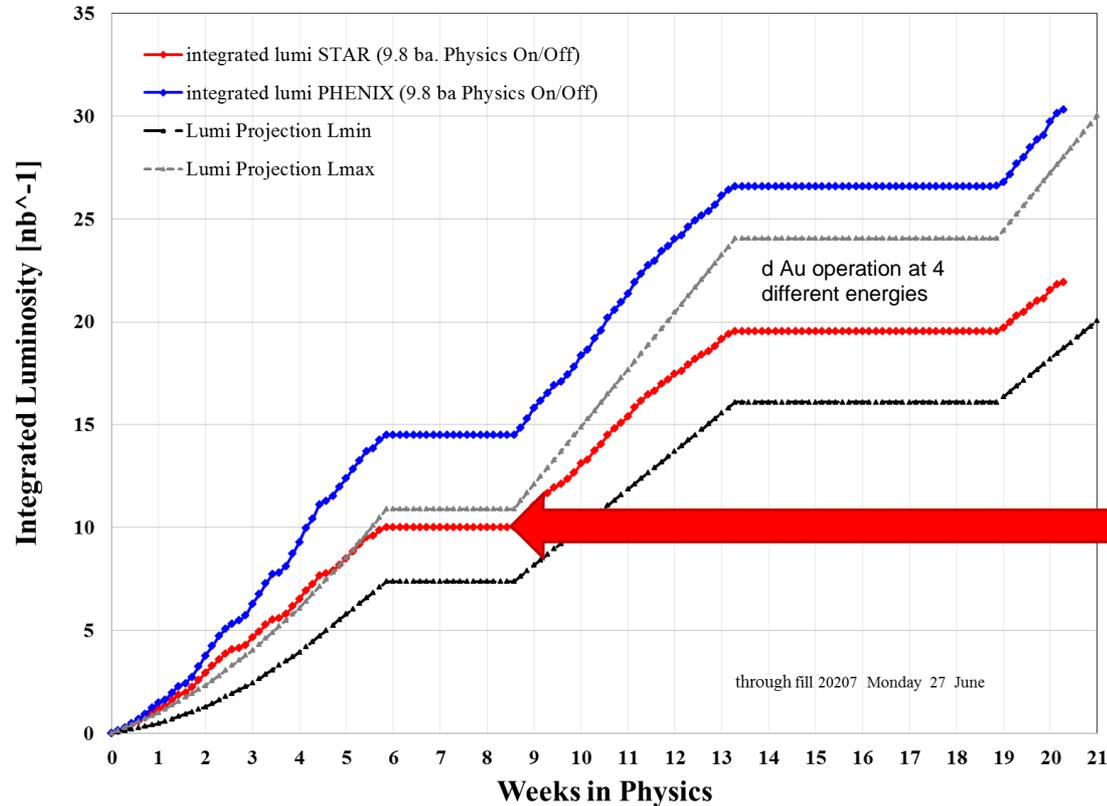
Run16 Delivered Luminosity

Au x Au $\sqrt{s} = 200$ GeV

Bottom Line
Run16

19 day interruption to
the physics program
during 2016 to replace
a quench protection
diode

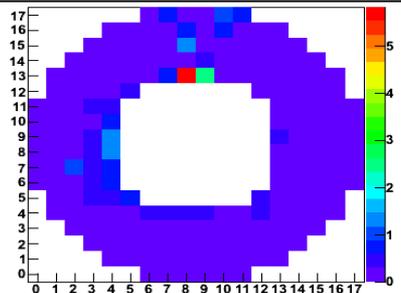
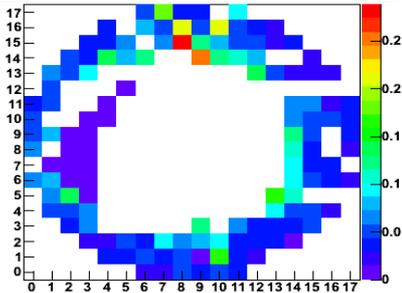
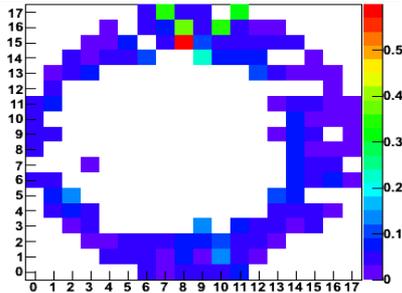
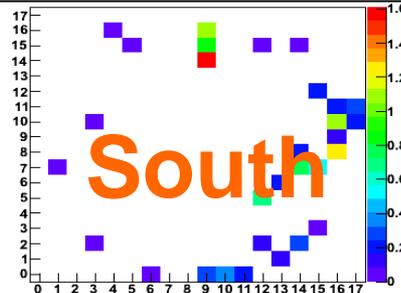
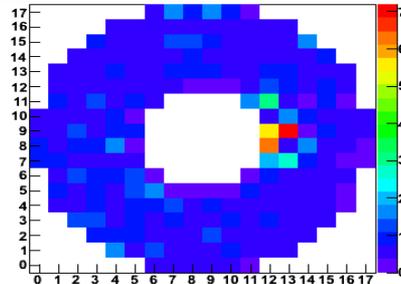
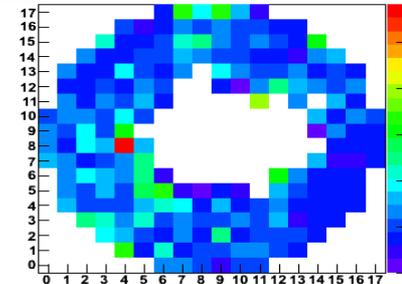
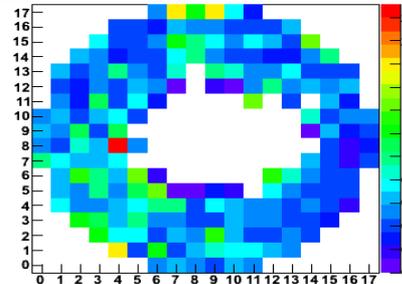
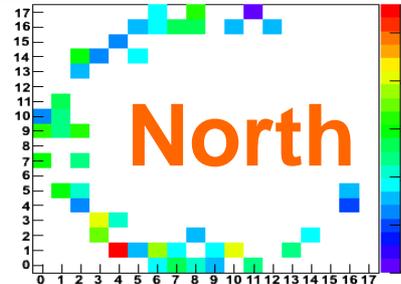
Pre-fires caused PHENIX RUN15 MPC Damage aggravated by “the right” conditions

Store# 19050

May 11

Damaged South
Impacted North

19116/18

May 28

We got lucky
No add'l damage

19134

June 1

The end of the
MPC in Run 15

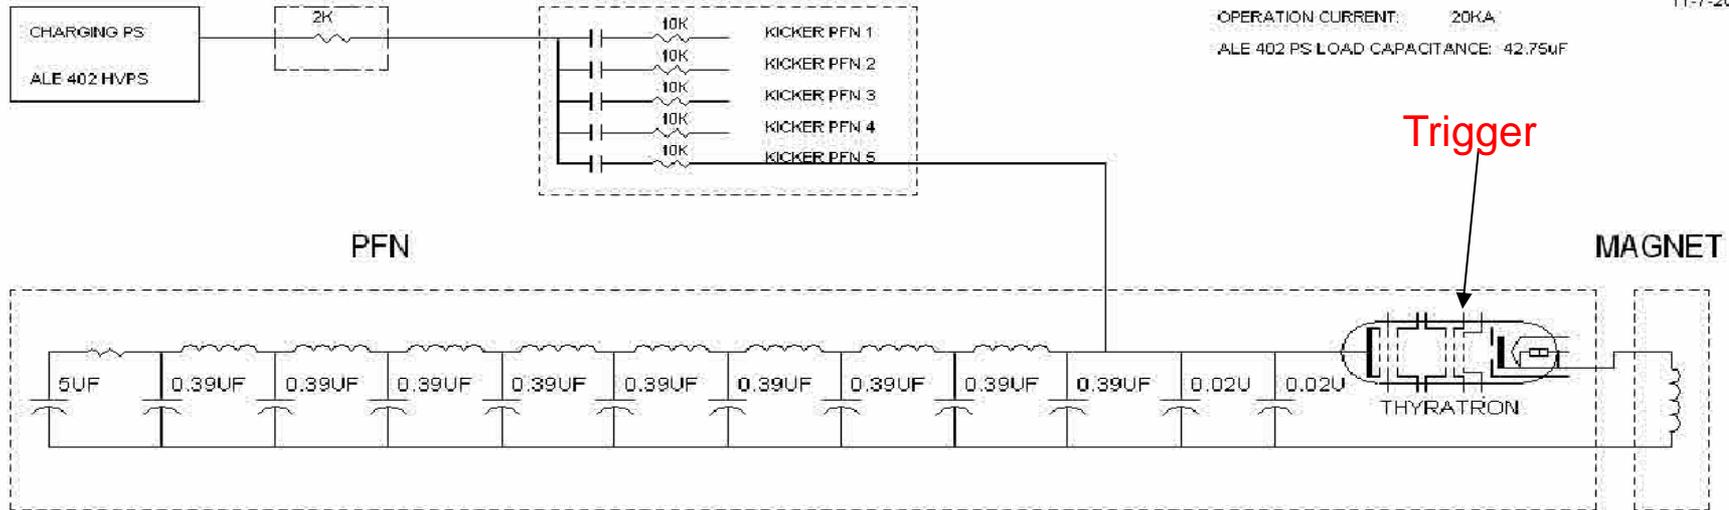
RHIC ABORT KICKER SYSTEM DIAGRAM

Abort Kicker System Circuit Diagram

TEST VOLTAGE: 30 KV
 OPERATION VOLTAGE: 27KV
 OPERATION CURRENT: 20KA
 ALE 402 PS LOAD CAPACITANCE: 42.75uF

- **The culprit: pre-fire is defined as a Thyatron spontaneously discharging a PFN through an abort kicker magnet unintentionally.**
- **The voltage on the abort kickers' PFNs is ramped up to match the energy of the RHIC beam and is maintained at high voltage (27 kV) during each RHIC store**
- **There are 5 kicker modules in each ring. Over a ten year period there have been an average of 8 pre-fires per ring per year**
- **Even after a great deal of effort there were 7 yellow pre-fires and 6 blue pre-fires (+ 4 caused by a bad trigger card) in 2017.**
- **Radiation is thought to be one contributing cause that triggers a thyatron to fire. The Pulse Forming Networks (PFN) are in the beam enclosure**

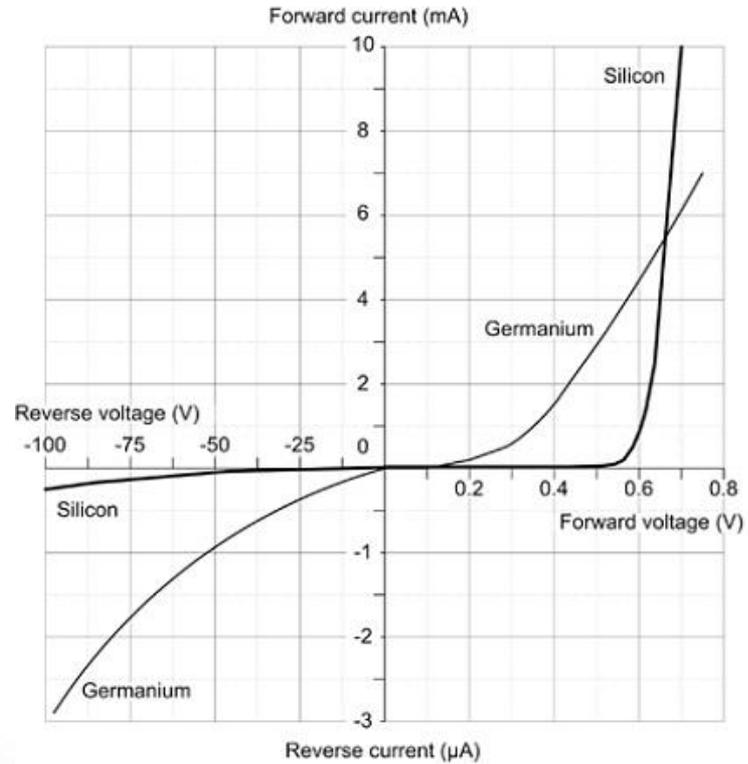
Basic Diode Operation

Blocks current flow in the reverse (voltage) direction

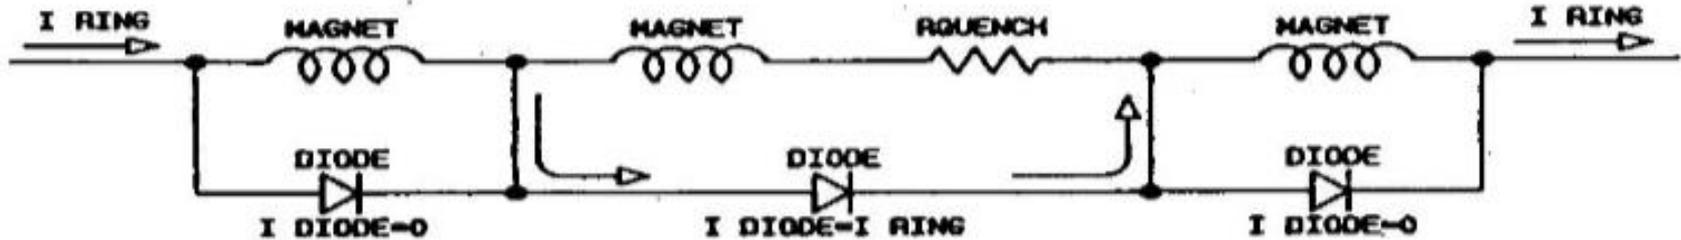
Superconducting Protection Diodes

- Each magnet (except the DX dipole) is capable of dissipating its own stored energy without being damaged
- The purpose of the diodes is to bypass the current from the other superconductive magnets in a string around a quenching (resistive) magnet
- When cold the diodes have a high forward break over voltage, in RHIC, **3 to 10 volts**.
- During normal ramping operation ($di/dt = 25.8$ amps/sec) the forward voltage across an arc dipole never exceeds **0.625 volts**
- If a magnet becomes resistive this voltage quickly rises and the diode conducts
- Once the diode conducts it heats up in milliseconds and its forward voltage drop decreases

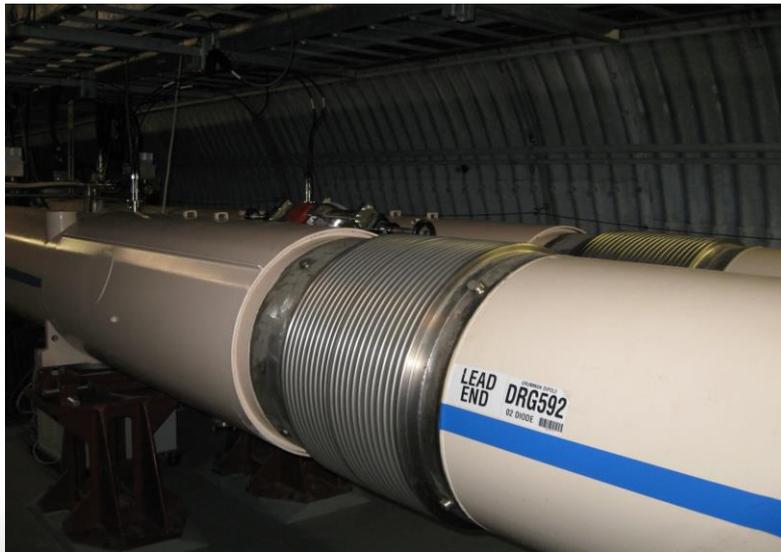
Replacing a Quench Protection Diode (2016)

Cryostat - encloses SC magnets

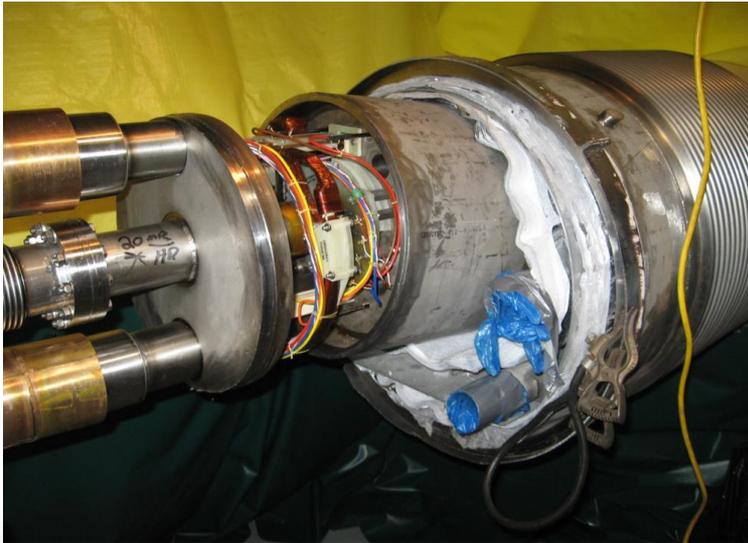
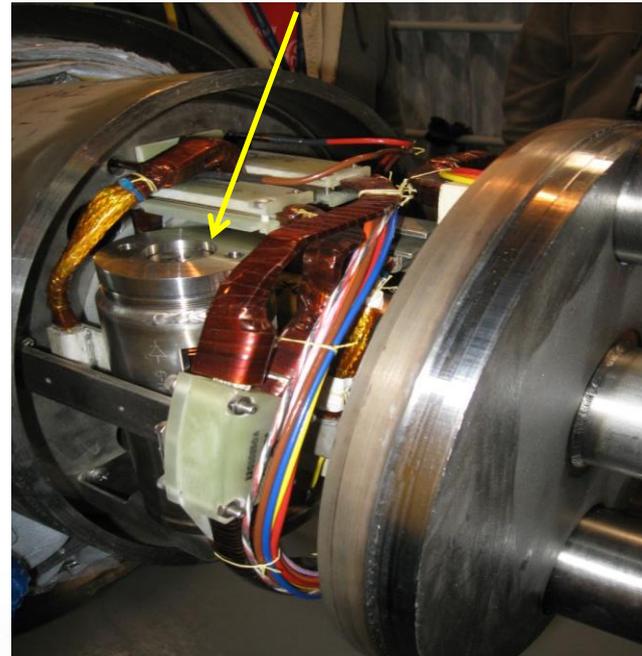
End Volume Cut Open

The Diode

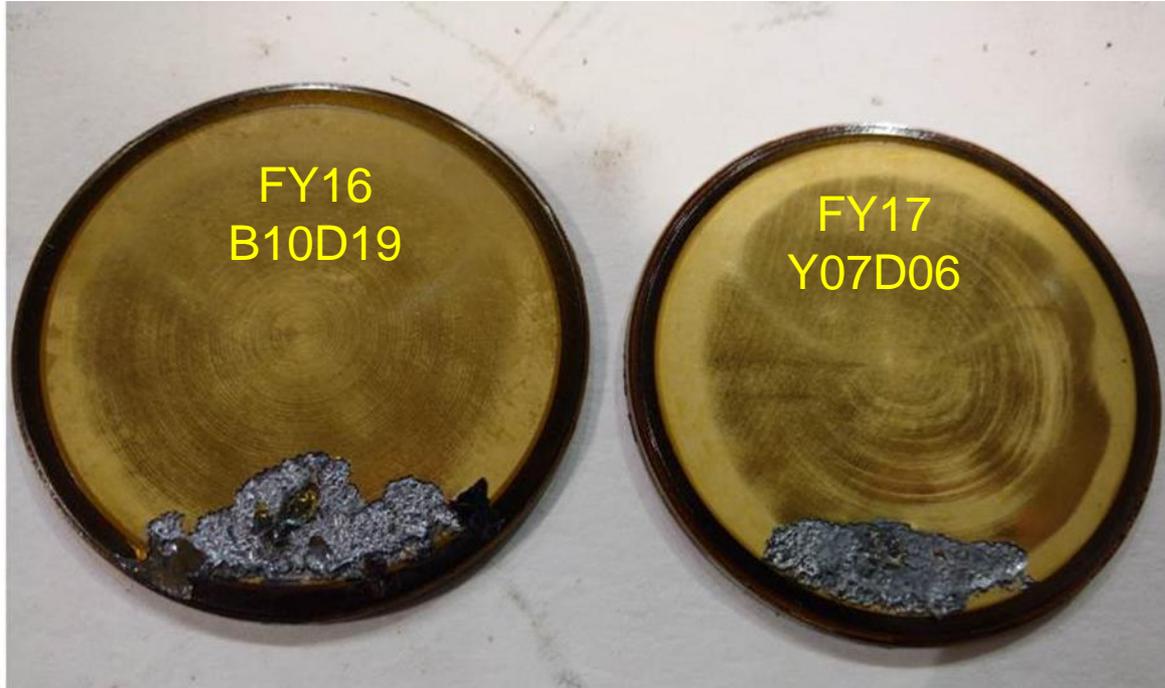
Damaged Diodes

- There have been two known diode failures in RHIC and one diode discovered with a reduced forward voltage drop. (1 out of 168 tested)
 - In 2016, B10D19 failed partially shorted. This failure occurred after a massive quench in which this magnet **probably** quenched while being sprayed with beam. The magnet was able to be ramped after this event one time but failed shorted afterwards during another “Quench Link Interlock”. (Type 2 Diode)
 - In 2017, Y07D06 failed partially shorted. This occurred after a massive QLI in which the magnet **probably** quenched while being sprayed with beam. This was caused by the failure of the delayed abort system. We were able to run with the diode in this condition from March 11, 2017 to the end of the run in early July. (Type 1 Diode)

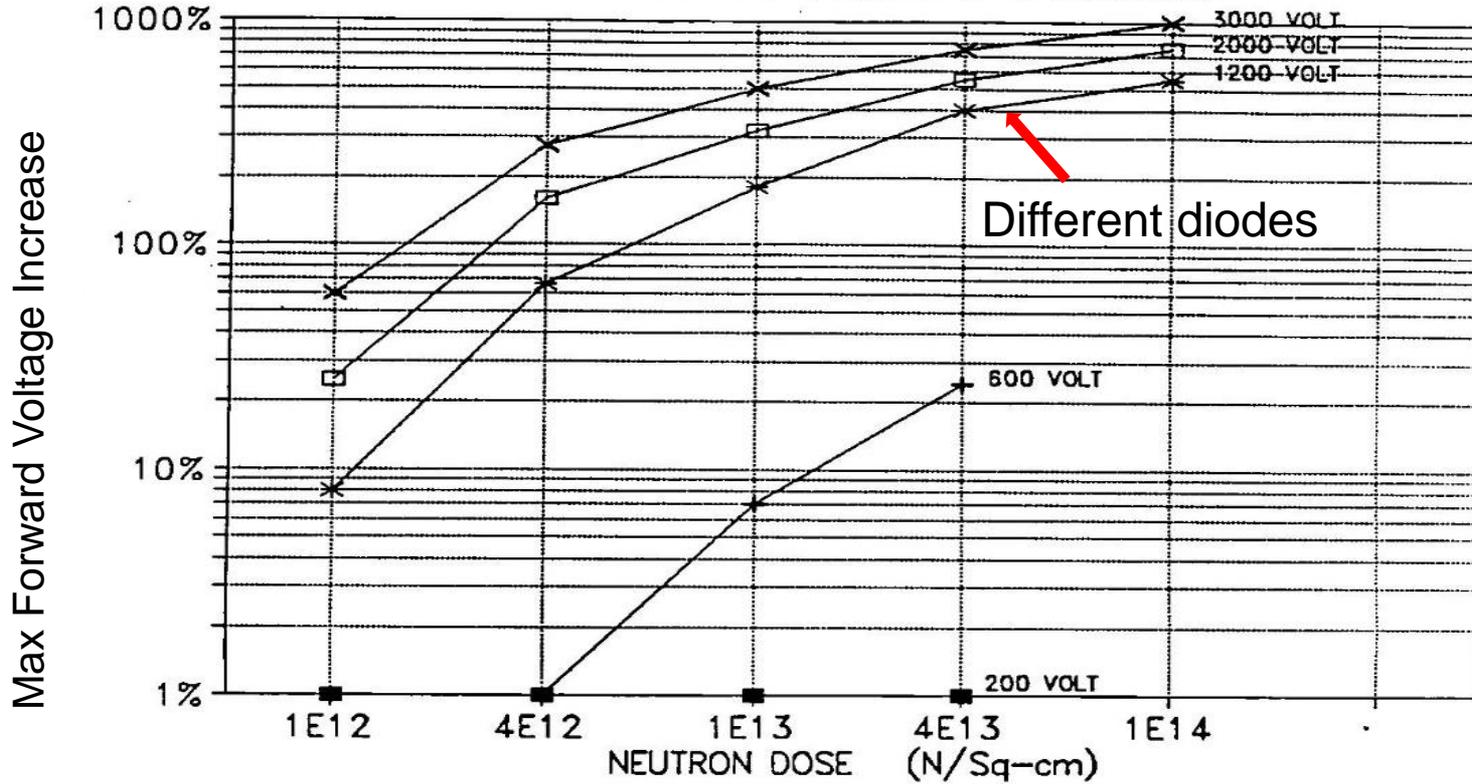
VFM DEGRADATION vs NEUTRON DOSE DATA FROM VARIOUS SOURCES

- **Radiation effects may not be uniform across the diode -
- “Gradient Effect”**
- **A gradient of different Forward Voltage Drop (FVD) may cause current crowding across the diode worsening the effect**
- **There is an annealing process whereby warming the diode up reverses some of the radiation damage. Maybe as much as 80%**
- **One of the only ways to determine the health of a diode is to study its FVD at high current when cold**

- The estimated integrated lifetime exposure of RHIC diodes from the specification to procure the diodes was:
 2×10^{12} neutrons/cm²
- Pre-RHIC BNL Testing showed problems with similar diodes at:
 5×10^{12} neutrons/cm²
- Integrated exposure at ionization chamber closest to diode this run:
0.1 kGy
- Estimated integrated diode exposure extrapolating from ionization chamber for this run:
11 kGy (difficult to relate dose to neutron flux)

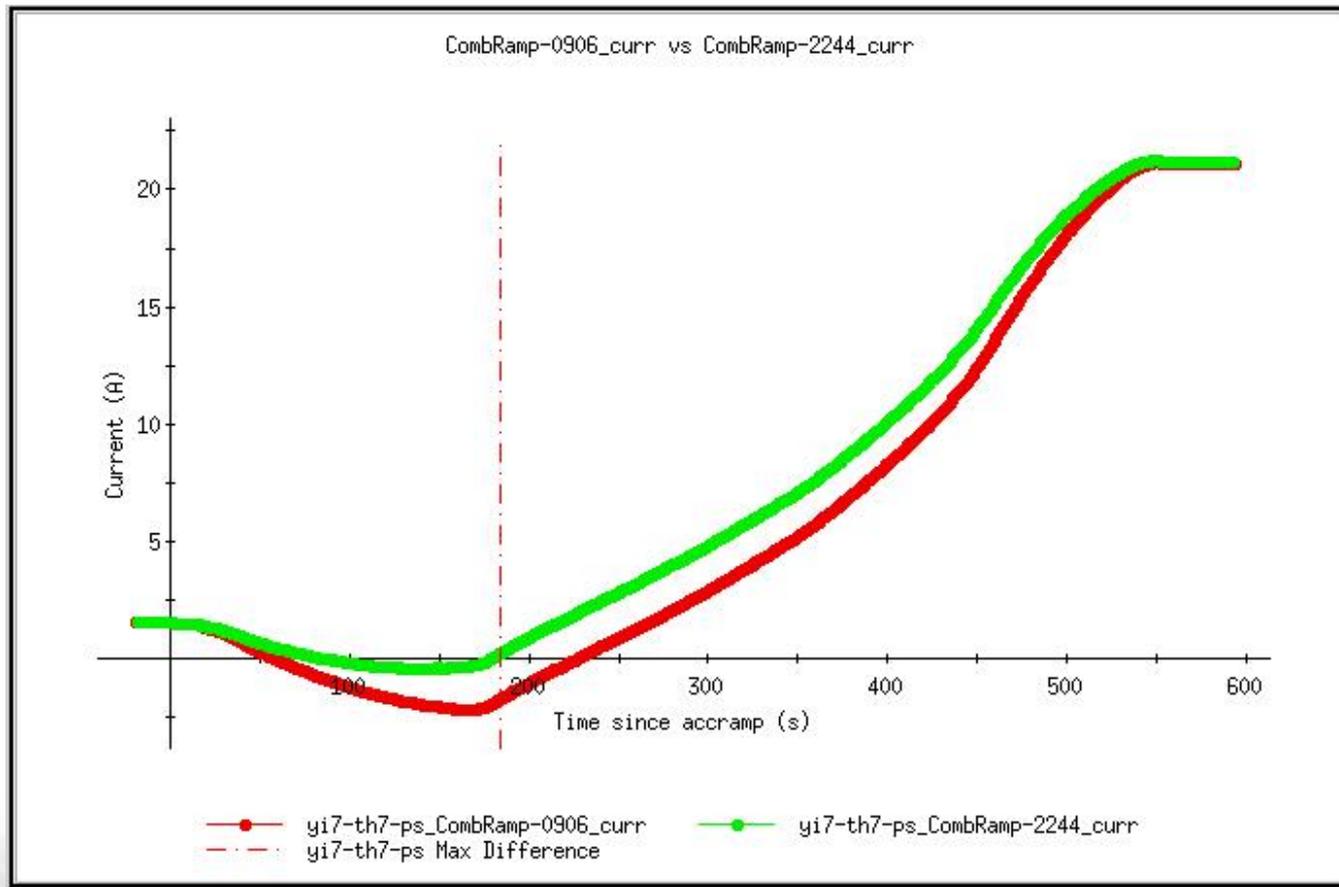
Changes in yi7-th7 corrector power supply (2017)

Difference in current (before {red} and after {green} diode damage) flowing through the corrector magnet indicates corrector is compensating for reduced field in the dipole. The corrector is part of the orbit control system.

- **The correction strength of yi7-th7 was monitored after every QLI after 3/11/17. The current through the diode was estimated based on this correction**
 - **After the event 54 amperes out of approximately 1000 amperes was going through the diode at Slow Factor 1 (25.8 A/sec ramp rate)**
 - **At Slow Factor 2 (12.9 A/sec ramp rate), 9 amperes went through the diode**
 - **It was observed that after clean quenches the current through the diode decreased and after dirty quenches it increased ?**
- **Concerns were either we would run out of correction or the correction would go to zero possibly indicating an open diode.**
- **The magnet will be opened and the Diode in Y07D06 will be replaced in the September 2017**

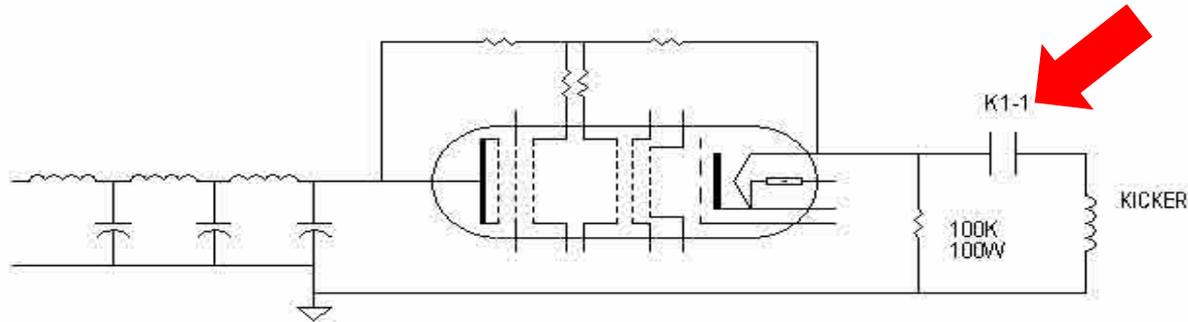
ABORT KICKER MAGNET SWITCH TEST CIRCUIT

A solution to this problem would be to put another switch in series with the Thyratron whose pre-firing characteristics is decoupled from that of the Thyratron

- Much work has gone into investigating the inclusion of a switch (mechanical or solid state) in series with the thyatron
- The use of a mechanical switch was tested during Run17. The first attempt failed.
- The major issue is to determine the amount of beam lost (due to the orbit change) from the time the “Quench Link” triggers the shunting of the current in the magnets and the firing of the abort kickers that is delayed due to the introduction of the switch in series with the thyatron.

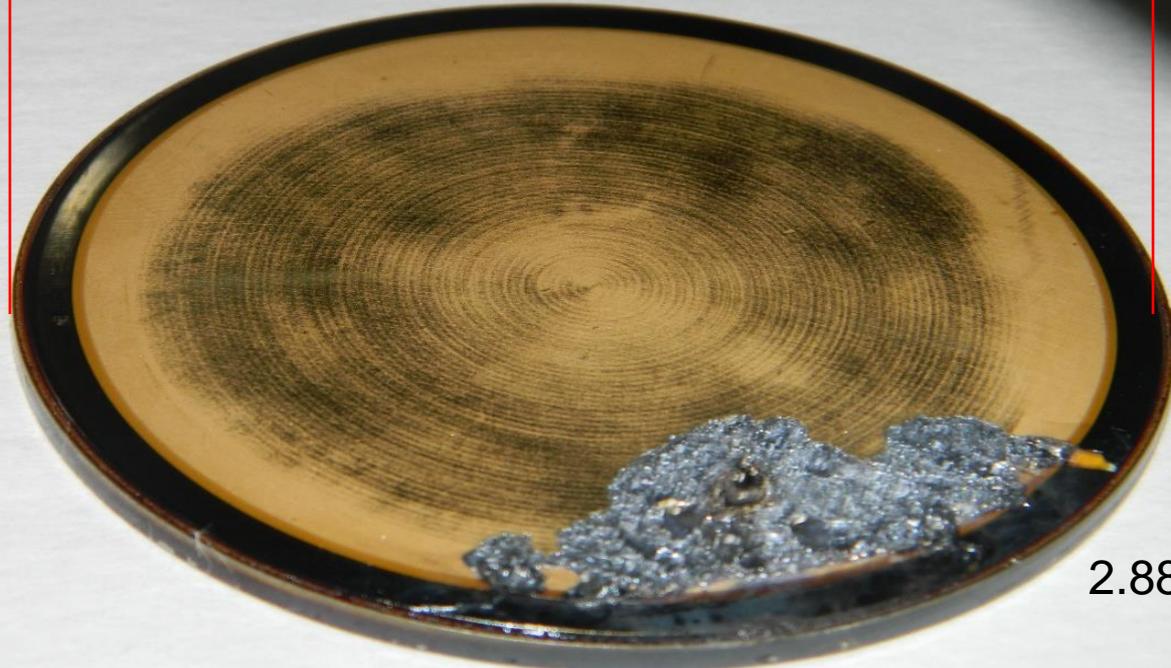
Failed Diode at Sector 10

Edge closest to beam 230 $\mu\text{R}/\text{Hr}$ In April

67 mm

2.88 mm thick

After 3 months
cool down
65 $\mu\text{R}/\text{Hr}$ &
39 $\mu\text{R}/\text{Hr}$

Edge furthest from beam

100 $\mu\text{R}/\text{Hr}$ in April

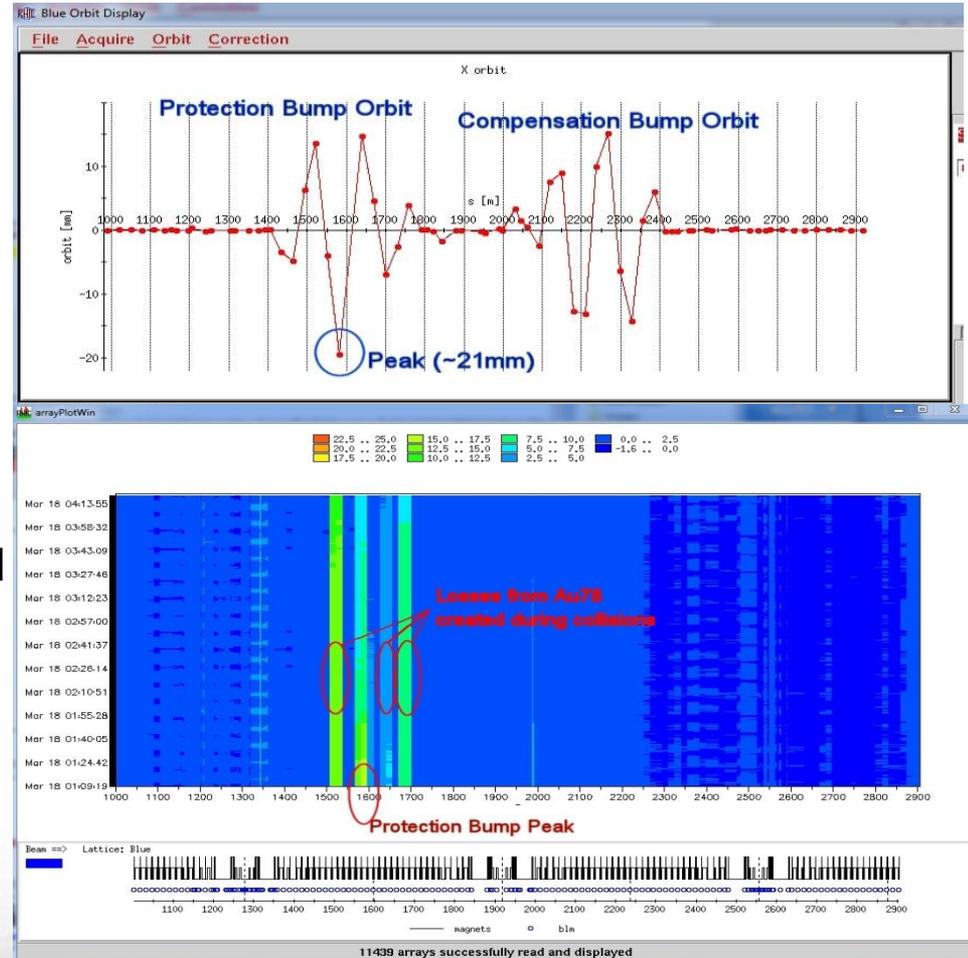
Abort Kicker Pre-fire Protection Bump

- Bump generated in 11 o'clock arc pushes orbit to -21mm. In a pre-fire condition bunches kicked by the pre-firing module will crash into the cryostat at that location, preventing damage to the experiments. In 1 o'clock arc is a compensation bump to adjust for off-center orbit in quads and sextupoles in the pre-fire bump.
- Chronic losses in the arc are due to Au^{+78} beam created during collisions and off-momentum particles at the protection bump peak. The peak loss is located at g10-lm20 loss monitor, located just downstream of dipole 19 where the failure occurred
