# Experience with the KEKB/SuperKEKB magnet cooling water system

Mika Masuzawa, KEK, Japan

# T15 : Strategies for Continuous Reliable Operations

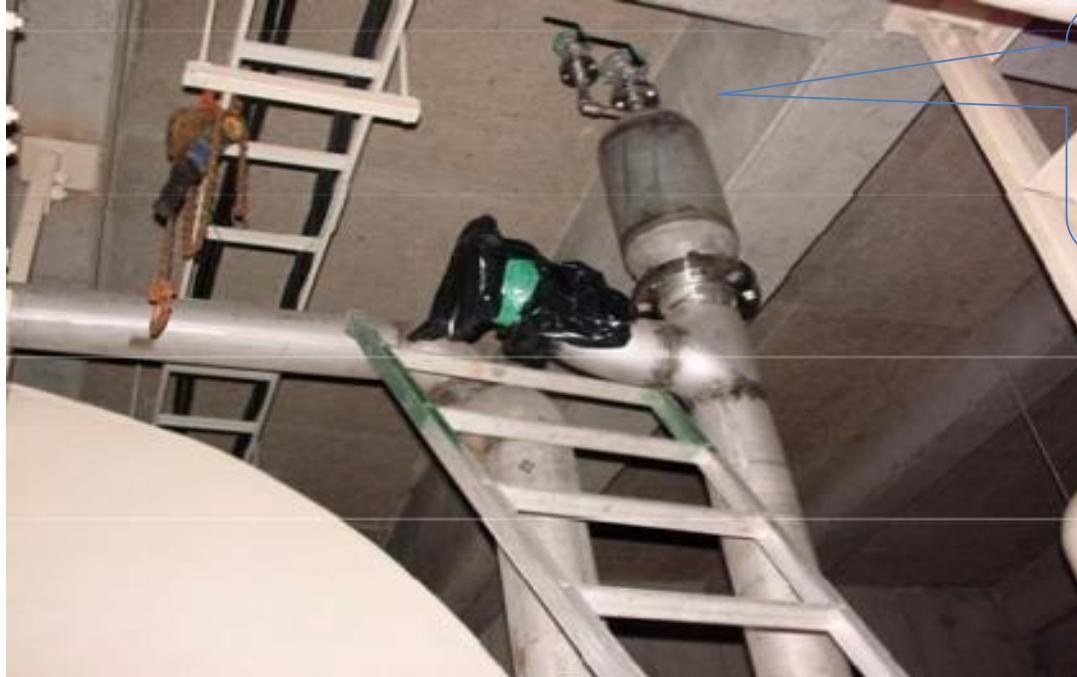
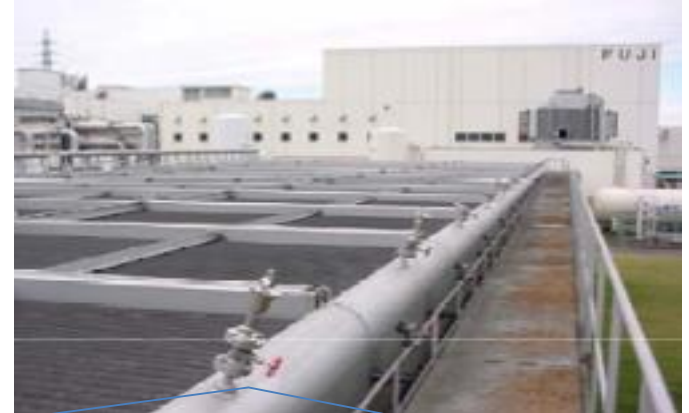
# Air bubbles

Air bubbles were not removed from the system because purge valves were not properly located. We relocated the valves in 2000.

Added more purge valves to the outside cooling tower. Also control logic was changed from pump discharge pressure control to automated differential pressure control, which resulted in more stable flow.

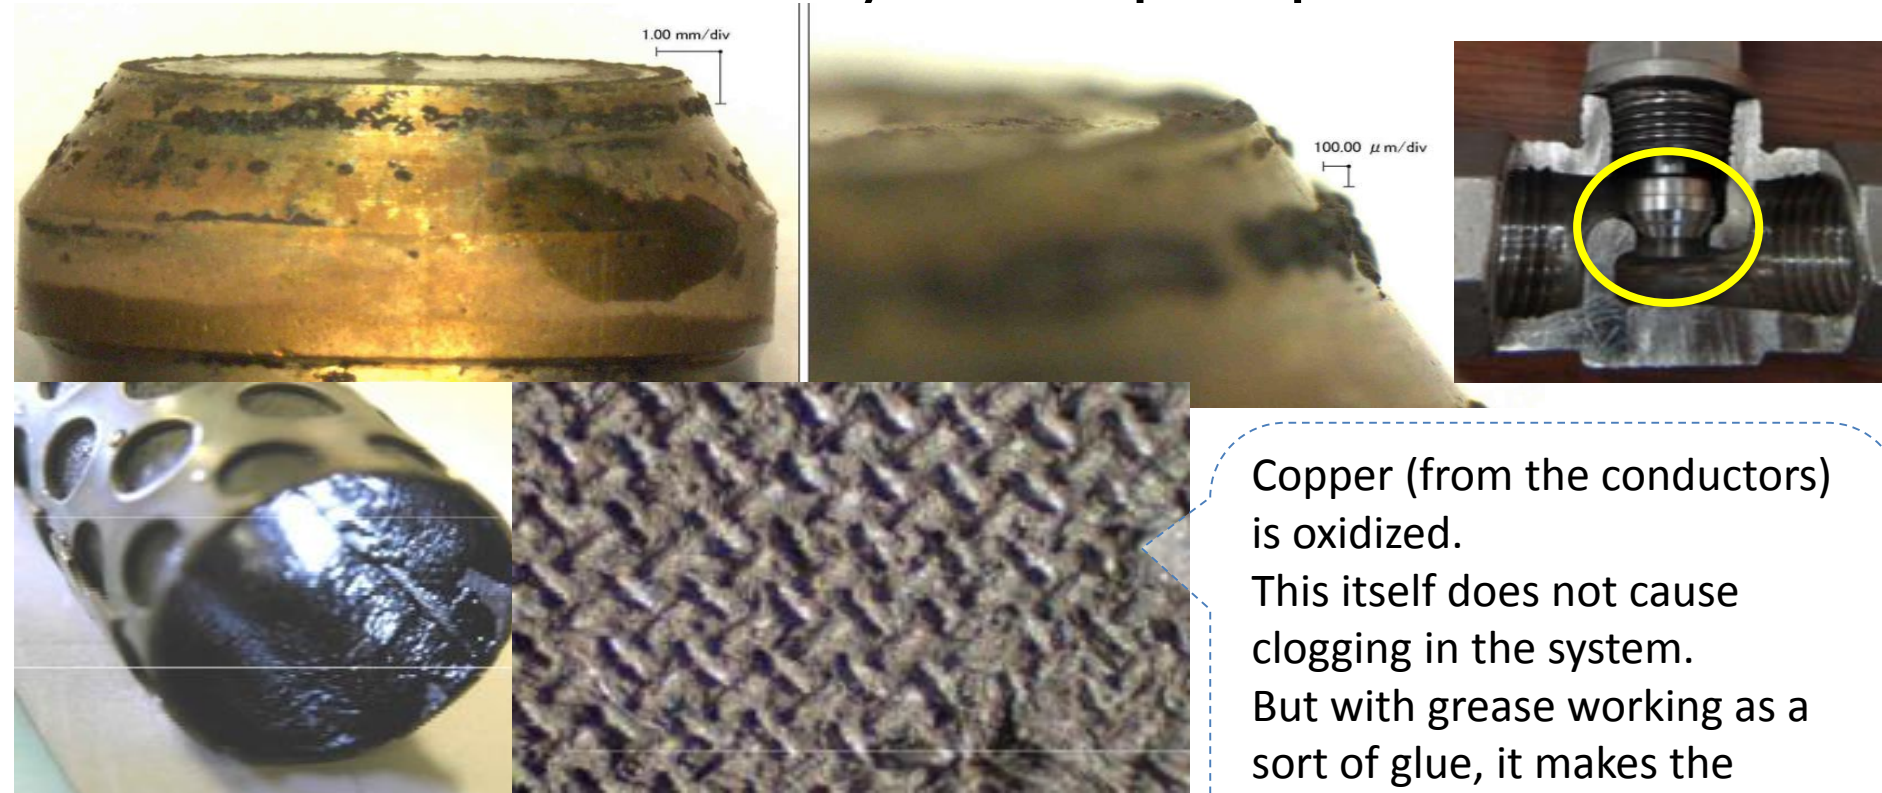
# Clogging caused by oil contamination caused by maintenance work (by the Facilities Division...) of the pumps!

Copper (from the conductors) is oxidized. This itself does not cause clogging in the system. But with grease working as a sort of glue, it makes the situation a lot worse.

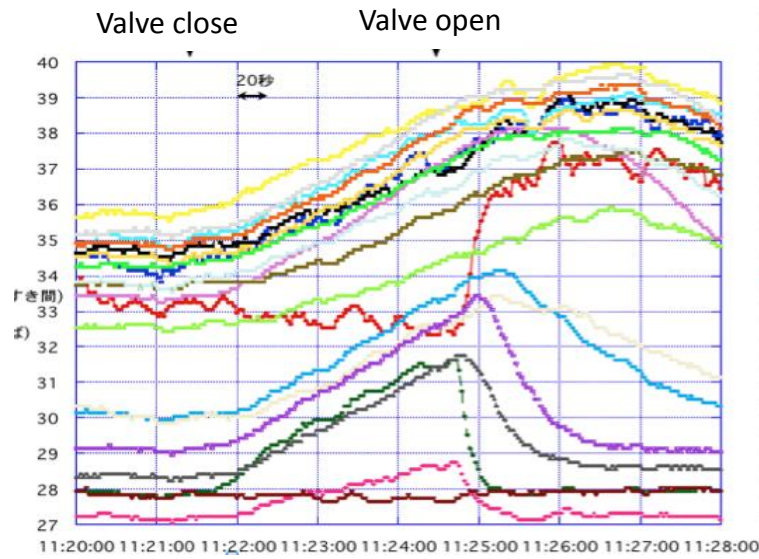
# Changed the Interlock decision time from 1 second to 20 seconds

- Sometimes, clogging gets cleared up by water pressure and by the time we go into the tunnel after a water-stop, the flow rate is back to normal.
- So we did an experiment with a wiggler magnet, where the temperature rise is the highest.
- The coils will not be burnt within three minutes after the valve are completely closed.
- So we changed the water-stop decision time from 1 second to 20 seconds.

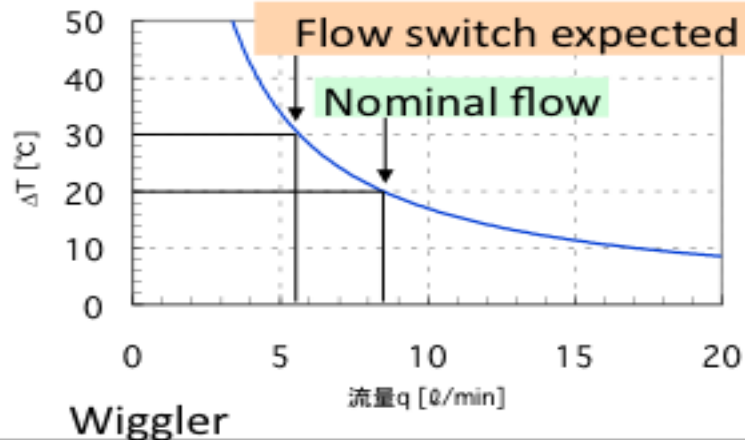
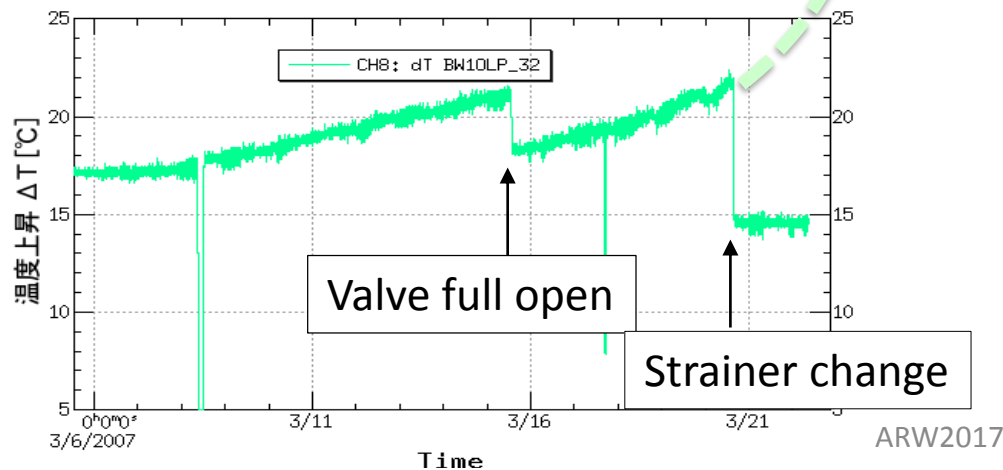
# Prevent beam aborts by monitoring temperature rise and looking for the next tunnel access opportunity

- Inexpensive
- Attached outside

Sudden beam aborts during luminosity tuning due to water stop were prevented by water temperature monitoring.

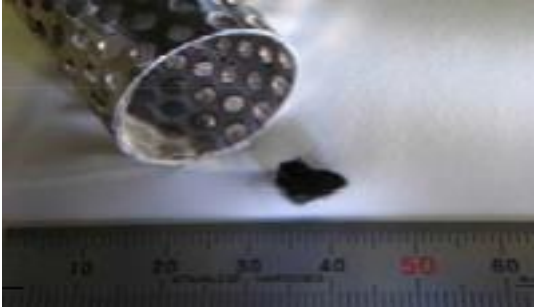
# Rubber pieces in Fuji pumping station

Water stop in the Fuji pumping station area.  
It turned out some pieces of rubber triggered a flow switch.
