RF Modules Update

MICE Collaboration Meeting 46
Andrew Lambert
Lawrence Berkeley National Laboratory
October 7th, 2016

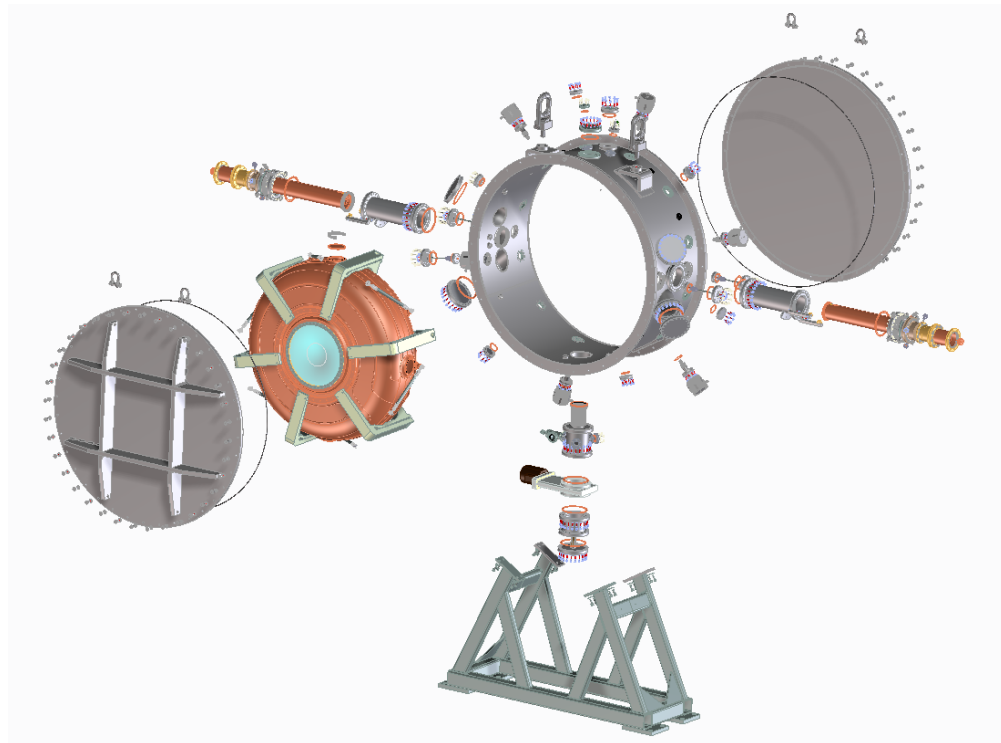
- **Each MICE RF module has**
 - One 201 MHz RF cavity
 - Two Beryllium windows
 - Two RF power couplers
 - One vacuum vessel hosting the 201 MHz RF cavity
 - Six tuner arms and six actuators
 - Cavity support struts
 - Vacuum pump system and water cooling
 - Diagnostics and bypass lines

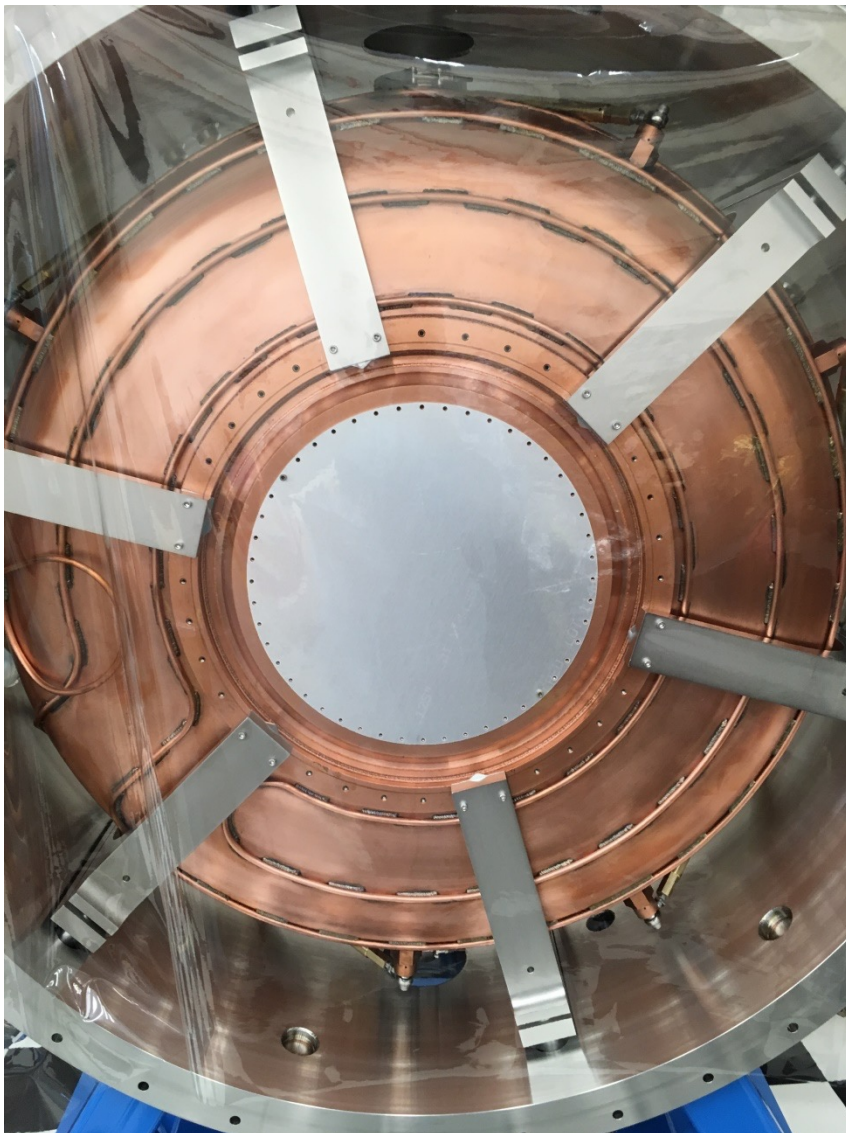
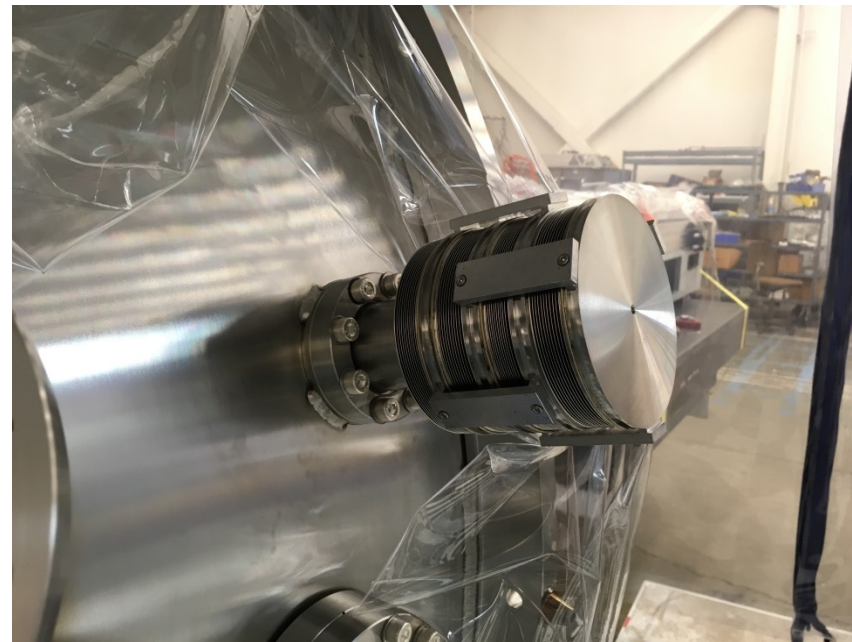
RF Module 1 Assembly

- Tuners and actuators installed
 - Six tuners on cavity body for frequency tuning
 - Actuators thread into tuner bodies; pressurize bellows “squeezes” or “stretches” the cavity to change the frequency
 - +/- 200 kHz

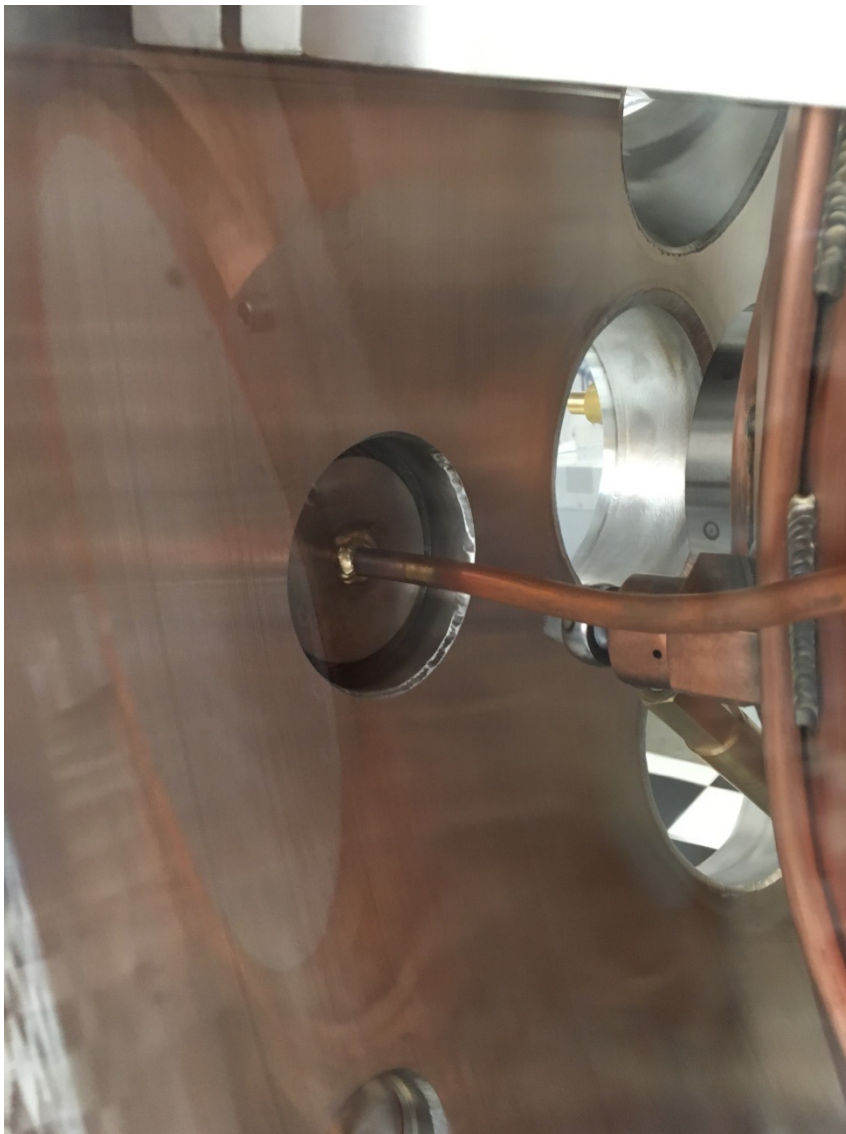
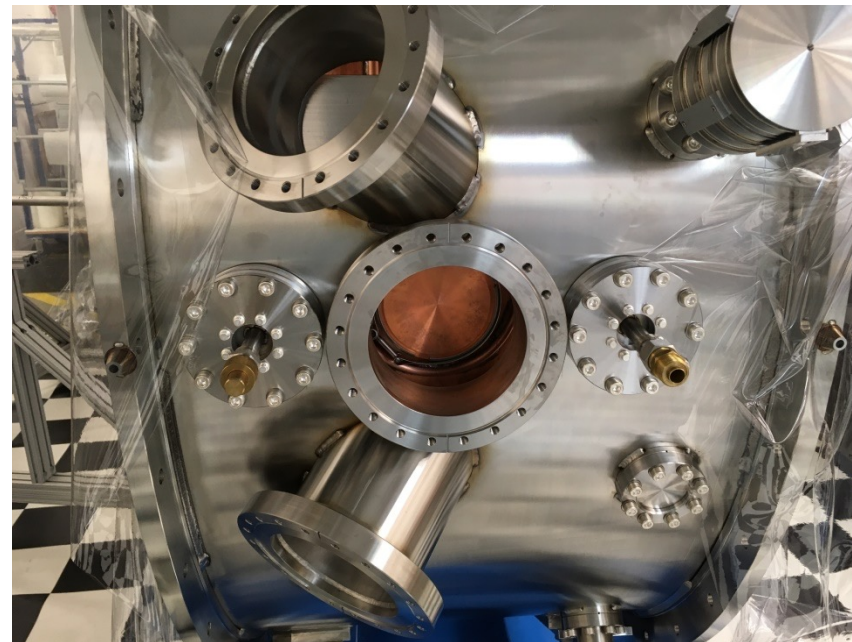
RF Module 1 Assembly

- Water feedthroughs welded and installed on the cavity
 - Provide cooling water to the RF cavity
 - Leak checked
 - Vacuum checked

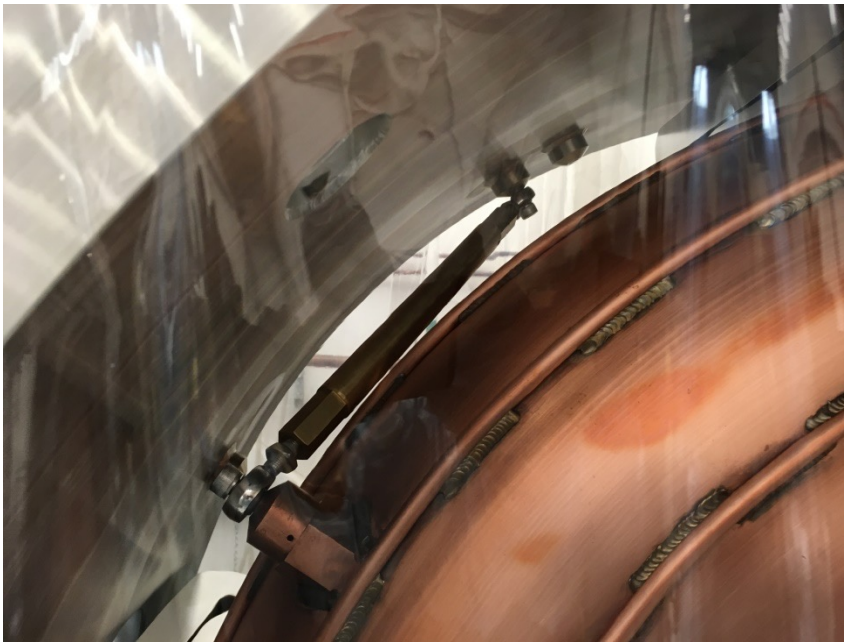
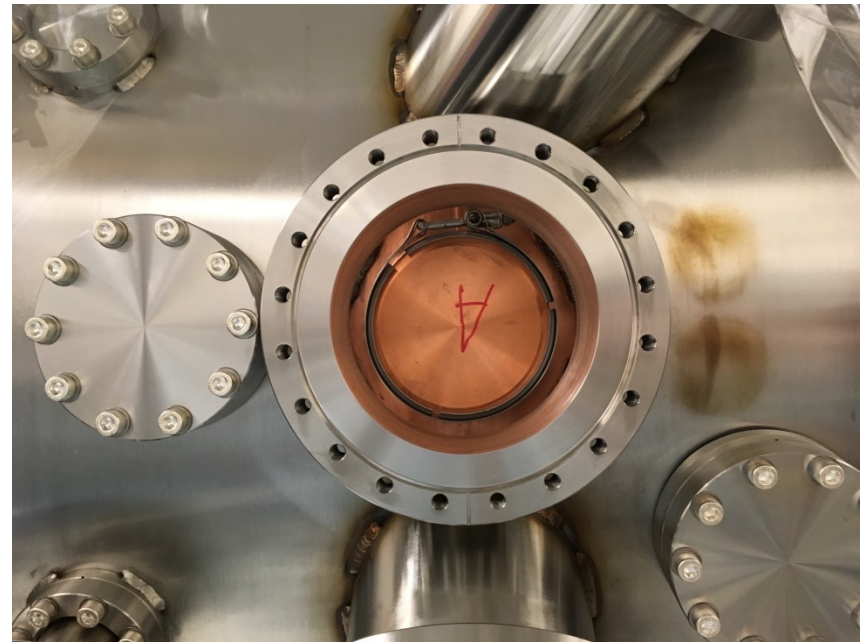
RF Module 1 Assembly

- Six strut system holds cavity in the vacuum vessel
 - Laser tracker survey of the vacuum vessel and the RF cavity determine strut length pre-installation
 - Quick installation and alignment
- RF coupler ports aligned
 - High power tested at MTA
 - Successful

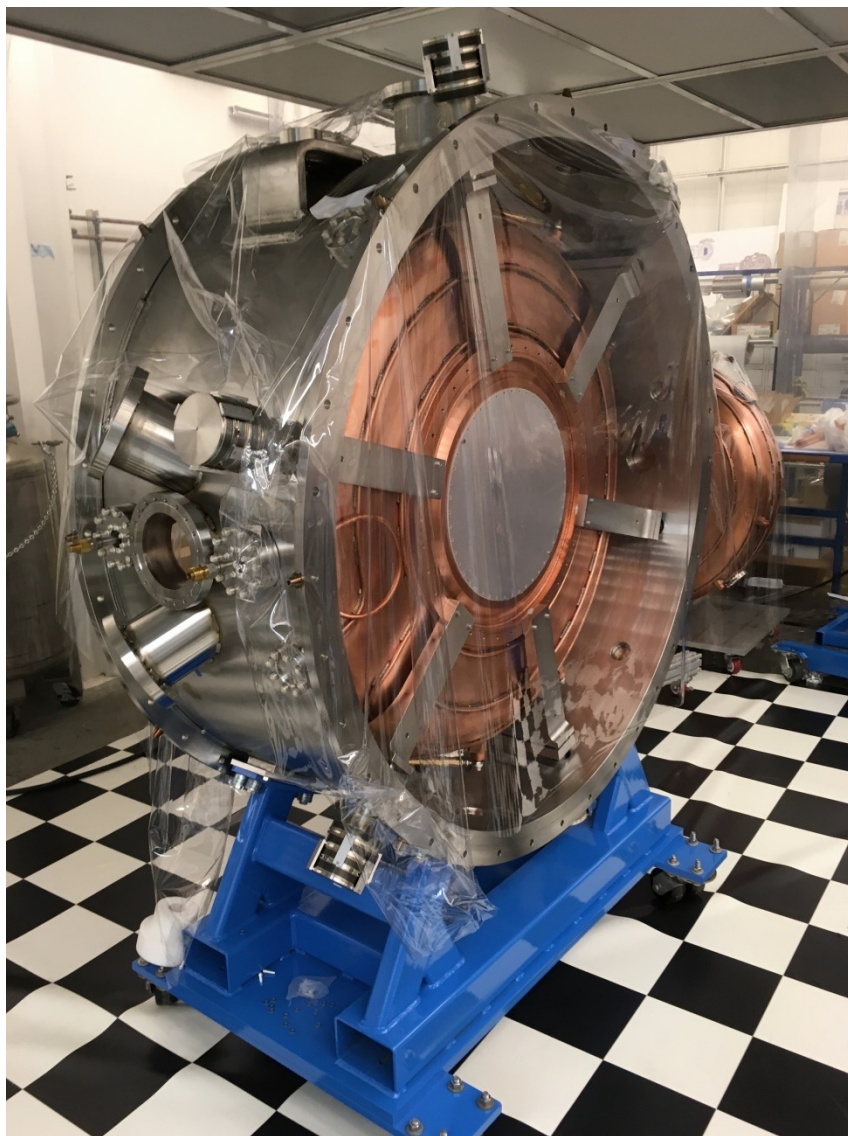
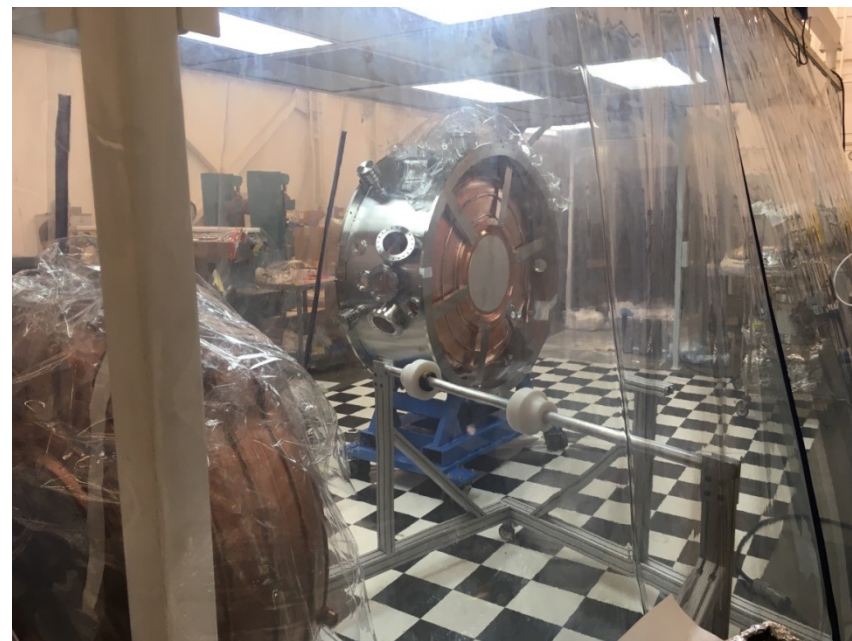
RF Module 1 Assembly

- RF module 1 assembly in clean tent on short stand
 - Needs couplers, end plates, production stand

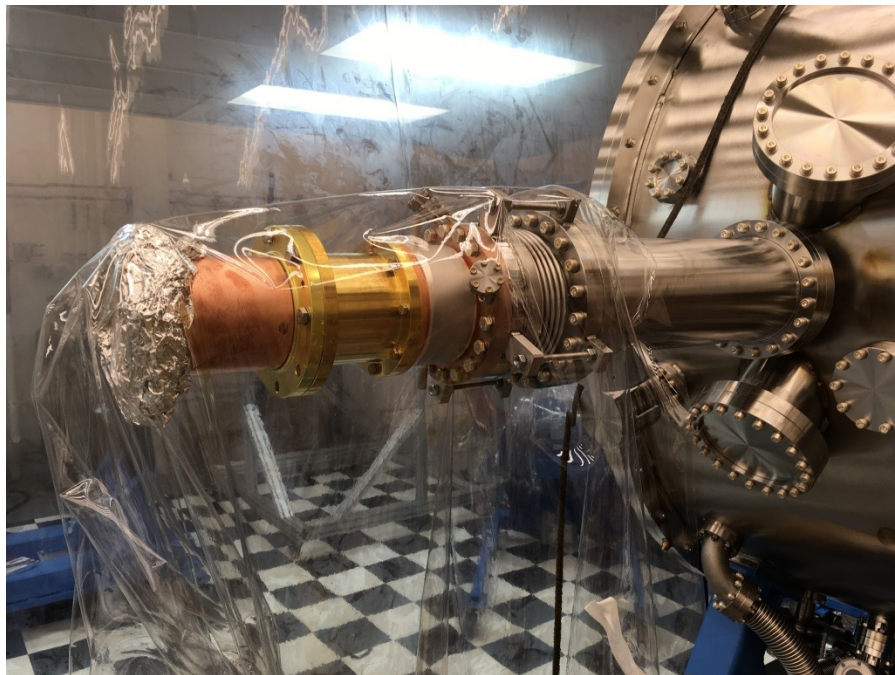
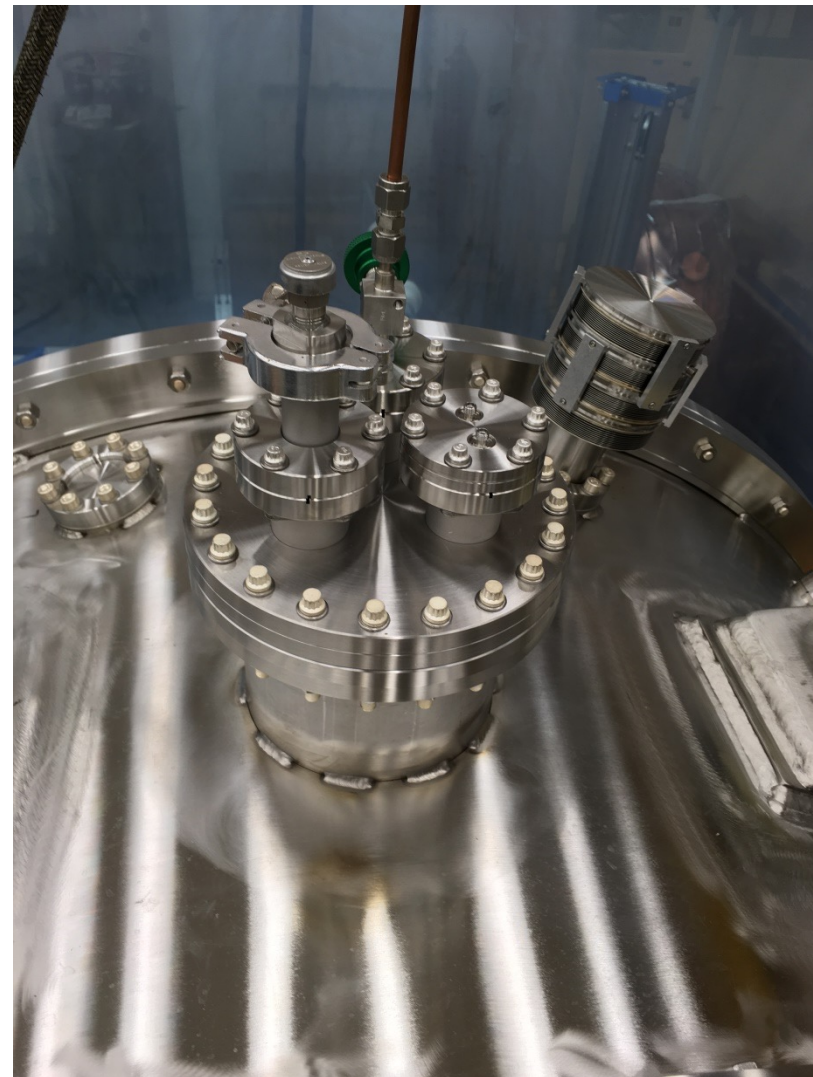
RF Module 1 Assembly

- Couplers installed to the RF cavity and vessel after cleaning
- RF pickup feedthrough port installed at top of the vessel
 - Image at right show pressure relief and nitrogen vent line during vacuum system testing

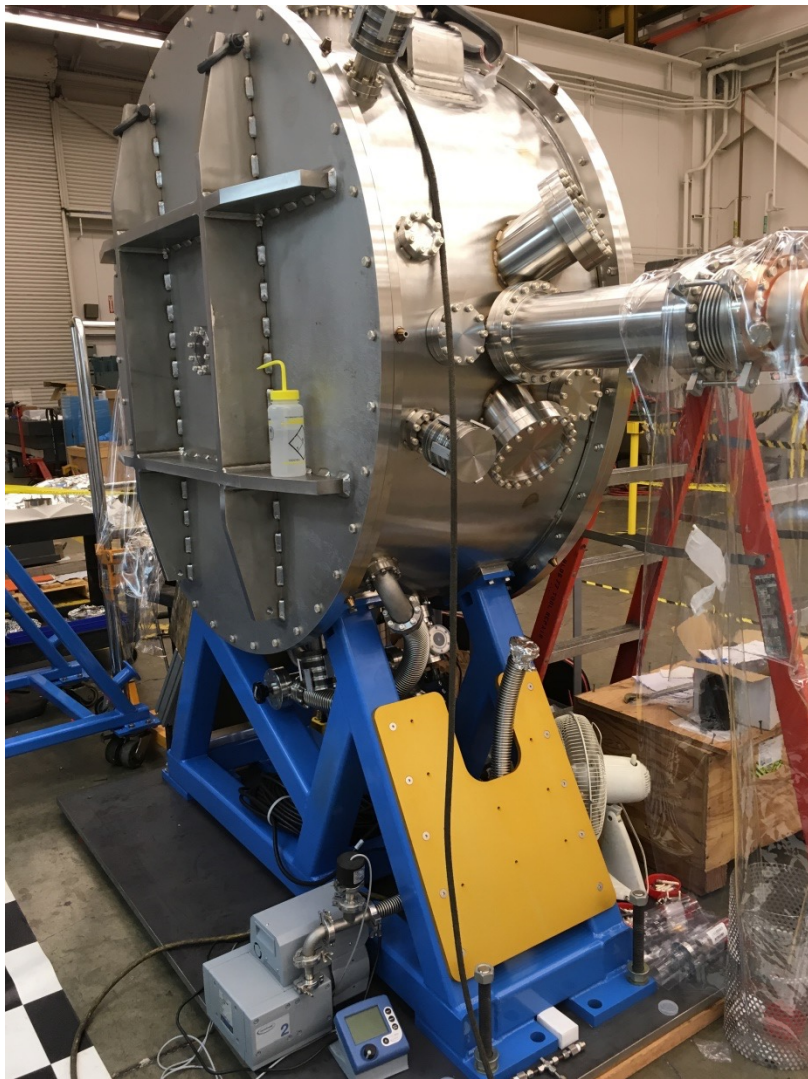
RF Module 1 Assembly

- Differential pressure box tested - Be window protection
- Tuning system fabrication and installation underway
 - Mounted on support stand plate, rigid manifold with flex line to actuators
- Once tuning tests completed
 - Install Be windows
 - Rotate, tune & mark RF coupler position
 - Package Module 1

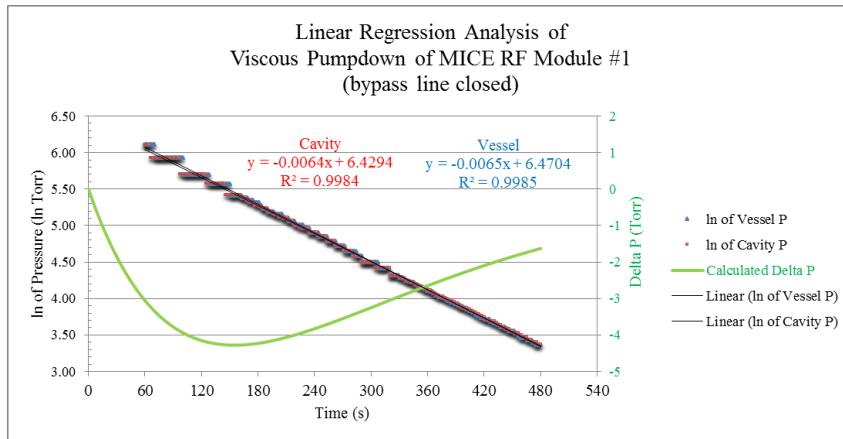
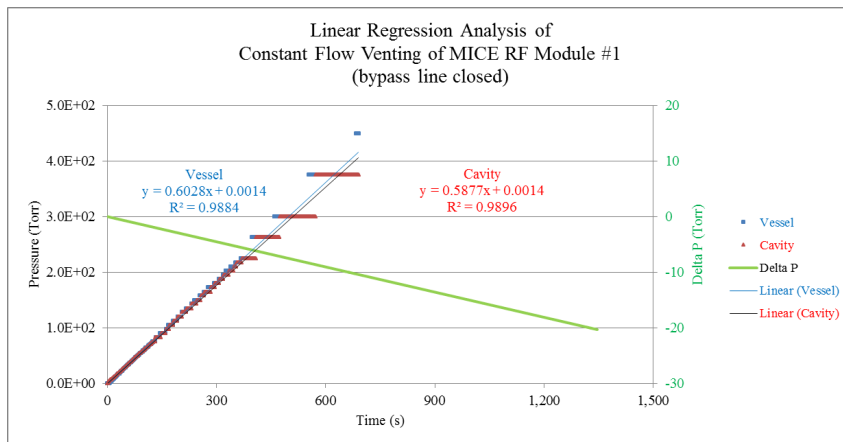
Module 1 Vacuum Test

- Linear regression analysis of the viscous pumpdown (top) and vent (bottom)
 - In each test, the bypass line is closed
 - Conductance through differential pressure box only
 - Check valves crack at < 7.75 torr differential
 - Maximum differential pressure during pumpdown = 4.5 torr
 - Maximum differential pressure during vent = 20.0 torr
 - Exterior vacuum volume of vessel is << than outer vacuum volume at RAL, would expect lower differential during vent at RAL
- Differential pressure box acts as designed and limits differential pressure during pump-down, providing protection against Be window failure
- Closed bypass line simulates minimum conductance between the two volumes
