CM45 Hydrogen System

06/10/16

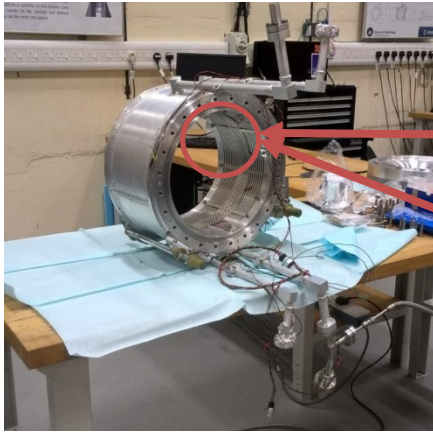
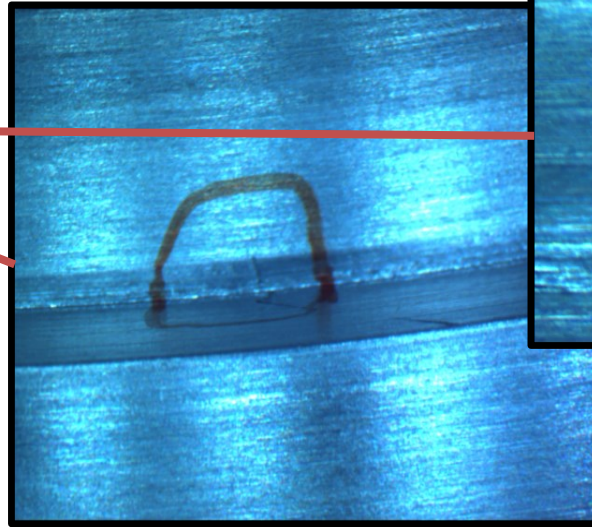
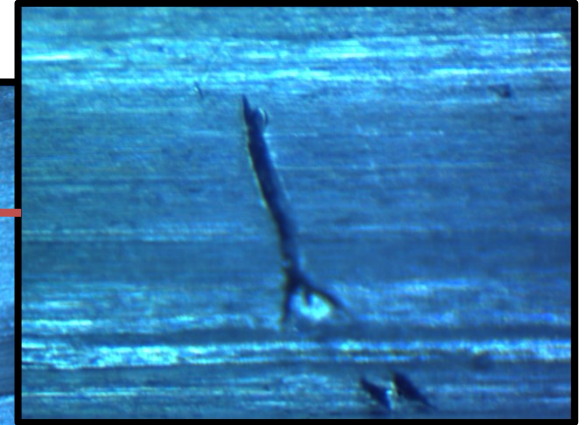
Indium Seals

Surface defects – x-ray and dye penetration test showed no results

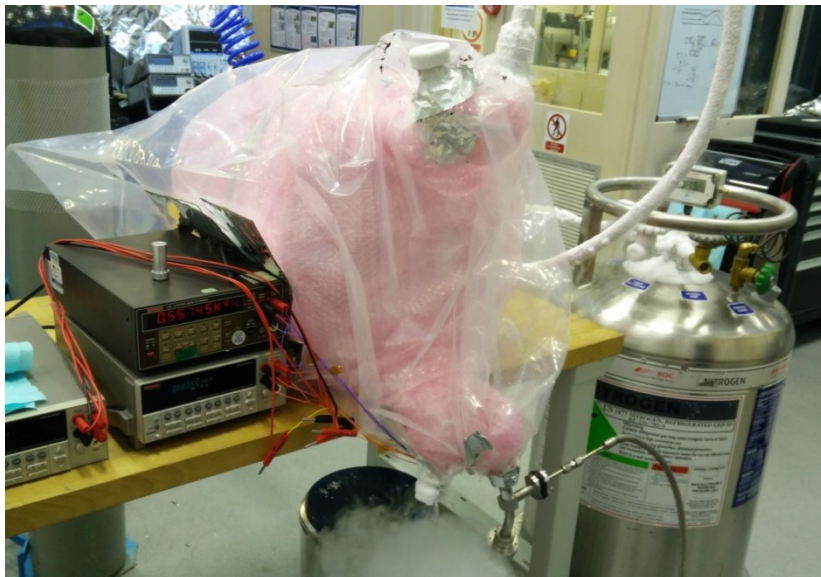
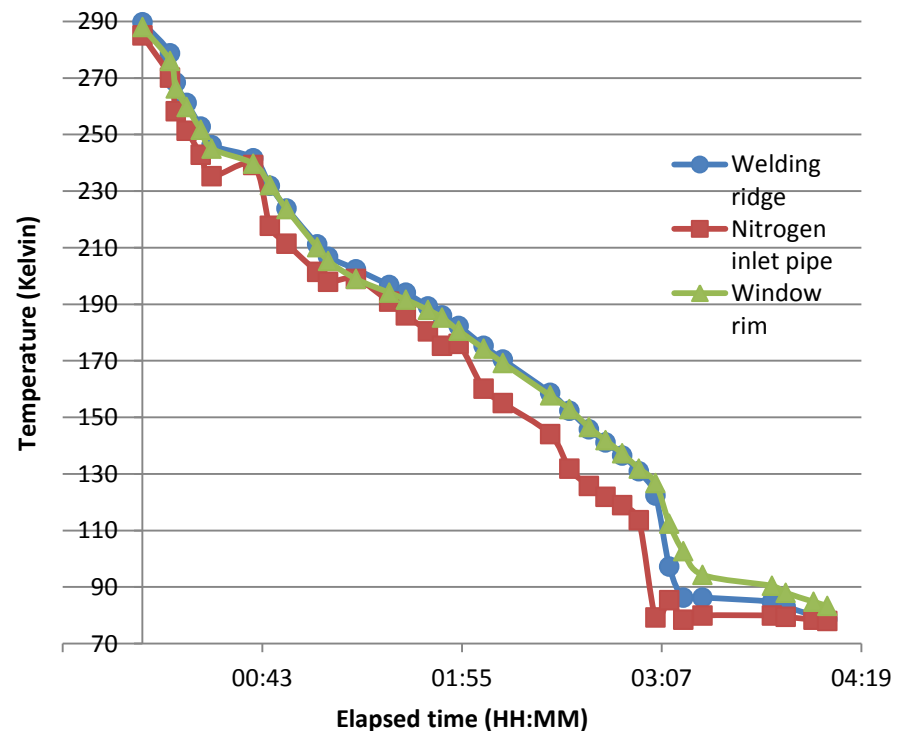
Indium seals

Absorber was thermally cycled three times to below 90K.

Leak checking showed no sign of a leak developing.

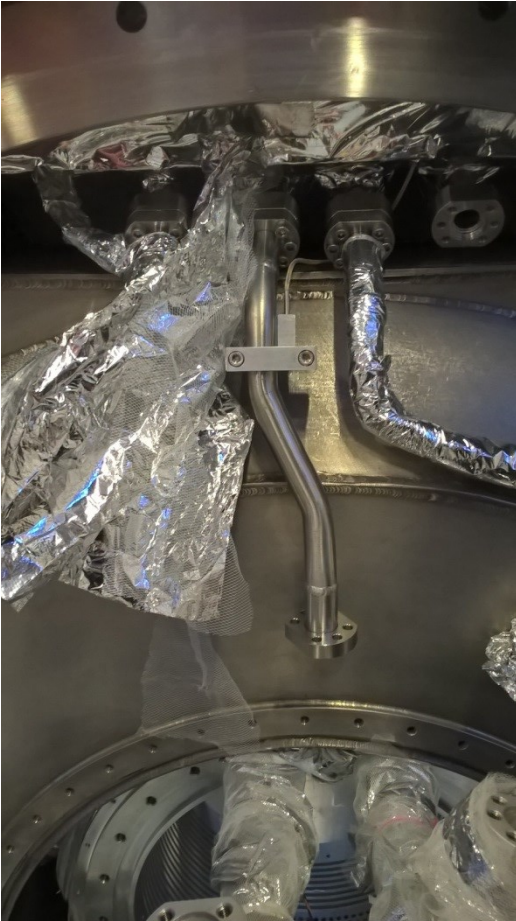
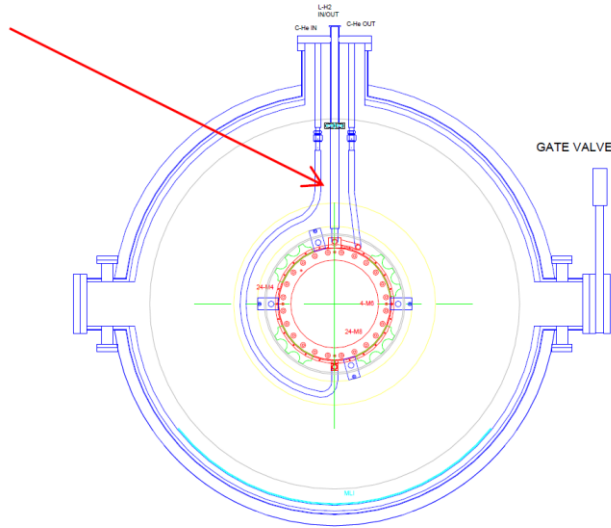
Improving cooling: forcing flow

Heater installed on Hydrogen return pipe.

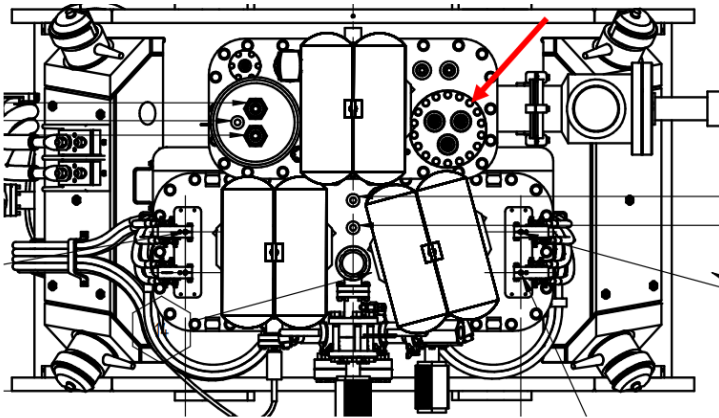
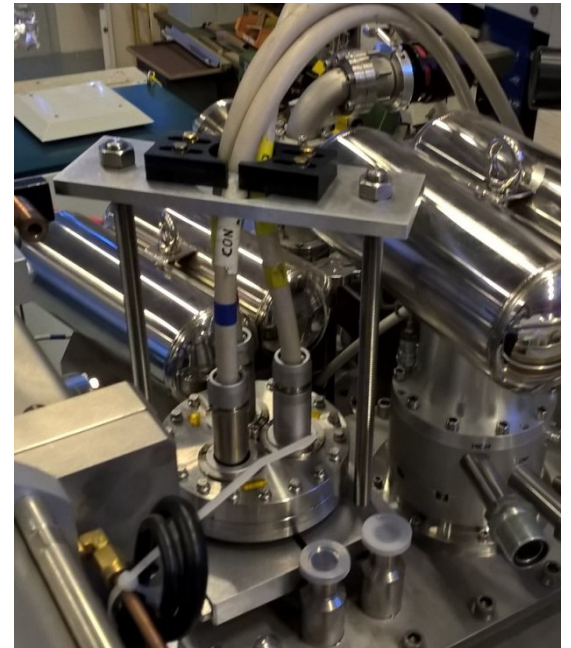
Sensors

- Three replacement Fischer connectors were fitted and the new heater was wired in
- Wiring thoroughly checked following work on absorber and replacement of feedthroughs.
 - Intermittent fault at the Fischer plug/socket
 - Not in the vacuum space
- Mechanically supporting cabling

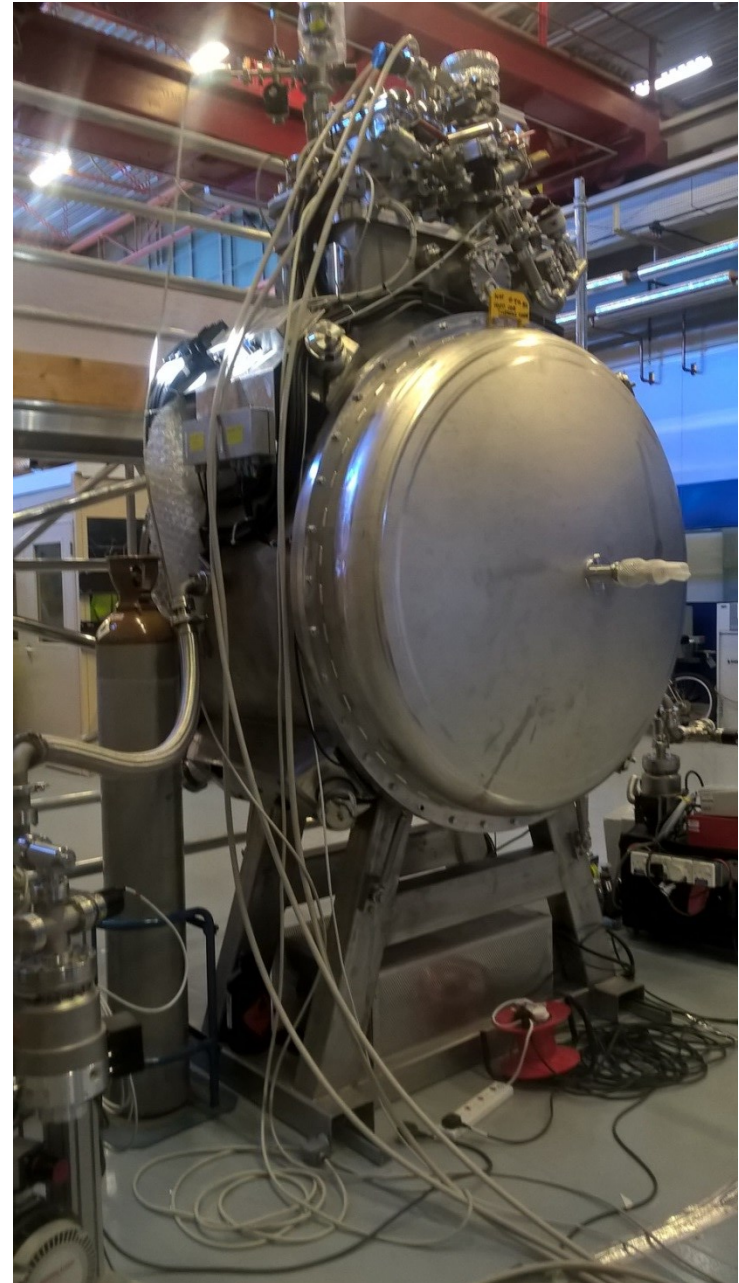
Testing

Leak checking with end caps on:
on:

No leak detectable between...

- helium-filled absorber and bore vacuum
- helium-filled pre-cool circuit and bore vacuum

Indium joints are ok!

But... leak from outside atmosphere into bore vacuum through end-cap flange.
