Qualification of linear cavity welds

Konrad Eiler

31/10/2016

Explosion bonding Ti to 316L with pure Ta interlayer

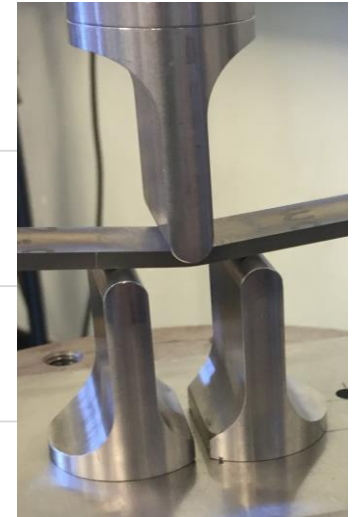
Nb cavity welds transversal bending tests

— W01
— W02
— W03
