# **Xband Klystron/modulator experience at CERN**

HG2017

G. McMonagle

16/06/2017

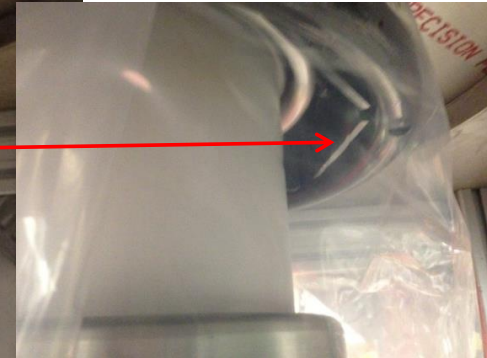
## S/N 003 Mitigation at CPI

Ferrites added to inside of lead cylinder on subsequent iteration

Ferrite tiles on gun corona can

Ferrite tiles also on a plate resting on bottom of oil tank below gun

- 3rd Klystron ordered from CPI
- Klystron acceptance was done in January 2016
- When dismantling test load klystron went up to air
- Broken window
- Klystron repaired
- Initial testing (~January 2017) gun oscillation observed
- Discussions between CPI and SLAC
- Modification to gun and modulator tank (ferrite tiles)

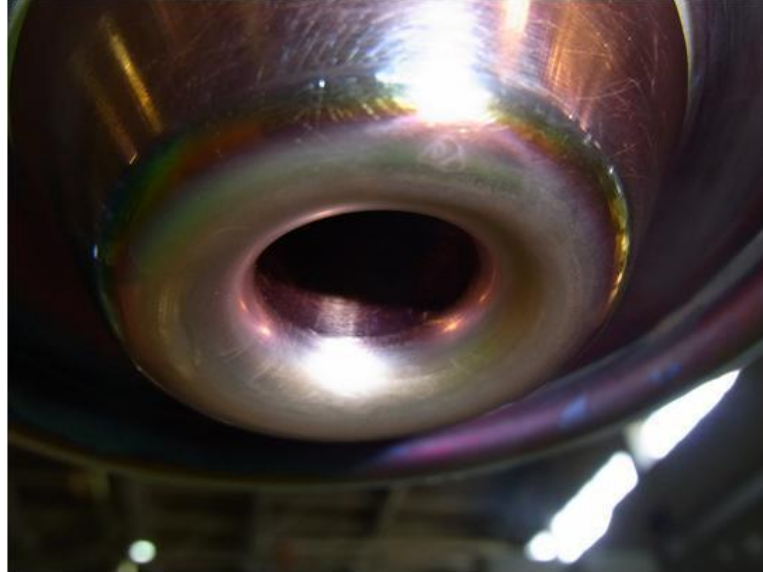
Anode electrode

Discolored

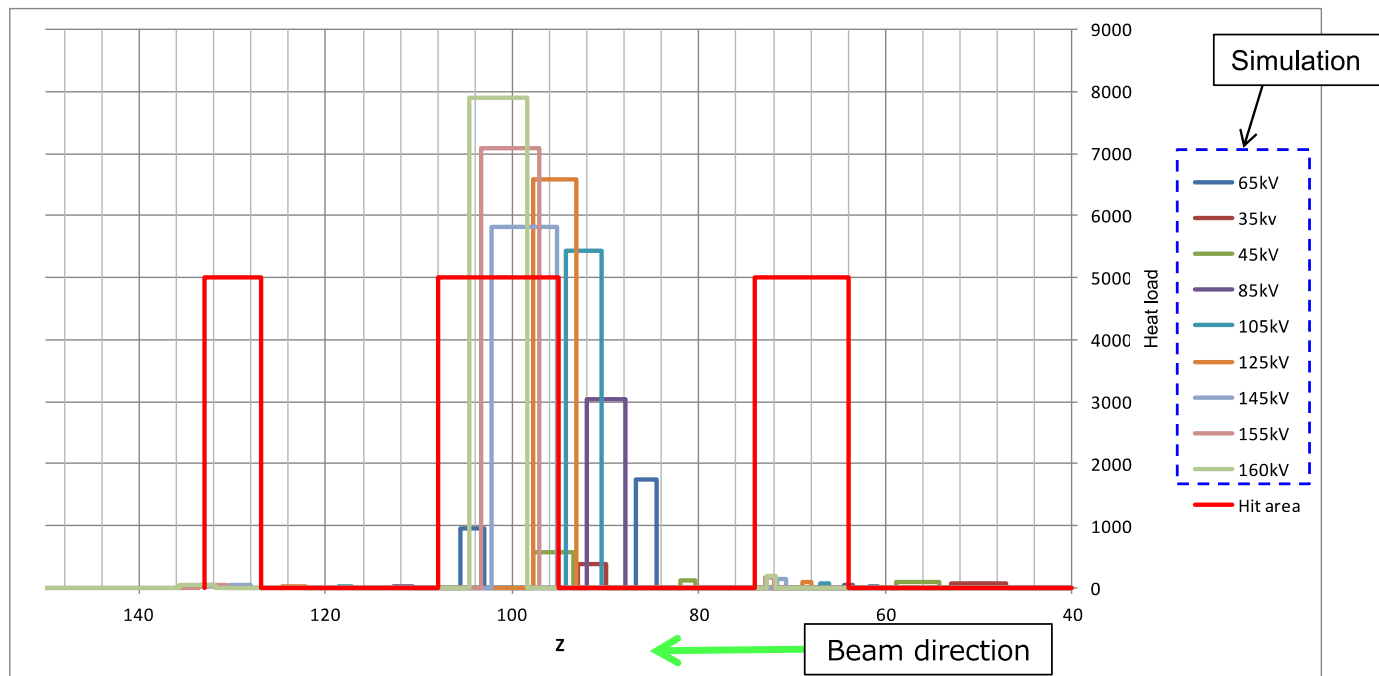
- Reverse polarity of counter coil field

Beam landing position of reverse counter coil current operation

**Simulation and the same trend [○]**

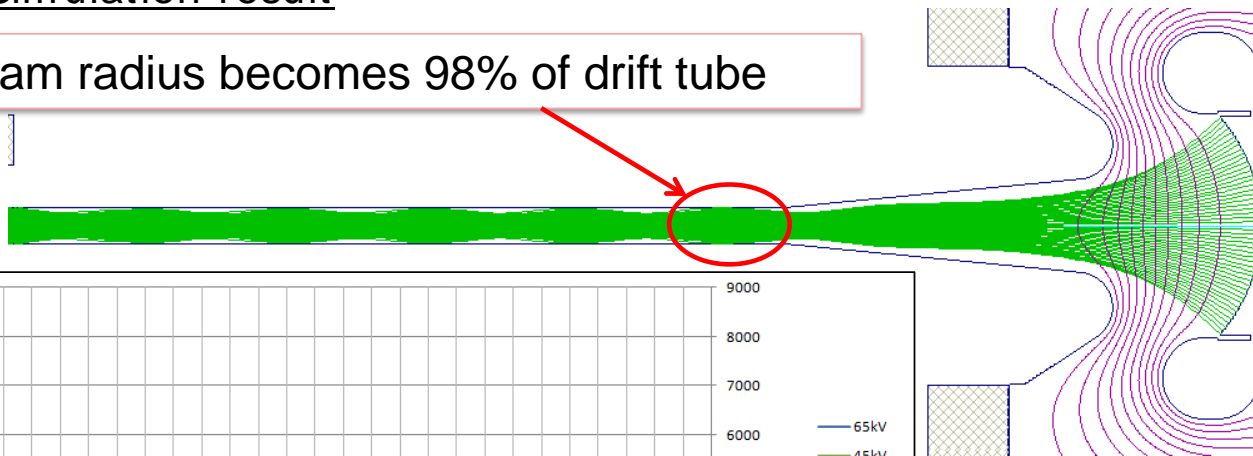
Simulation result

## □ Without counter coil current

Beam radius becomes 98% of drift tube

**Simulation and the similar trend □ □ □**

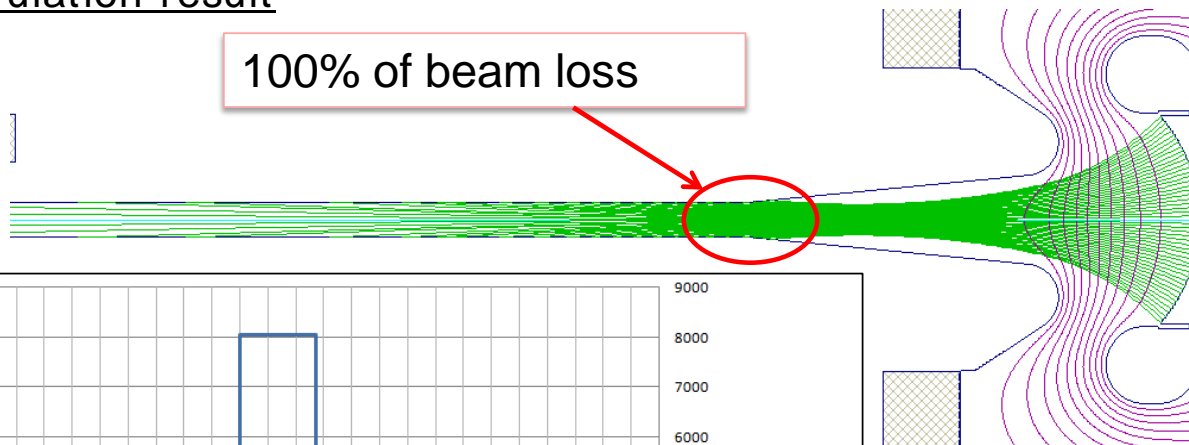
Simulation result

## Without focusing magnetic field

100% of beam loss

Simulation and the different trend ◻ ◀◻

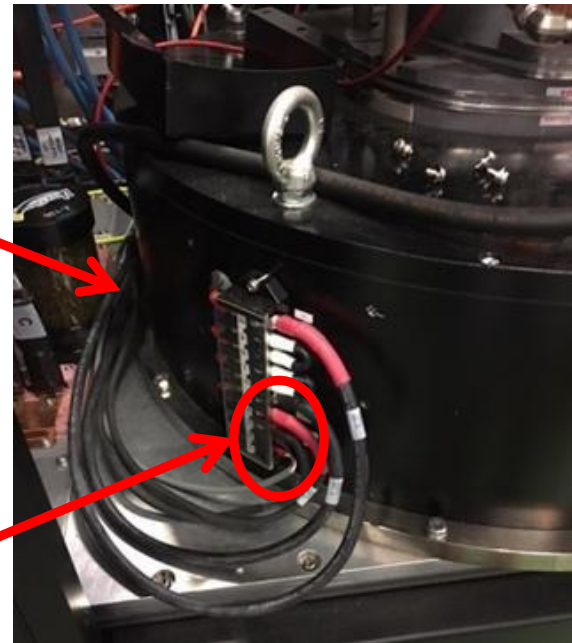
## 4-2. Wiring of counter coil check

While checking the polarity of the power supply side.

CERN confirmed the correct connection.

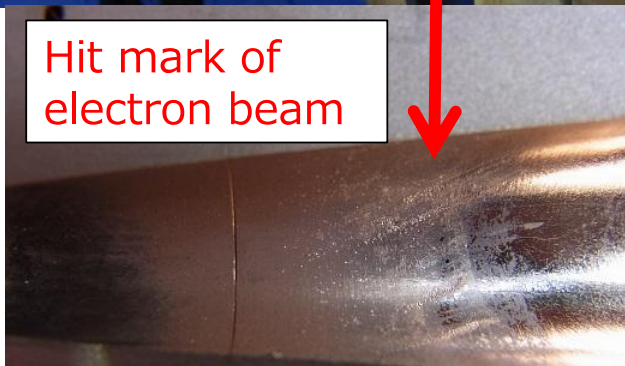
Hit marks of electron beam were observed on the klystron drift tube.

- **Hit marks of electron beam were observed on the klystron drift tube.**
  - **Hit the drift in same place with reverse polarity or without current of counter coil simulation.**
  - **Wiring of counter coil check**
    - **While checking the polarity of the power supply side.**
- Unknown when the polarity is reversed.**

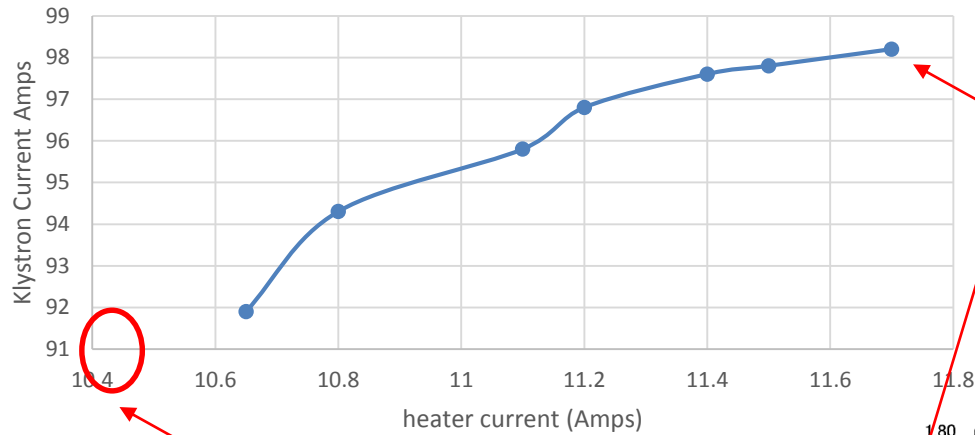
heater curve **Constant Klystron Voltage 150kV**

Limit of heater power supply in modulator

Nominal operating point from factory test

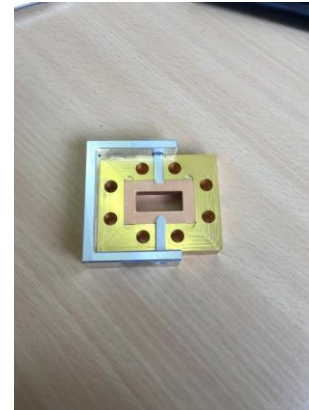
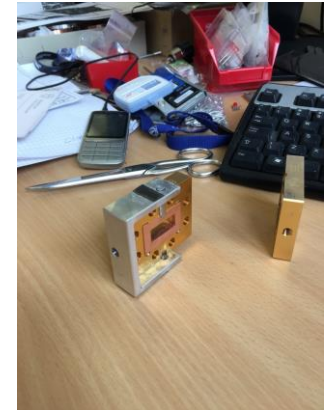
# IUWR90 flanges

- Stamped gaskets
  - Friction fit
  - No problem in mounting
  - external machined edges of flange allowed alignment by touch

- Machined gasket
  - Loose fit needs to be held in place
  - Mounting jig needed

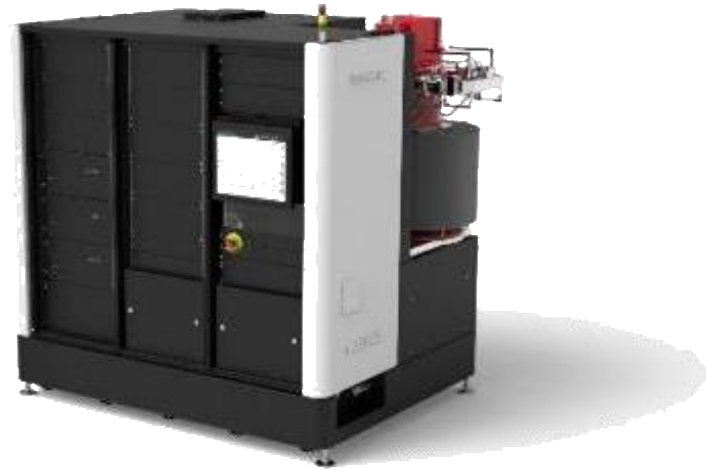
K300 Platform front/side view

## DUAL X-BAND 2X 6MW RF UNIT BASED ON K300 PLATFORM

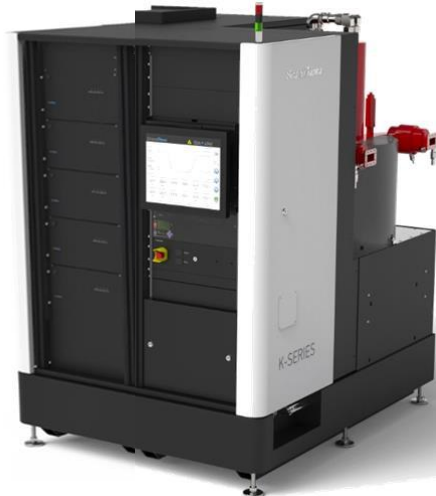
K200 Platform front/side view

## DUAL X-BAND 2X 50MW RF UNIT BASED ON K200 EXTENDED PLATFORM

Main Parameters	Values
RF Peak Power	100 MW (2x50)
RF Average Power	7.5 kW
Pulse Width	1.5 $\mu$ s
Pulse repetition	50 Hz
Klystron Efficiency	75%
Perveance	0.86 $\mu$ perv
Pulse Voltage	360 kV
Pulse Current	185 A
Mod. Average Power	21 kW
Length	1420 mm
Depth	1815 mm
Height	1990 mm
