LHCb and VELO

VeloPix Asic Tests:

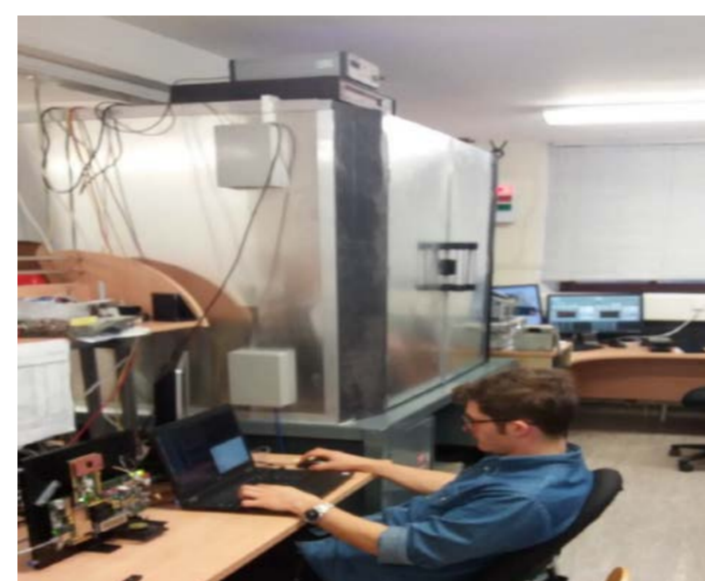
TID Test

- TID Test:
 - Test done with X-ray machine at Glasgow university in Dec 2016.
 - Irradiated up to 400 Mrad.
 - No change in digital power consumption.
 - No drift in analogue parameters: Pixel thresholds, noise and global DACs remain stable.

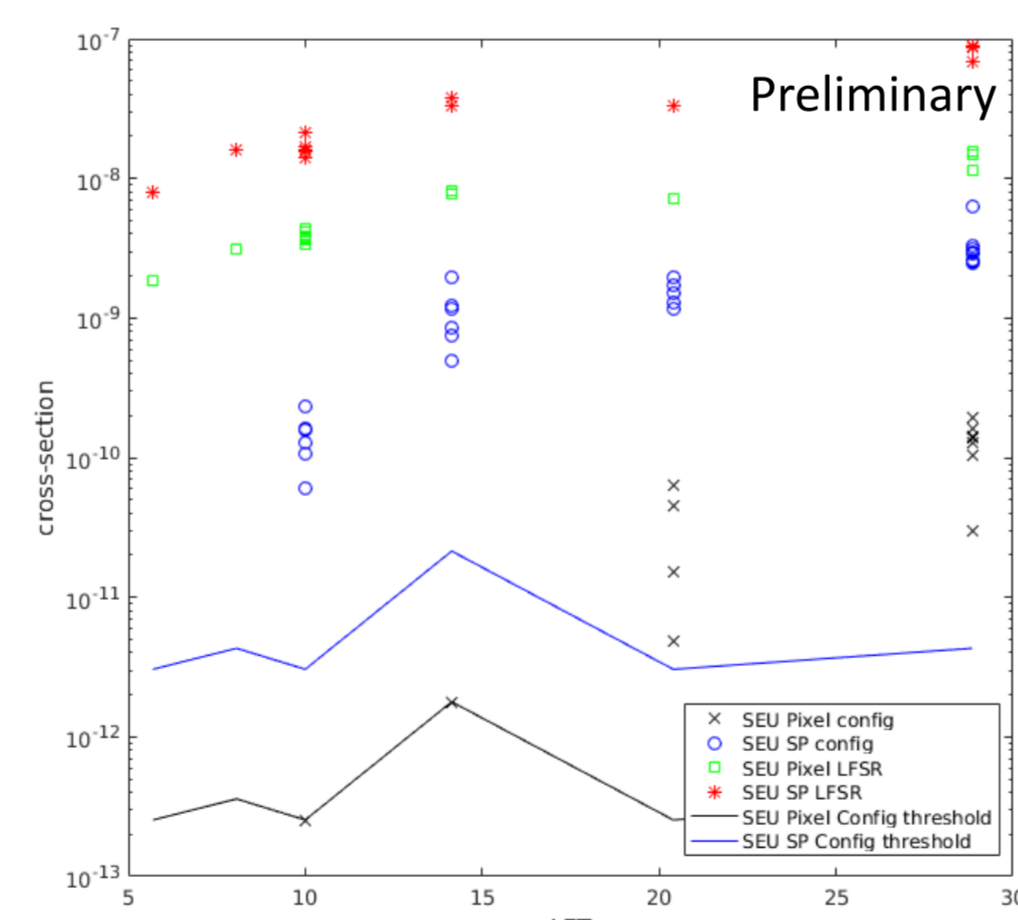
SEU Cross-section

- Aims was to determine cross-section for single event upsets (bit-flips).
 - Shoot heavy ions of various type / angles.
 - Found some issues:
 - Single Event Latch-up (SEL):

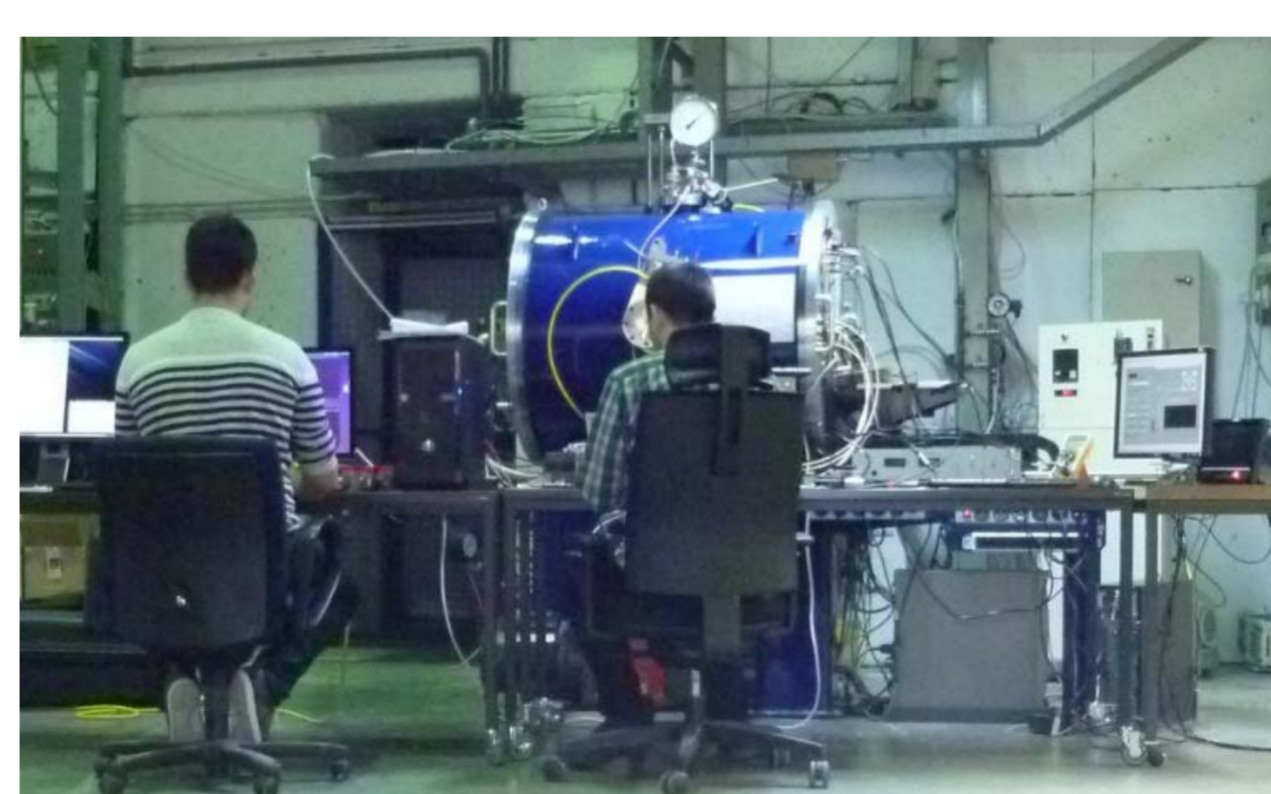
SEE Louvain-Le-Neuve

- It is a (local) short circuit on the power lines. 30 mA current rise per SEL.
 - Recovery is only possible by power cycling the chip.
 - Occurs only in pixel matrix (use of custom high density library). Not in the periphery (use of standard cell library). it prevents read back of data from the internal shift register (e.g. read of config settings)

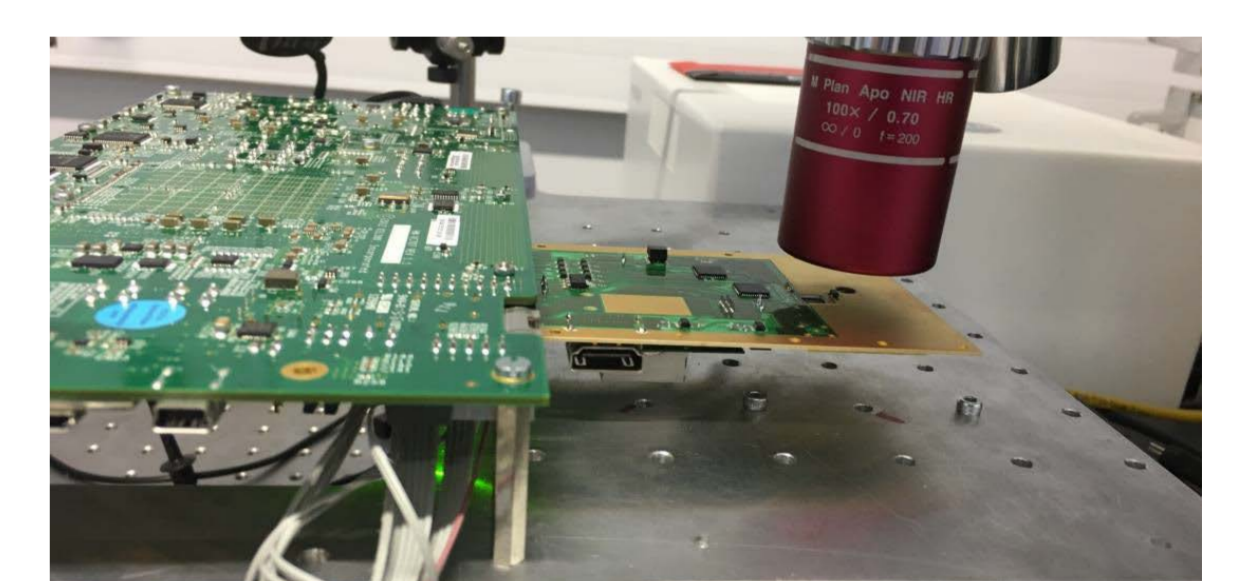
Montpellier laser facility

- Temperature dependant. Not occurring below -10°C.
 - SEL is due to high n-well and p-substrate resistance.
 - SEL confirmed by injection of laser light at Montpellier facility.

- Solution: n-well and substrate contacts need to be placed closer to P+ and N+ implants of CMOS.**
 - Large cross-section for the SLVS receivers:
 - Covered matrix to get rid of SEL. Then we observed frequent resets of the chip.

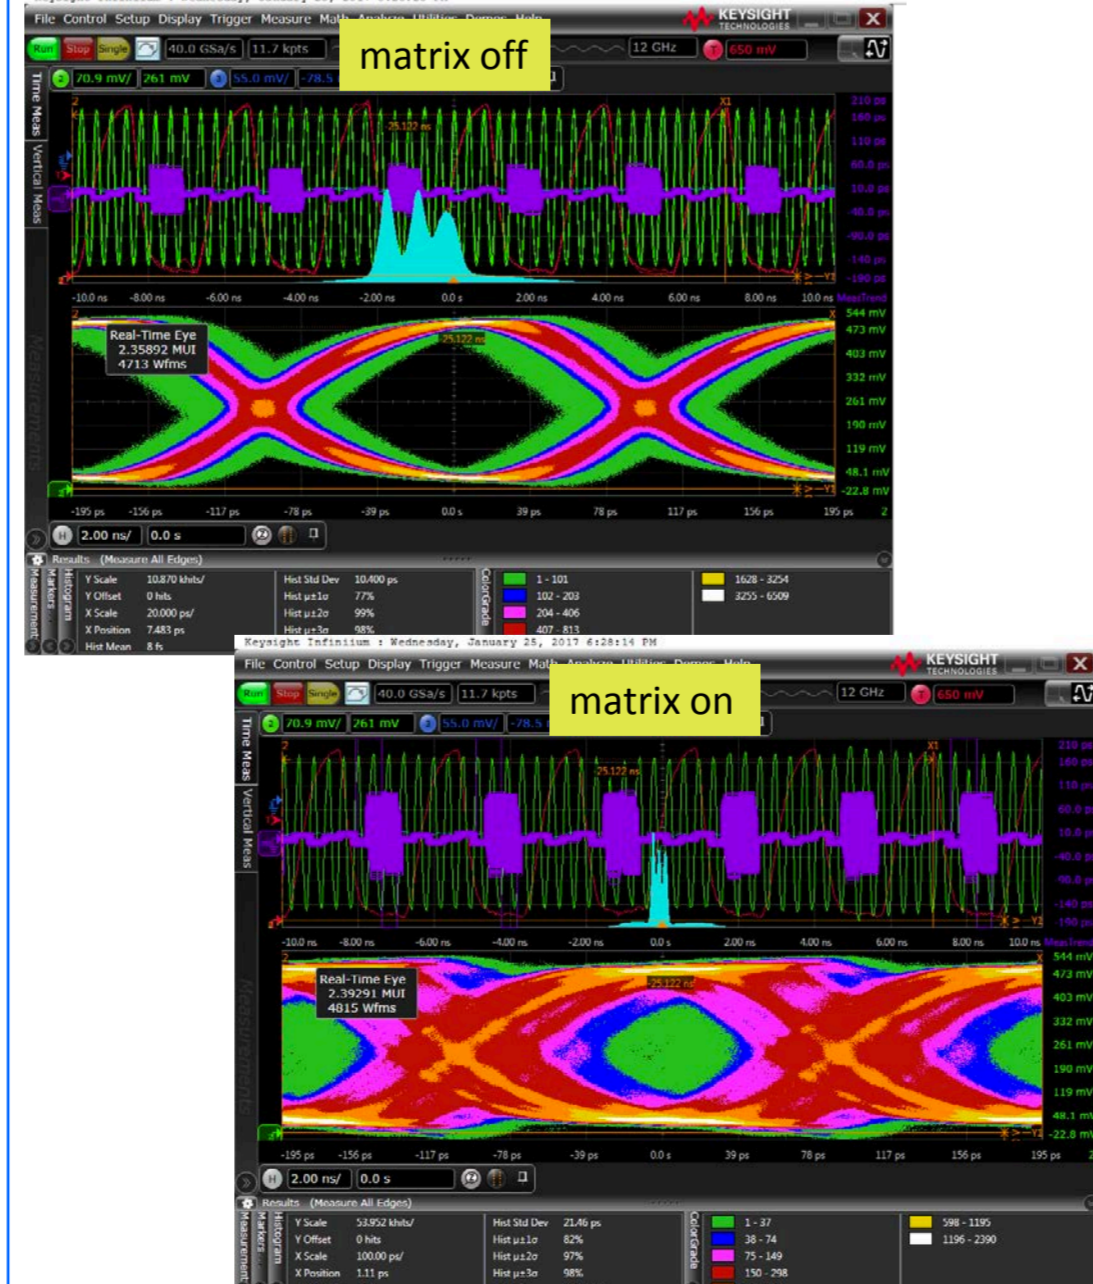
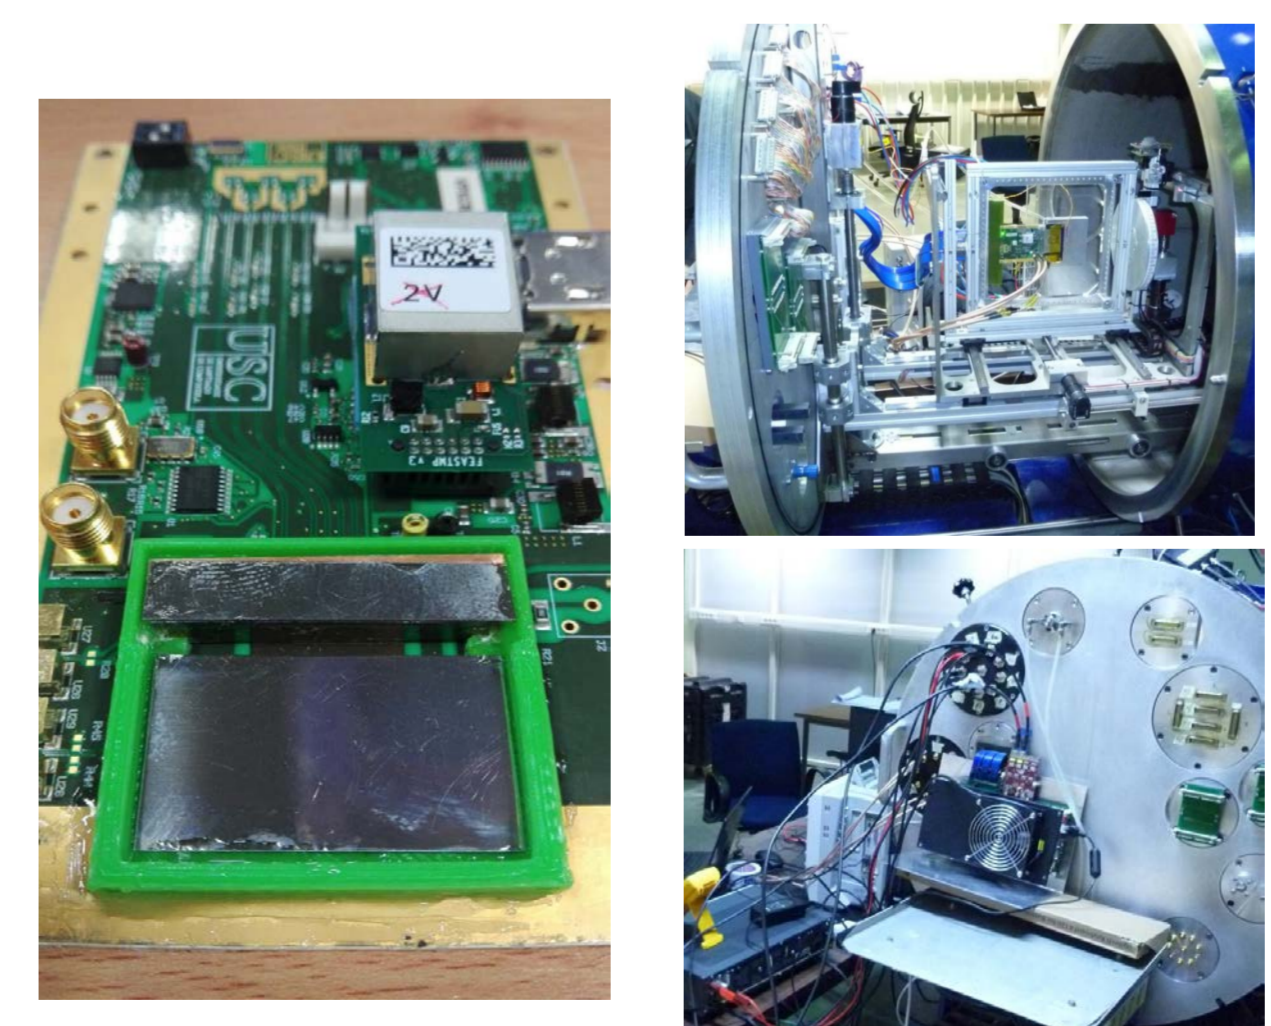
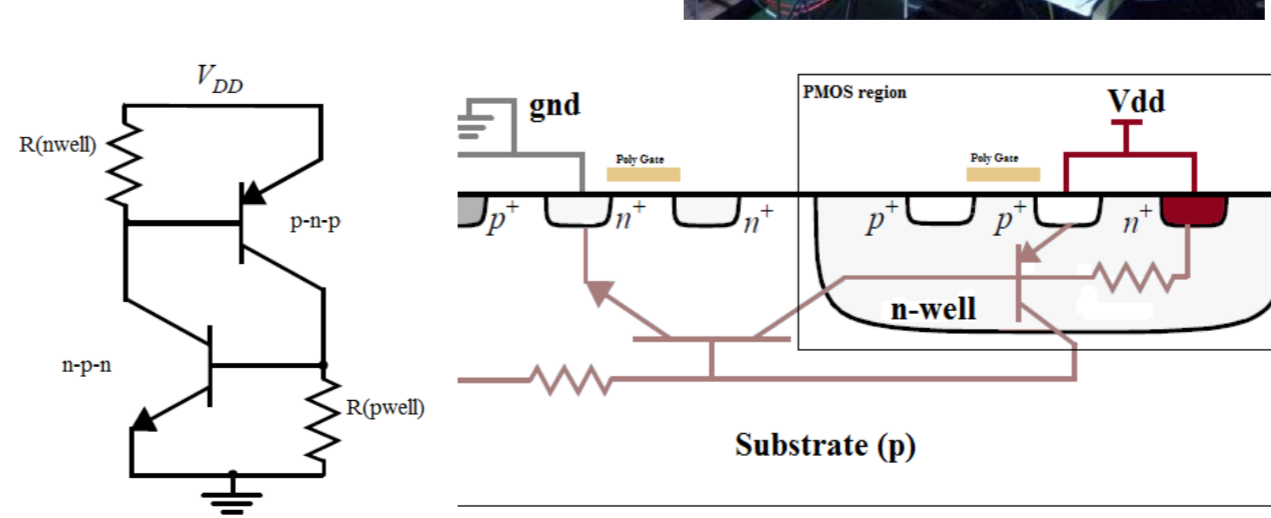
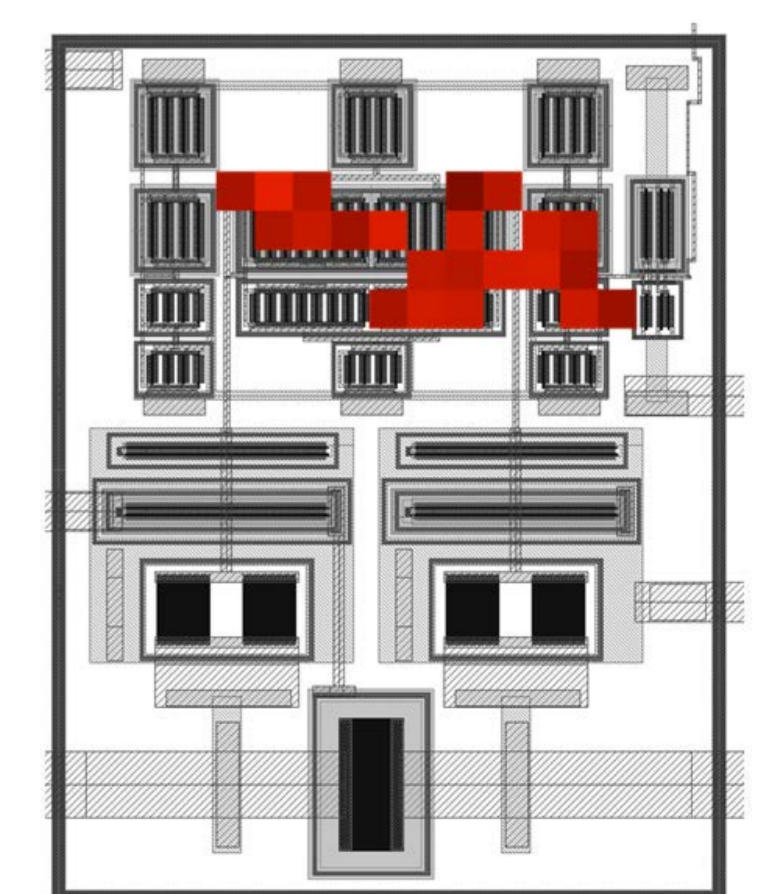
High Speed Test

- Solution: Triplicate the SLVS reset receiver and on other ECS / TFC signals.**
 - Few small design flaws.
- High Speed Test:
 - Excessive jitter on GWT due to the too much cycle-to-cycle period variation of the internal 320MHz.

- Rate can be lowered (to almost zero) by tuning an internal clock phase.
 - Origin understood as Vcc & GND bouncing
 - Solutions:**
 - Add extra on-chip decoupling.

- Splitting of internal supplies in ePLL
 - Shorter bond wires and add external decoupling
 - Smaller, slower, clock buffers
 - Smaller current peaks, and spread in time
