- On PS Ring
- About 200 flanges to be measured,
- Use of a trolley with big pneumatic wheels because of the rails on the PS
- **1st part of the job:** Interventions where Vacuum chambers are disconnected, we previously removed all the RF Bypasses according to a given list then once the Vacuum group has finished each one of them, we measure the impedance of the flange as the collars risk to damage the enamel insulation of the flanges and cause short-circuits. If ok, we put back the RF Bypass and make a measurement to be sure. 200uS radiation taken.

RF Bypass Impedance Measurements

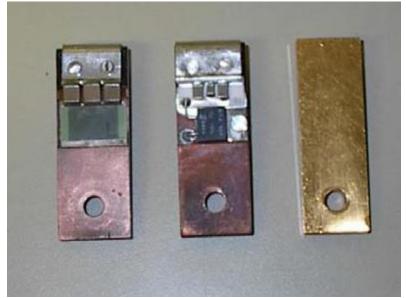
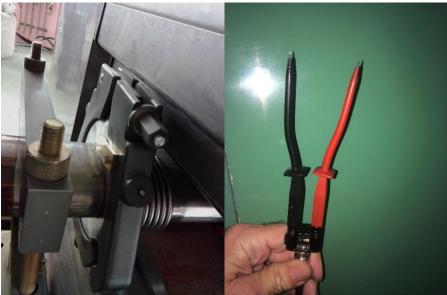
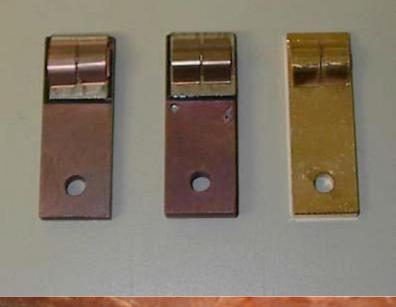
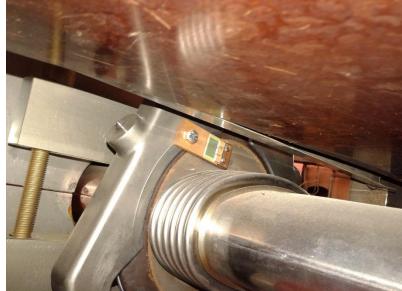
- On PS Ring
- About 200 flanges to be measured,

- Use of a trolley (with big pneumatic wheels because of the rails on the PS) to carry VNA,

extension cord, etc...

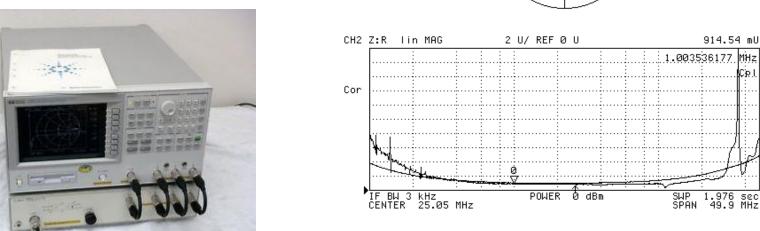
SS02 Upstream

... 2013, then 2015 and 2016 Agilent 4395A

843.08 mΩ -354.23 mΩ 447.72 nF

1.003536177 MHz

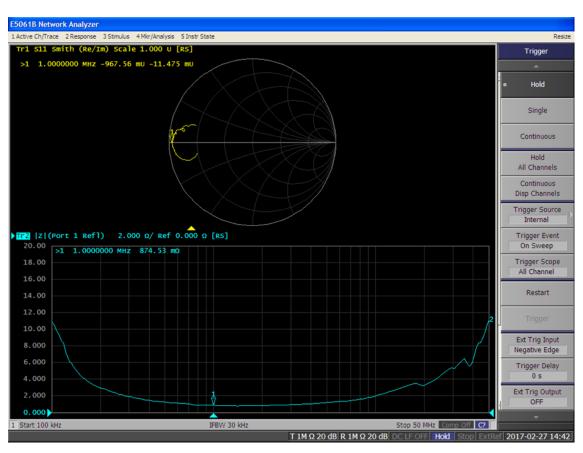
SS52 Downstream

2014 and 2017 Agilent E5061B

- 🙁 Very slow Boot 3 minutes (MS Windows),
- © Image saved to USB, about 10 seconds,
- © Inserted UPS, huge gain of time
- Problems in 2015, we forgot to press hold before saving plots, this VNA continues to scan while its saving, bad contacts caused bad pictures.

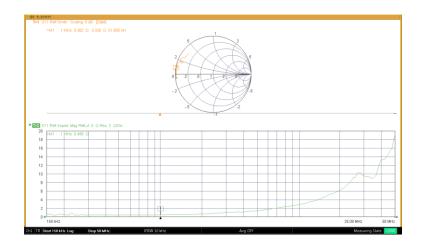
- Powered by USB Only,
- © Friendly user interface software,
- Uery Fast Scanning,
- © Easy to save plots,
- ⊗ Min Frequency starts at 150kHz ⊗

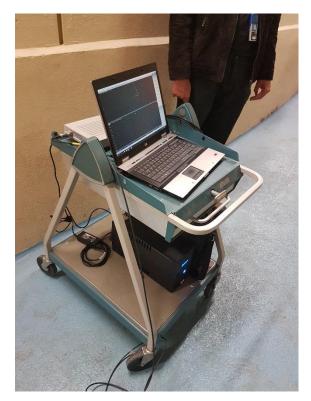
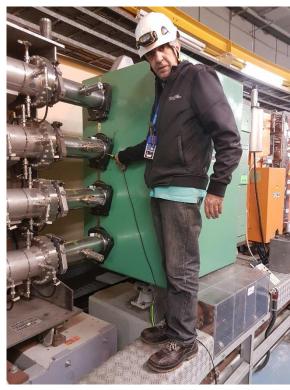
Copper Mountain Technologies TR5048

- Used with a laptop,
- Needs 1.25A, 12V, power supply,
- Very fast scanning,
- We used this trolley with only the UPS powering,
- All 120 measurements in about 1hour,
- Radiation taken: Joao 8uS, Bruno 4uS.

- All 120 measurements in about 1 hour without saving plots,
- The UPS can handle it, over 50% left,
- Radiation taken: Joao 8uS, Bruno 4uS,
- Measurement from interior or exterior of the ring could improve speed of measurements,
- The biggest part of time can be saved if cord extension is avoided,
- Continue to search a better portable USB connected VNA solution, automatization of the measurements.
