LHCb VELO detector the effects of radiation damage so far

David Hutchcroft

University of Liverpool
on behalf of the LHCb collaboration

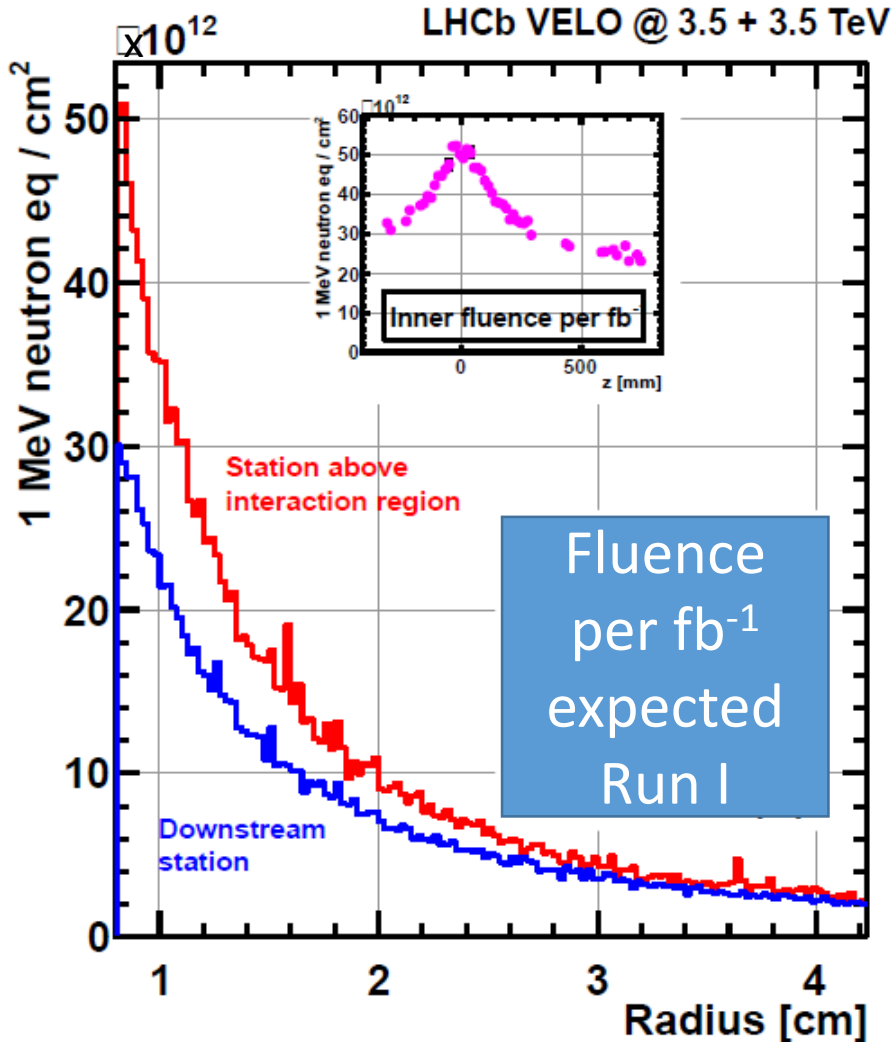
x3 this for Run I total dose

Fluence varies exponentially with radius and by x2 between stations

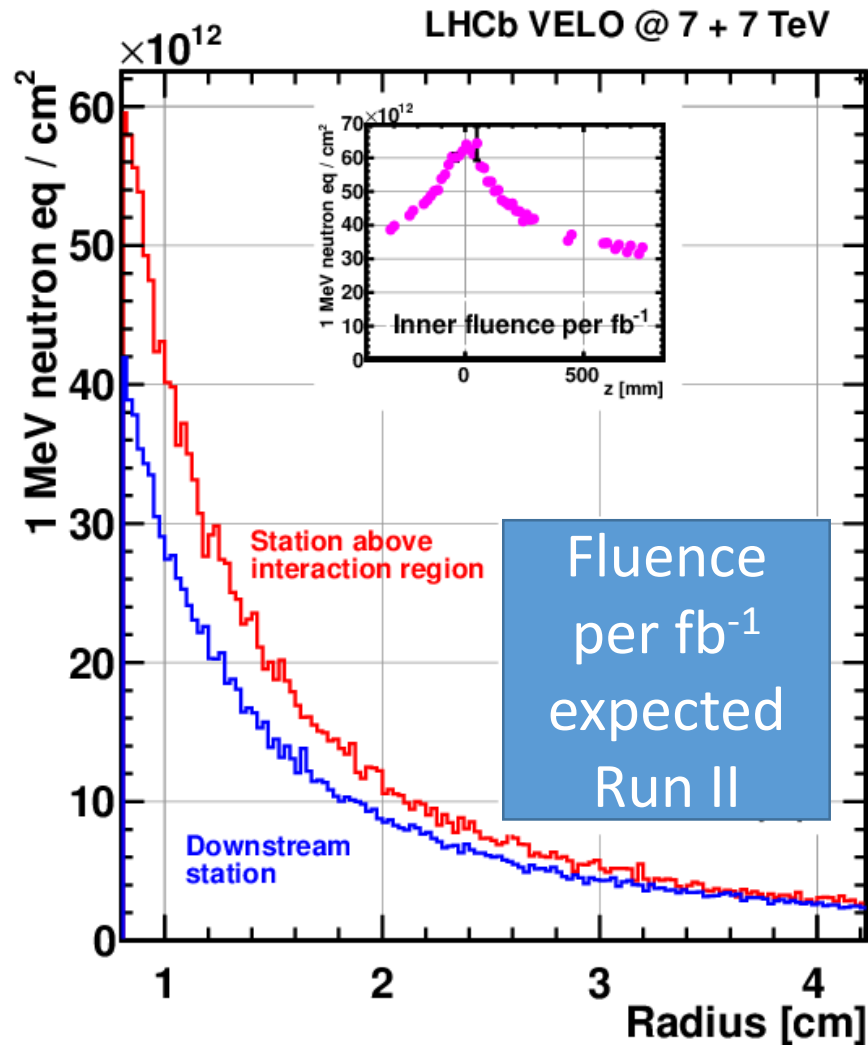
x2 this for Run II dose so far

Effects of \sqrt{s} are smaller, about 30% between Run I and Run II

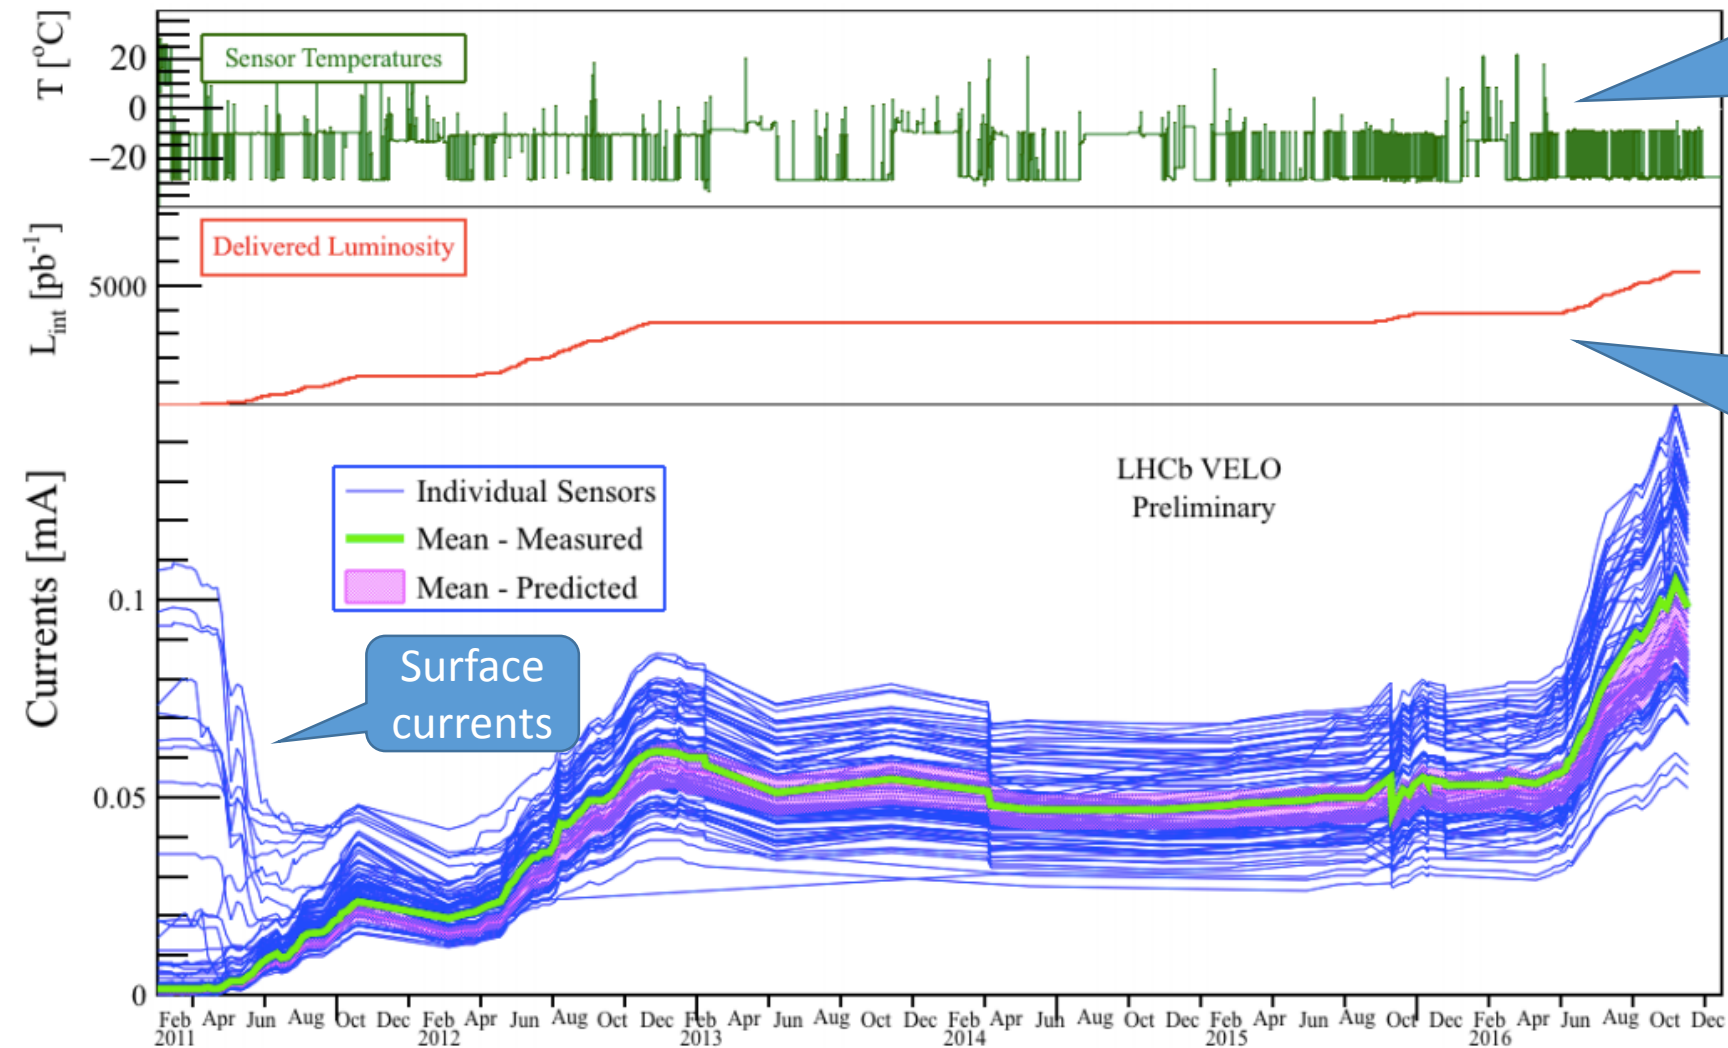
Operational temperature is about -8°C .
Sensors at -30°C when the chips are unpowered

Long periods between data taking due to LS1 and end of year shutdowns
Need to avoid annealing

Currents measured at approx -8°C without beam

Typical increase was $1.9 \mu\text{A}$ per 100pb^{-1}

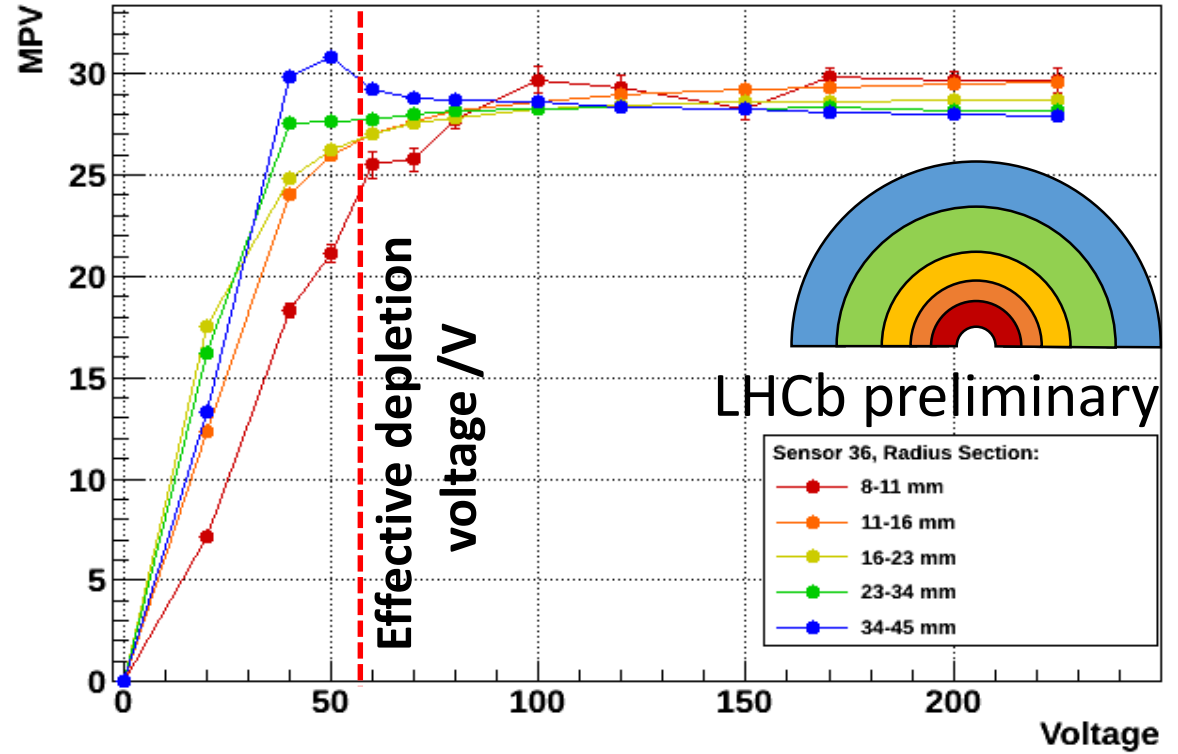
HV increasing
20 – 250 V

Measure EDV during HV scans in data taking by looking at the charge collection efficiency vs Voltage curves

Running all sensors fully depleted at 150V, with one at 250V to test the effects

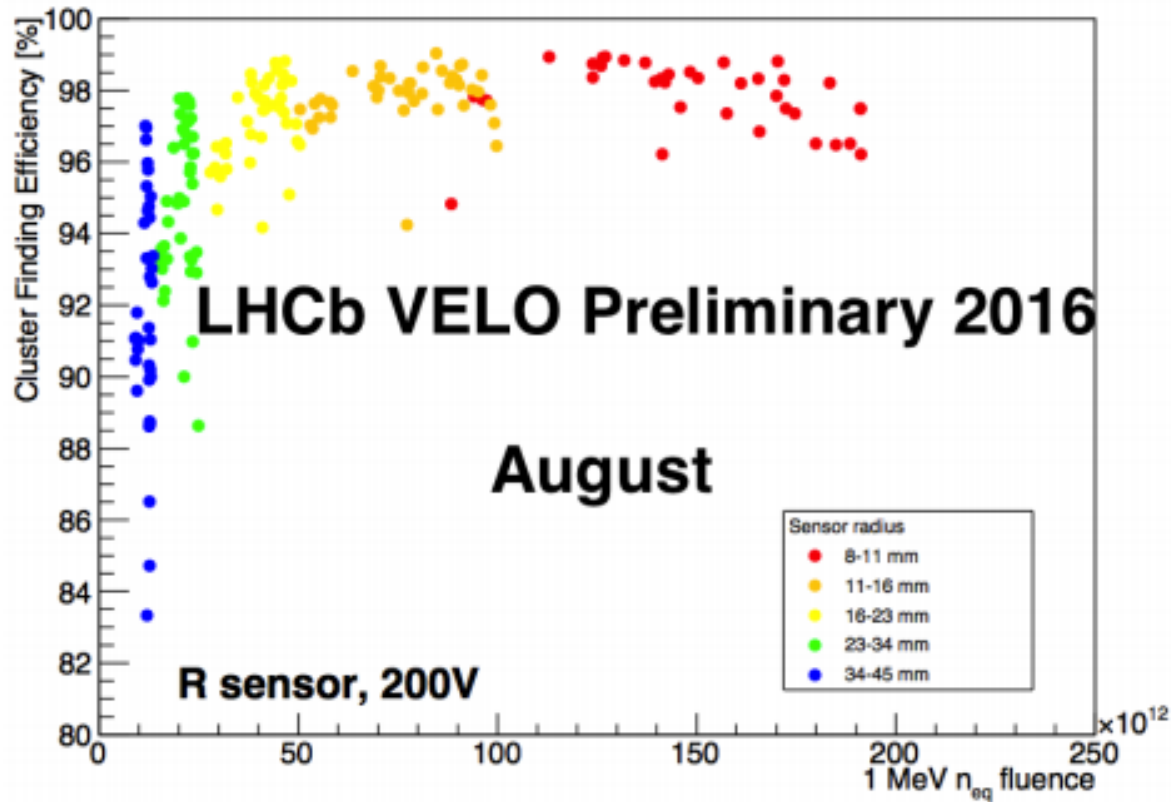
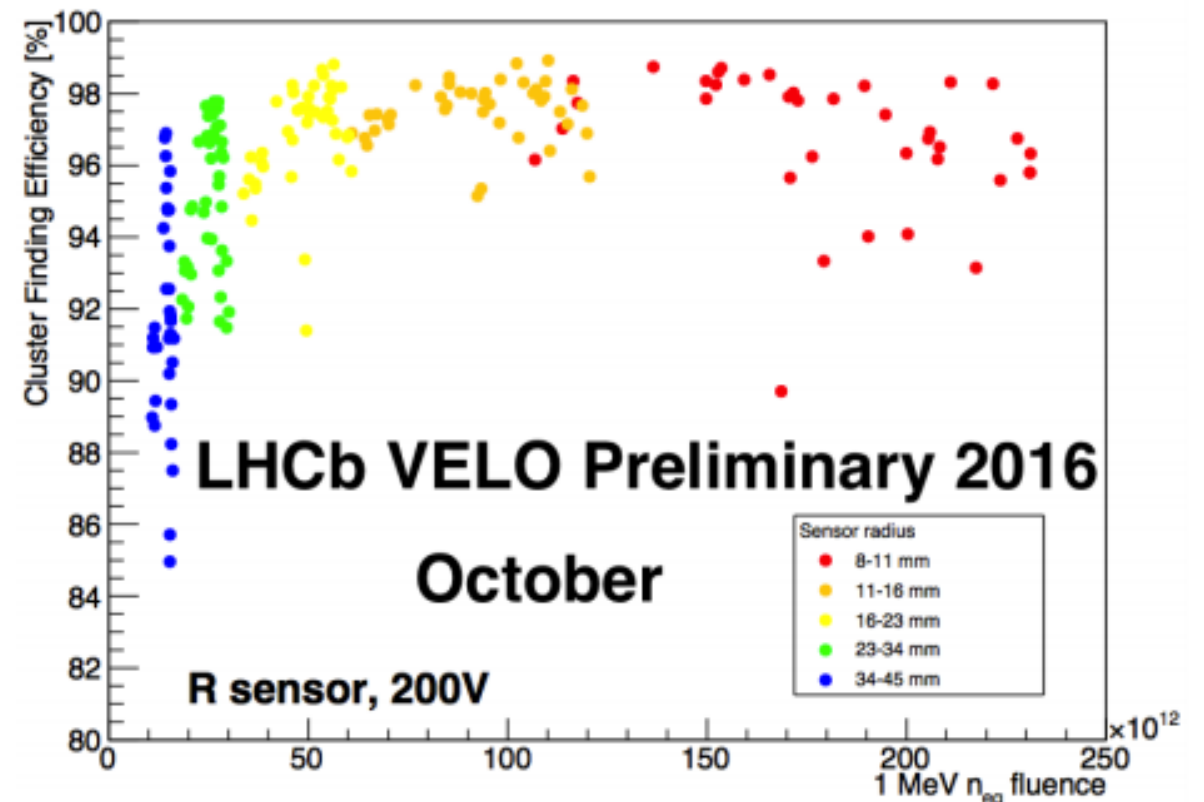
Cluster finding (pseudo) efficiency

Note: these points are affected by fake tracks, reducing the apparent efficiency

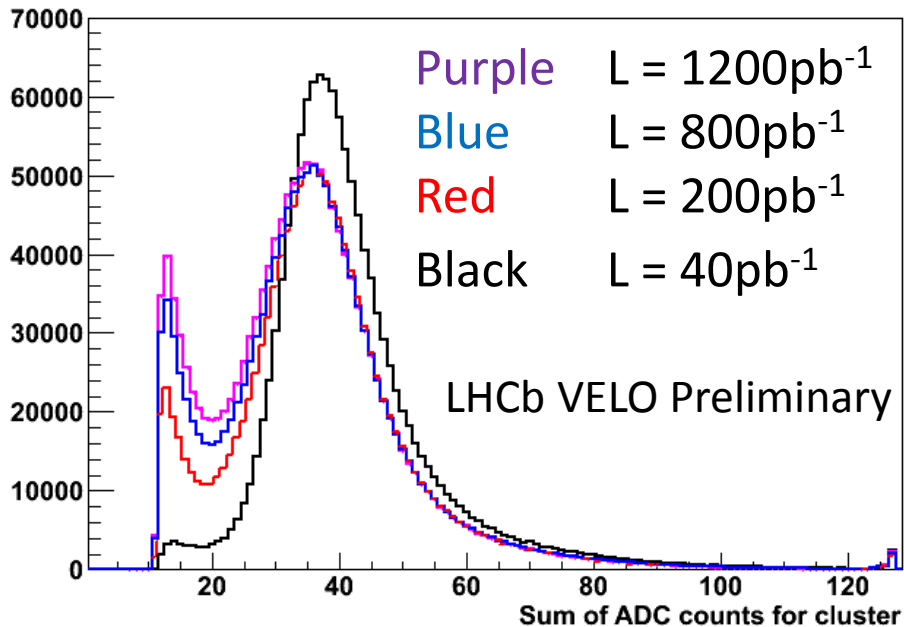
Cluster on inner R strips at very low ADC counts appearing

Predominately at the inner regions of the sensors, not where tracks crossed the sensors

Lower charge collected in R sensors than phi sensors

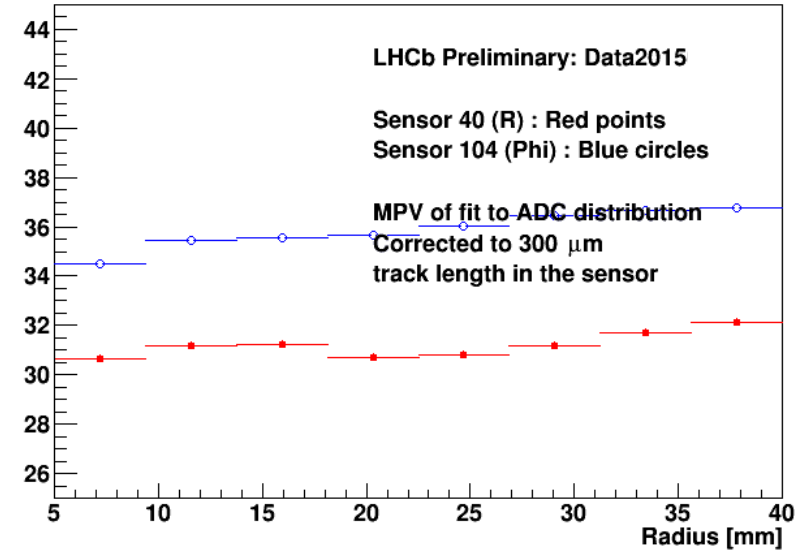
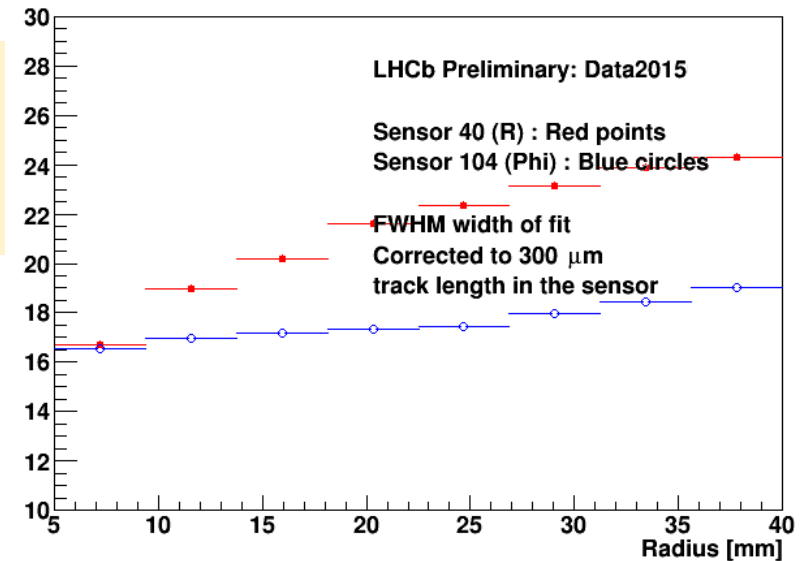
Cluster size for R sensor clusters in ADC counts

Wider distribution due to only some clusters losing charge

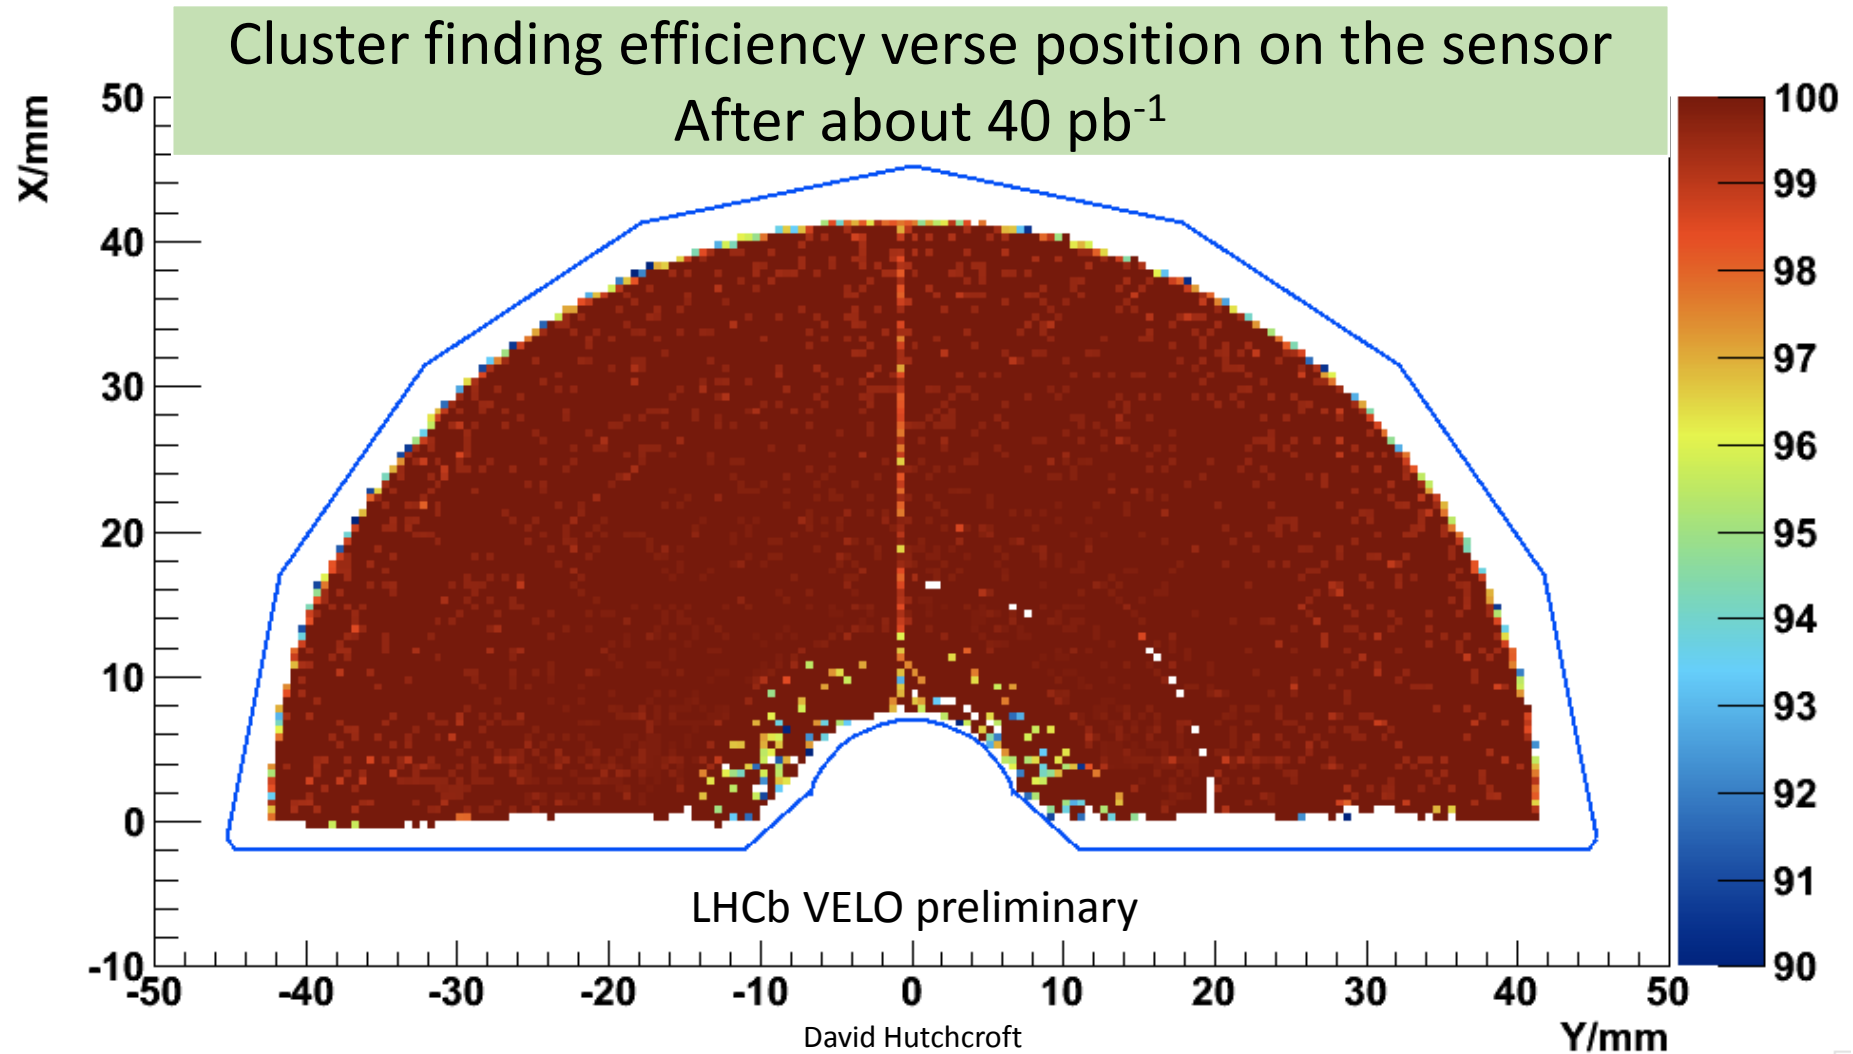
Cluster finding efficiency 2D map for one R sensor, when new...

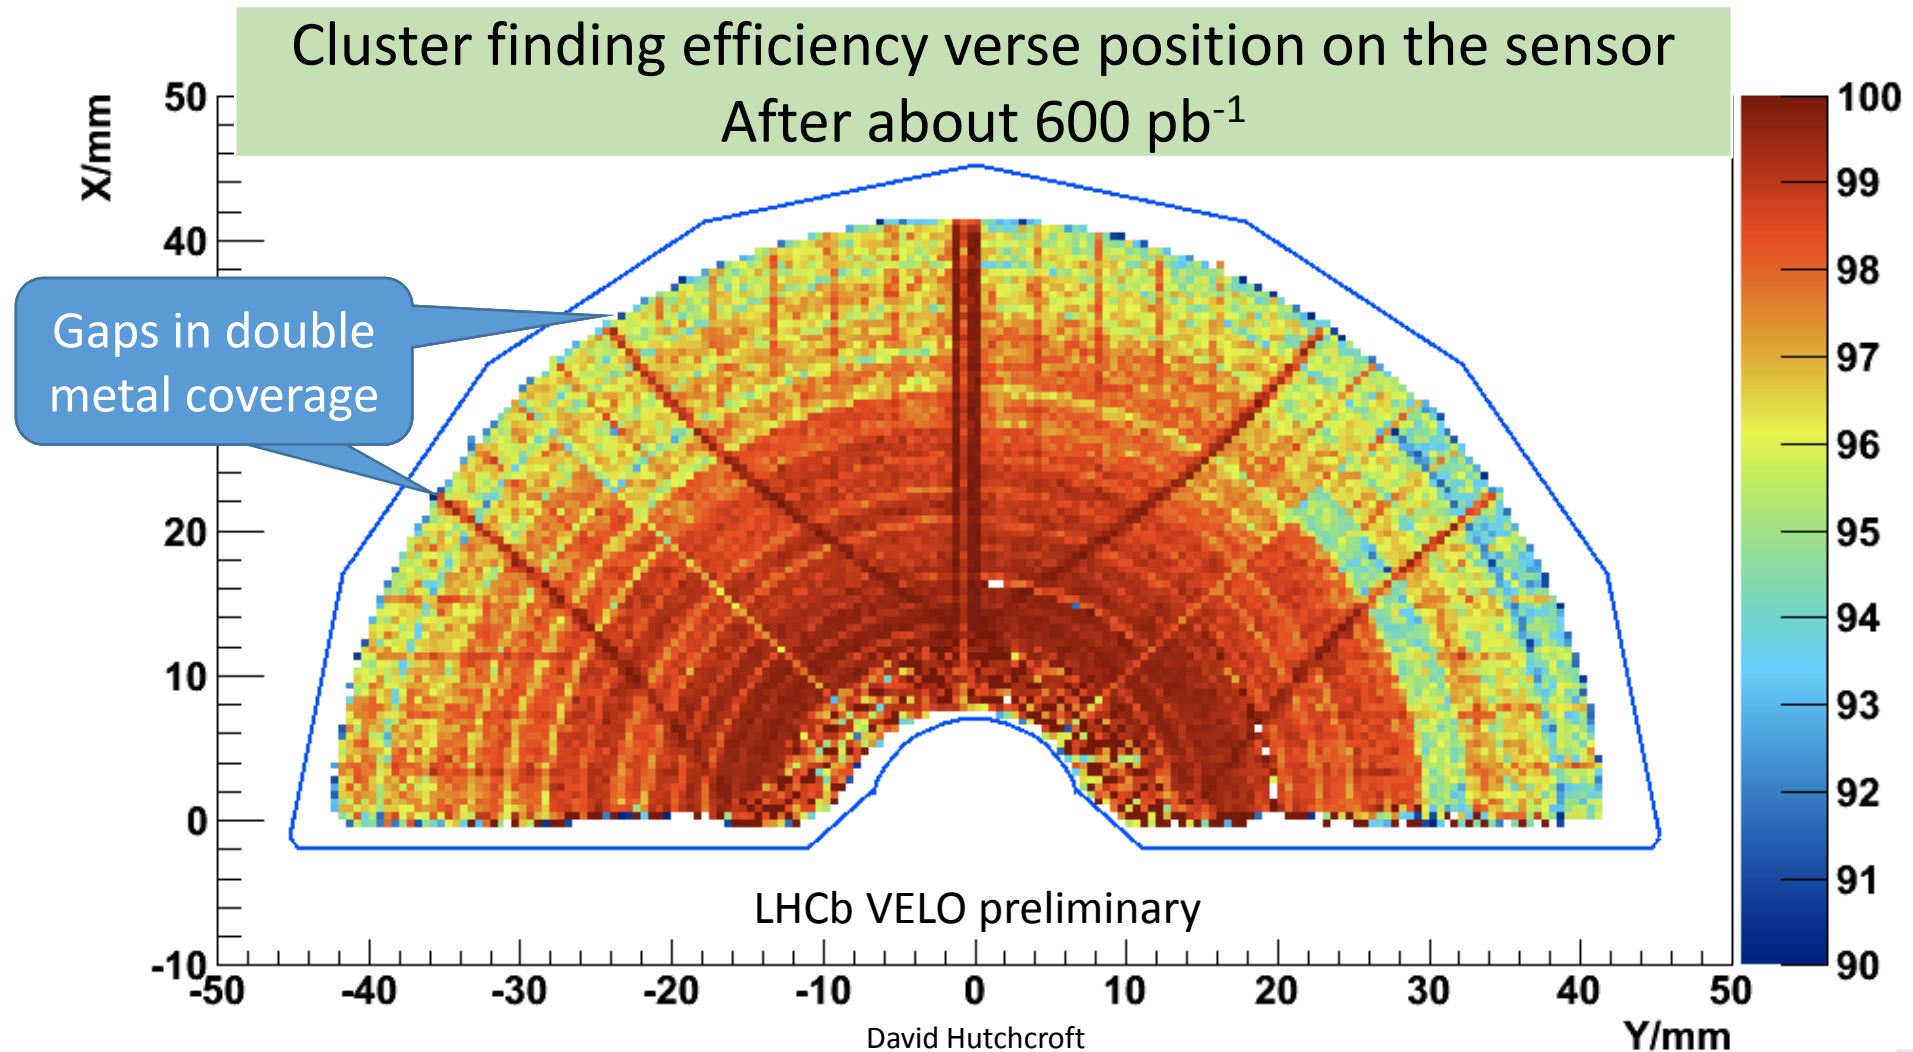
Cluster finding efficiency 2D map for one R sensor, in the second year of data taking

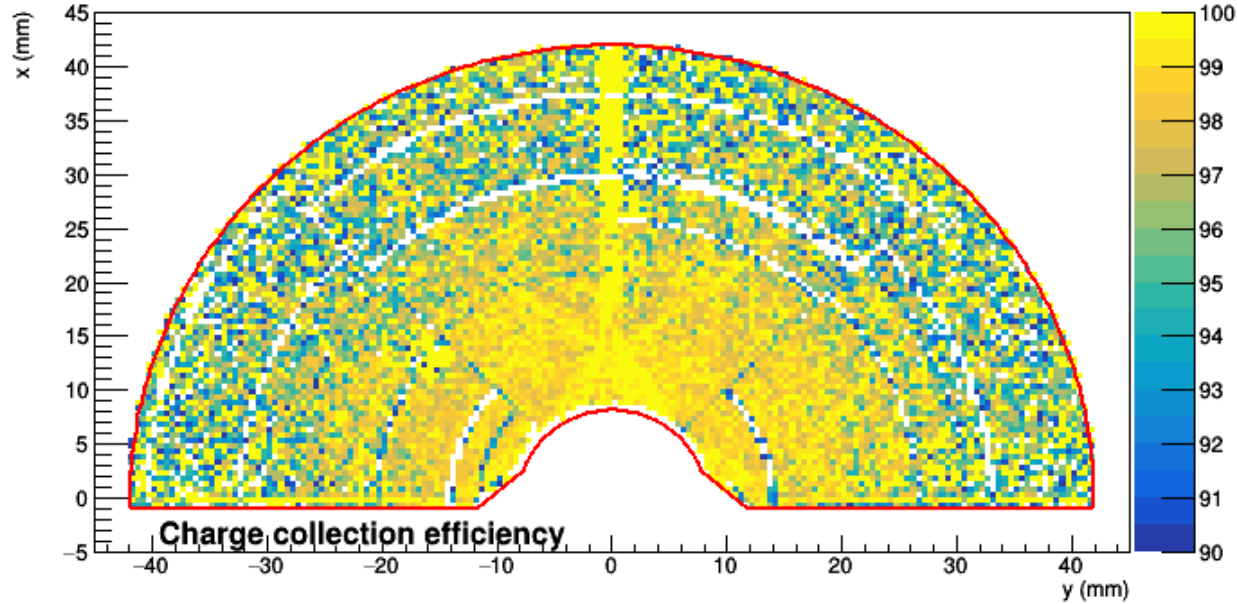
LHCb Preliminary Data Sept. 2016 Sensor 31

Cluster finding efficiency 2D map for one R & phi sensor, September 2016

After about 5000 pb⁻¹

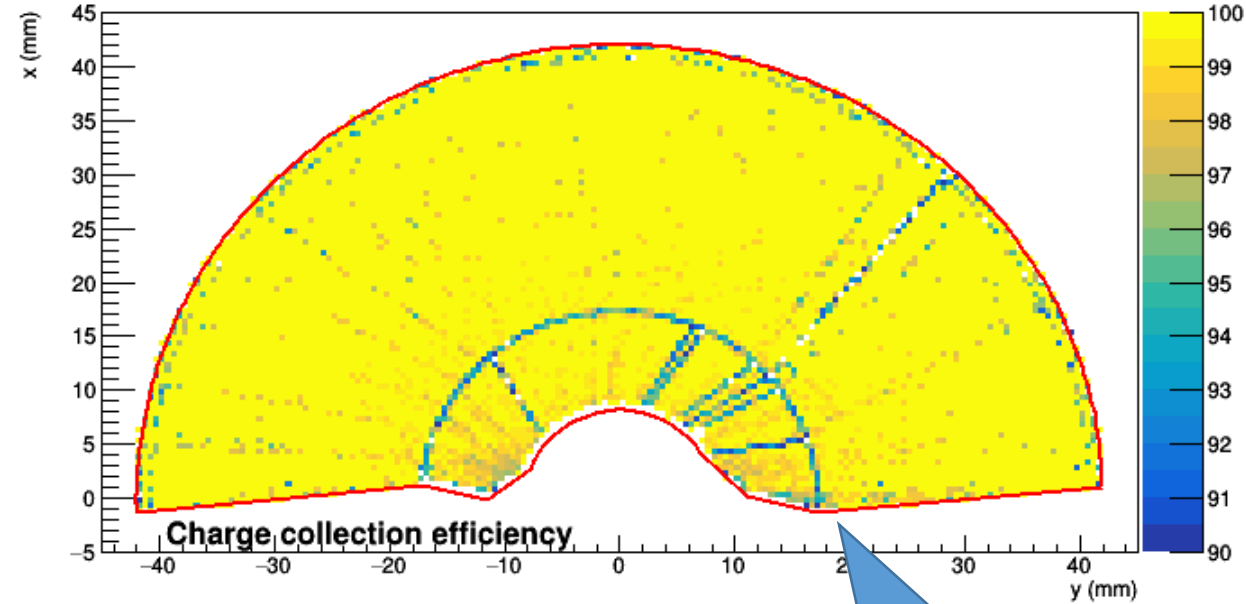
LHCb Preliminary Data Sept. 2016 Sensor 95

Different R sensor, so different pattern of dead strips

Inner to outer region

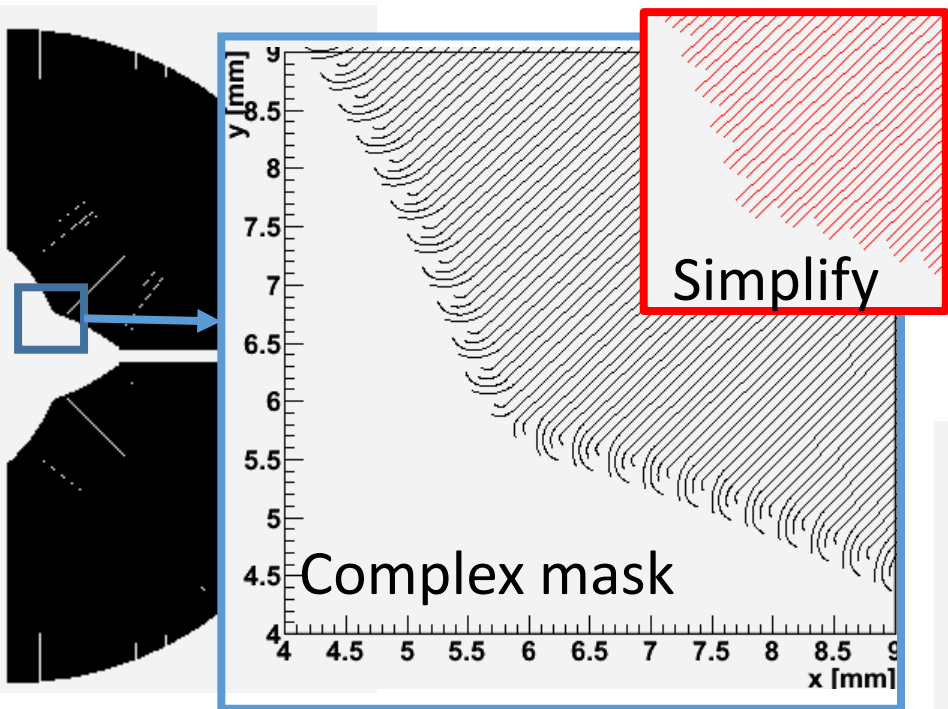
To simulate the 2nd metal effects we had to add the 2nd metal to the detector description

Real routing lines are complex to fit Micron's design criteria

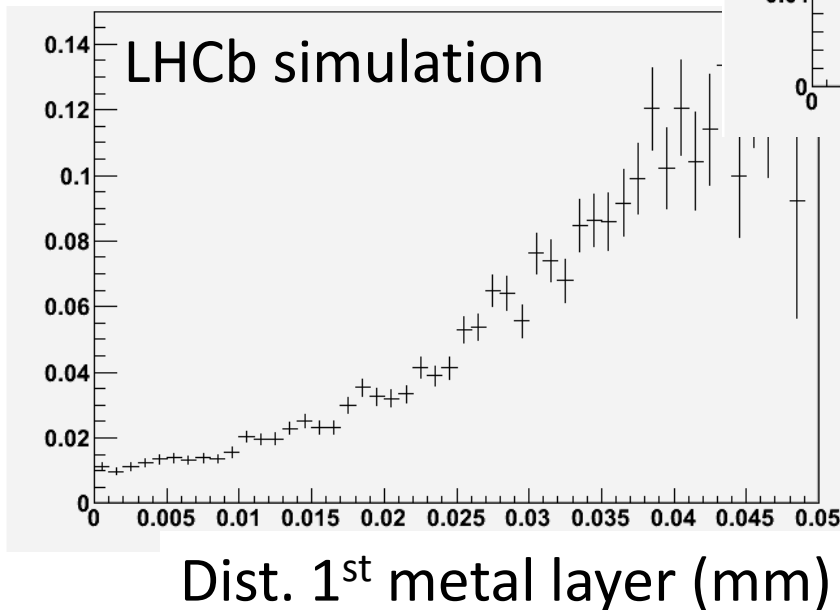
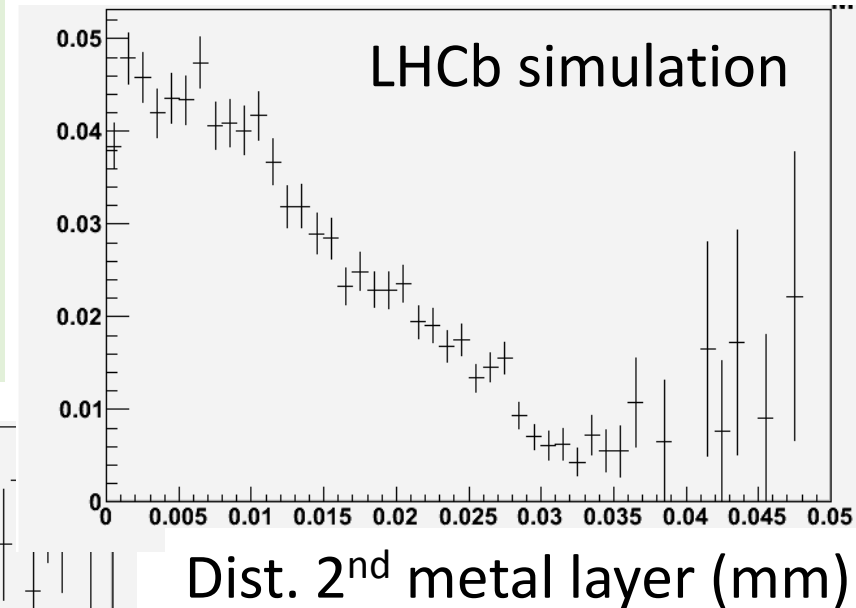
Need to correct charge sharing for the track position wrt the 1st and 2nd metal layers

Use rate of production of fake clusters to tune simulation
