ELENA ION SOURCE

UPDATE

VACUUM LEAK

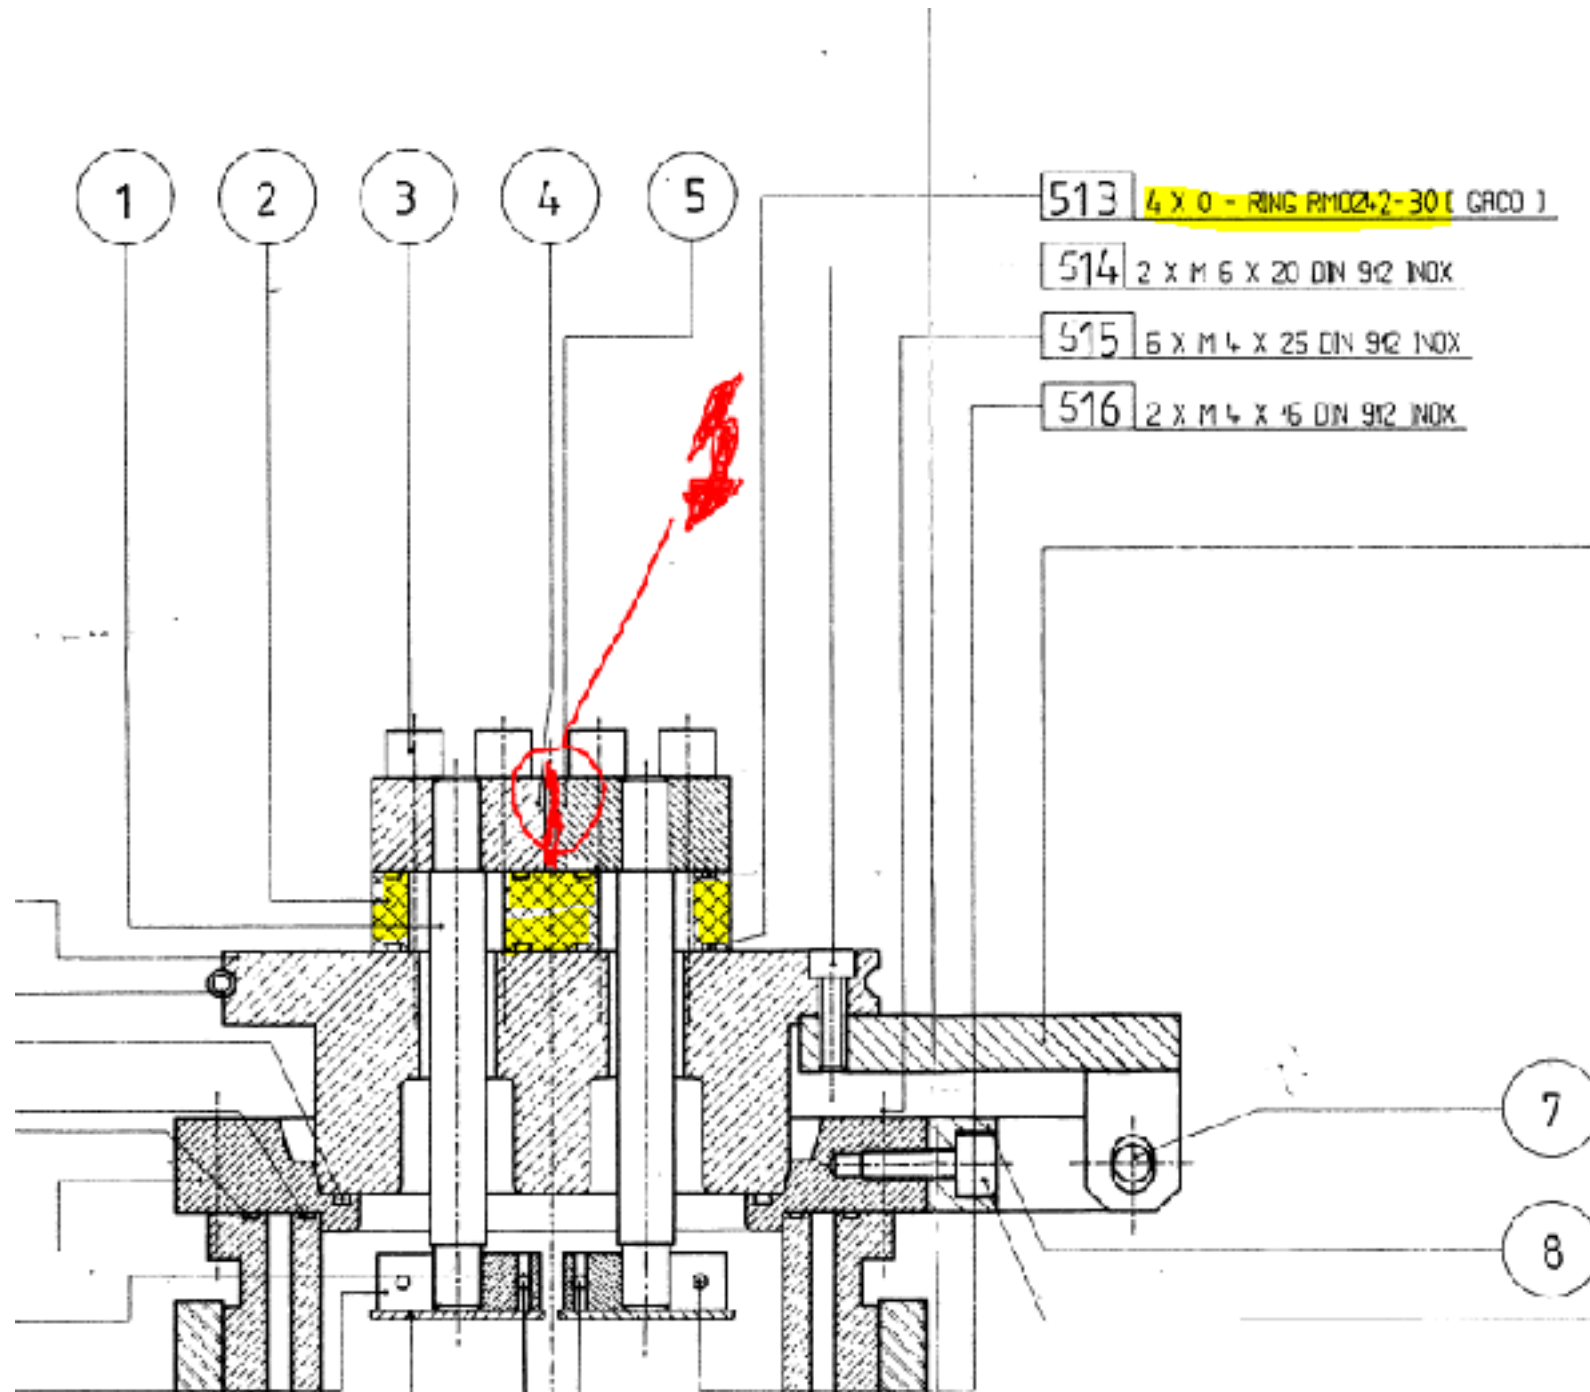
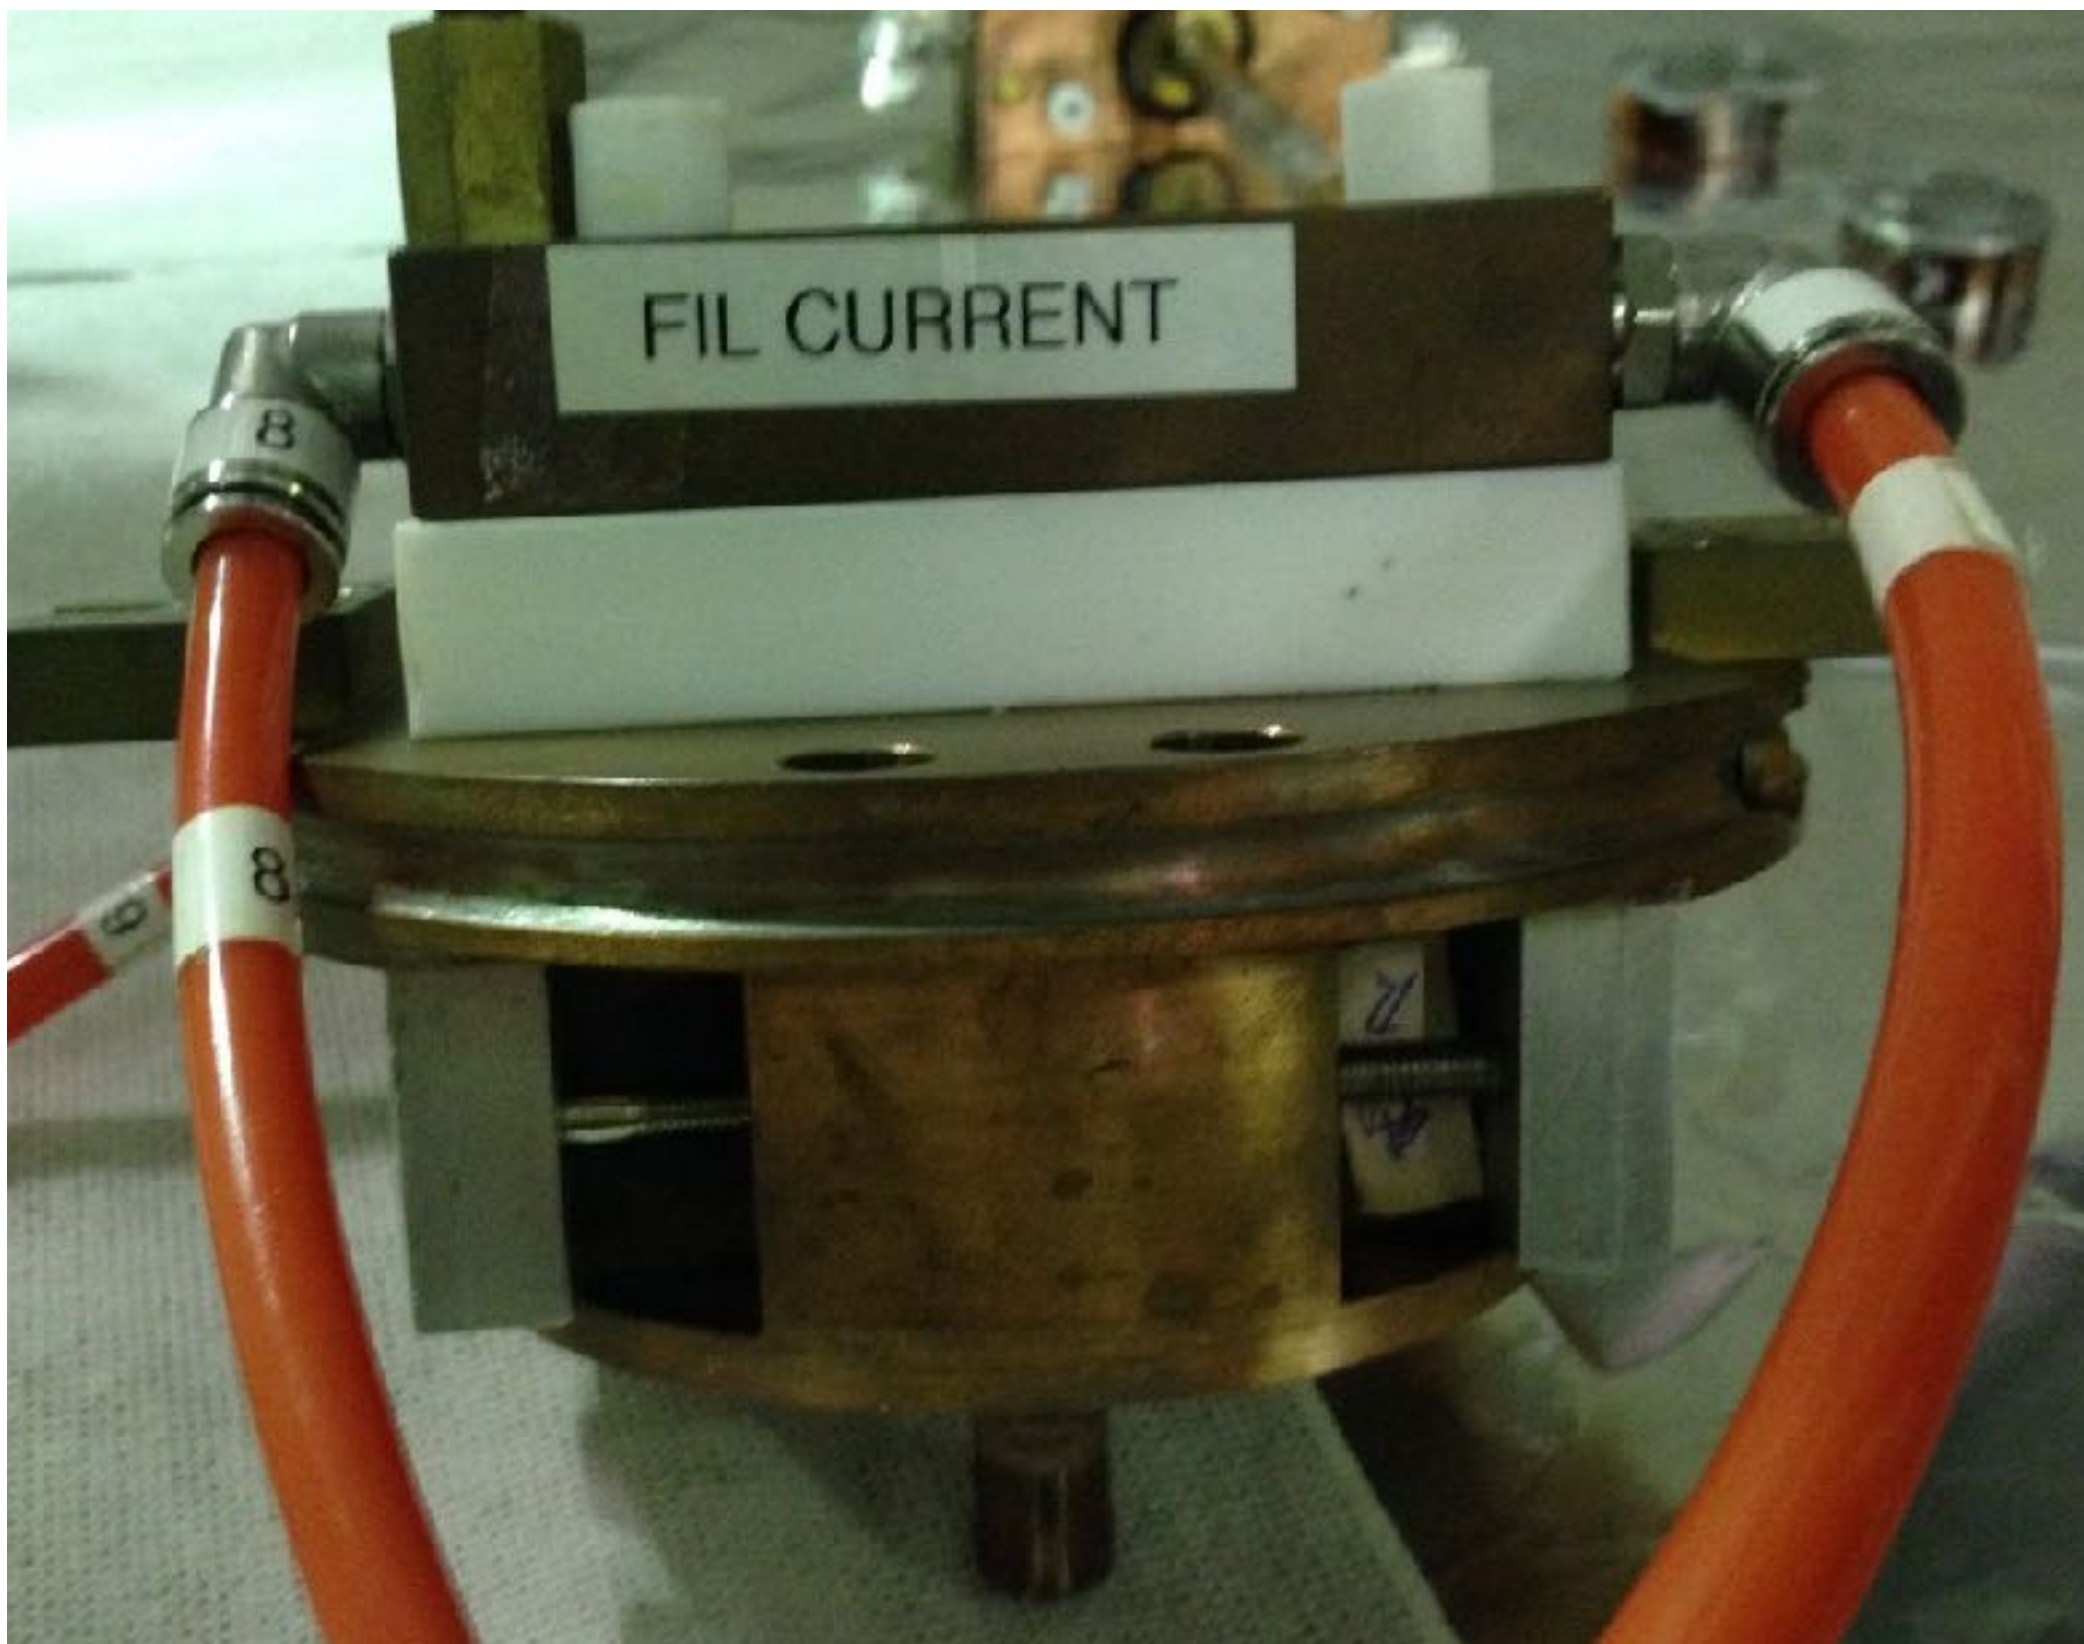
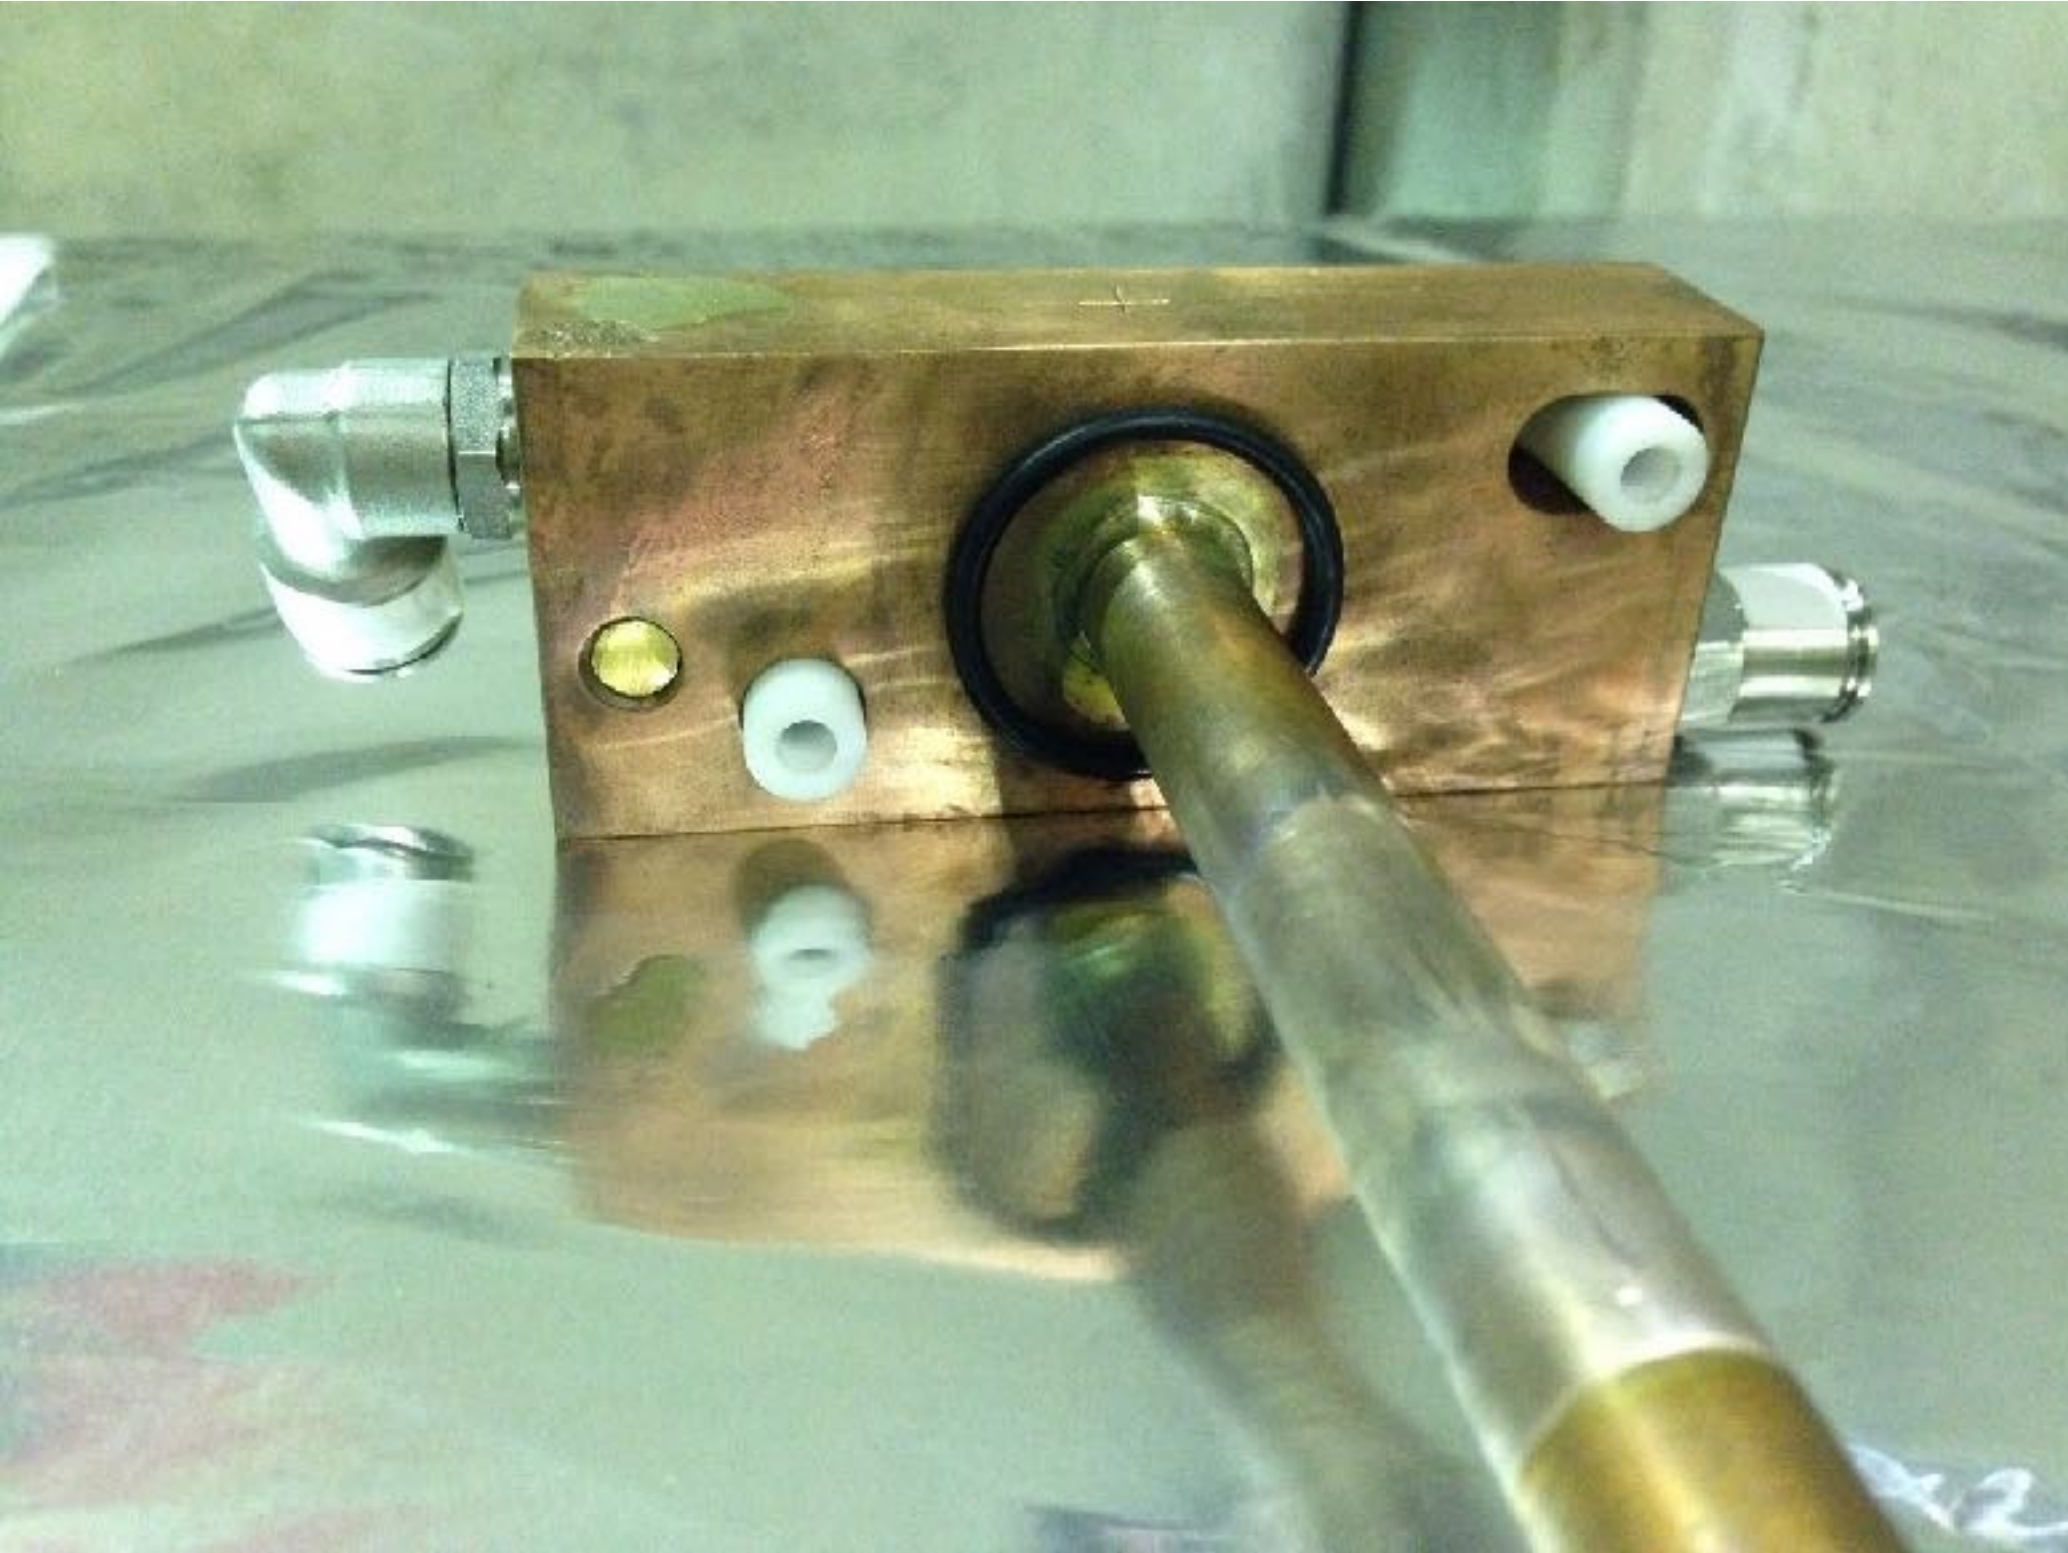
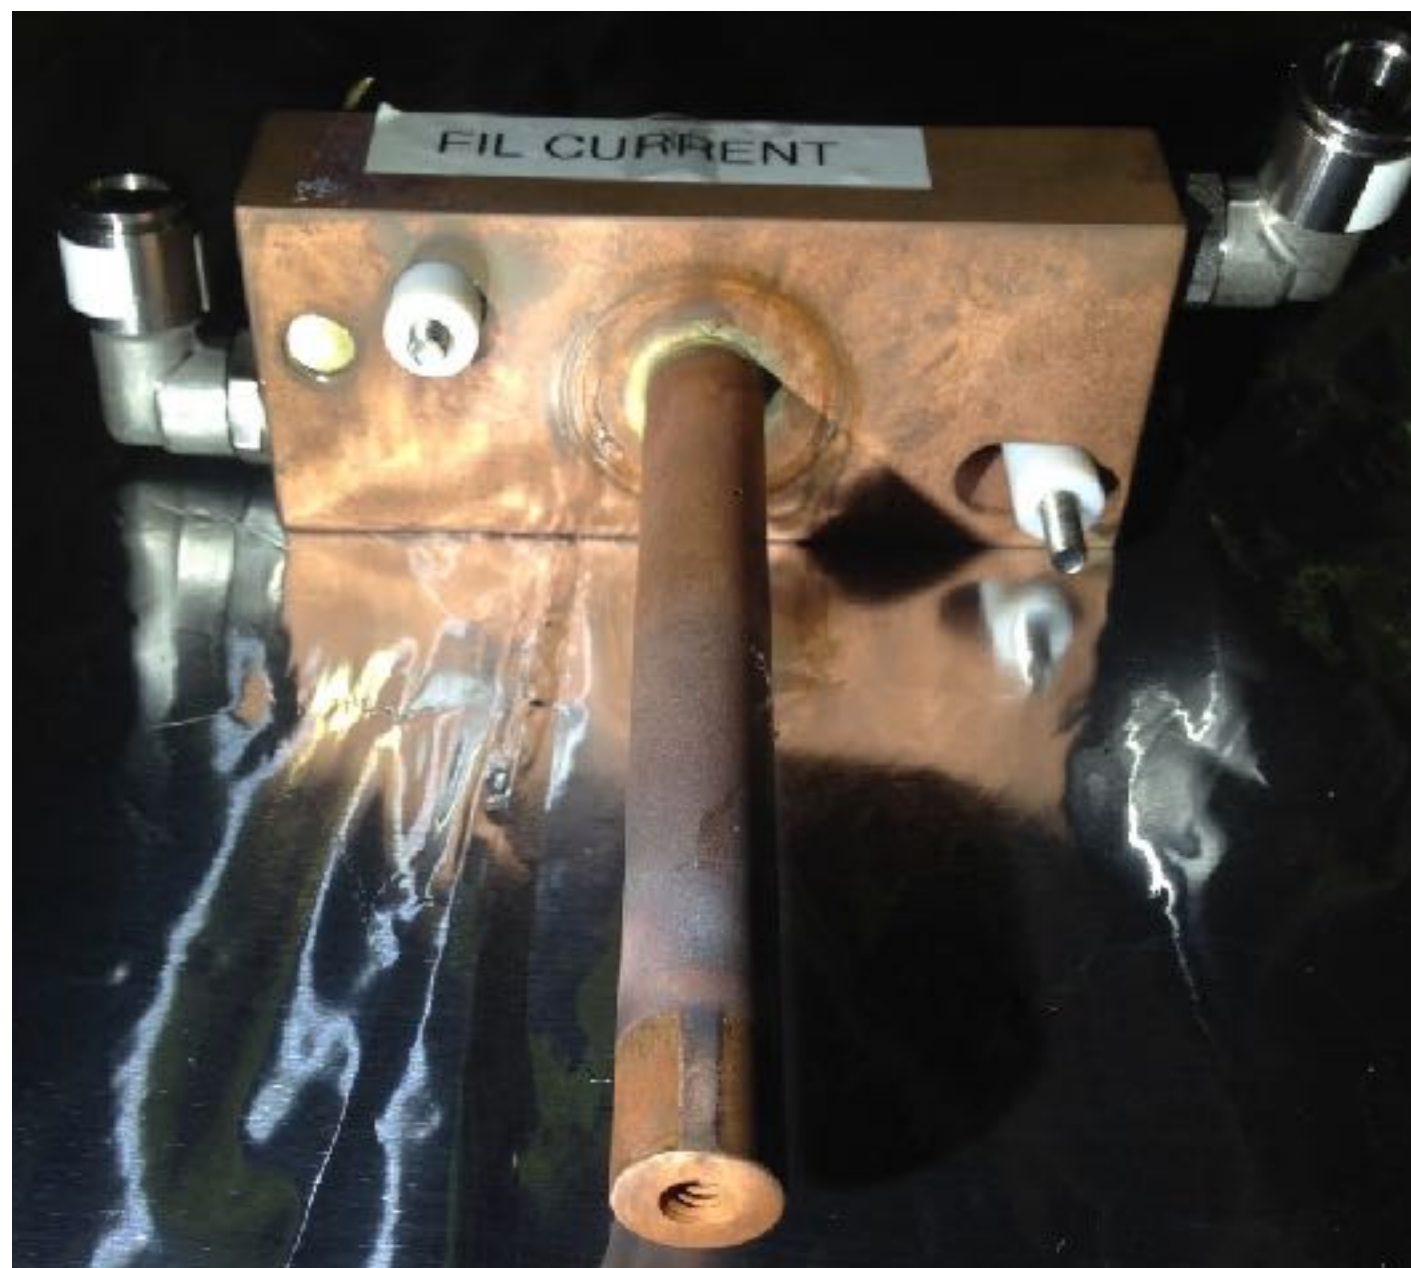
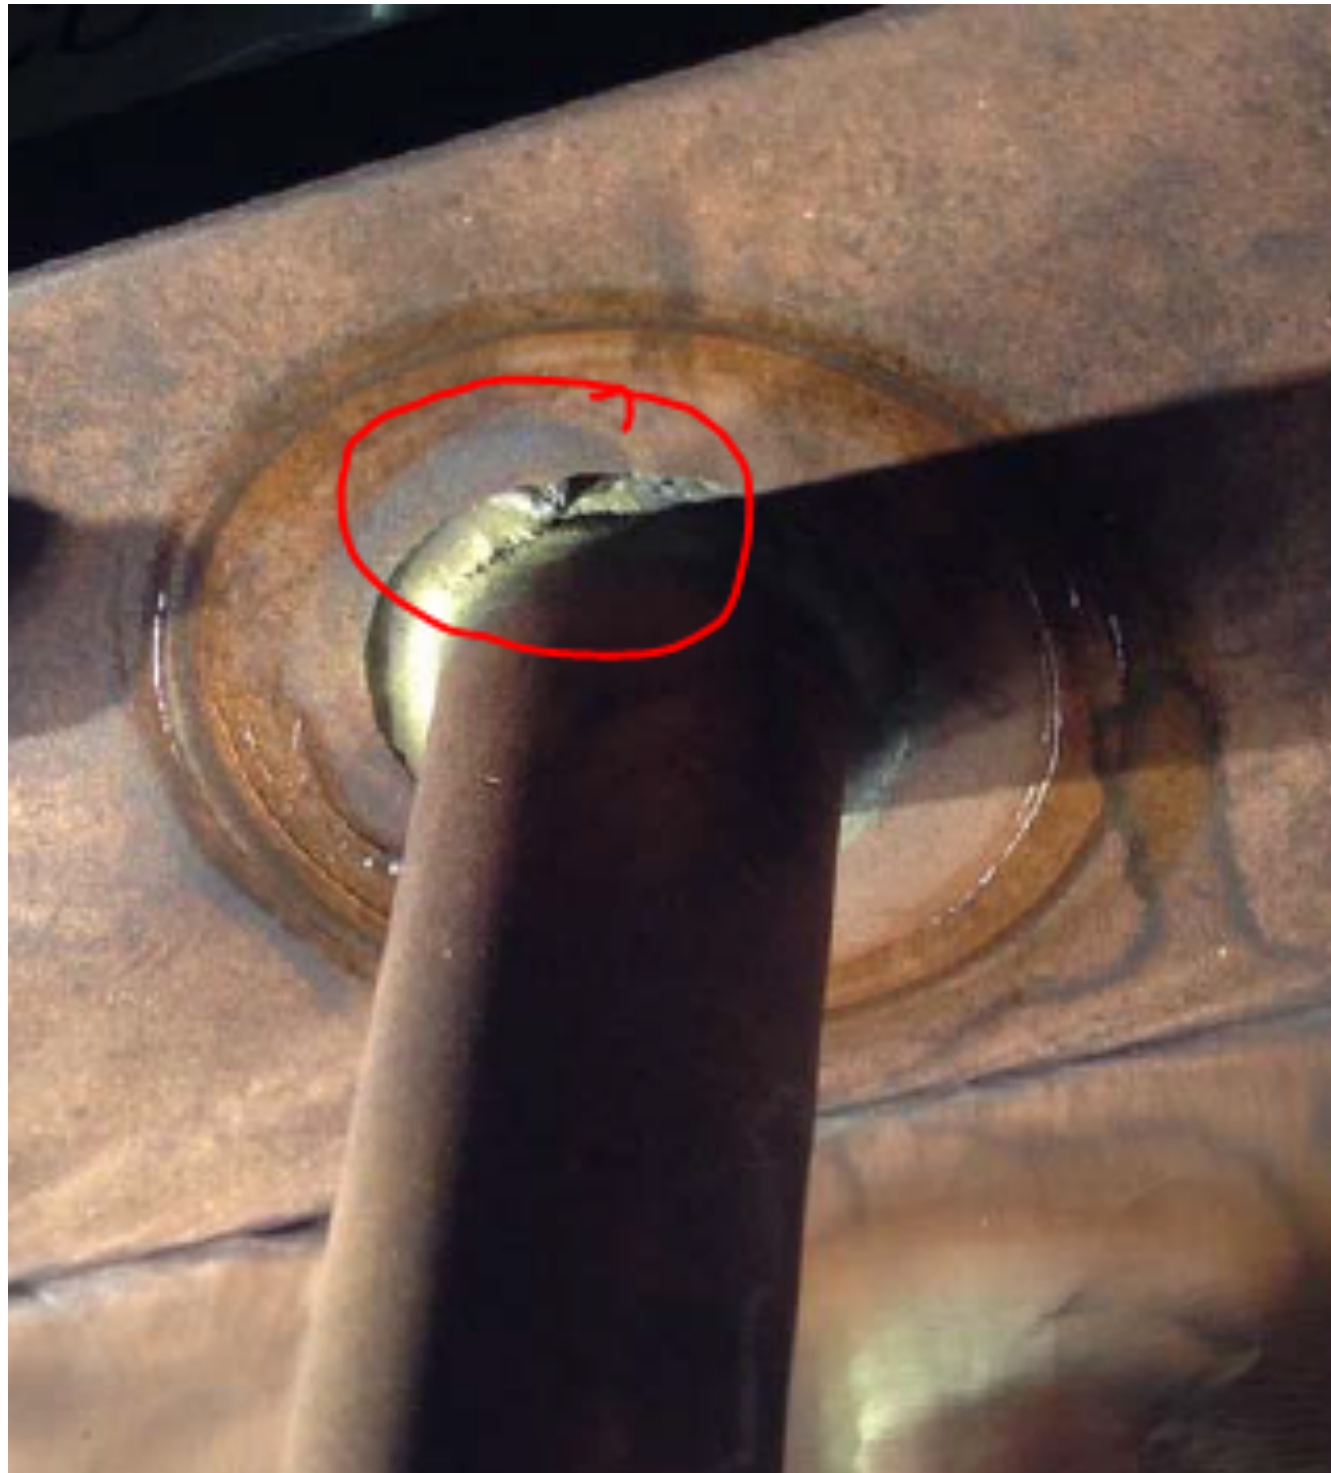
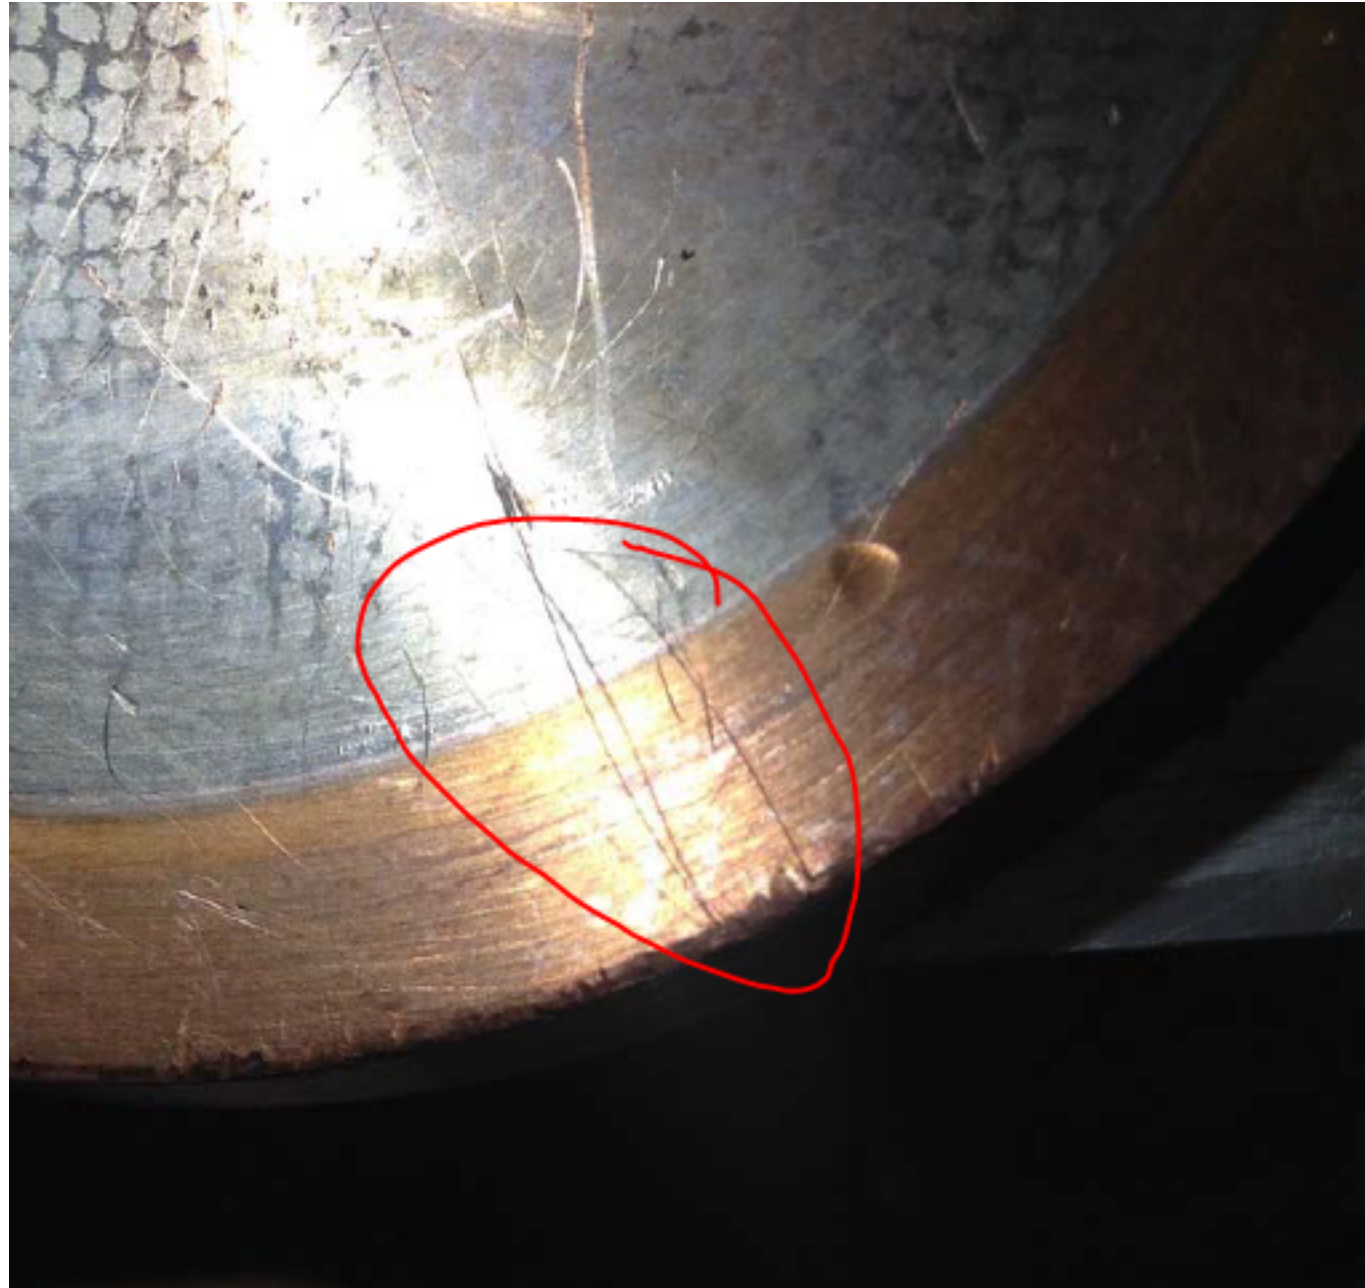
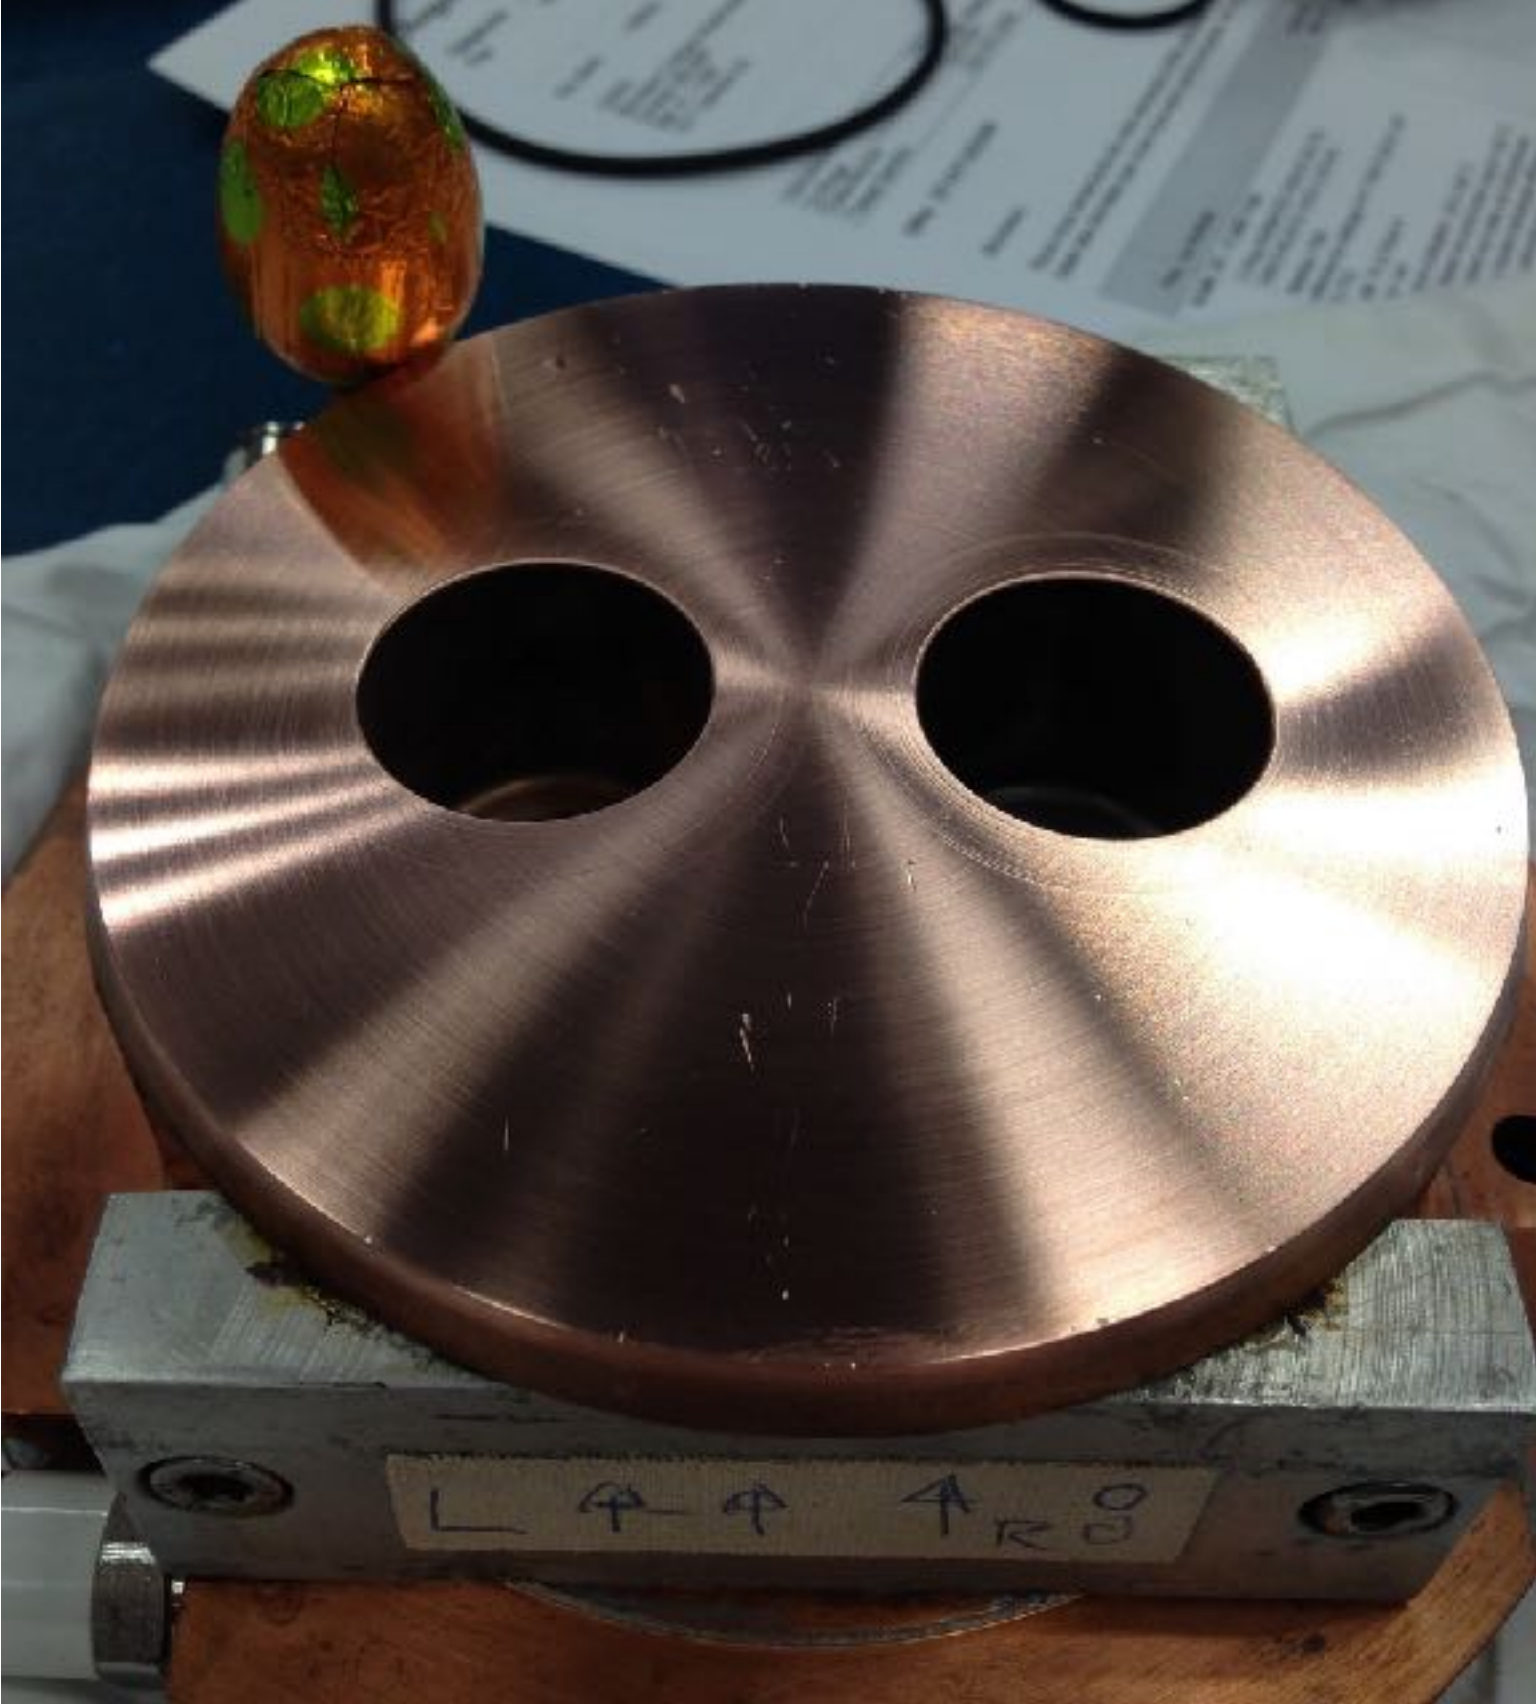
VACUUM LEAK

- ▶ check of sealing surfaces and improvement by polishing
- ▶ degrease the o-rings
- ▶ Replace 4 o-rings on the PTFE block
- ▶ use 1 mm diameter filament
- ▶ adjust maximum current for ARC mode to about 49 Amps
- ▶ filament length is not okay: limits the emission to 2 Amps by reaching 11 Volt of filament power supply

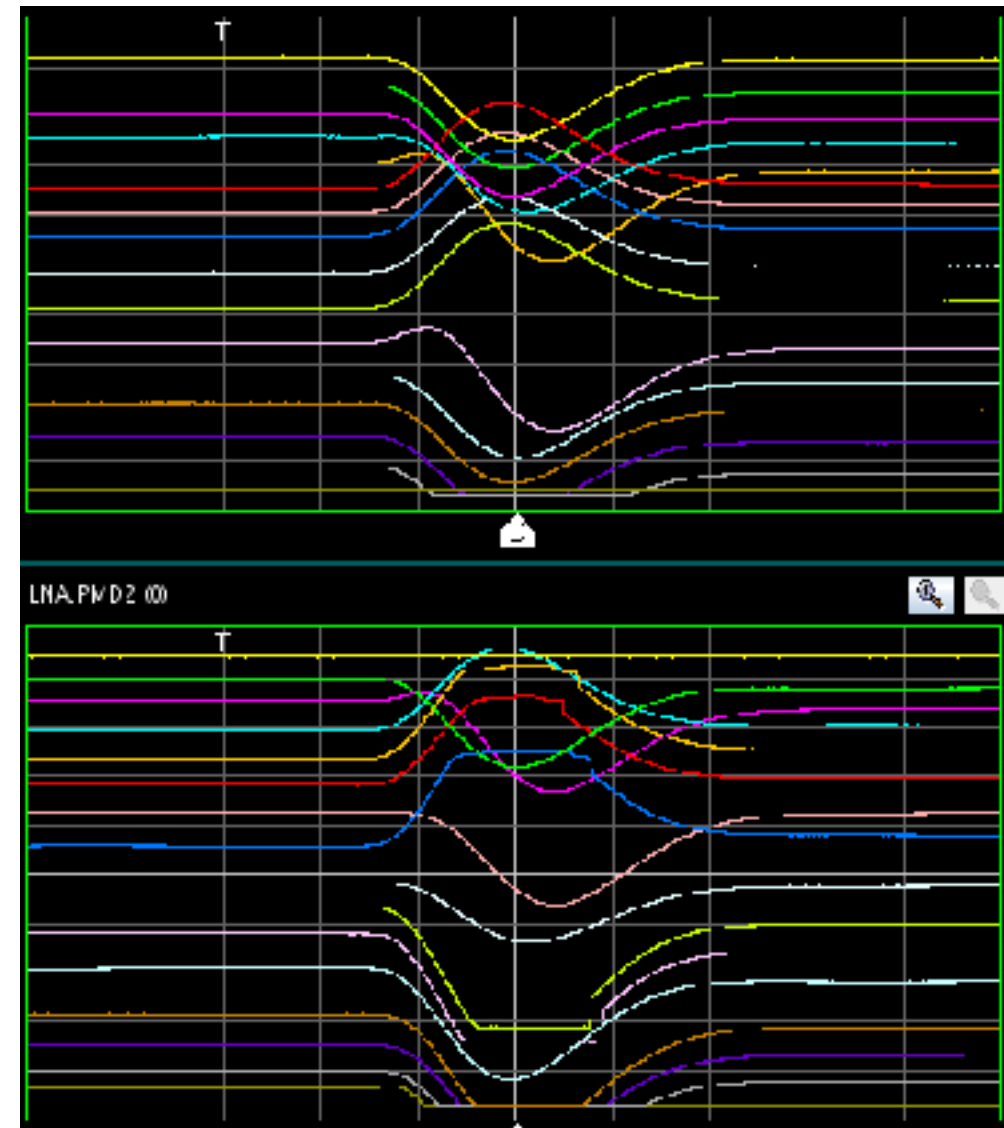
H+ SEM TESTS

- ▶ Test Beam current about $70\mu\text{A}$ and length about $3\mu\text{s}$.

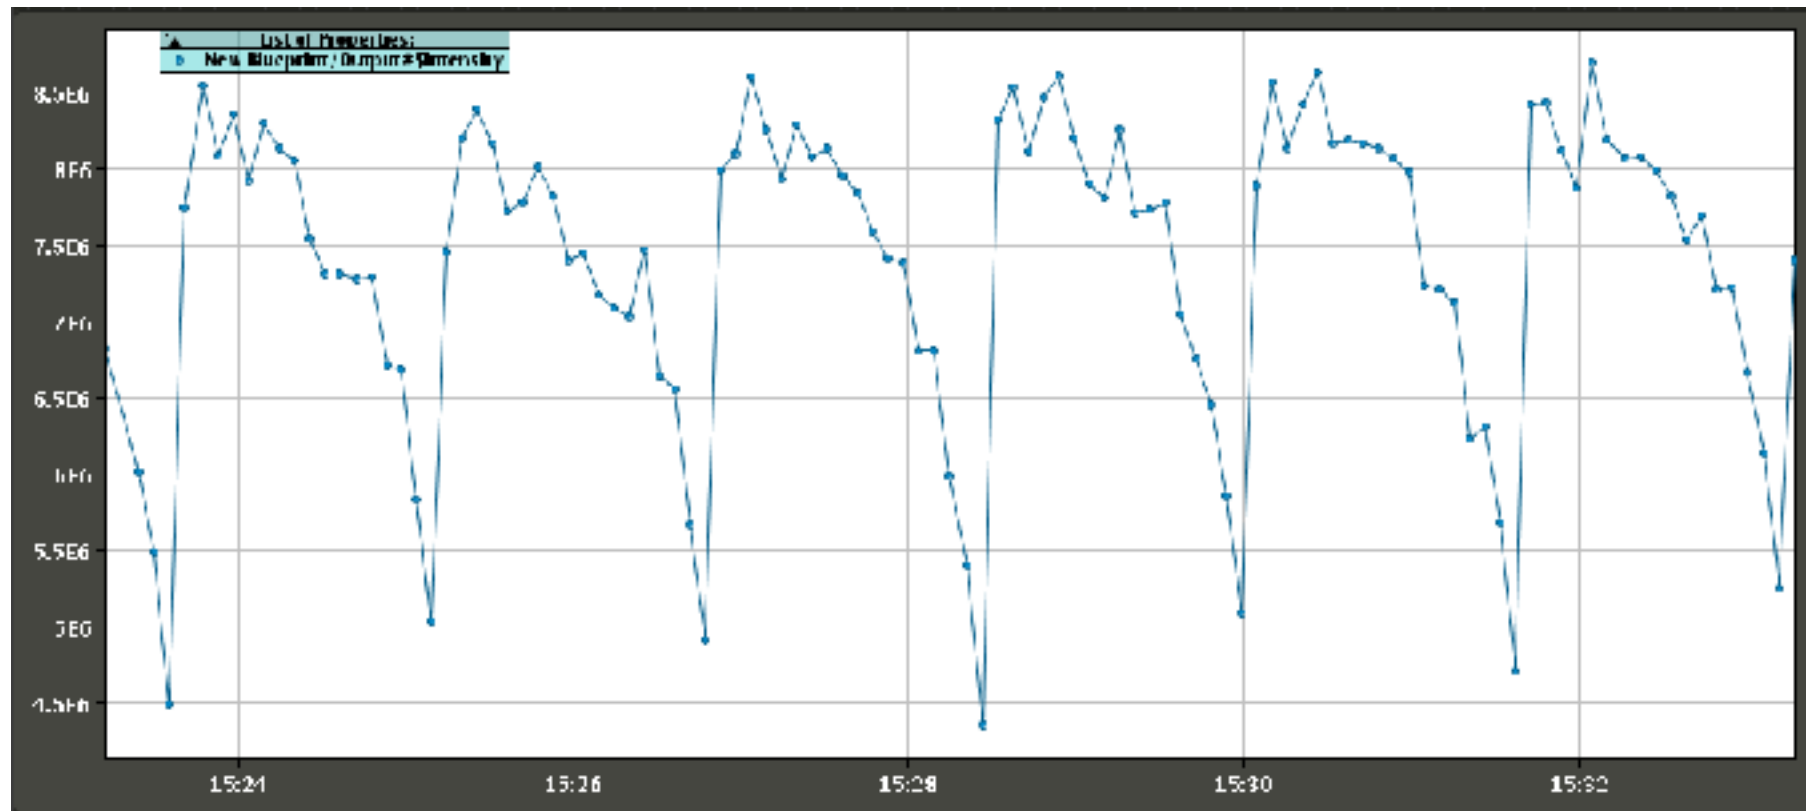
SOURCE STABILITY

- After reaching thermal equilibrium, Position on First BTV is stable.
- Life Time in the machine still fluctuating.

- ▶ Electrons are also going out of the source and this was maybe not foreseen during the design of the quadrupoles and the SEM grid.
- ▶ Dielectrics charging up could explain intensity fluctuations and lifetime variations.
- ▶ Removing the SEM ?
- ▶ Double check the design of all the elements between the source and the ion switch for dielectrics visible from the beam point of view.
