# Structural defects in residential buildings: A study of Quetta, Pakistan

**Keywords:** Housing survey, Structural defects, Residential buildings, Building safety, Quetta

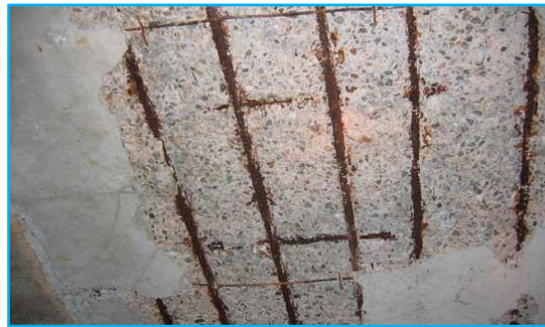
Such defects occur due to water seepage or water leakage from the roof slab. These defects cause bulging, pattern cracking, falling off clear cover from concrete which would expose the reinforcement. The reinforcement gets rusted by corrosion effect; water leakage may also react with adjacent walls which might cause plaster or tile delamination. The spalling of roofs is shown in Figure 1.

Figure 1. Spalling of roofs

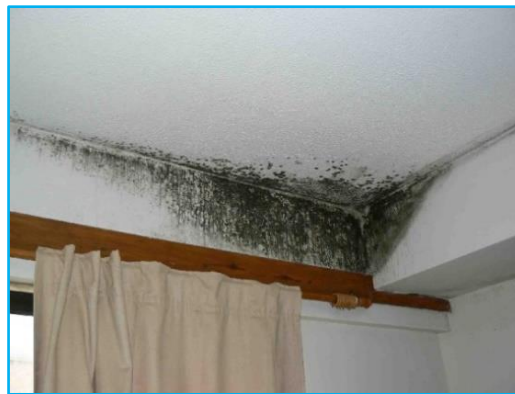
Cracking in external walls may cause water seepage which would result in water stains, peeling off and discolouration of paint or wall paper, water dripping and the growth of fungus. This would in turn cause defects in concrete (permeable) and in plaster or tiles. The stains in structures as shown in Figure 2 can be a cause of water seepage and may occur due to several reasons including cracks on external wall, honeycomb, defective concrete, defective windows, waterproofing membrane at roof etc.

Figure 2. Stains in Structures

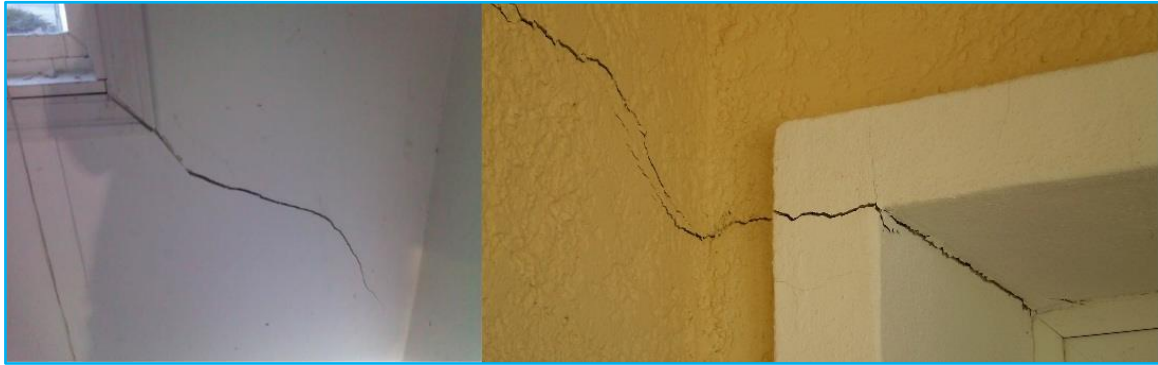
Structural cracks may occur due to several reasons including settlement of soil, foundation, overloading, poor design, and construction or use of substandard materials etc. The cracks shown in the Figure 3 produce cracks which penetrate through finishes into the bricks, long cracks across width of the wall, diagonal cracks at corners of window or door and cracks with rust staining.

Figure 3. Structural cracks found in doors and windows

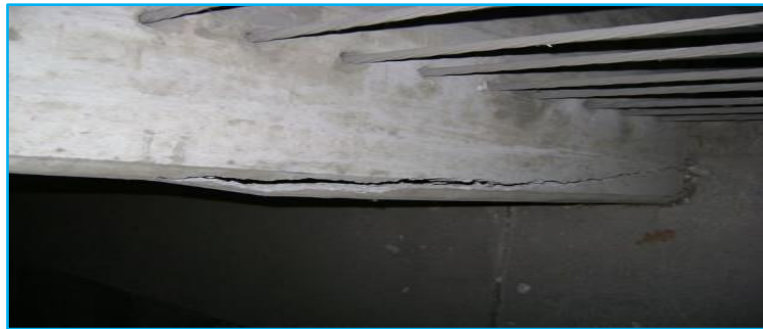
These cracks may produce due to same reasons as explained in 2.3. Cracks, shown in Figure 4 are formed in the columns and beams and produce spalling as well.

Figure 4. Cracks found in Beams due to excessive loading

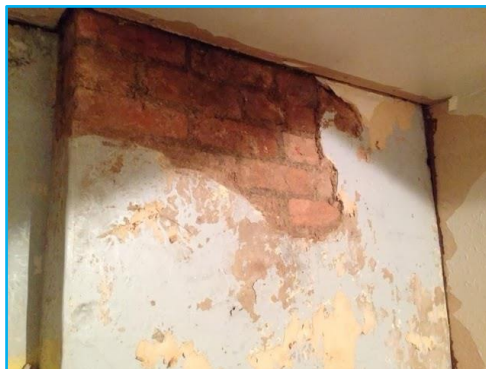
These defects may occur due to ageing, defective workmanship, thermal movement in expansion joints or by external factors such as falling parts as shown in Figure 5. This would result in de-bonding and delamination of finishes/ tiles from structure and when tapped with a hammer results in a hollow sound. Other defects are falling off and loosening of parts.

Figure 5. Falling off Plaster found in Walls

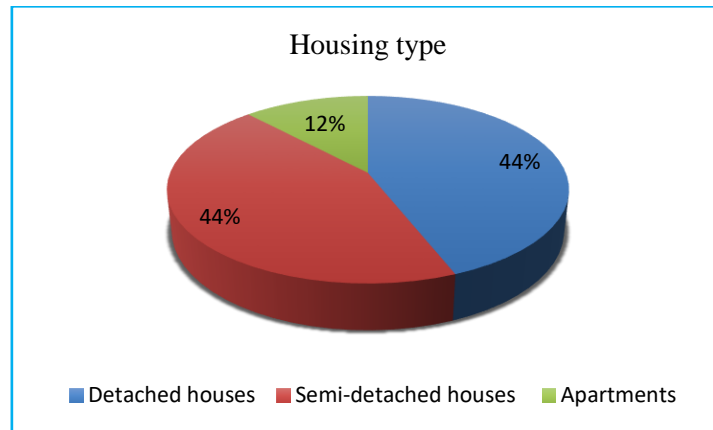
Most of the people in Quetta are living in houses and less likely choose to live in apartment buildings. The results show that building system in residential areas of Quetta mainly represent detached, semi-detached houses and apartments, see Figure 6.

Figure 6. Housing type in the survey

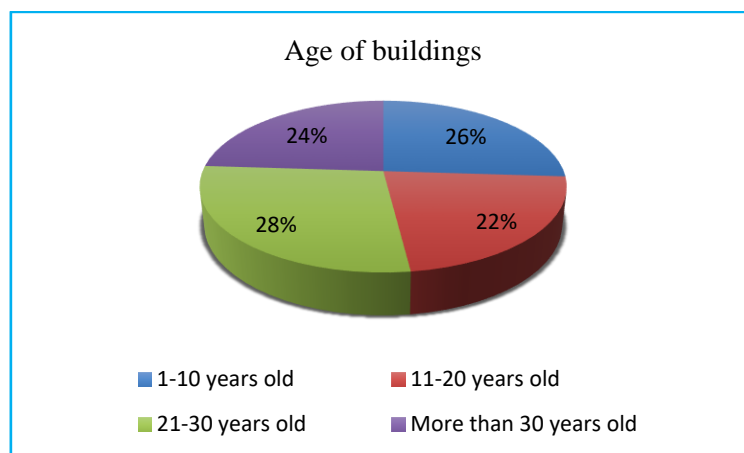
The age of a building shall also be considered to have a better understanding of the structural defects. The age of building can be a primary factor in the deterioration and occurrence of defects in the buildings, especially the cracks may be produced due to the prolonged effects of the loads (Figure 7).

Figure 7. Age of the buildings

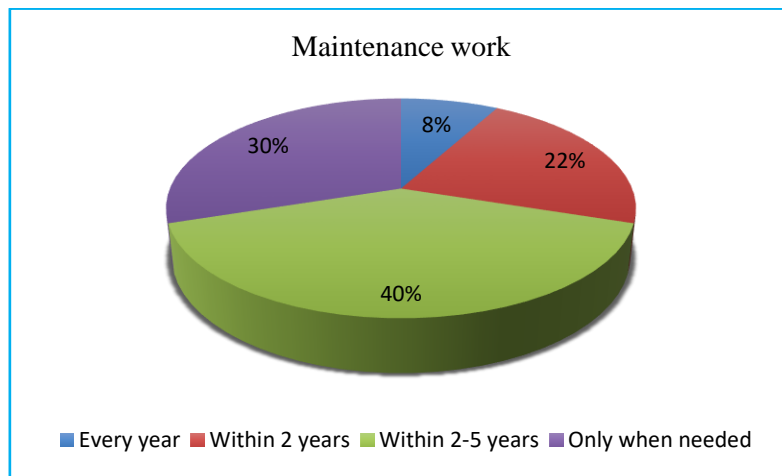
The frequency of defects and their occurrence after specific time is an important aspect. This can be helpful to propose and carry out the maintenance work for the houses. Some defects might occur frequently, and some occur after specific time. In our sample most of the houses (figure. 8) needed some maintenance and repair work within 2-5 years after the construction of the house, i.e. 40%.

Figure 8. Maintenance work carried out in houses by time

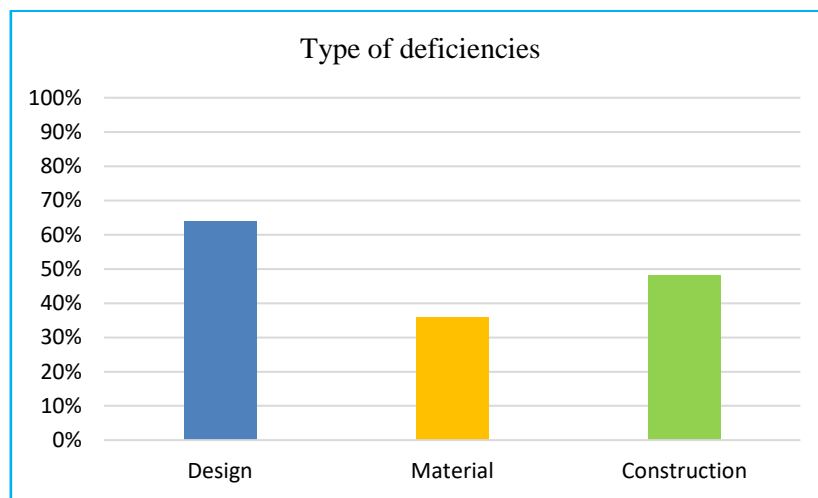
The common type of deficiencies considered for this study includes; design, material, and construction deficiencies. Sub surface deficiencies were not included as it need further detailed analysis using scientific tools and methods. The results show that one building have one or more type of deficiencies, figure 9.

Figure 9. Type and percentage of deficiencies

Design deficiency contributes to the greatest number of defects, about 64% of design deficiencies were found in the selected houses in Quetta. The typical design deficiencies found were: cracks in slabs; leakages from walls and roofs; cracks in the structural elements. The design deficiencies occur due to overstress of structural elements which produce cracks. When the rebar is subjected to tension, they will stretch, thus the concrete covering the reinforcement will stretch and produce cracks.

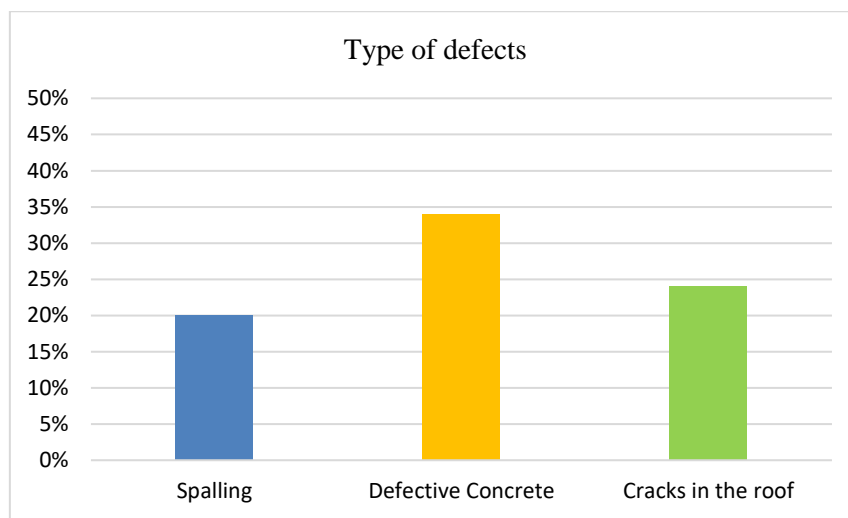
Questions were asked about the construction of roof and roofing materials. From the obtained data the defects from defective concrete, cracks in roof and or spalling are presented in Figure 10.

Figure 10. Percentage of defective concrete, spalling and cracks in the roof

Majority of the houses, i.e. 78% in sample size were built of reinforced cement concrete (RCC) structure and only 17 houses showed the symptoms of defective concrete accounting for only 34% of the overall percentage. The concrete may get defective due to water leakage from the plumbing (construction deficiency) or due to the use of substandard or inappropriate materials (material deficiency). Patching process can be used to tackle the defective concrete by cutting off or hacking down and it can be replaced.

Spalling was found only in 20% of the houses, which might have occurred due to overloading of the element (design deficiency) or because of the usage of salty water in concrete mix (construction deficiency). To fix the spalling problem concrete may be torn off to check the reinforcement for rustiness and if it is insufficient for use then reinforcement can be replaced. Structural and load calculations may be required to complete this process. Houses in Quetta cantonment area found more affected by spalling, Table 2. One of the reason is could be the age, since 30% of the houses (as per sample) in cantonment area were constructed 20-30 years ago and 20% of them were more than 30 years old. Another possible reason is the location of City Nallah which passes close to some of the areas located in cantonment.

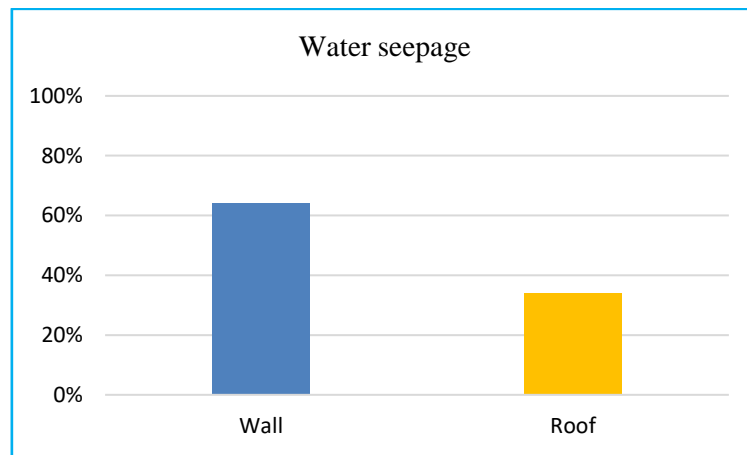
To understand the causes of seepage or leakage of water in building it is important to know the composition and construction of building elements. Data was gathered regarding the construction of walls and its finishing materials in addition to the roof as mentioned in 4.3.1. The following Figure 11, provides us an overview of the defects such as, water seepage from walls and roofs found in the houses during our survey.

Figure 11. Water seepage percentage found in walls and roofs

Cement plaster is the most common type of wall finishes found in the survey representing 60% and the main material of the walls was backed bricks 68%. The seepage from roof was found in 34% and from walls in 64% of the houses. The seepage from roof or walls may occur due to plumbing leaks (construction deficiency), defective concrete, deep cracks found in the wall and defective finishes which are used protect the building from rain seepages.

The plumbing leaks can be fixed by fixing the leaked pipes between the walls and the roofs. The cracks developed due to water leakage can be fixed by injecting chemicals and repairing them with water proofing mortar. Whereas the defective concrete such as honey combing of concrete should be removed and replaced by water proof mortar.

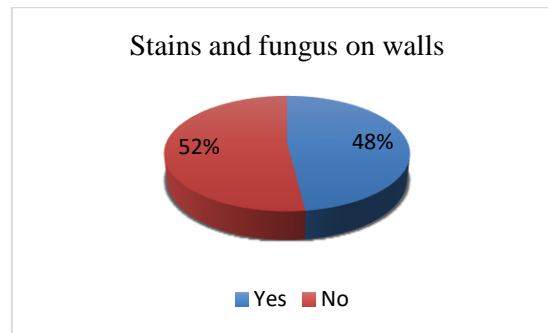
The defects in this category mainly occur due to the absorption of water or seepage from an external source or environment. It may cause moisture in surfaces, discolouration of paint, plaster, and tile delamination etc. nearly half of the houses were found affected by this type of defects as mentioned in figure 12.

Figure 12. Percentage of Stains and Fungus found on the walls

The stains and fungus were found in 48% of the houses. The stains are caused by water seepage which may enter in the building from its roof or walls. Some factors provide favourable environment for the growth of stains or fungus on surfaces which may also include temperature variations between indoor and outdoor climate. Table 4, presents the overall picture of stains and fungus found in houses situated at different localities.

There are serval types of micro-organisms which can grow in the structure and different types of algae growth have different remedies. Some stains can be removed by using sodium hydrochloride solution which can be made up of chlorine bleach whereas in some cases cold water and cleaning with a brush can do the job. Apart from this, water proof membranes should be used in construction of buildings near such parts of the building.

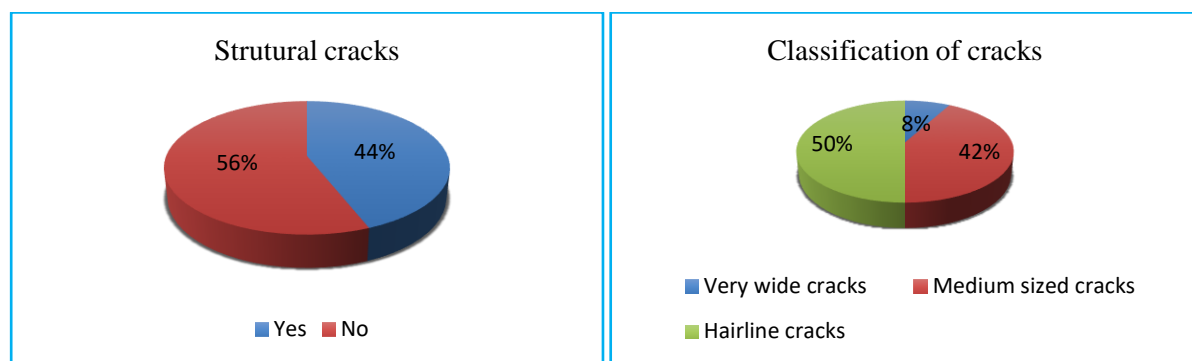
Structural cracks may occur due to soil settlement and are formed on the walls in diagonal directions. The data obtained from the questionnaire provide an overview about structural cracks found in the residential buildings of Quetta, Figure 13(a). These cracks were further classified as: very wide cracks, medium sized cracks, and hairline cracks. As presented in figure 13(b) majority of the cracks are hairline cracks, i.e. 50%.

Figure 13(a) Structural cracks

Figure 13(b) Classification of cracks

Structural cracks were found in 44% of the residential buildings. These cracks penetrate through walls and finishes and were also found diagonally on doors and windows. Structural cracks may appear due to structural movement, soil settlement, weakness of structure caused by rusting or corrosion, overloading, or acid attack on concrete. Such problem need to be thoroughly investigated before repairing these cracks.

The high percentage of strutural cracks were found in the areas of Balochi Street, Quetta cantonment, Brewery road, and Pashtoonabad localities (Table 5). Several houses in Quetta are built without designing architectural plans and structural loads and the construction work is executed by people with inadequate knowledge and professional background. A good number of houses, i.e. 40%, needed repair and maintenance within 2-5 years of their construction. The repair of these cracks can be done by grouting, opening, and refilling it with concrete (patching), or using epoxy resins.

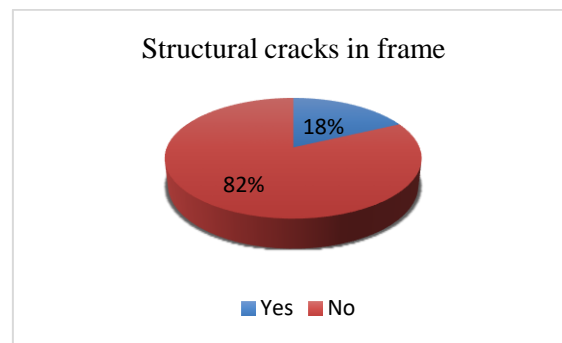
The structural crack in frame can be dangerous and cause some spalling in the beams and columns which may lead to structural failure and cause damage to the property and the human lives. In our study 18% of the houses found with structural cracks in the frame of the building (figure. 14)

Figure 14. Percentage of cracks in frames

In the survey, 92% of the houses possessed the frame structure using beams and columns. Structural cracks in frames have the same causes as explained in section 4.3.4.1. They may also occur due to the use of substandard materials, design and construction deficiencies, settlement of ground, and damage by accidents etc. It is important to identify and understand the actual cause of these defects before fixing the cracks in building frame. These cracks may also be repaired as mentioned in the section 4.3.4.1. If the cracks are big enough and the reinforcement is affected, then section should be changed with respect to proper structural design calculations. Houses in Quetta cantonment found with higher percentage of structural cracks in the frame (Table 6). 30% of the houses (as per sample) in cantonment area were built 20-30 years ago and 20% of them were built more than 30 years ago. The repair work carried out in the houses was also inadequate to fix the problem.
