# HiRadMat 28 & 35 TCDI / TDI material tests on ASL 3D Carbon/Carbon and SGL Graphite R7550

*7<sup>th</sup> HL-LHC Collaboration Meeting – 15<sup>th</sup> November 2017 - Madrid*

Inigo Lamas Garcia – CERN (EN-STI)

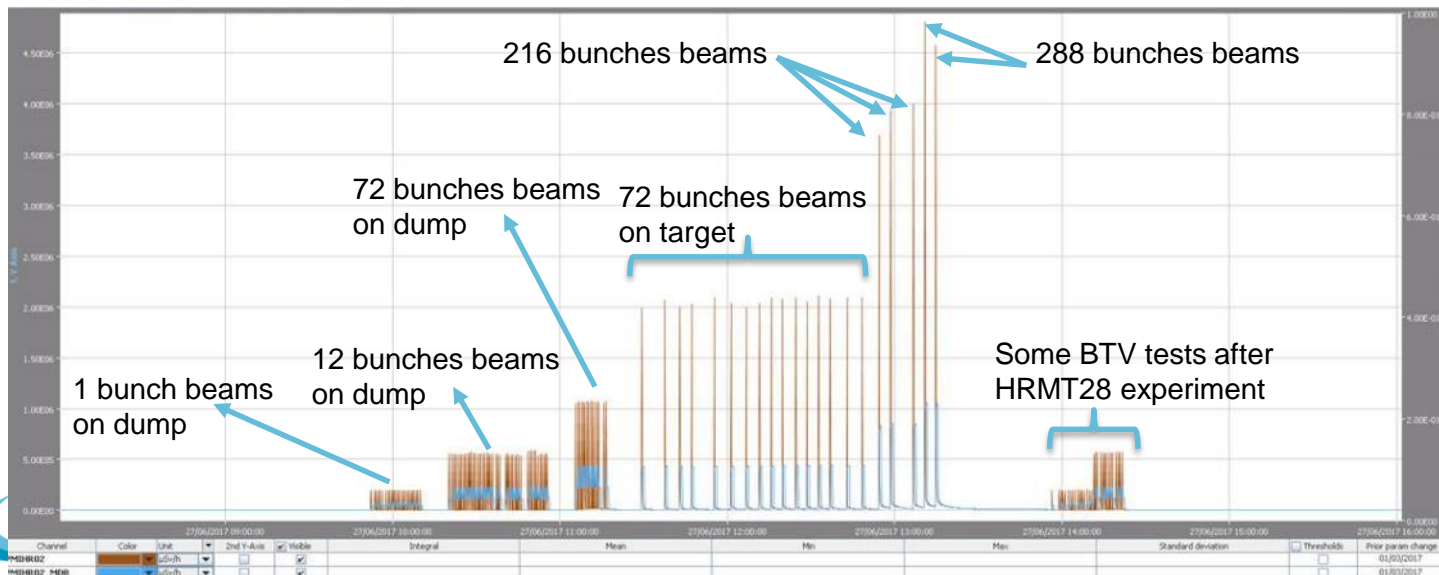
RP Monitor  
PMIHR02,  
showing residual  
dose rate versus  
time

Residual dose rate	After 9h of cool down	After 44h of cool down
PMIHR02	1 mSv/h	227 $\mu$ Sv/h

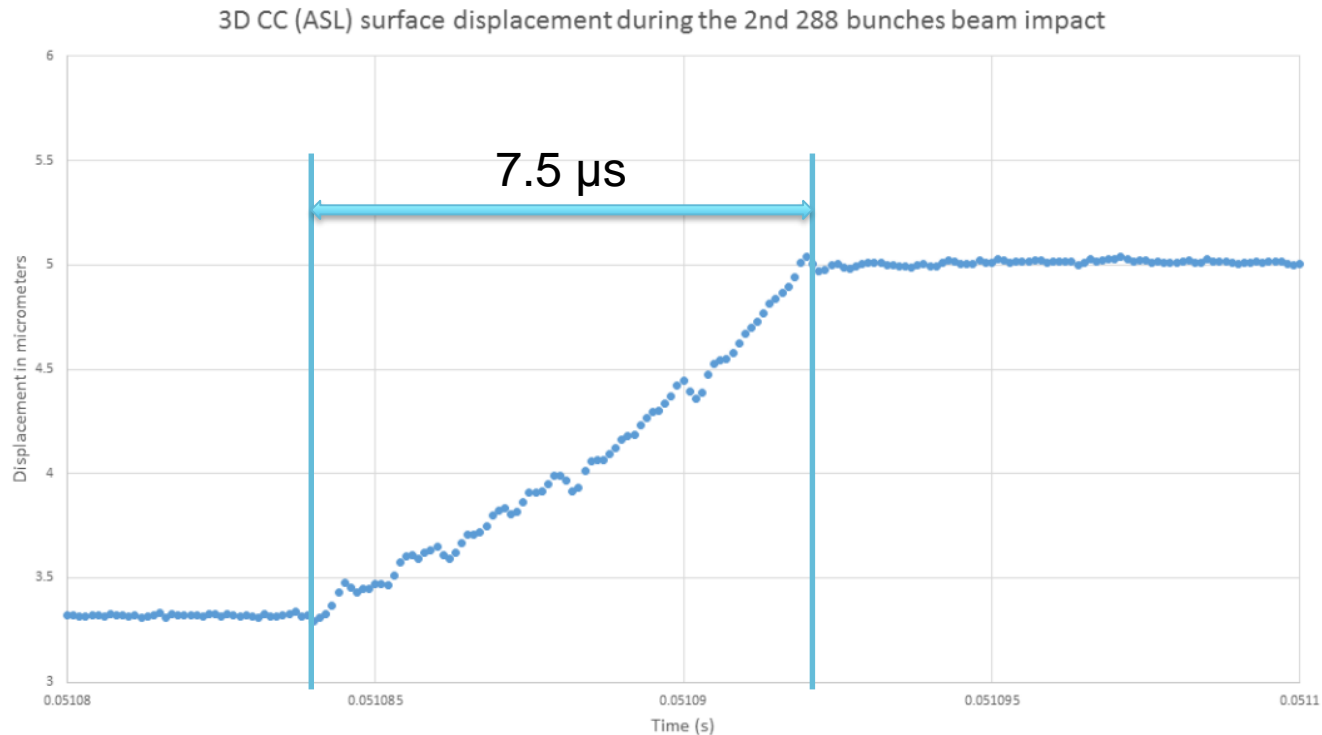
# 3D CC surface displacement when impacted (LDV 10 MHz)

- Correct bunch length ✓
- Expected magnitude of the surface displacement ✓

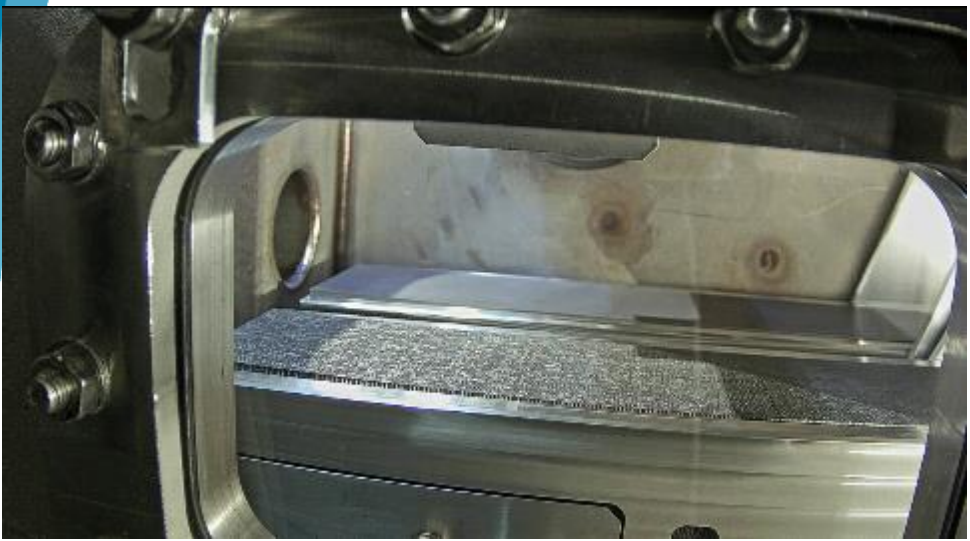
After 2x216 and 2x288 bunches shots on graphite

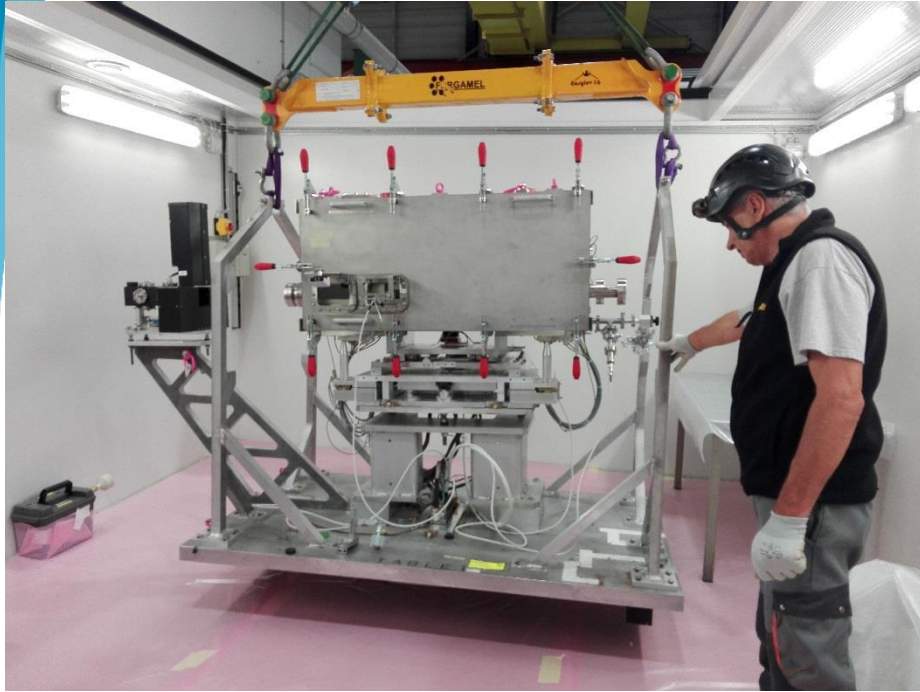
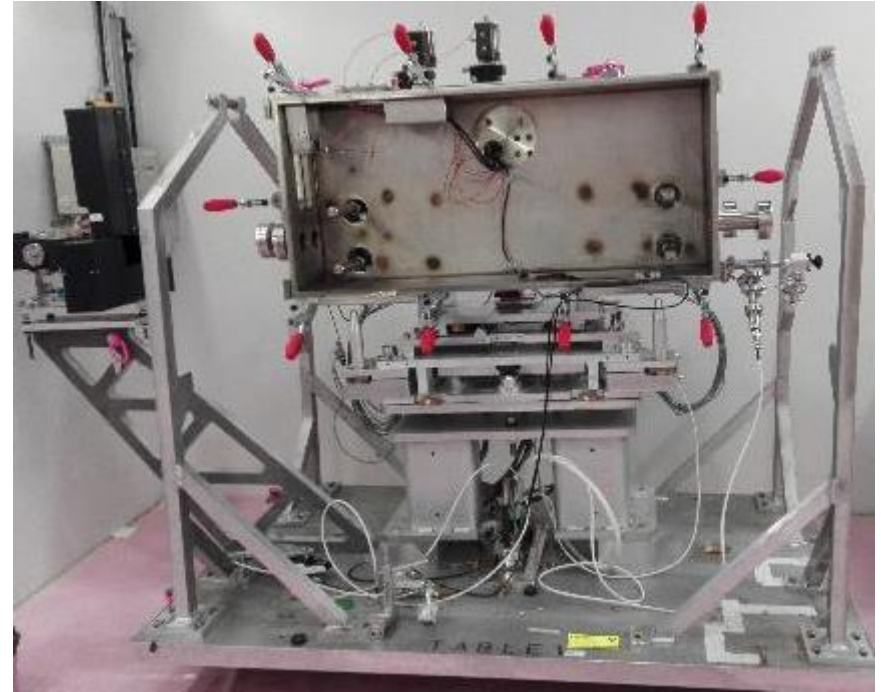
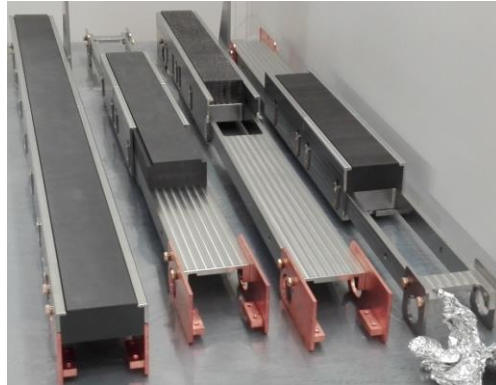
The opened vacuum vessel with jaws removed

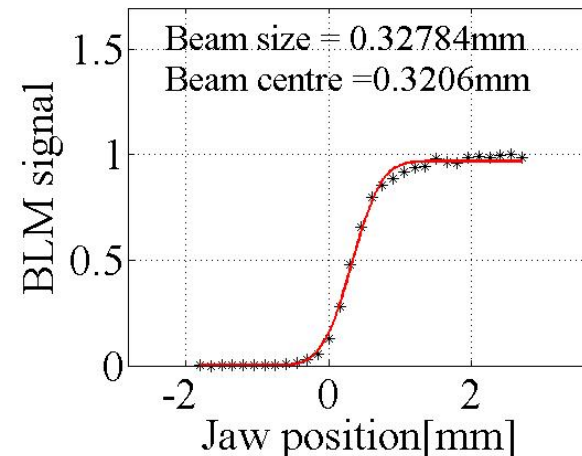
- First BBA took place 21th August 2017:
  - BBA on Graphite/Cu and CFC/Mo jaws with INDIV ( $\sim 1,2E11$ ppp, x 50 shots)
    - Left/Top jaw (CFC with Mo Coating)
      - Beam center = 0.387 mm
      - Beam size = 0.275 mm
    - Right/Bottom jaw (Graphite with Cu coating)
      - Beam center = 0.320 mm
      - Beam size = 0.330 mm
  - We assume an average beam center of 0.350 mm and the nominal beam size of 0.3 mm.

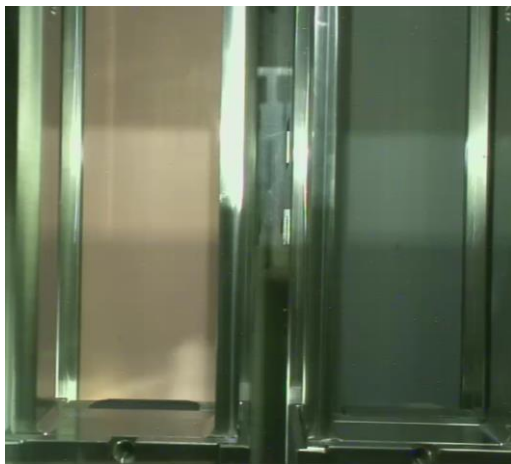
HD RadHard camera any before impact

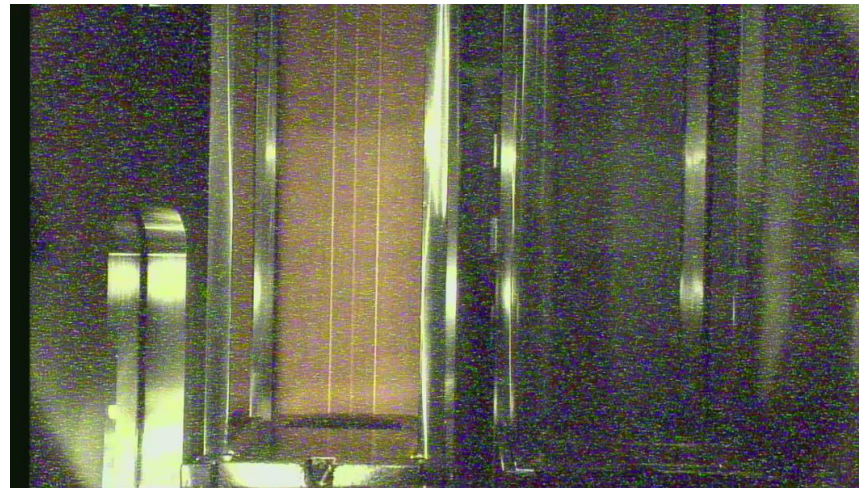
HD RadHard camera after Graphite Cu coating impacts

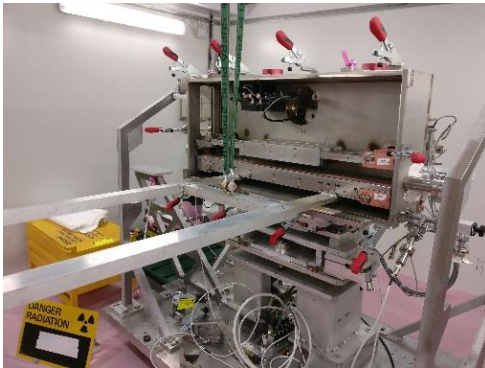
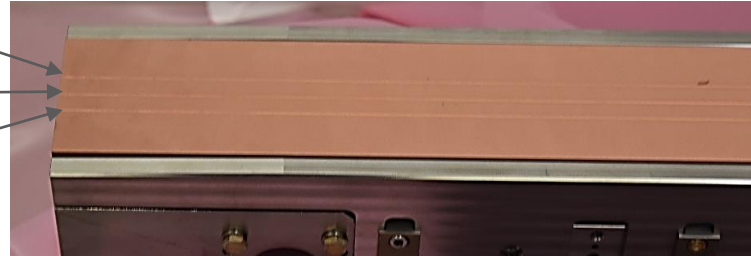
1mSv/h at contact

Impact type 2

Impact type 1

Impact type 3

- HRMT35 preliminary results indicate quite good coating adhesion with no apparent surface rupture for Cu coated graphite;
- The currently installed TDI and its SGL R7550 graphite blocks sputtered with Cu can perform under the worst impact conditions;
- Further PIE (e.g. coating adhesion tests and tomography) will be performed when residual dose rate will allow;

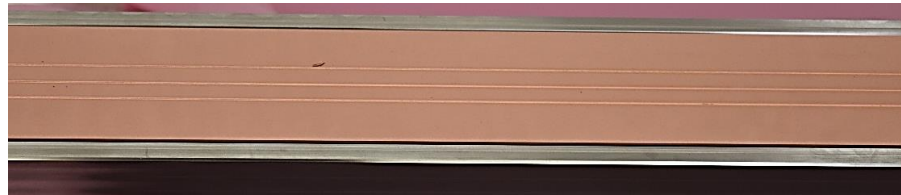
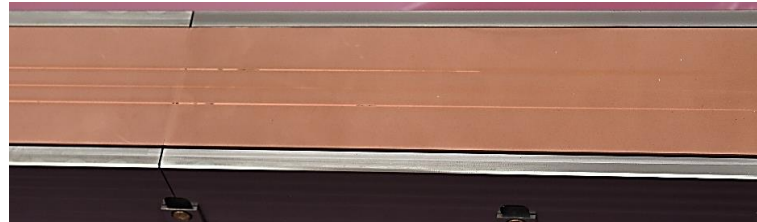
Upstream

Downstream

Surface CO2 blasted  
before Cu sputtering ~3  
um
