# Vertical EP successfully applied to the LHC Crab cavity

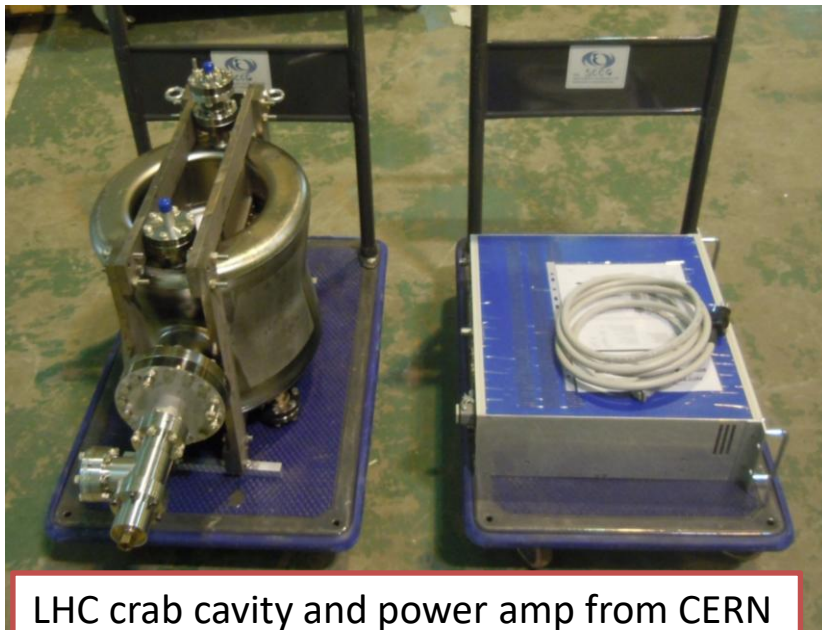
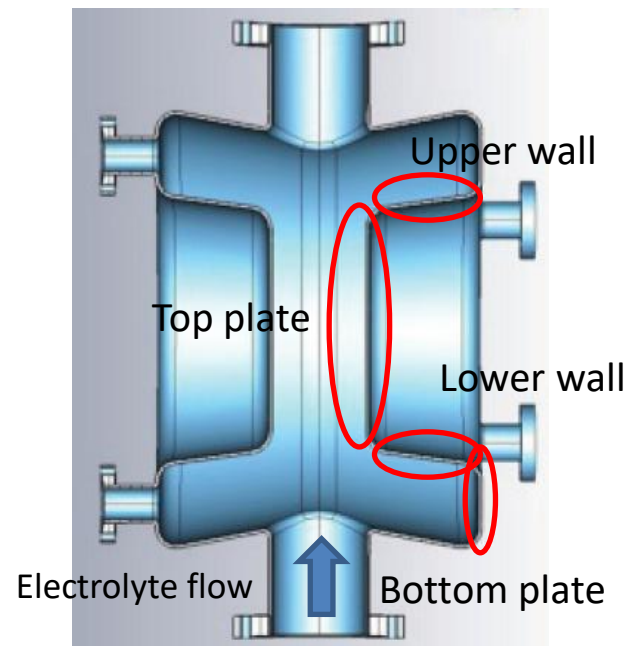
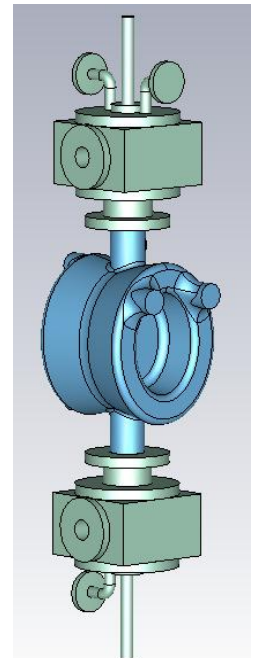
Average removal thickness: 35  $\mu\text{m}$

1. Top plate: 44  $\mu\text{m}$
2. Bottom plate: 22  $\mu\text{m}$
3. Upper wall: 30  $\mu\text{m}$
4. Lower wall: 80  $\mu\text{m}$

Large removal. Need to improve. Turnover during polishing is an option.

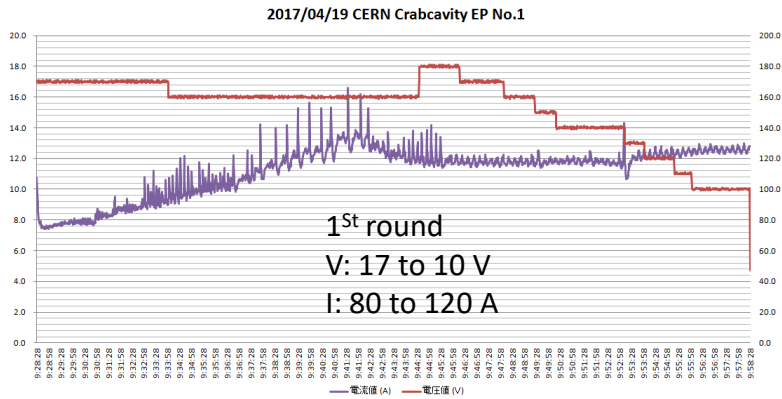
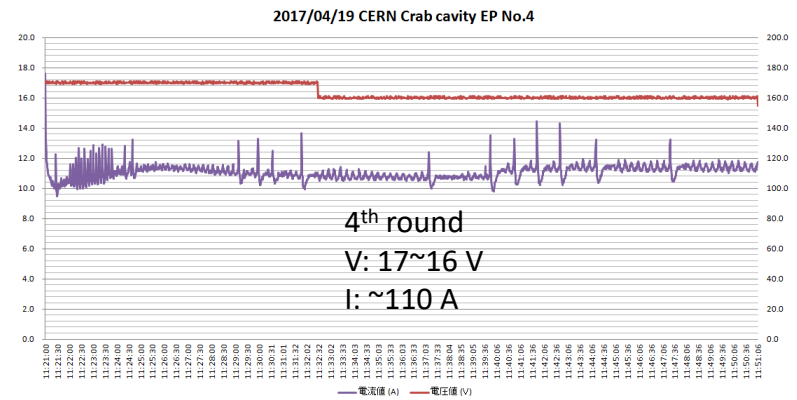
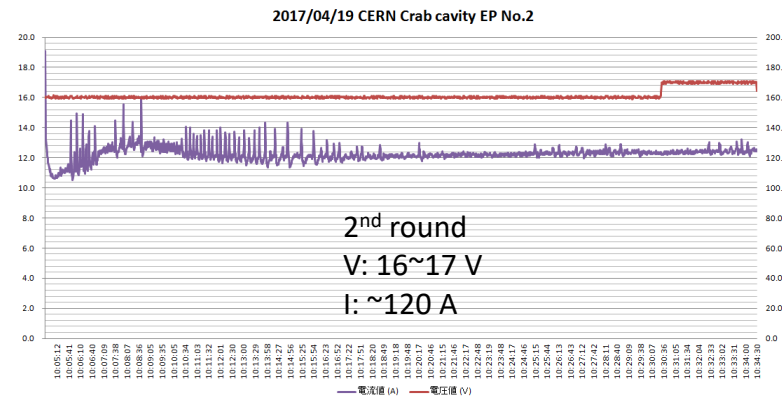
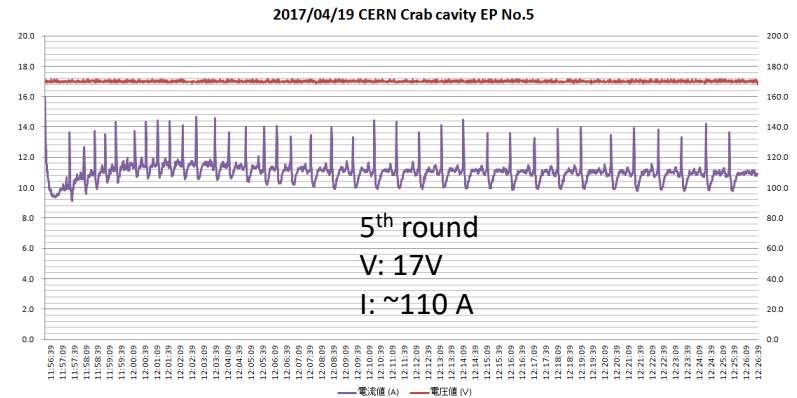
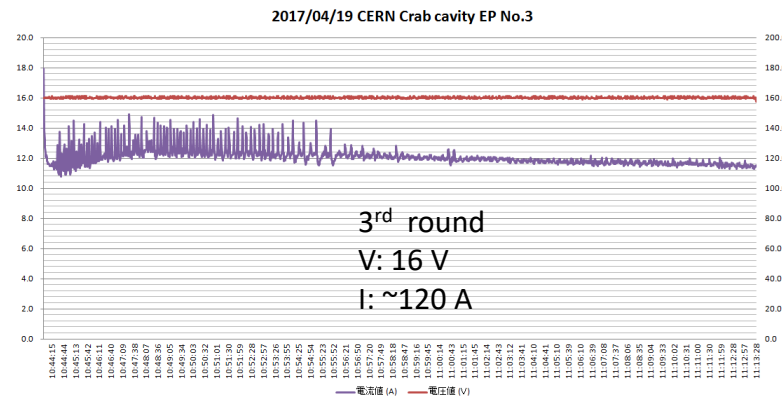
# Applied voltage and current

We stopped VEP every 30 minutes to check the surface removal measured with an ultrasonic thicknessmeter

Average voltage: 17 V  
Average current: 120A  
Average current density: 18 mA/cm<sup>2</sup>

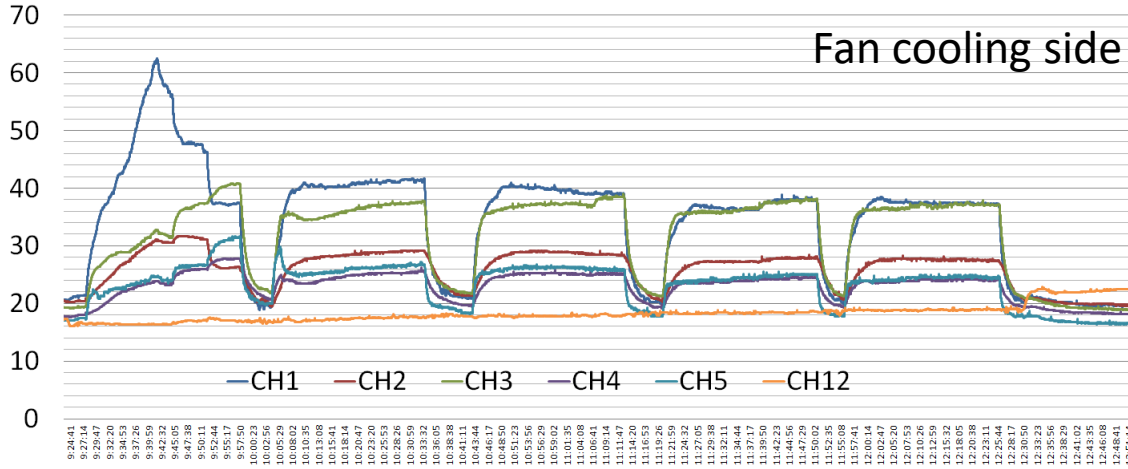
2017/04/19 CERN Crab cavity surface temperature at EP (°C)

CH12: VEP room temperature

Temperatures at the upper beam pipe were higher than others. Temperatures at the top plate of the inner conductor were around 40 deg. Other temperatures were below 30 deg. We plan to apply more cooling fans to cool down the upper beam pipe.

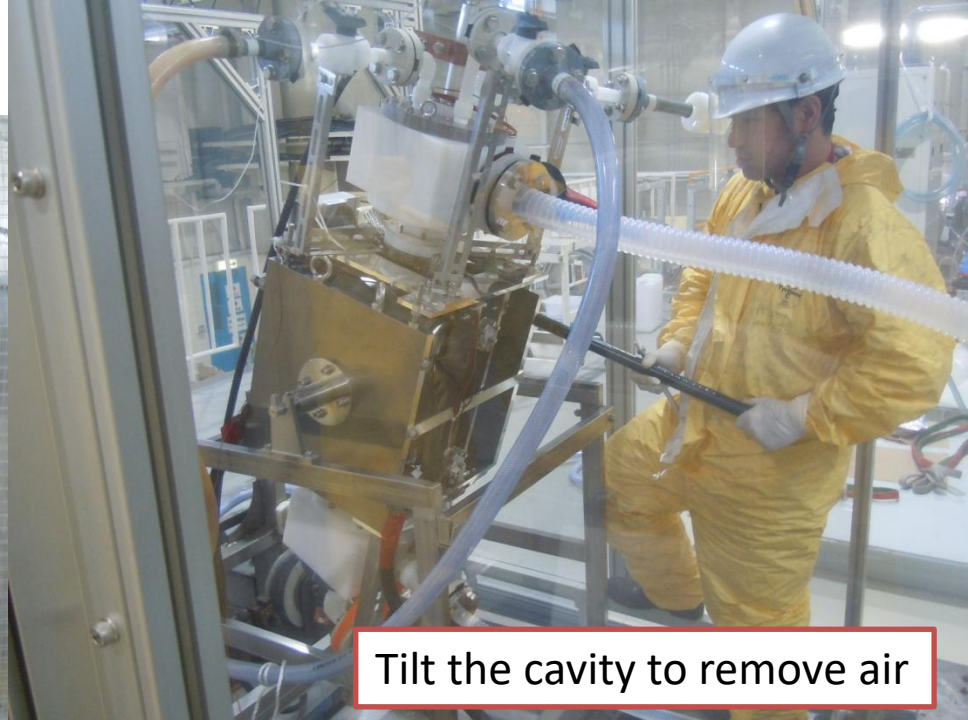
Tilt the cavity to remove air

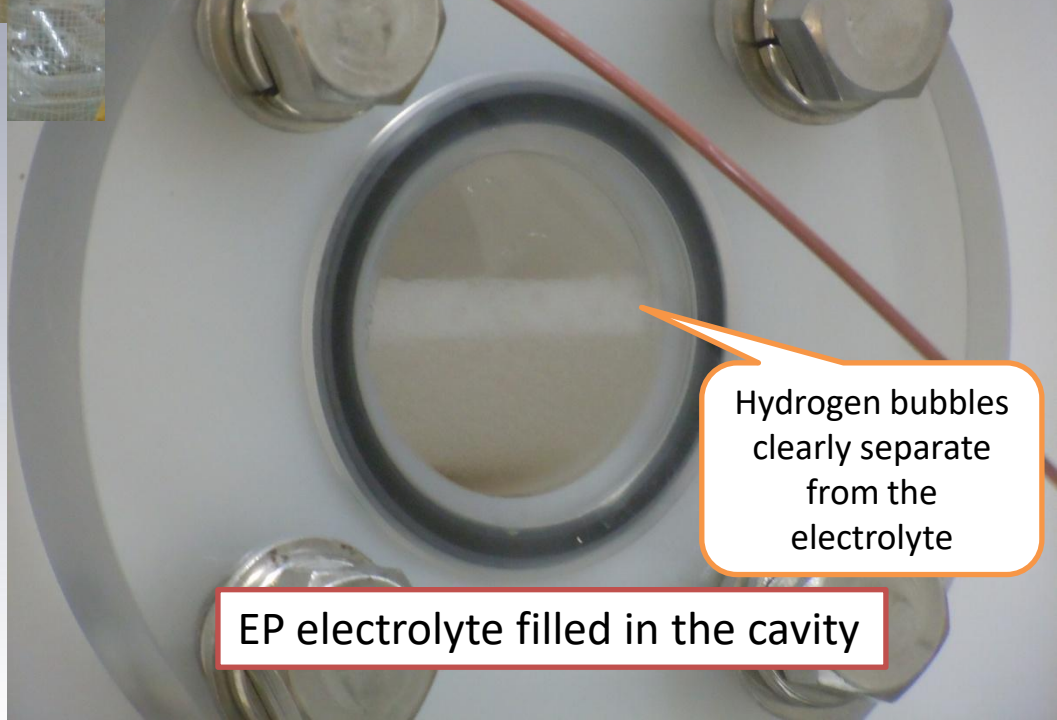
Hydrogen bubbles clearly separate from the electrolyte

EP electrolyte filled in the cavity

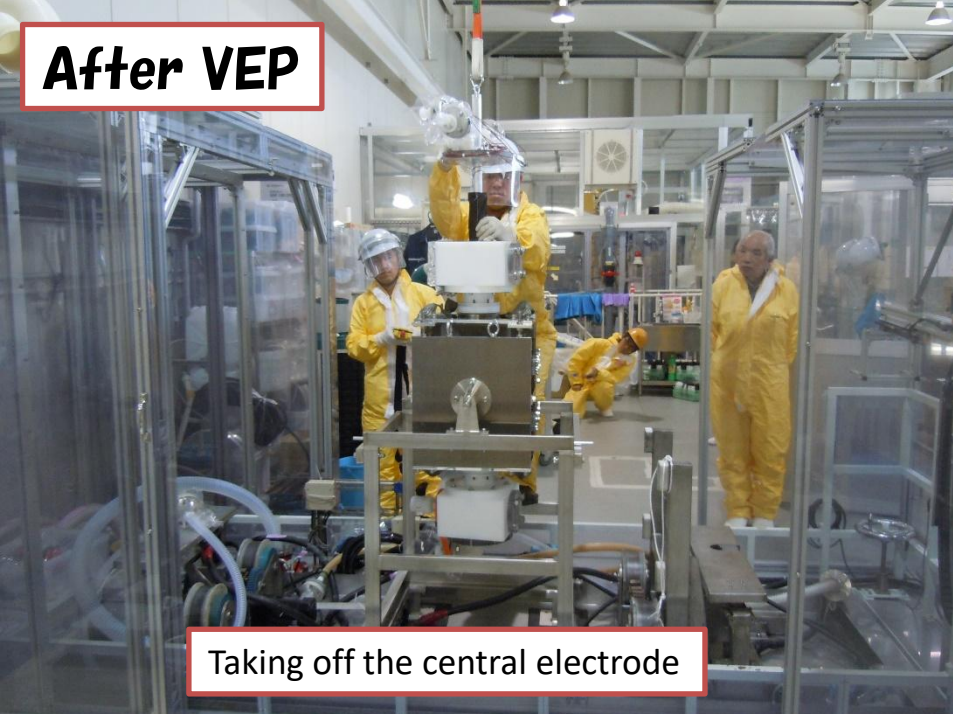
Taking off the central electrode

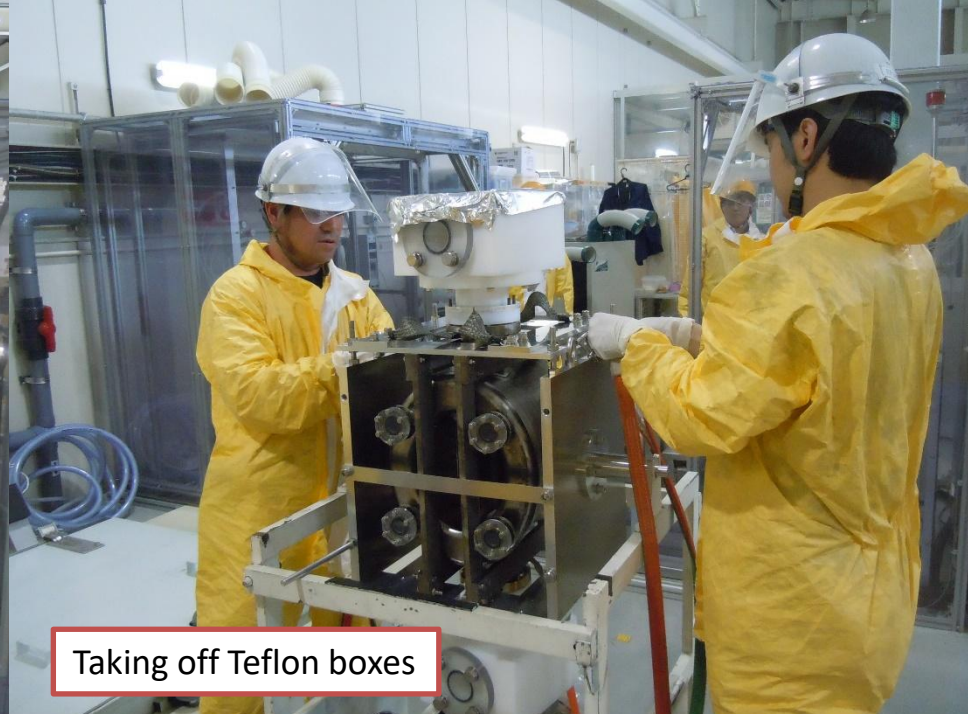
Taking off Teflon boxes

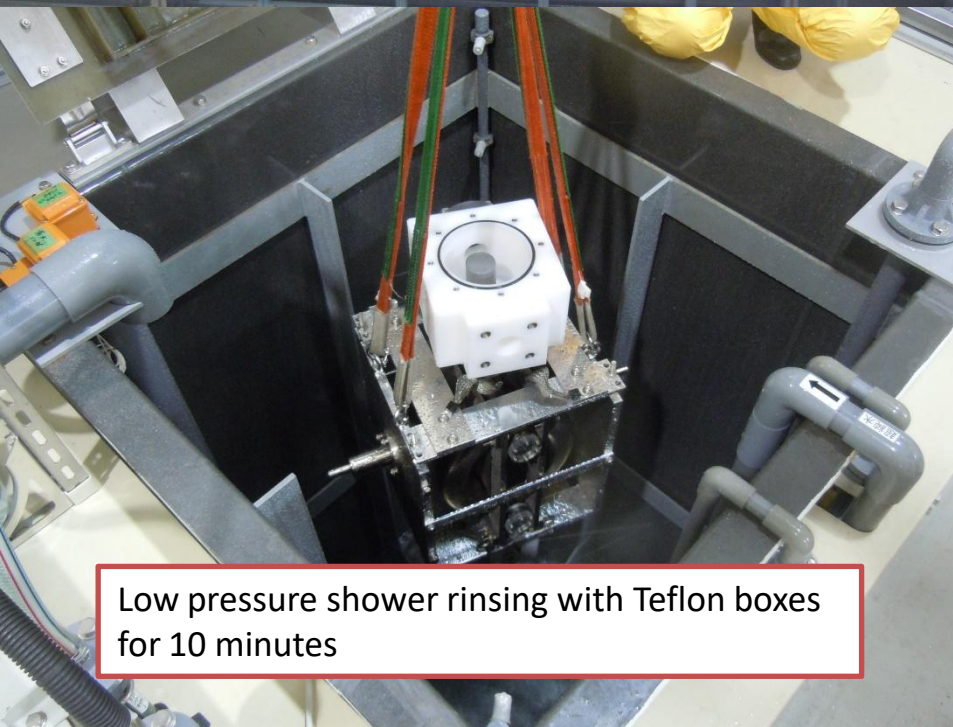
Low pressure shower rinsing with Teflon boxes for 10 minutes

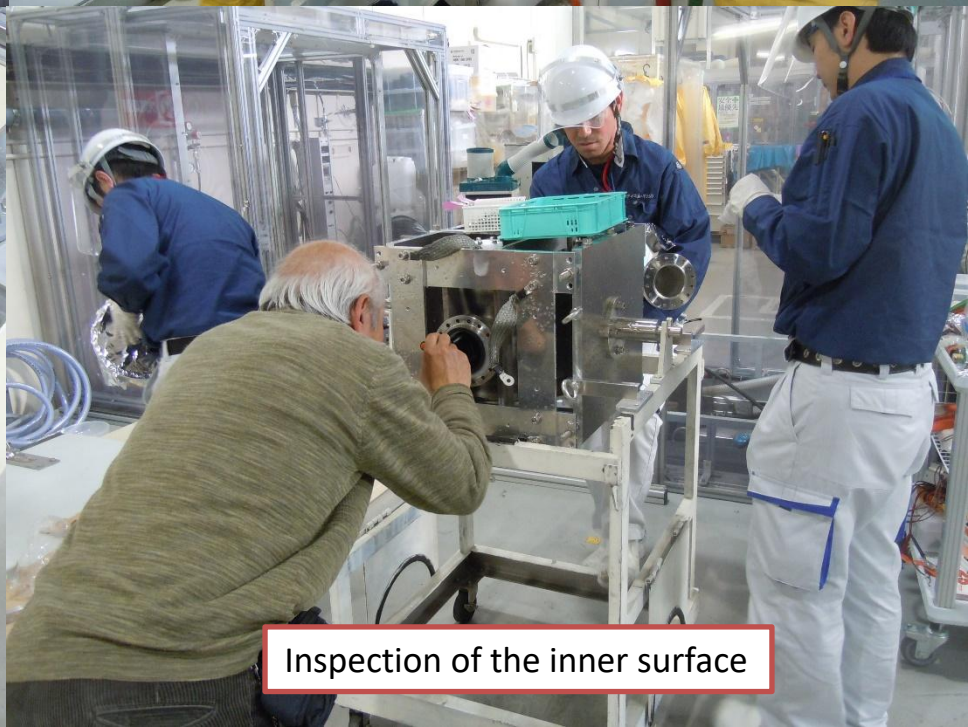
Inspection of the inner surface

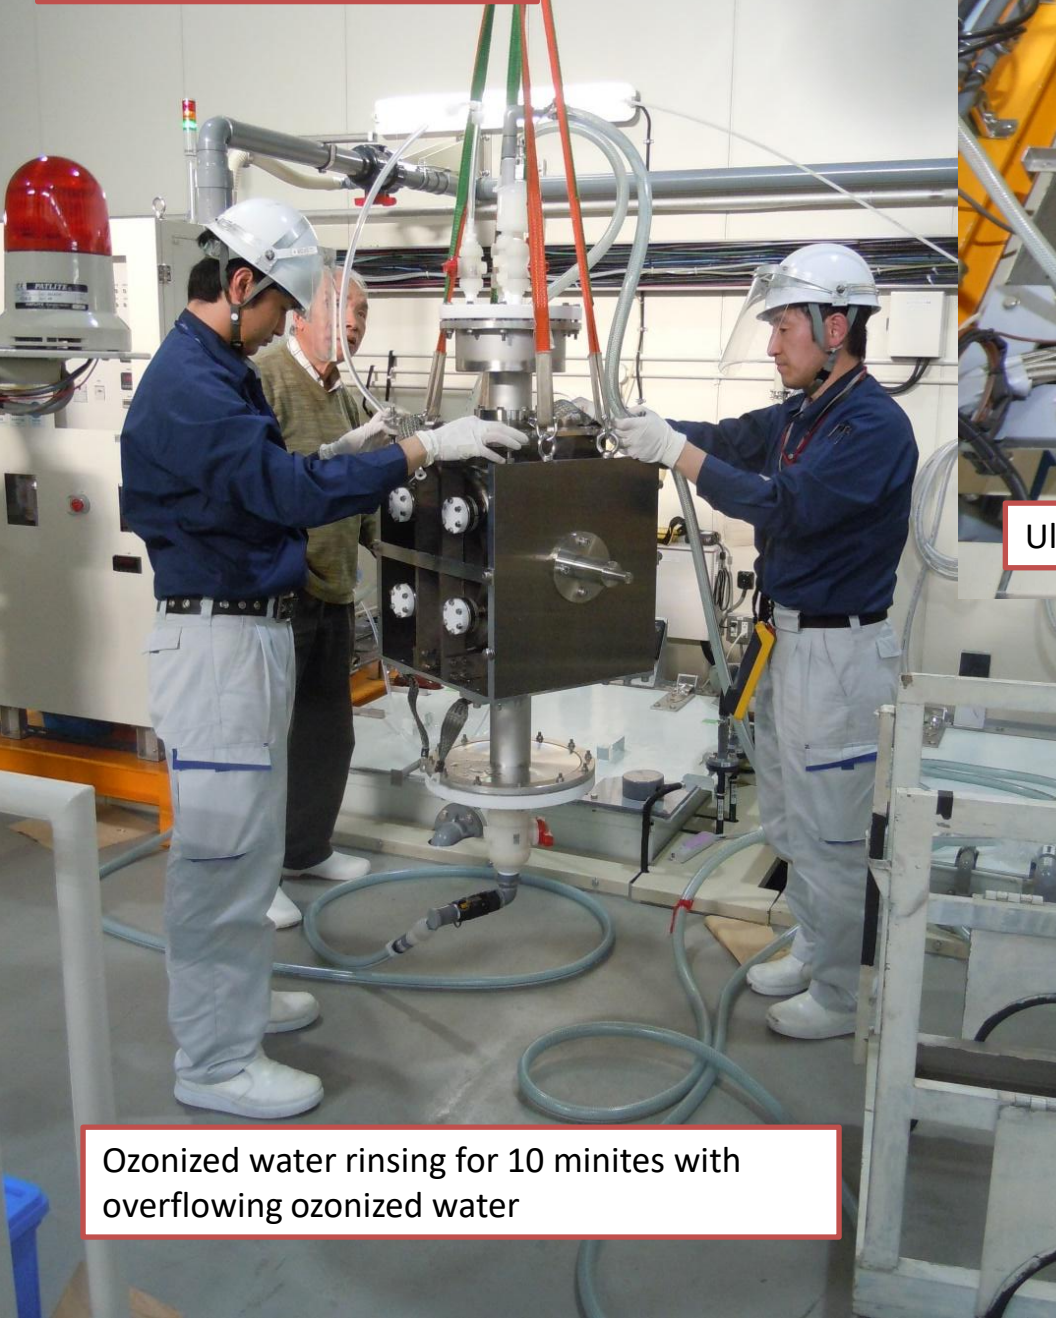
Ozonized water rinsing for 10 minutes with overflowing ozonized water

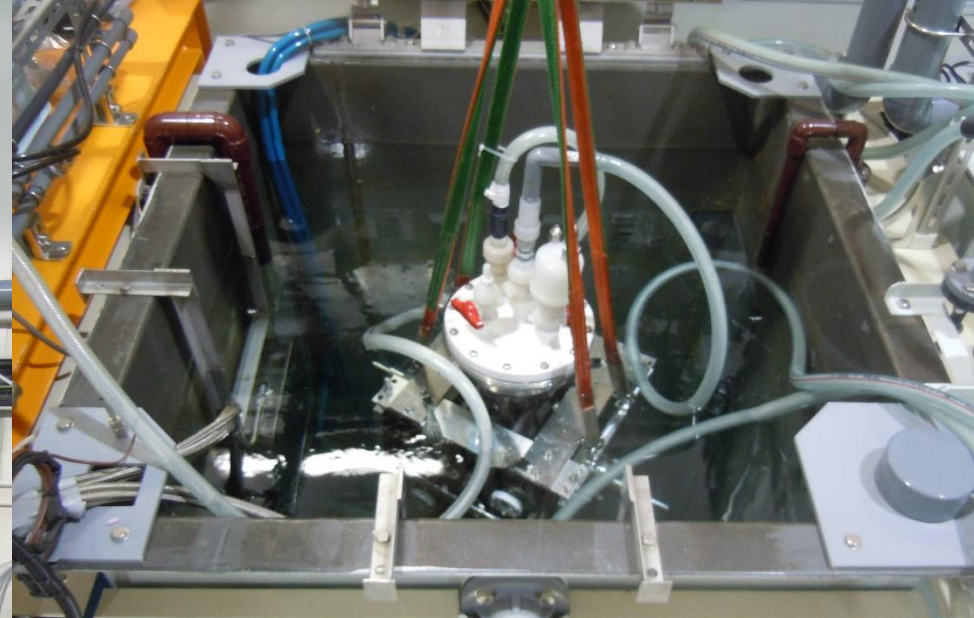
Ultra sonic rinsing for an hour in a 50 C hot water bath

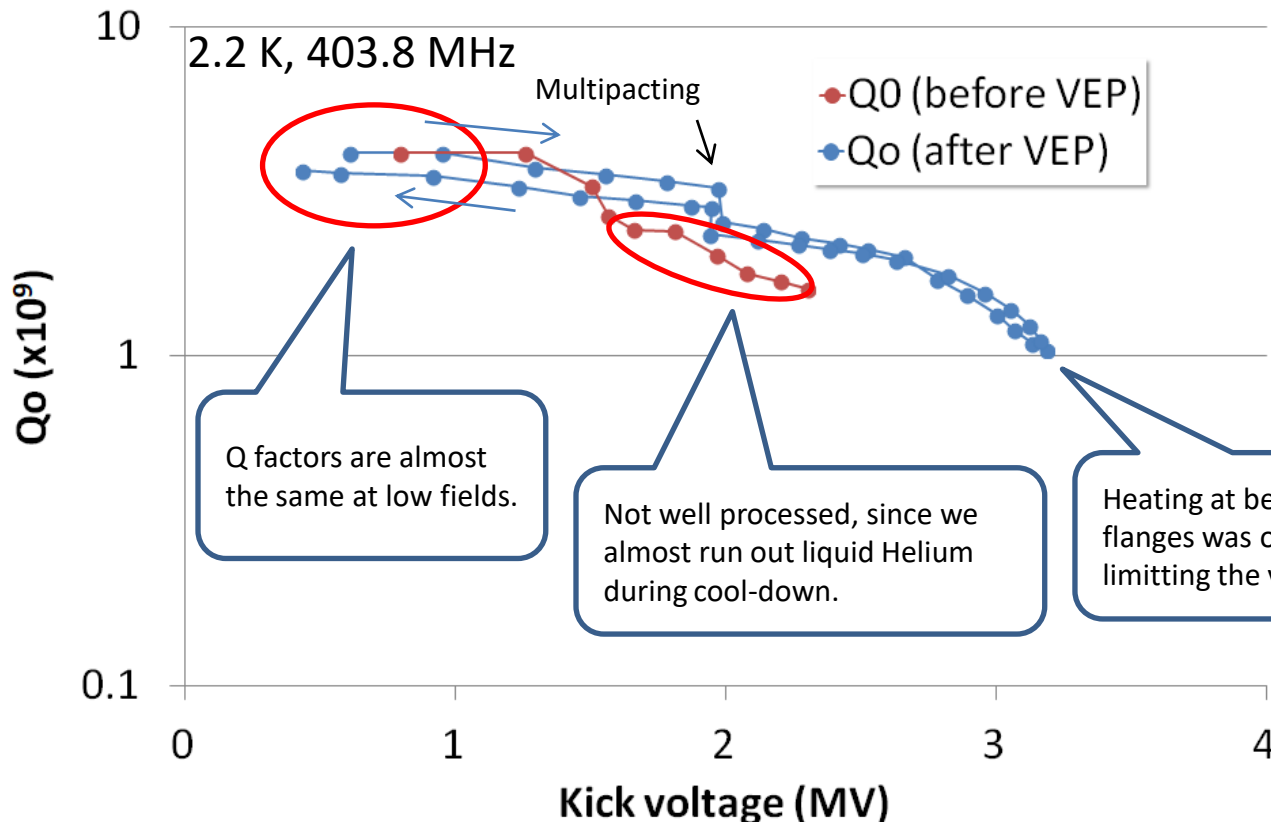
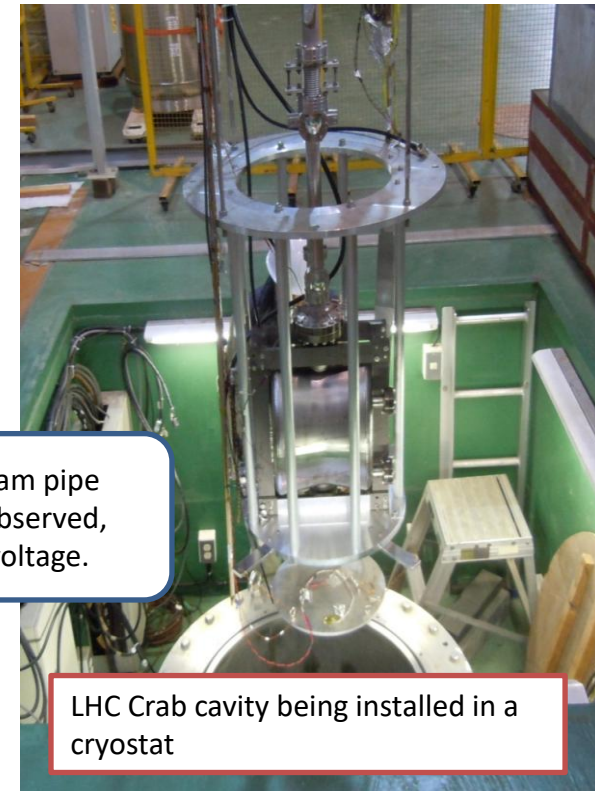
Results of cold tests

1. Q factors are almost the same at low fields. Significant improvement was not observed for this cavity.
2. Heating at beam pipe flanges limited its fields.
3. Field emission was observed at relatively low fields (2.6MV), suggesting particle contamination during leakage repairing.

Our cold test stand modified from the KEKB system successfully cooled the cavity to 2K. Newly developed 400 MHz RF measurement system worked well to measure the cavity performance before and after the VEP.

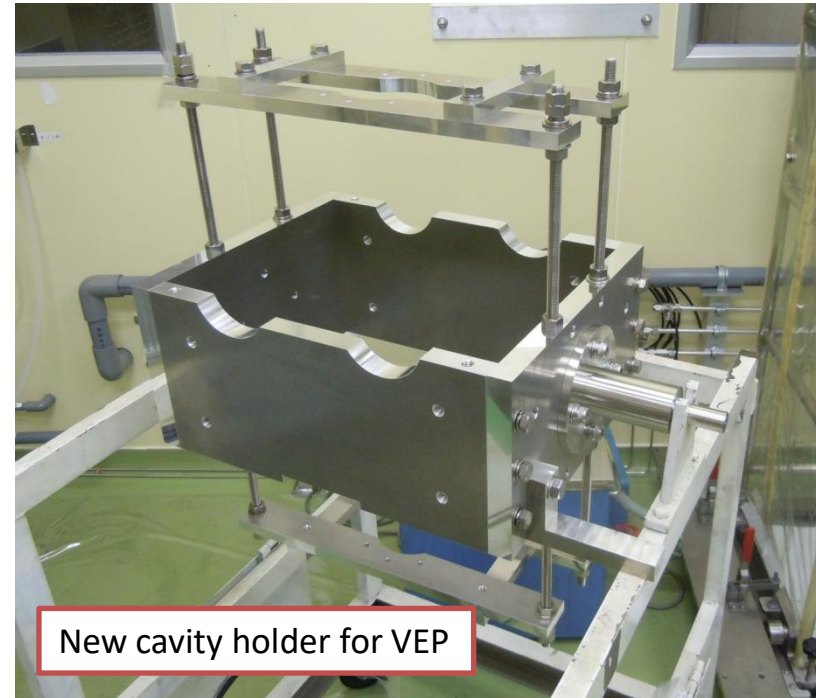
New cavity holder for VEP

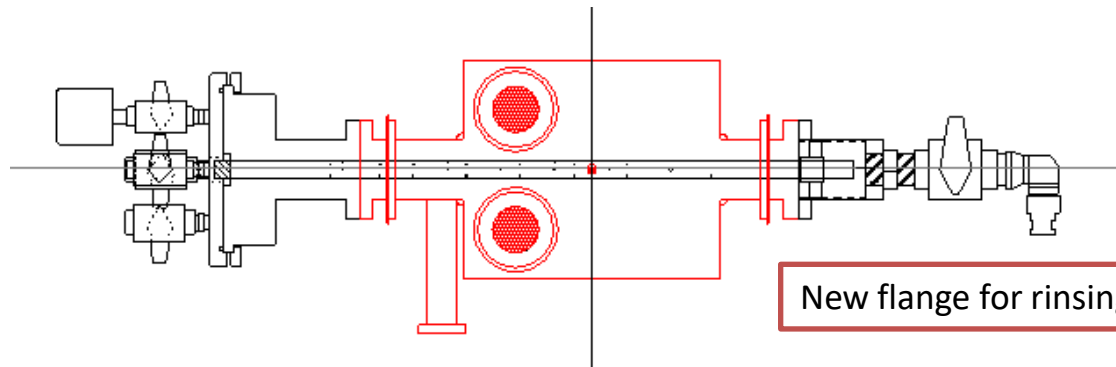
New flange for rinsing
