**UNIVERSITÉ
DE GENÈVE**

Capacitor tiles

Scanning Electron Microscopy

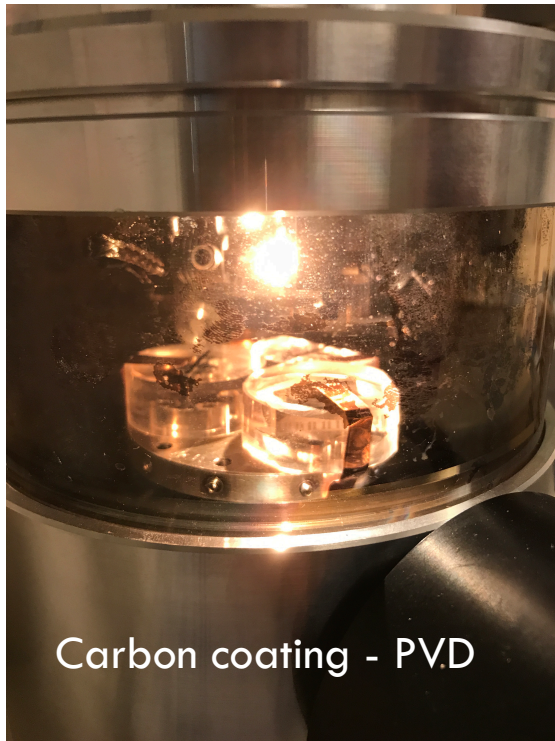
- To avoid charge accumulation and image deformations, conductive carbon coating by PVD is done on the samples

Carbon coating - PVD
