BESSY II STATUS REPORT

Markus Ries et al.

BESSY II - A THIRD GENERATION LIGHT SOURCE

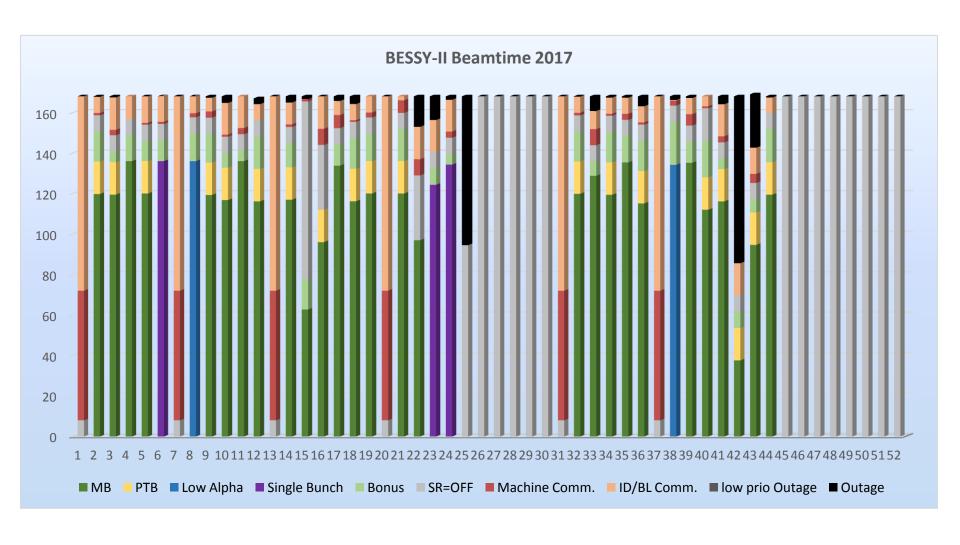
Operation statistics

- 2013: shutdown extension, poor vacuum
- 2014: 3 major incidents
- 2015: 2 long shutdowns, reduced beam current
- 2016: no major incidents, EMIL optics, reduced beam current
- 2017: Cavity Vacuum and Linac-Gun problems

Year	Scheduled	Downtime	# Outages	Availability	MTBF	MTTR
2013	4505 h	159.3 h	105	96.5%	42.9 h	1.52 h
2014	5408 h	384.4 h	136	92.9%	39.8 h	2.83 h
2015	3896 h	92.5 h	90	97.6%	43.3 h	1.03 h
2016	4855 h	62.9 h	69	98.7%	70.4 h	0.91 h
2017	4299 h	249.5 h	62	94.2%	69.3 h	4.02 h

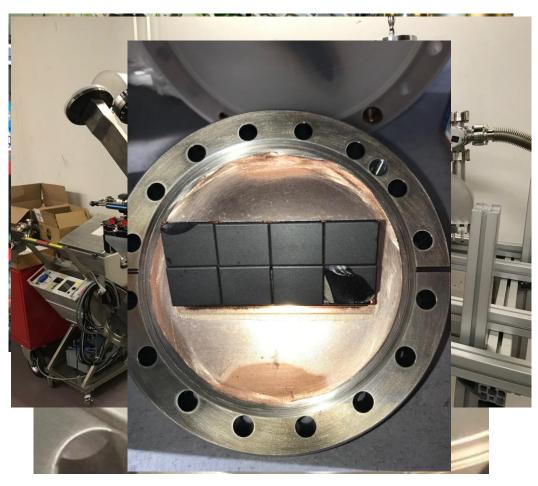
LANDAU CAVITY – VACUUM LEAK

- event in 2016 leading to removal of Landaus due to increased radiation levels in user area
- HOM load ferrites broken but presumably not the source
- Vacuum leak found in Landau cavity 2 → repair not possible
- spare Landau cavity refurbished
- "knee"-design for HOM loads
- HOM load test option
- new HOM loads
 → some didn't pass FAT, some
 broke → installation mid 2018
- Vacuum lifetime increased
 14 h → 20 h

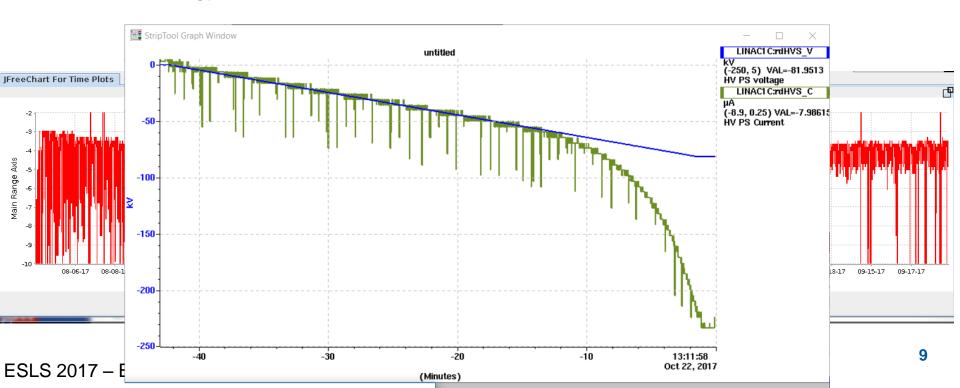
LINAC GUN – HIGH VOLTAGE TROUBLES

- reoccurring failure scenario since 2014
- leak current of static GUN HV behaves erratically → power supply breakdown
- so far: reproducibility is bad, phenomenology

Parameter	value
voltage (DC)	90 kV
current limit	25 μΑ

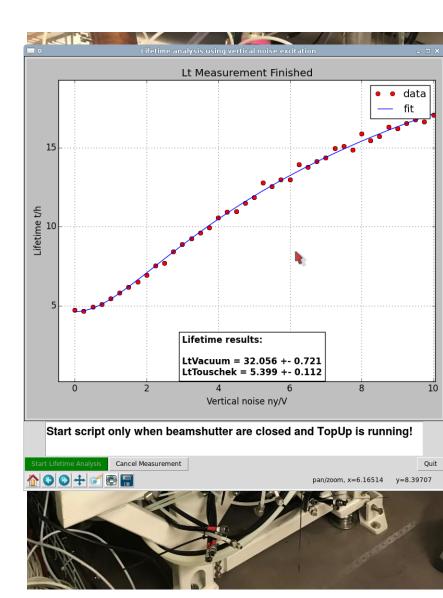
VACUUM LEAK: RF CAVITIES

- systematic weakness found in the 500 MHz cavities
 - → more details will be reported by Ji Li (see MLS status talk)
- fix applied in a matter of weeks (based on the ALBA design)
- vacuum lifetime dramatically increased $20 h \rightarrow 35h$
- no side effects observed so far

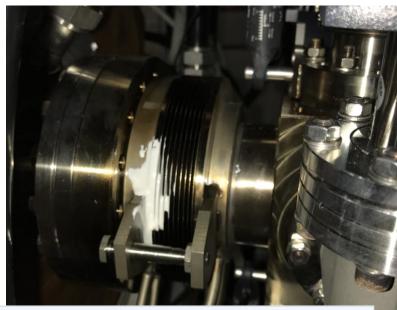
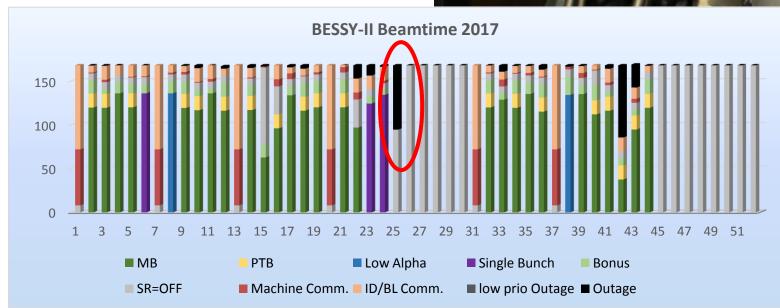
VACUUM LEAK: BELLOW

- significant pressure increase
- → lifetime drops
- → TopUp conditions violated
- → enforced early shutdown

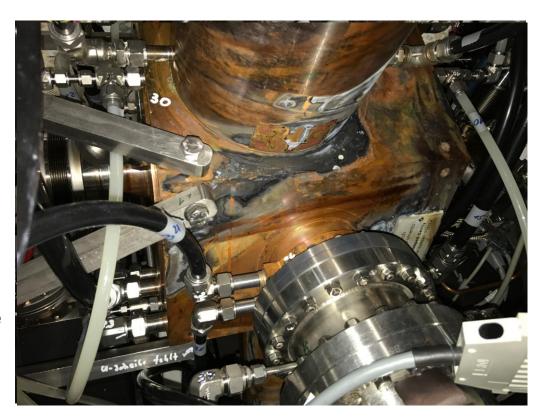
RF CAVITY UNSTABLE OPERATION

- phase noise & vacuum response observed at RF voltages of > 100 kV
- no significant loss of beamtime
- operational risk increased
- presumably heating malfunction
- presently being replaced

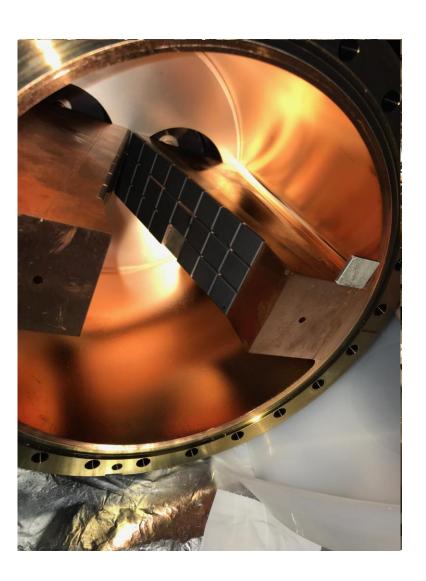
HOM absorbers (soft)soldering issues

- loose ferrite plates
- full batch affected → 12 absorbers
- re-assessing our FAT
- enough spares to fix this shutdown

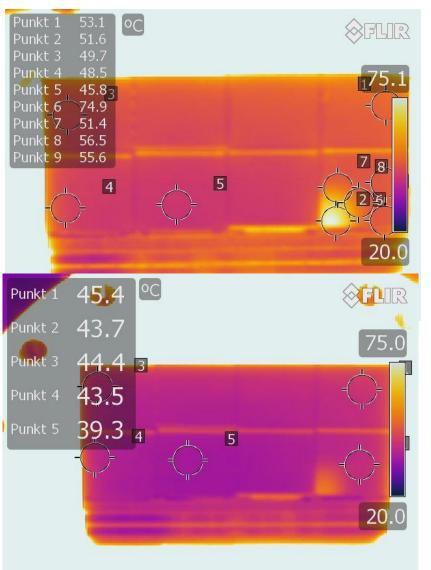
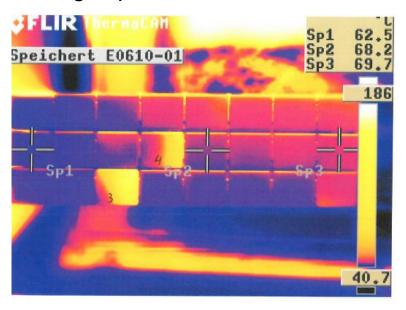
HOM absorbers (soft)soldering issues

- loose ferrite plates
- full batch affected → 12 absorbers
- re-assessing our FAT
- enough spares to fix this shutdown

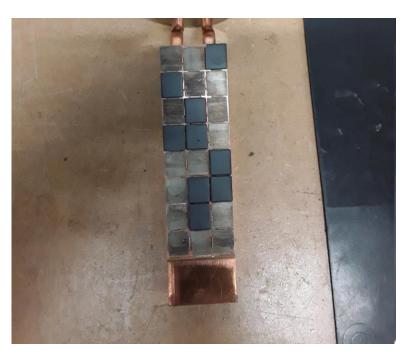
HOM absorbers (soft)soldering issues

- loose ferrite plates
- full batch affected → 12 absorbers
- re-assessing our FAT
- enough spares to fix this shutdown
- new spares will be ordered
- systematics are being investigated

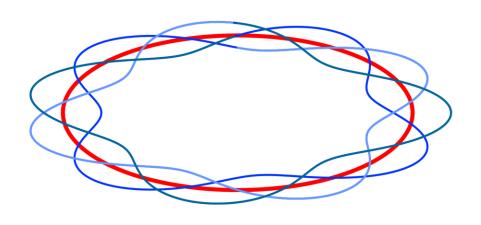
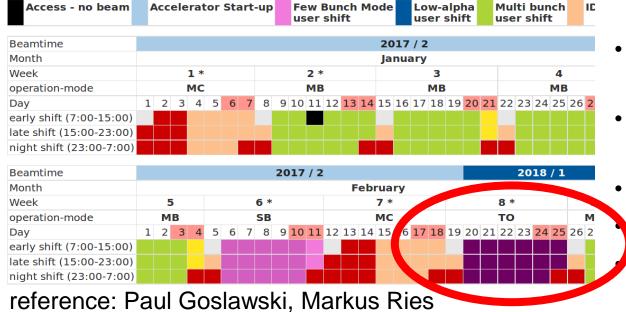
TRIB STUDIES

- scheme first investigated at MLS
- now being implemented at BESSY II
 - TopUp conditions reached!! user test week scheduled BESSY VSR potential to be investigated

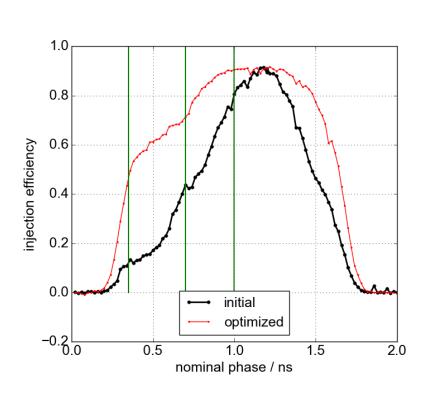
optimizing momentum acceptance

- phase acceptance used as figure of merit
 while optimizing sextupole magnet
 strengths
- small gaps for certain IDs have significant impact
 - → include to optimization
 - → no linear superposition
- optimization algorithm:
 - by hand
 - particle swarm
 - try RCDS?
- on energy injection studies
- strong impact → BESSY VSR injection to short bunches

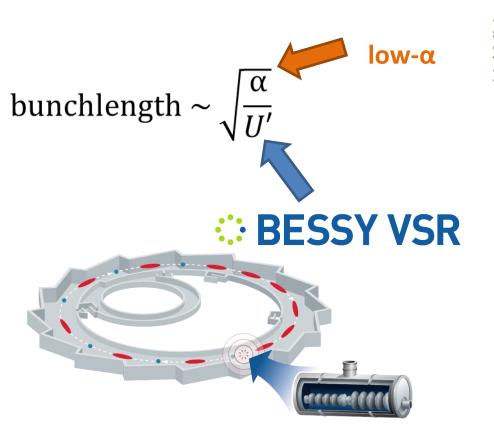
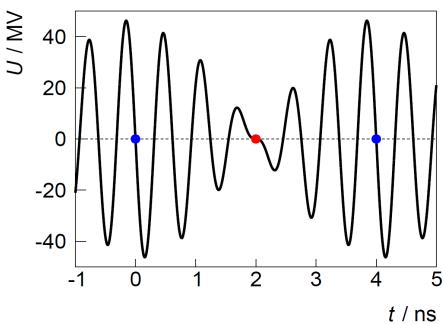
BESSY II MODIFICATIONS

- 0.5 GHz NC x 4
- 1.5 GHz SC x 2
- 1.75 GHz SC x 2

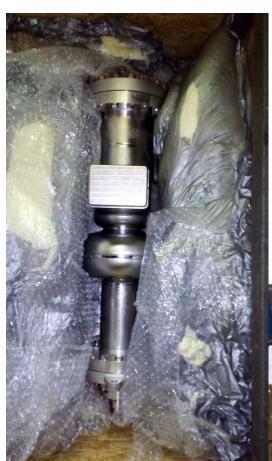
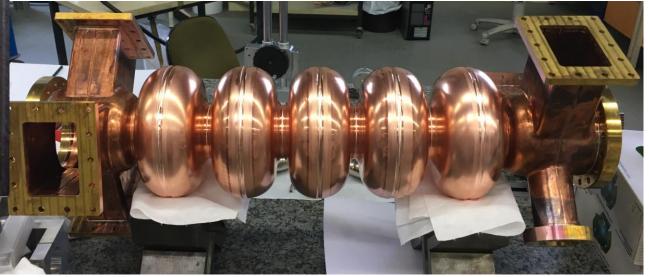
- fully funded project !!
- normal conducting multi-cell cavity on site
- superconducting singe-cell cavity on site
- 15 MV / m reached in vertical test stand (single cell)
