# Characterization of irreversible degradation of Nb<sub>3</sub>Sn Rutherford cables due to transversal compression stress at room temperature

## 1) Introduction and objectives

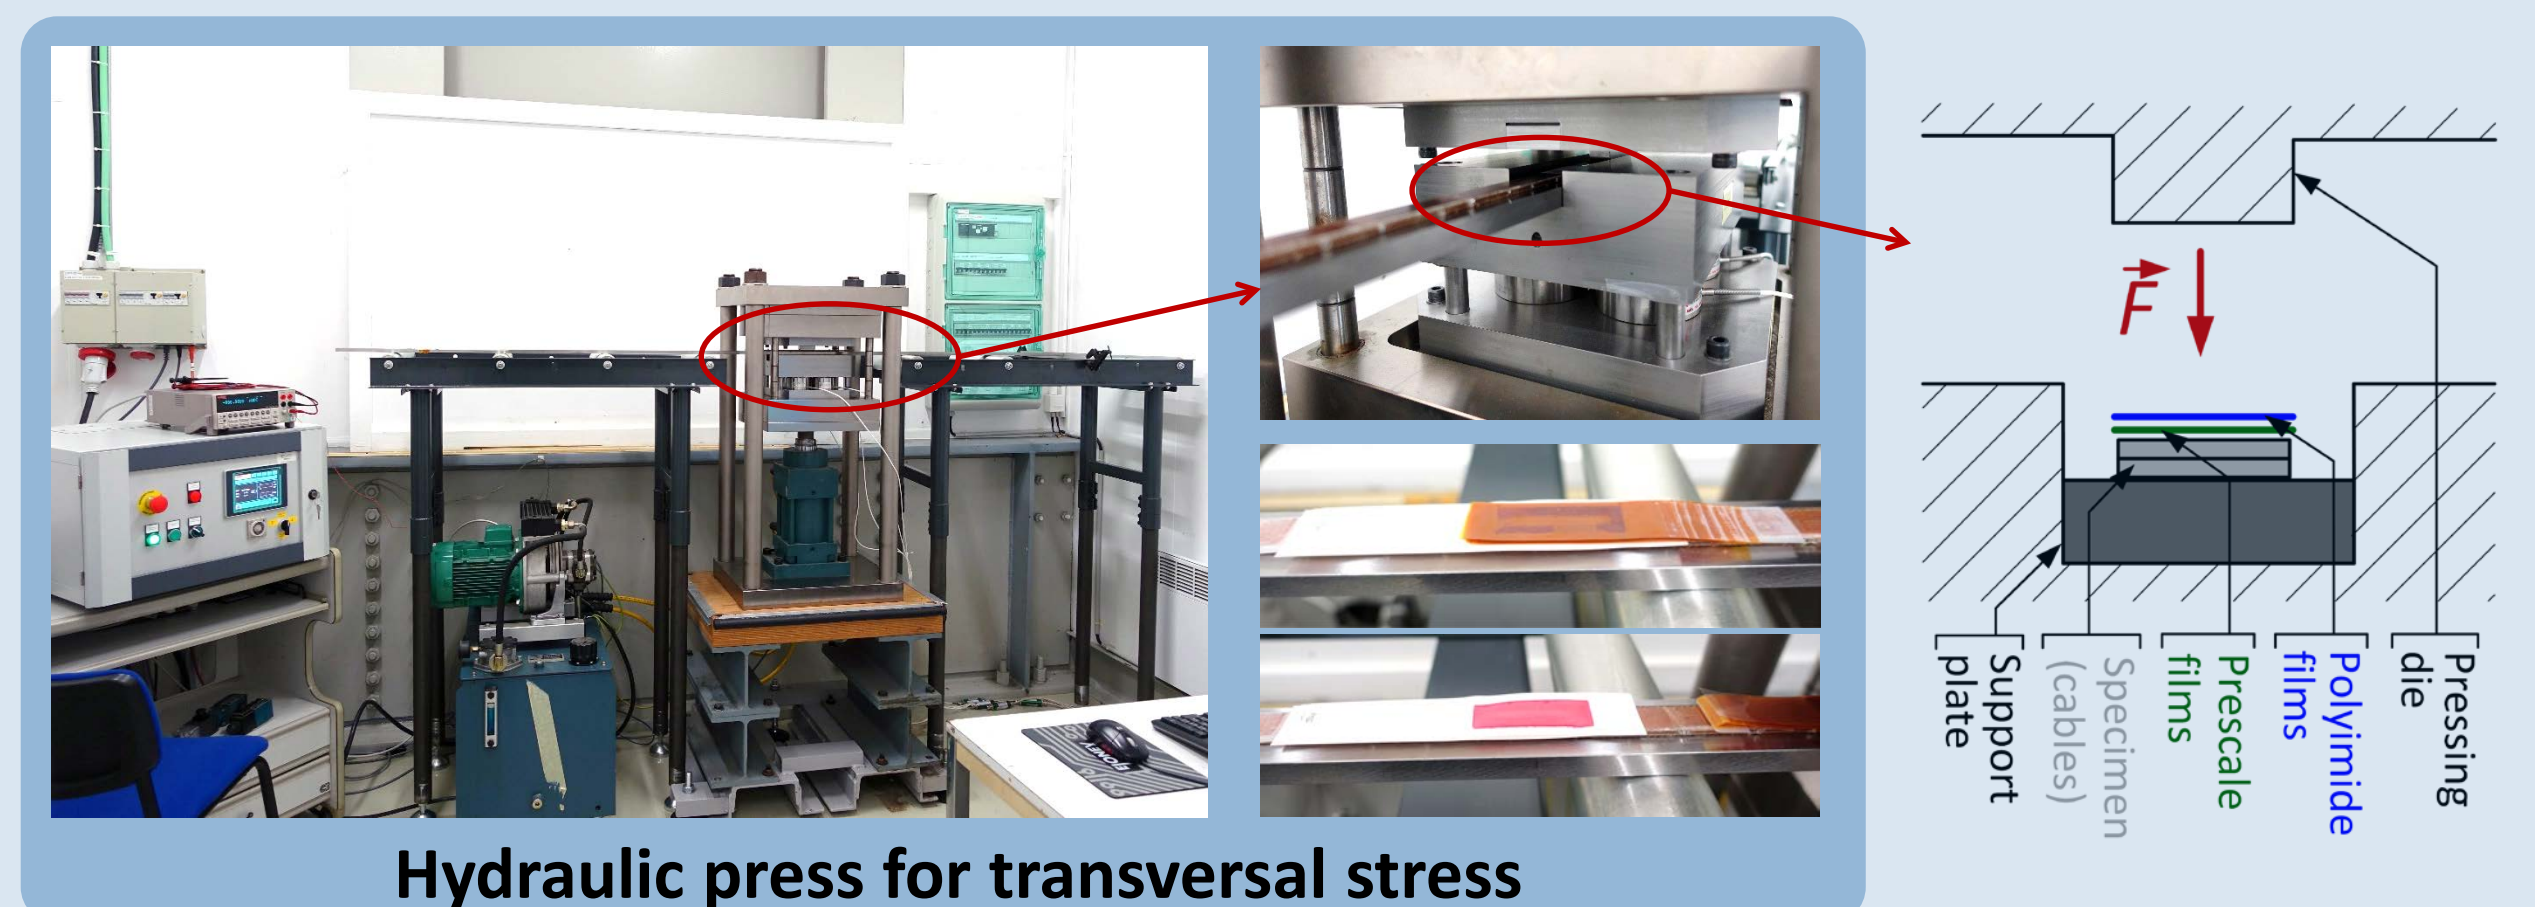
- Iterative compression **at room temperature** before every I<sub>c</sub> measurement.
- Applying stress by using a hydraulic press and evaluation of force with load cells [7].
- Evaluation of **pressure distribution and optimization of the alignment** parameters by using FUJIFILM Prescale© [8].
- Self-written **image processing software** for evaluation of the Prescale films.
- Multilayer of Prescale films of different sensitivity was used to **cover a higher range**.

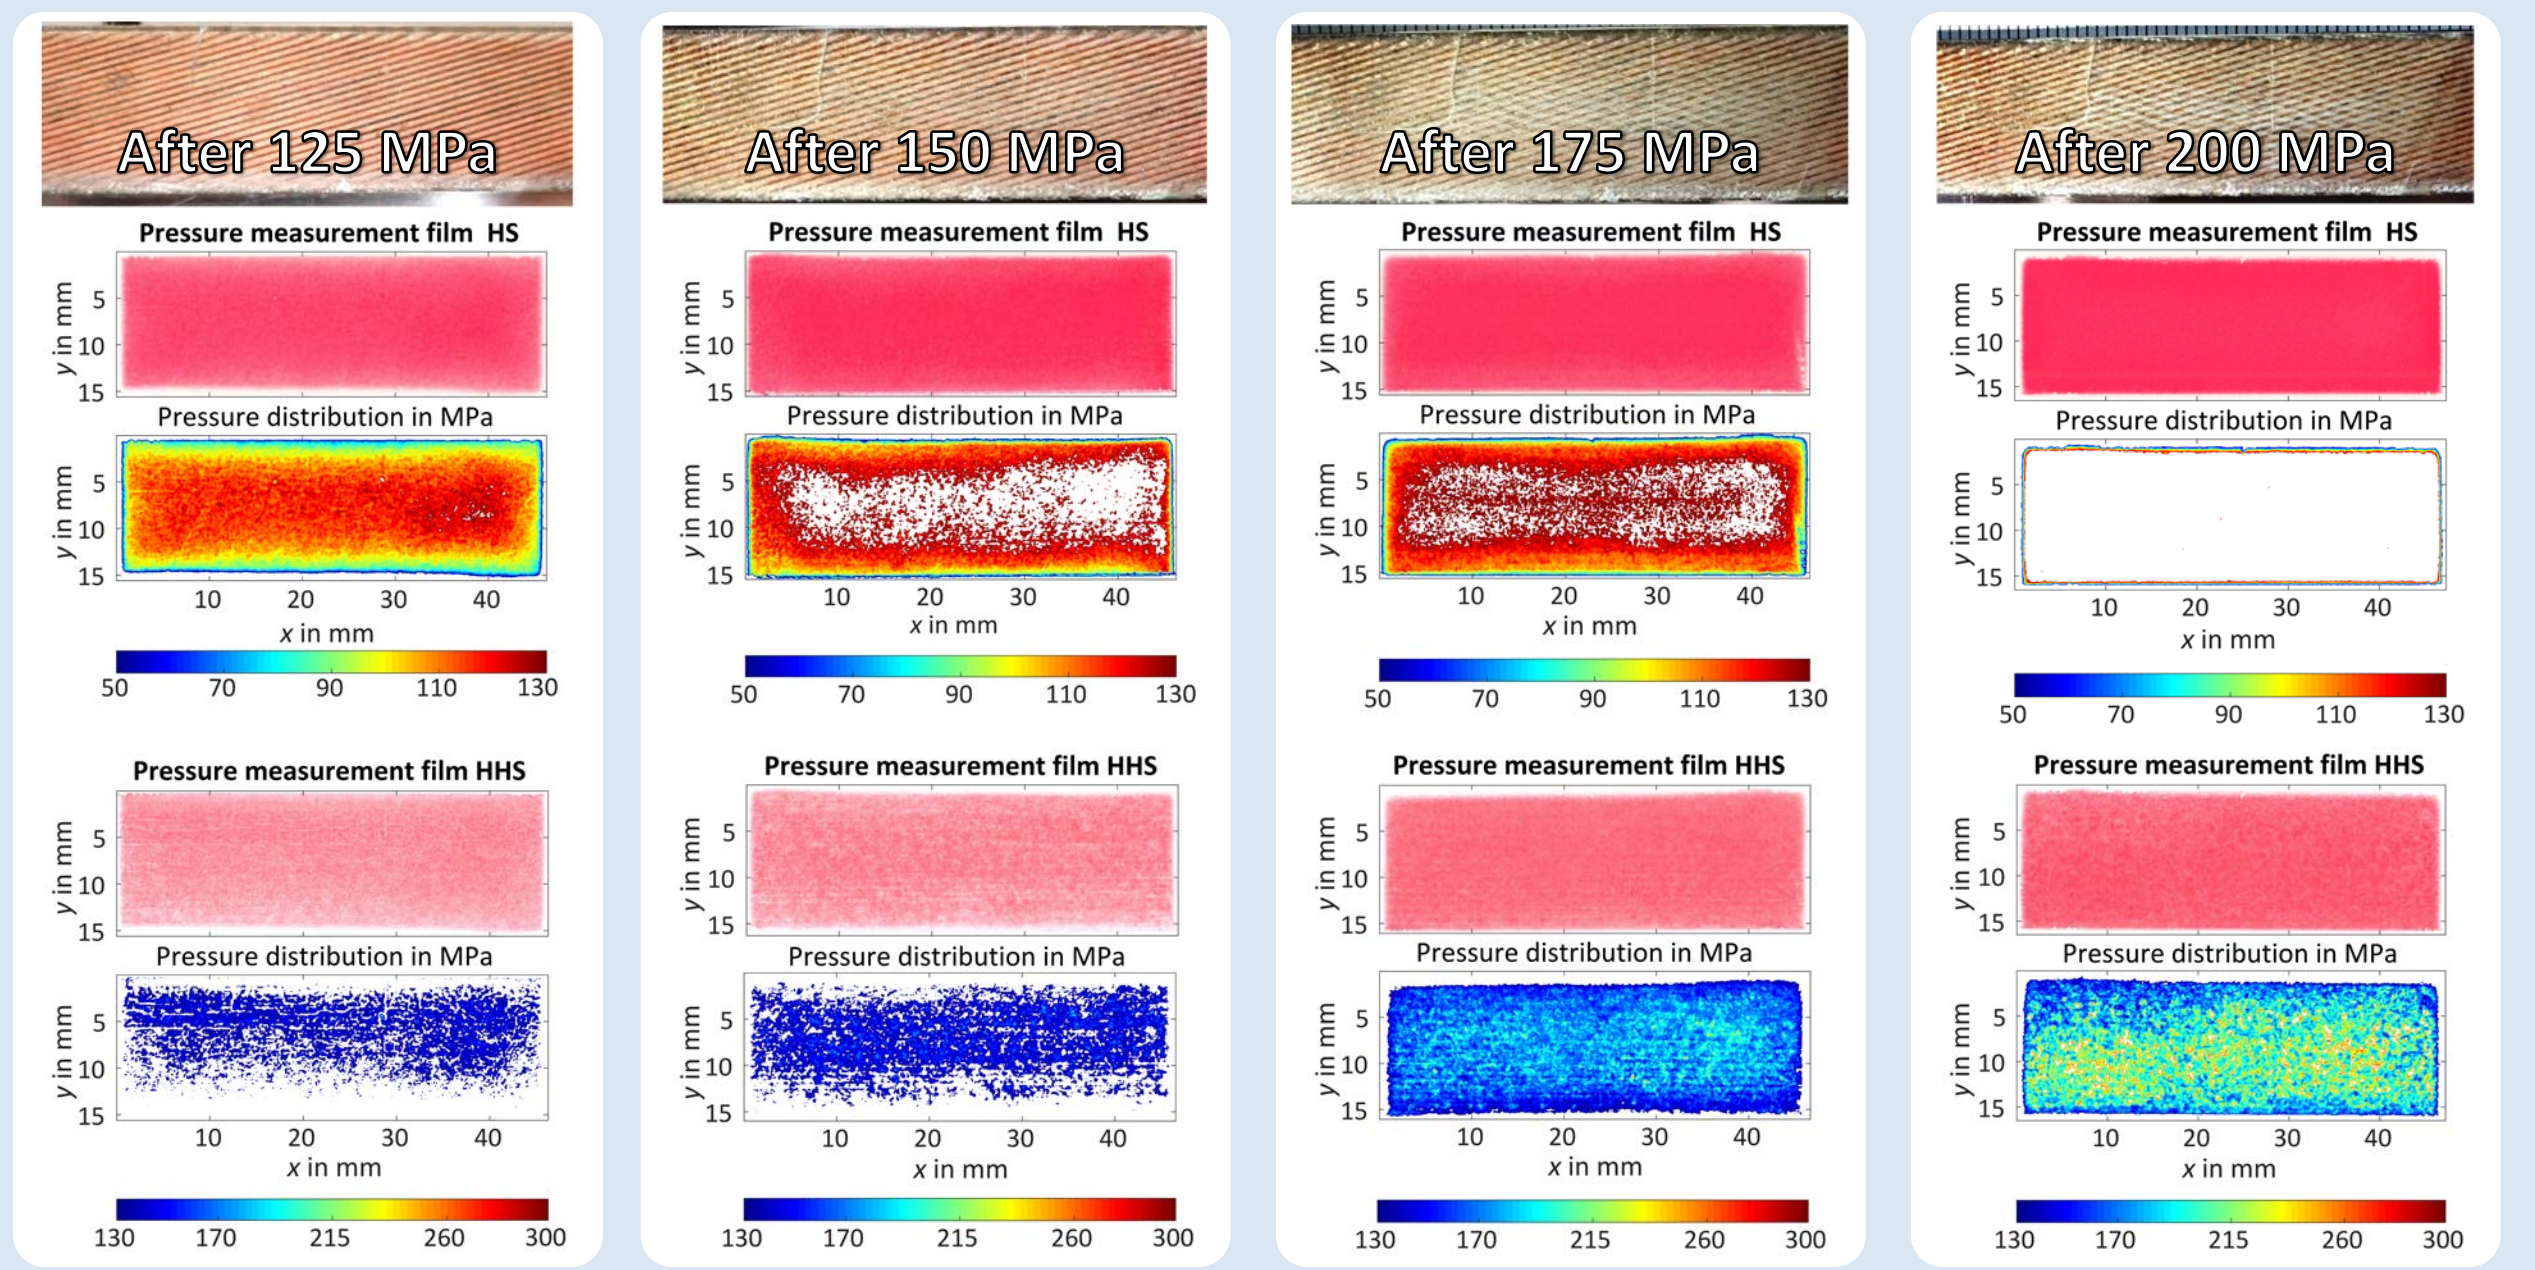
Stress application results			
Nominal	$\sum_{i=1}^4 F_{LoadCell,i}$	$\bar{\sigma}_{LoadCells}$	
kN	MPa	kN	MPa
68.64	100	68.93	100.42
85.80	125	85.24	124.18
102.96	150	103.00	150.06
120.12	175	118.00	171.91
137.28	200	137.90	200.90
