I_c survival of the delaminated coated conductor and its potential application in superconducting joint

Feng Feng¹, Qishu Fu¹, Hui Mu¹, Timing Qu^{*2}, Chen Gu³, Yubin Yue⁴, Zhenghe Han³

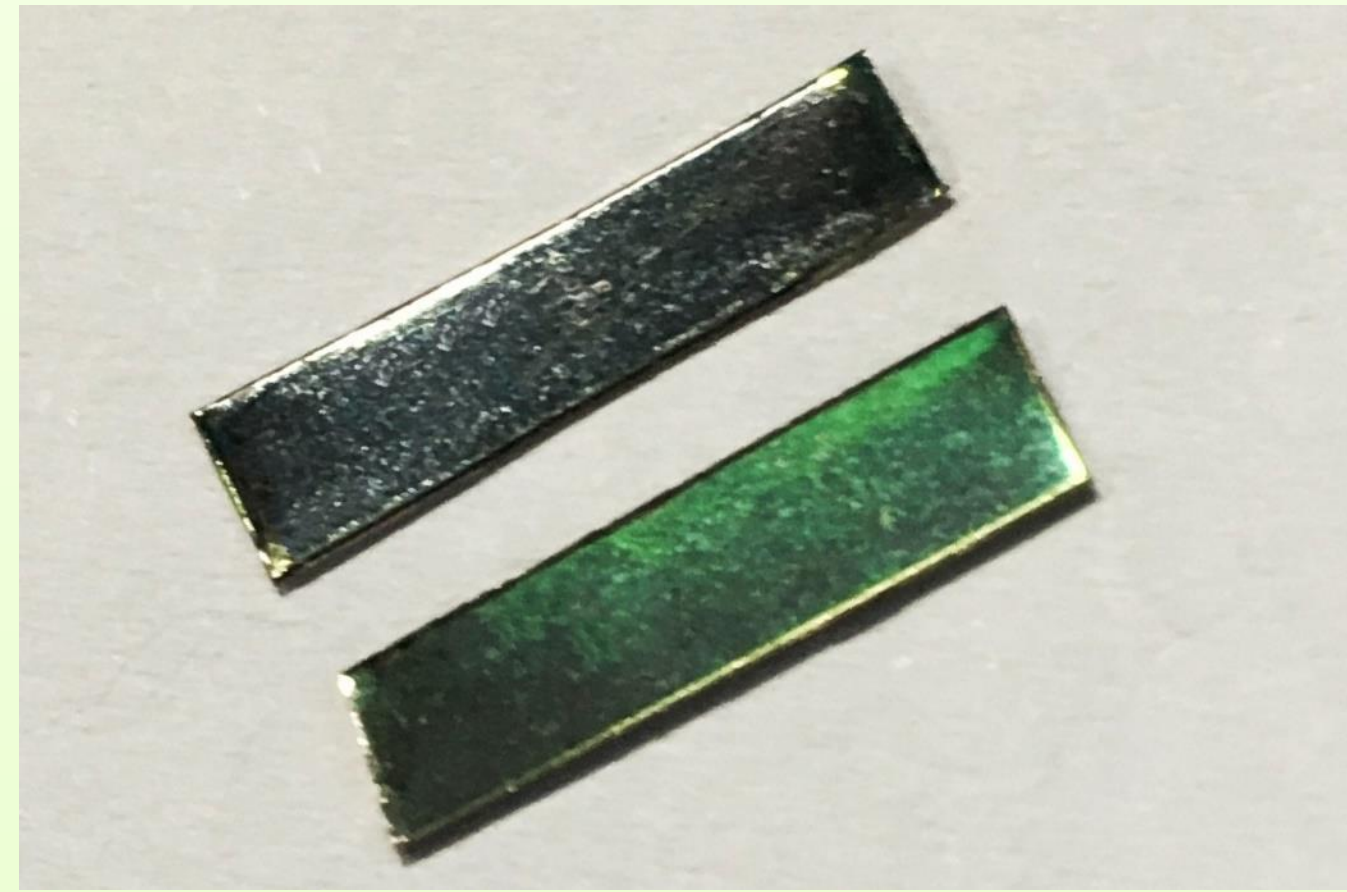
Delamination picture of a CC sample fabricated via MOD route after liquid nitrogen immersing. The upper one was the delaminated sample with YBCO layer, the other with buffer layer.

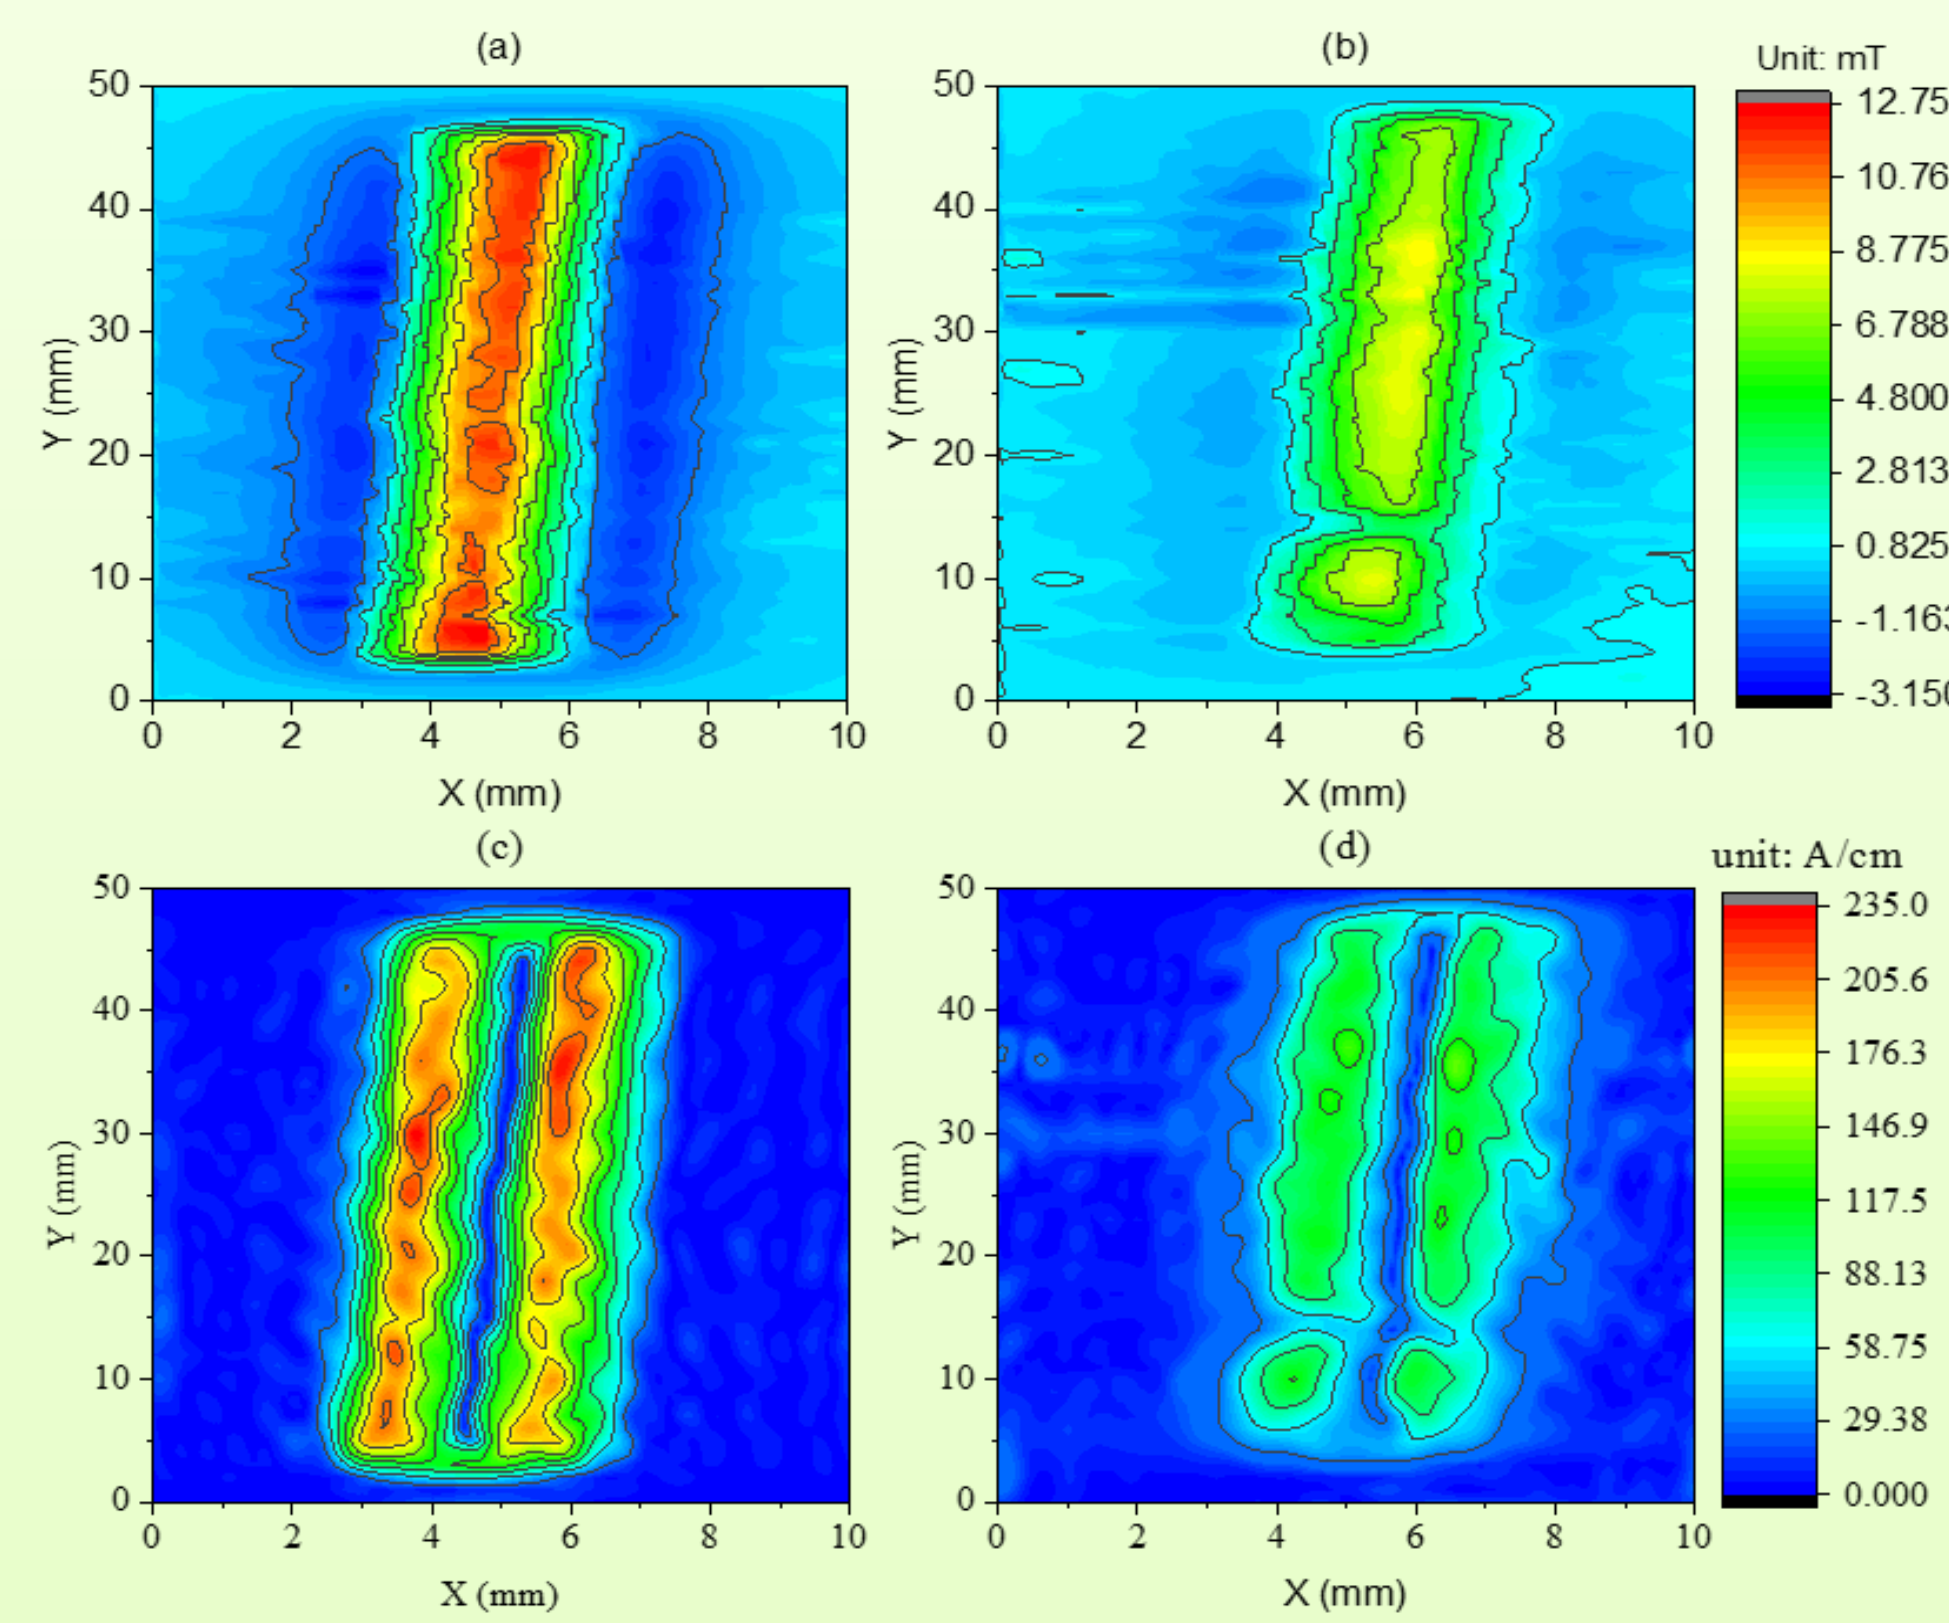
B distributions: (a) the original sample, (b) the delaminated sample. I_c distributions: (c) the original sample, (d) the delaminated sample.

- I_c could survive in the delaminated sample, with about 50% preserved percentage relative to the original sample. SEM and XRD indicated that delamination occurred inside the YBCO layer and near the YBCO-CeO₂ interface.
- In MOD-YBCO fabrication, BaCeO₃ could be formed easily, and the epitaxial relationship between BaCeO₃ and YBCO was not favorable. Therefore, the fact that delamination occurred near the YBCO-CeO₂ interface might be attributed to the degraded adhering strength caused by BaCeO₃.
- Silver owned a oxygen diffusion coefficient of 10^{-6} cm²/s at 450~600° C (a typical temperature range for the oxygenation process of YBCO), which is much larger than YBCO (typically 10^{-14} cm²/s in c -axial direction).
- The delamination behavior of CC might be a beneficial factor with new application potential.

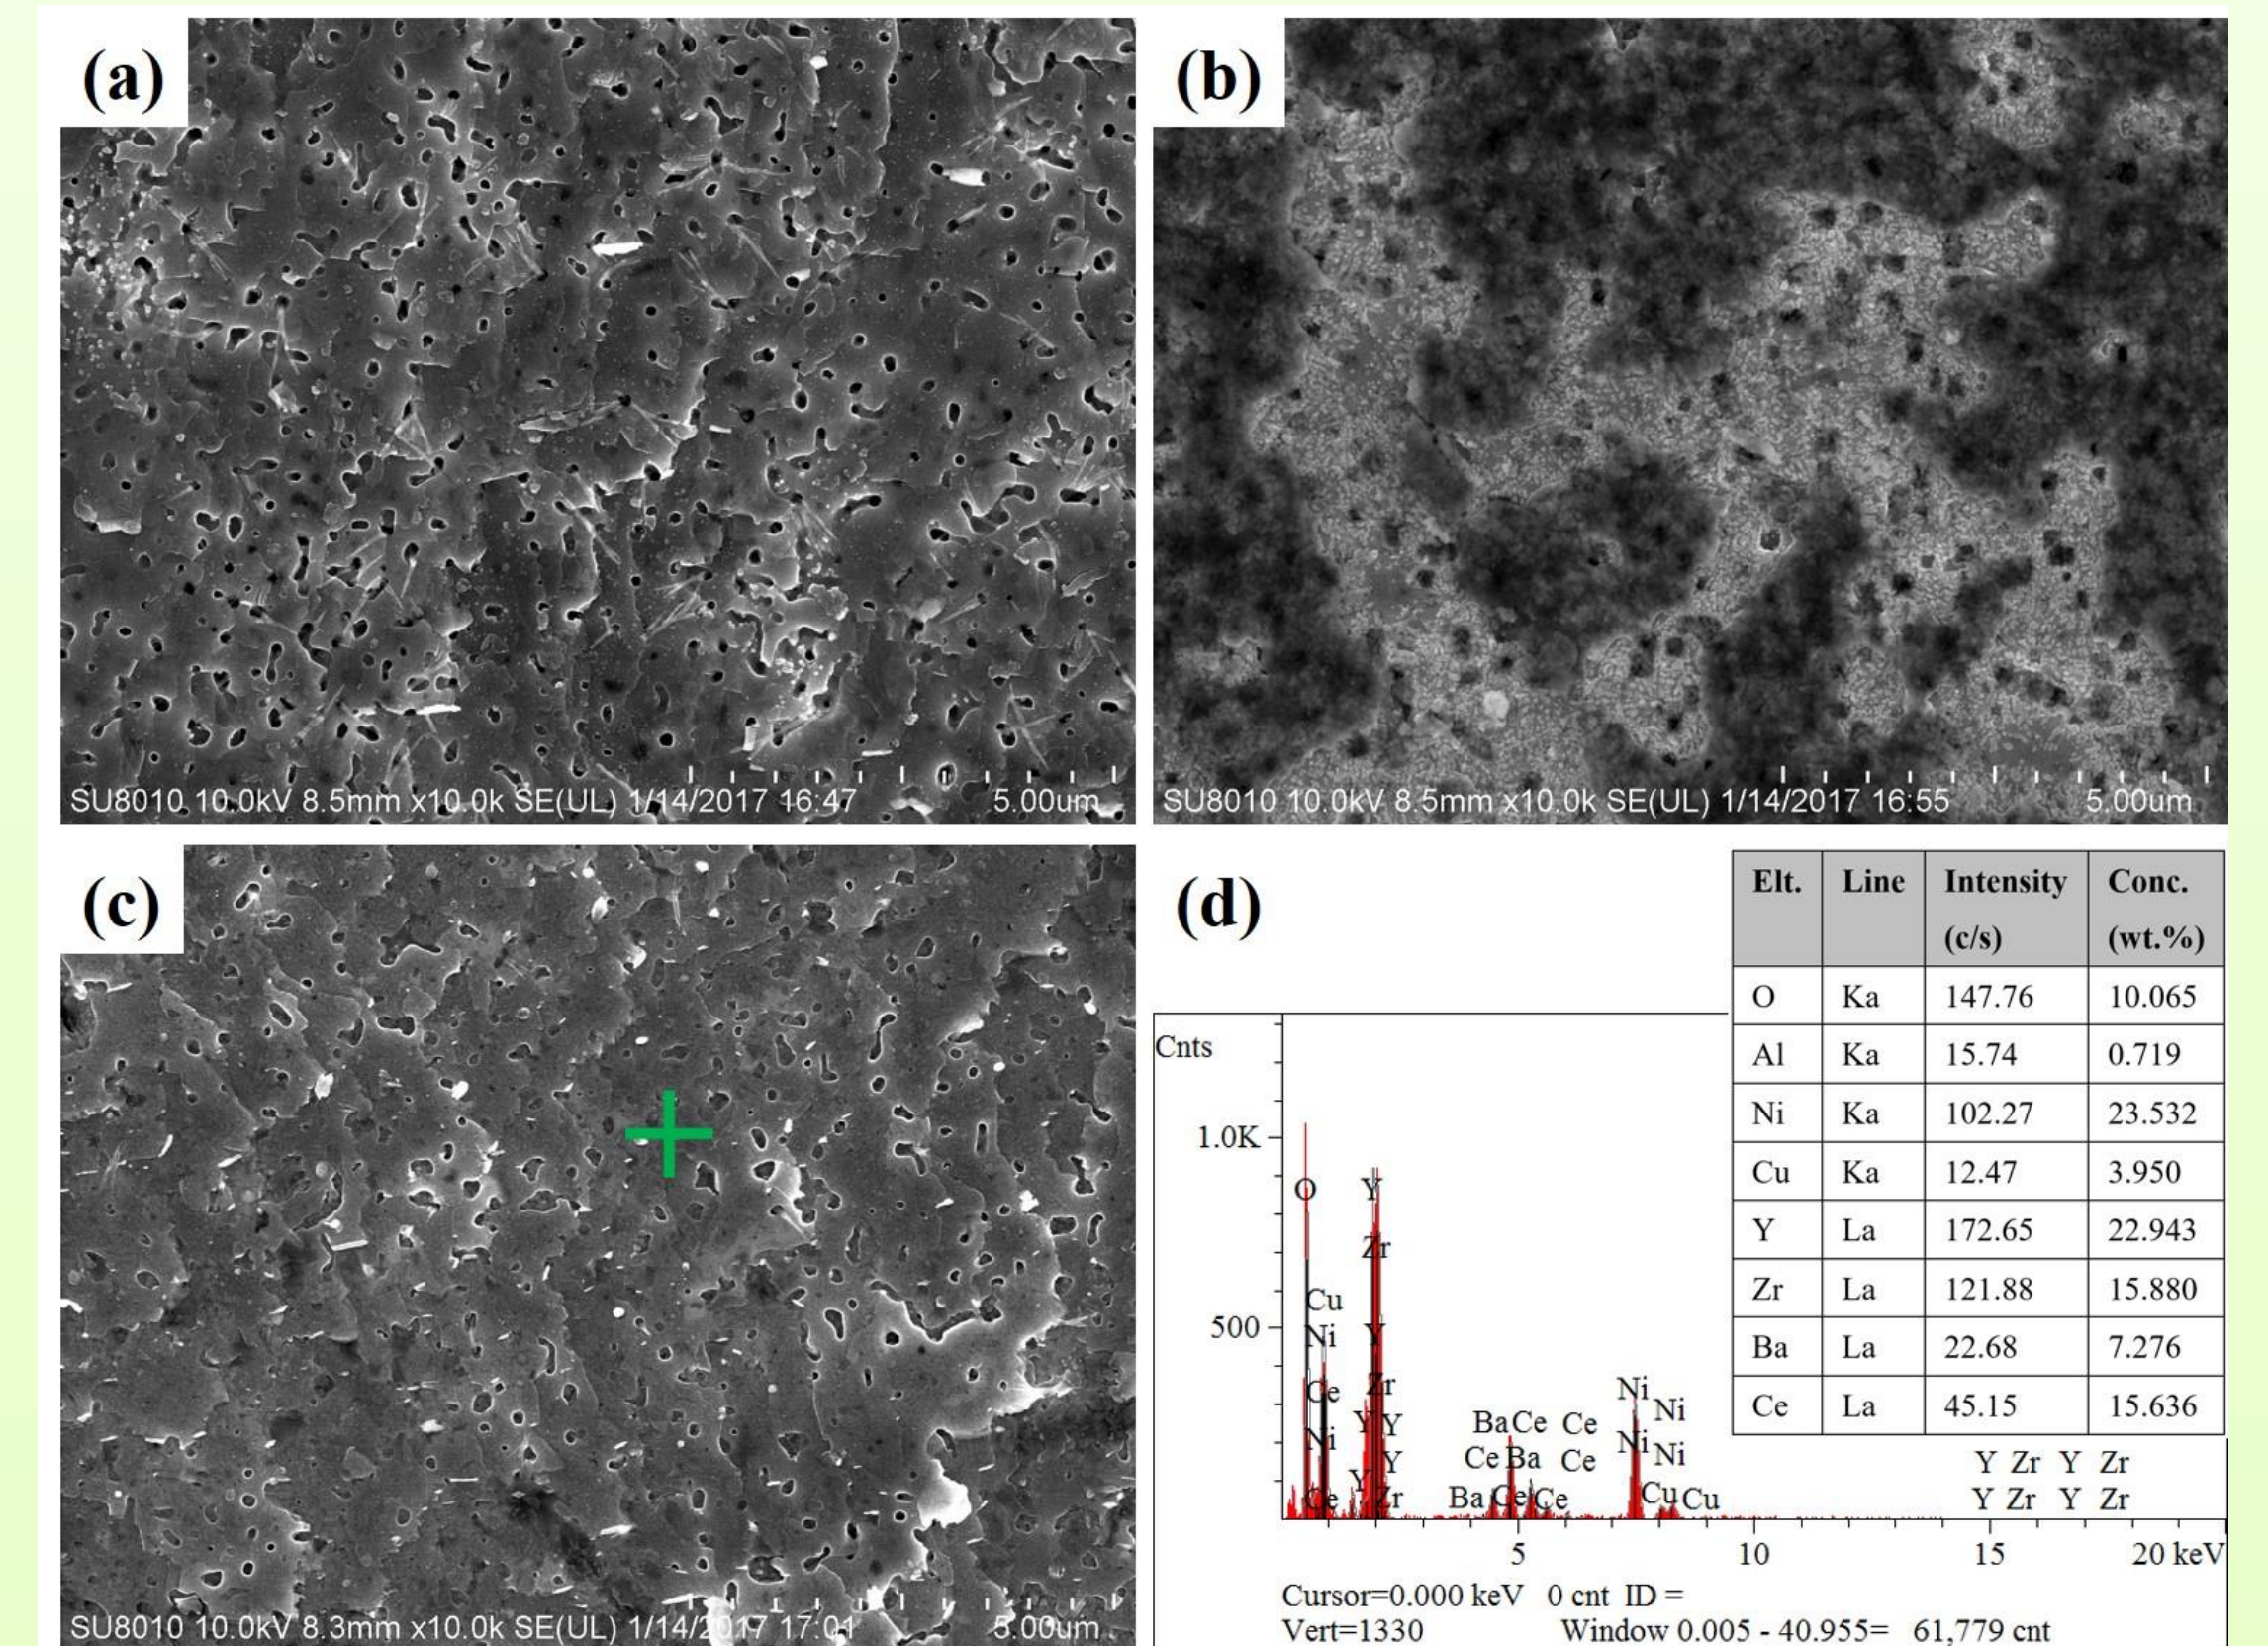
SEM images: (a) zone with preserved I_c , (b) zone with zero I_c of delaminated sample, (c) the delaminated part with buffer layers, (d) EDS result at the cross position.

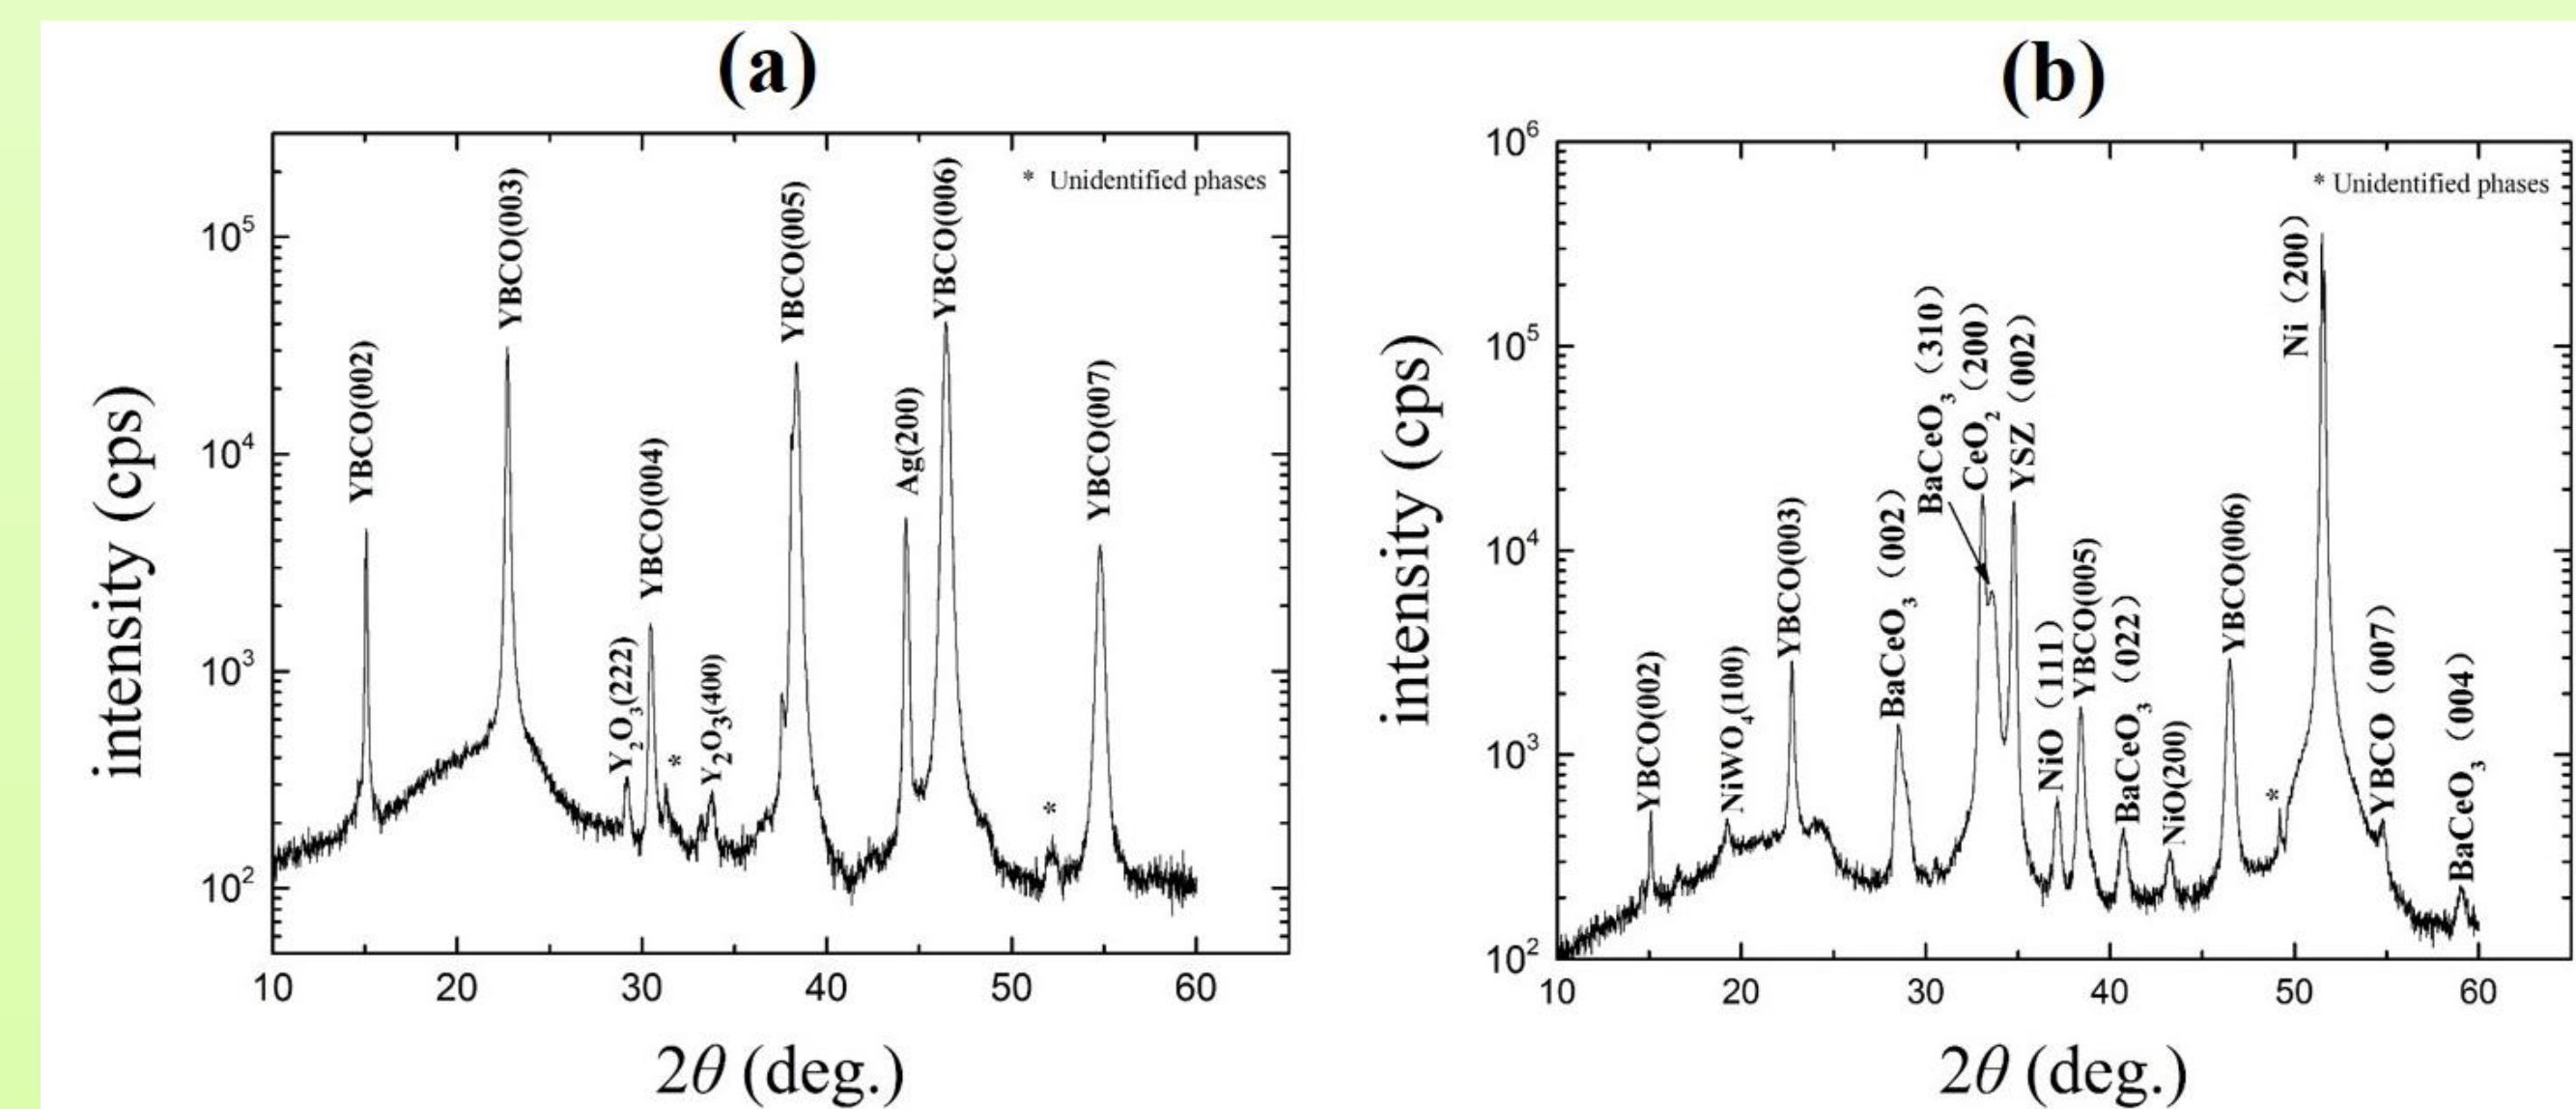
XRD patterns: (a) the delaminated sample with YBCO layer, (b) the delaminated part with buffer layers.
