STATUS OF MEDIPIX-3, PLANS FOR TIMEPIX-2

X. Llopart

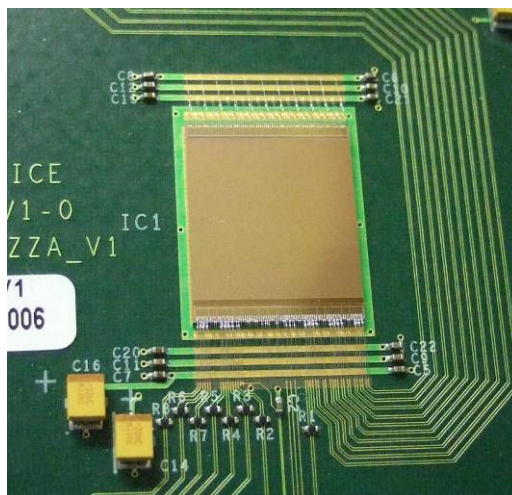
Medipix 3 - reminder

- Medipix3 builds on the success of Medipix2 as a single photon counting imaging chip
- Added Features
 - Analogue charge summing to keep all charge information
 - Spectroscopic mode with 8 threshold levels
 - Continuous readout mode (no dead time)
 - Increased counter depth increasing dynamic range
 - Increased readout speed
 - Increased radiation hardness from 130nm CMOS process

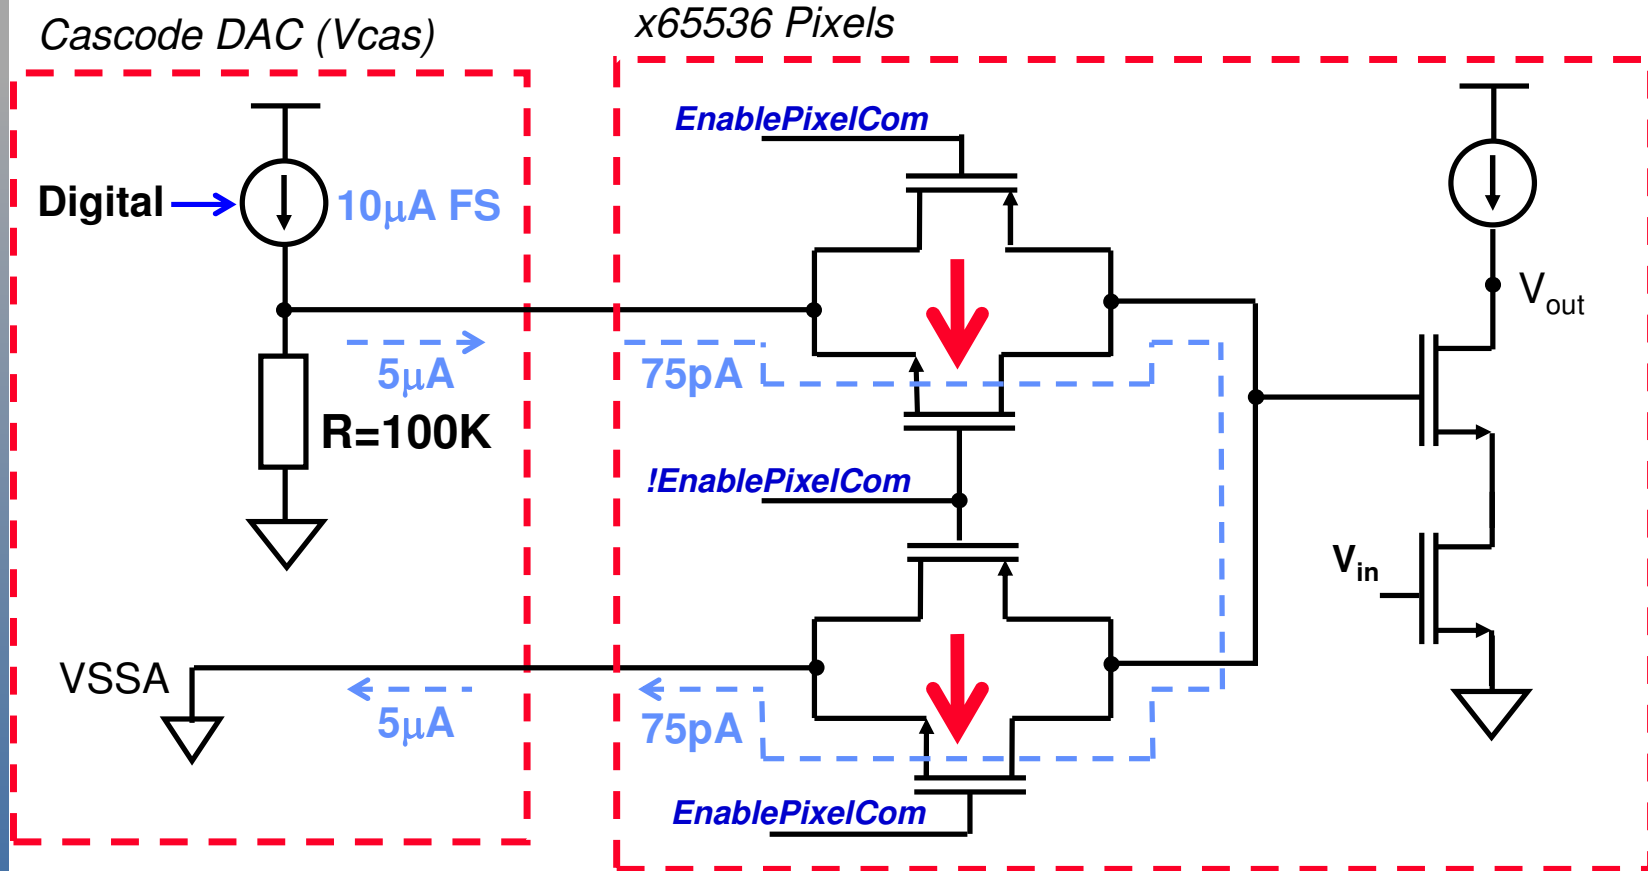
The “analog switches” (problem)

Due to radiation and temperature an increase in the leakage current of NMOS transistors is observed

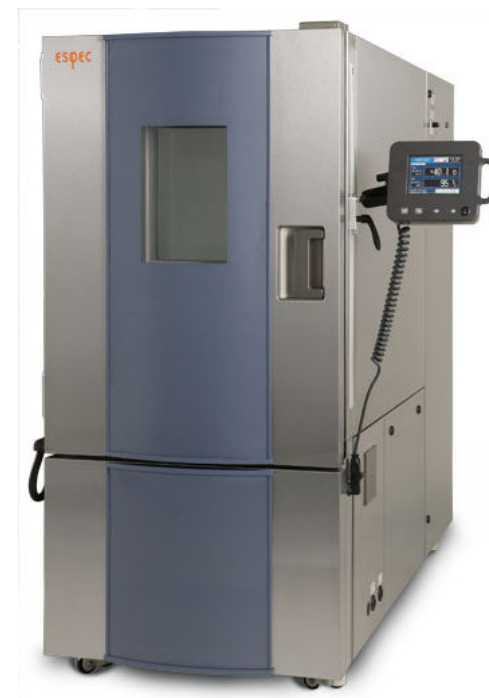
Temperature Measurements Setup

- The Medipix3 has an on-chip temperature sensor in the chip periphery
- At CERN we have available the Climatic Chamber ESPEC EGNX12-6CWL (-70 °C to +180 °C)
- Measurements covered the -60 °C to 60 °C range

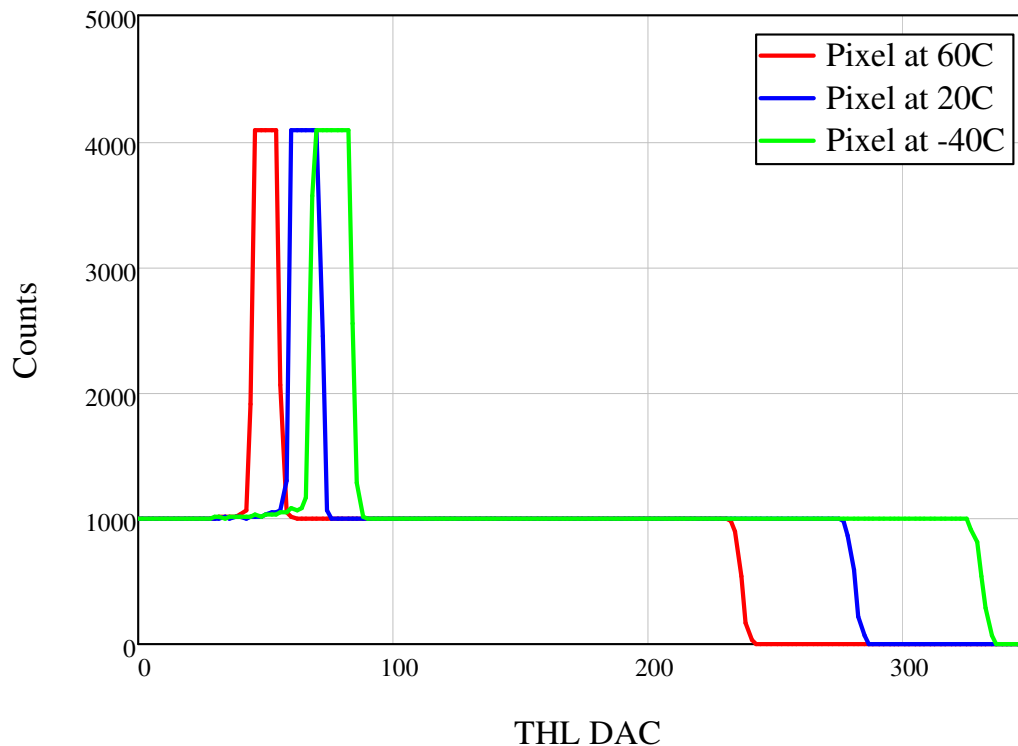
Temperature effects in one pixel

- The chip is operational in all the studied temperature range
- But, we observe variations on the noise, threshold position and gain

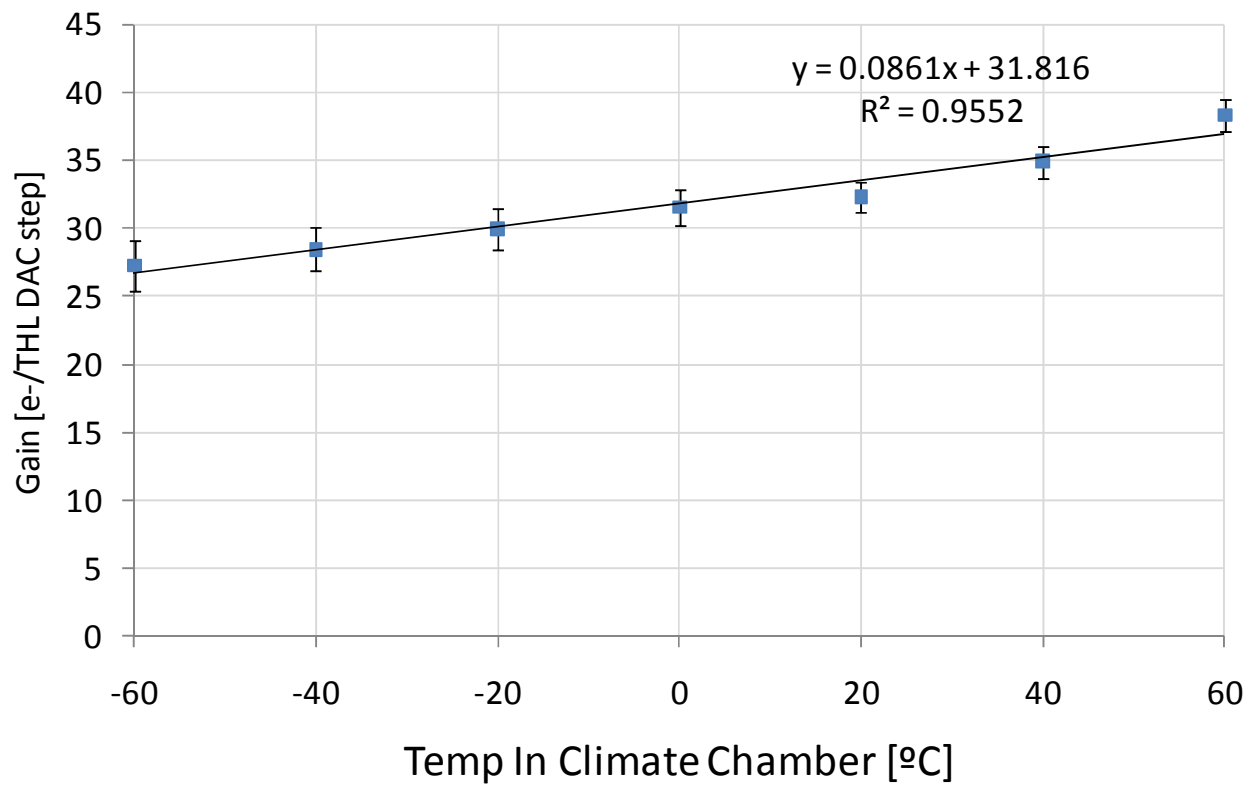
Pixel to pixel gain variation

- Gain variation (0.086 e-/THL DAC step) is due to the Medipix3 shaper stage

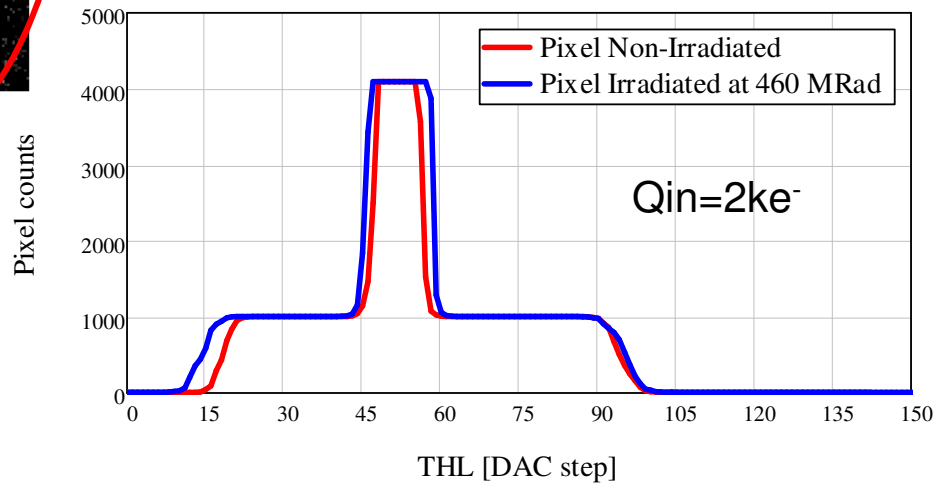
Performance after 460MRad

After 460MRad there is essentially no gain variation observed

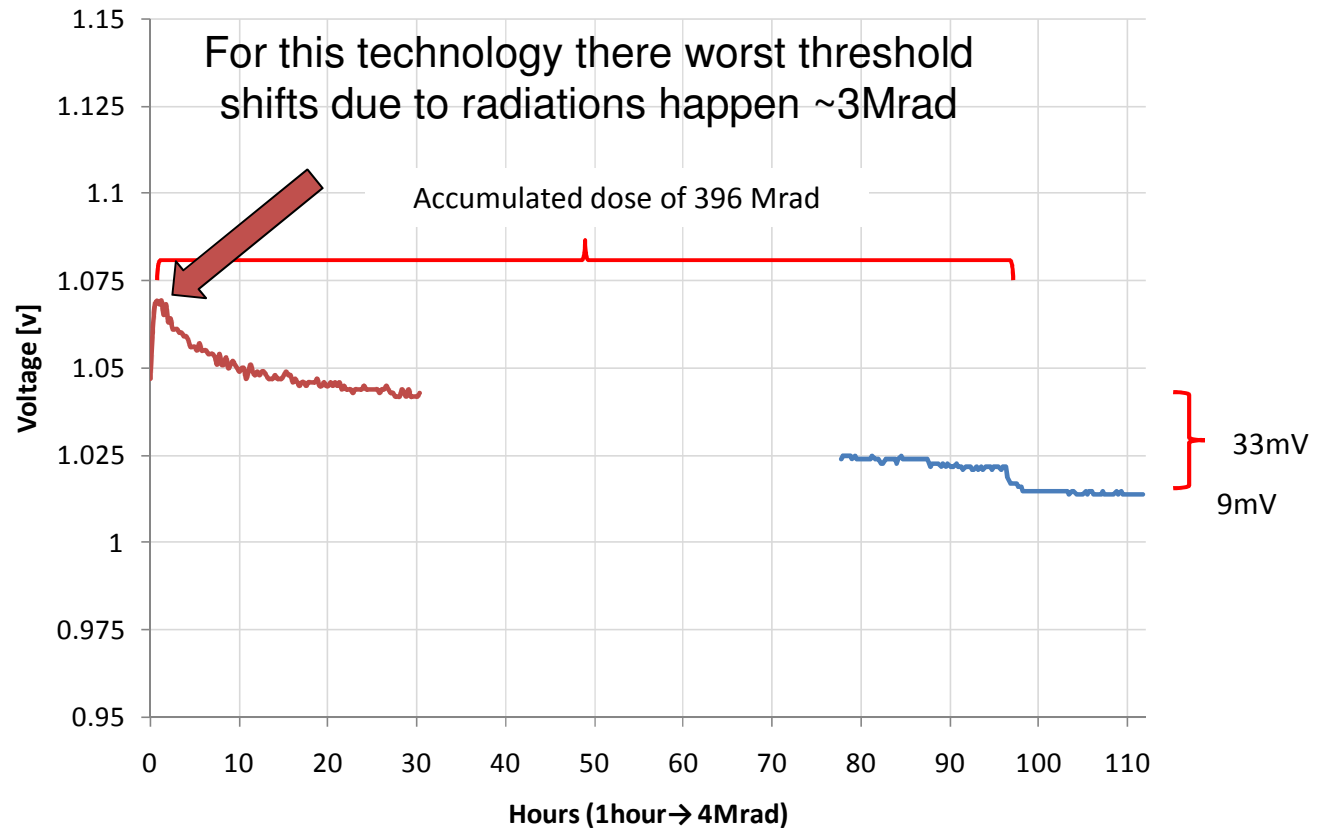
DAC Measurement

NMOS DAC (Preamp) PMOS DAC Gap

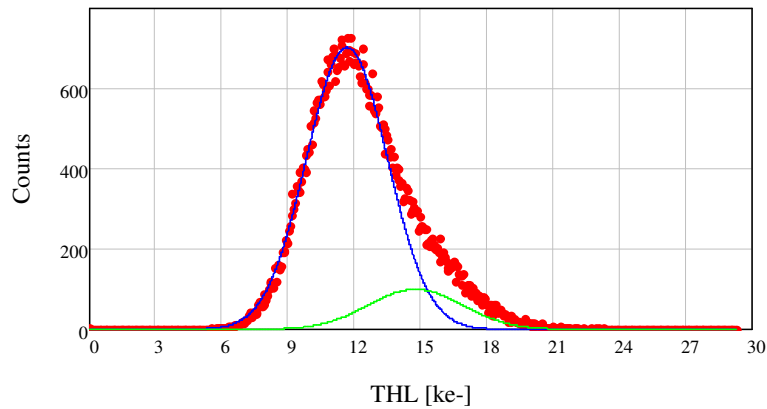
Threshold

General behavior after 3 Mrad

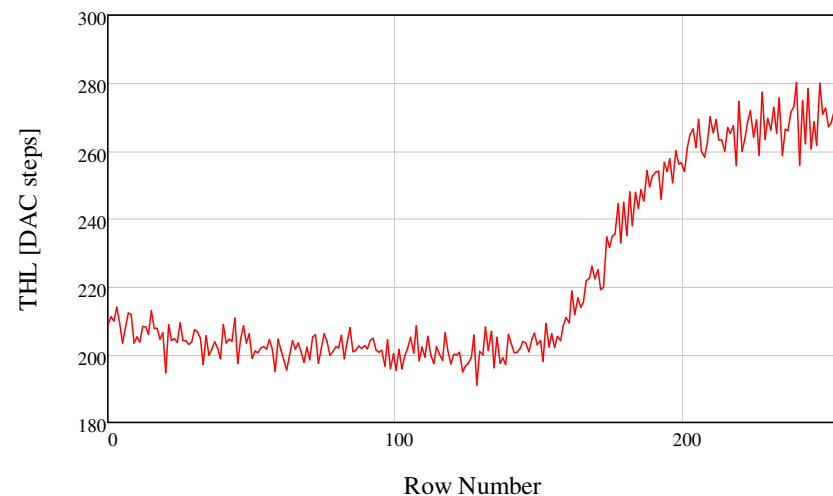
Overall threshold position variation

Main contributor is the protection diode. In order to minimize the pixel to pixel threshold variation I_{krum} is set to 16nA which indicated that the leakage of this diode at 3Mrad is ~5 to 10 nA. This is the worst radiation operation point.

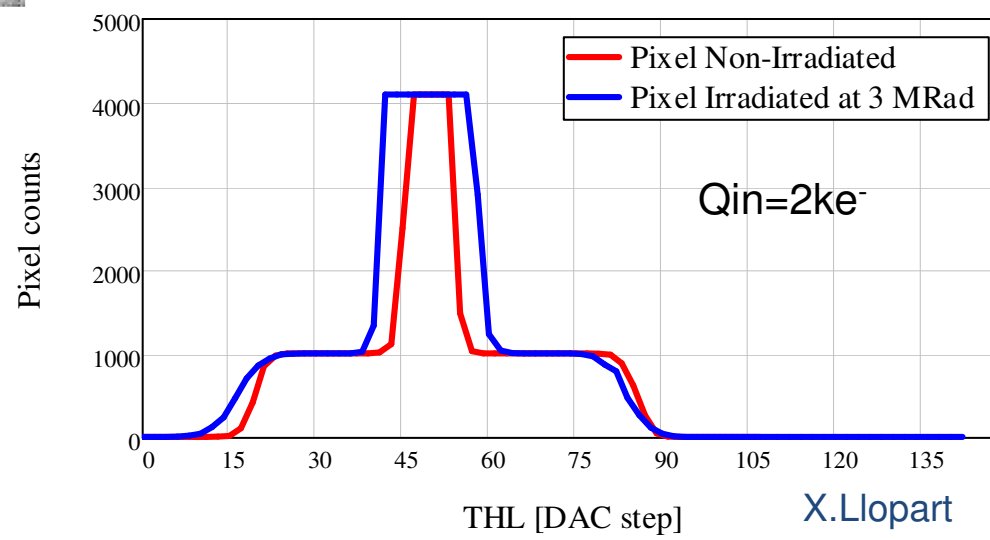
3MRad Noise and Gain Result

In this worst case situation the noise is still less than 100e⁻ and the gain variation is still minimal
