Industrial Production of ATLAS Micromegas Readout Boards

Status, Issues and Solutions

RD51 Collaboration Meeting
September 28 2017

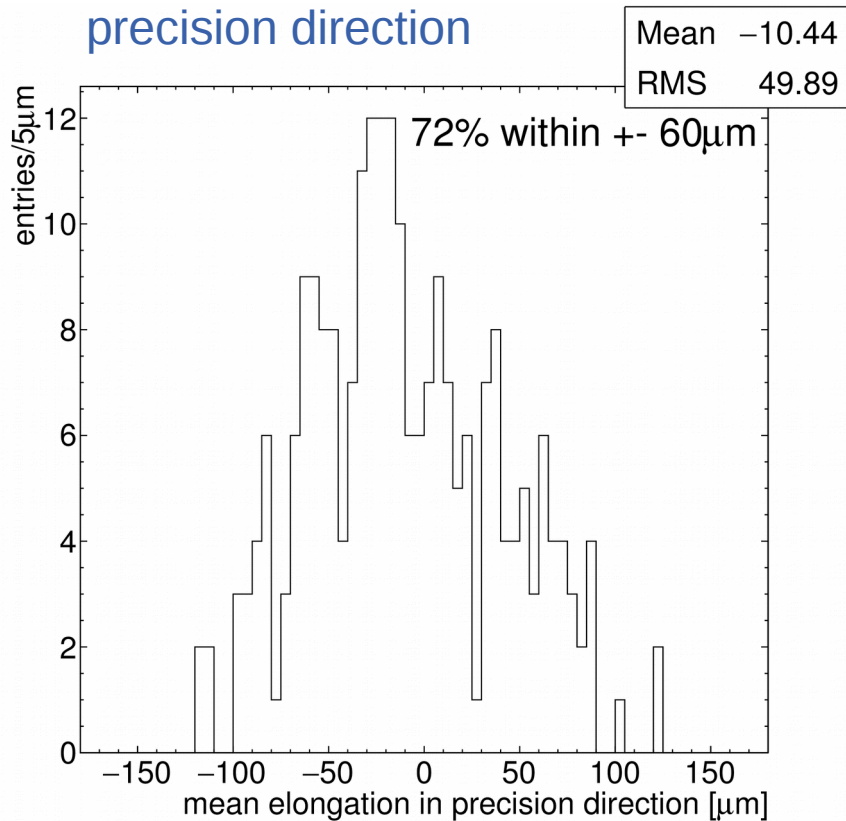
precision direction

measured with special cameras (Brandeis contact-CCDs) at defined positions on granite table

- setup accuracy $\sim 25\mu\text{m}$
 - humidity in QC lab not controllable (up to $150\mu\text{m}/\text{m}$ increase for 20% RH increase)
 - not all boards fully expanded during QC
- measurements indicative: **good board accuracy in precision direction**
well tolerable accuracy in strip direction (only mechanical constraints)

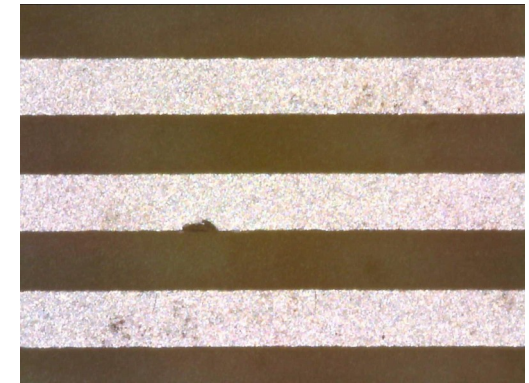
- microscope picture of Zebra footprint, automatically analyzed

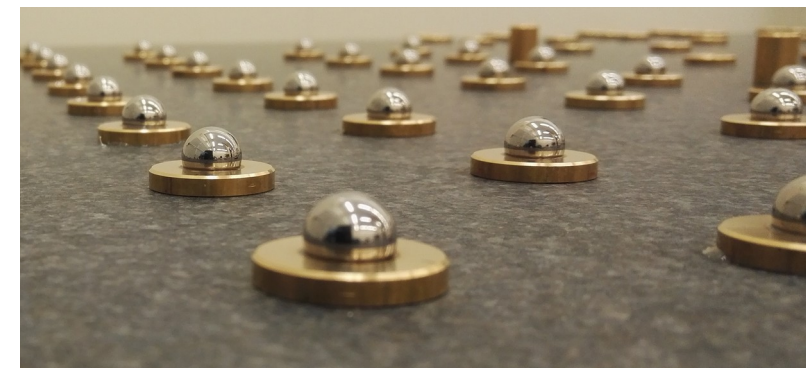
- registration of strip position in center + rasmasks
- nine contact CCDs on granite table
- surveyors resting on pairs of precision spheres $O(30\mu\text{m})$, glued onto table
- fast measurement and analysis with custom GUI with direct interface to QC form (Pavia, Tokyo)
- flexible configuration

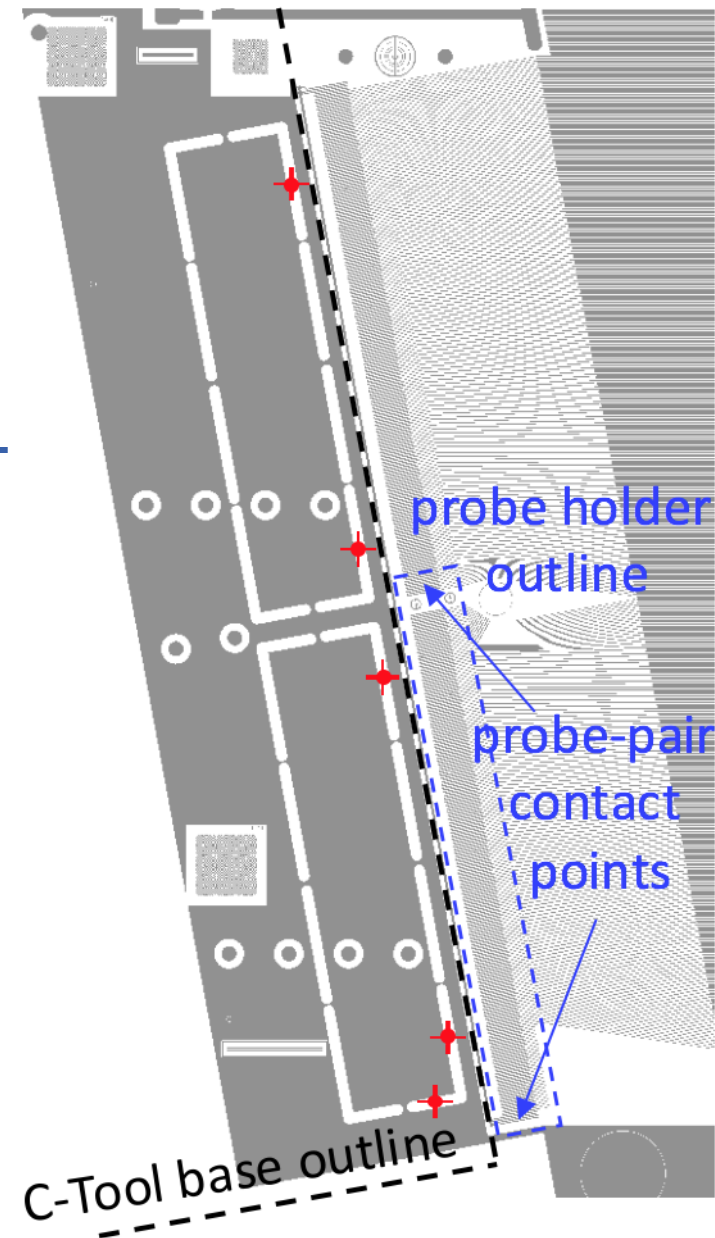
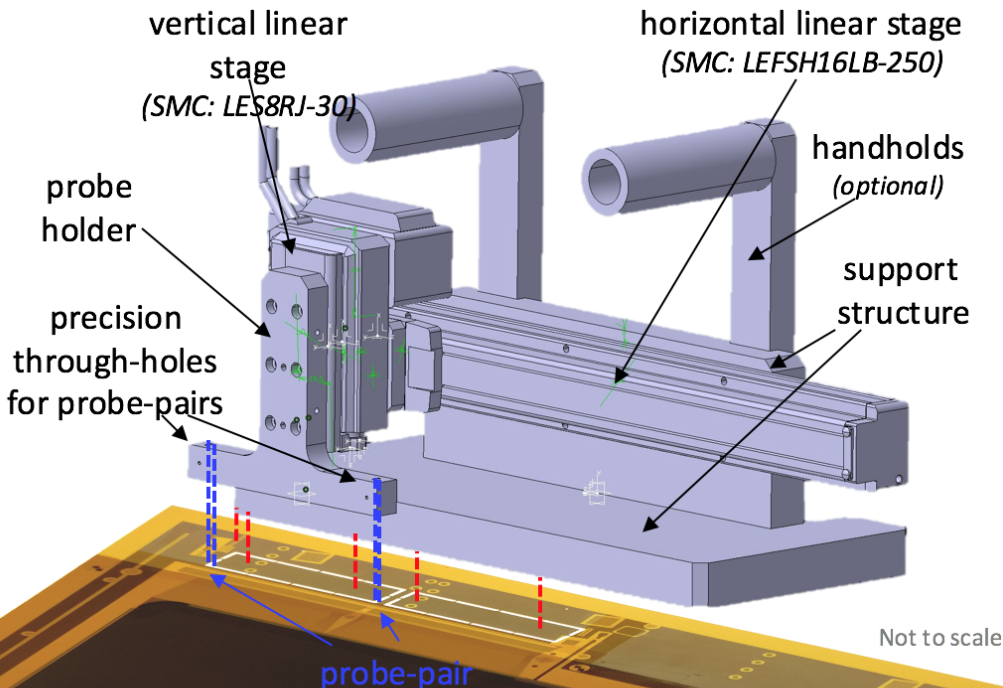
capacitance of neighboring strips measured

→ 1.15pF/cm for SM1 & SM2

→ 0.8pF/cm for LM1 & LM2

→ **tool for automatic measurement of C between neighboring strips with known length** → interruptions & shorts
