153<sup>rd</sup> MPP meeting

# Oxidation behavior of graphite in air at high temperature

A. Perillo-Marcone, M. Calviani (EN-STI-TCD)

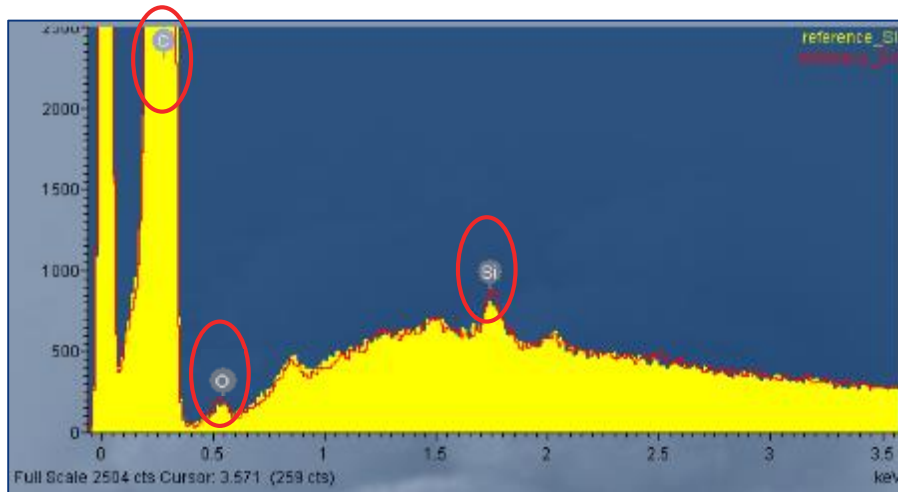
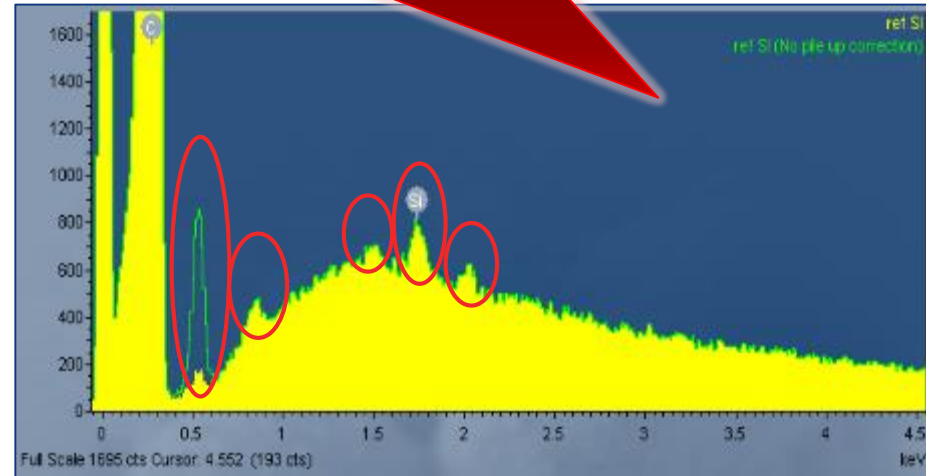
# EDS – Sigraflex as received

Presence and quantification of O cannot be 100% ensured

- Peak of C, O, Si
- Similar Chemical Analysis

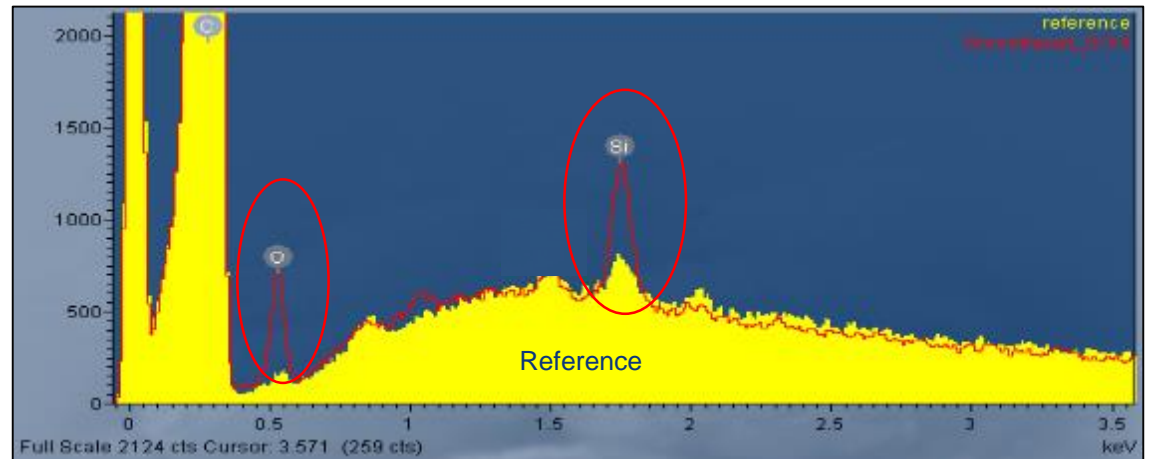
# EDS – Sigraflex after impact

Higher amount of O and Si

Common features in all Sigraflex samples

- Higher amount of O and Si
- Presence of pollution → probably due to manipulation

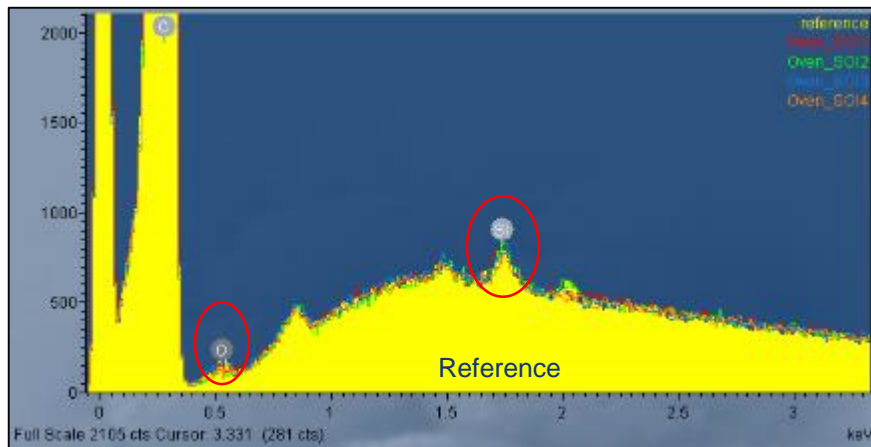
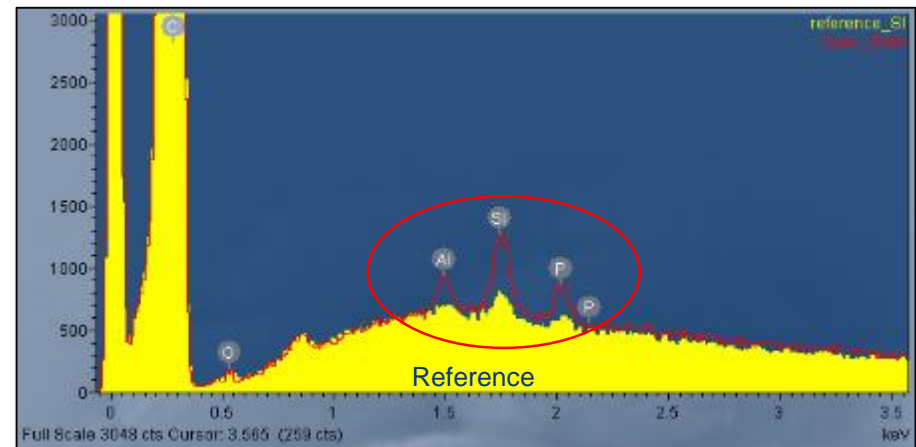
# EDS – Sigraflex

No changes in Si and O content

Pollution: Al, Si, P

- Amount of O and Si keeps constant before and after the study

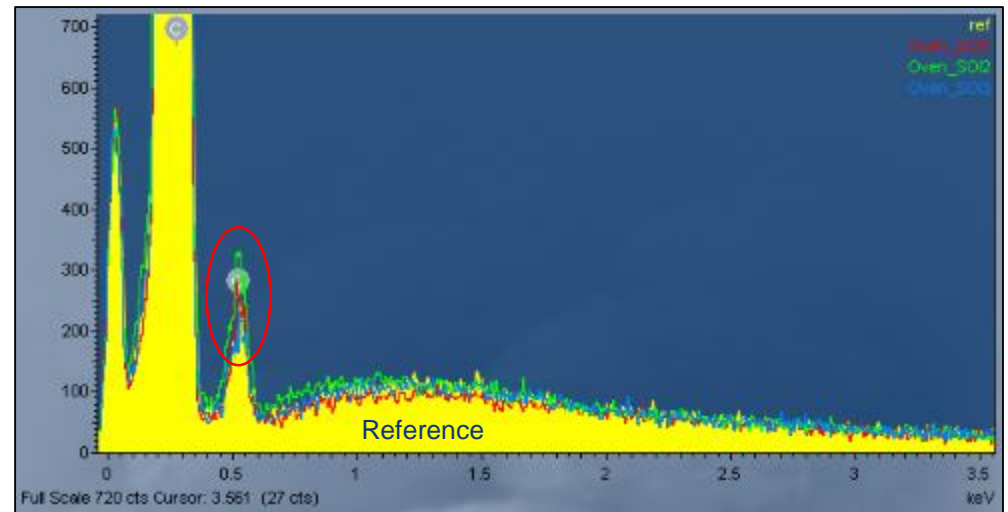
# EDS – Sigrafine

Same amount of O
