Intervention on T600 cathode panels at FNAL

A. Zani - CERN - 18/10/2017

Report on the intervention on cathode panels

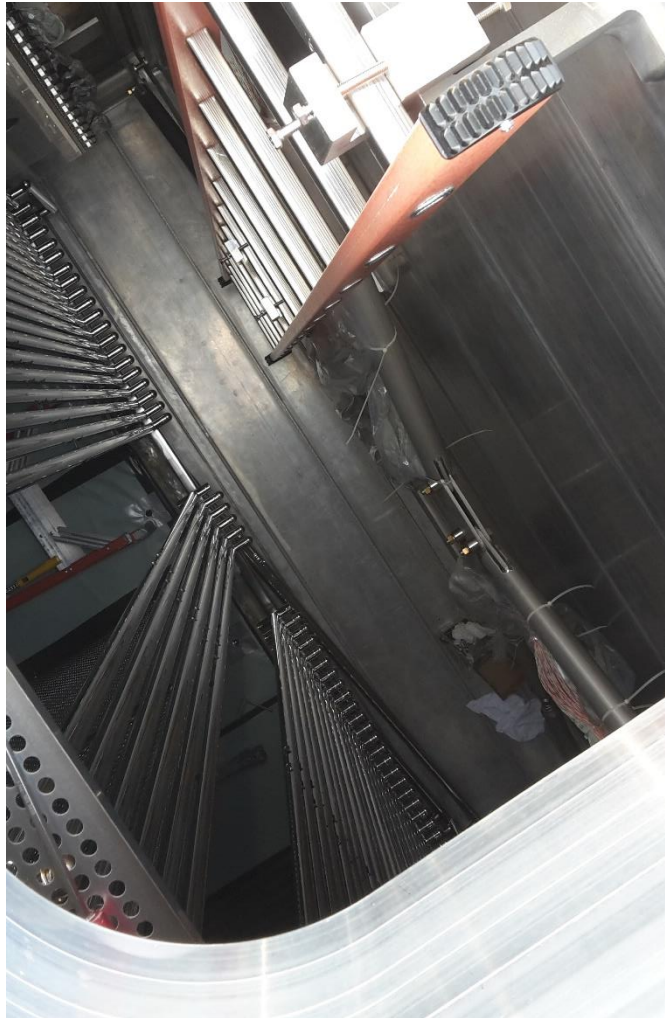
View from the man-hole of the race-tracks removed to access the drift volume.

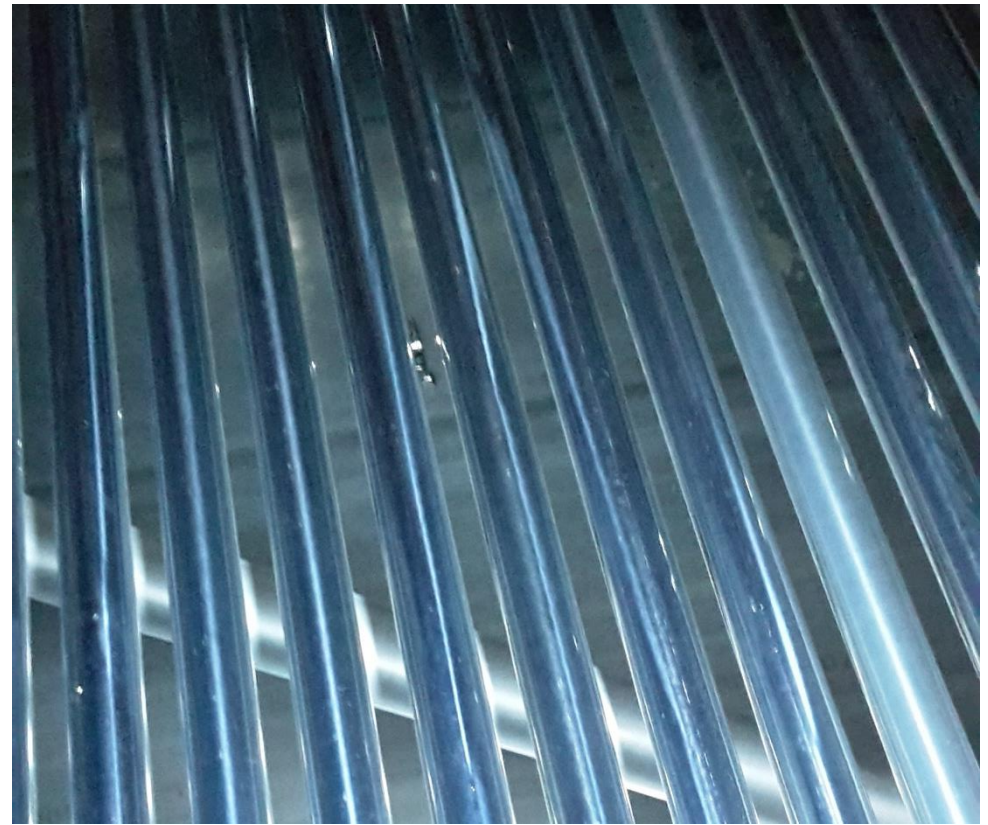
Example of a screw fallen through the horizontal race-tracks to the vessel floor:

- recovered with grabbers*

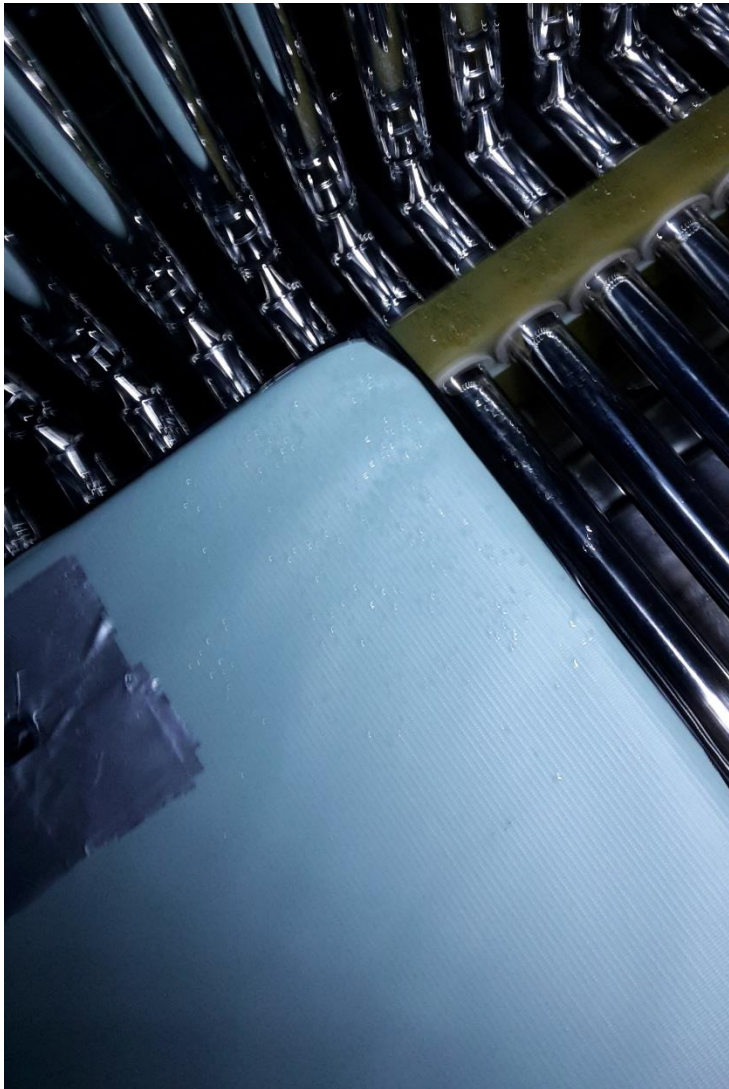
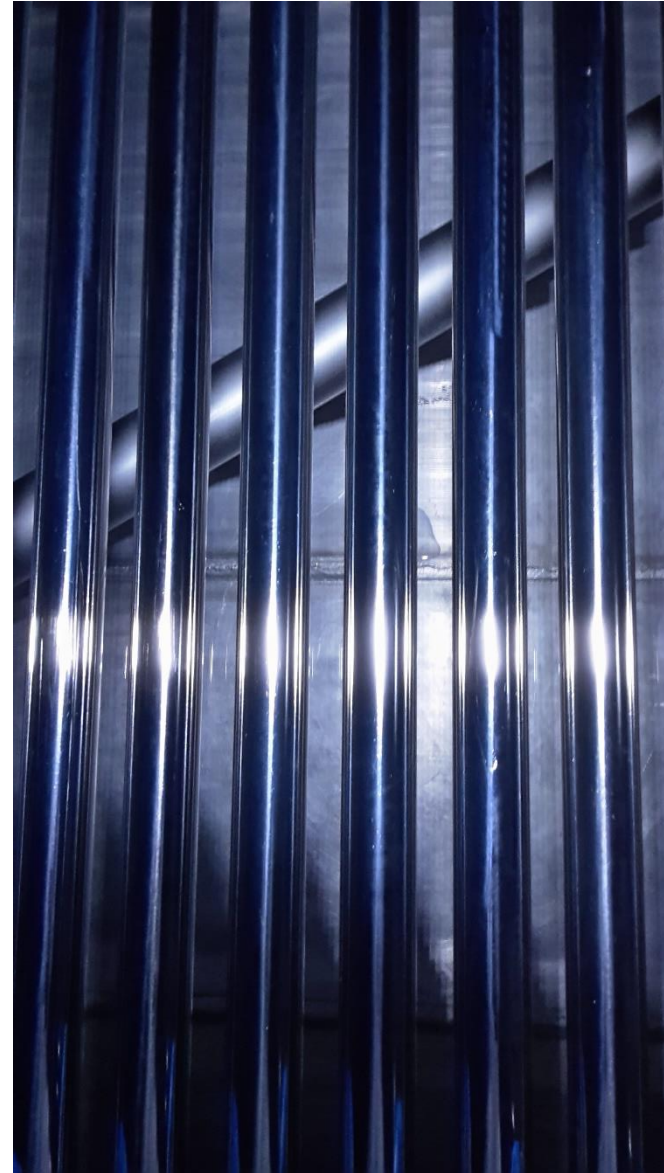
Water leak

A more significant problem was found on vessel #2 on Thursday the 12th : water on the floor of the container, in three points along the detector length.

- Water was absent on the first inspection on Monday 9th.
- Heavy rain on Tuesday 10th (and Wed. 11th)
- Rain filtered into the container due to a failure in the cover of one door (most probably due to previous episodes of bad weather)
 - **SOLVED**: the detector floor was dried and cleaned in two days, and new covers were installed on both doors of the two cryostats.
 - New covers "heavily tested" by very intense rain in the Chicago area on Saturday 14th: → on Sunday the detector was perfectly dry.

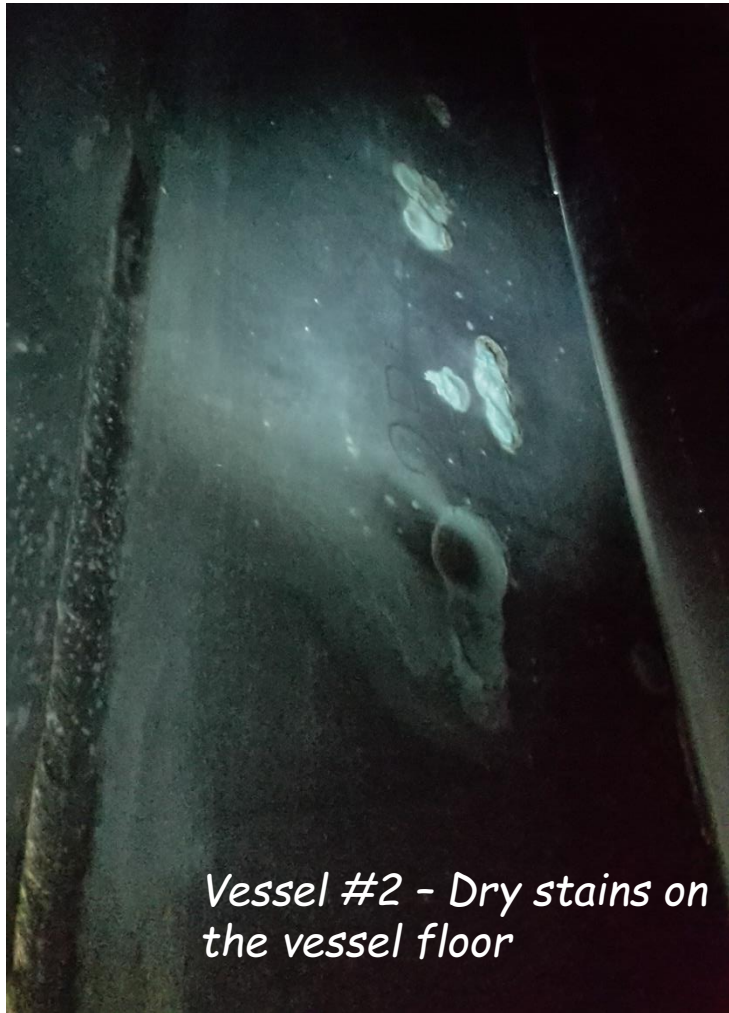
The soap for the cathode panels cleaning could not be entirely removed before installation, because it was unreachable. It remained in the frames of the panels. It came out due to bumps during the transport.

Vessel #2 - Dry stains on the vessel floor

Soap cannot be removed with alcool. It should not pose any threat, but it will be cross-checked in LAr at CERN.

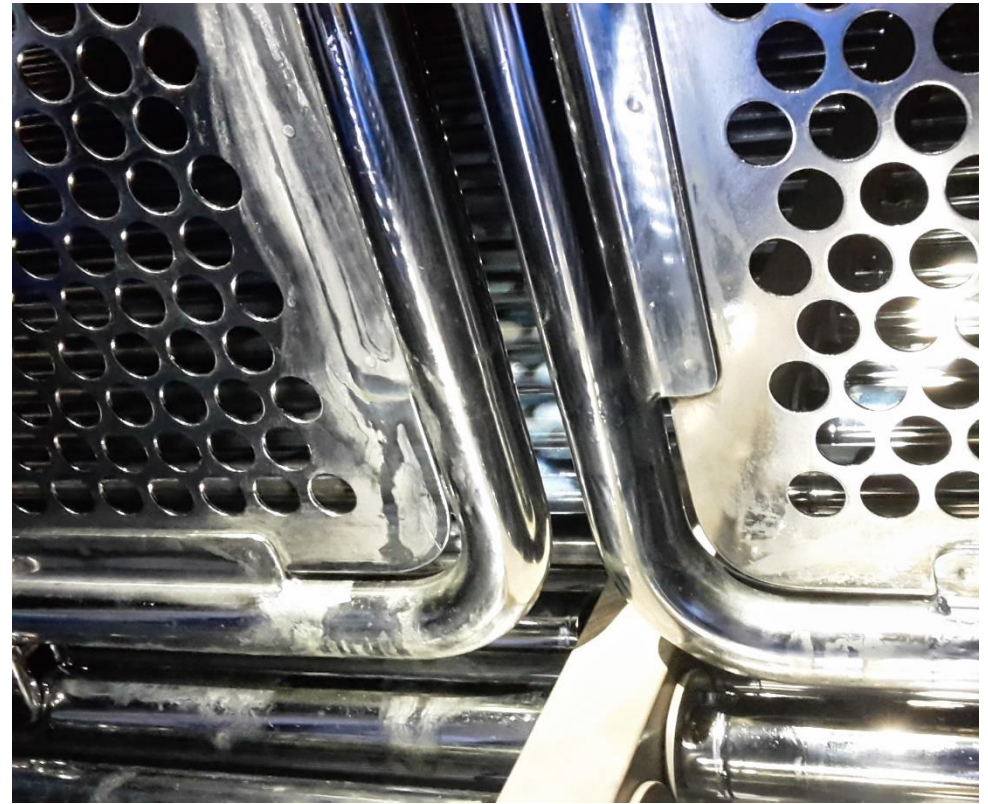
Vessel #1 - Dry stains on the panels

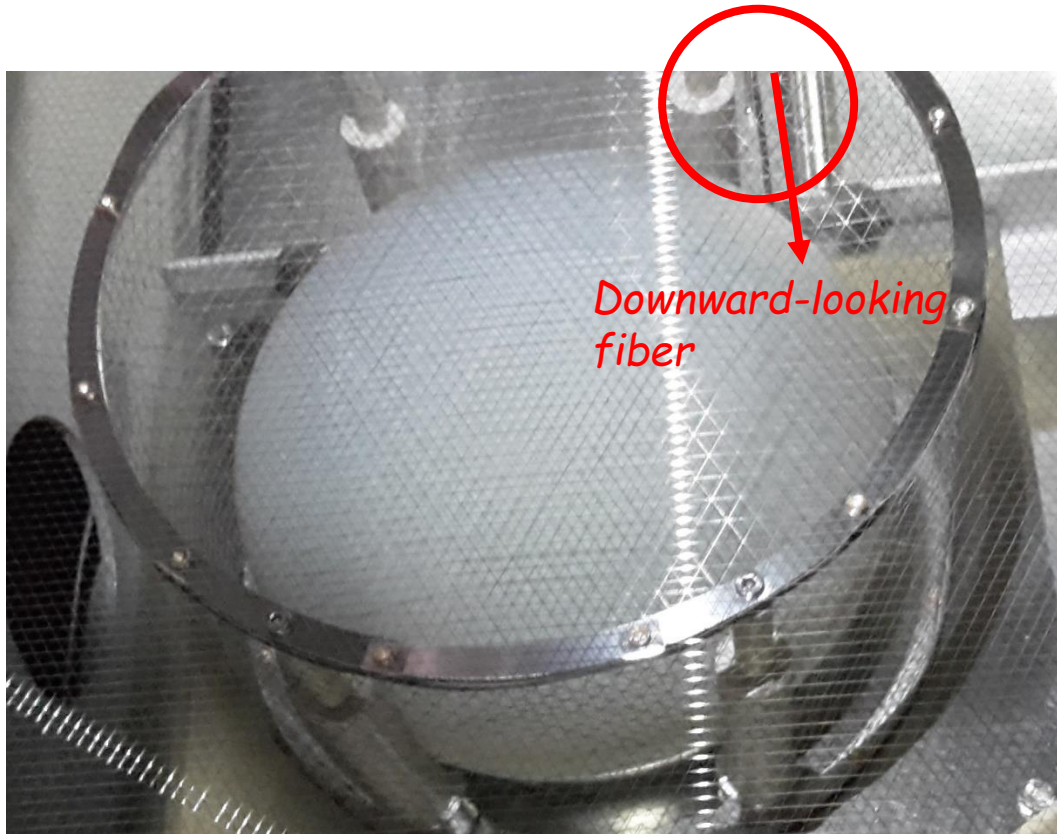
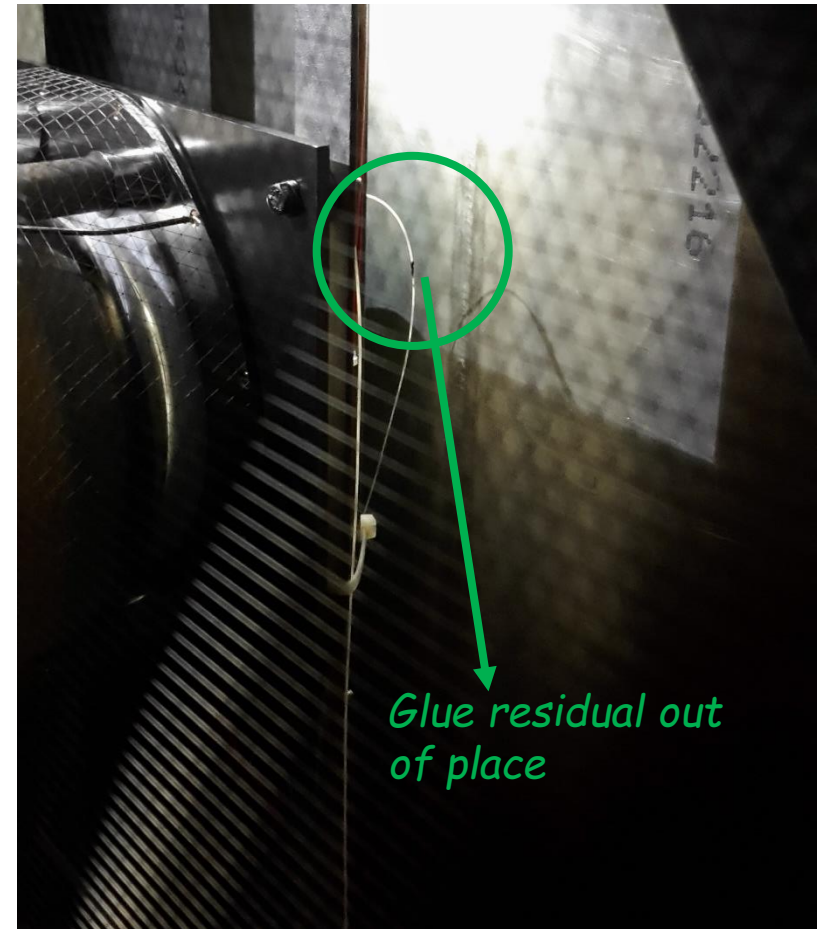
*Three fiber-holding pipes found to be not in place (i.e. not pointing towards the PMT centre)
One fiber got loose and it is not coming out of its pipe any more.*

It may not be possible to calibrate such tubes.

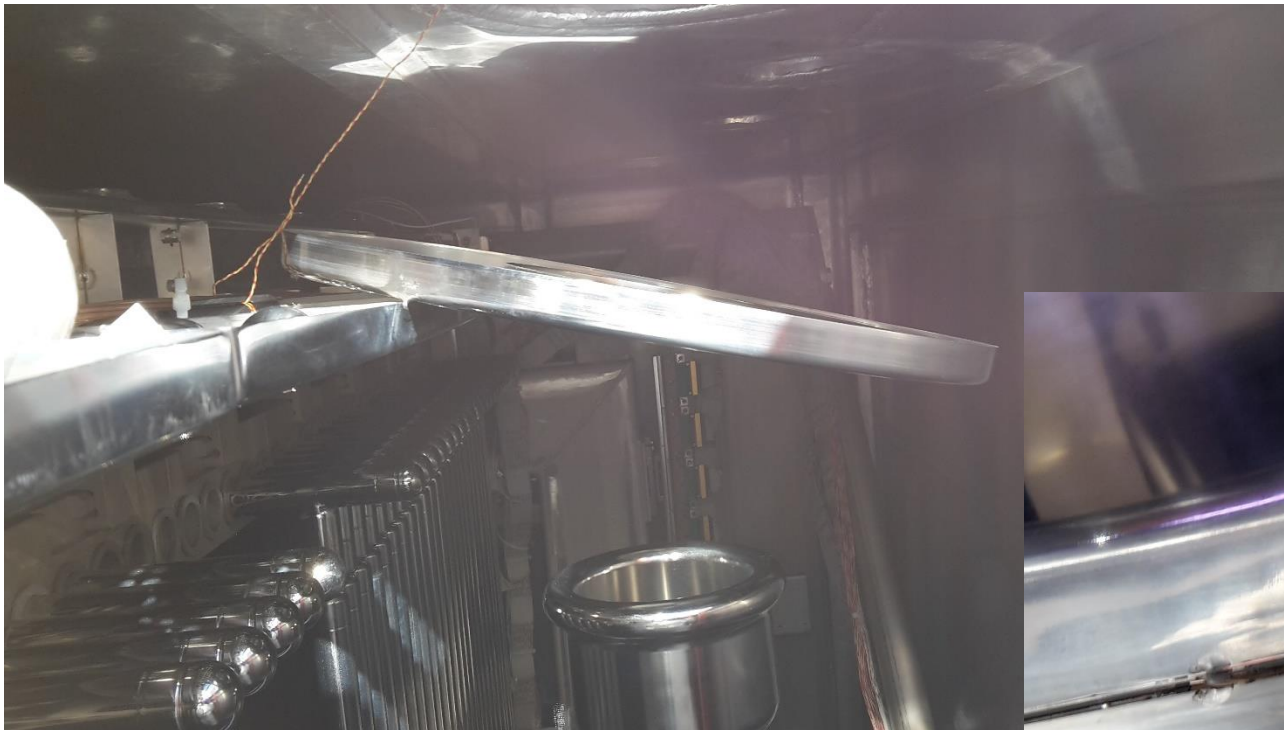
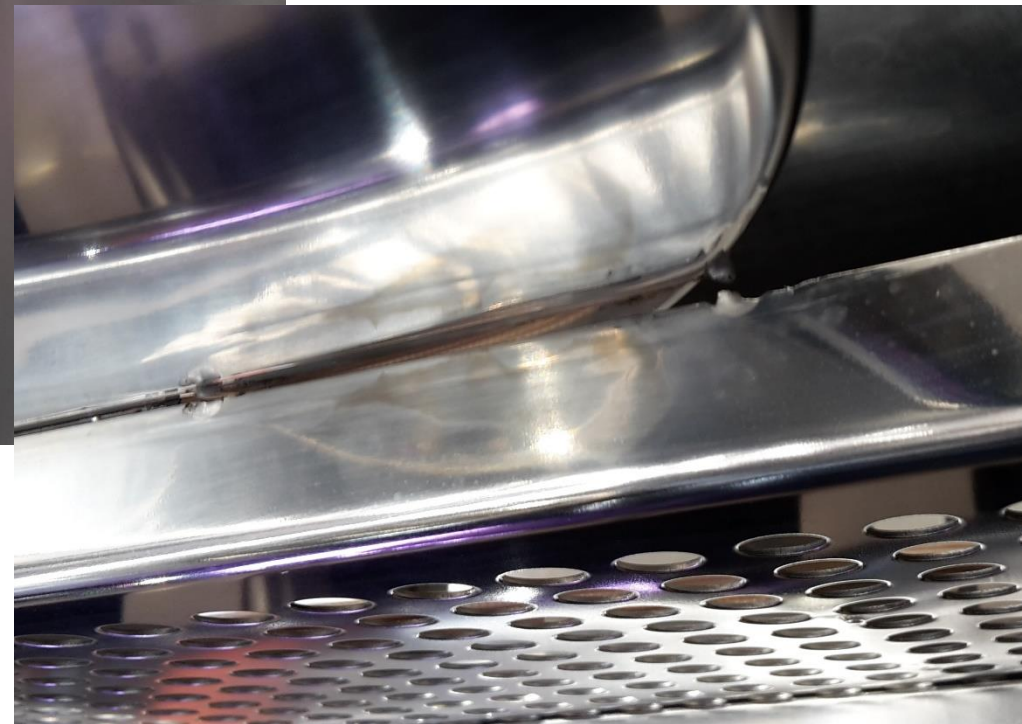
Disk around the HV feedthrough, above the HV cup, fixed with six welding points on the most external part of the ground plane. Three out of six welding points broke, making it unstable.

Re-stabilized by gluing it in place on the ground plane, with special glue, working at cryogenic temp.
