PT status

Norihiro DOSHITA

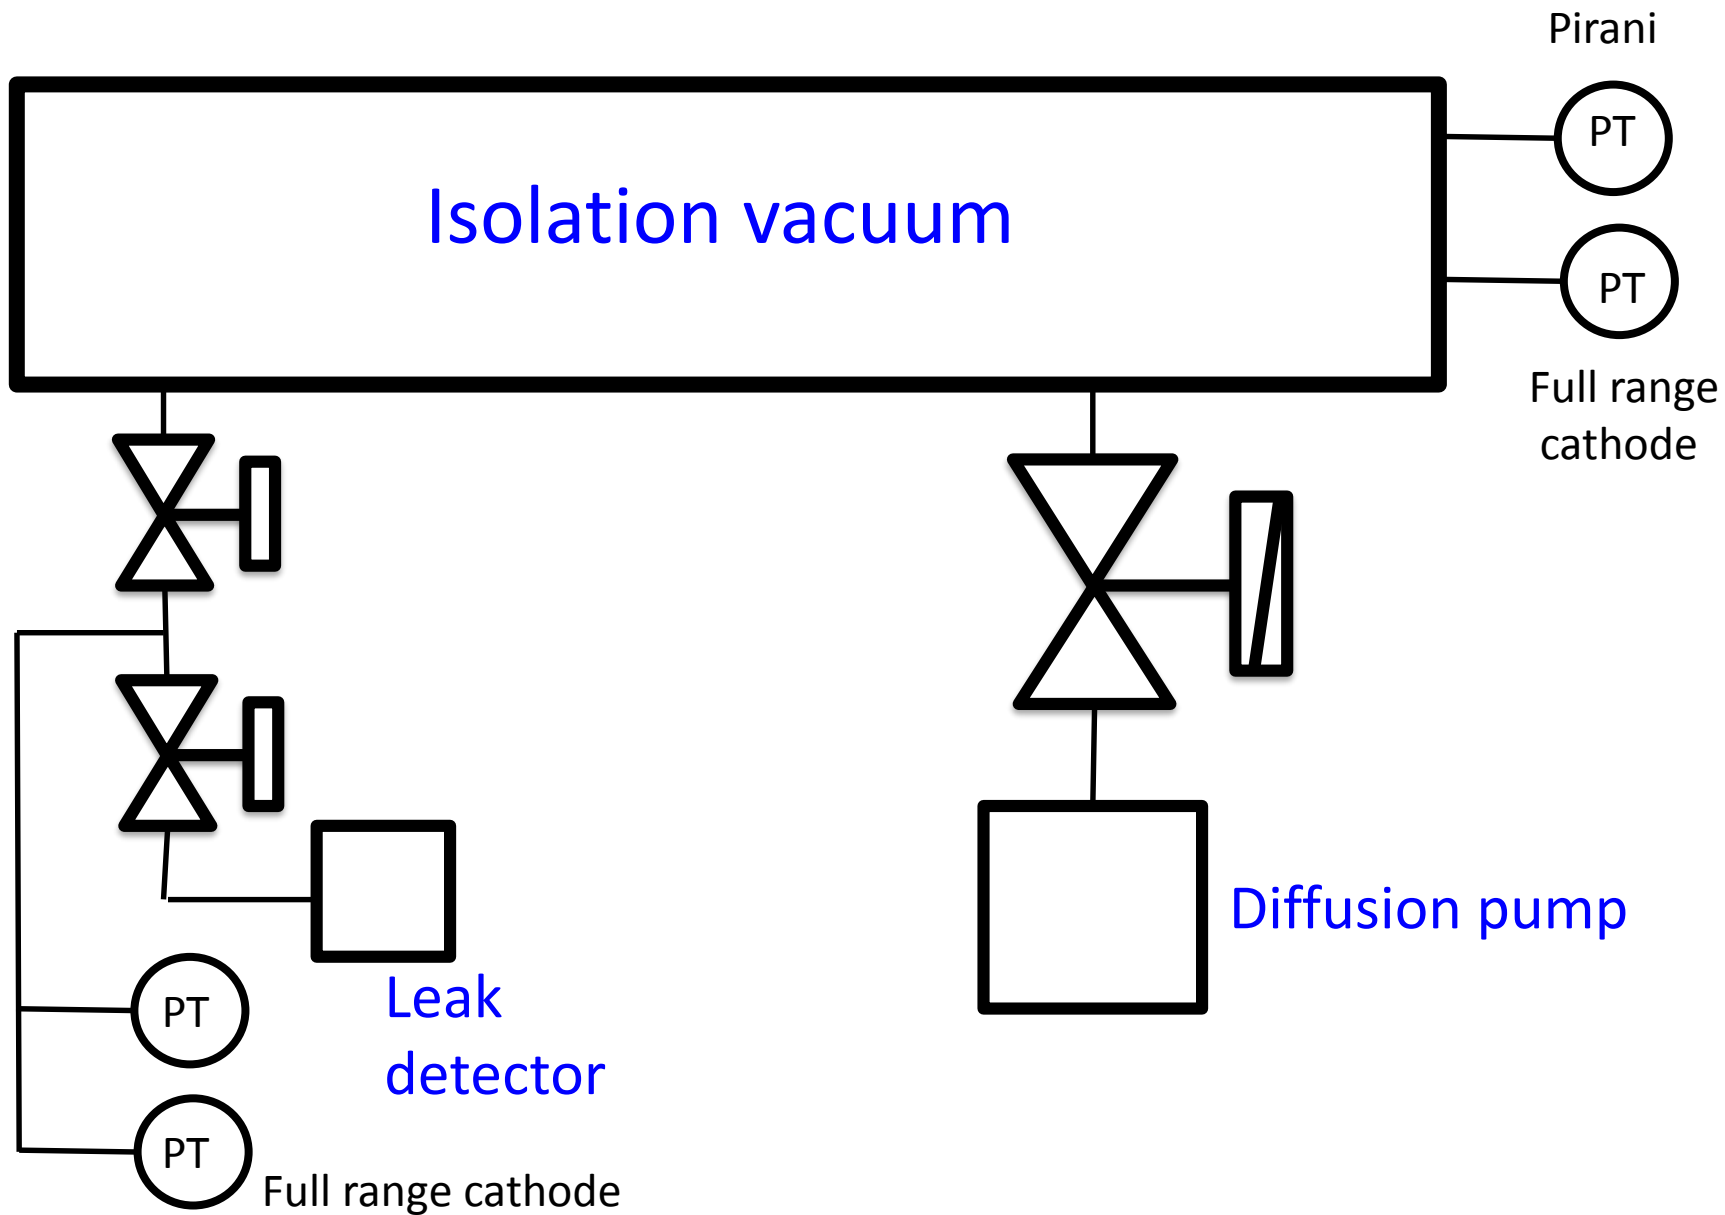
Isolation vacuum leak check 2 (Eric, Yuri)

- 22/11 14:15 started rotary pump
- 22/11 17:00 3.9×10^{-2} mbar
- 23/11 10:00 started diffusion pump
- 23/11 14:00 1.5×10^{-4} mbar
 - performed leak check (BG 1×10^{-10} mbarL/s)
 - small spike signals (up to 4×10^{-10} mbar)
- 24/11 9:00 3.5×10^{-5} mbar
 - performed leak check of microwave guide ports
 - closed diffusion pump valve
 - found leak around o-ring seal
- 24/11 15:30 stopped diffusion pump and broke isolation vacuum
→ for movement of PLC CPU
- 29/11 no leak from He vessel to isolation vacuum

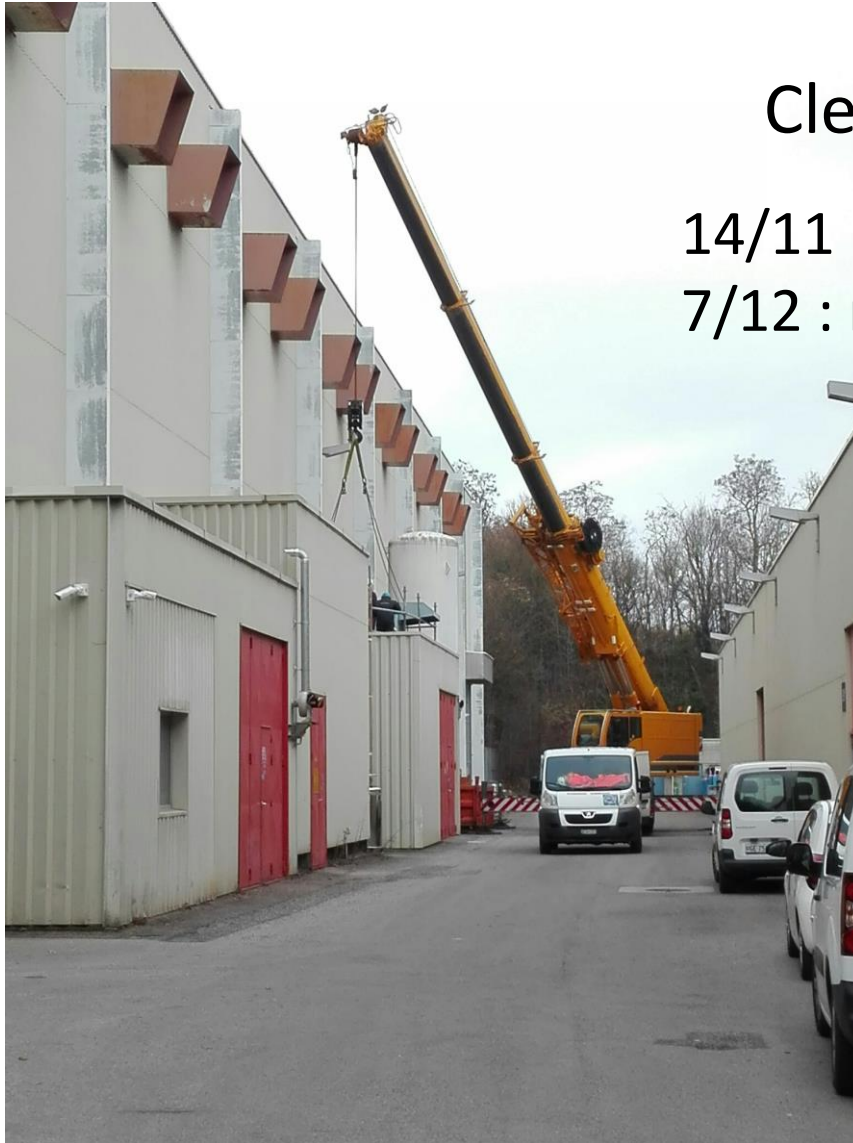
New air conditioner at pump room

14/11 : started and last for 3 weeks

7/12 : modification of cooling water line

→ stopped isolation vacuum

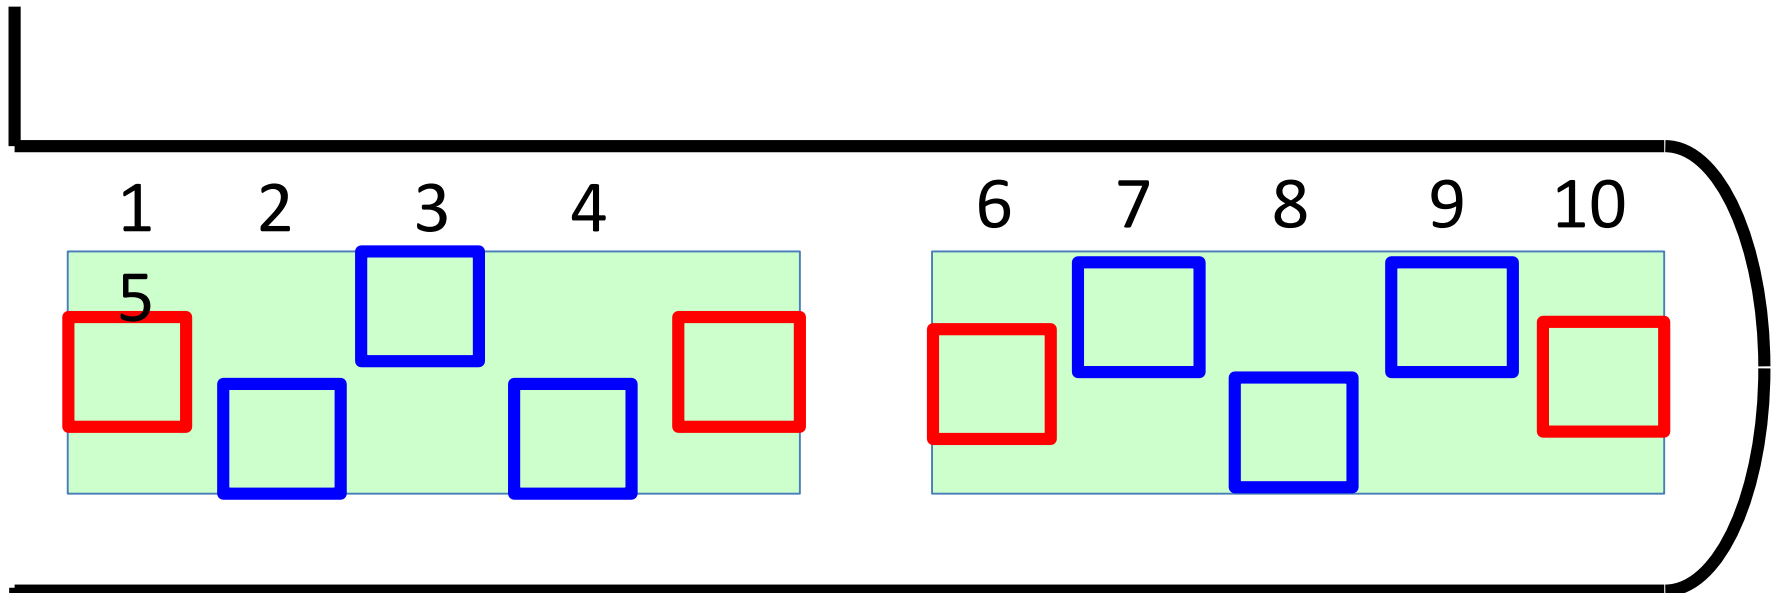
NMR coils location in 2015

Inside

Outside

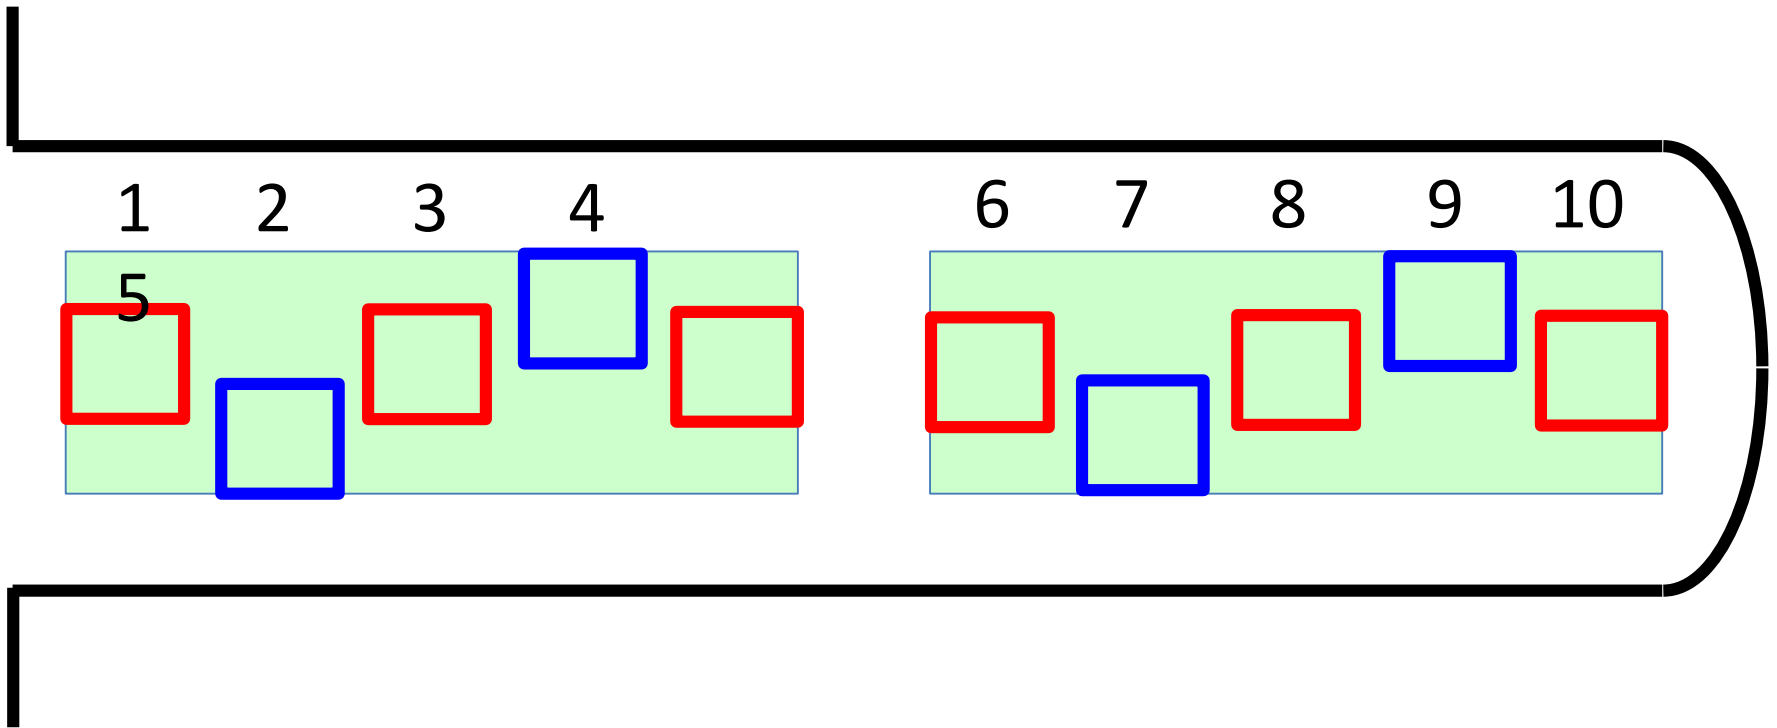
Proposed NMR coils location in 2018

NMR coil

Inside

Outside

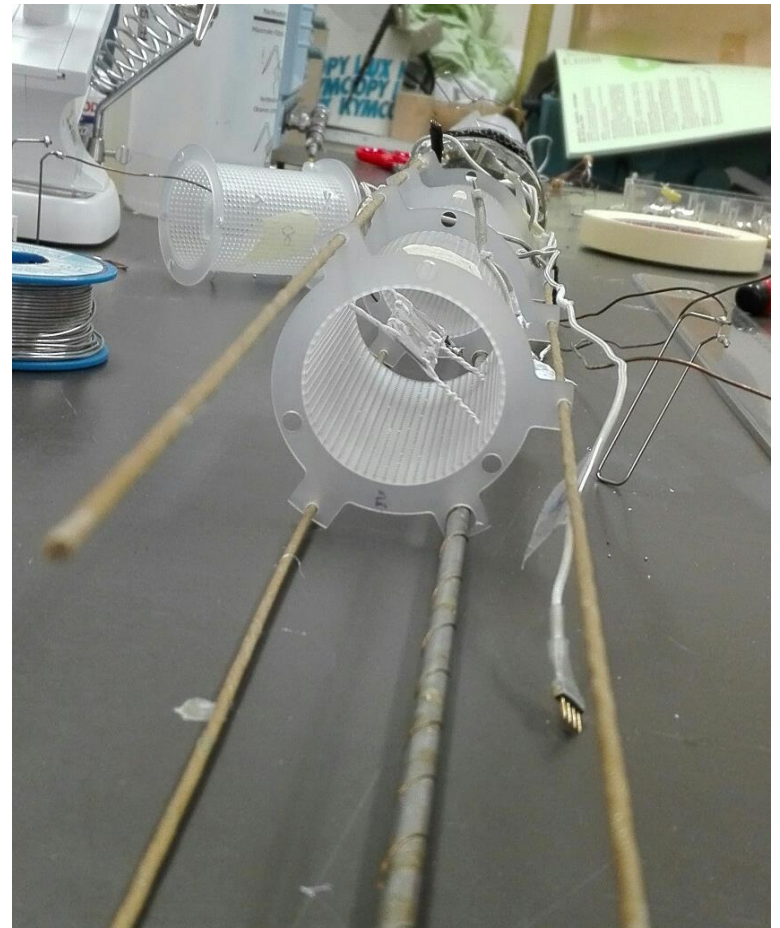
Target cell (Kaori)

- Disconnection of the downstream target cell
- Coil 8 installed
- Connection check by oscilloscope

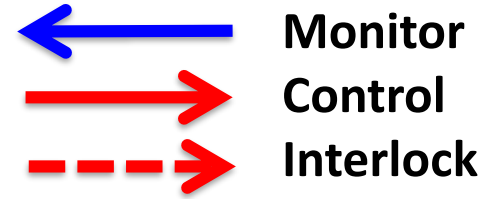
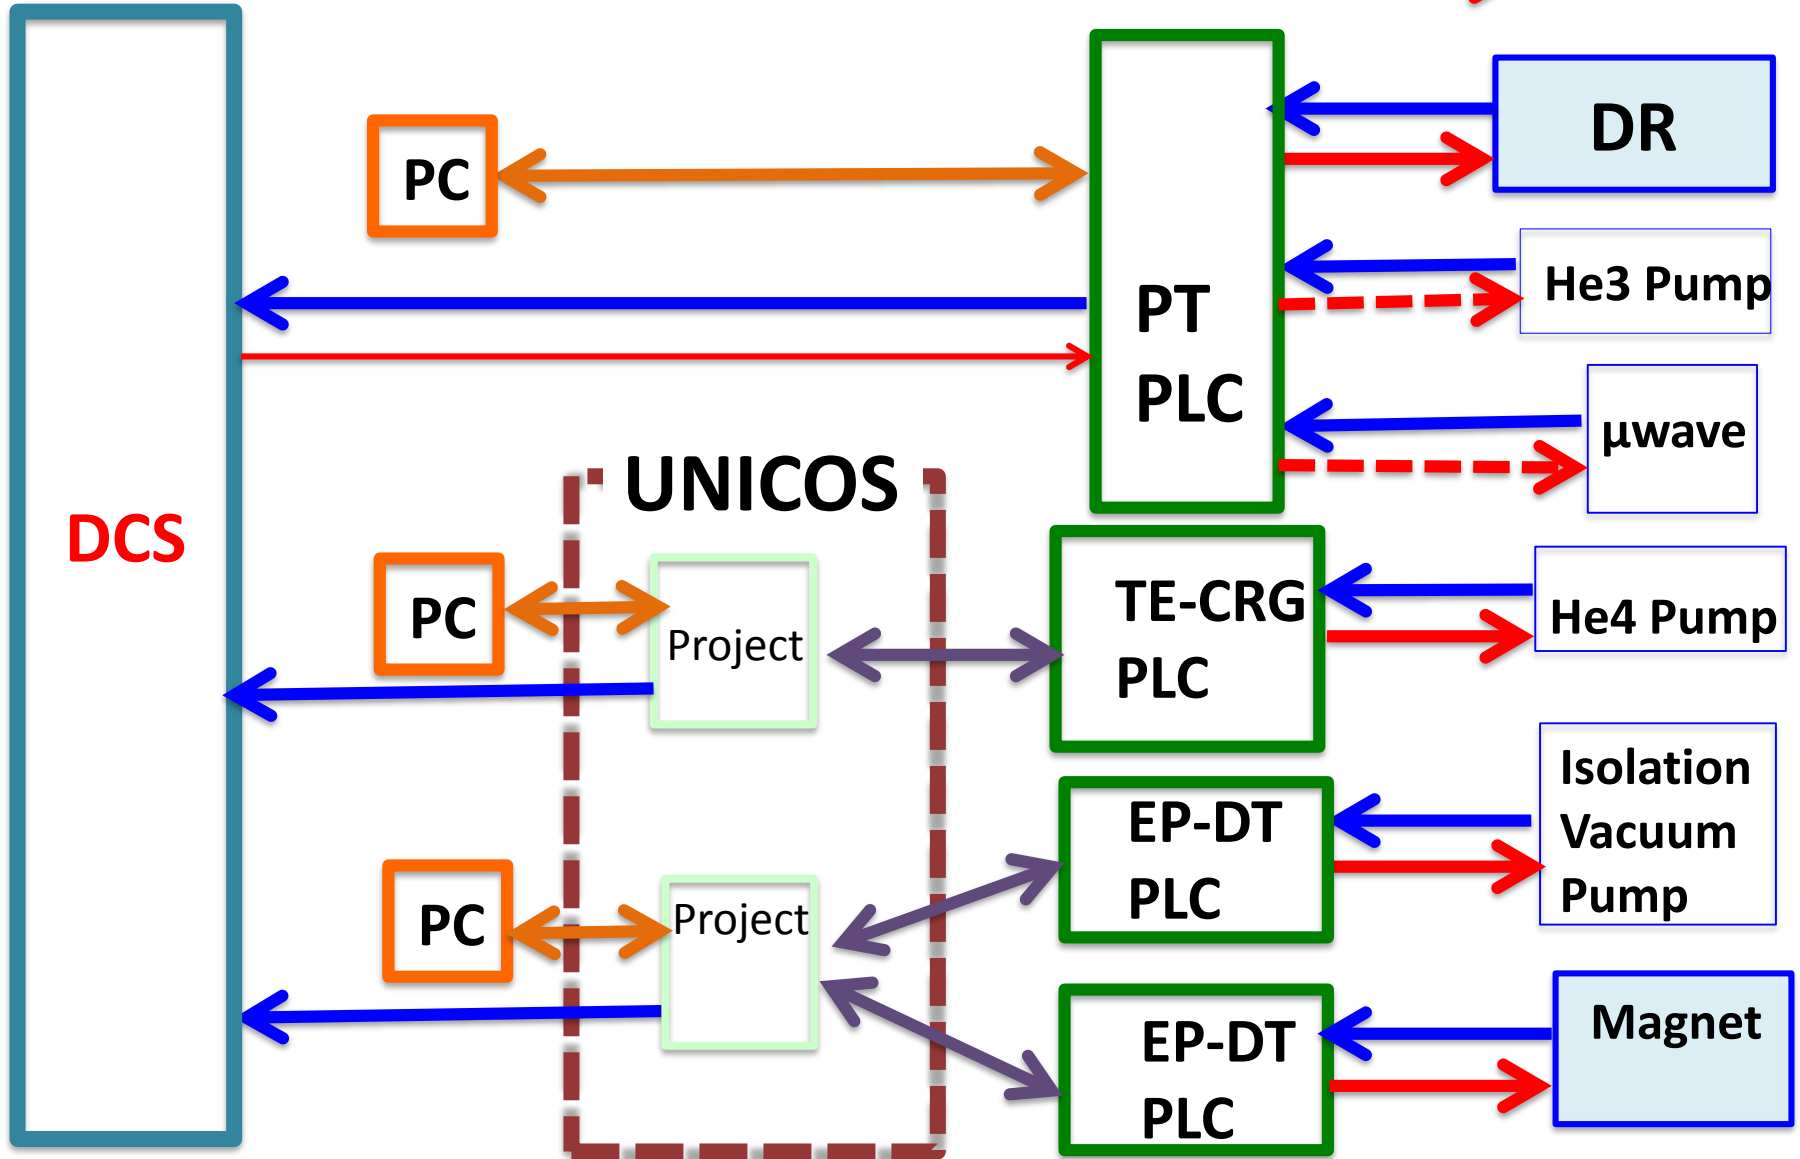
PLCs for PT system (2015)

- PT PLC (Siemens S7-300) since 2002
 - supported until at least 2020
 - S7-1500 after S7-300
- Hard disk broken
 - recovering from the PLC CPU :
 - main program : success
 - touch screen program : on going
 - DB information : lost → immigrate old DB and update manually
- Improvement of control from DCS for run 2018
- Immigration to UNICOS framework
 - UNICOS produced by CERN
- Rules of UNICOS framework
- Support of Christophe : **important**
