NW-LARP-DQW#2 Cavity + HOM Coupler Cod Test Report

Date: October 16, 2017

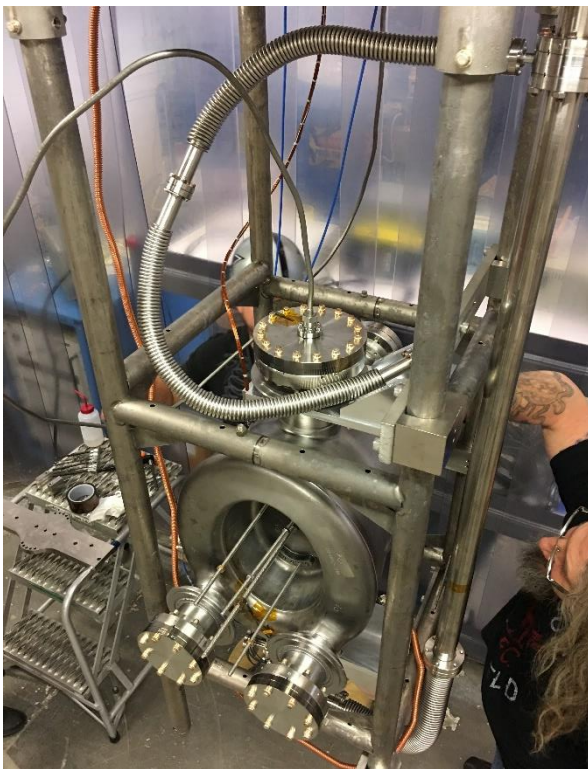
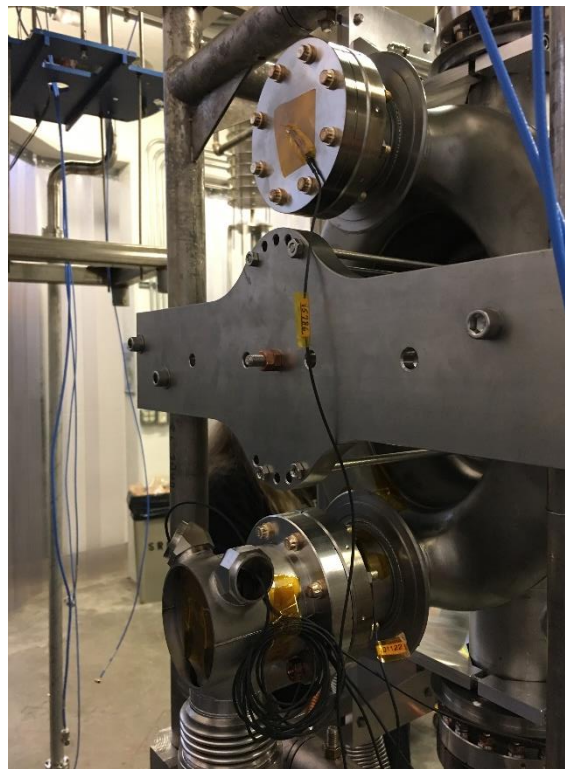
Thermal sensors are well attached at BNL defined locations before cool down, see Figure 4 for locations of 8 thermal sensors. Unfortunately, no signal was detected from sensor #5 since cool down.

Figure 4: 8 thermal sensor locations.

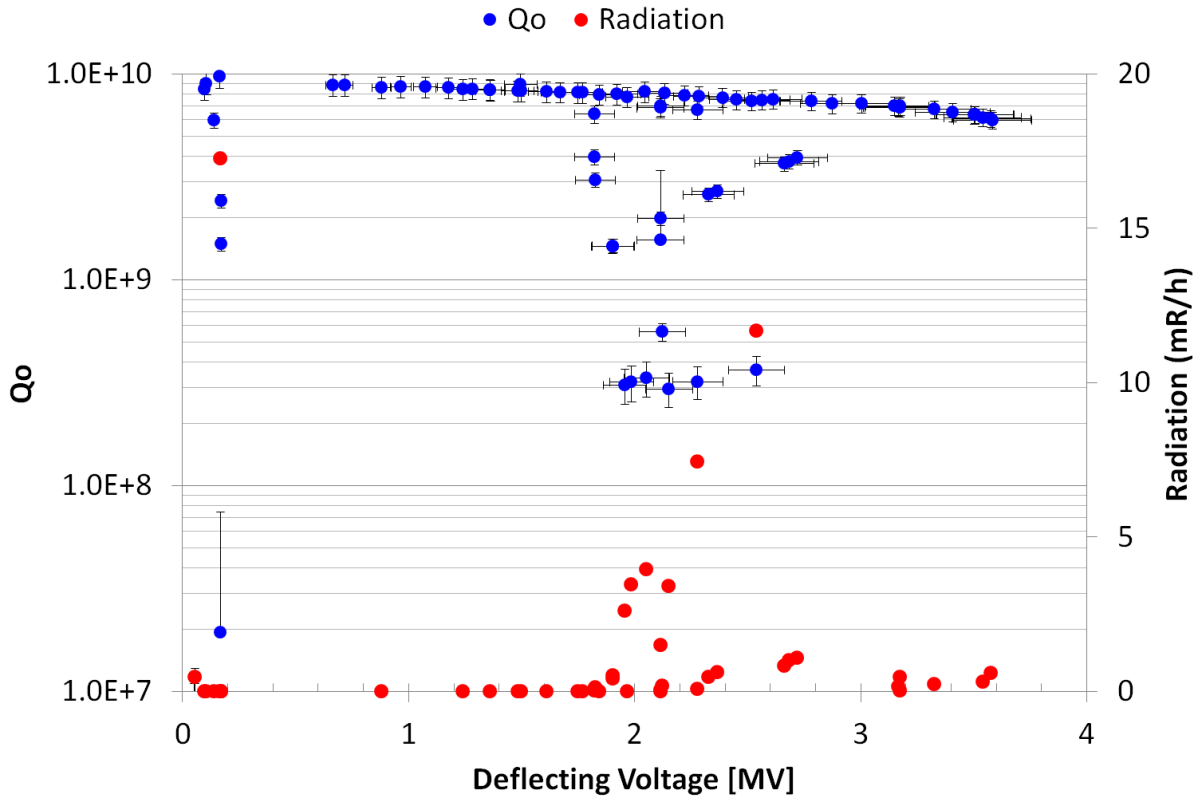
The cavity reached 3.6 MV in CW mode, and 4.12 MV in pulse mode during the high power test at 1.98 K.

The peak electric field at quench is 39 MV/m, and the peak magnetic field is 76 mT. Both are on the cavity. The field on the HOM coupler is always lower than the peak fields on the cavity.

Figure 5: Cavity reached 3.6 MV maximum and quenched in CW mode.

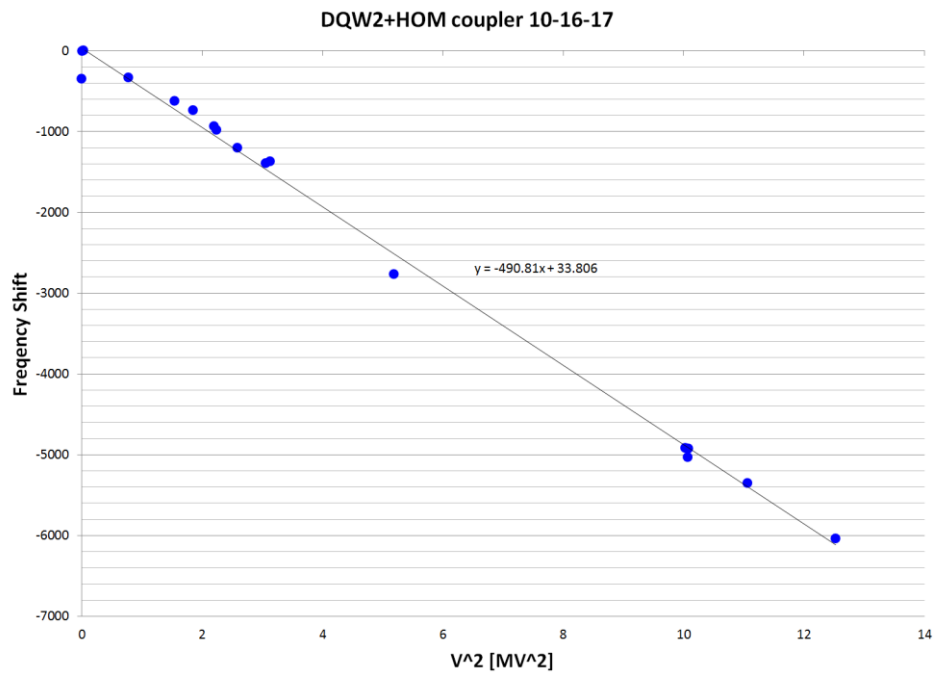
The Lorentz detuning factor measured for this cavity is $-491\text{Hz}/(\text{MV}^2)$. LD factor data are in Figure 6.

Figure 6: Lorentz detuning factor measurement at 1.98K

The Lorentz Detuning factor data in Figure 6 has eliminated the points during multipacting conditioning. The elimination criteria is radiation, Q0 degradation, and Dewar pressure spikes.

Comparing to the PoP cavity at 202Hz/(MV²), the large Lorentz detuning shows that the stiffening plate is poorly attached. This is comparable with the bare cavity test of DQW#1 at 449Hz/(MV²), which used the same stiffening system.

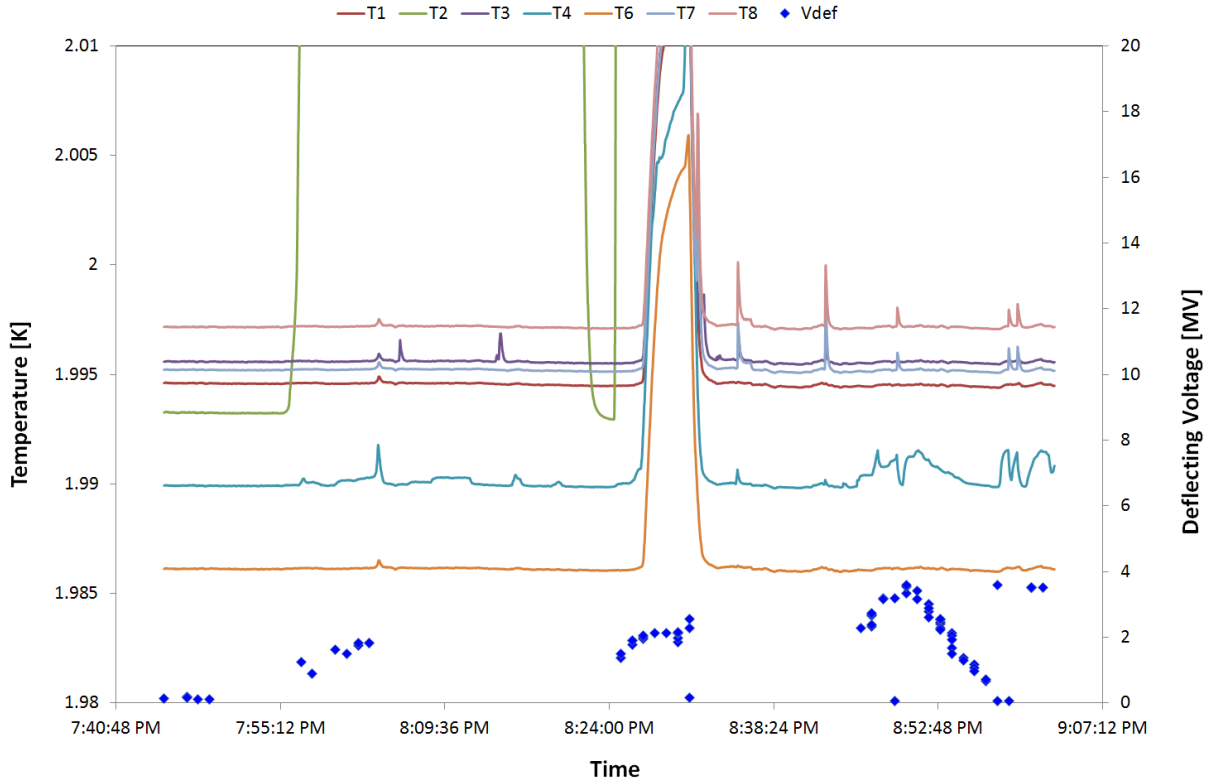
The temperature data with the high power RF activities are shown in Figure 8.

Figure 8: Temperature signal with deflecting voltage.

Compare to the other sensors attached to the high RF field region, signal from sensor #4 showed relatively the most active temperature change during the entire testing. This sensor is located at the highest RF field on HOM port vicinity.

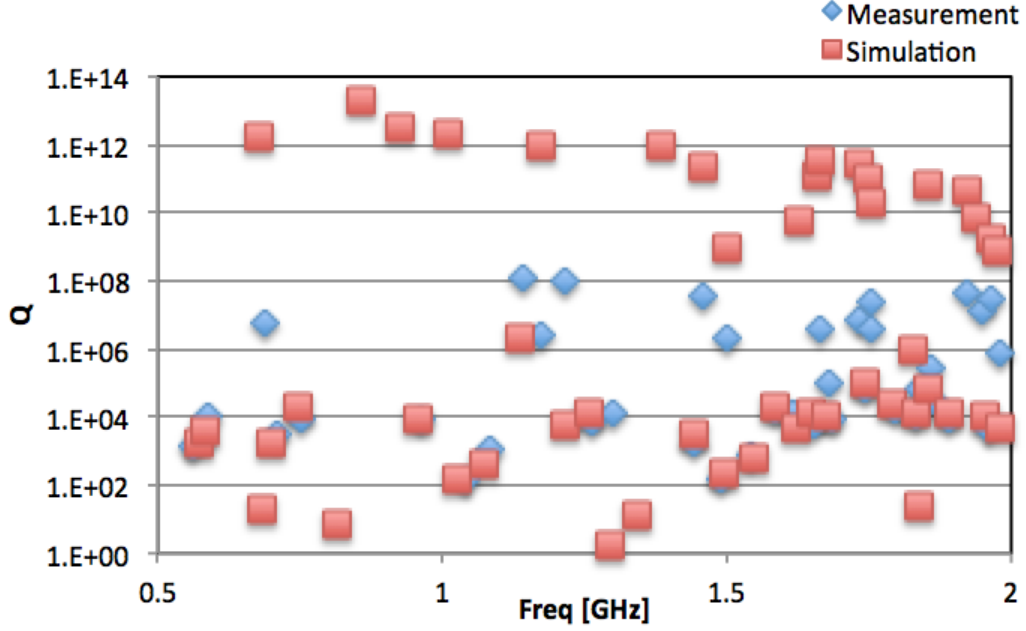
HOM were measured at 2K using a network analyzer with the following setup: scanning with 100MHz span from 500MHz to 2GHz, using 20001 number of points, 5kHz IF bandwidth, 5dBm power; and then zoom into each mode with reduced number of points and IF bandwidth. The results are plotted in Fig. 9, with numbers listed on Table 1. Please note here we listed all the HOMs we simulated, some of them cannot be damped using 1 HOM coupler configuration, which means they have high quality factor with 1 HOM, and normally cannot be measured using FPC/1 HOM ports combination.

The HOM measurement of the NW-LARP-DQW#1 with the same HOM filter in May, 2017 at JLab showed only 1 mode with Q higher than 10^6 , while this measurement showed 14 modes. One possible reason is that the previous measurement used wider frequency span and high Q modes are easier to be missed, another possibility is that the previous measurement used FPC/PU port combination and lots of HOM cannot be measured. (will confirm with Jamie). In order to understand the fabrication error induced HOM frequency shift, we plotted the frequency differences of HOMs in these two measurements in Fig. 10. The $\sim 570\text{MHz}$ mode's frequency is away by 1.1%, and all the other HOMs are within 0.2%.

Figure 9: Simulated and measured quality factor of HOMs.
