# Update on Chromium GEM studies @ UVa

**Kondo Gnanvo**

**University of Virginia, Charlottesville, VA**

*RD51 Mini week @ CERN, December 15, 2017*

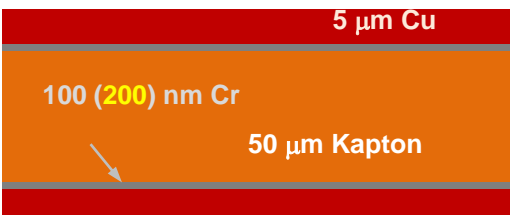
## Standard GEM

## Characteristic of Cr-GEM foil:

- Copper (Cu) clad raw material comes with 100 nm Chromium (Cr) layer between Cu and Kapton, 5μm Cu layers removed, leave only 100 nm residual Cr layers as electrodes, **Cr-GEM foils provided CERN PCB workshop**

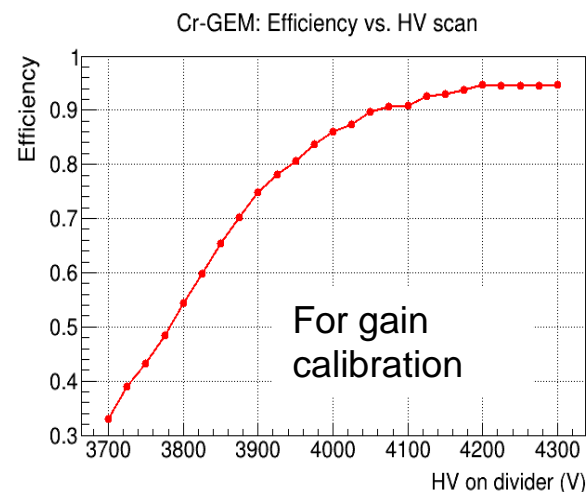
## X-ray setup

- Two small GEMs in the X-ray setting: Cr-GEM and standard Cu-GEM (used as reference)
- Sr90 used for HV scan  $\Rightarrow$  rough calibration of the detector gain data from literature

- X-ray:  $V = 15 \text{ kV}$ ,  $I = 200 \mu\text{A} \Rightarrow$  X-ray rate = 12 MHz/cm<sup>2</sup>
- HV = 4000 V  $\Rightarrow$  4 mC/cm<sup>2</sup> / day for 4 days
- Significant damages on GEM response after day #2**
- 50% of the dead area after 4 days

- Proto II: 3<sup>rd</sup> GEM of proto I foil replaced by a new foil
- X-ray:  $V = 15 \text{ kV}$ ,  $I = 50 \mu\text{A} \Rightarrow$  particle rate = 3 MHz/cm<sup>2</sup>
- HV @ 3800 V  $\Rightarrow$  40  $\mu\text{C}/\text{cm}^2$  / day for 65 days
- HV = 3950 V  $\Rightarrow$  300  $\mu\text{C}/\text{cm}^2$  / day for 30 days
- No significant damage to the chamber**

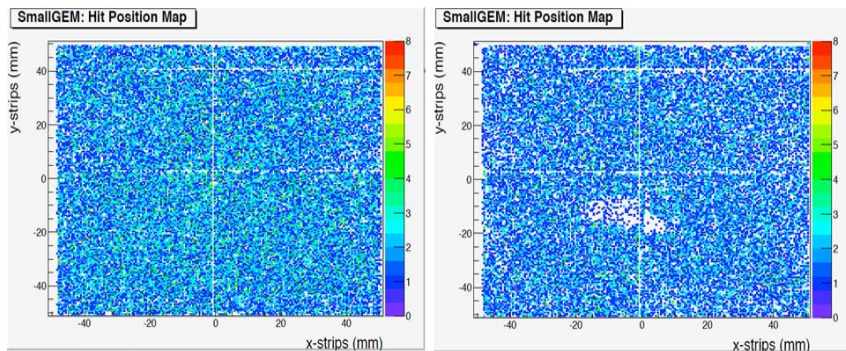
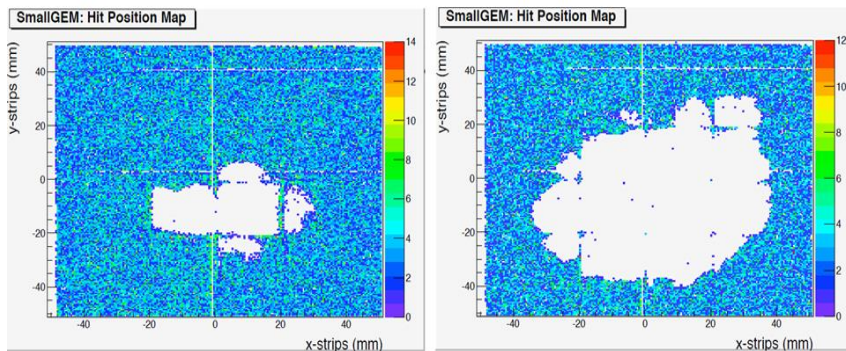
Test of Cr-GEM Proto I: photon rate = 12 MHz / cm<sup>2</sup>

- Dead area appears after 2<sup>nd</sup> exposure day and keeps increasing
- Cr layer at the bottom of 3<sup>rd</sup> Cr-GEM (just above readout board almost completely **vanished** ⇒ dark brown color is the Kapton
- Causes of damages unclear:
  - ⇒ **small discharges @ high rate or high detector gain**
- **Two other Cr-GEM foils show no damage** ⇒ HV test OK
  - ⇒ They were re-used in proto II

moderate X-ray rate (0.169 Coulomb)

higher X-ray rate (0.35 Coulomb)

high X-ray rate (0.47 Coulomb)

high X-ray rate (0.727 Coulomb)

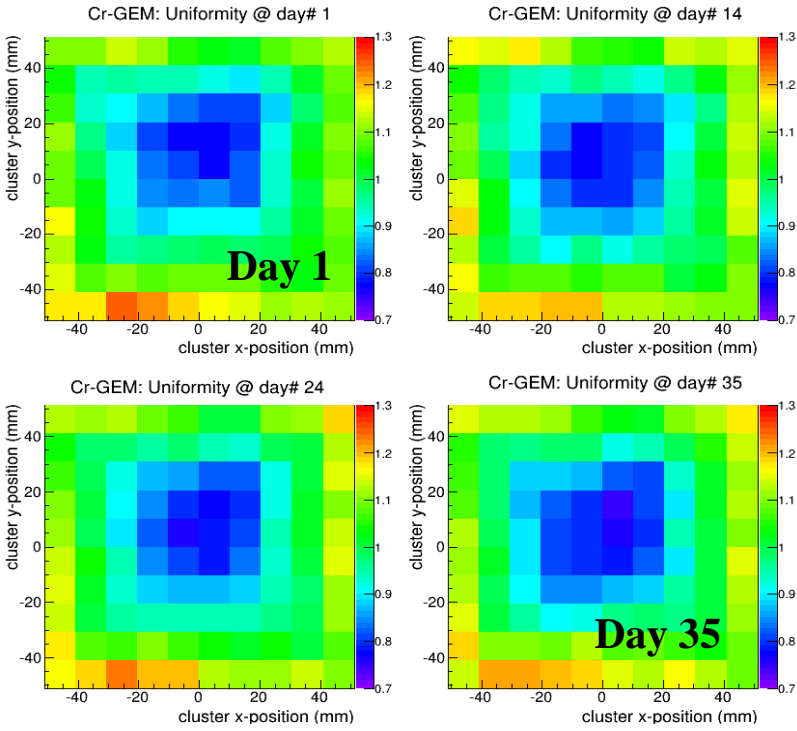
X-ray with estimated rate  $3 \text{ MHz} / \text{cm}^2$

- @ low detector gain ( $\sim 1 \times 10^3$ )  $\Rightarrow$   **$140 \mu\text{C}/\text{cm}^2$  after 35 days**
- Gain variation from edge to center due to bending of the X-Y readout
- No significant variation in the overall response of the 3-month long exposure to x-ray (gain uniformity, ADC etc ...)
- kind of **charging up effect** at beginning of the x-ray irradiation
  - ADC amplitude higher around Cu grid and the gain variation from the edge to the center increases
  - The effect usually disappear after one day of continuous exposure

*~5 hours after the start of the x-ray exposure*

*after the a day of continuous the x-ray exposure*

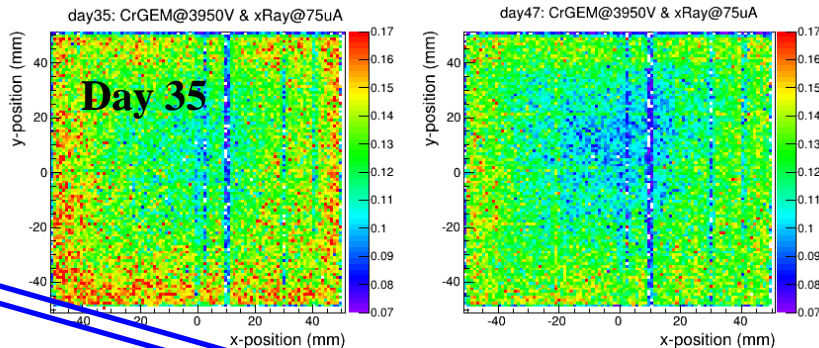
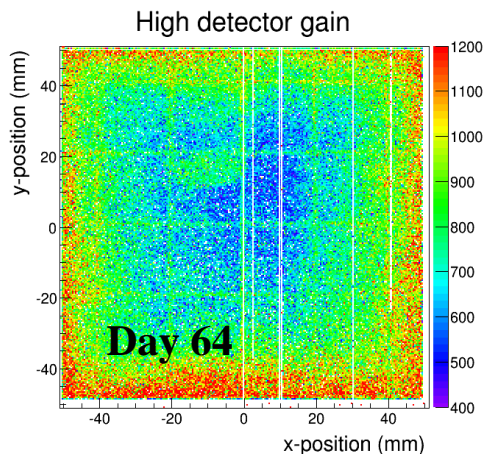
X-ray with estimated rate  $3 \text{ MHz} / \text{cm}^2$

- @ high detector gain ( $\sim 5 \times 10^3$ )  $\Rightarrow$  **0.7 mC / cm<sup>2</sup> after 30 days**
- **Similar charging up effect** shows up again slowly with time and was pretty strong after 30 days
- However, once again when switch back again to low gain  $10^3$  the gain becomes once again more uniform

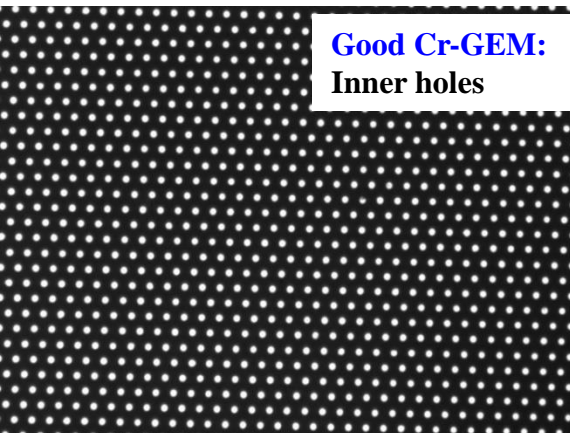
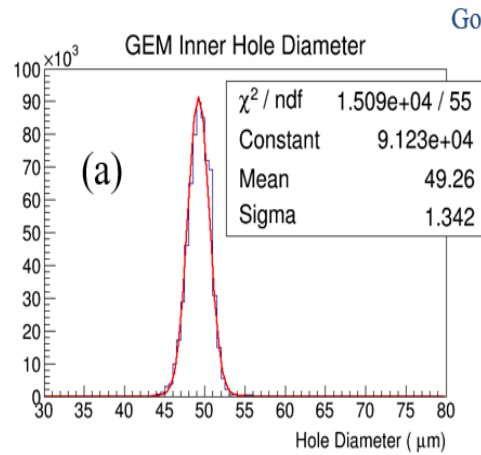
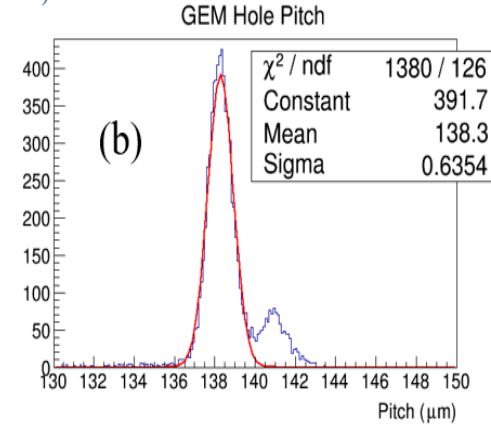
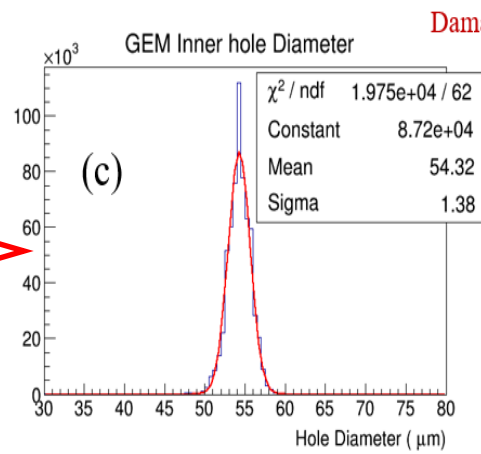
- Holes parameters for both damage and good foil are well within the specs for a standard GEM foil
- Inner hole diameter:** Narrow distribution ( $\sigma \sim 1.4 \mu\text{m}$ )
  - ⇒ Good uniformity across the entire active area
  - ⇒ no Kapton etching for the damaged Cr-GEM
- Hole pitch:**  $\sim 138 \mu\text{m}$ 
  - ⇒ Small bump at  $141 \mu\text{m}$  for good Cr-GEM
  - ⇒ Wider distribution for the damaged Cr-GEM but could just be measurement artefacts

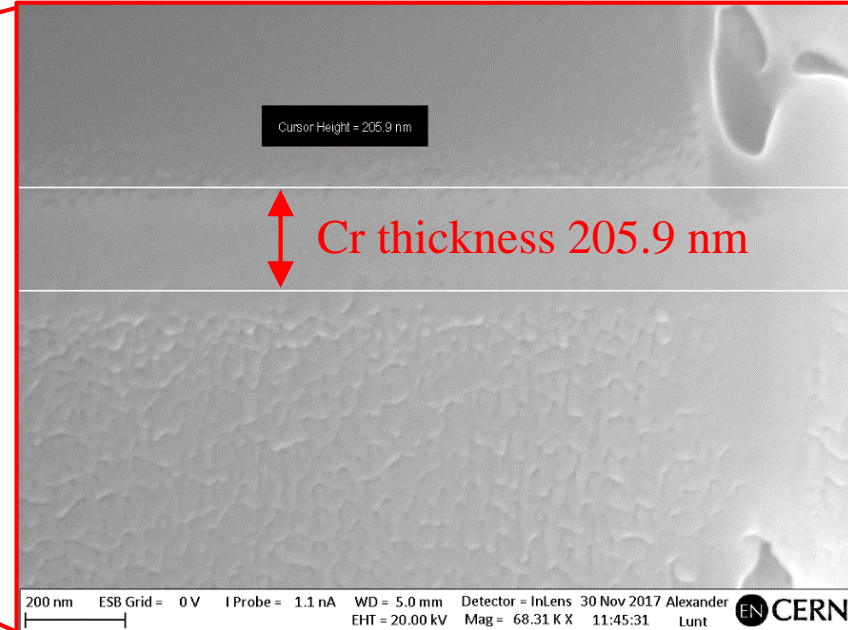
*Cr-GEM hole cross section*

*Zoom into Cr layer*

**Cr layer 2  $\times$  thicker than original assumption**

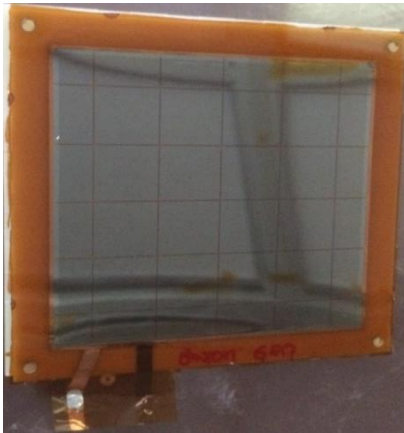
Cr-GEM1 top

- SEM images of the top and bottom side of the heavily damaged Cr-GEM1 foil.
- As expected, SEM images of top side are high quality with holes dimensions configuration looks like normal GEM foil.
- Pictures of the bottom side of the foil appears severely distorted  $\Rightarrow$  bad image resolution
  - Cross section of the holes: looks as if the Cr layer melted with some other material but the Kapton looks fine

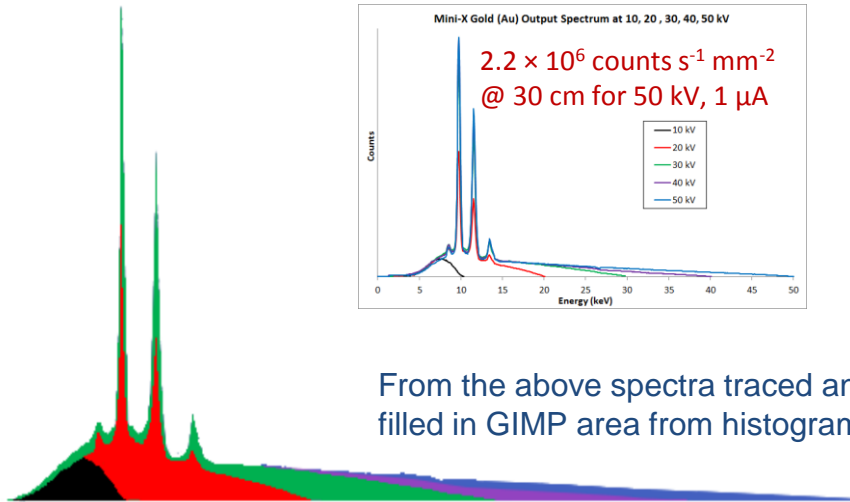
The flux proportional to the area of the spectrum

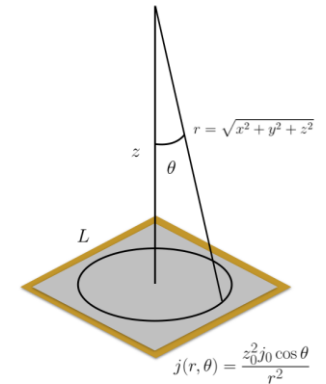
Photon flux integrated over detector

$$\phi = \int j dA$$

$$j(x, y, z) = \frac{z_0^2 j_0 \left( \frac{z}{\sqrt{x^2 + y^2 + z^2}} \right)}{x^2 + y^2 + z^2}$$

$$\phi = 4 \int_0^{L/2} dx \int_0^{L/2} dy j(x, y, z)$$

$$\phi = 4z_0^2 j_0 \arctan \left( \frac{L^2}{2z\sqrt{4z^2 + 2L^2}} \right)$$

$$j = \left( \frac{I}{I_0} \right) \left( \frac{m \times V + b}{a_0} \right) \left( 4 \frac{z_0^2}{L^2} \arctan \left( \frac{L^2}{2z\sqrt{4z^2 + 2L^2}} \right) \right) e^{-\mu(z-z_0)} j_0$$
