Update: ISU Stave Core QA

ISU WEEKLY STAVE QA MEETING

APRIL 27, 2018

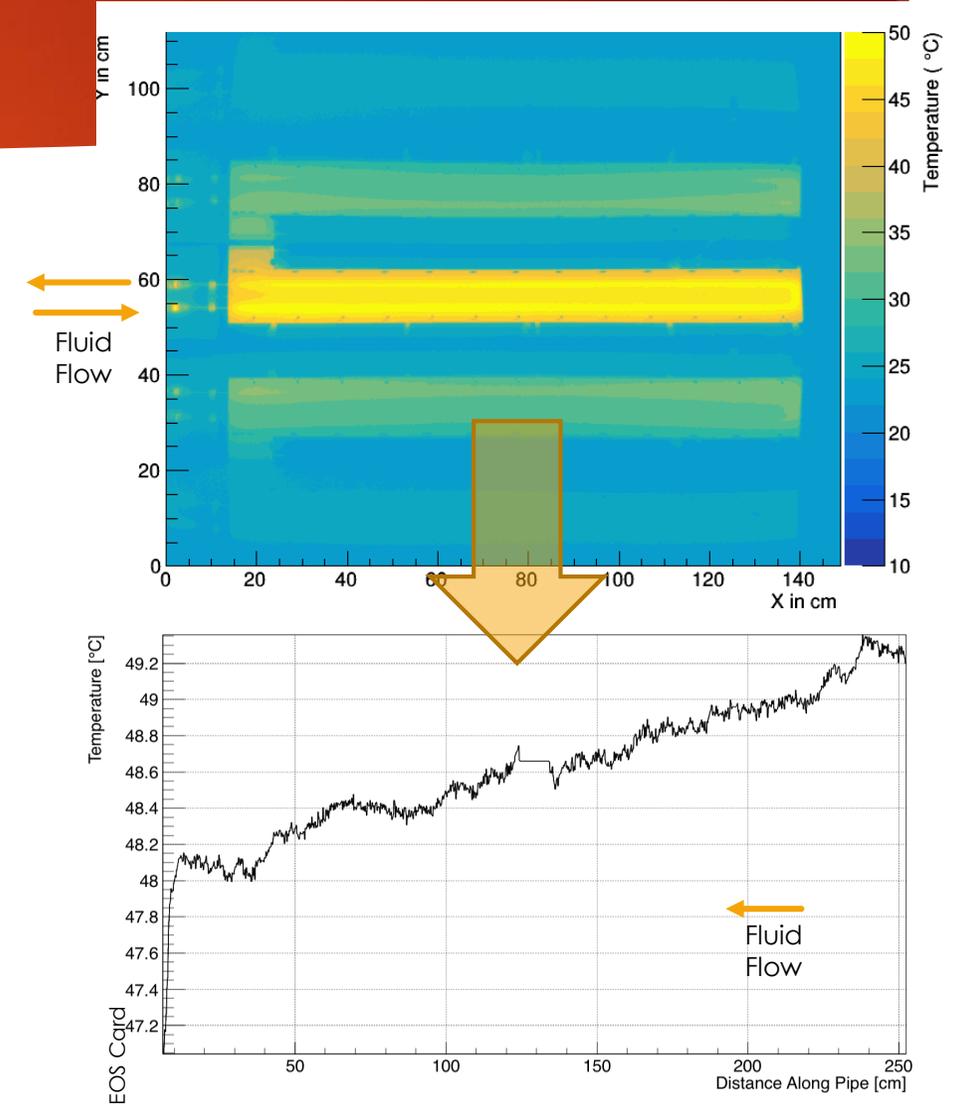
Thermal Measurement Method

- ▶ The thermal measurements were made with fluid flow through the stove of ~ 1 l/min with high (+50C) or low (-40C) temperature fluid.
- ▶ Before data is taken, 10 minutes are waited without any nitrogen airflow in the enclosure.
- ▶ A series of 200 frames were taken at 25 frames/second with the FLIR A655sc camera with an 80 degree lens
- ▶ The 200 frames of raw data are averaged into a single frame using an emissivity value of 0.95 (read_sequence.sh)
- ▶ The stove location is then extracted from the image (configFinder.py) and the thermal profile along the cooling pipes of the stove excluding the end regions are found. (frameanal.py)
- ▶ The defect finding algorithm is then used to find any defects on the stove and create plots. (defectFinder.py)

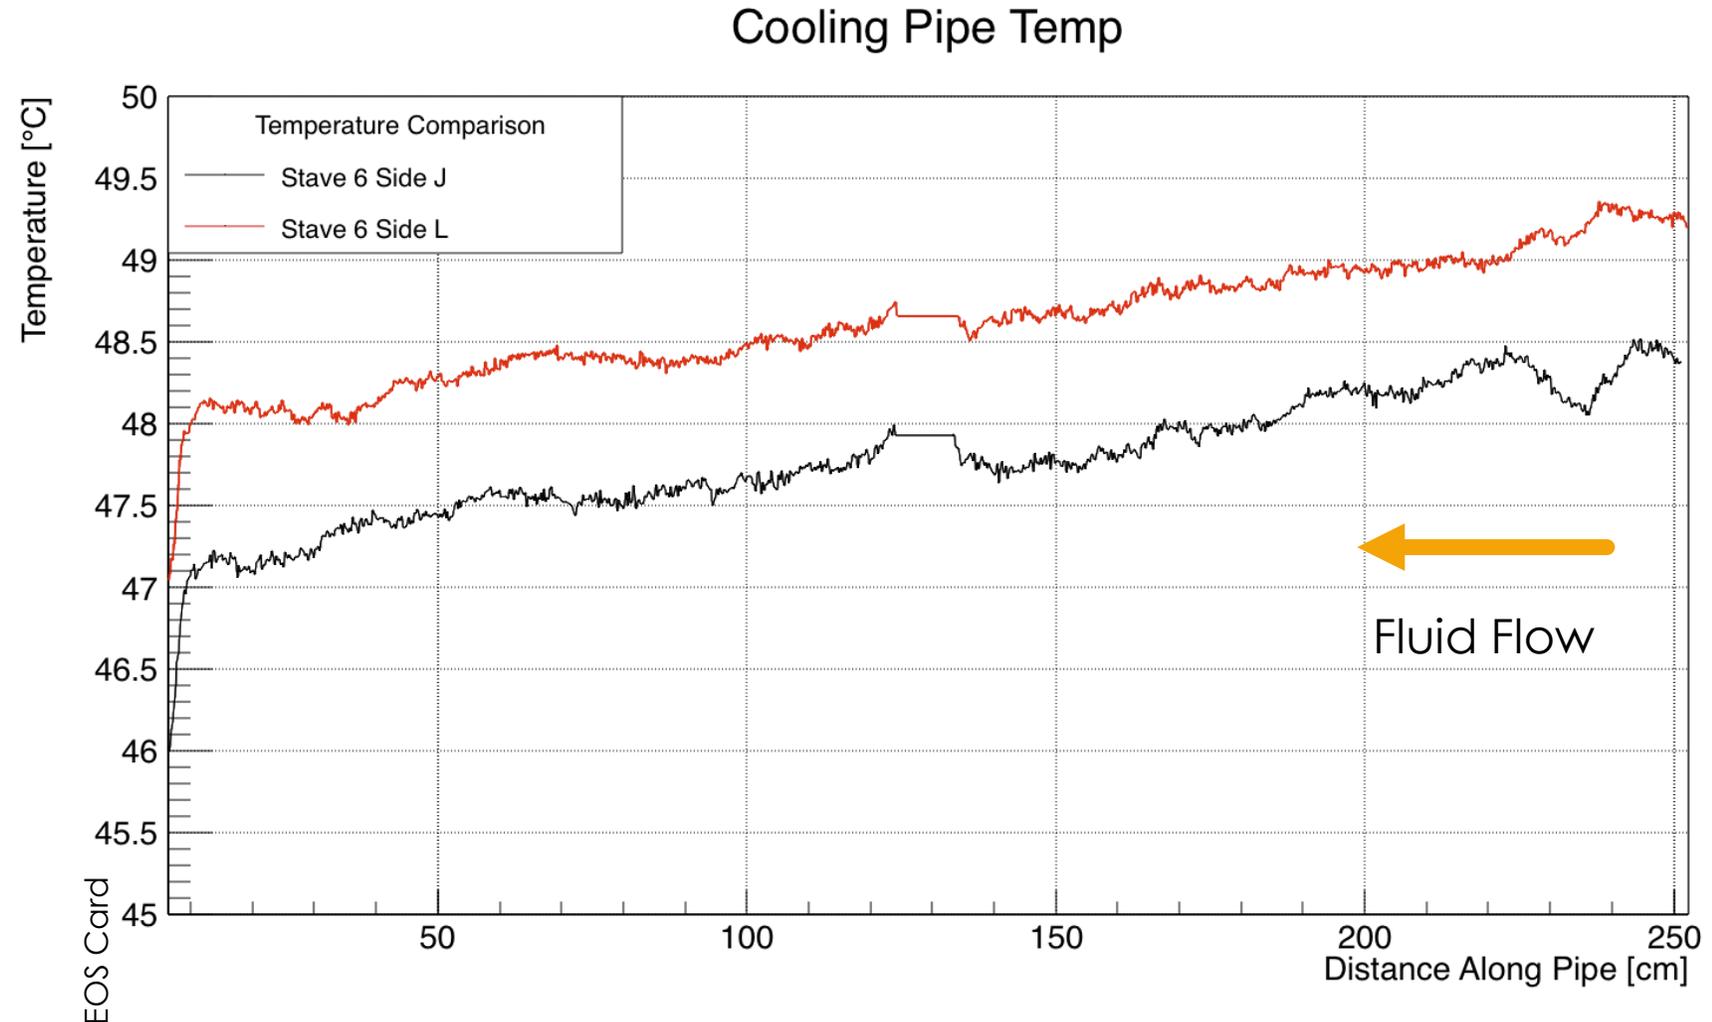
Stave 6: Thermal Measurement Hot

- ▶ Thermal measurements were taken on both sides of the stave with 50 C fluid flowing into the stave core
- ▶ The defect finder found no flaws
- ▶ Linear Fit RMS was found
 - ▶ J Side: 0.12 C
 - ▶ L Side: 0.09 C

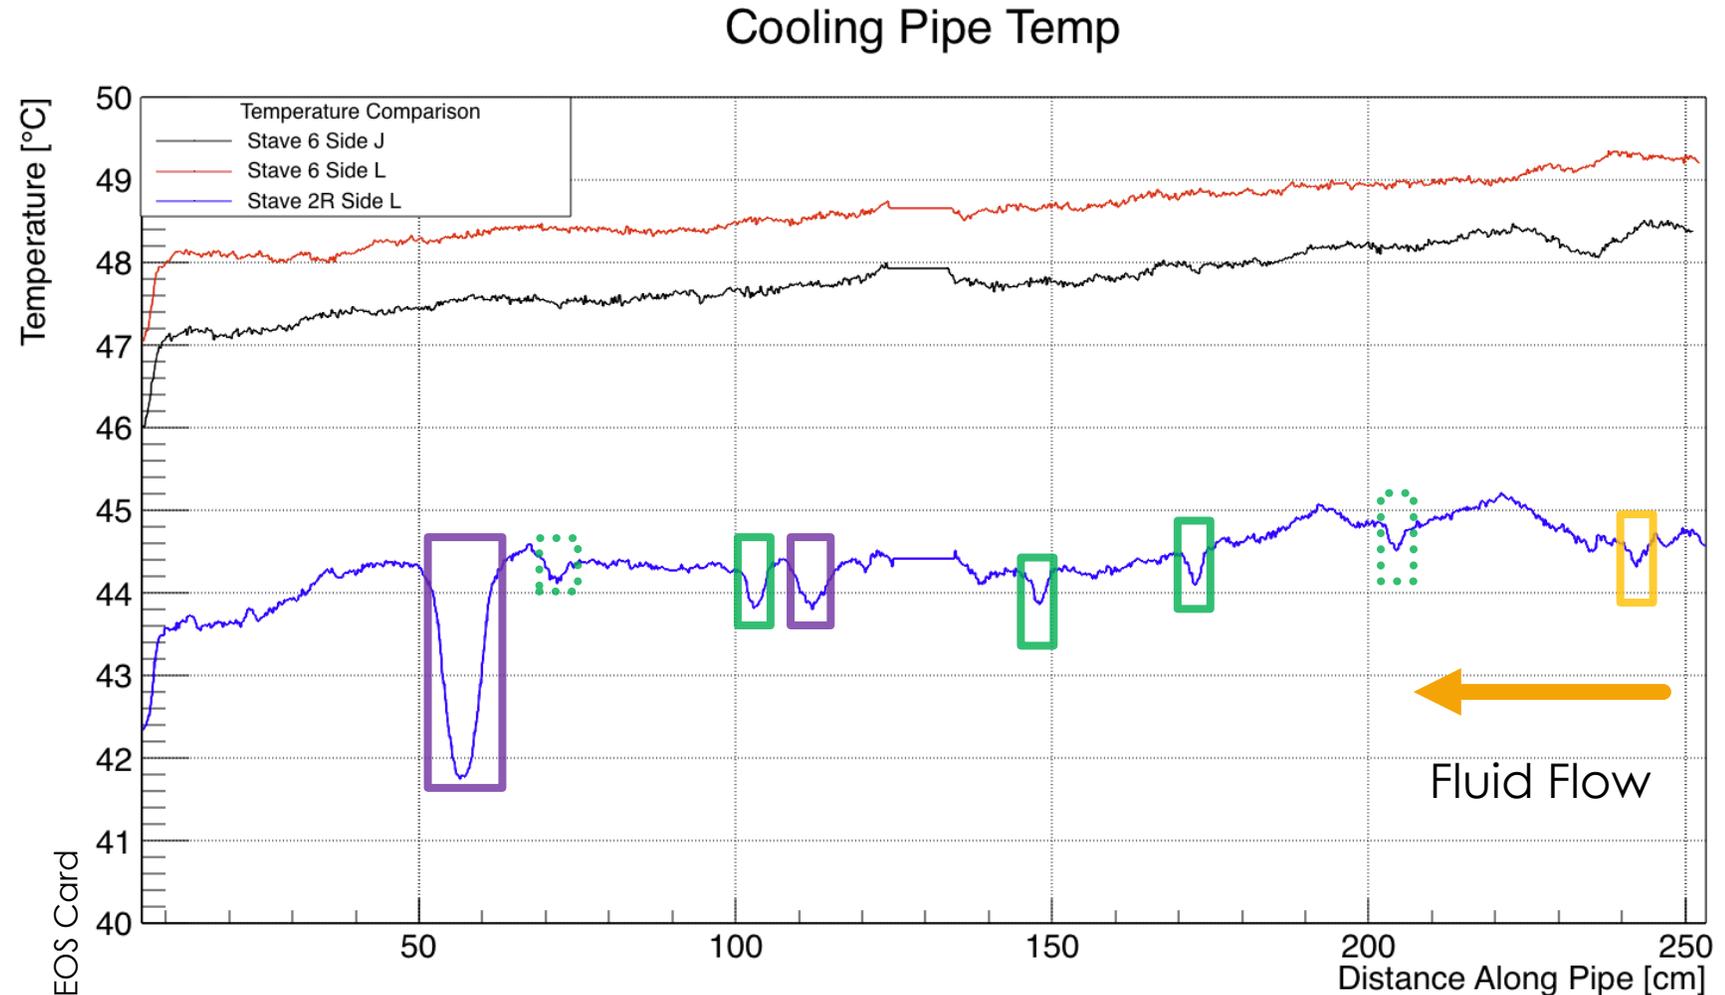
Stave 6 Comparison with Stave 2R Hot

- ▶ This is a comparison between stave 6 and 2R with +50C fluid flowing
- ▶ The defects found are boxed on the 2R profile
 - ▶ **Purple**: Pipe-Foam
 - ▶ **Green**: Foam-Facing
 - ▶ **Green Dotted**: Partial Foam-Facing
 - ▶ **Orange**: Unimplemented

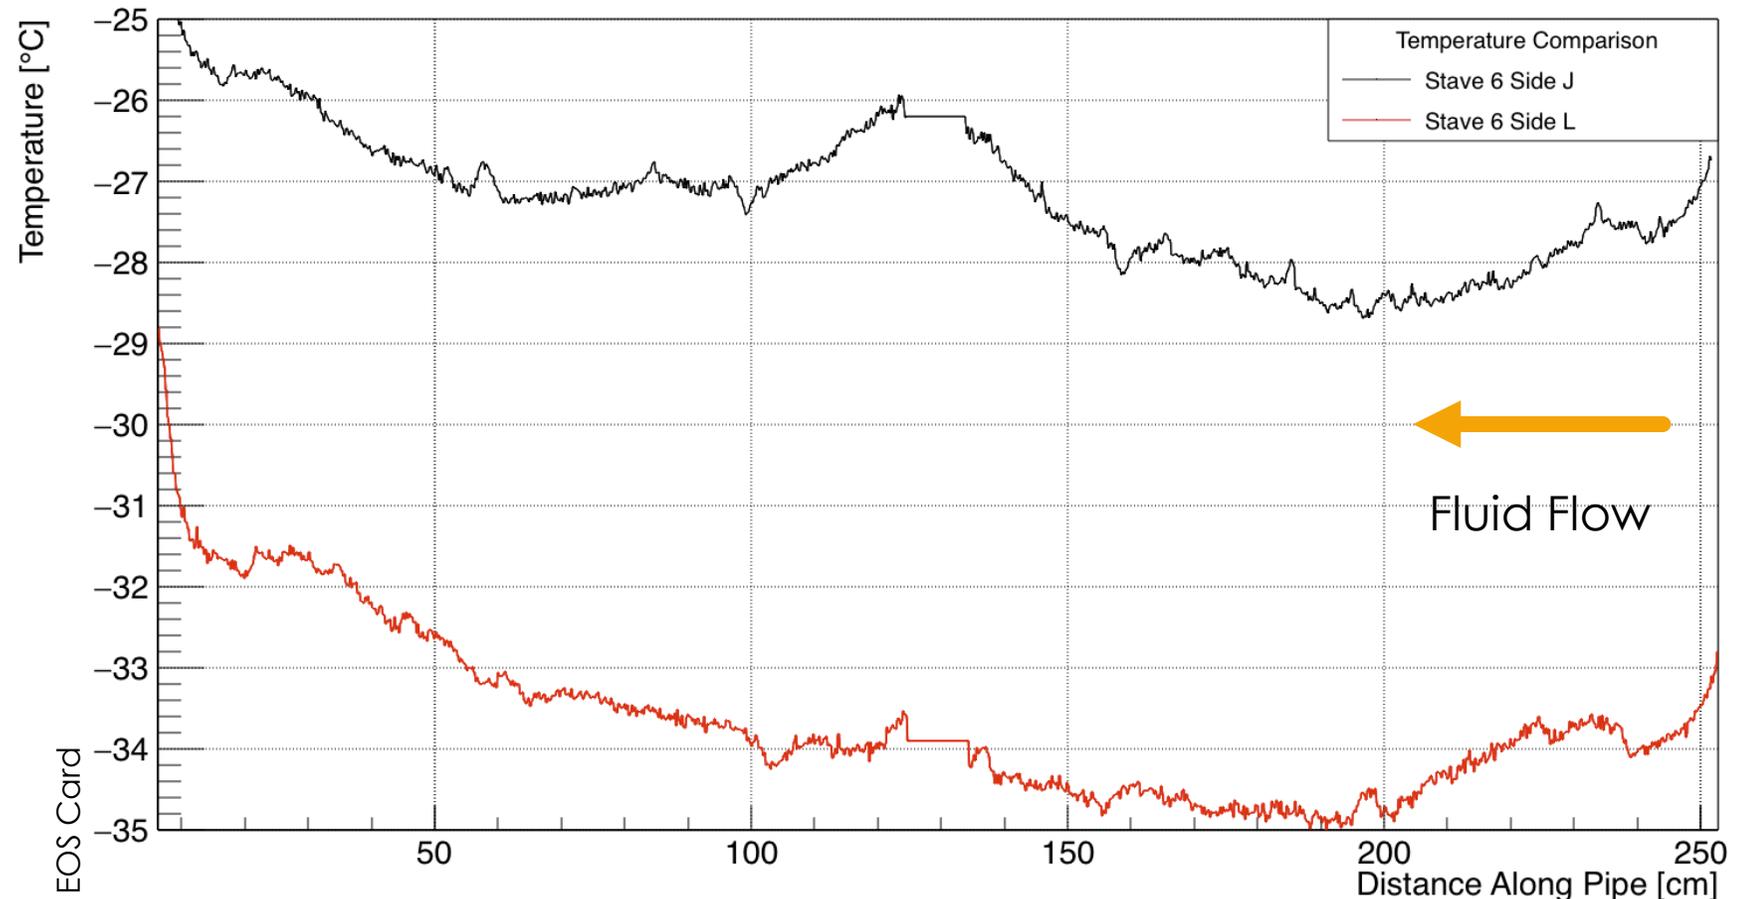
Stave 6: Thermal Measurement Cold

- ▶ Thermal measurements were taken on both sides of the stave with -40°C fluid flowing into the stave core
- ▶ Dry nitrogen was turned off at least 10 minutes before measurements were taken
- ▶ The large differences are due to slight differences when the measurements were taken and how long the system had been at low temperature.
 - ▶ Next set of studies will be to find what needs to be kept constant to get identical results
- ▶ The defect finder found no flaws
- ▶ Linear Fit RMS was found
 - ▶ J Side: 0.6 C
 - ▶ L Side: 0.6 C

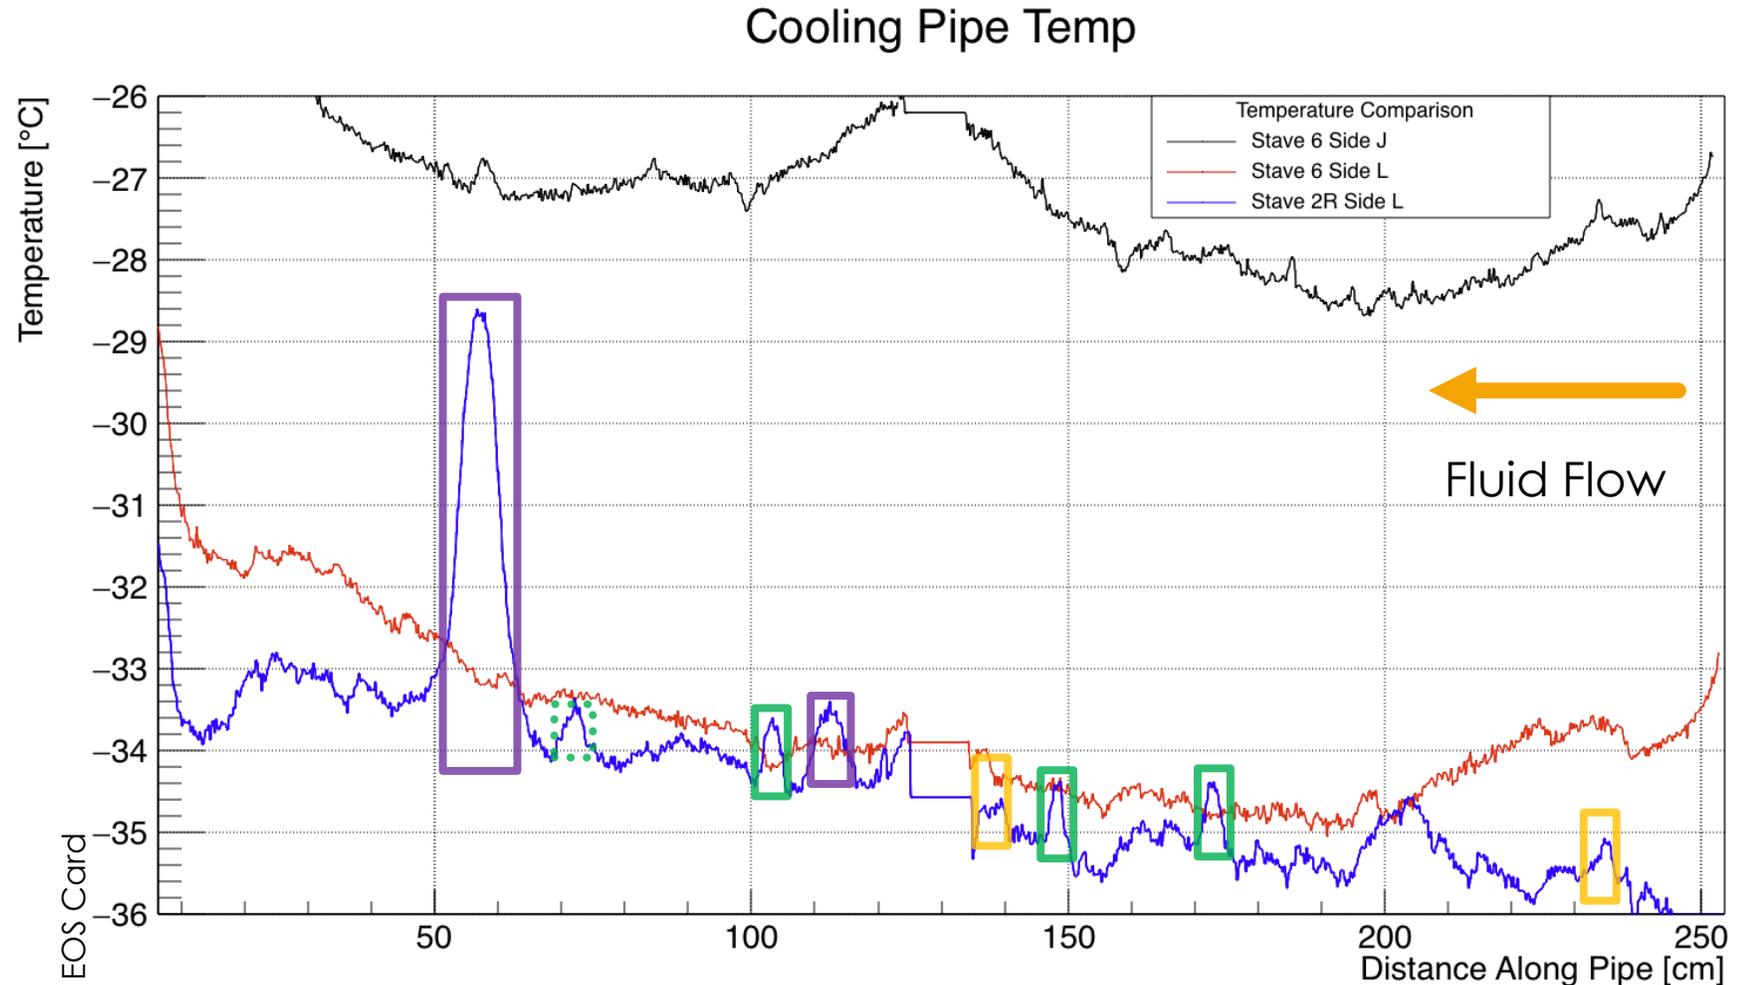
Stave 6 Comparison with Stave 2R Cold

- ▶ This is a comparison between stave 6 and 2R with -40C fluid flowing
- ▶ Profiles are more chaotic...
- ▶ The defects found are boxed on the 2R profile
 - ▶ **Purple:** Pipe-Foam
 - ▶ **Green:** Foam-Facing
 - ▶ **Green Dotted:** Partial Foam-Facing
 - ▶ **Orange:** Unimplemented

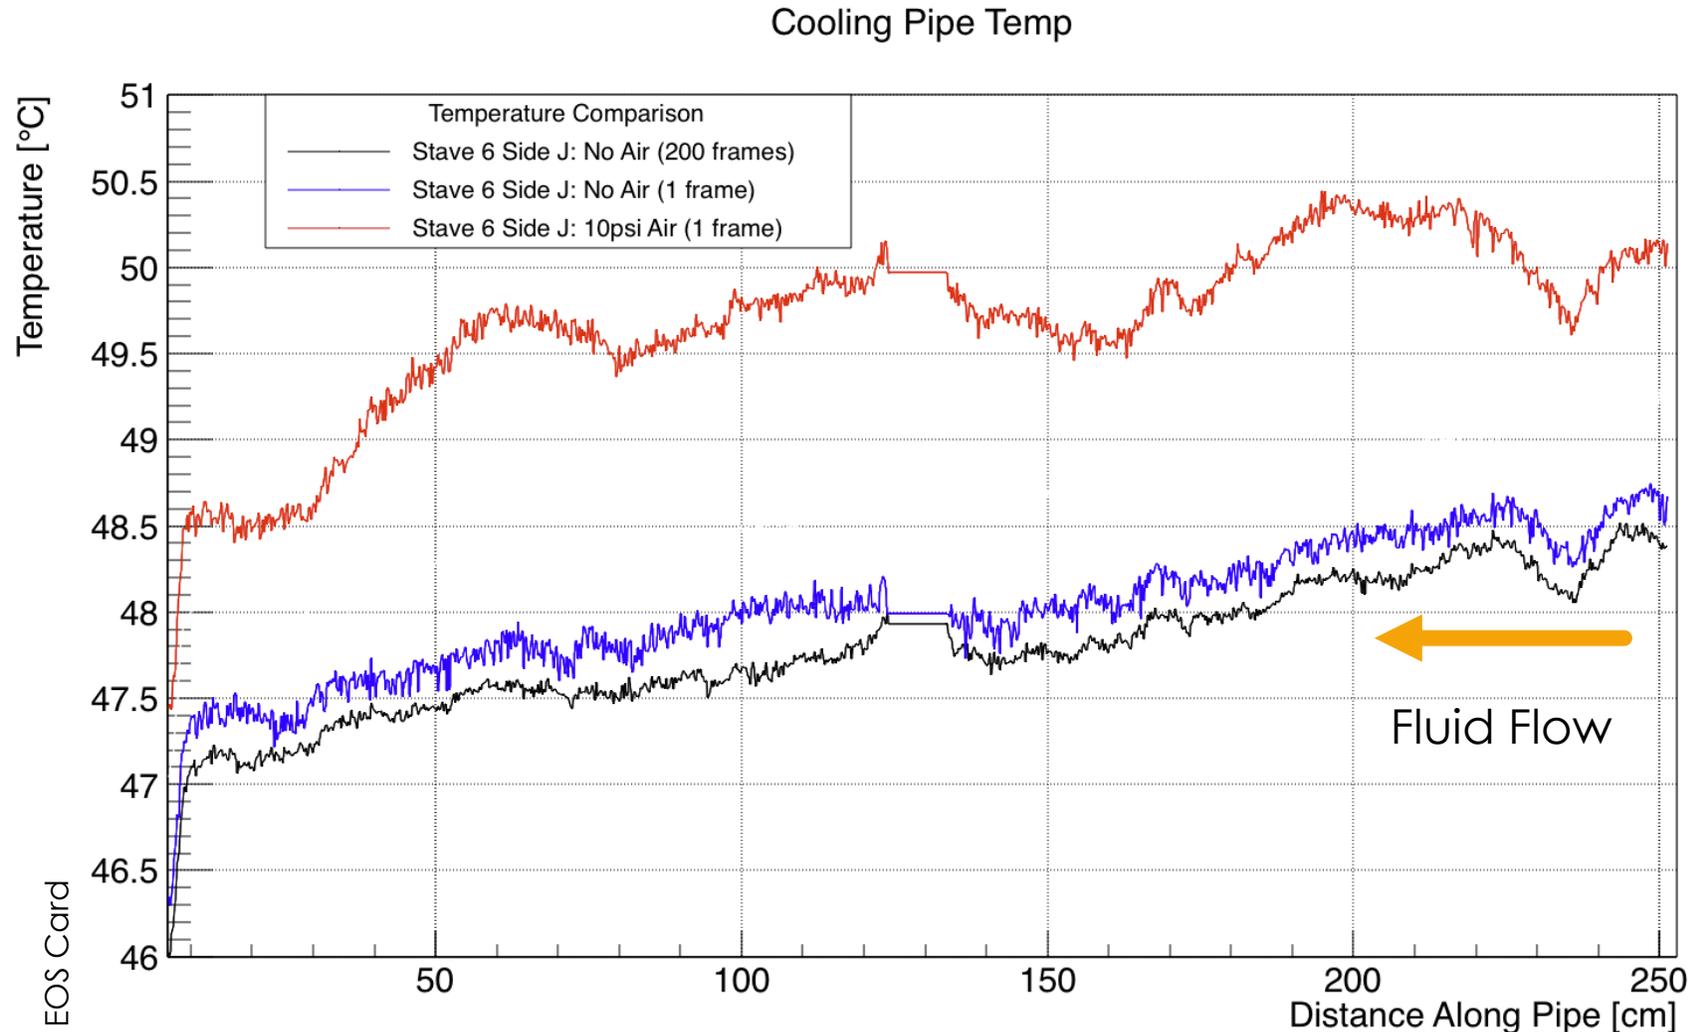
Stave 6: Air Flow Effects Hot

- ▶ To stop frosting from occurring during low temperature measurements, dry nitrogen is pumped into the enclosure.
- ▶ Air flow rate into box at 10psi: ~40 l/min
- ▶ With the nitrogen on there is a definite change of shape thermal profile
- ▶ Convection effects the baseline temperature by pulling it further away from ambient

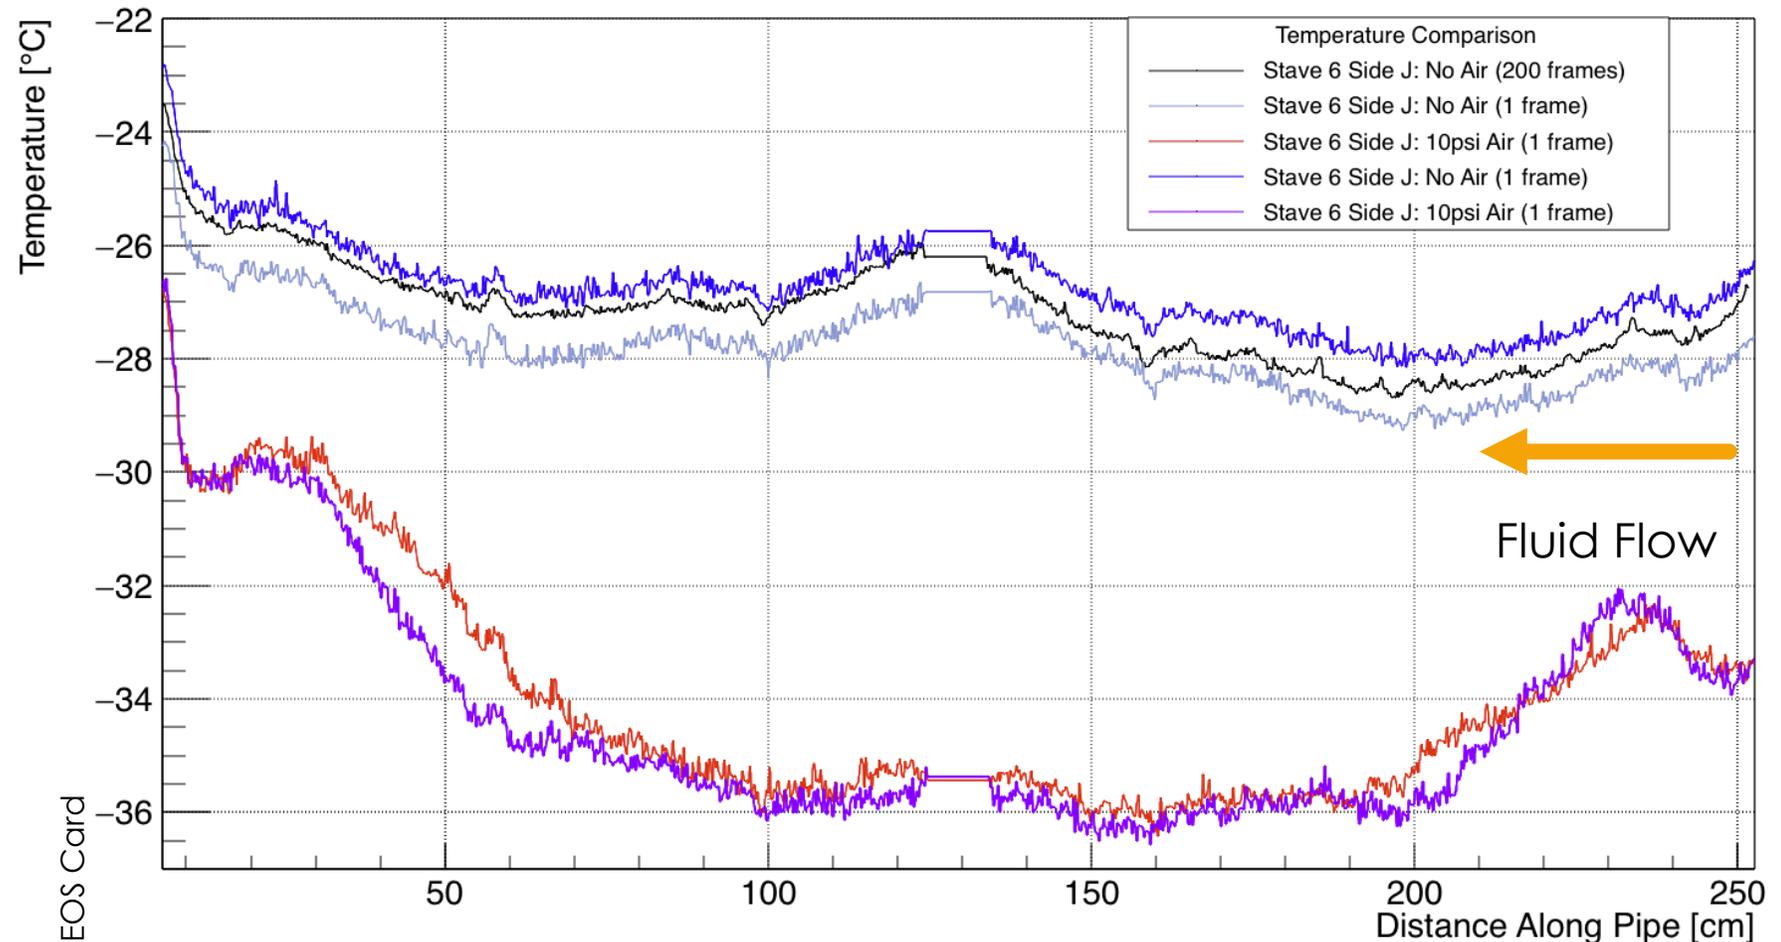
Stave 6: Air Flow Effects Cold

- ▶ Air flow rate into box at 10psi: ~40 l/min
- ▶ With the nitrogen on there is a definite change of shape thermal profile
- ▶ Convection effects the baseline temperature by pulling it further away from ambient
- ▶ If you were to timestamp each measurement
 - ▶ Red: T = 0 min
 - ▶ Grey: T = 33 min
 - ▶ Black: T = 35 min
 - ▶ Blue: T = 36 min
 - ▶ Purple: T = 69 min

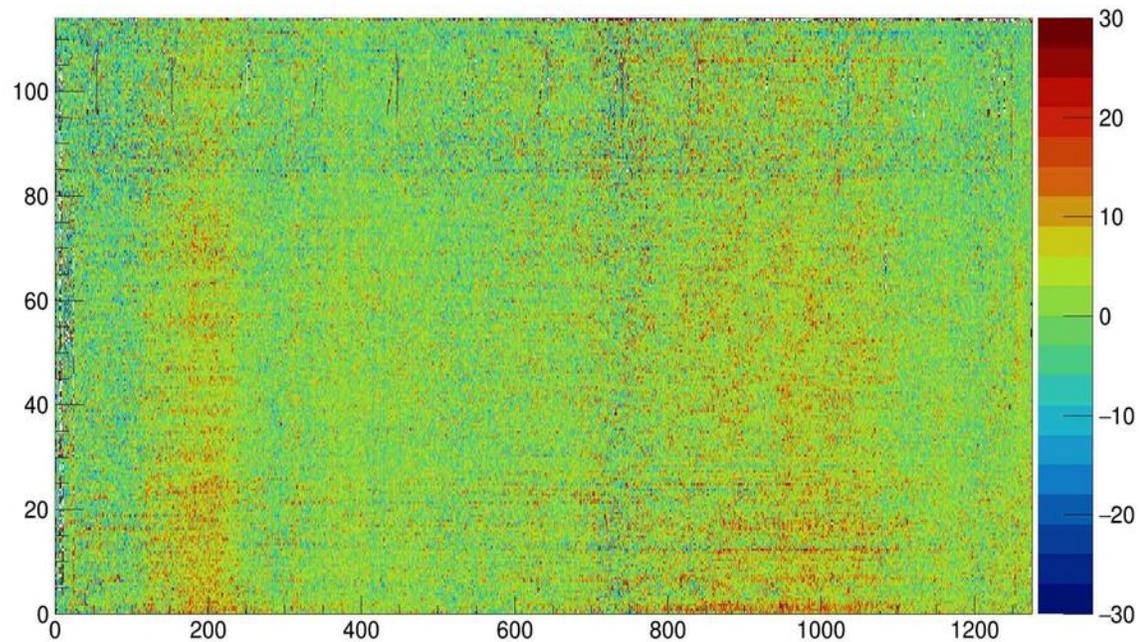
L side 5-0psi

Stave 6: Full Support Pressure Test (10 supports on both sides of the stave)

RMS: 7.4

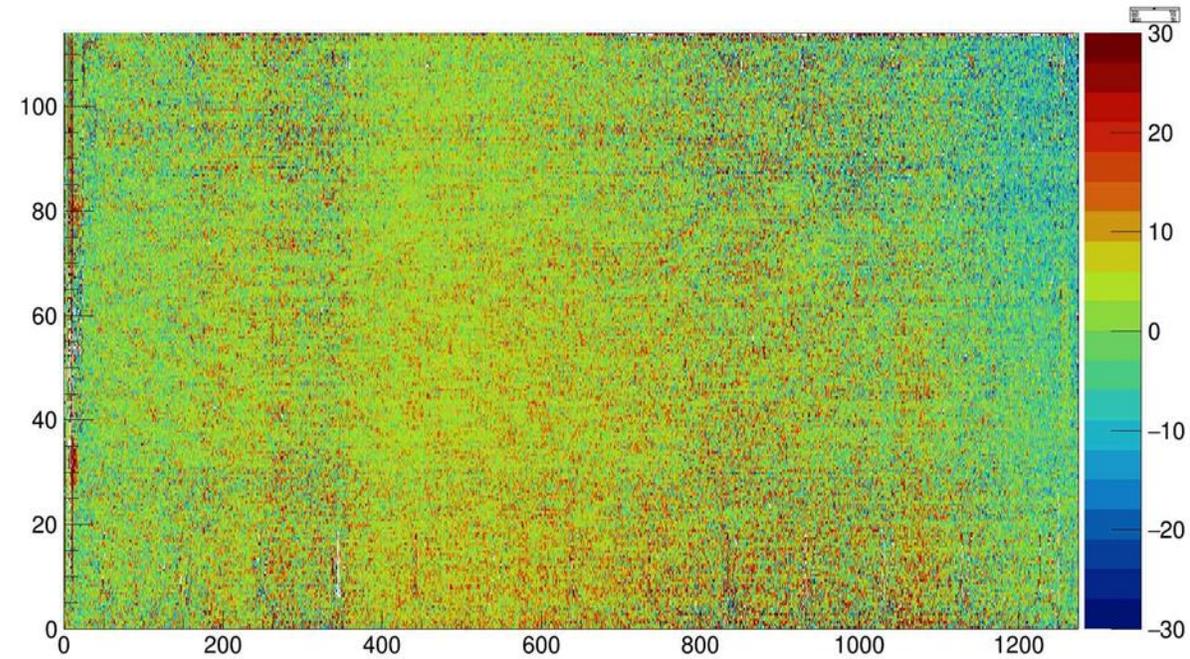
J side 5-0psi

RMS: 9.4

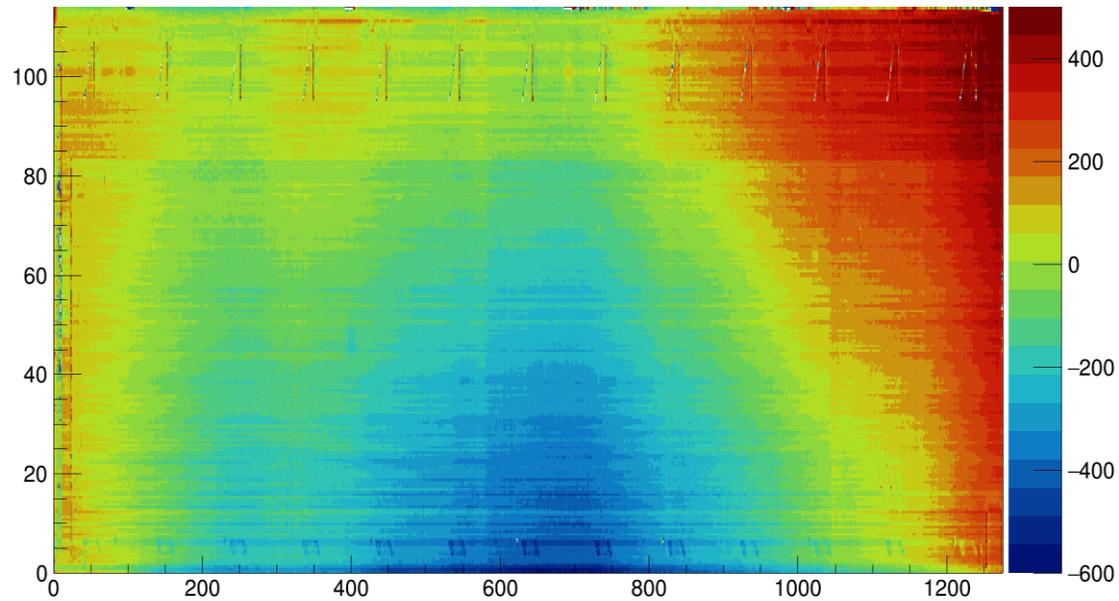
L side

Stave 6: Edge Support

(5 supports one side, 2 supports on other side)

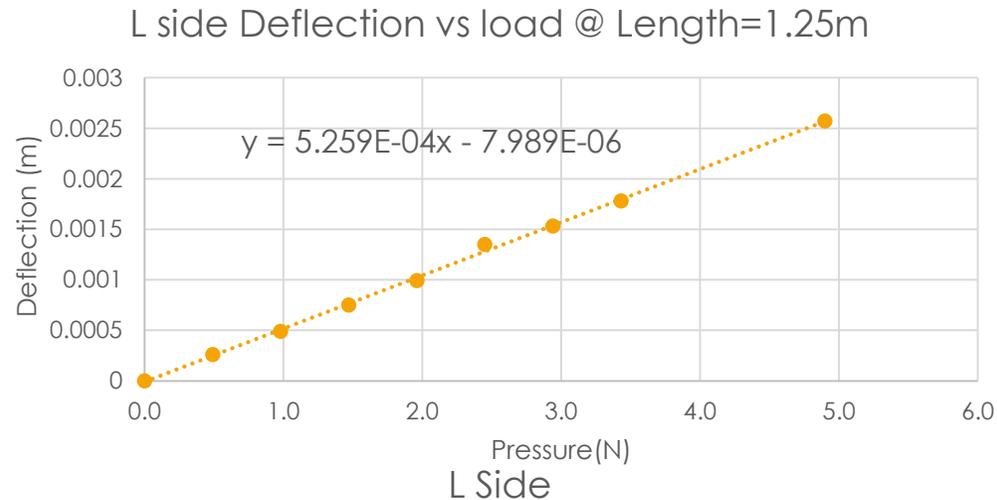
The deflection versus load was measured for each length

$$L \text{ Side : } D = \frac{1}{48 \times 2.54E - 4} = 82.01 (N m^2)$$

$$J \text{ Side : } D = 79.87 (N m^2)$$

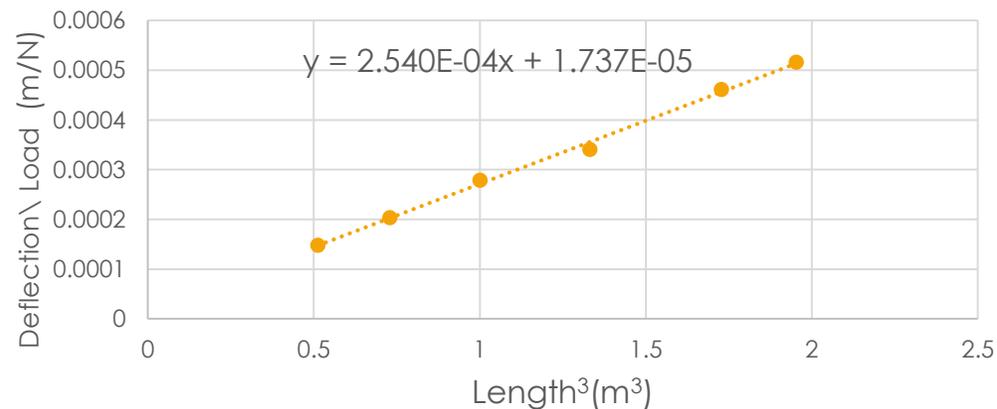
The deflection was measured with different loads at several fixed lengths

$$\delta = \frac{1}{48D} L^3 P$$

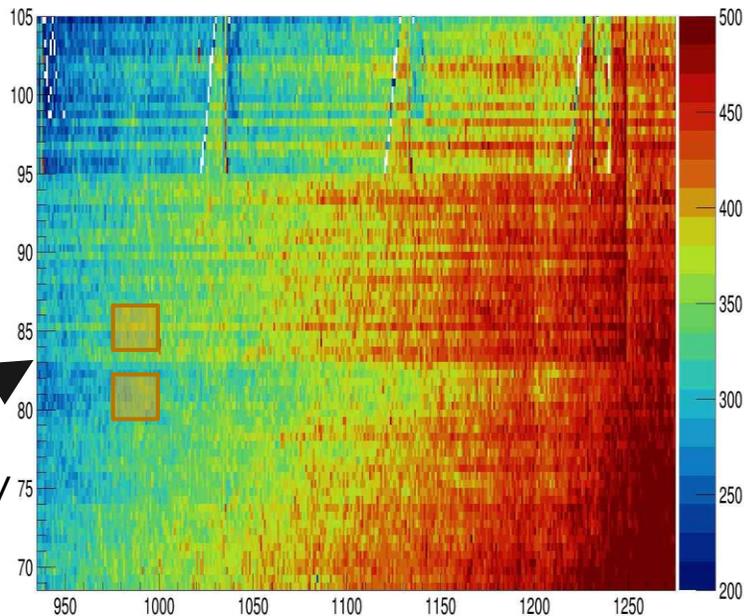
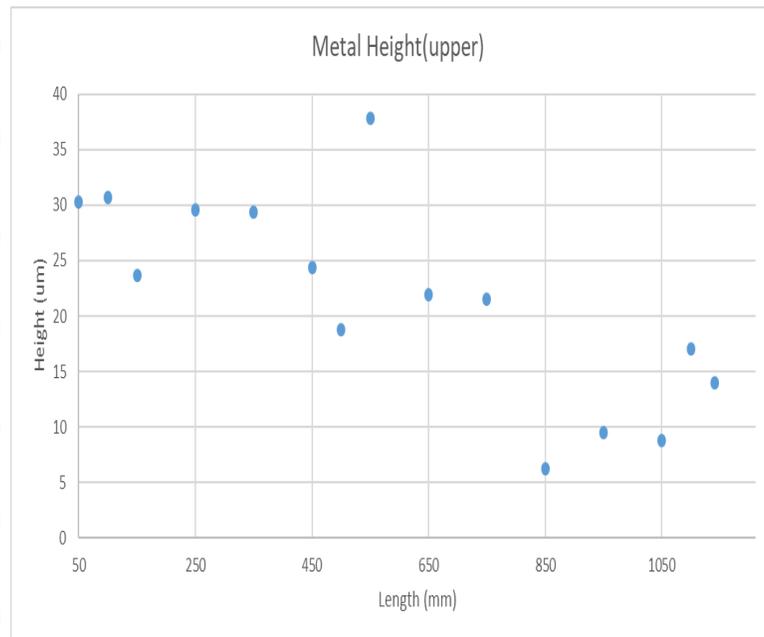
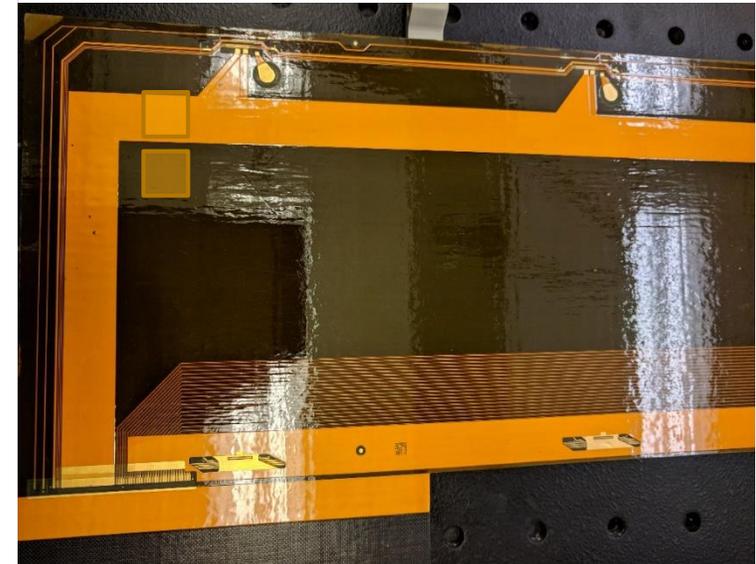
Stave 6: Metal Height (upper)

Method: Two $3 \times 3 \text{ (mm}^2\text{)}$ squares were chosen across from the boundary and the difference of the averaged values were calculated.

Same area height difference
~8μm

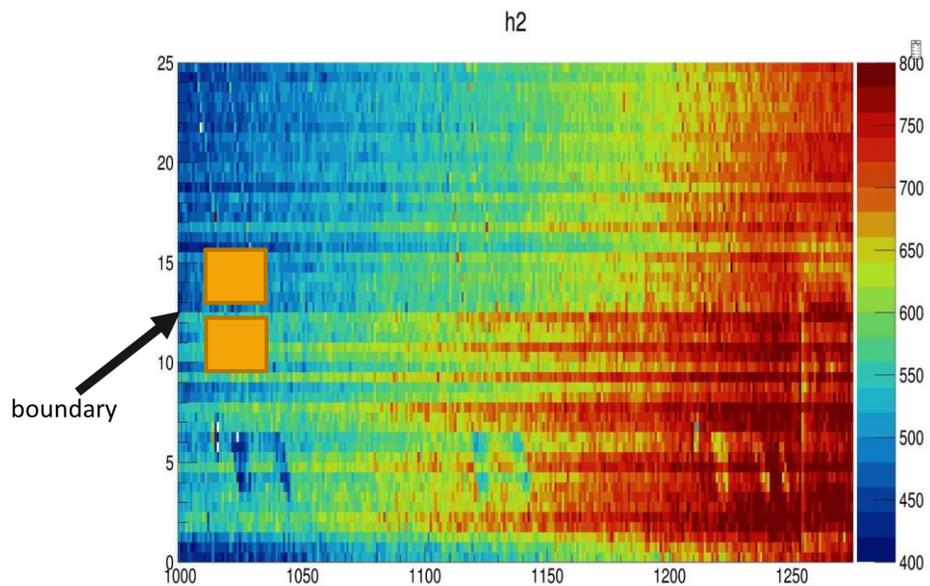
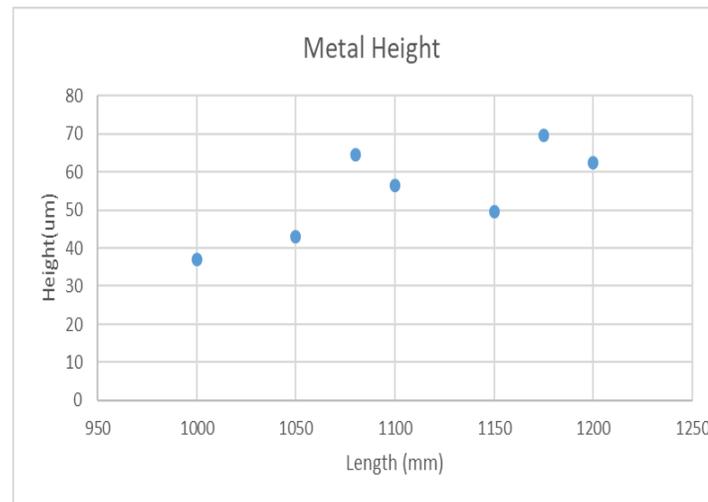
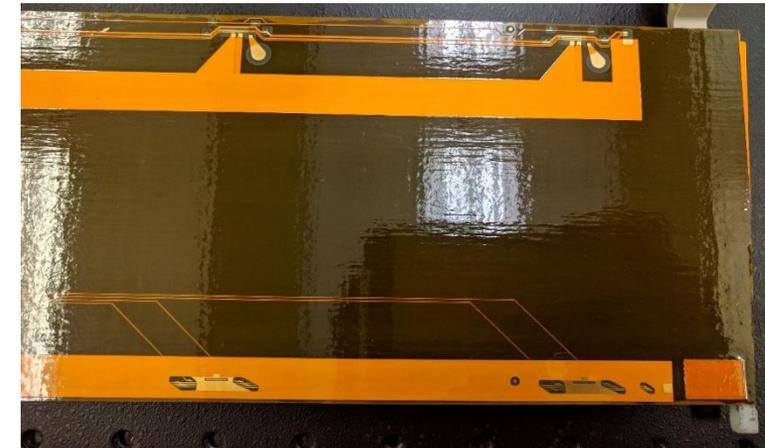
Stave 6: Metal Height (lower)

Same area height difference ~14um

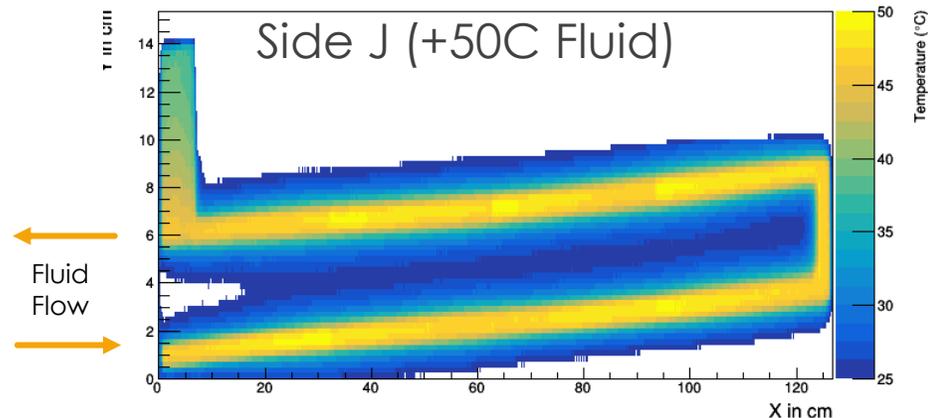
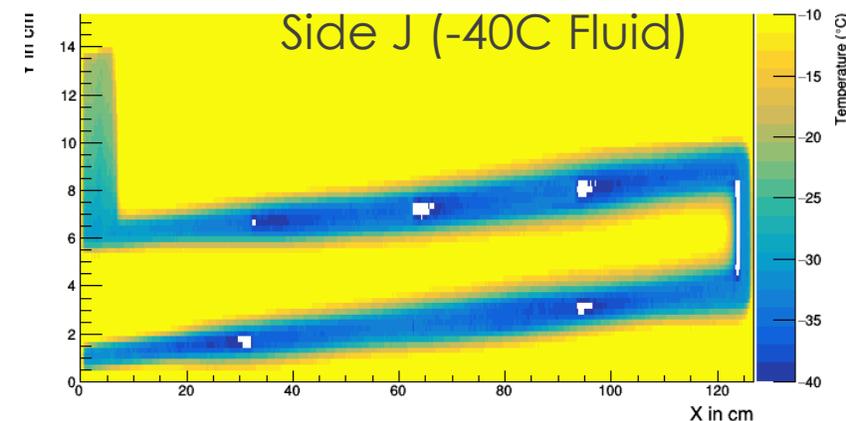
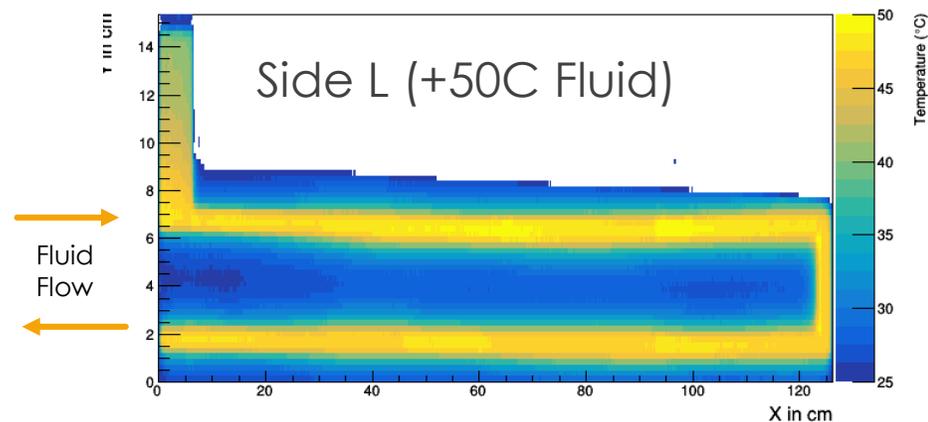
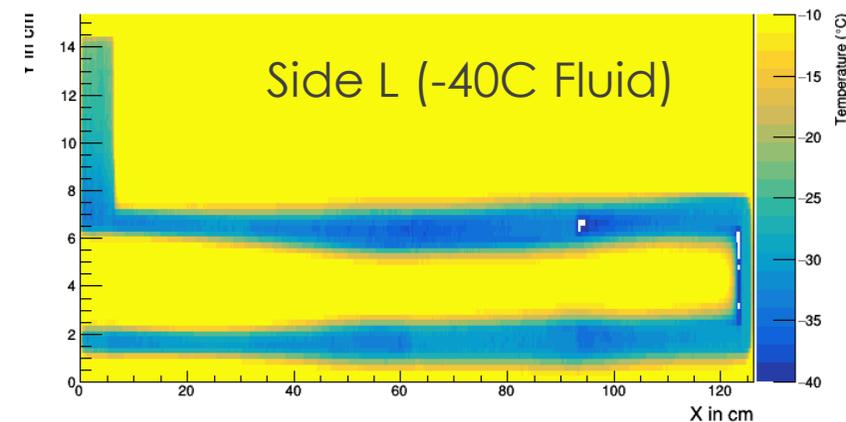
Pipe-Foam Stave: Thermal Measurements (Thermal images)

- ▶ Use similar procedure as mentioned (slide 3) for data conversion
- ▶ Emissivity problems
 - ▶ All profile plots use a thermal data conversion with emissivity = 0.73
 - ▶ This is not correct. Small swings in the value (+0.06) can contribute to large absolute changes
 - ▶ >1 C with high temp fluids
 - ▶ >5 C with low temp fluids
 - ▶ Does not significantly affect the relative shapes of the profile

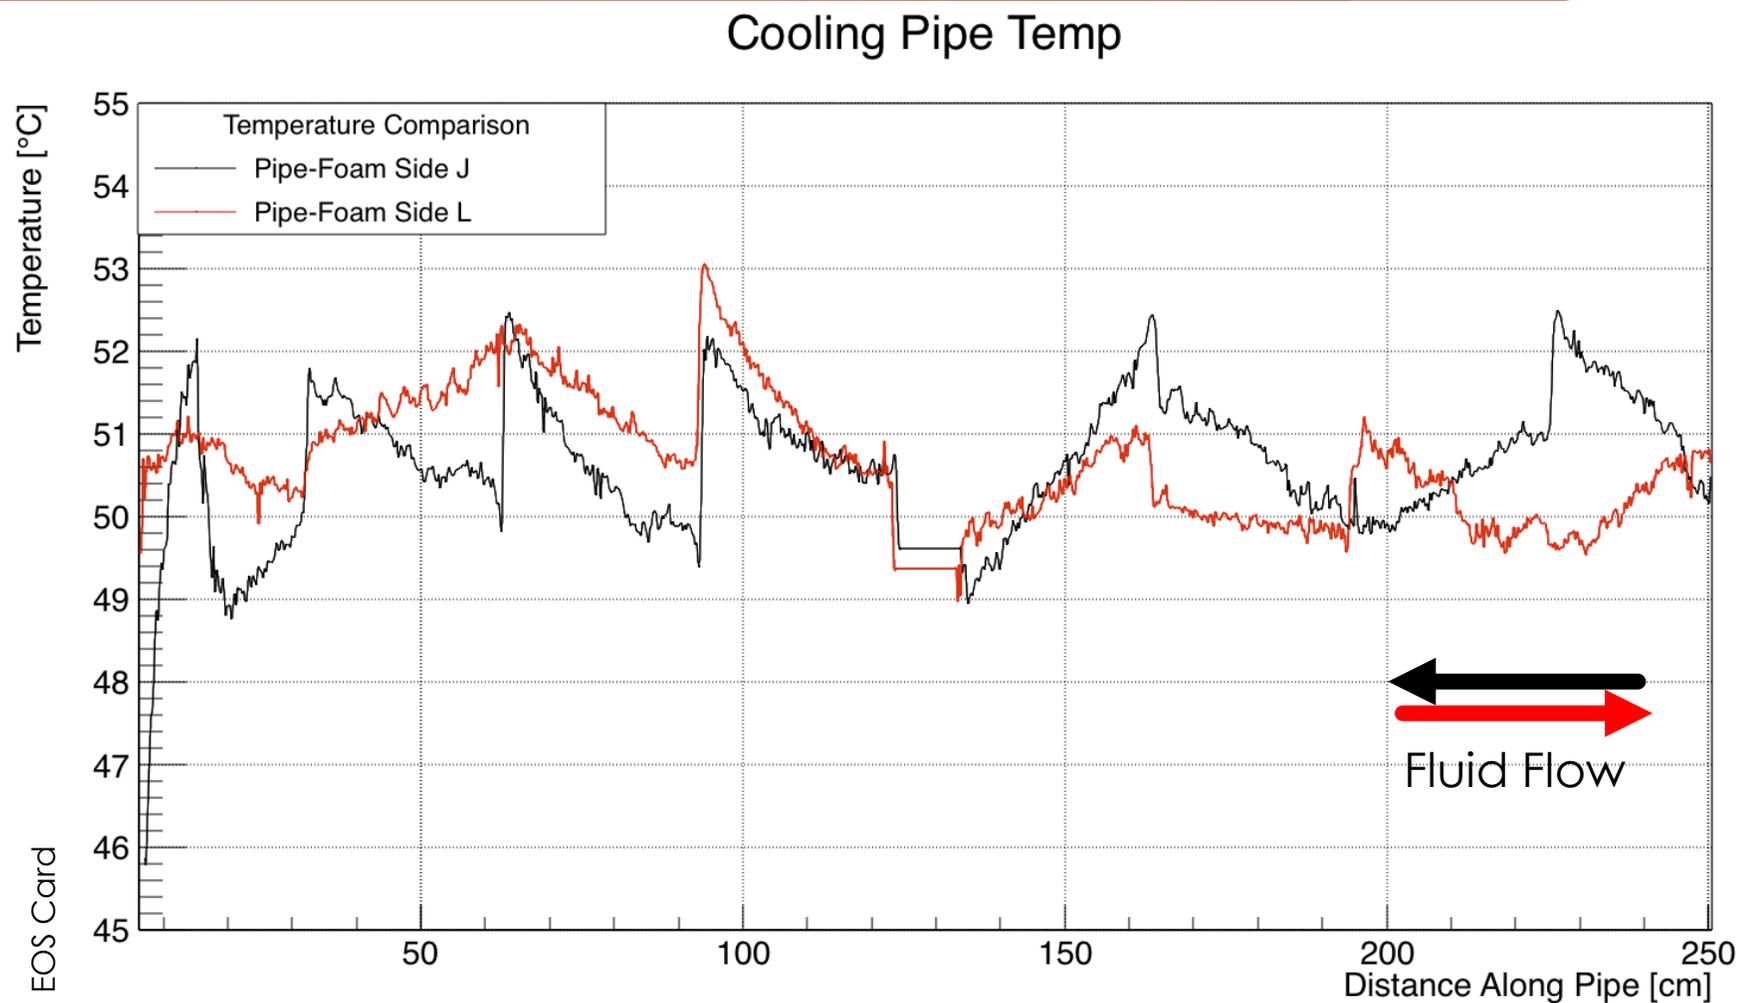
Pipe-Foam Stave: Thermal Meas. Hot

- ▶ Hot fluid at around 50C is being pumped through the stave at a rate of around 1 l/min
- ▶ Each individual foam chunk that has been viewed through the camera has a distinct sloped chunk of the profile.
- ▶ Depending on the flow direction the end of stave card has different effects on the profile

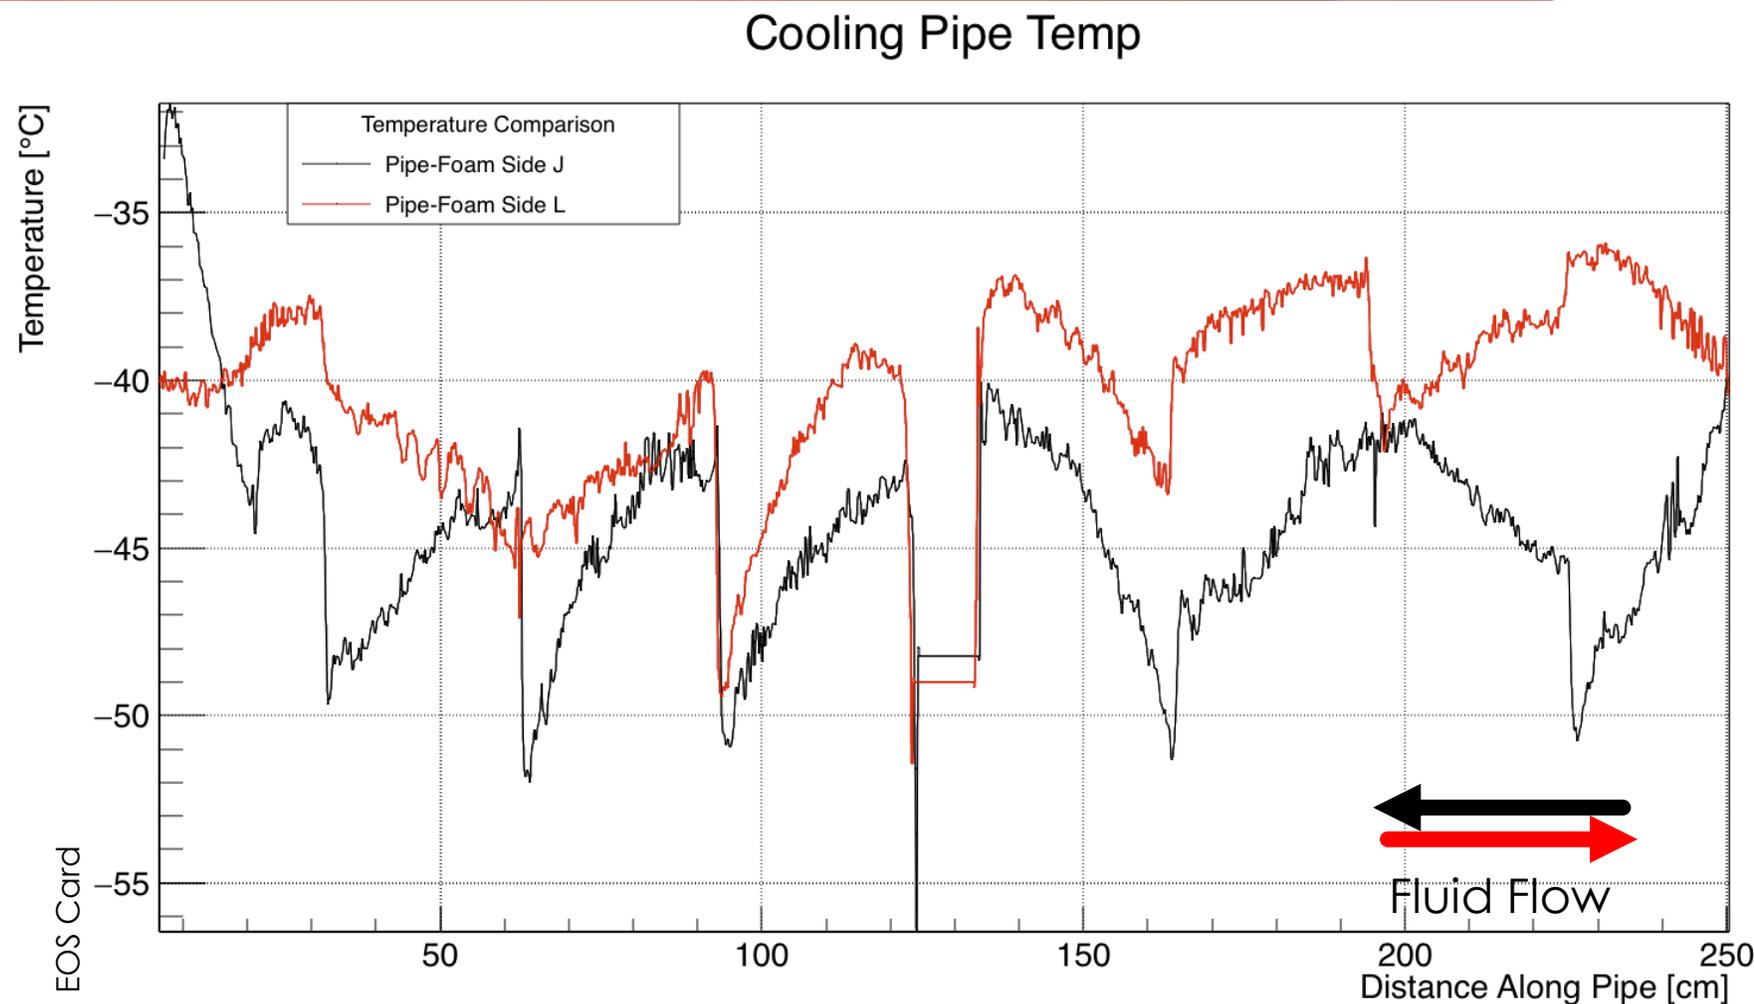
Pipe-Foam Stave: Thermal Meas. Cold

- ▶ Cold fluid at around -40C is being pumped through the stave at a rate of 1 l/min
- ▶ Parallels structures seen in the hot temperature profile
