Update: ISU Stave Core QA

ISU WEEKLY STAVE QA MEETING

APRIL 27, 2018

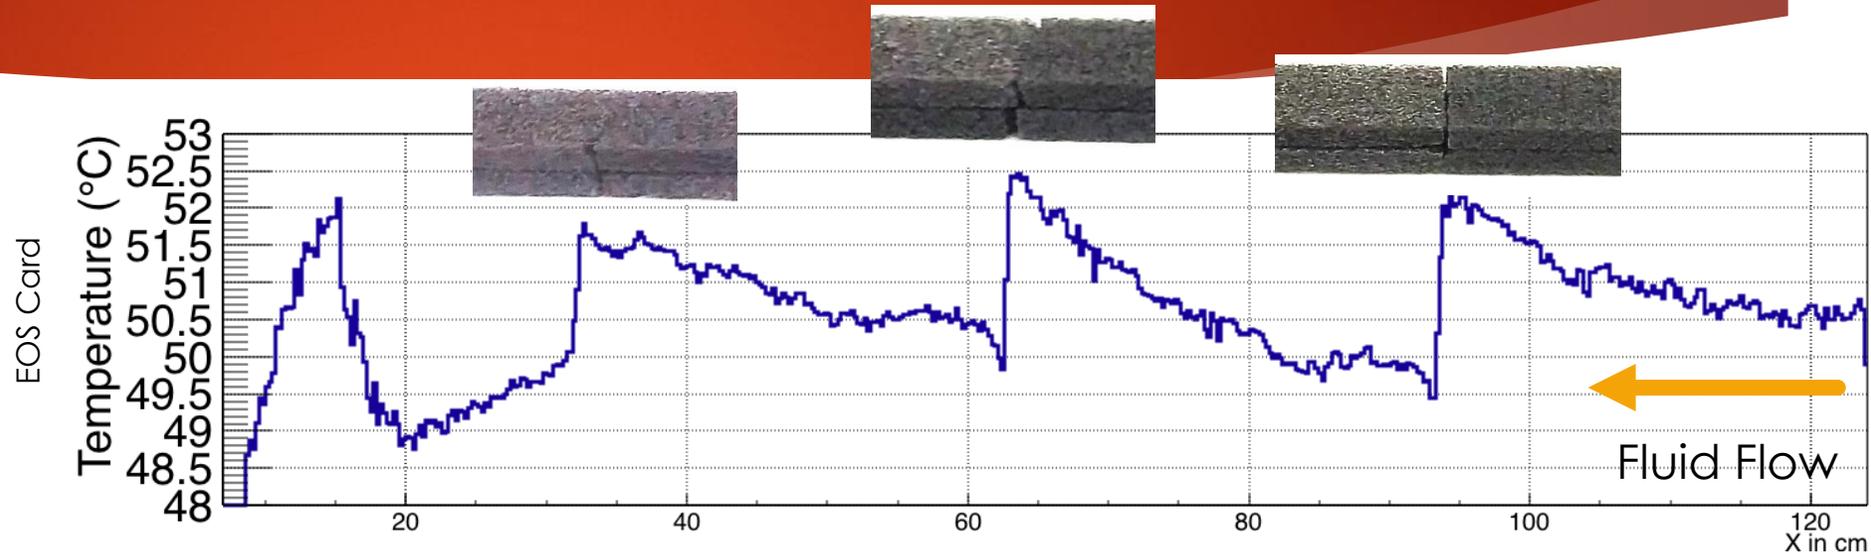
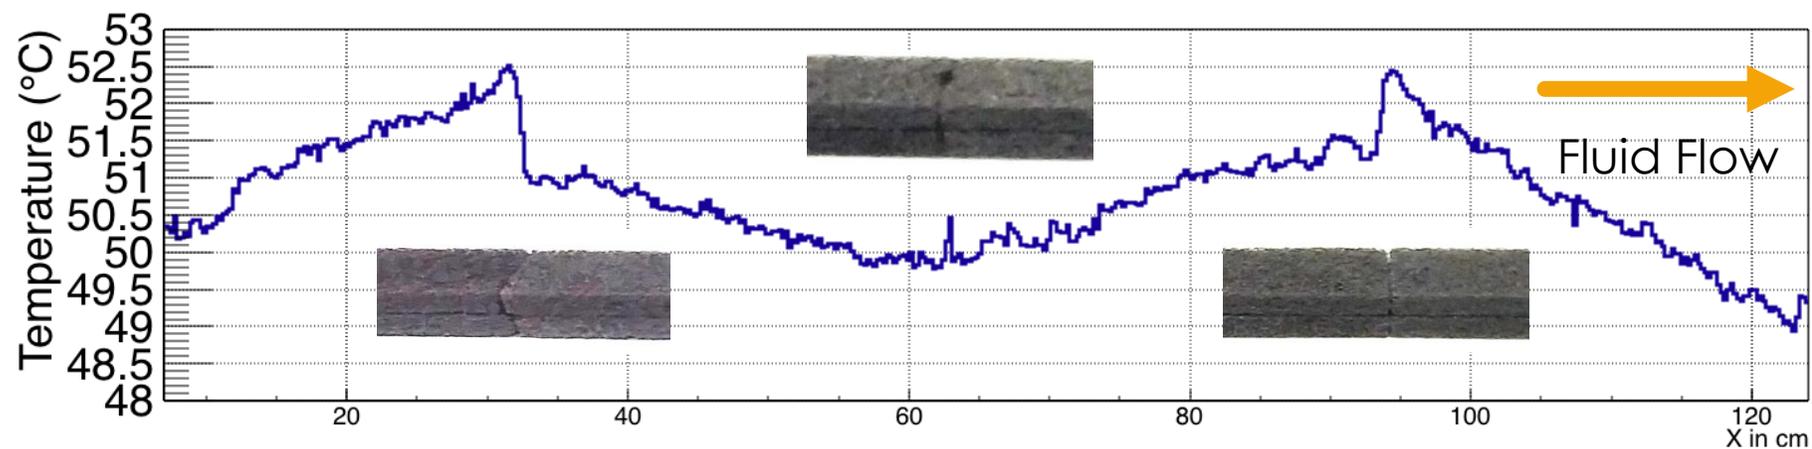
Pipe-Foam Stave: Comparisons with Structure J Side

- ▶ At each of the 3 seams in the foam the peak is seen corresponding to a crack in the foam.
- ▶ The smoothest transition is where the glue has seeped out of the crack
- ▶ These changes in slope could be due to differing emissivity along the foam?

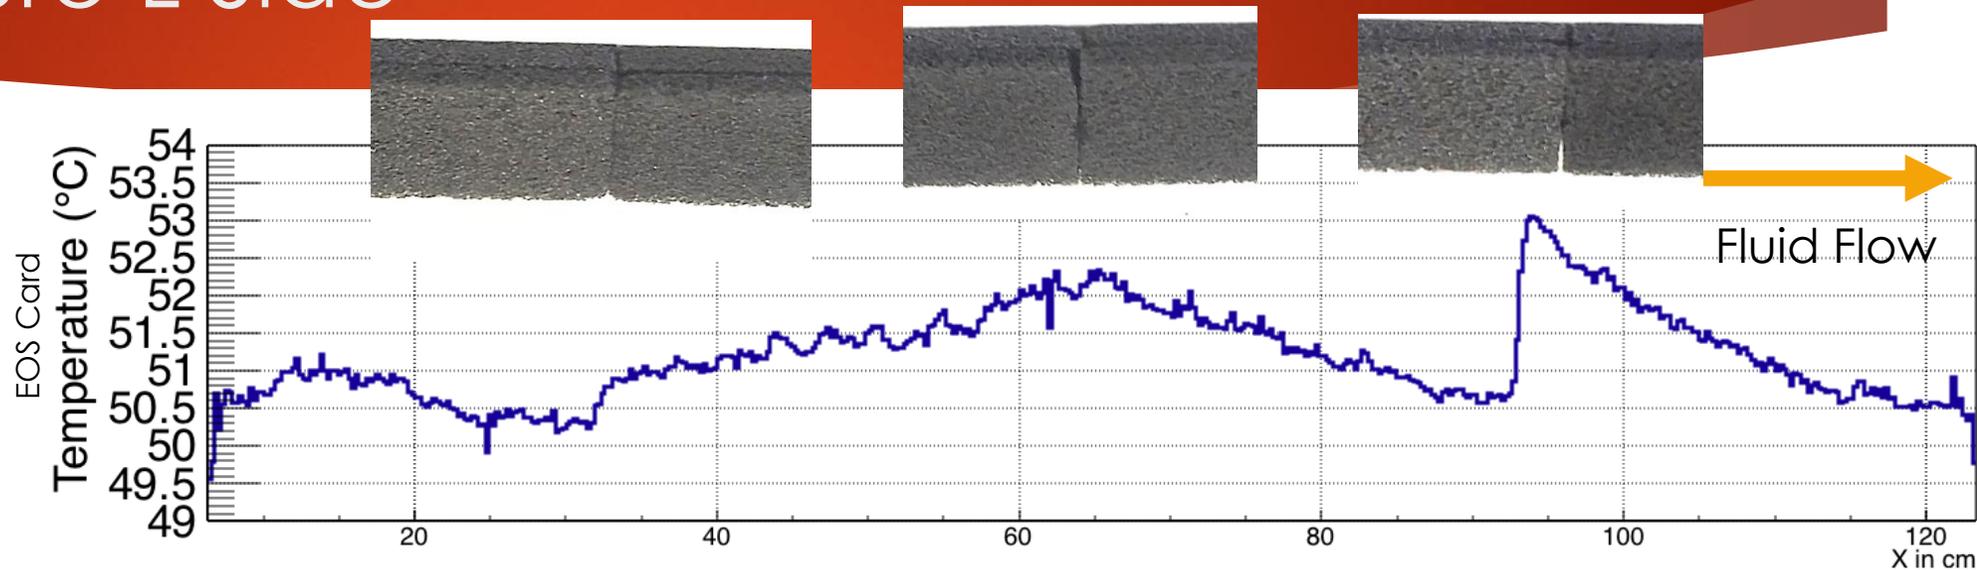
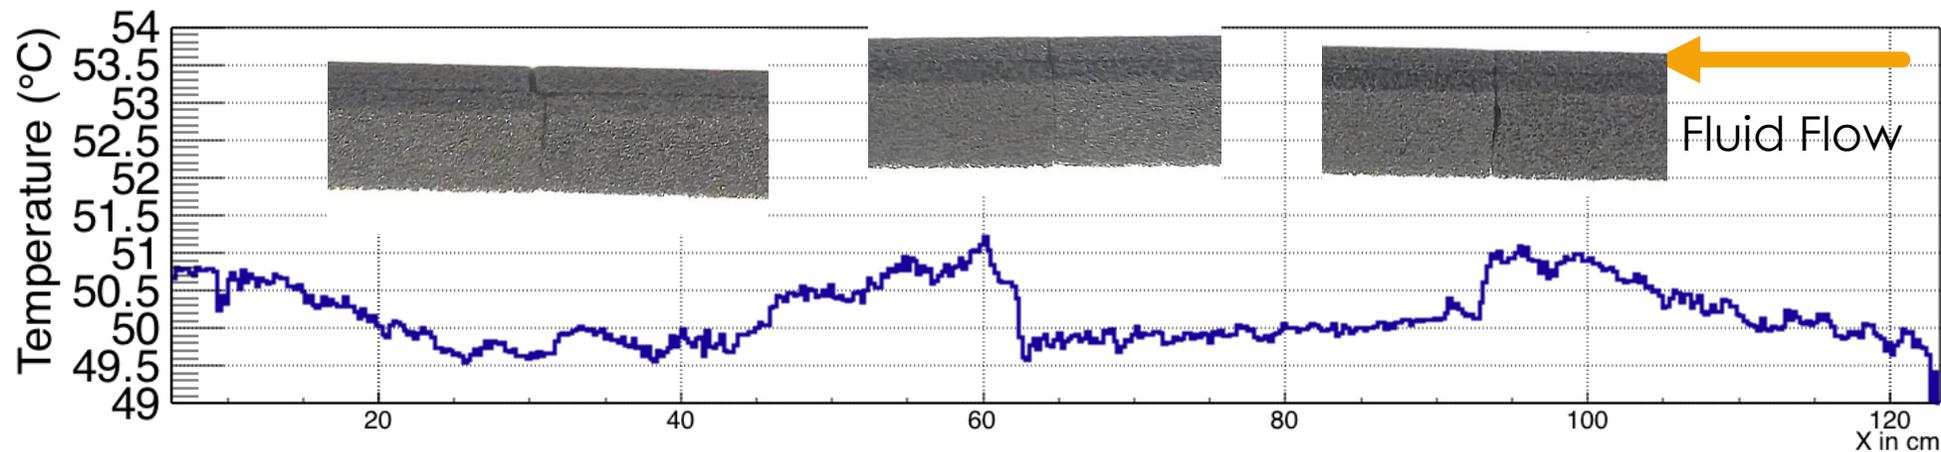
Pipe-Foam Stave: Comparisons with Structure L Side

- ▶ Each of the peaks again corresponds to foam joints. Though they are less obvious in the thermal profile
- ▶ The very obvious peak corresponds with a color change between foam chunks. (May be hard to see on the plot)
- ▶ Transitions seem smoother here than on J Side

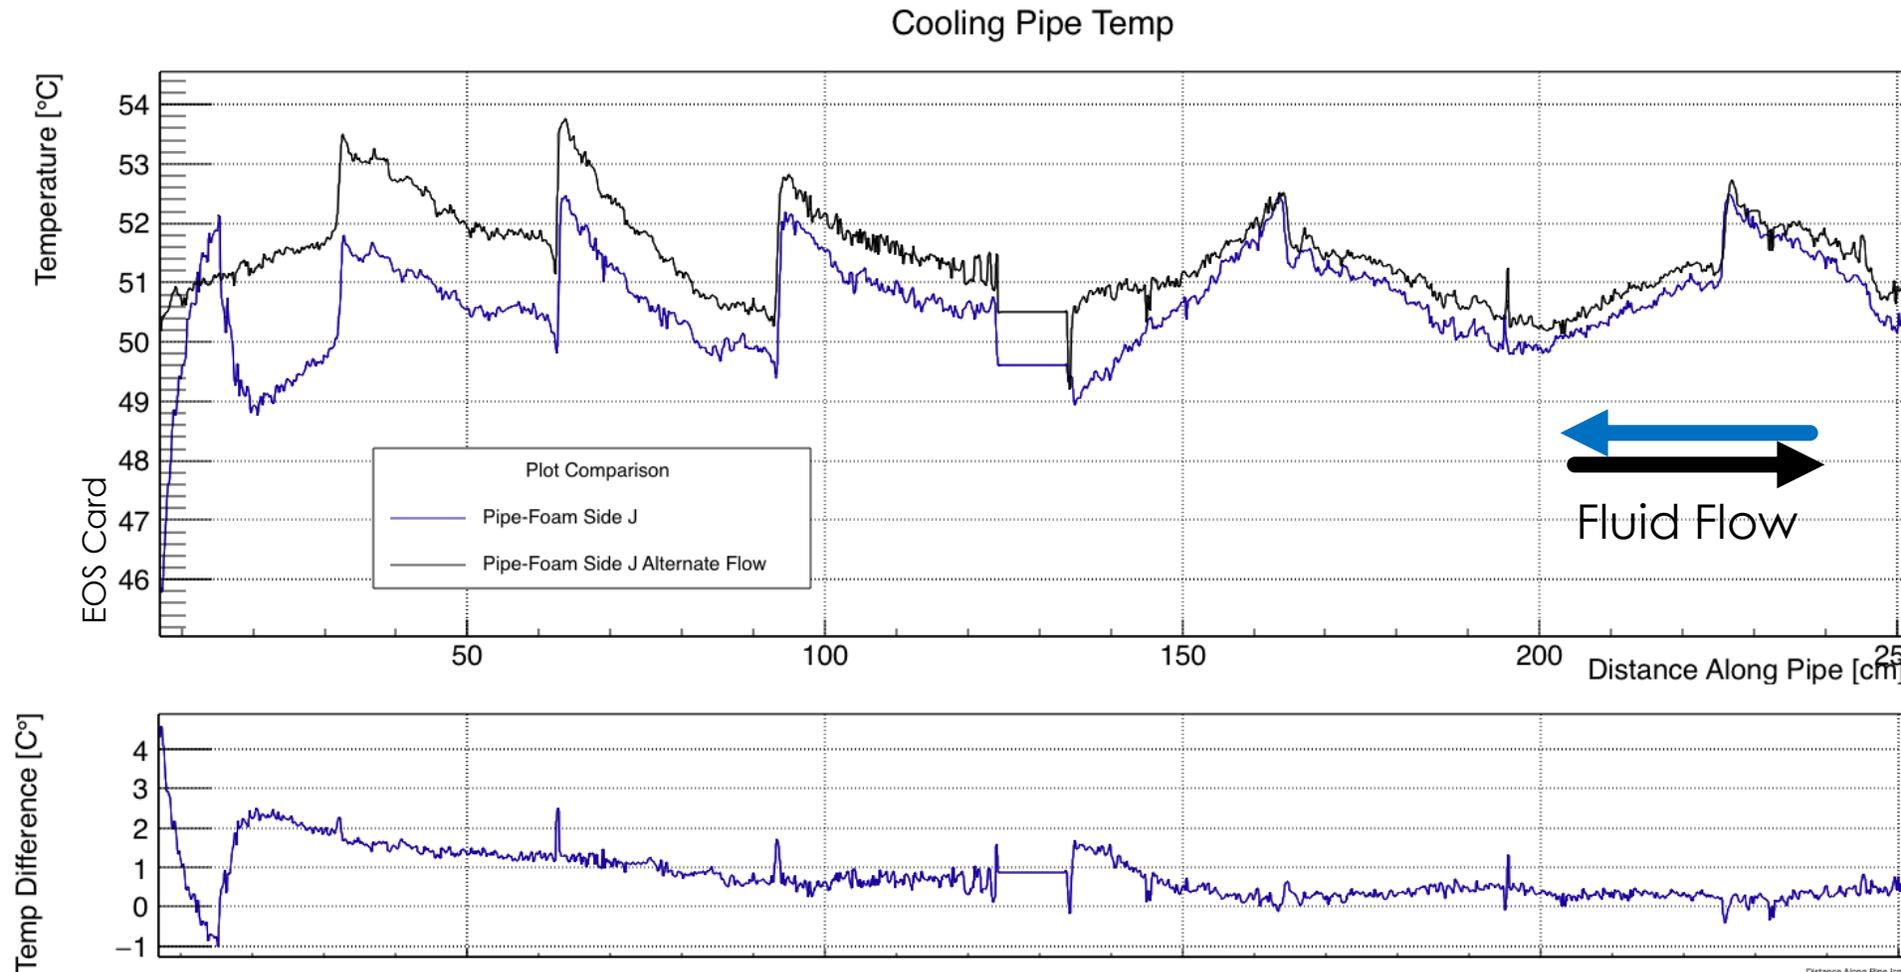
Pipe-Foam Stave: Fluid Reversal Hot

- ▶ Looking at the same image with fluid reversed has little effect on the main structure.
- ▶ Main change is located near the end of stave card

- ▶ Actual pipe-foam emissivity is much higher than what was used. Need to find a better way to measure it
- ▶ Pipe-Foam Stave has structures that are related to the foam chunks
 - ▶ Breaks between each foam chunk are clearly visible
 - ▶ Emissivity may vary along each foam chunk
- ▶ Fluid reversal has little effect on the thermal profile except near the end of stave card

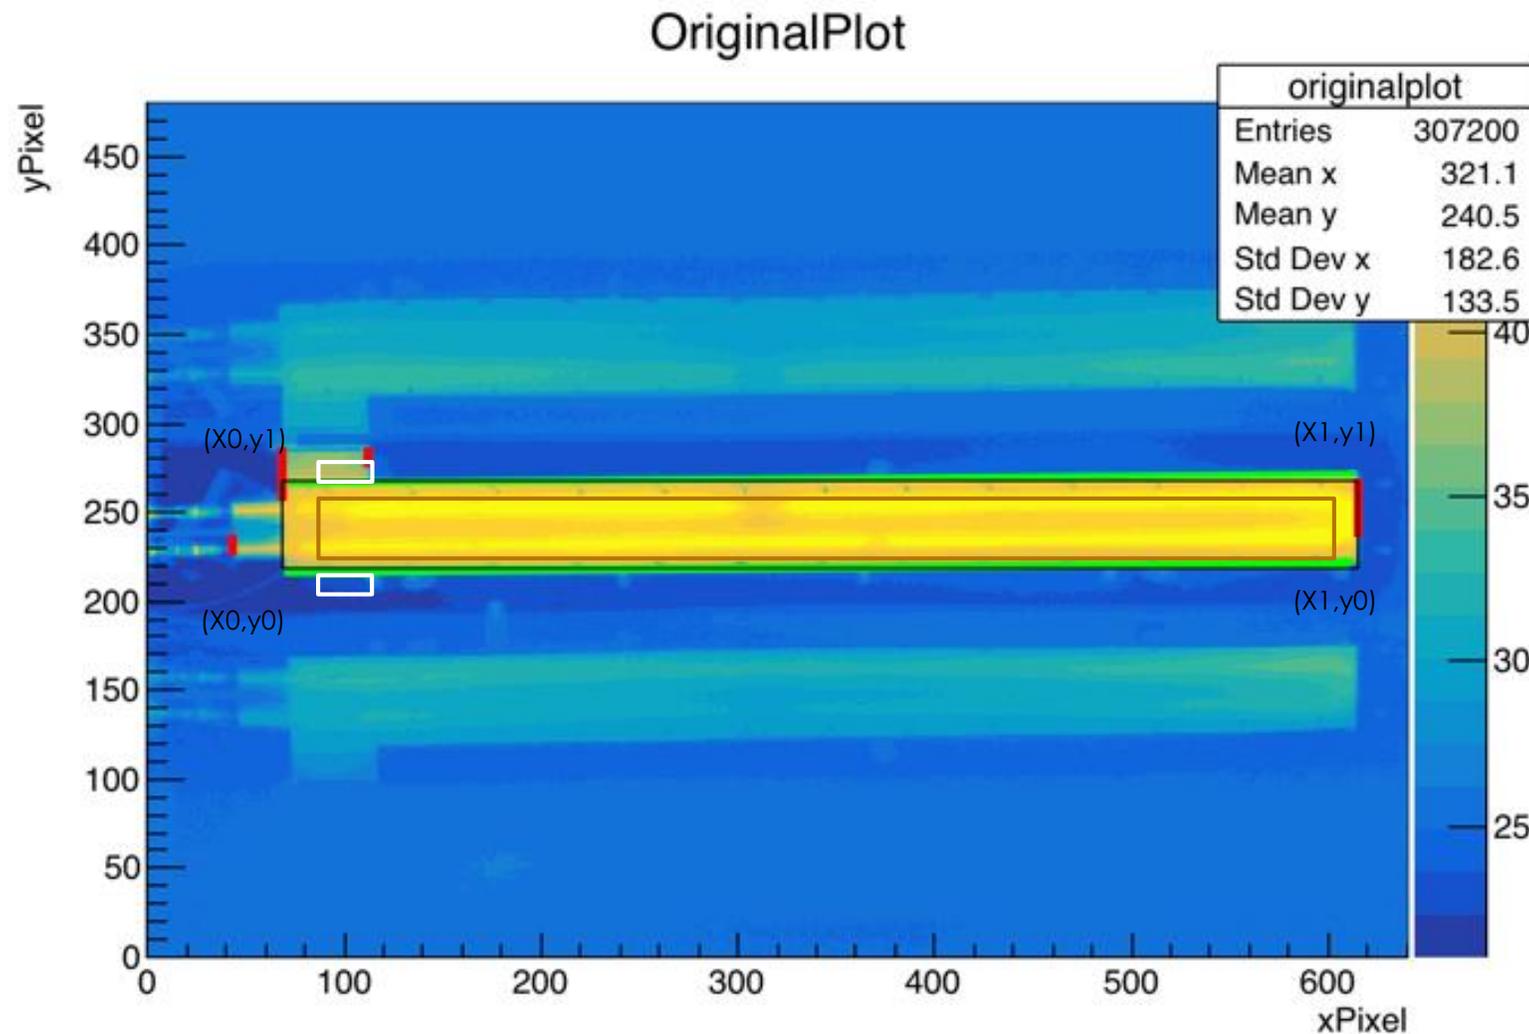
How configFinder.py works...

1. Filter image with Canny Edge Detector
2. Find long horizontal lines using Hough Lines(Green)
3. Find short vertical lines using Hough Lines(Red)
4. Determine stave area(Black)
5. Cut stave area to pipe area using predetermined percentages (Brown)
 - ▶ Cut on X_0 Cut = $X_0 + 0.05 * \text{StaveLength}$
(Removes area without foam)
 - ▶ Cut on X_1 Cut = $X_1 - 0.023 * \text{StaveLength}$
(Removes pipe turn)
 - ▶ Cuts on Y Cut = $Y \pm 0.17 * \text{StaveWidth}$
(Removes metal attachment points)
6. Determine Temperature of the stave (Hot or Cold)
 - ▶ Finds average temperature in the cut area.
Currently assumes that Hot = (ChillerSetting 50C)
Cold = (ChillerSetting -55C)
7. Determine orientation of the stave (L or J side)
 - ▶ Calculates temperature in both regions(White) and compares the average to the stave temperature to find the orientation

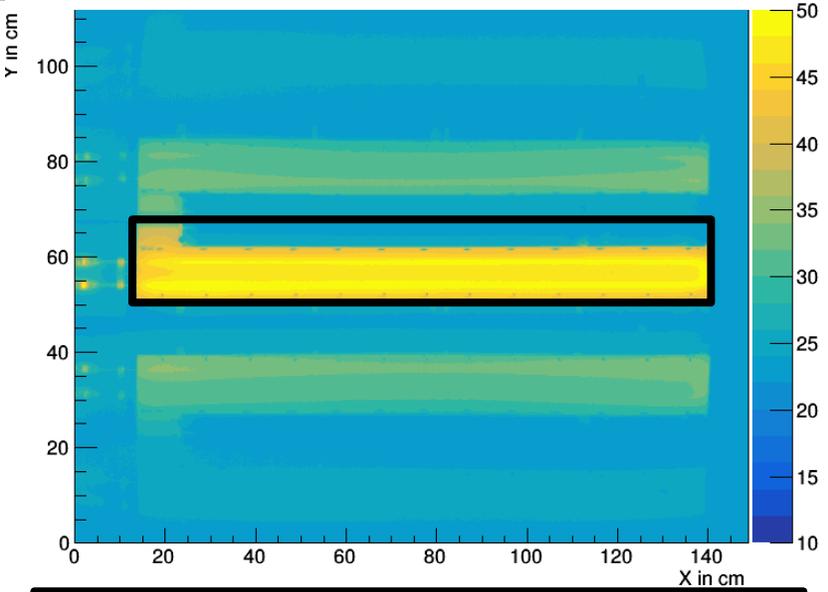
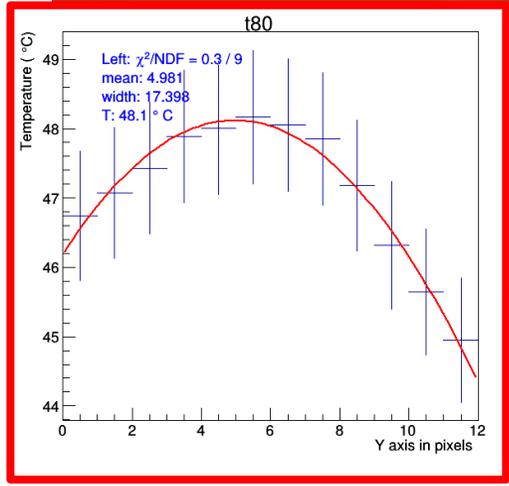
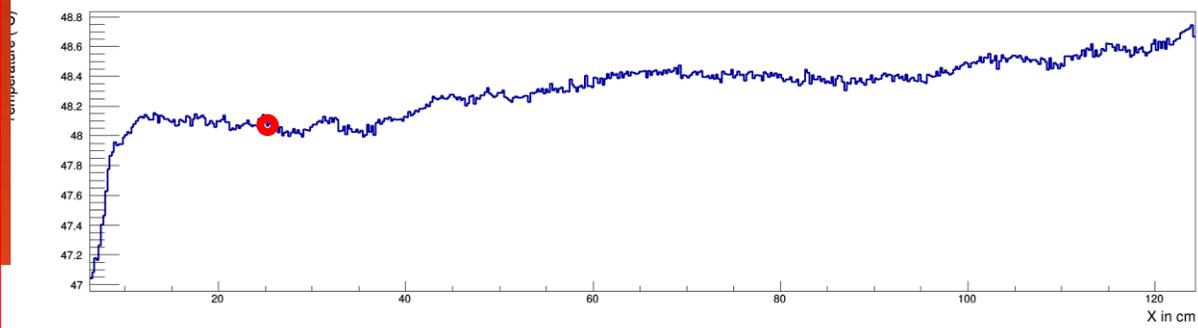
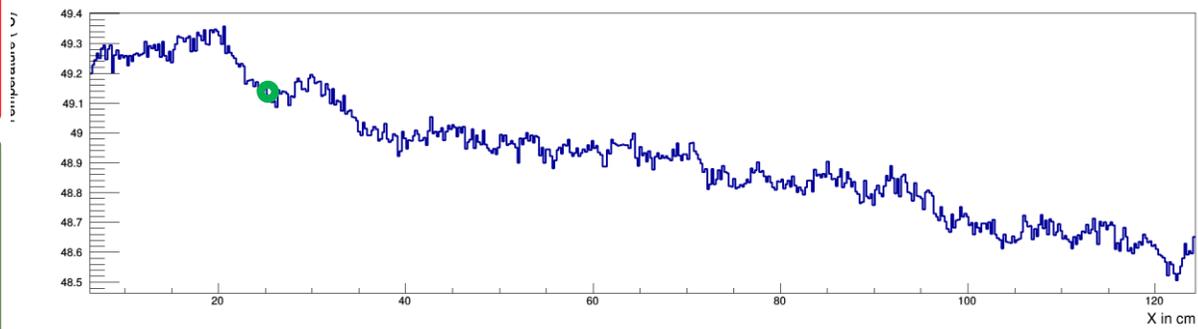
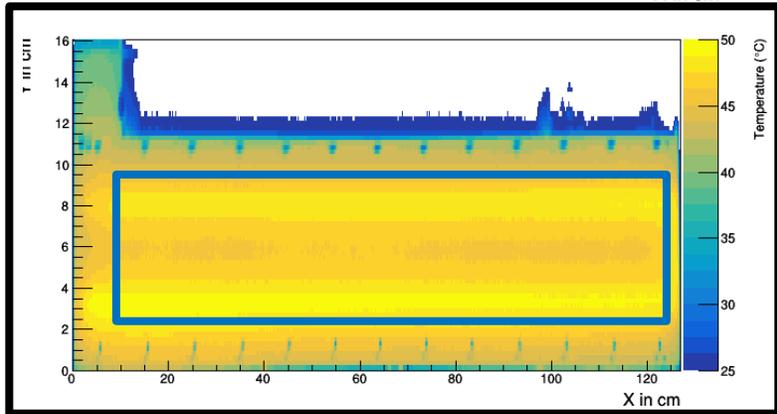
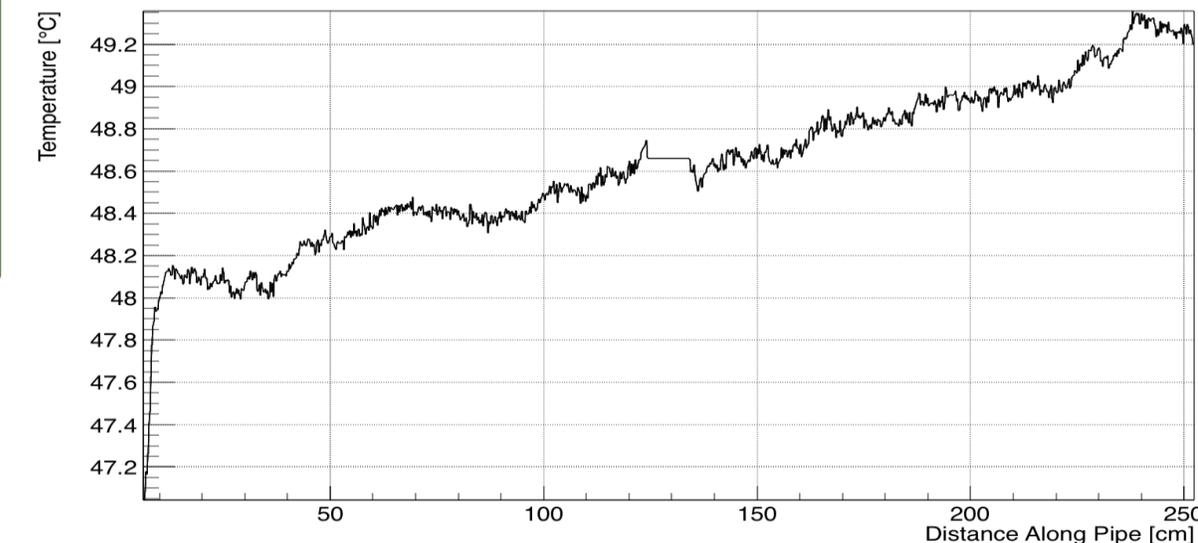
How frameanal.py works...

- ▶ Takes the image data from the configFinder and creates plots of the stave and the pipe area.
- ▶ Using the pipe area temperature data, it finds the maximum along the pipe, by fitting the thermal profile perpendicular to the pipes with a Gaussian peak.
- ▶ It does this for both pipes and creates data sets for the thermal profile along the pipes, along with the width, and position of each fit.

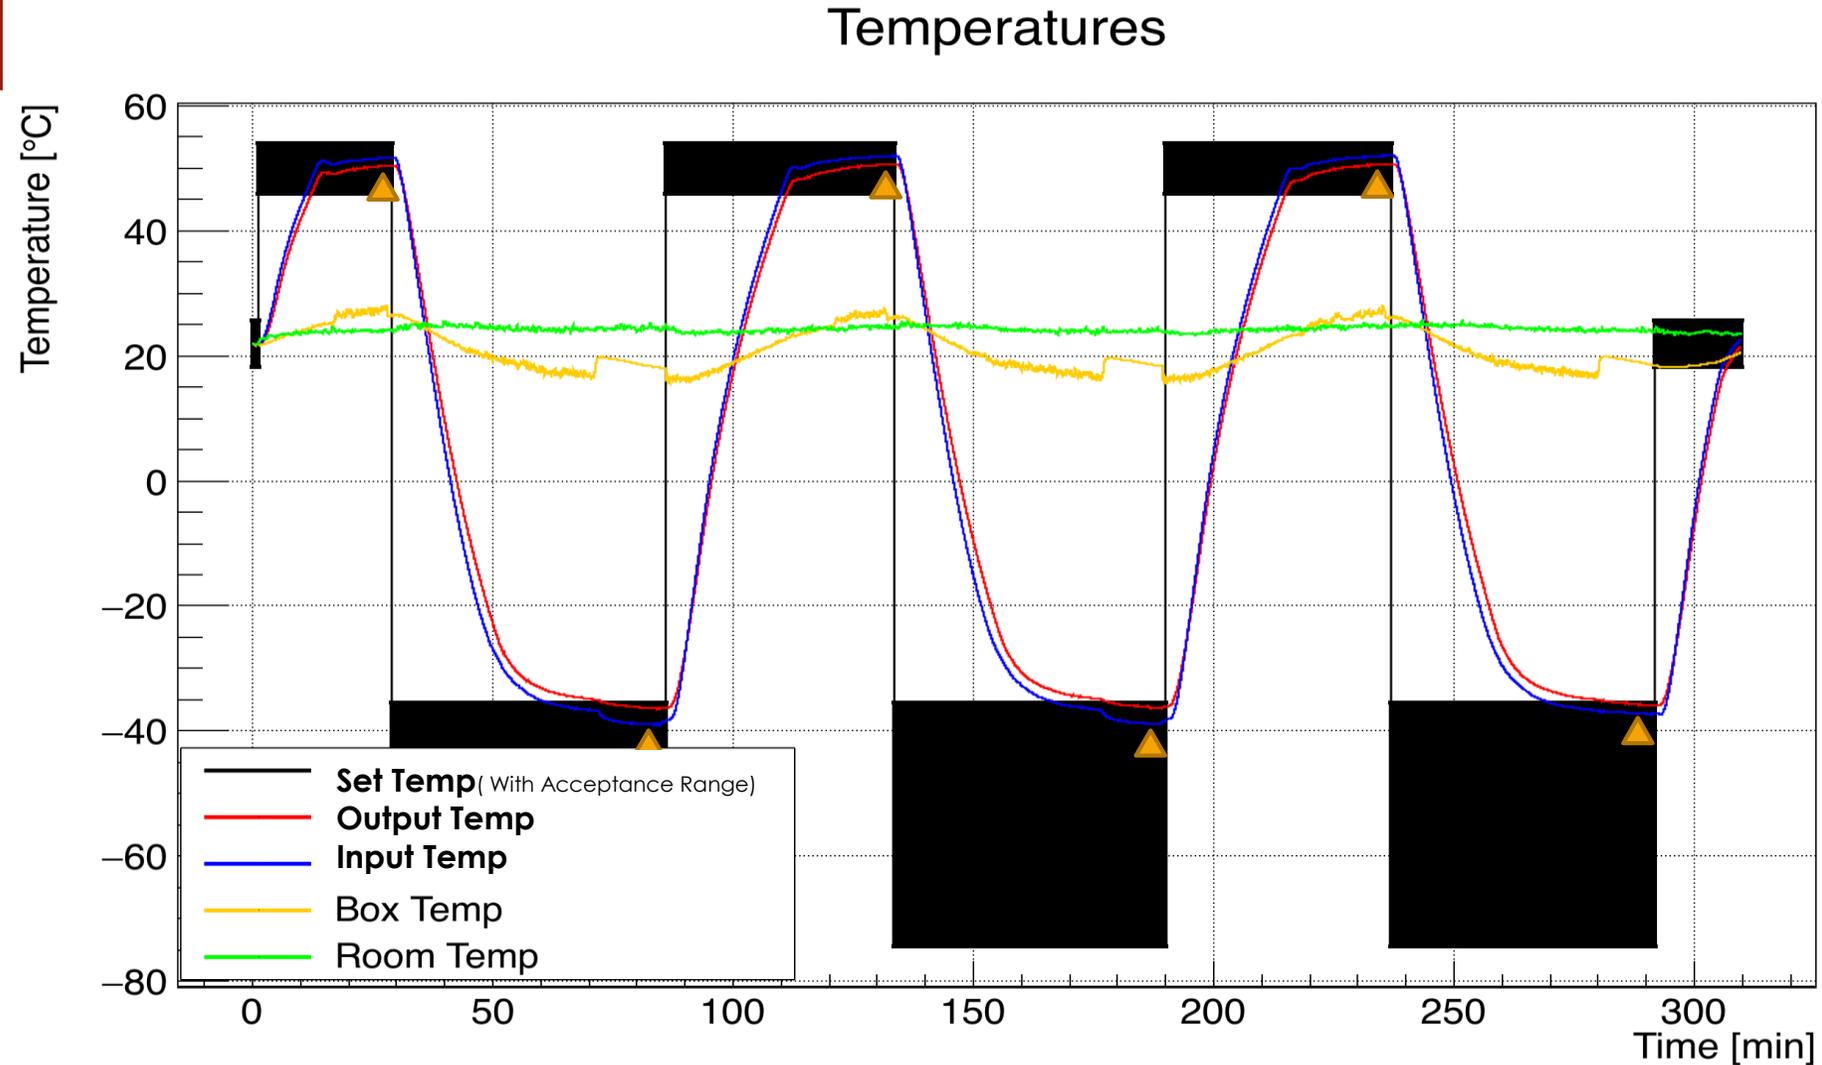
Reproducibility: Variables Plot 1

- ▶ The PF stove's thermal profile was measured for high(+50C fluid) and low(-40C fluid) input temperatures 3 times.
 - ▶ While the chillerctrl program was working toward the set temperature, the airflow was on at ~10psi(40 l/min)
 - ▶ Once the fluid reached the trigger temperature and stabilized, the airflow was shut off and the system was left for 10 minutes to stabilize.
 - ▶ An image was then taken from an average of 200 frames at a rate of 25 frames/sec
 - ▶ The system then looped to the next temperature(high,low,high,low,high,low)
- ▶ All variables were measured from the log file to note any differences between the measurements
 - ▶ Each measured variable's uncertainty is characterized by its maximum fluctuation over the time in the log file

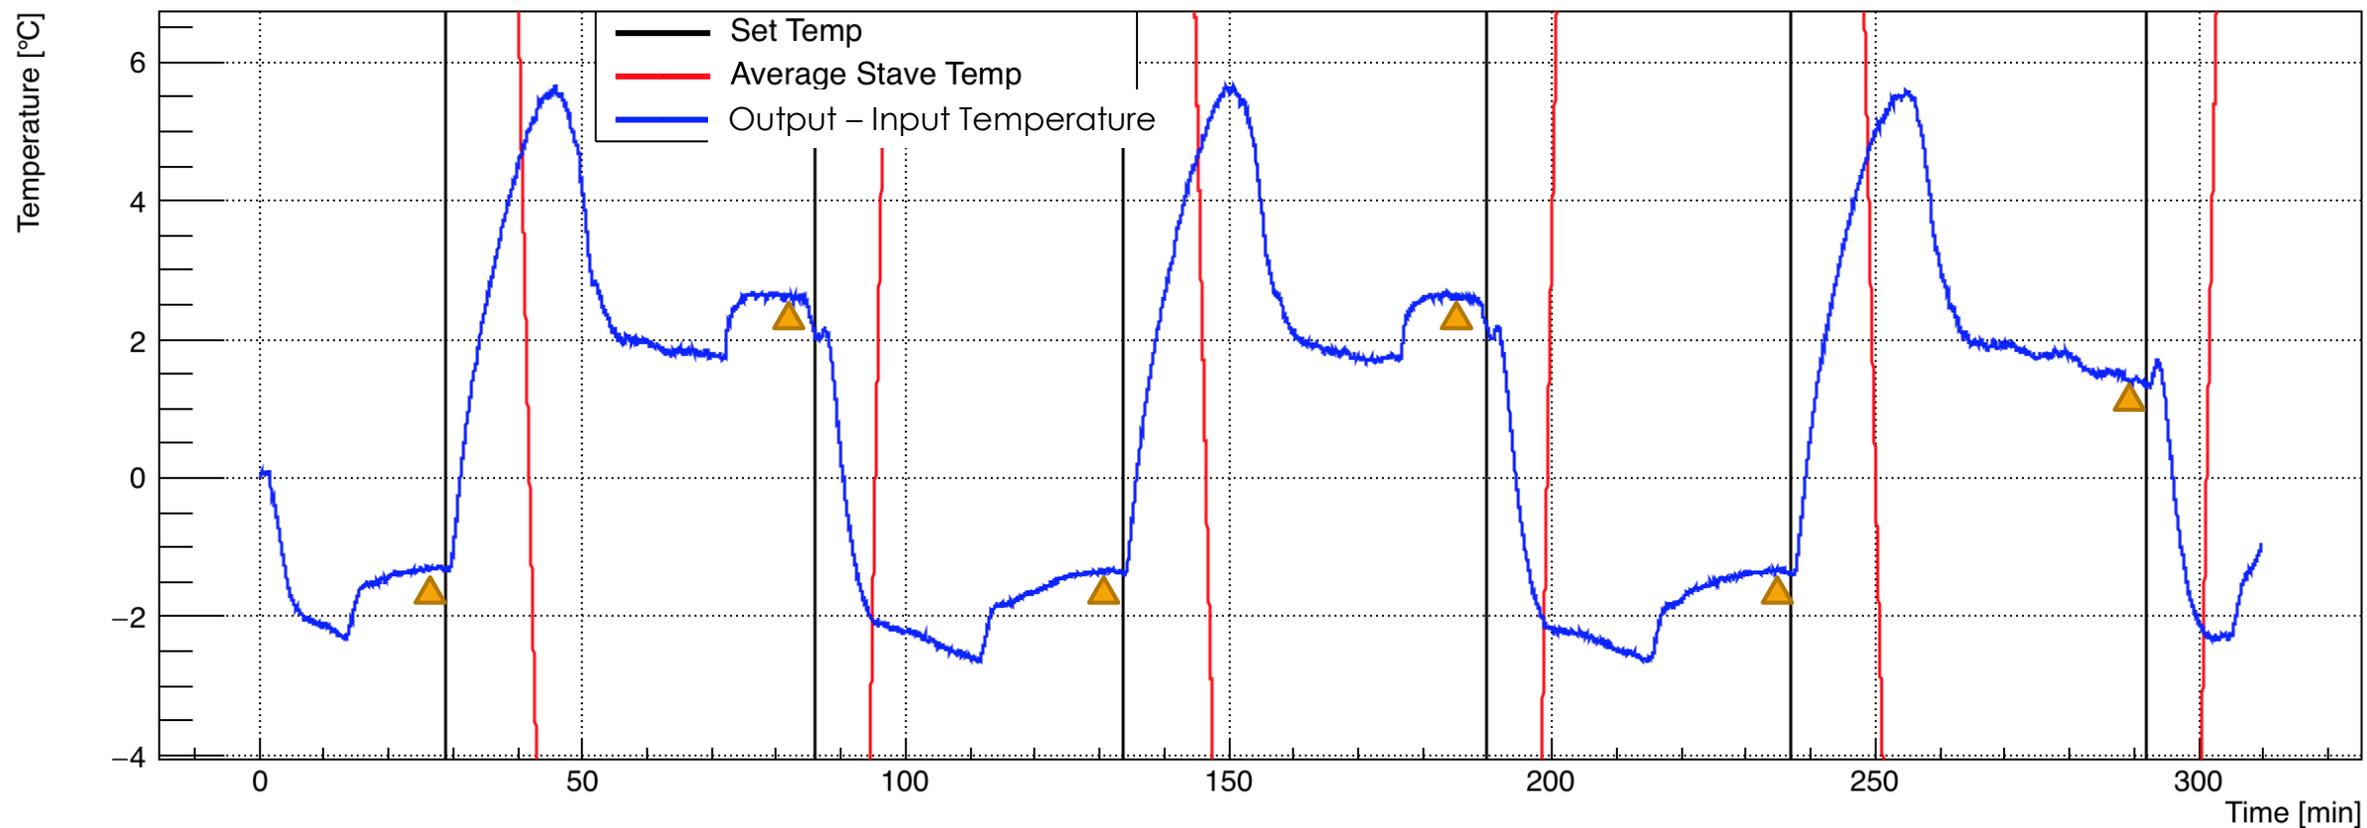
Reproducibility: Variables Plot 2

Average Stave Temperature

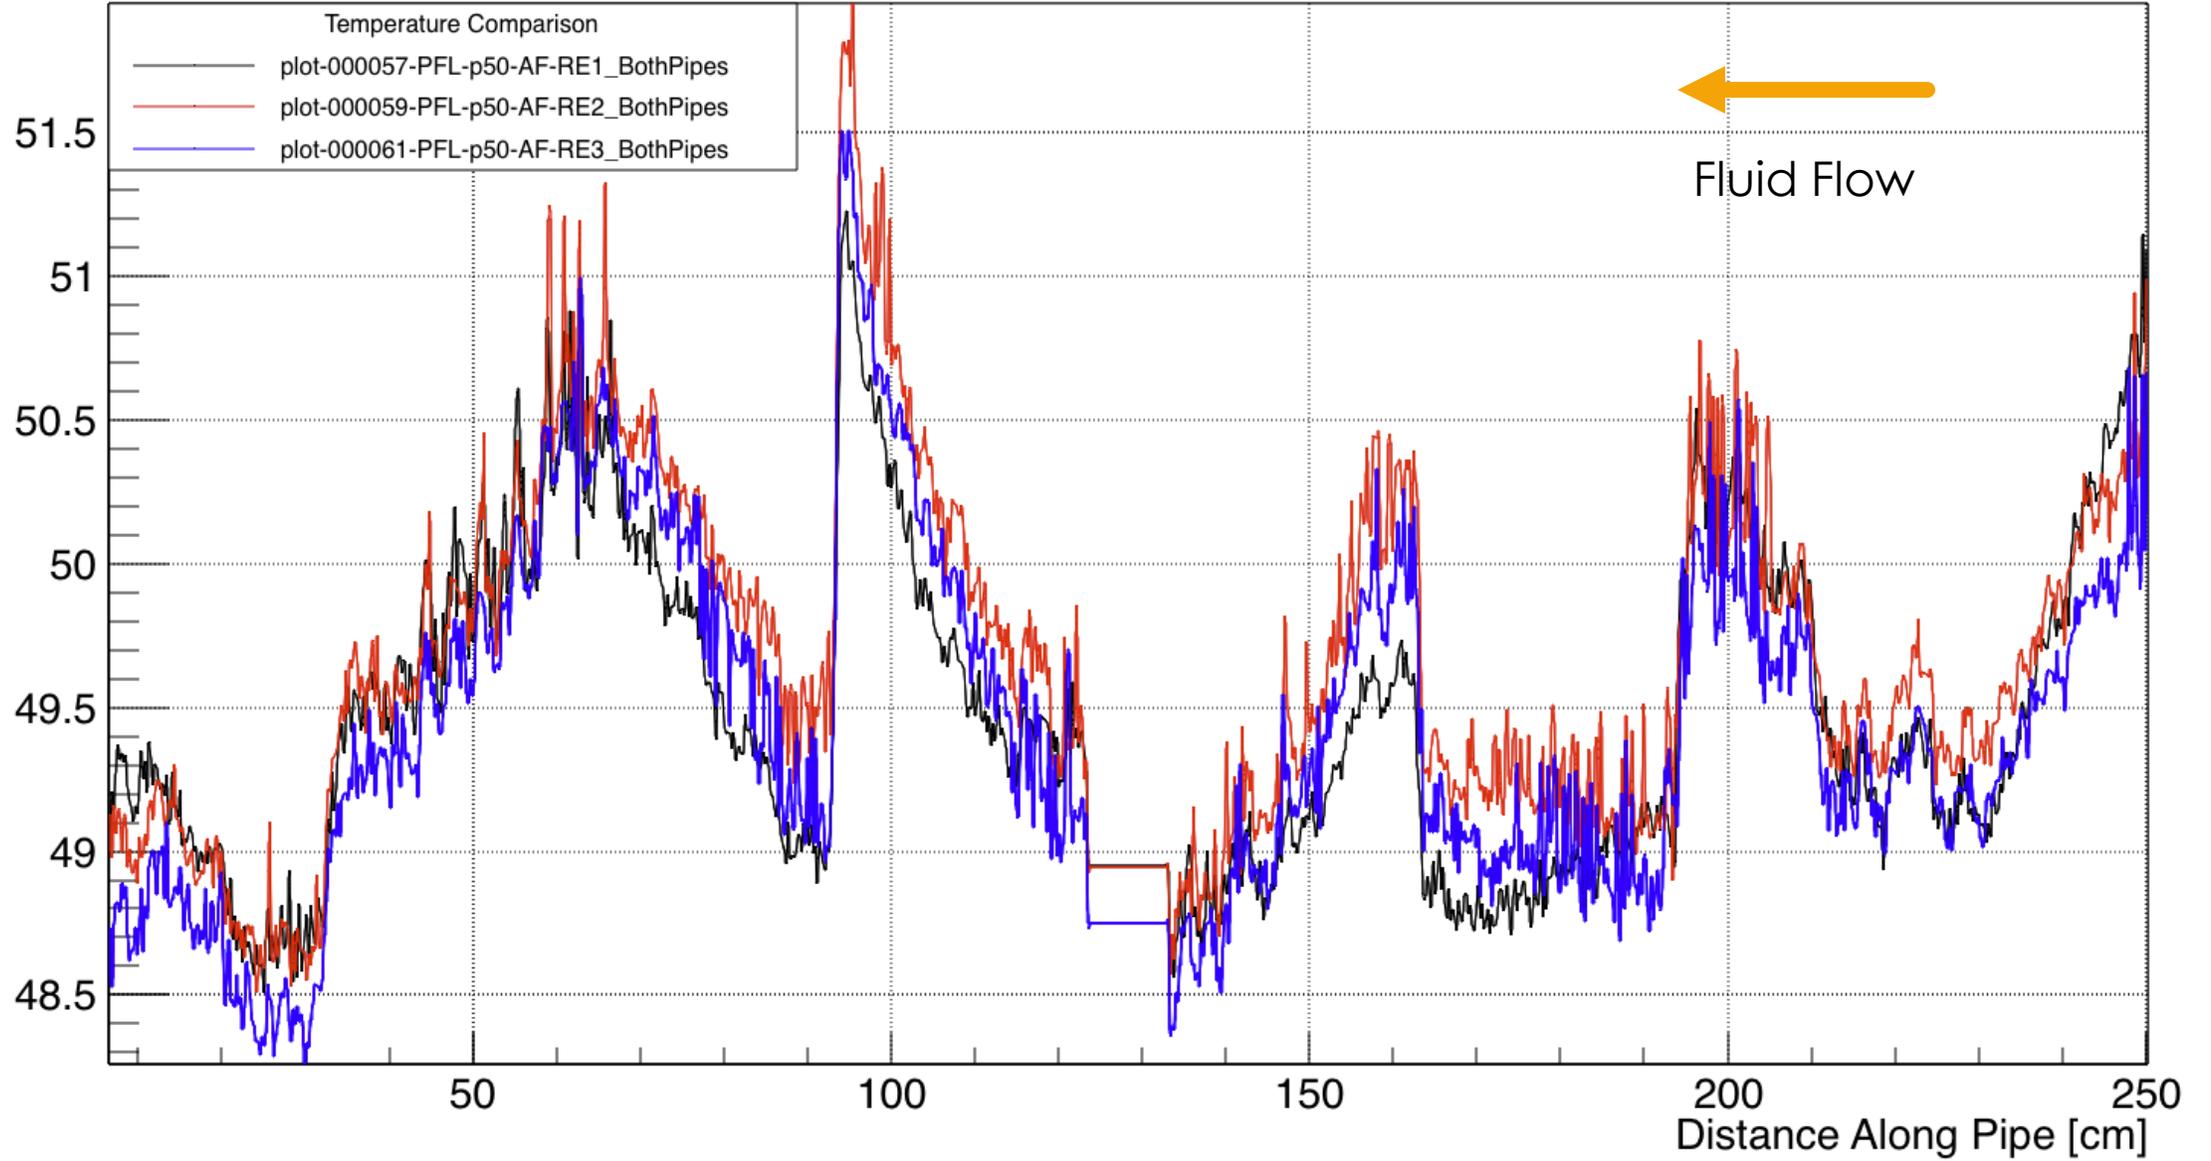
- ▶ These values are for the hot temperature measurement
- ▶ During trial 3, the wait time was slightly longer
- ▶ Only 2 significant differences in measured variables
 - ▶ Input temperature is different on run 1
 - ▶ There is about 1% humidity in run 1

(Its good...)

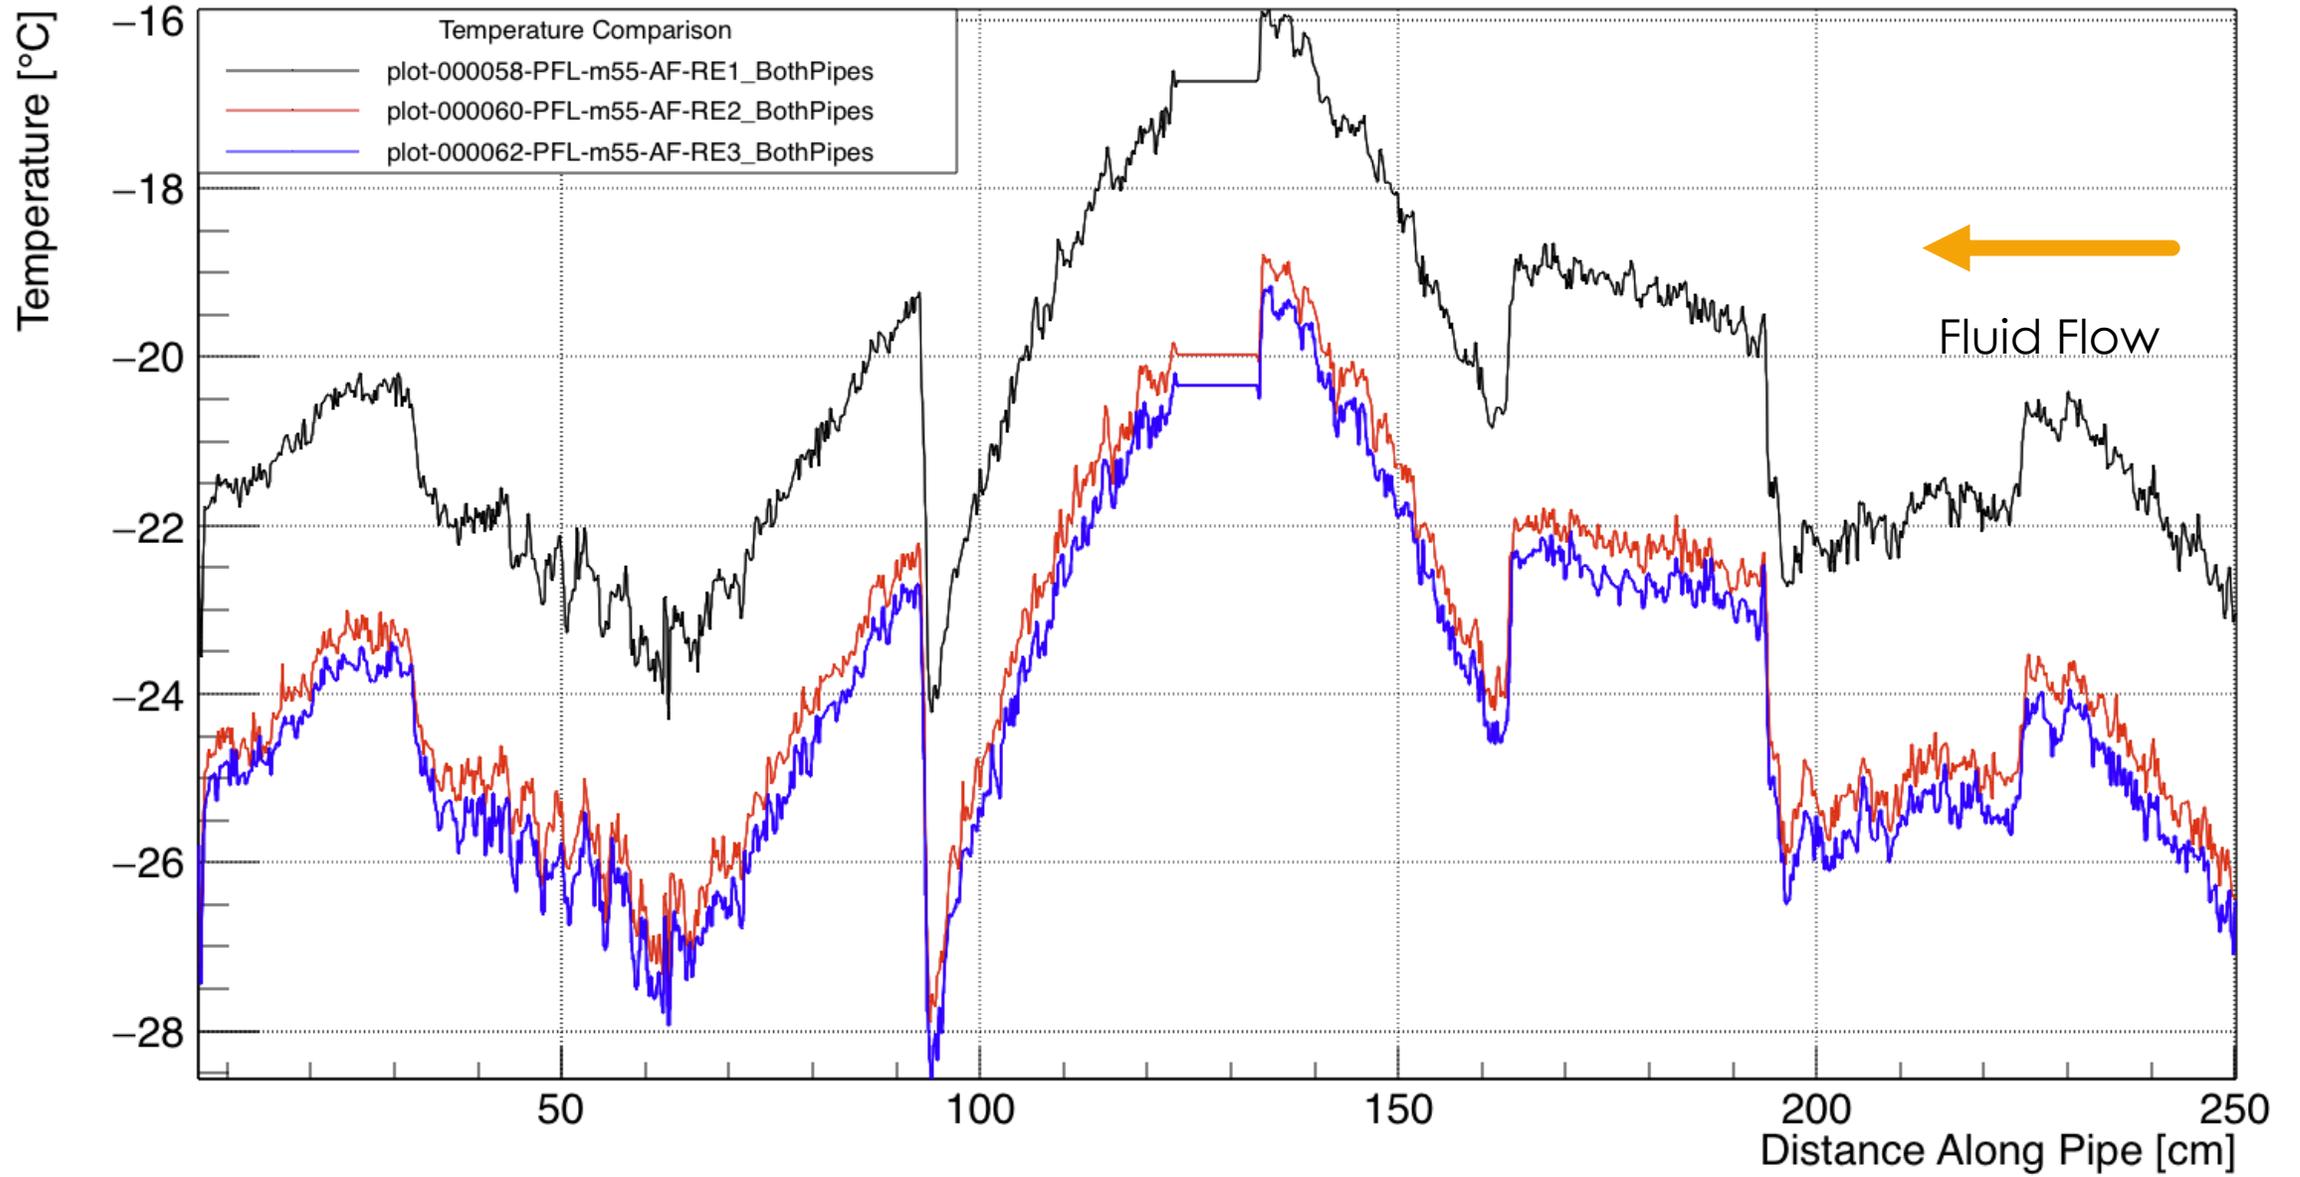
- ▶ These values are for the cold temperature measurement
- ▶ During trial 3, the flow rate was not adjusted
- ▶ 2 significant differences in variables
 - ▶ Input temperature is different on run 3
 - ▶ TLoss is much lower on run 3

(Less good...)
