# Radiation hardness of present pixel modules

T. Rohe<sup>1</sup>, A. Bean<sup>2</sup>, W. Erdmann<sup>1</sup>, H.-C. Kästli<sup>1</sup>, S. Khalatyan<sup>3</sup>, B. Meier<sup>1</sup>, V. Radicci<sup>2</sup>, J. Sibille<sup>1,2</sup>

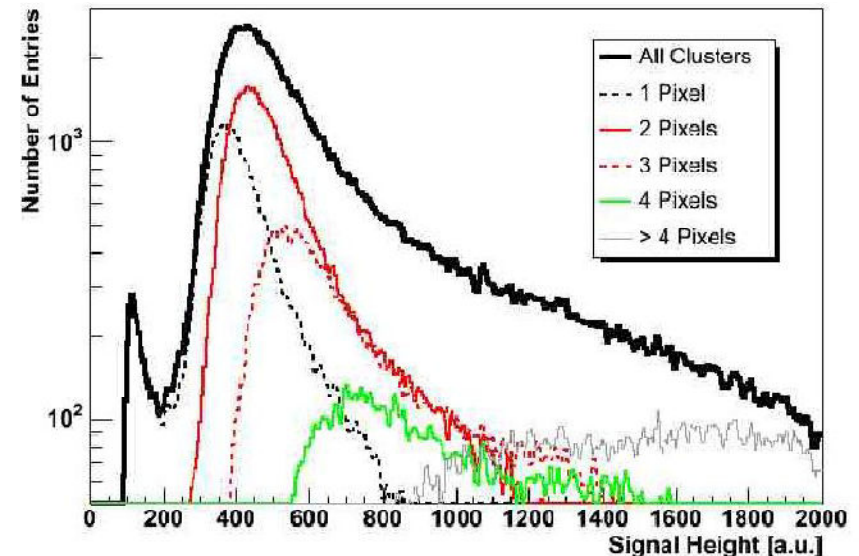
- Highly irradiated sensors operative up to 1kV
  - Presently problems with high voltage capability of the setup (connectors, PCBs etc.)
- No signal saturation with bias for  $\Phi > 2 \times 10^{15} n_{eq}/cm^2$
- Sensor with  $\Phi = 2.8 \times 10^{15} n_{eq}/cm^2$  deliver  $> 5ke$  (at 800V)
  - No sign for charge multiplication
- Sensors seems suitable for upgraded LHC

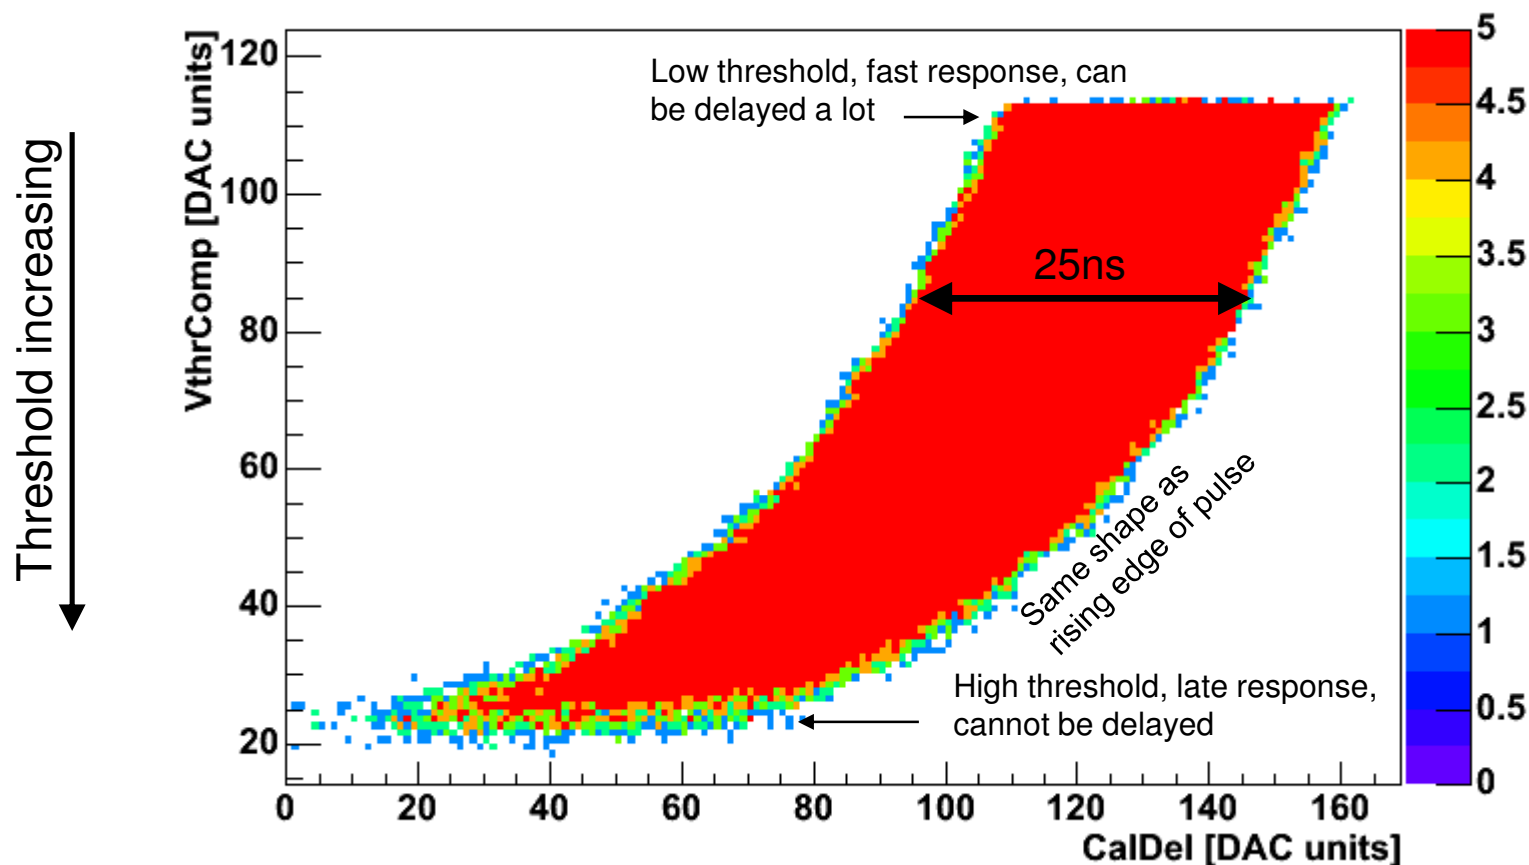
VthrCompCalDel\_c5r5\_C0

- Cannot directly be measured (no “transparent” mode)
- Presented method is very indirect and time consuming
- Use feature to delay injection of calibration signal
- Now have to calibrate both axis

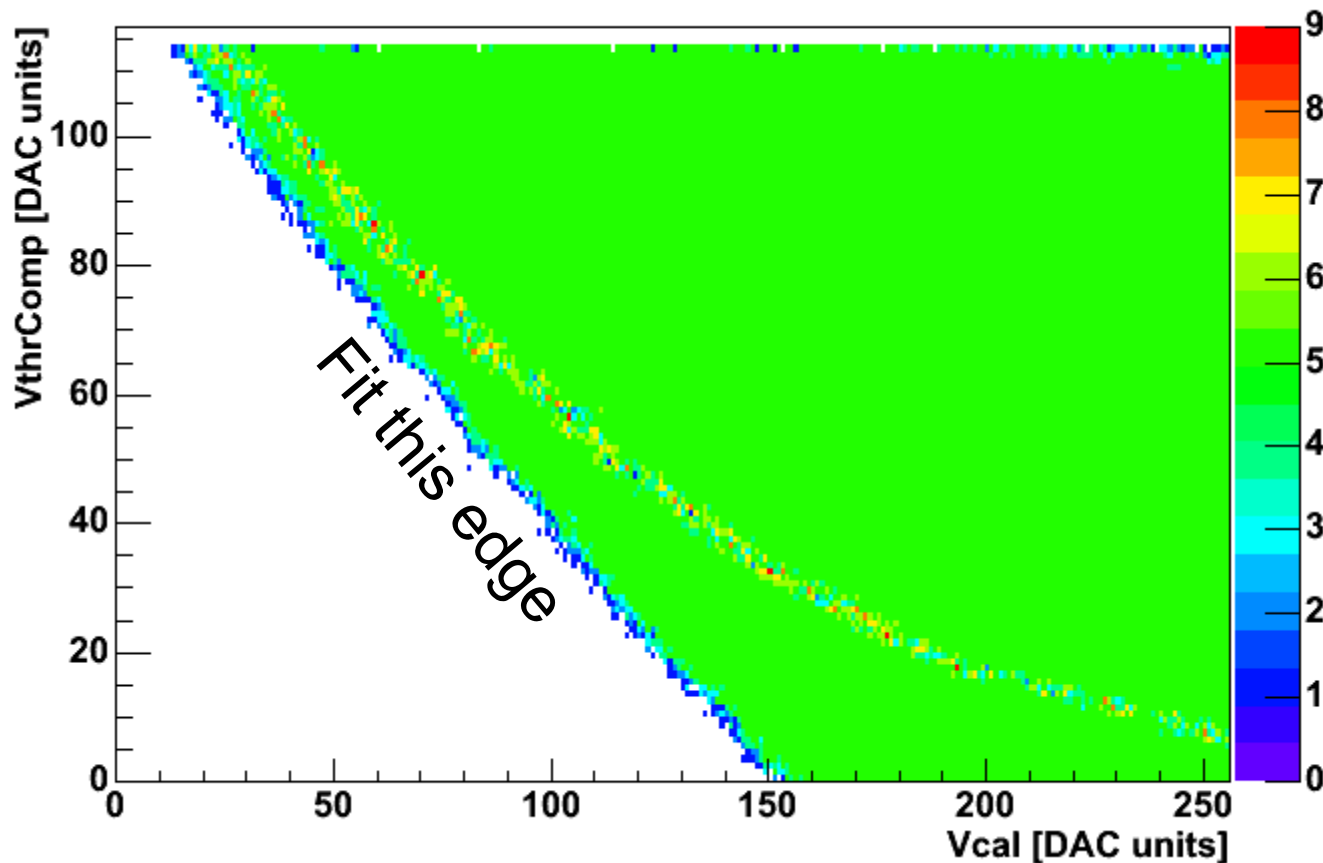
VthrCompVcal\_c5r5\_C0

- Use 2 settings for the trigger latency to also get low amplitude pulses from the next bunch crossing to get the “real” threshold

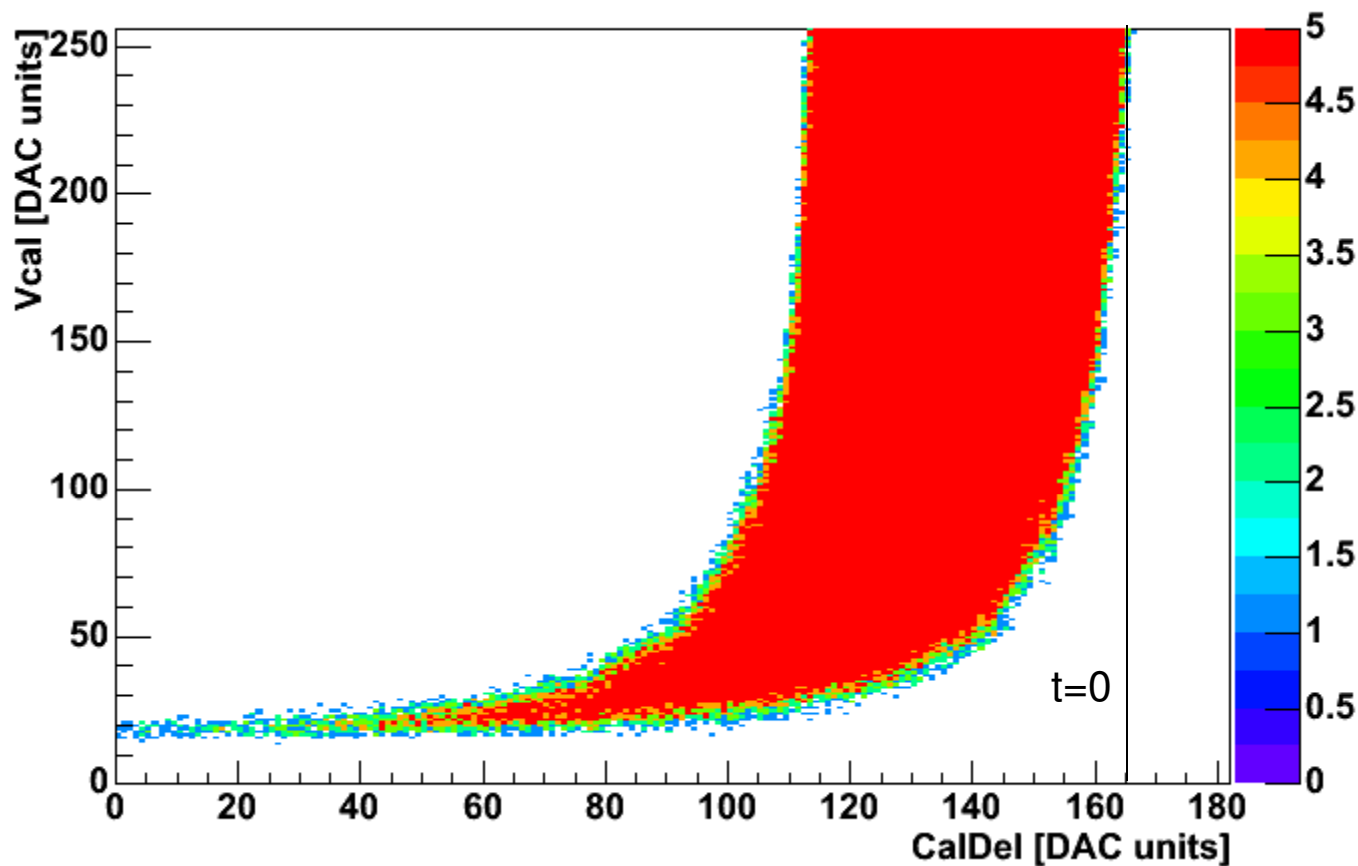
VcalCalDel\_c5r5\_C0

- Use the lowest possible threshold and a very high signal to define time = 0

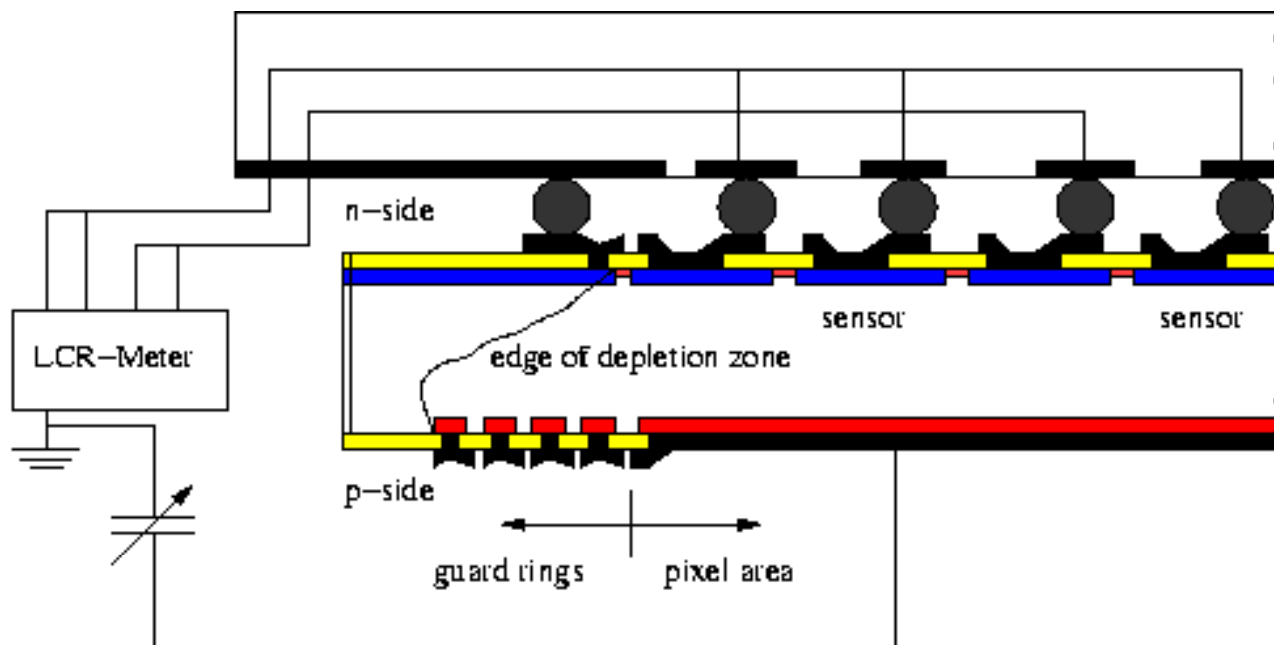
- For  $V < V_{\text{depl}}$ : all pixels are connected
  - capacitance value does not make sense
  - transconductance (G in parallel mode) reflects is high
- For  $V > V_{\text{depl}}$ :
  - transconductance drops rapidly and stays constant
  - capacitance steadily decreases

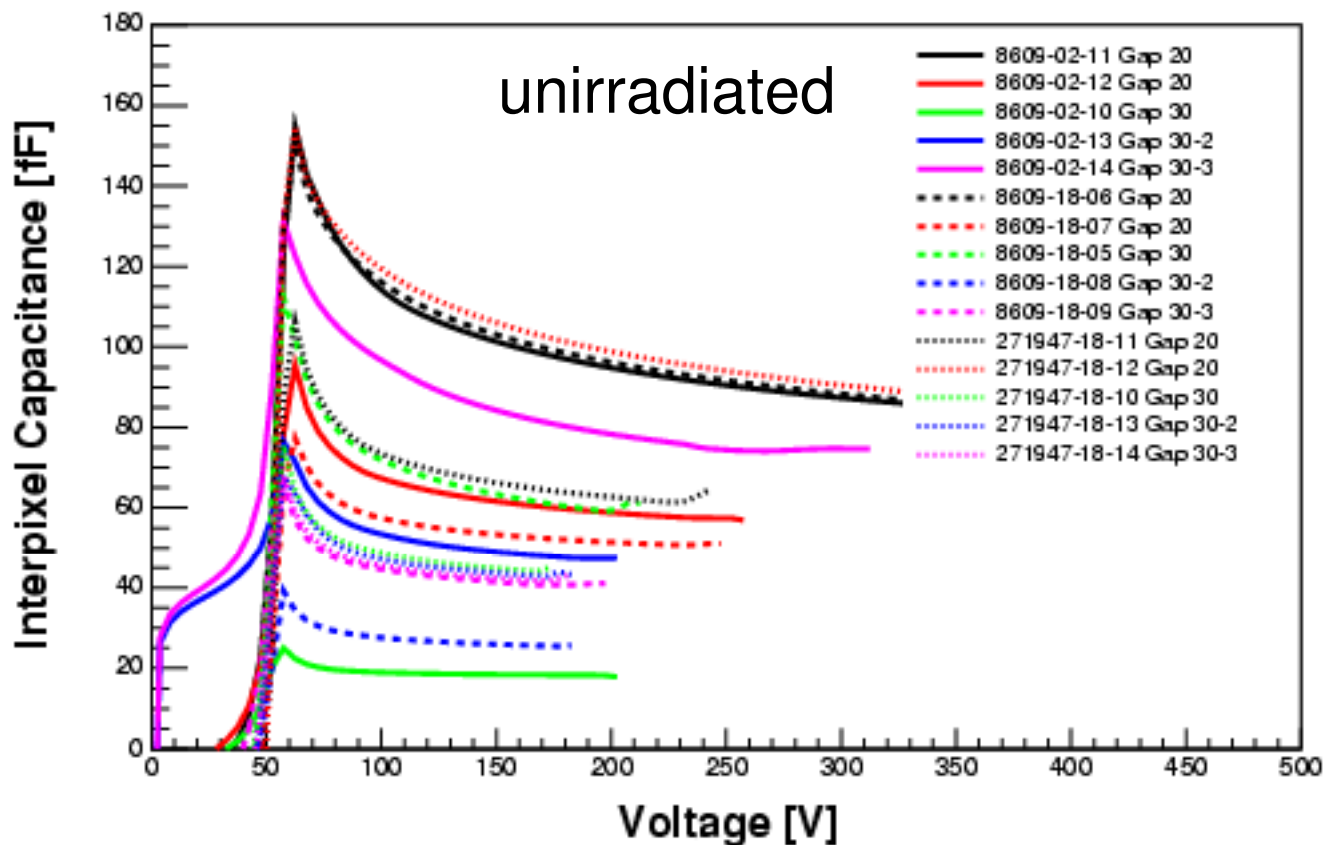
- Inter pixel capacitance is **bias dependent** and saturates about 300-350V
- Increasing the gap from 20 to 30  $\mu\text{m}$  results in a drop of  $C(150\text{V}) \sim 100$  to 70 fF
- **Large fluctuations** and some outliers
  - more statistics
  - check dependence on technology parameters (mainly p-spray dose)

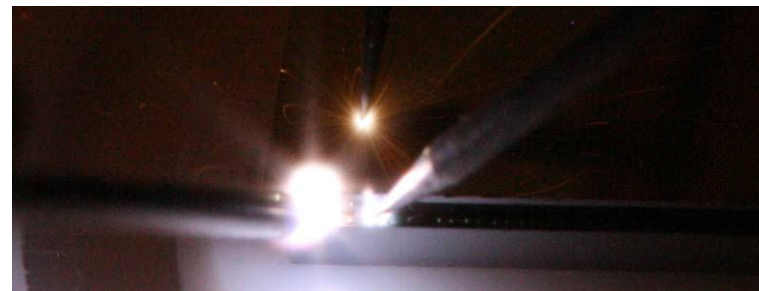
- Bump bonded rejected material from PSI-PILATUS project (p-in-n sensors and defective ROCs)
- Applied bias voltage to the sensor while ROC was grounded
- Breakdown occurs at  $\sim 500V$ 
  - Grounded pad on ROC completely destroyed
  - Other pads also damaged
  - Voltage surprisingly high
    - spark comes from sensor back side?
    - $500V \rightarrow 500\mu m$  air?
    - Aluminium also evaporated on sensor backside

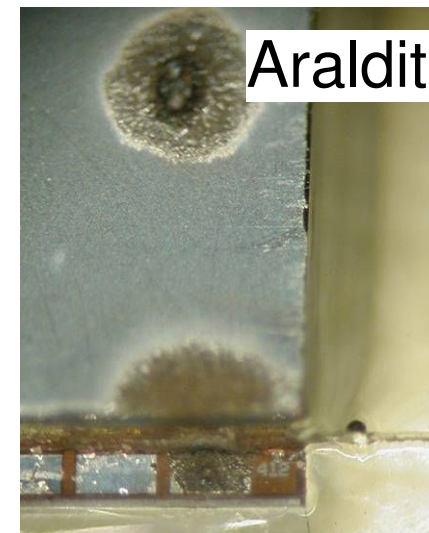
- Araldit (standard)

- used as underfill and glue in CMS module production
    - no change of break down voltage
