# **Updated Results of Breakdown Study for 509-MHz Continuous-Wave Accelerating Cavities based on Direct In-situ Observation**

Tetsuo ABE

*High Energy Accelerator Research Organization (KEK), Japan*

MeVArc2018 @ Puerto Rico

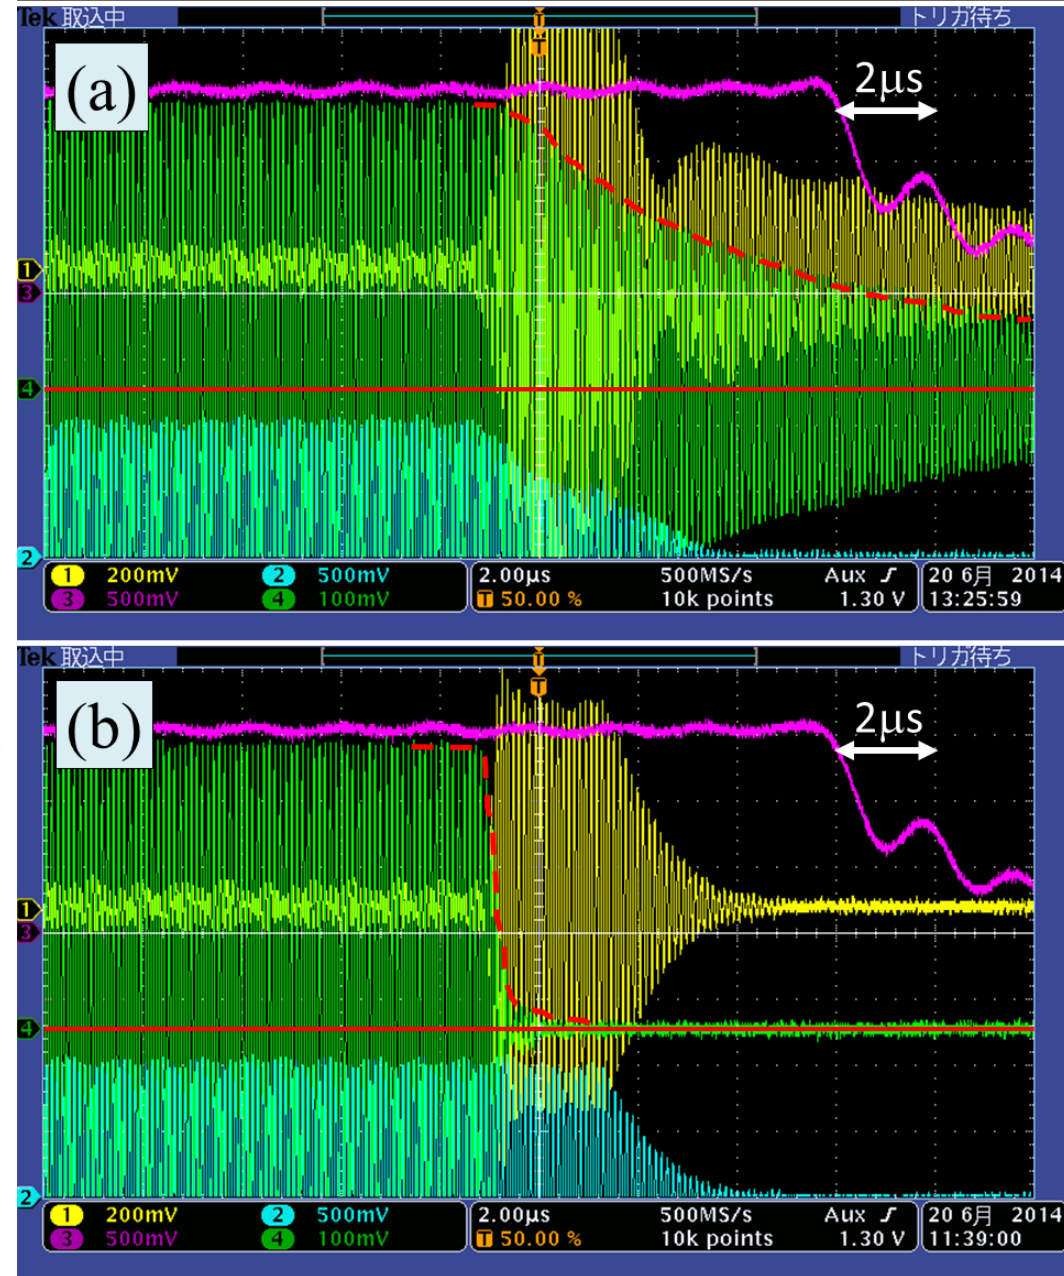
1. Candidates selected by reflected-wave interlock.
2. Check the decay time of the pickup signal of the accelerating mode:

- $\sim 8 \mu\text{s}$  → Not breakdown
- $\ll 8 \mu\text{s}$  → Breakdown

FIG. 6: Waveforms of the oscilloscope displayed for a time span of  $20 \mu\text{s}$  ( $= 2 \mu\text{s}/\text{div}$ ) when the interlock system was activated. The red dashed curves indicate the envelope of the 508.9-MHz pickup signal from DR Cavity No. 2, and the red solid lines indicate its zero level. (a) The RF switch was turned off for a reason related to the klystron. (b) Example of the cavity breakdown events.

$Q_L=13000@509\text{MHz} \Rightarrow \text{Filling time: } 8\mu\text{s}$

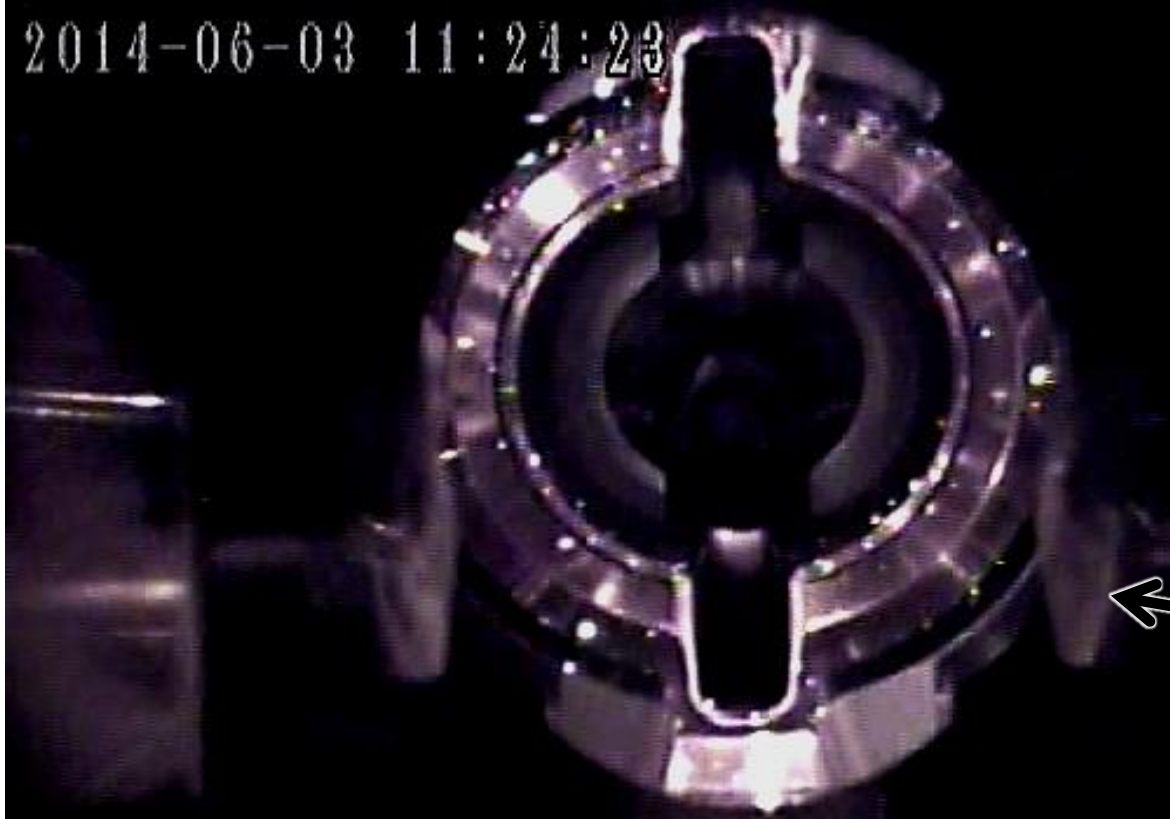
Upstream Endplate at  $V_c = 0.90$  MV

- ✓ Image recorded by TV camera 3
- ✓ During operation with  $V_c = 0.90$  MV
  - $E_{acc} = 3.5$  MV/m (← Gap: 256 mm)
  - $E_{surf} = 4 \sim 13$  MV/m
- ✓ Non-breakdown status

**During the high-power operation, such bright spots:**

- Maintained their intensity for hours or longer, and
- Had no significant effects on the high-power operation as long as they remained stable.

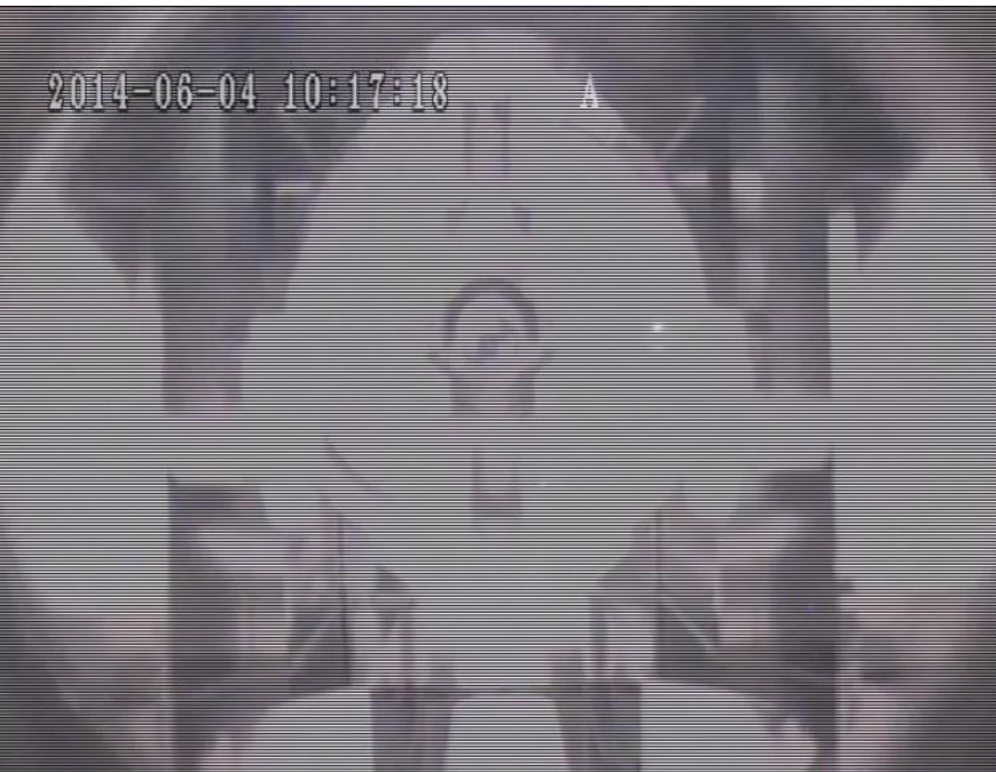
***Big Flash!***

Upstream Endplate

Downstream Endplate

Coaxial Line of the Input Coupler

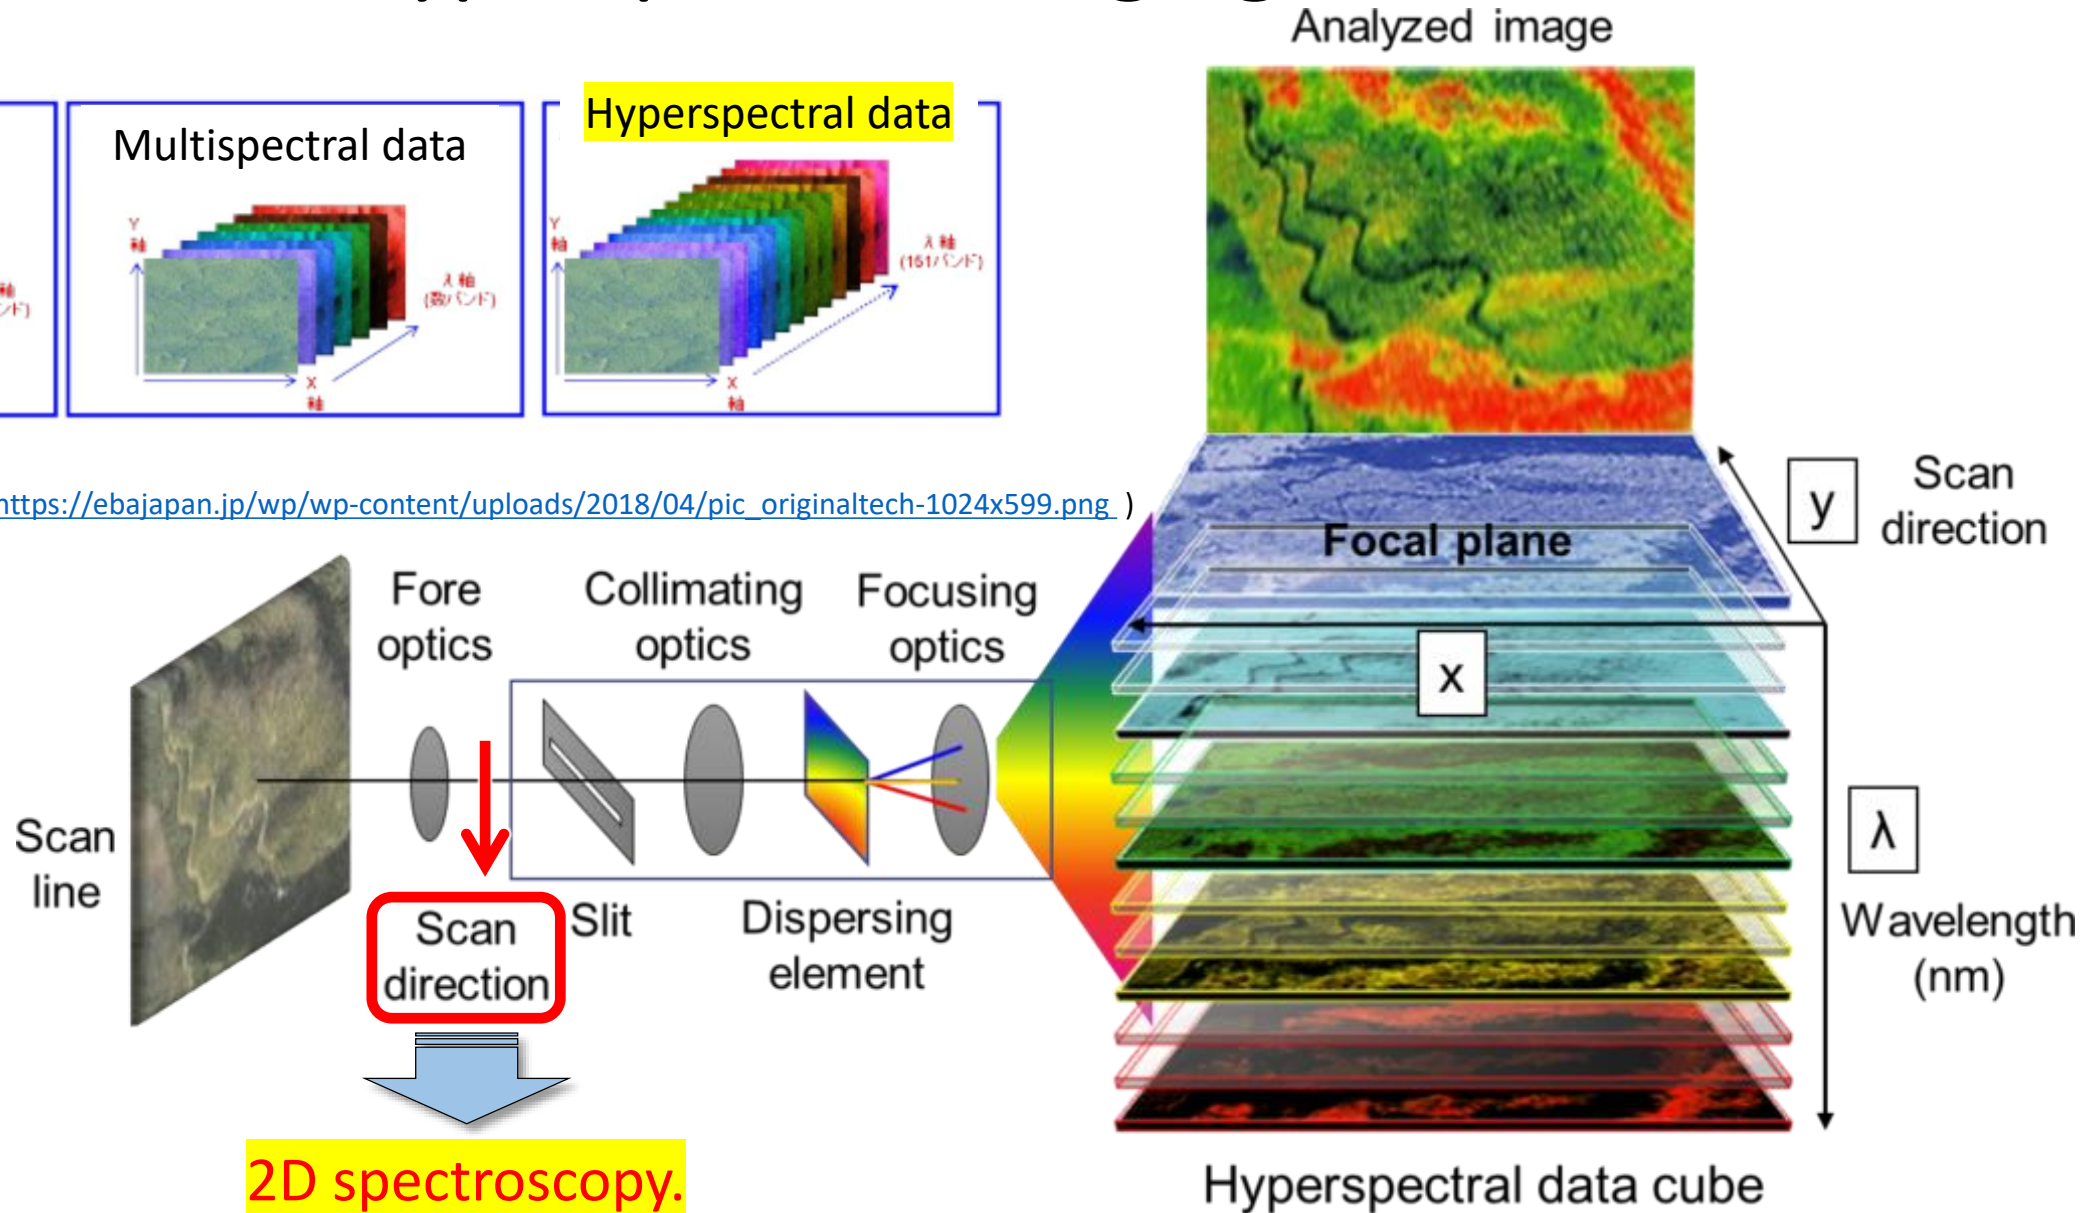
# Hyperspectral Imaging

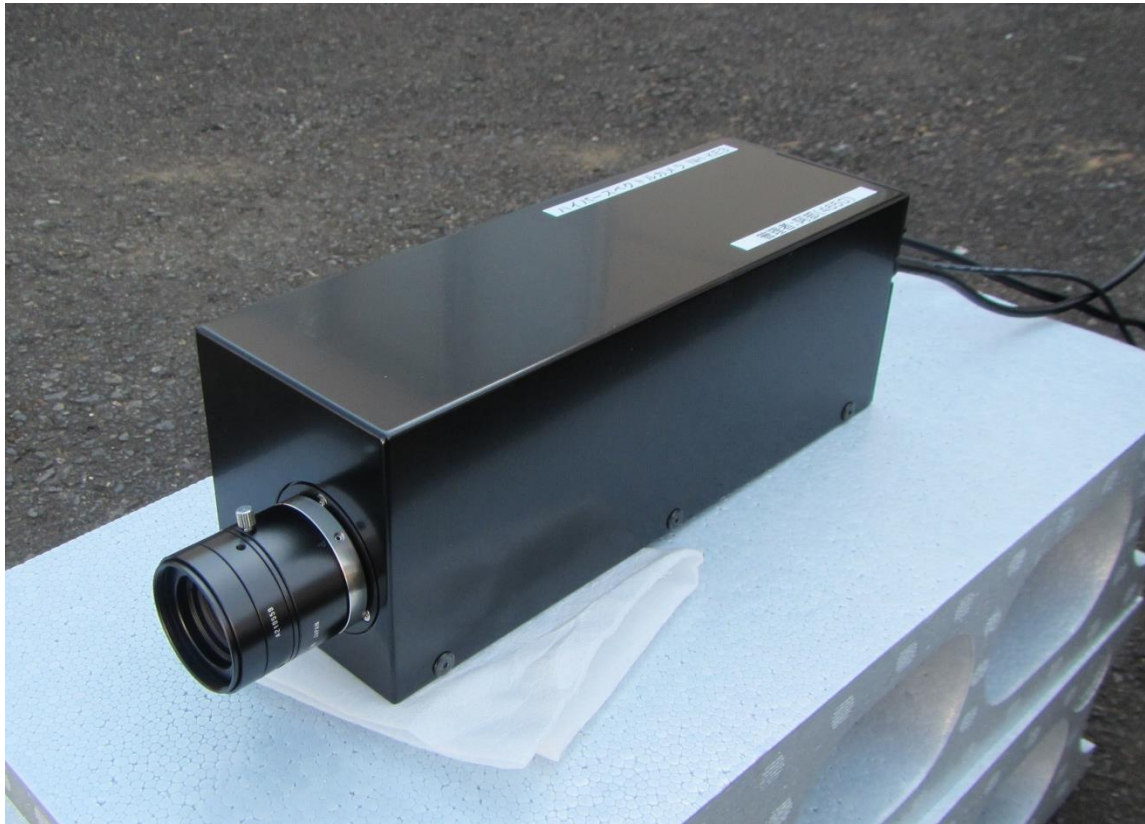
# Hyperspectral camera used in this measurement

Model: NH-KE3

made by EBA JAPAN CO.,LTD.

Item	Spec.
Detector	CMOS
Number of pixels	360,000
Max. frame rate	100 fps
ADC bits	10
Range of wavelength	400 to 1000 nm
Enclosure size	H76.0mm x W72.4mm x L213mm
Net weight	1030g

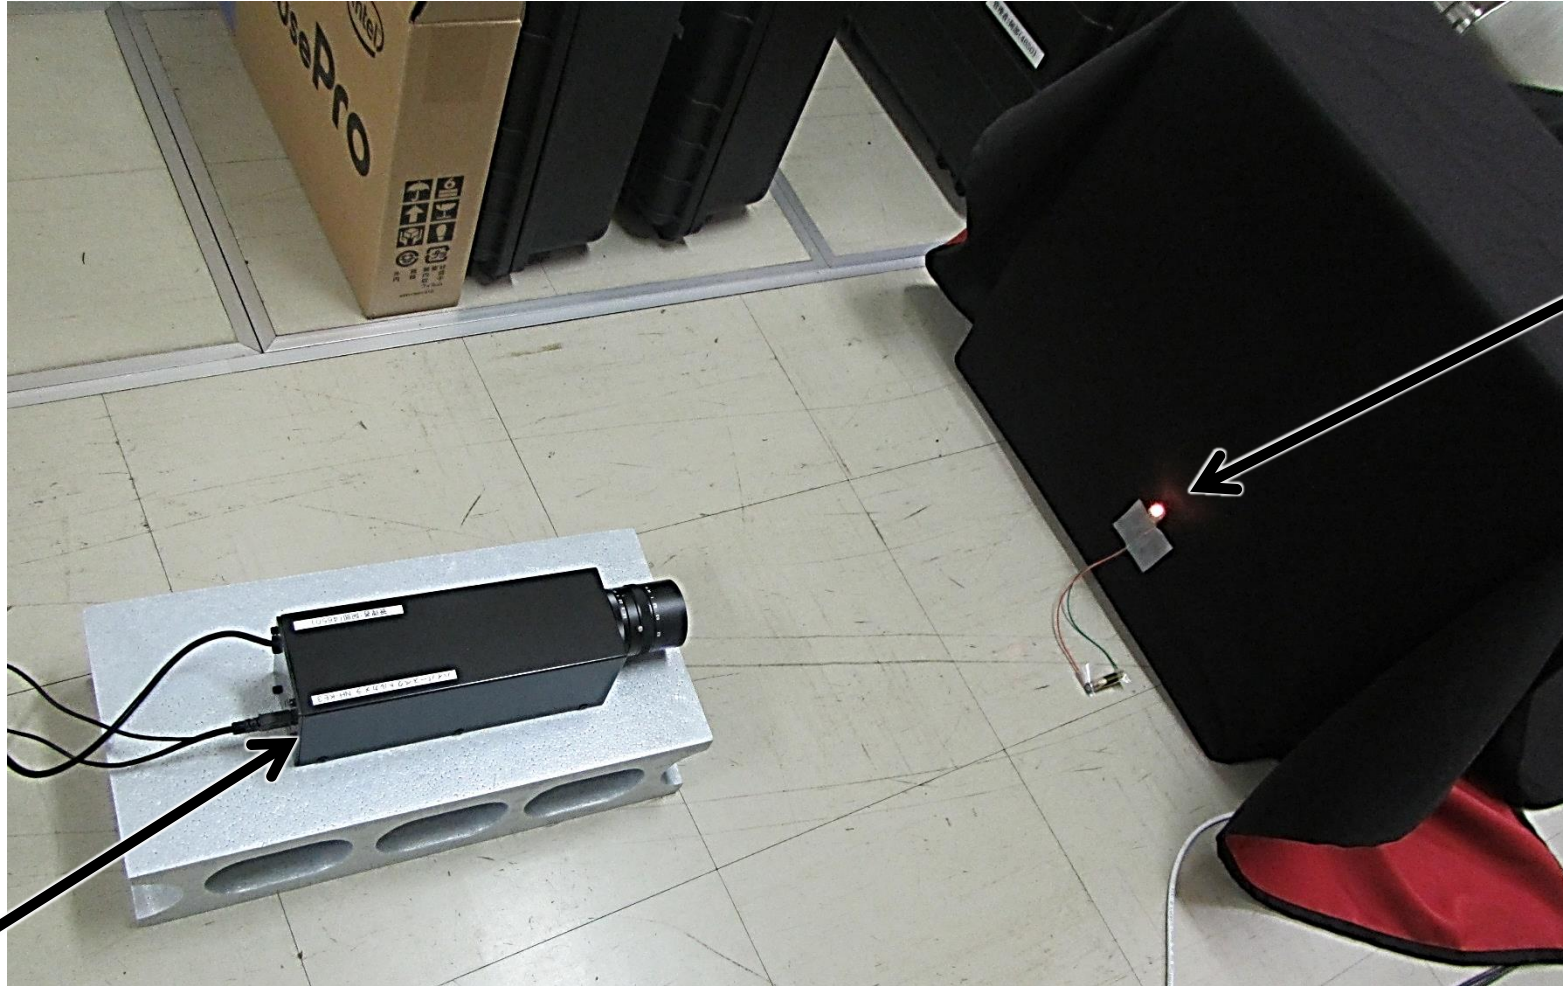
## Measurement Setup

Hyperspectral camera

Miniature bulb

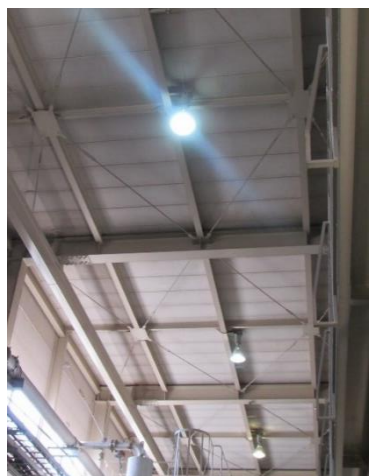
# Check of the wavelength calibration using a multi-halogen lamp

- Made of Panasonic
- Model: MF400LBUSCN
- Included elements
  - ① Sodium (Na)
  - ② Thallium (Tl)
  - ③ Indium (In)
  - ④ Scandium (Sc)
  - ⑤ Lithium (Li)

We confirmed that the peak of the Na D-lines (589.0 nm, 589.6 nm) did not change before and after any measurements.

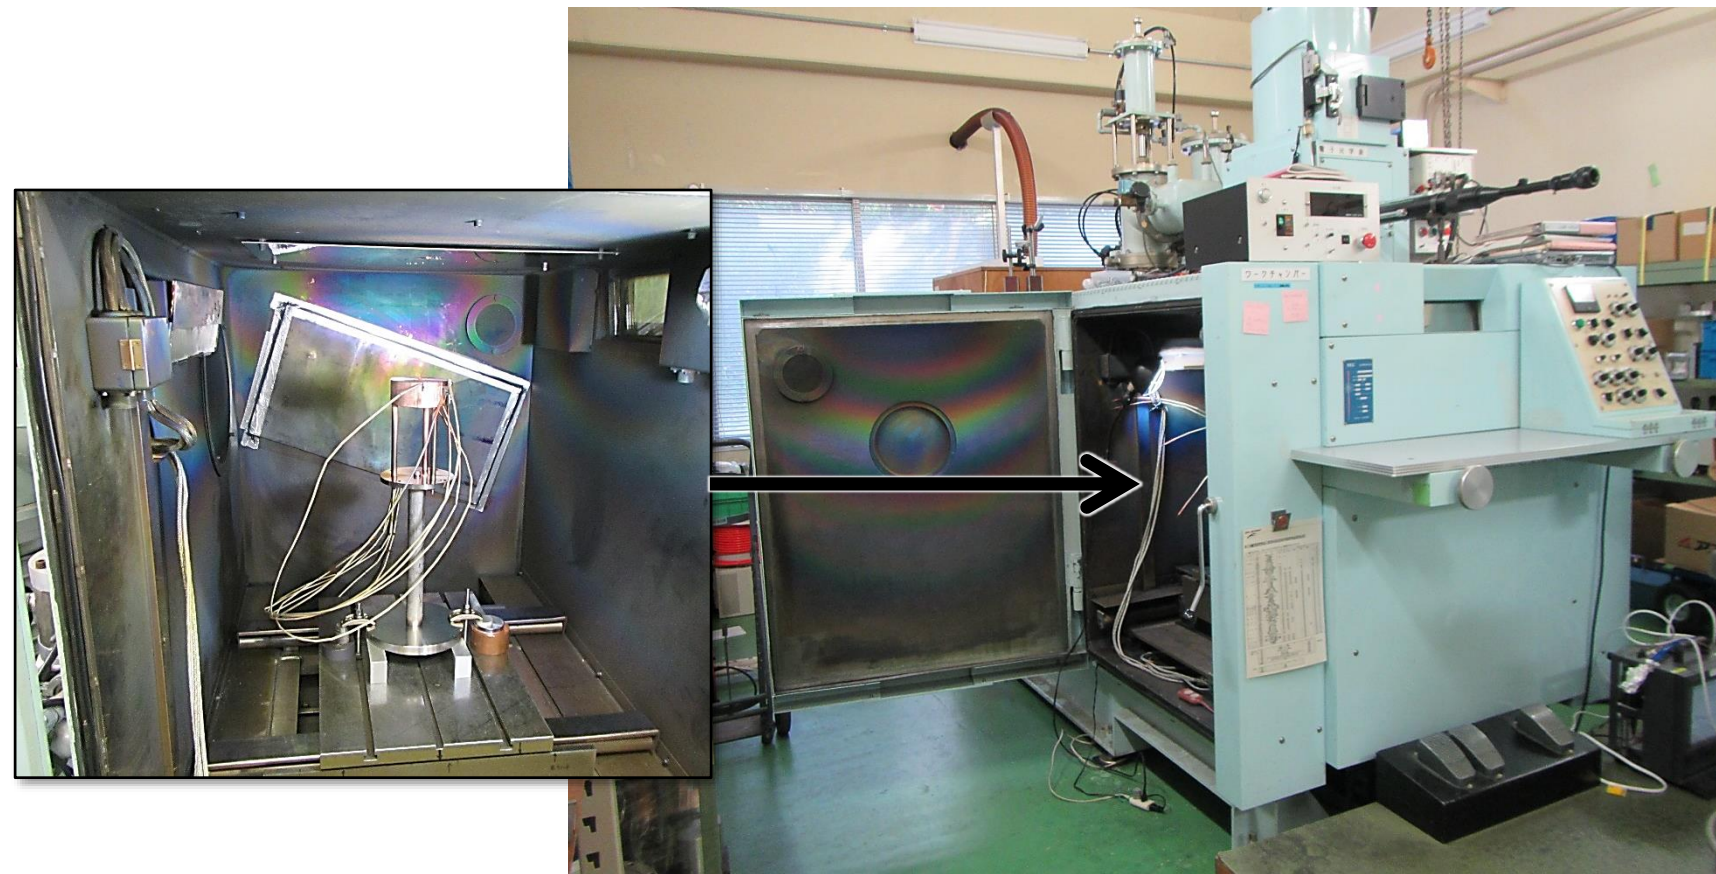
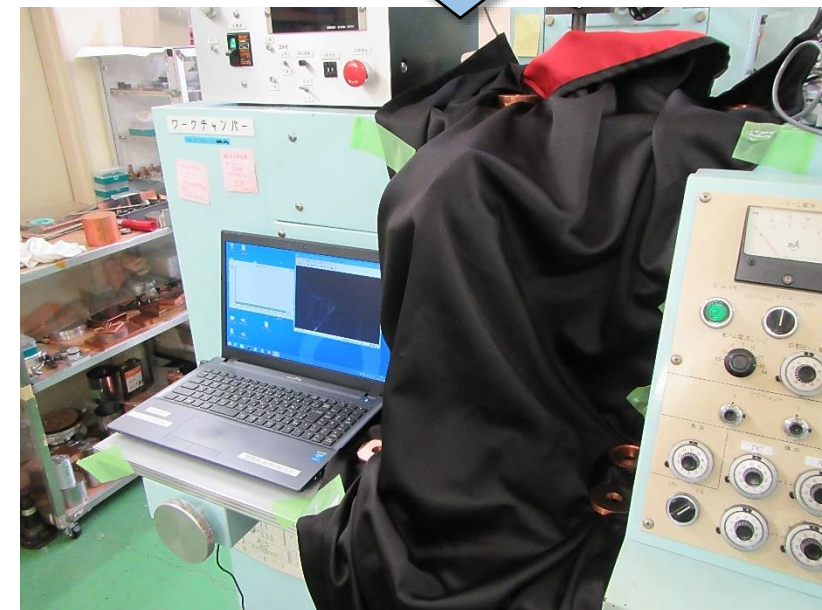
# Electron-Beam-Welding machine at KEK Mechanical Engineering Center was used.

# ~580 degC

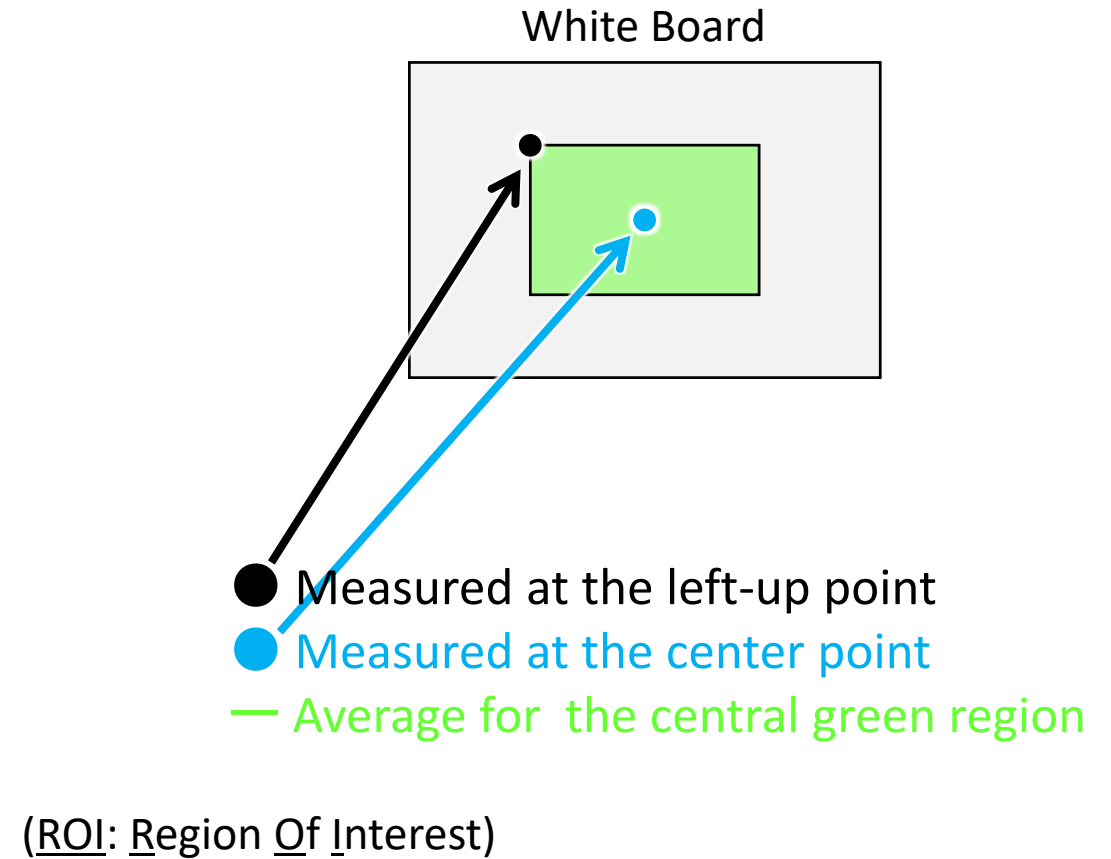
# Measurement of the Transmissivity of the EBW-Machine Window

Only the wavelength dependence is used in this study;  
the absolute value has no meaning.

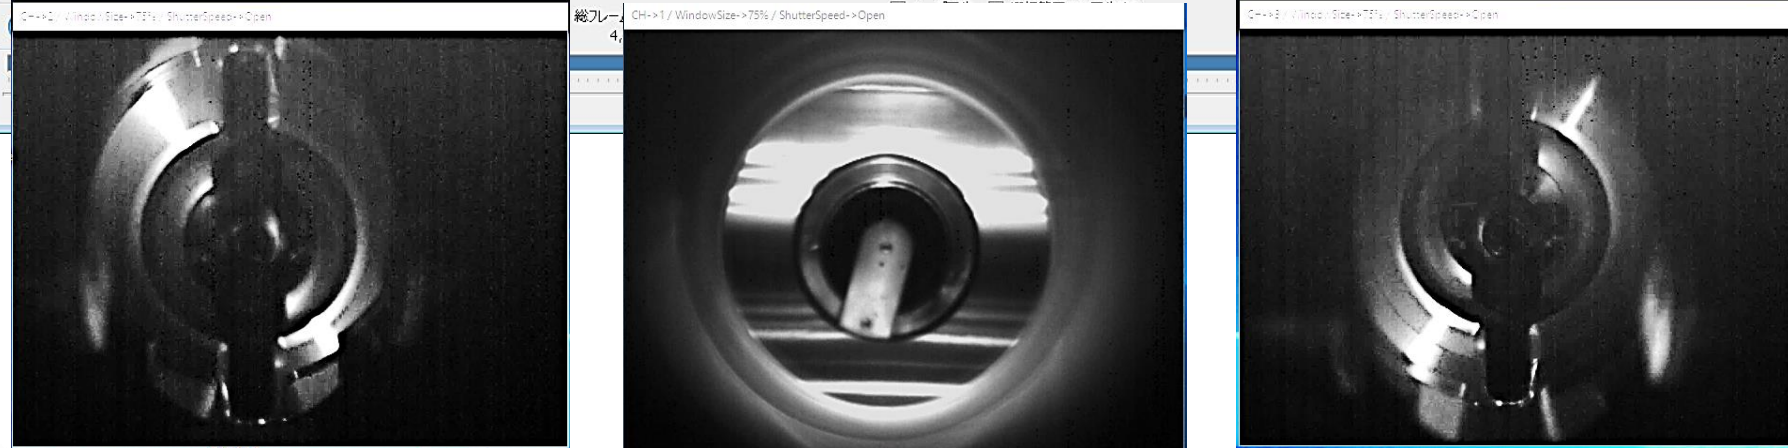
# Event 1/4: Downstream → Upstream, then impact and BD

RF OFF, LED injected

(Frame rate : 1,000 fps)

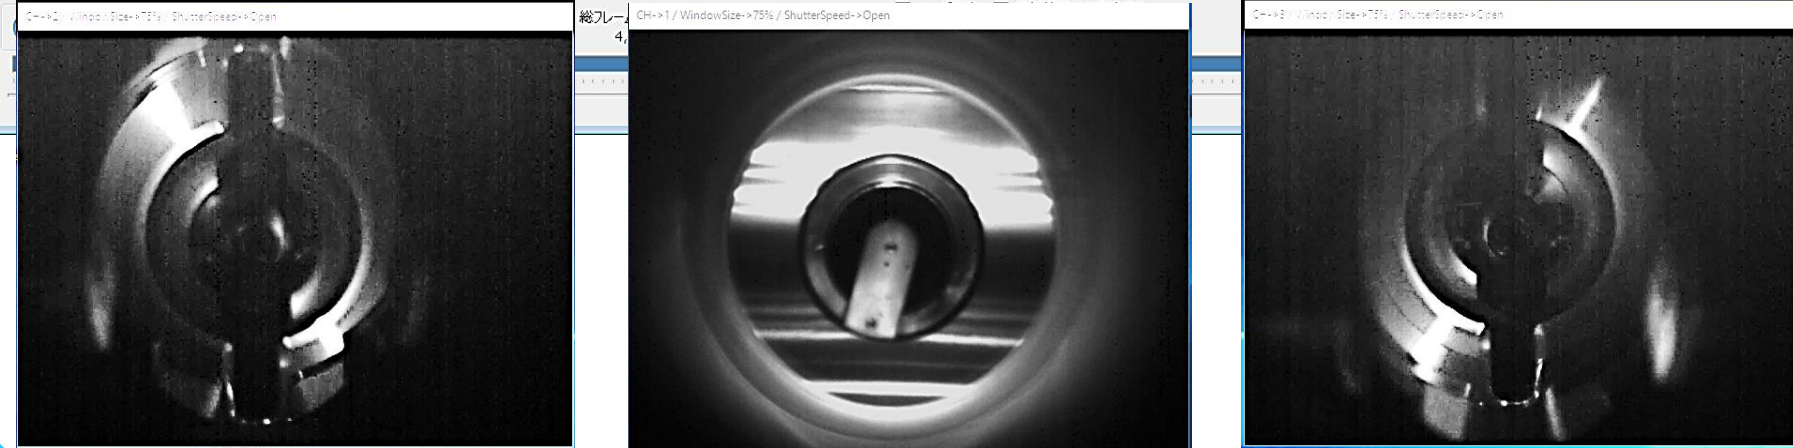
# Event 1/4: Downstream → Upstream, then impact and BD

RF OFF, LED injected

(Frame rate : 1,000 fps)

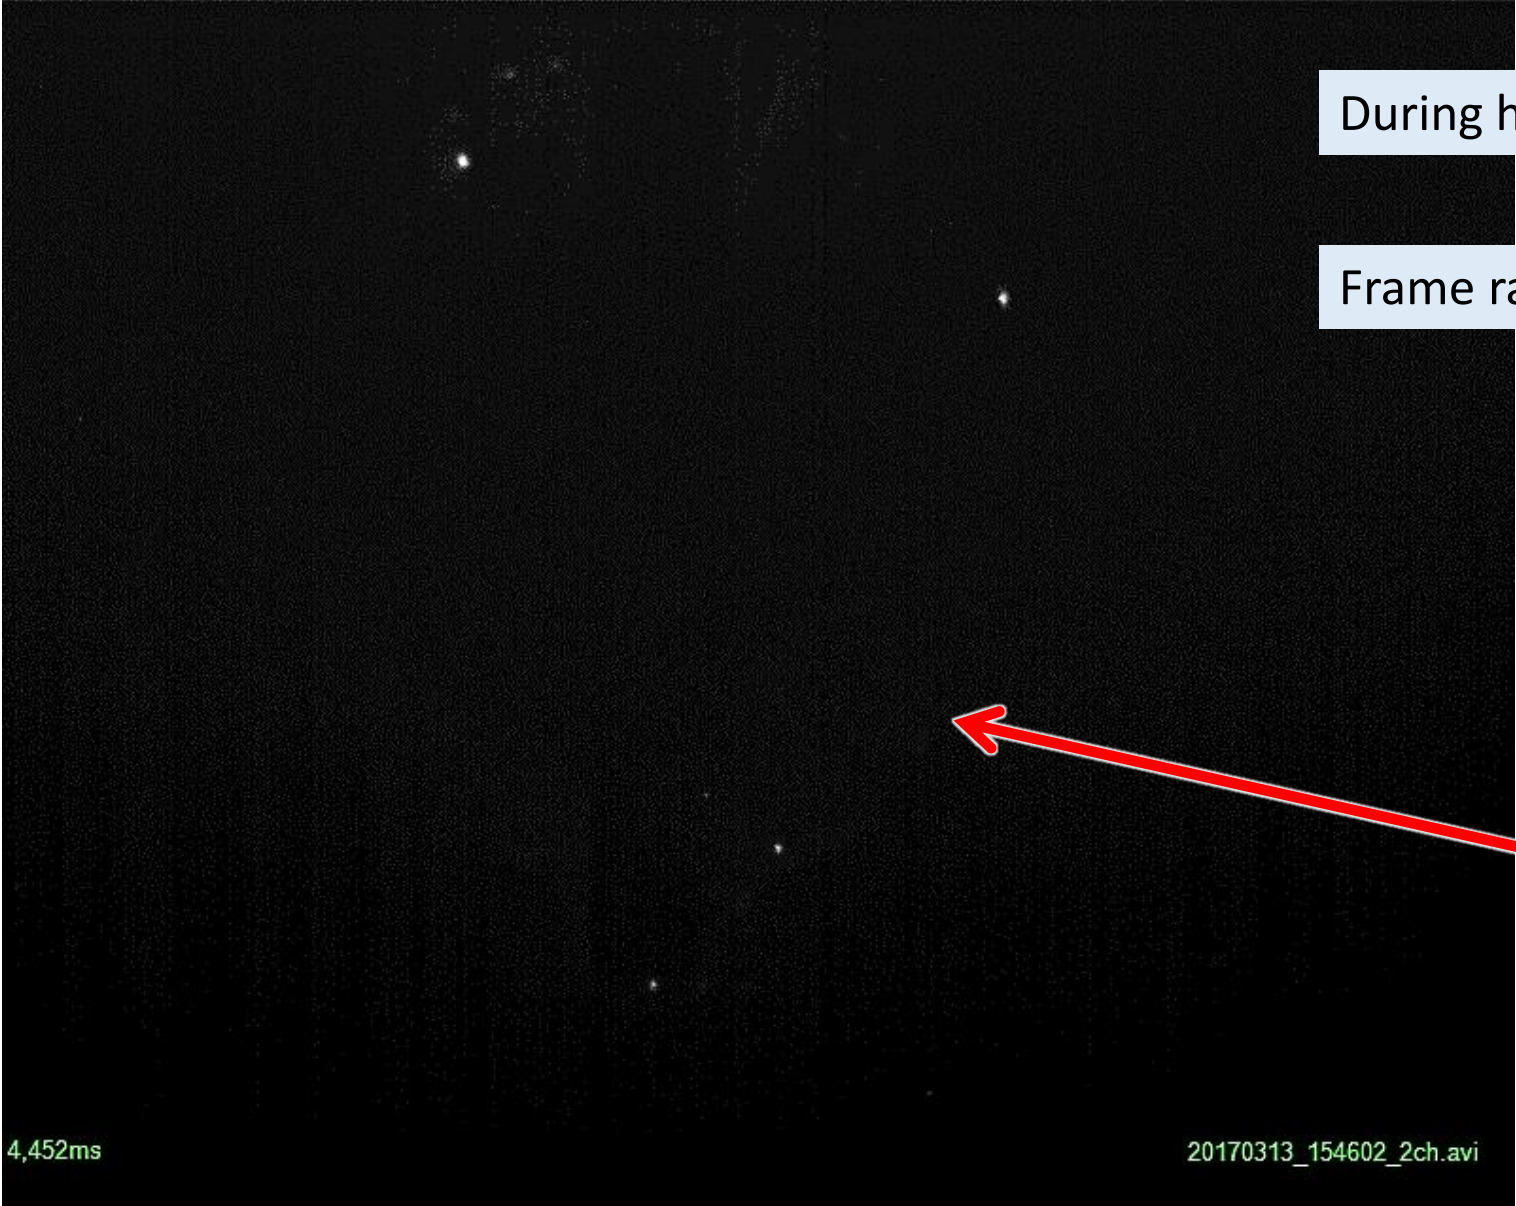
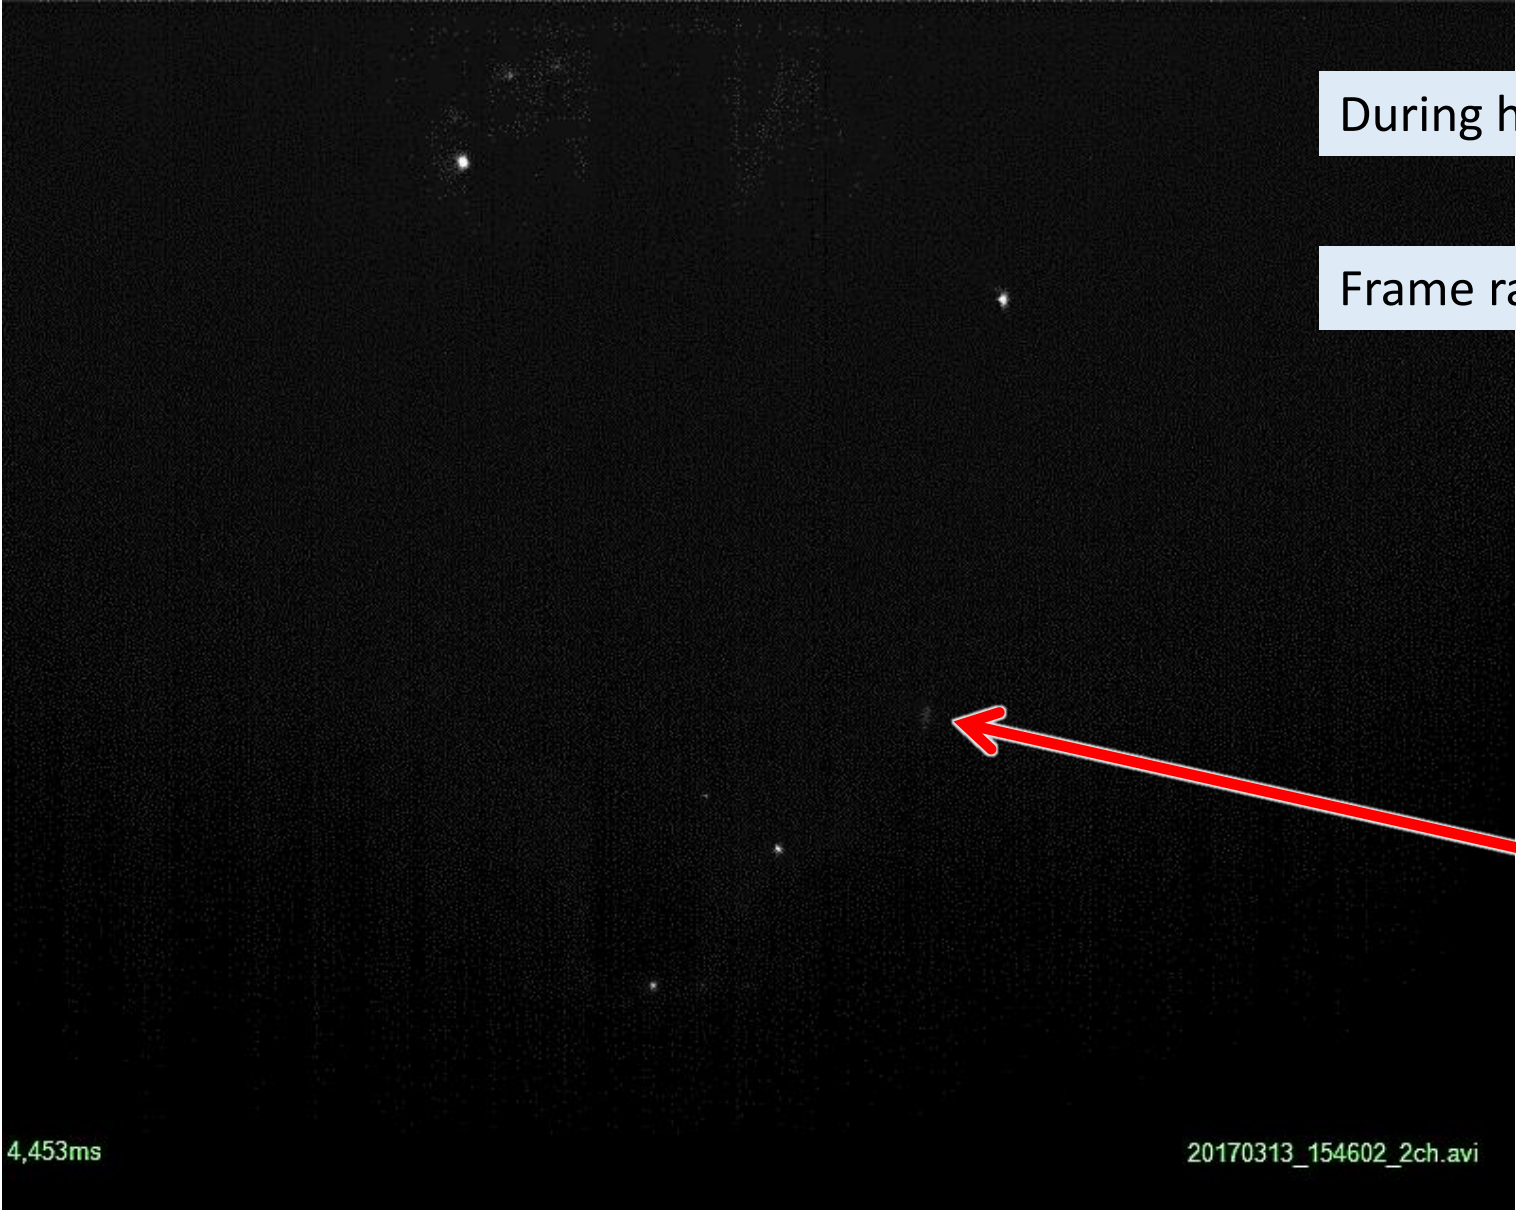
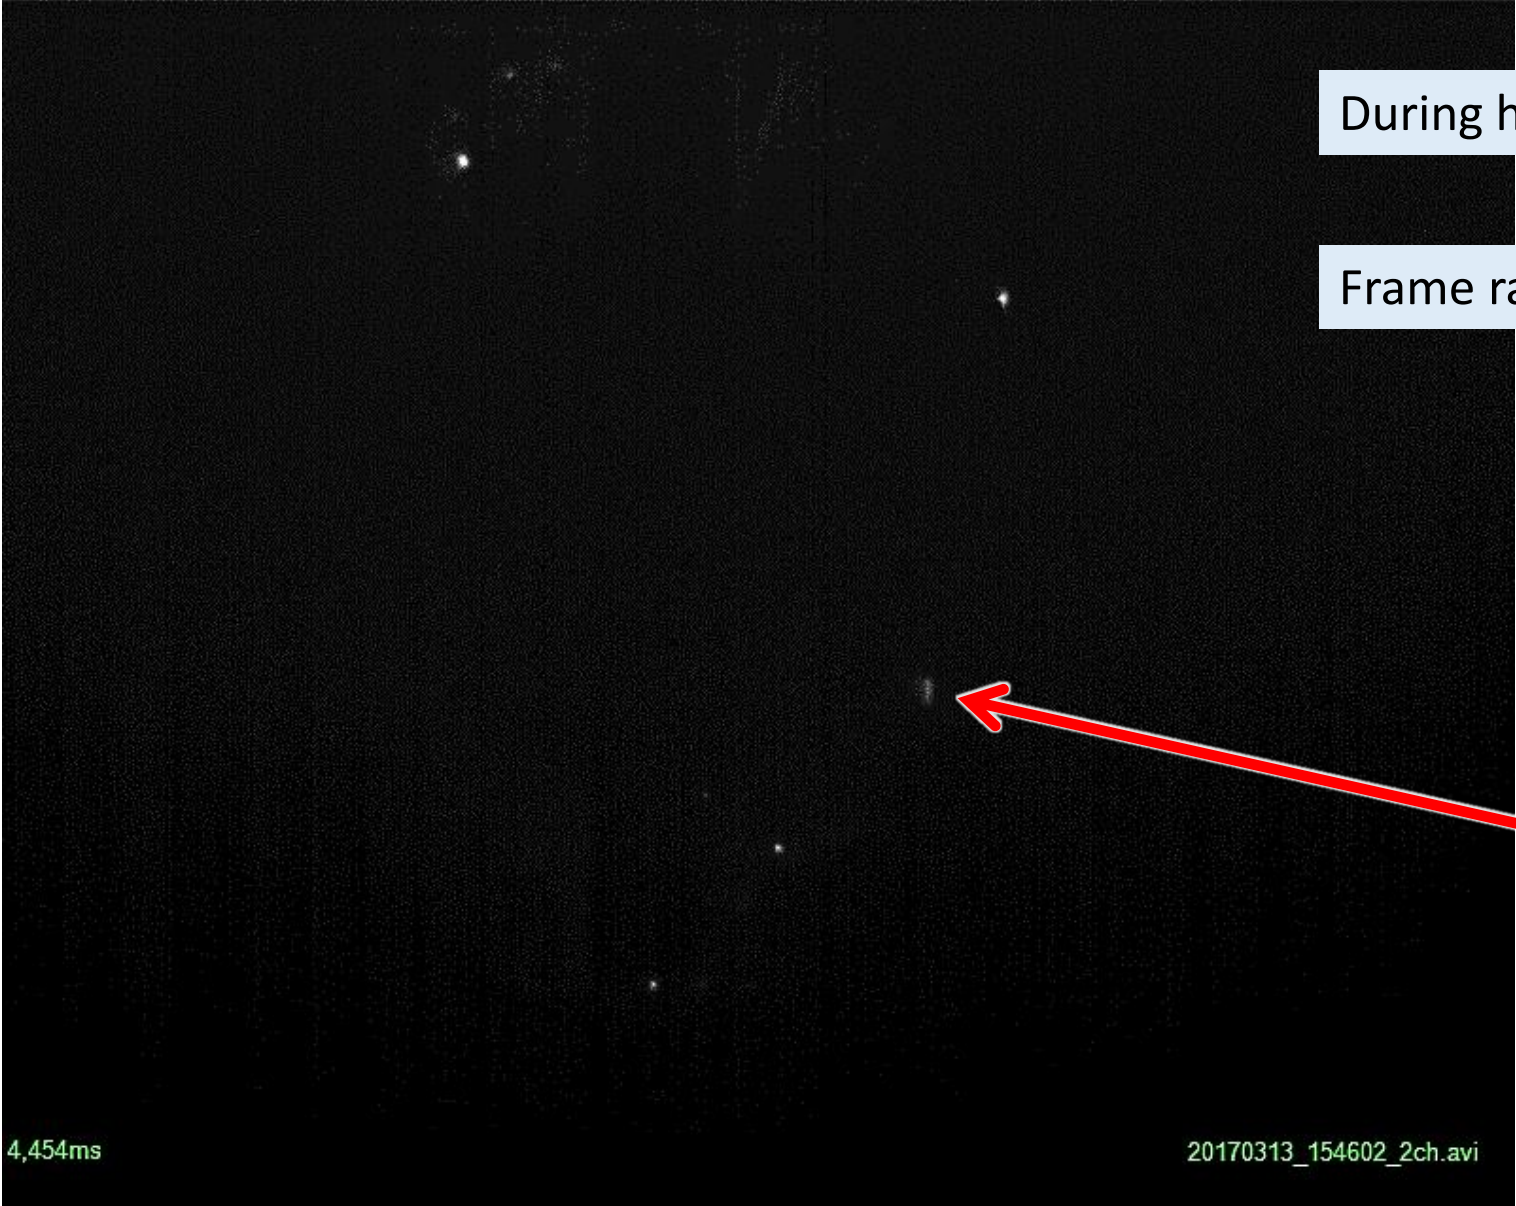
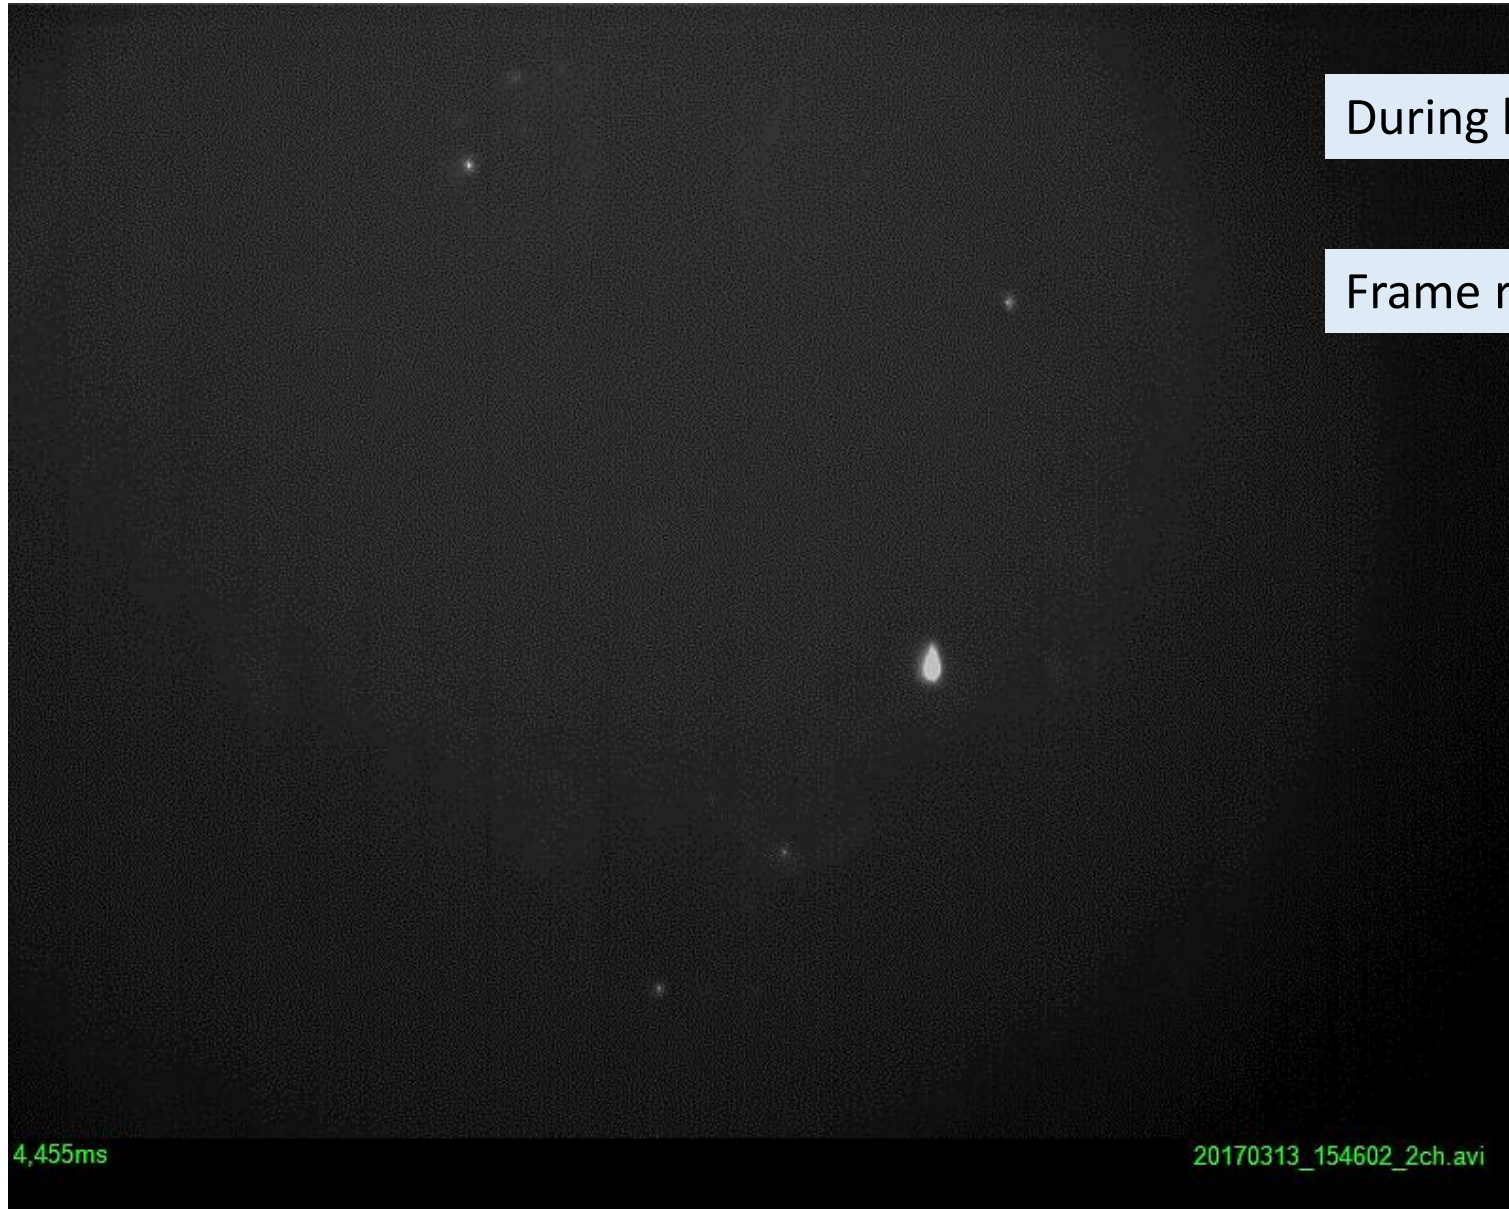
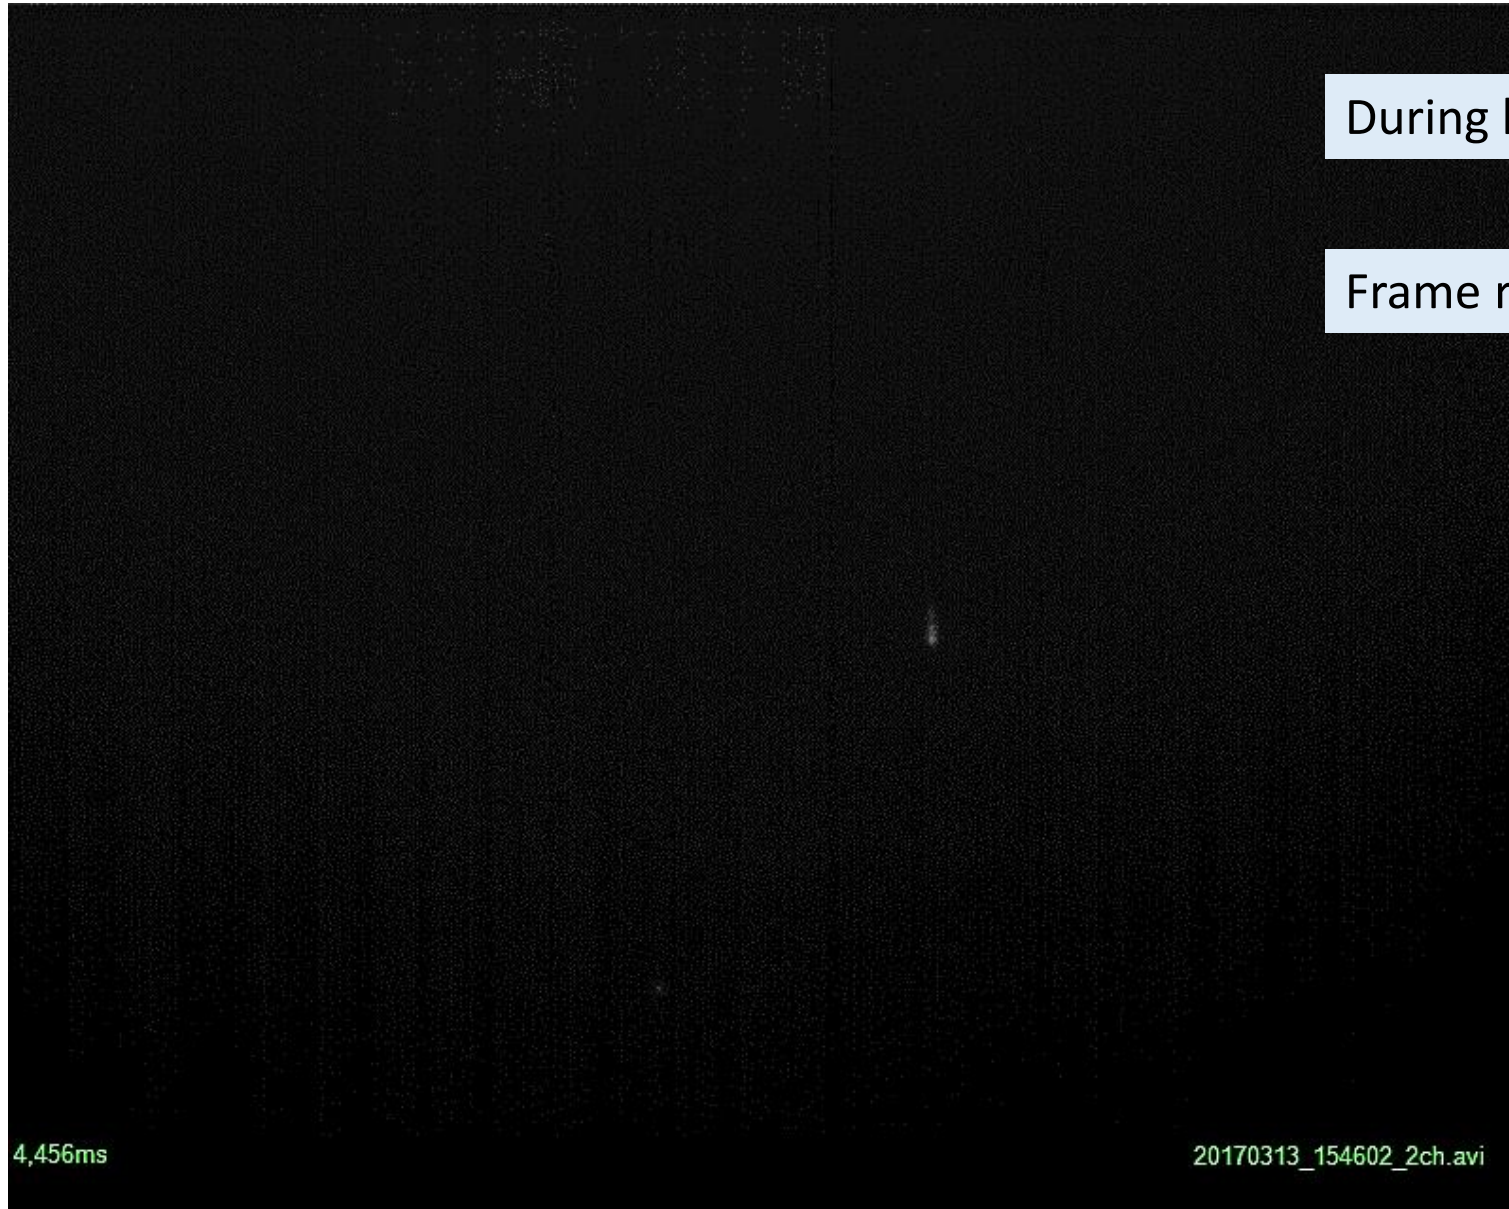
# Event 2/4: A flying object impacted on the downstream endplate!

Photo of the downstream endplate

- ✓ No RF
- ✓ LED light injected

During high-power operation

Frame rate : 1,000 fps
