# **Updated Results of Breakdown Study for 509-MHz Continuous-Wave Accelerating Cavities based on Direct In-situ Observation**

Tetsuo ABE

*High Energy Accelerator Research Organization (KEK), Japan*

MeVArc2018 @ Puerto Rico

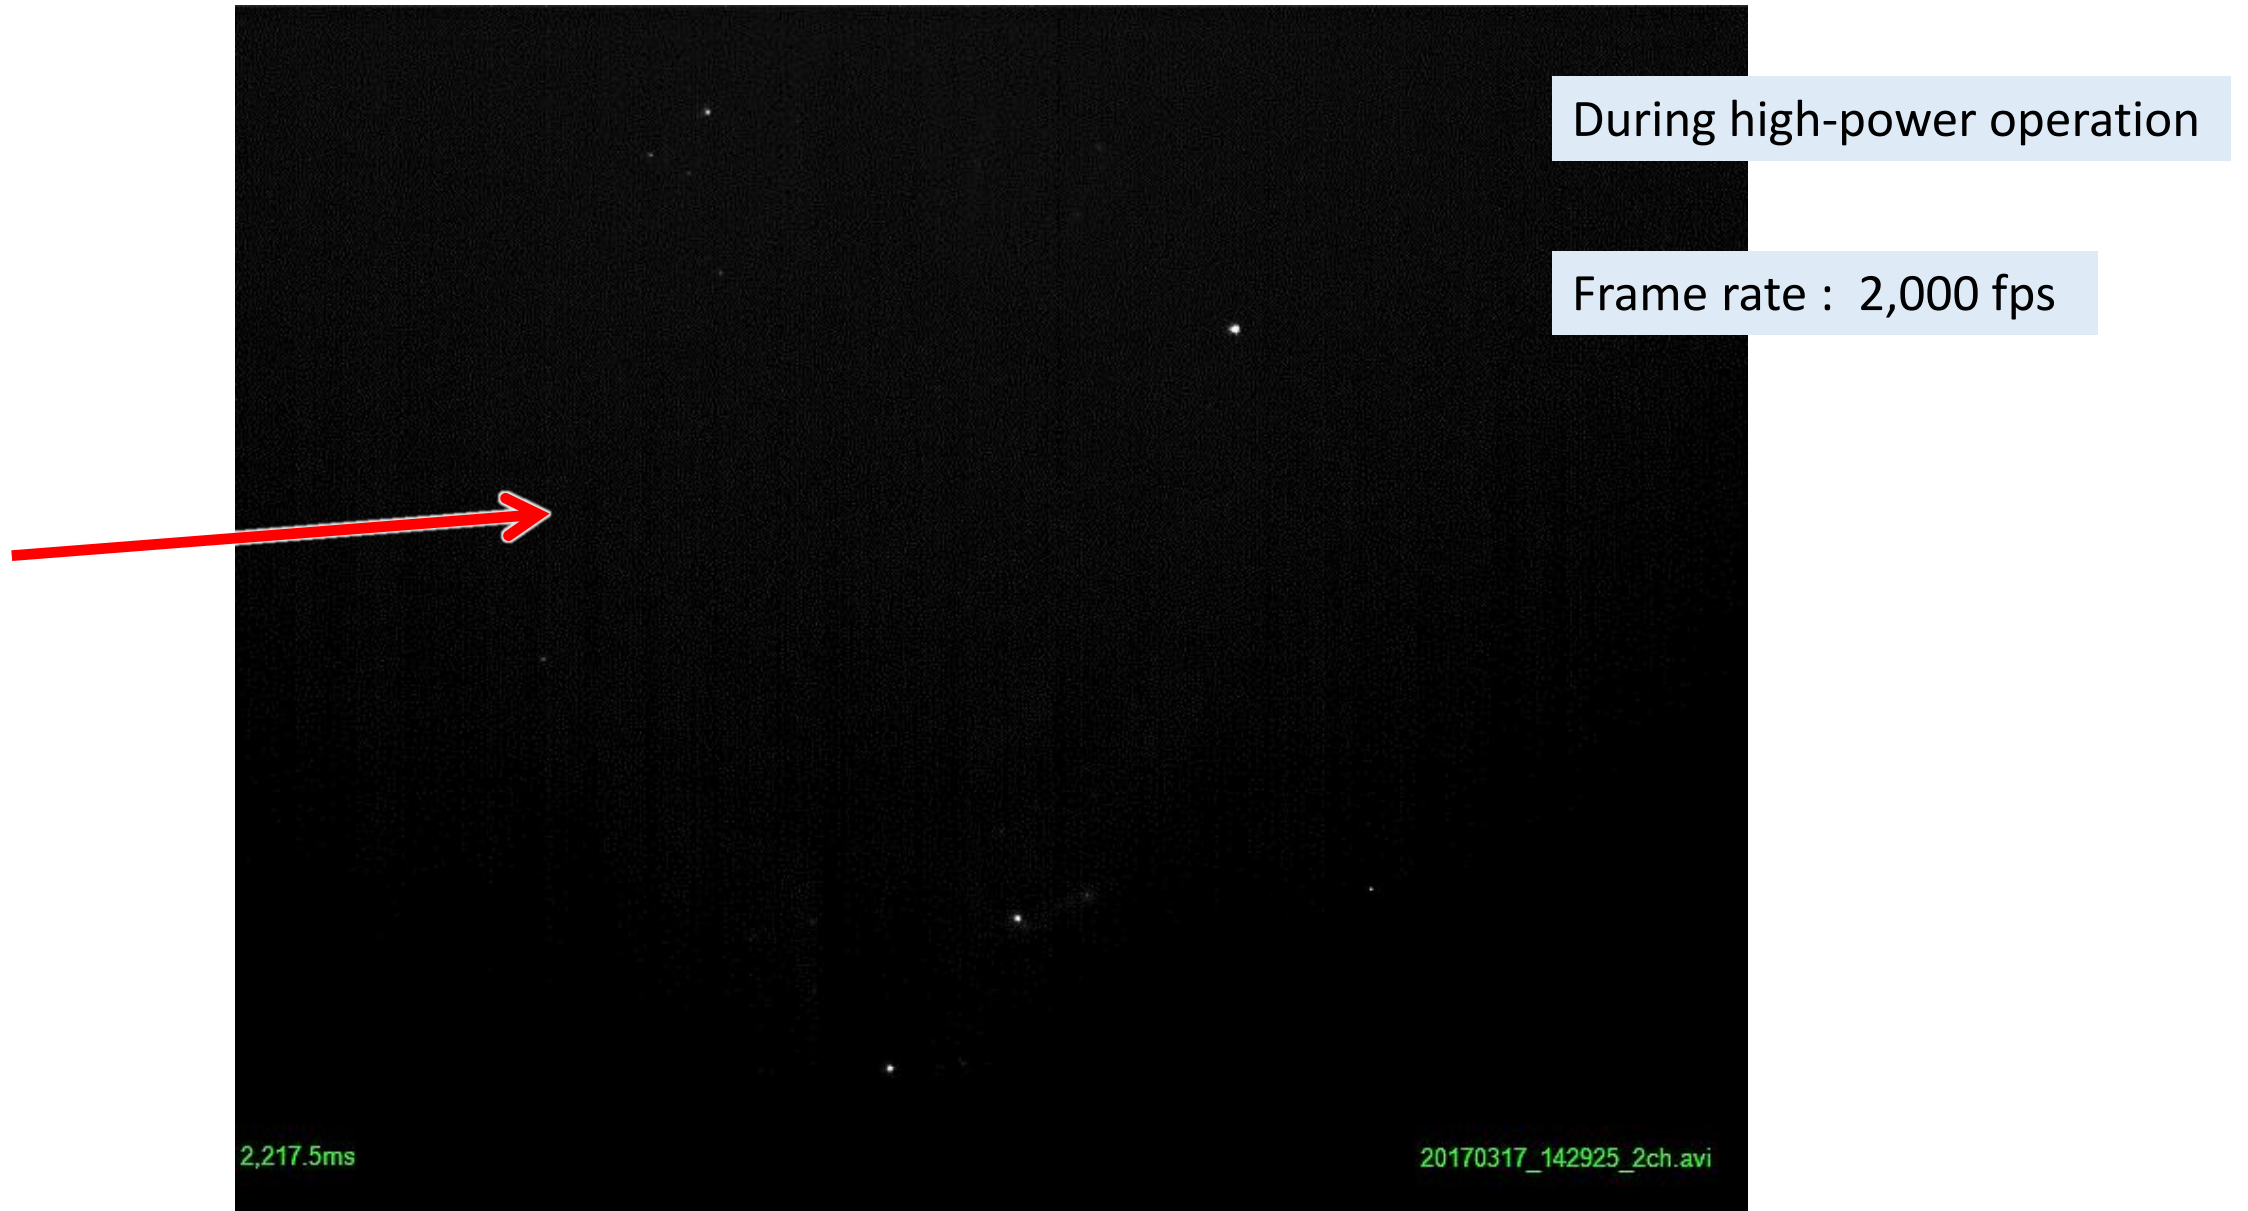
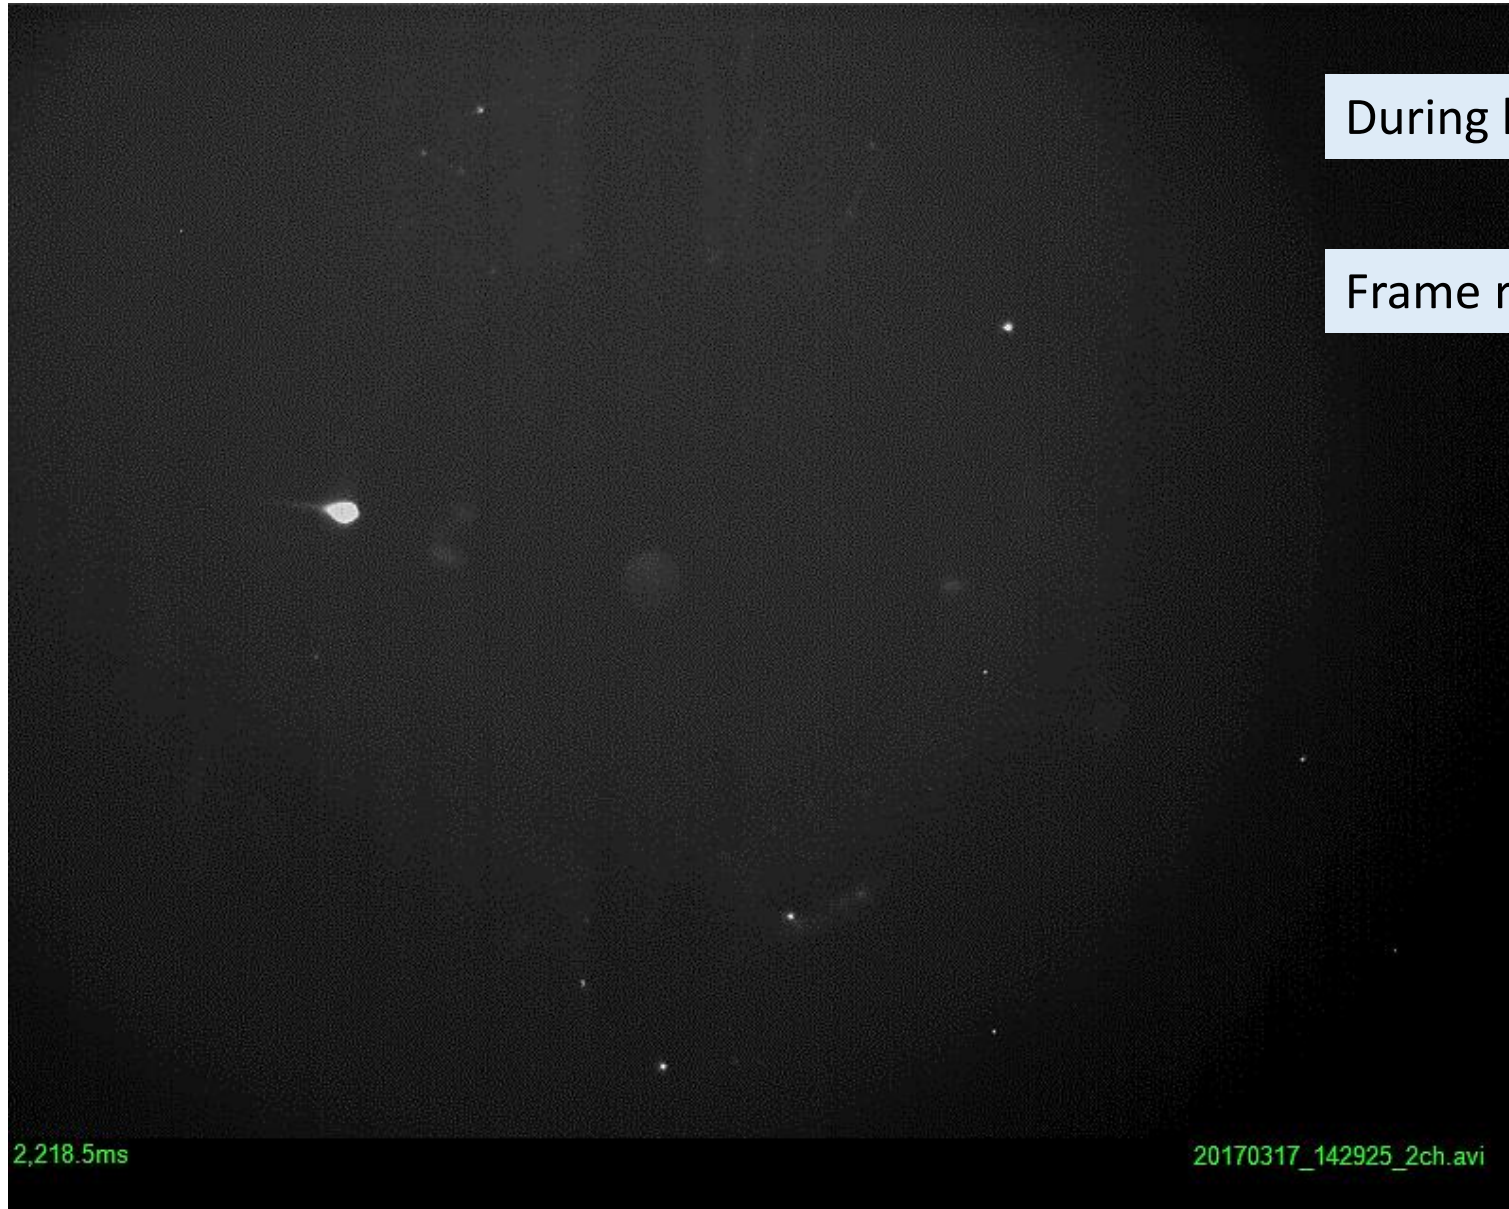
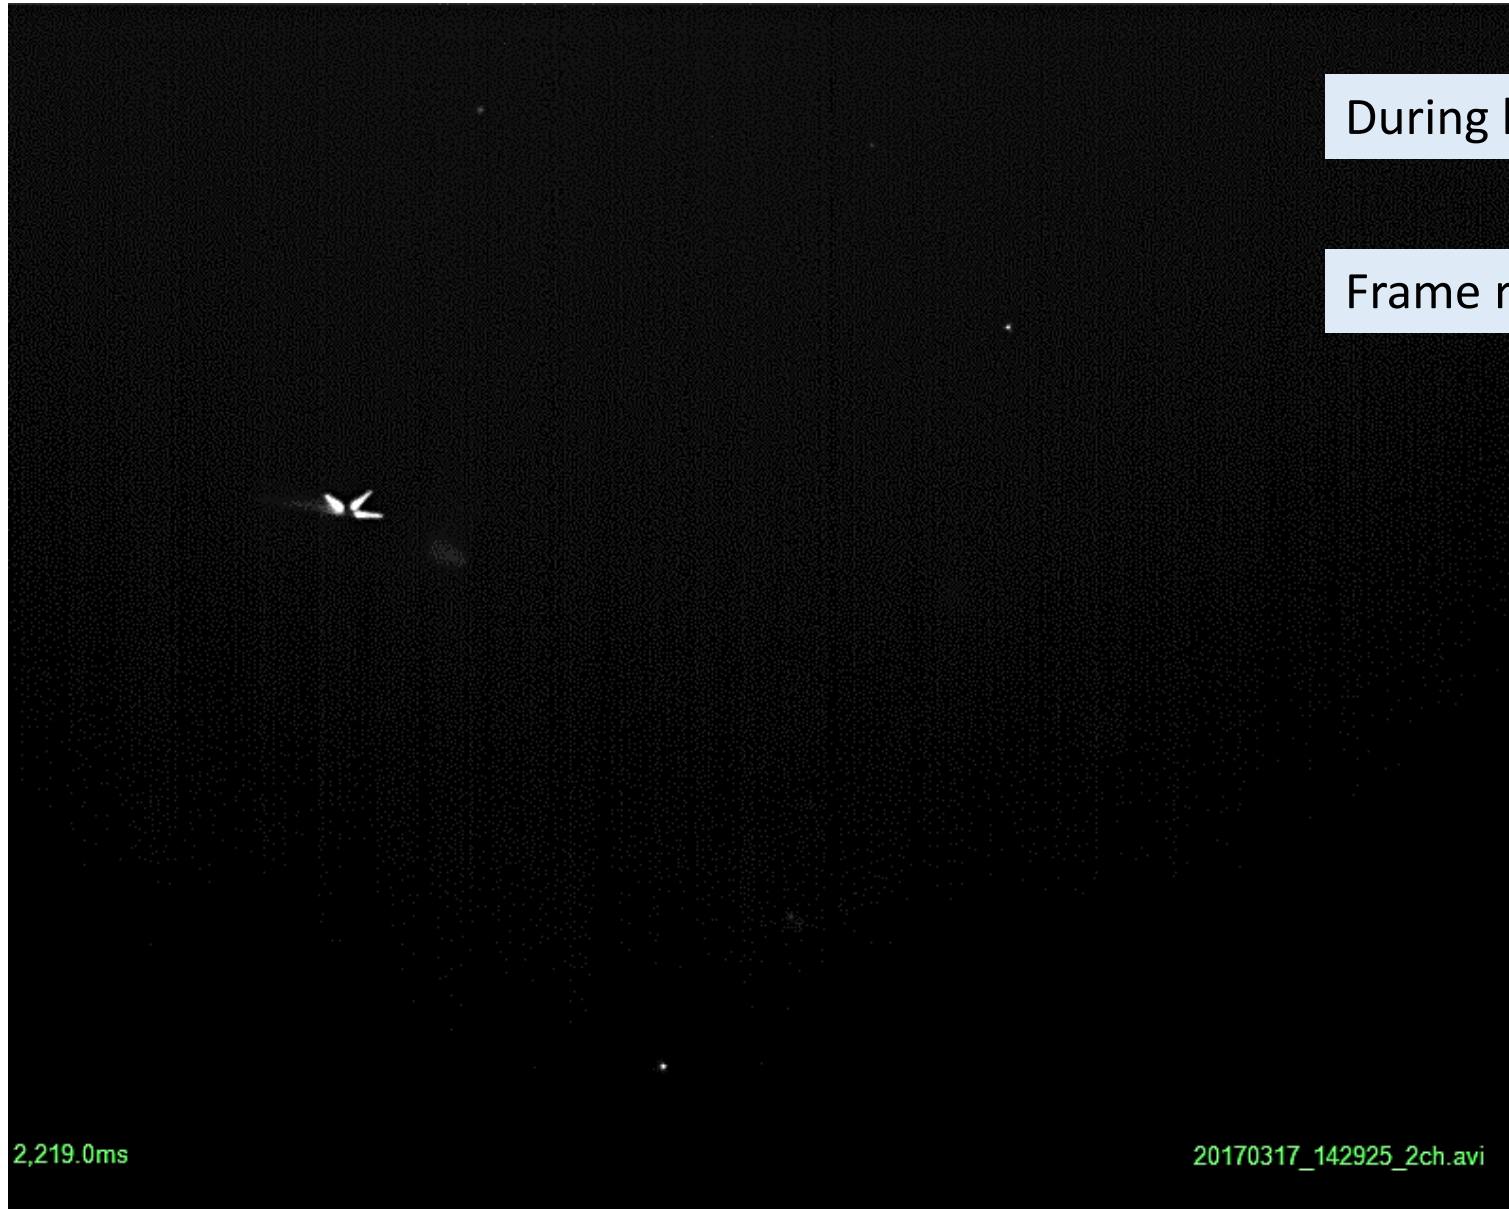
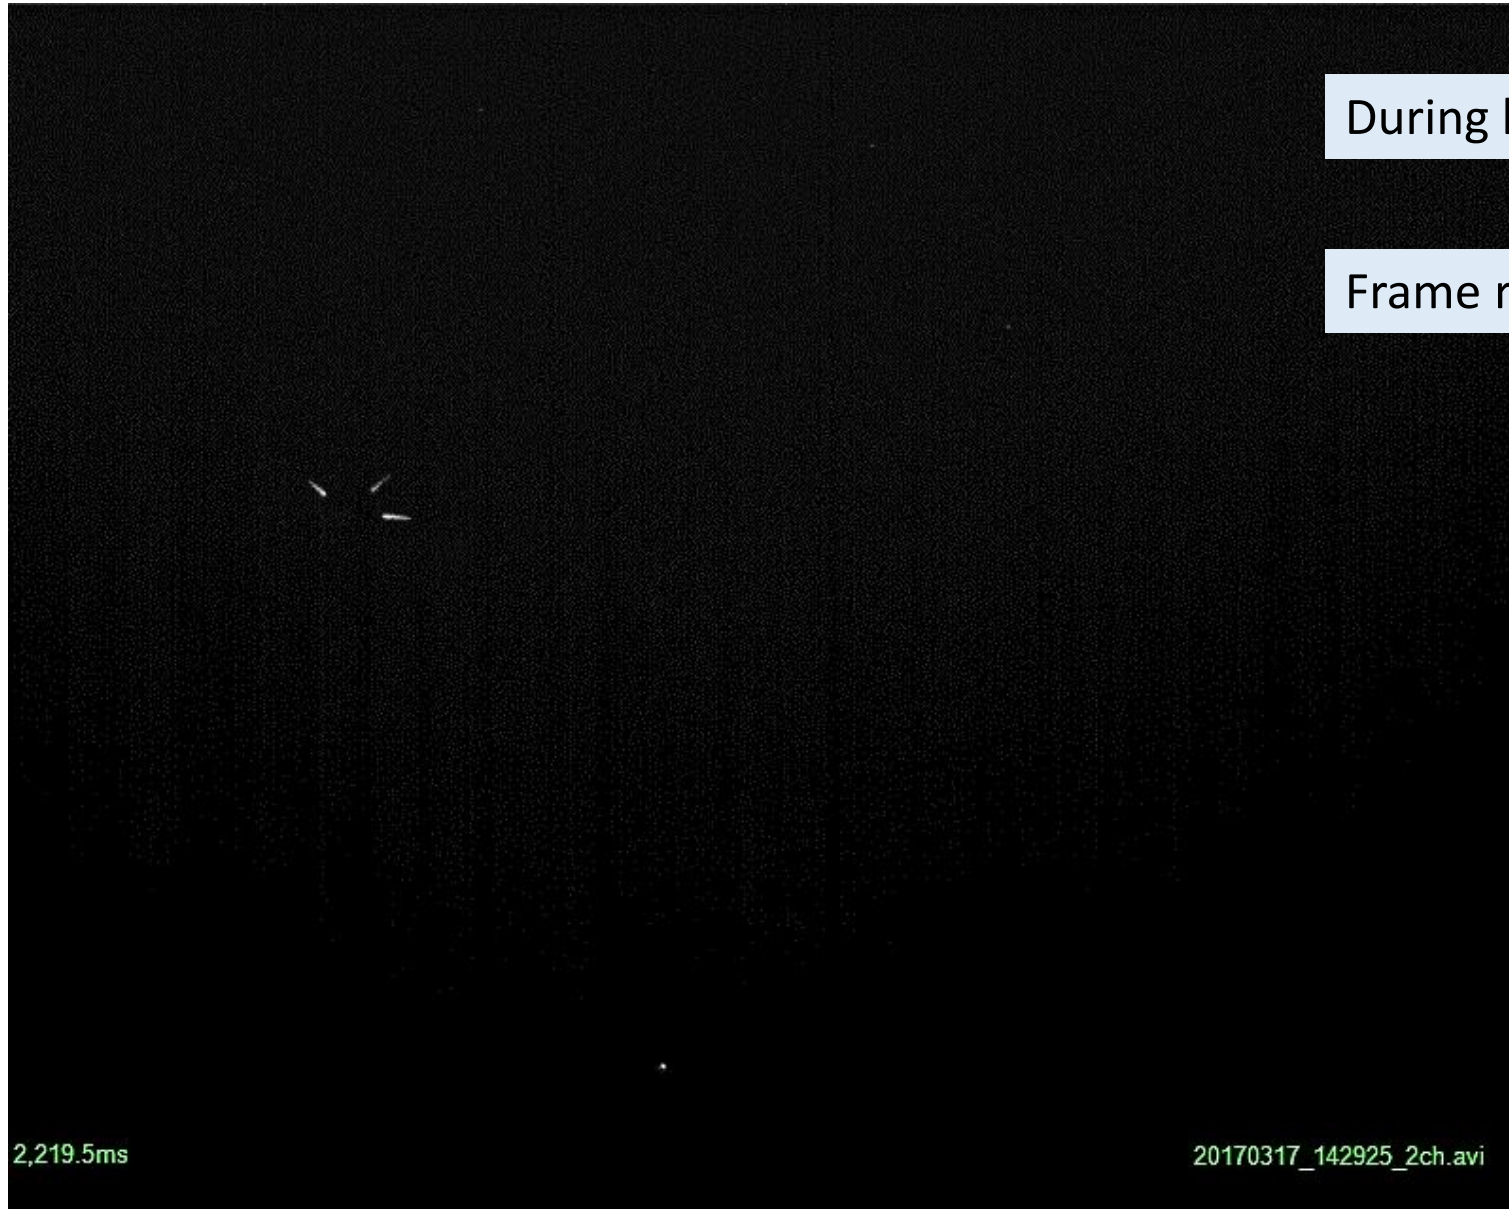
# Event 4/4: A flying object impacted on the downstream endplate!

Photo of the downstream endplate

✓ No RF

✓ LED light injected

During high-power operation

Frame rate : 2,000 fps

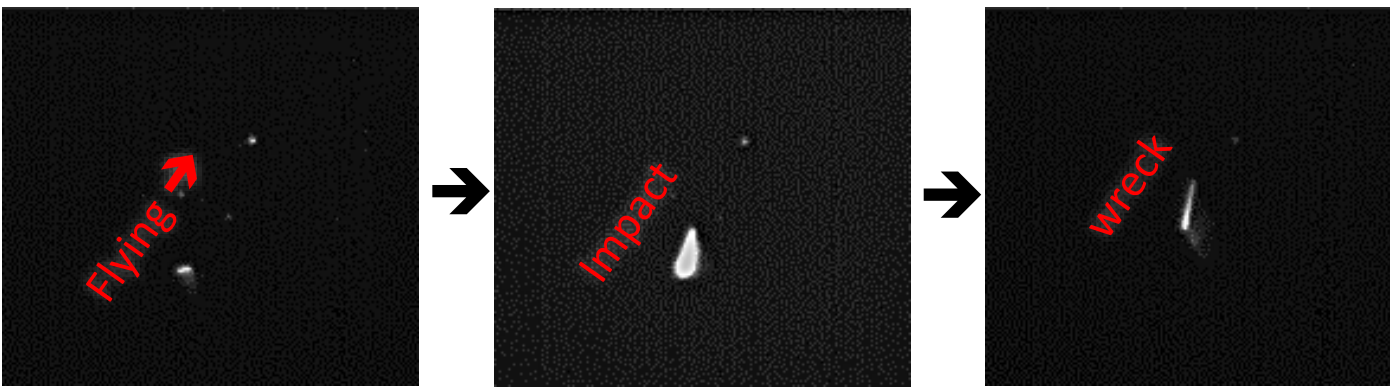
## Spot-type explosion not originating from a stable bright spot

- A charged-up carbonic microparticle with  $> 500 \text{ degC}$  was extracted by the RF field from the copper surface in one side.
- Accelerated by the RF field
  - Impact on the copper surface in the other side
  - Enough oxygen was provided from oxides, including  $\text{H}_2\text{O}$ , in the copper surface at the impact point in a moment.
  - Explosion
  - Vacuum breakdown

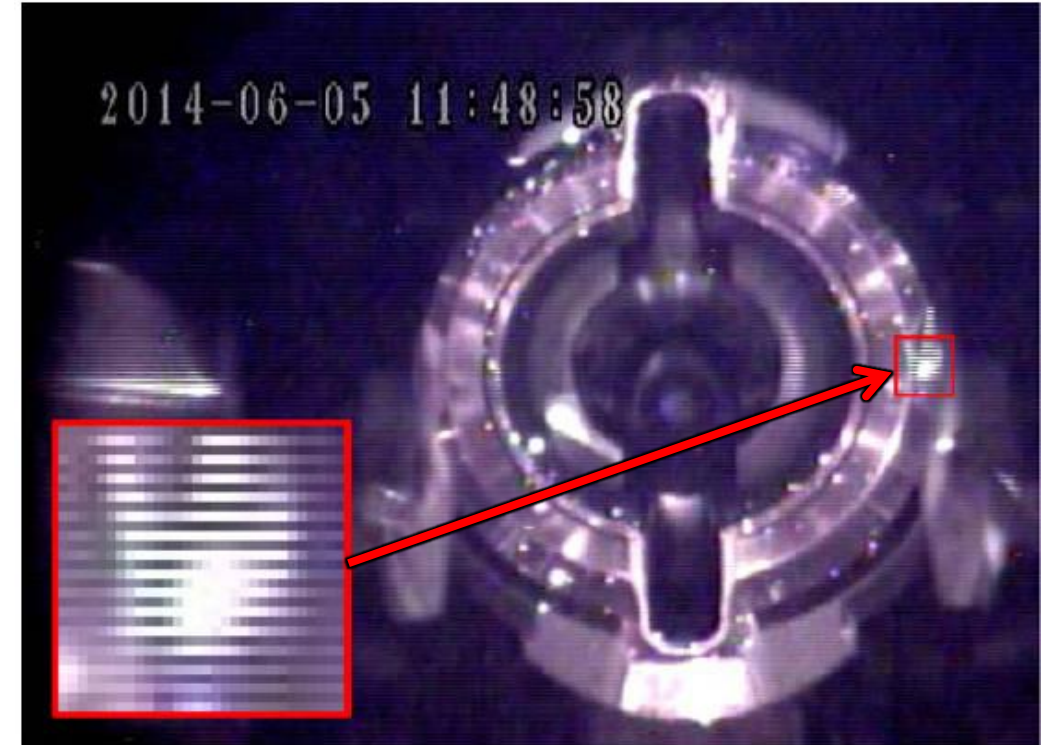
## Spot-type explosion of a stable bright spot

Enough oxygen was provided to the bright spot (= carbonic microparticle with  $> 500 \text{ degC}$ ) by a certain mechanism.

- Bright-spot explosion
- Vacuum breakdown

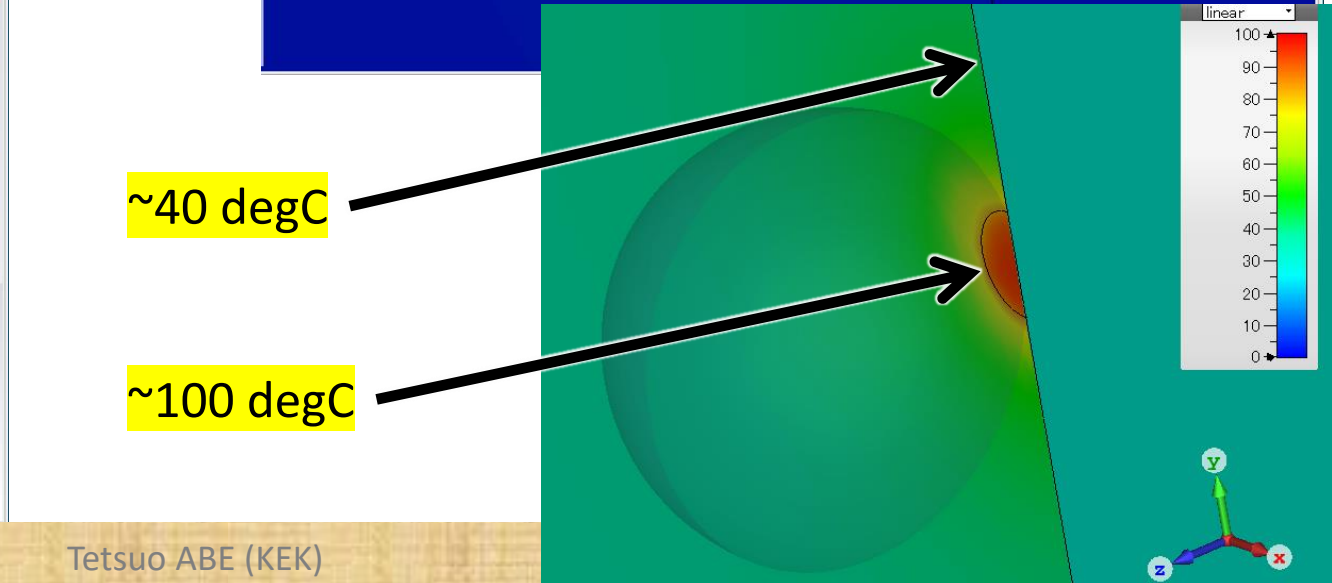
# Simple Simulation using CST MPHYSICS STUDIO
