Landau Cavity Improvements, and Issues with Drift Tube Linac Upgrades

2018 CWRF Workshop
Hsinchu, Taiwan

Landau cavity issues with higher beam intensities

200 MeV Linac RF Pulse width increase

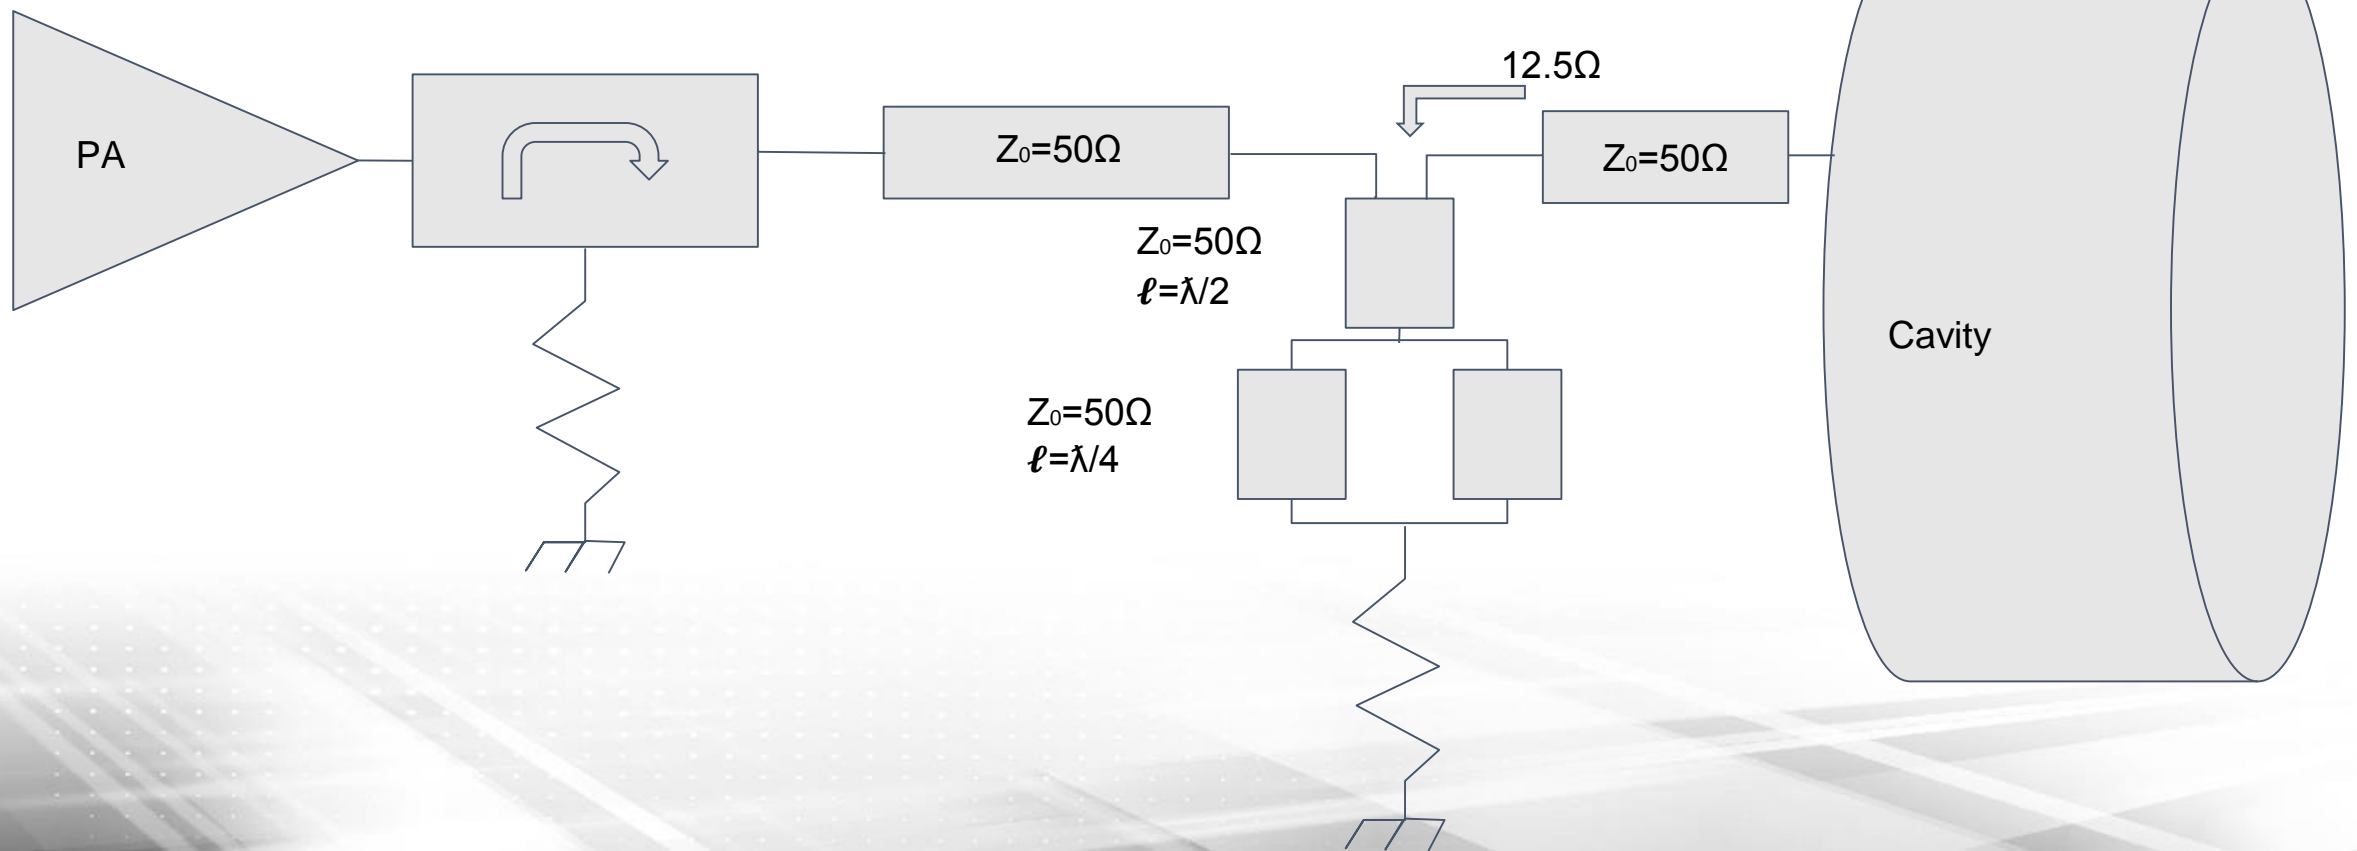
External Loading Network

- No vacuum work required
- Can modify impedance on the fly
- Reduces stress on existing circulator
- Made from off-the shelf components

Parameter	Critically Coupled	Ideal Externally Loaded
β	1	5
Q_L	22,000	8,000
R_{SL} (M Ω)	3.63	1.21
Z_{in} (Ω)	50	10
FFB Gain (dB)	40	33

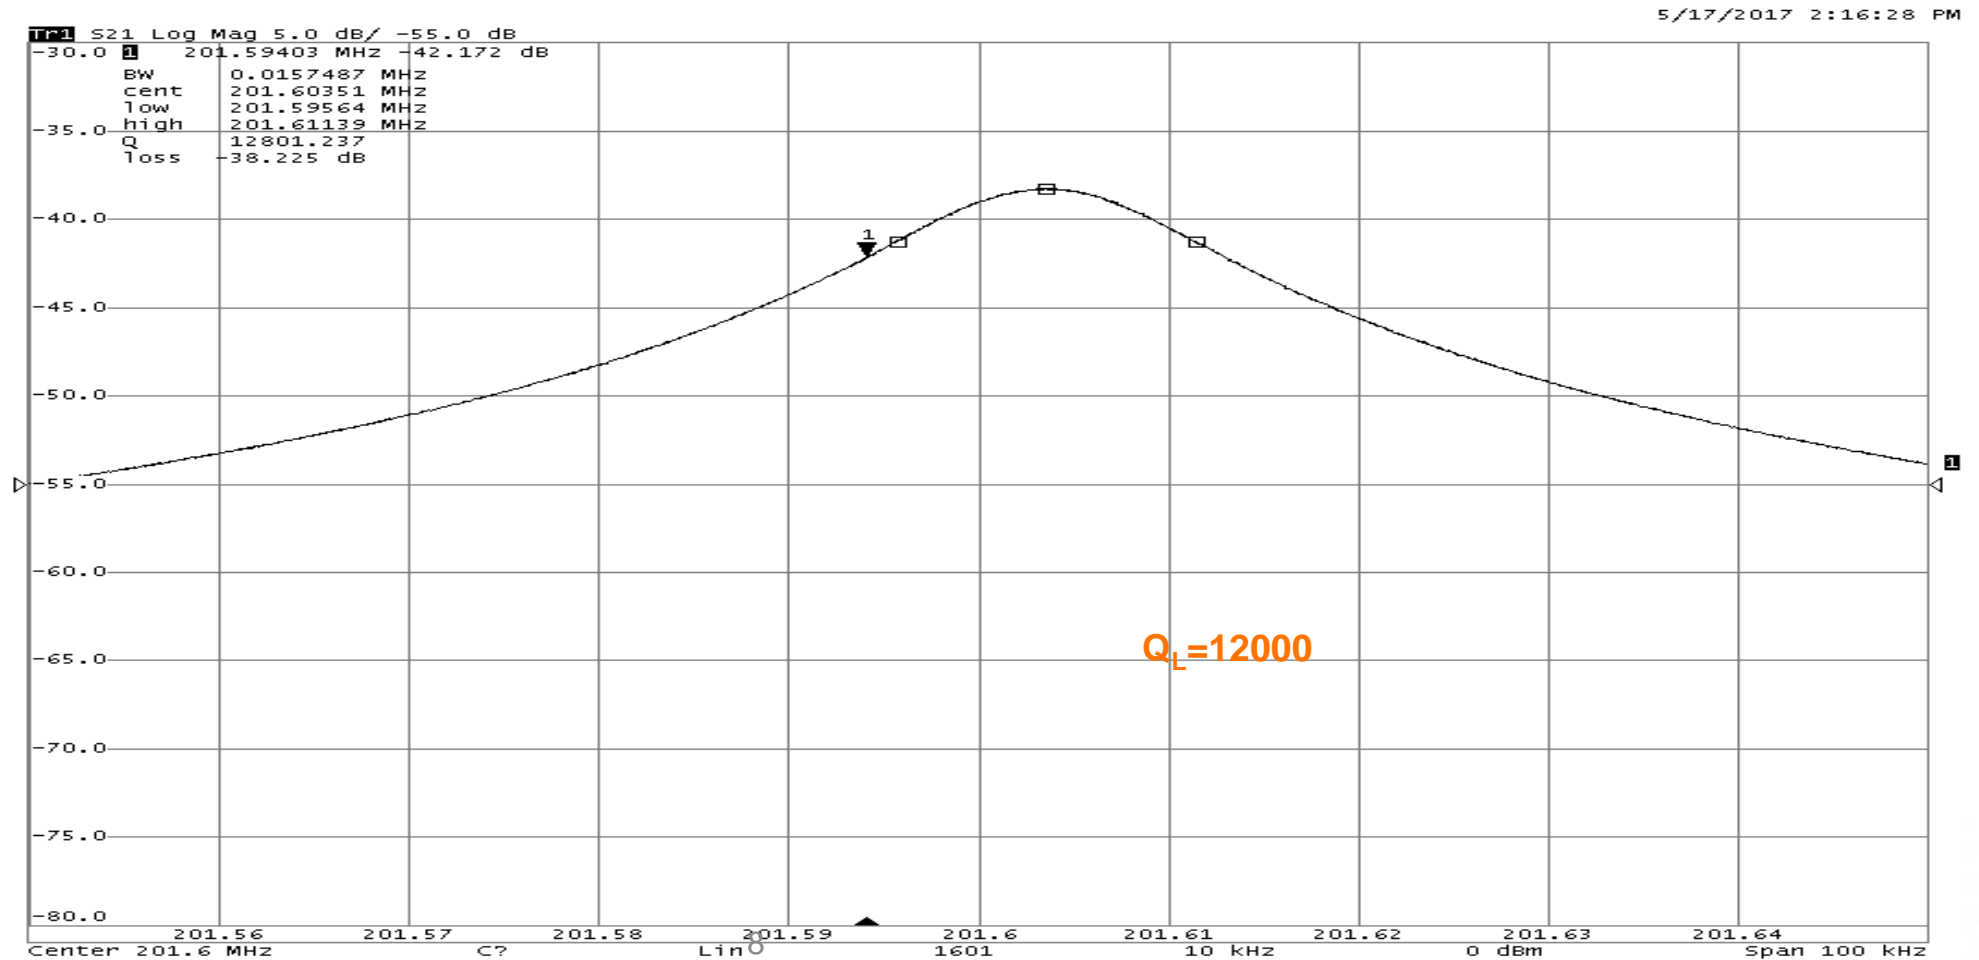
Measured Parameters

- Network not yet fully optimized
- β only 2.6

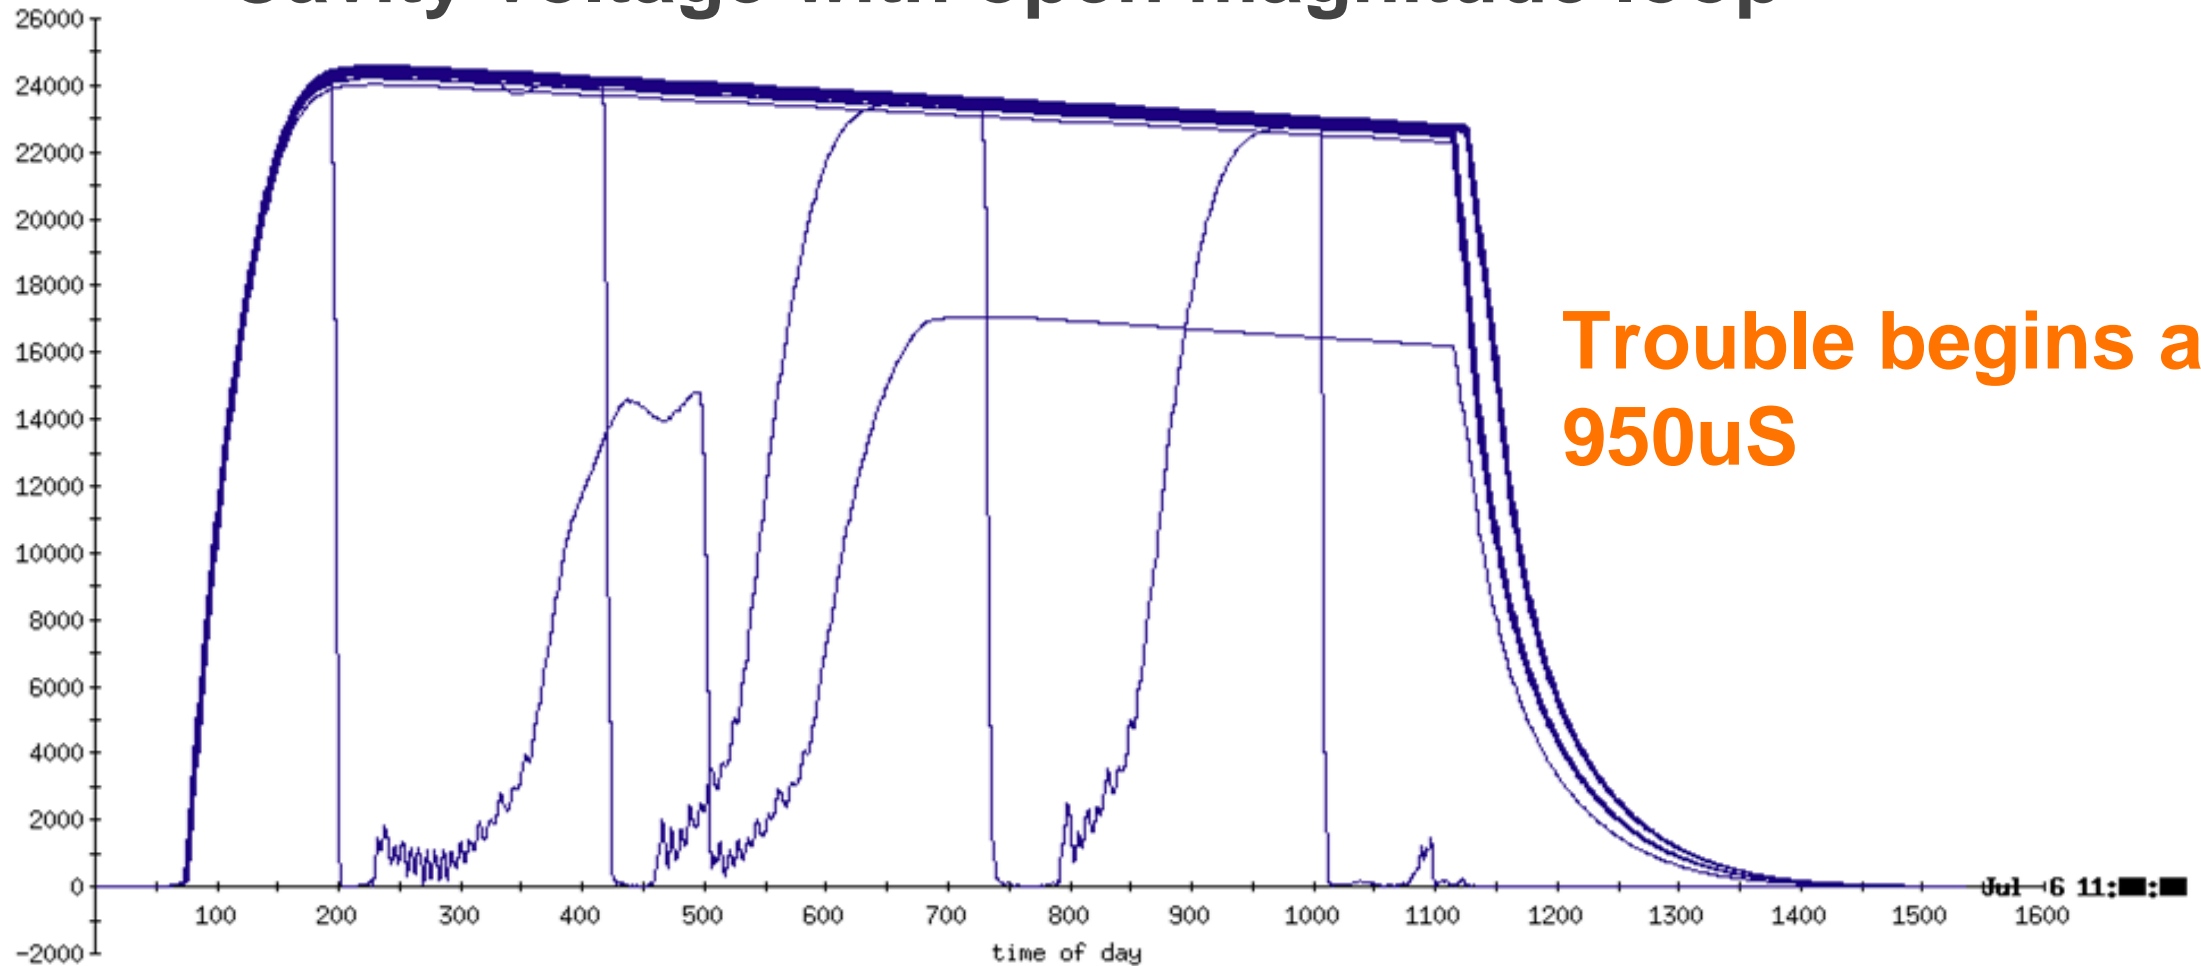
Cavity voltage with open magnitude loop

- Shut system down to let vacuum recover
- Ended testing after observing excessive vacuum activity
- Opened up Tank 5 to inspect damage

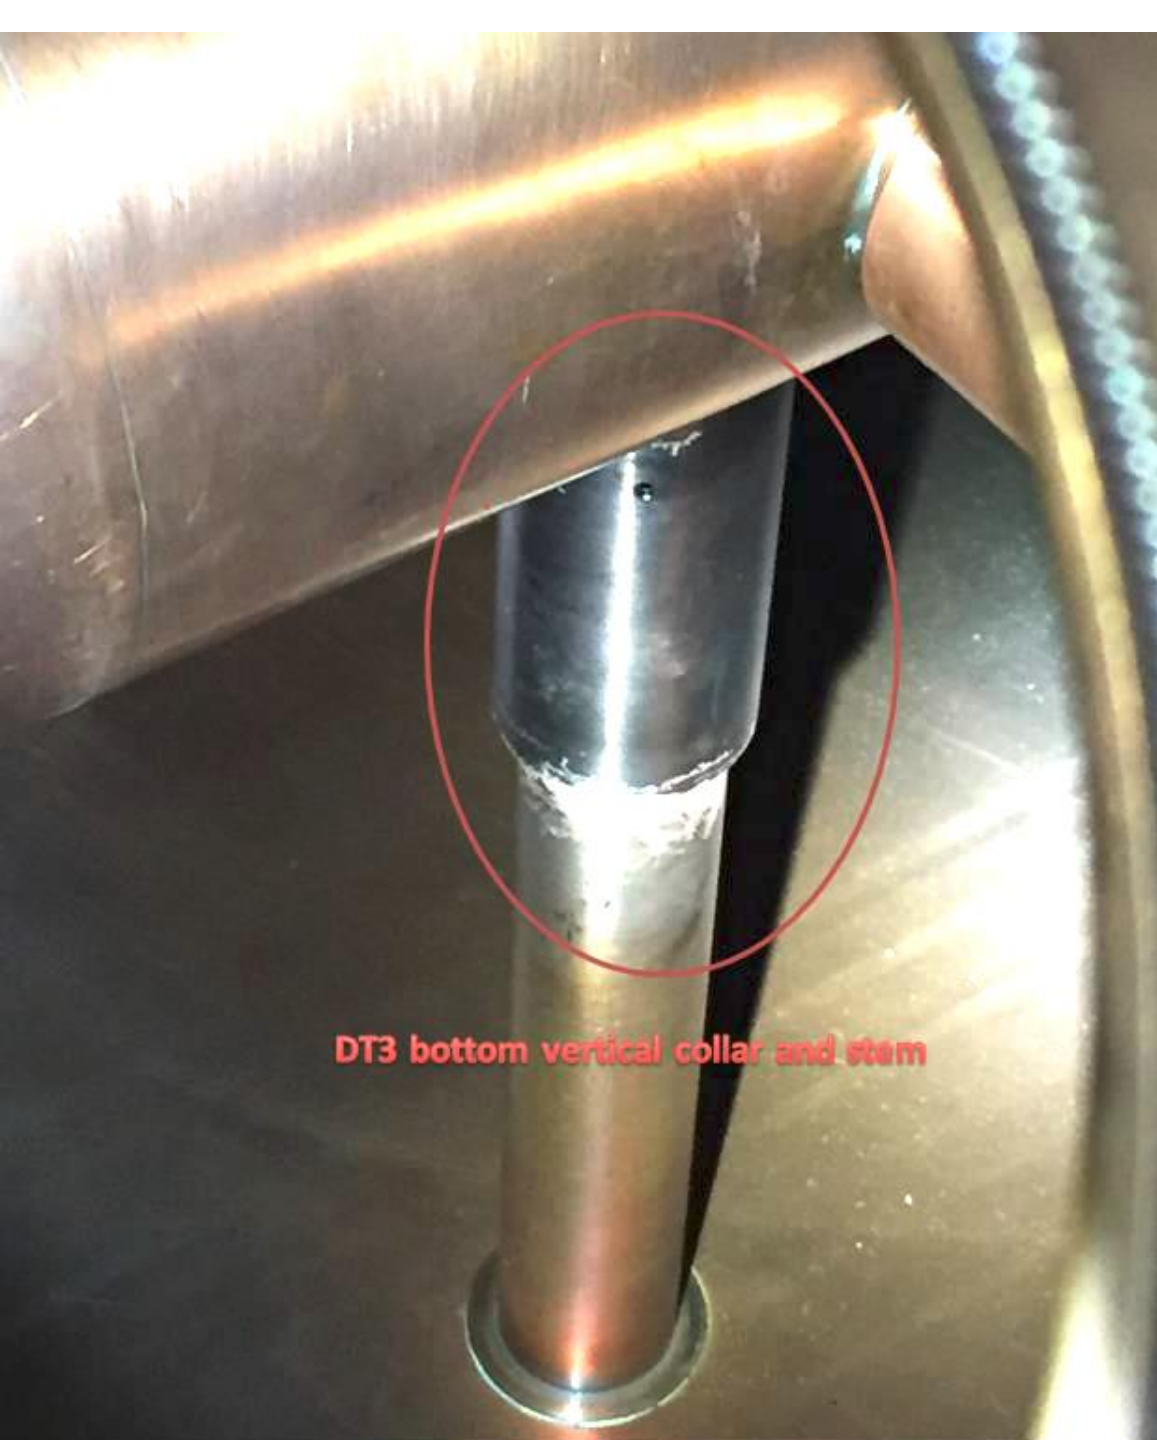
DT3 bottom vertical collar and stem

- Drift tube stem and collars were overheating

12 of 96 stems/collars suffered damage

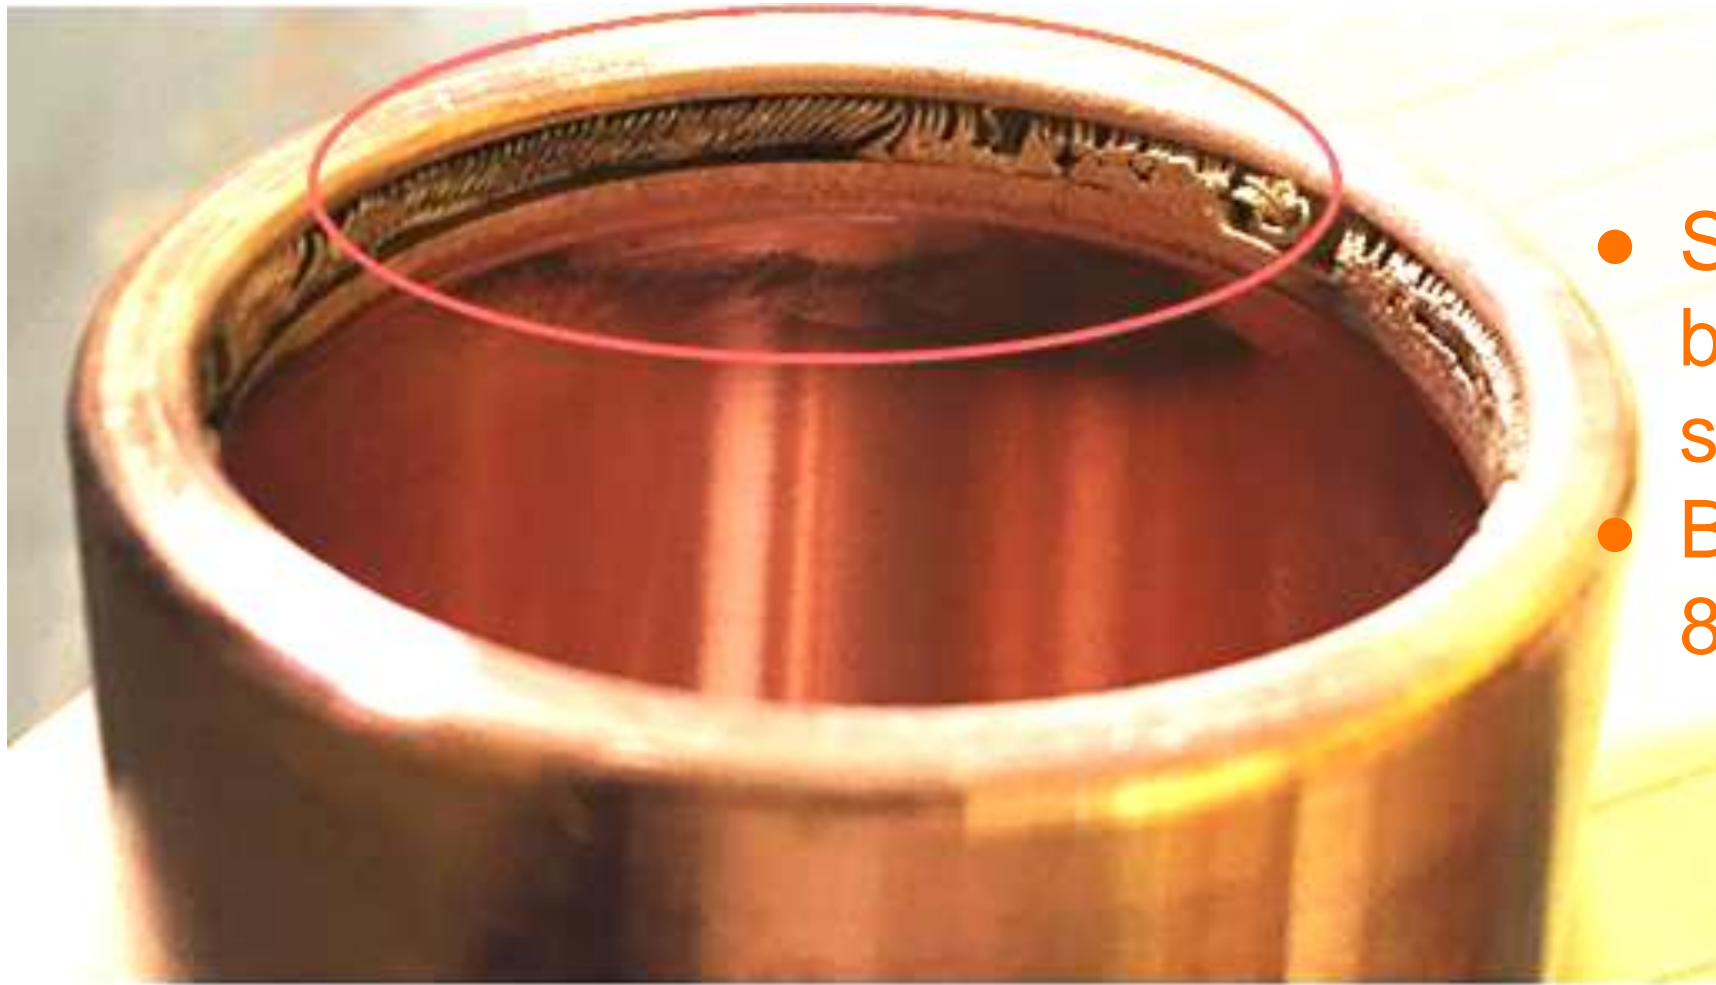
RF Spring ring remnants

- Silver plated beryllium copper RF spring ring melted
- BeCu melting point = 800-900°C
