Commissioning and operating of high power SSA of 25MeV SC proton Linac

Institute of Modern Physics, Chinese Academy of Sciences

Outline

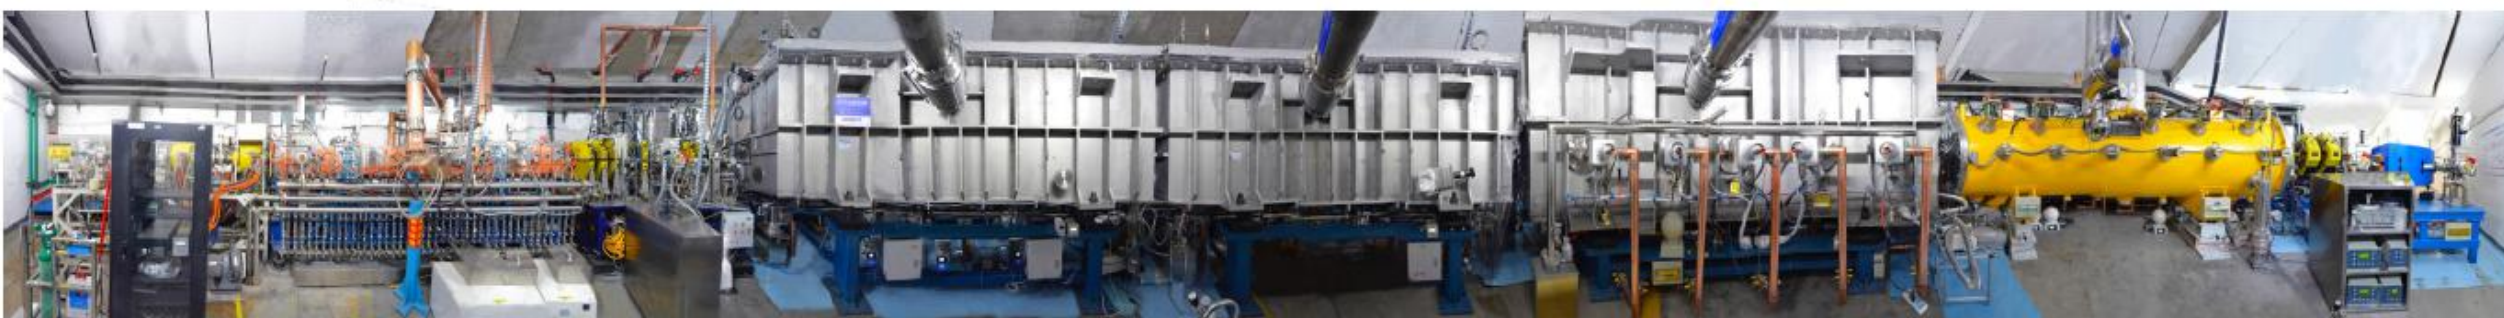
25MeV SC proton Linac

ECRIS + RFQ + CM1 + CM2 + CM3
+ CM4
Energy is ~25 MeV
First beam June 5th, 2017

CM1/IMP	CM2/IMP	CM3/IMP	CM4/IHEP
Frequency	162.5 MHz	162.5 MHz	162.5 MHz	325 MHz
Energy	6 MeV	11 MeV	18.6 MeV	26.2 MeV
Type	HWR010	HWR010	HWR015	Spoke021
Number	6	6	5	6

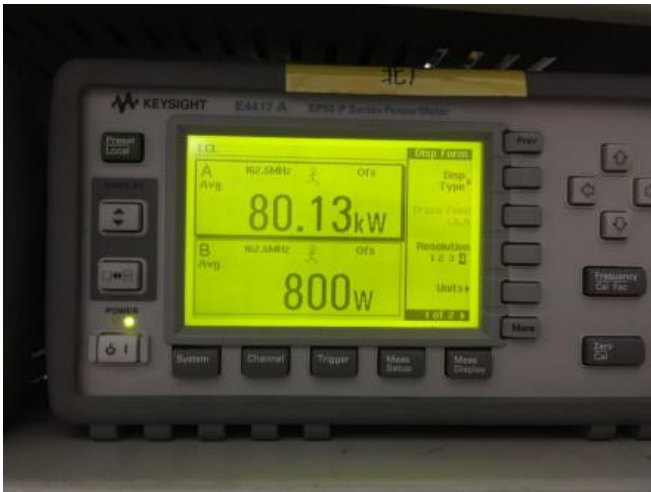
Harmonic Power Output \leq -44dBc

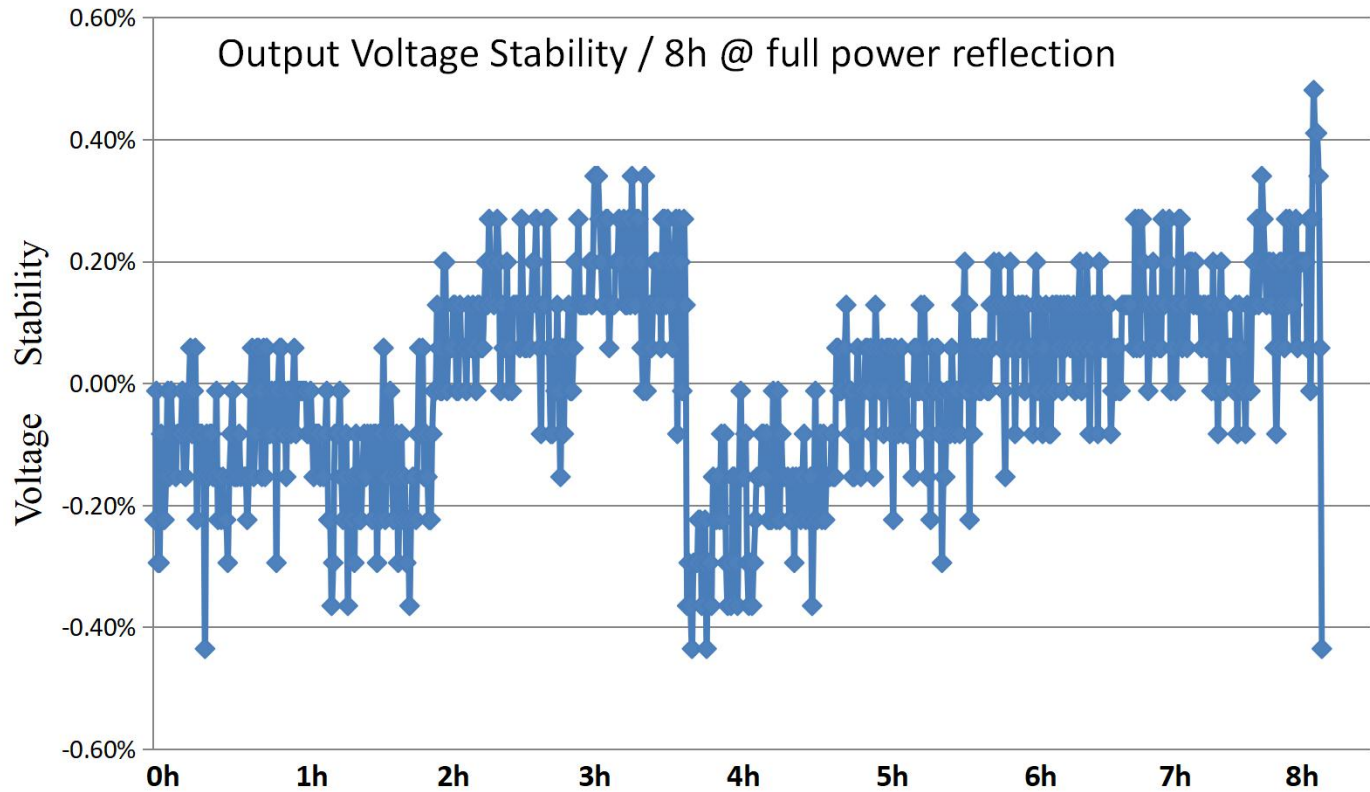
Full power reflection Test

Eight hour 80kW full power reflection test is performed to verify the reliability of the amplifier under 100% mismatched load.

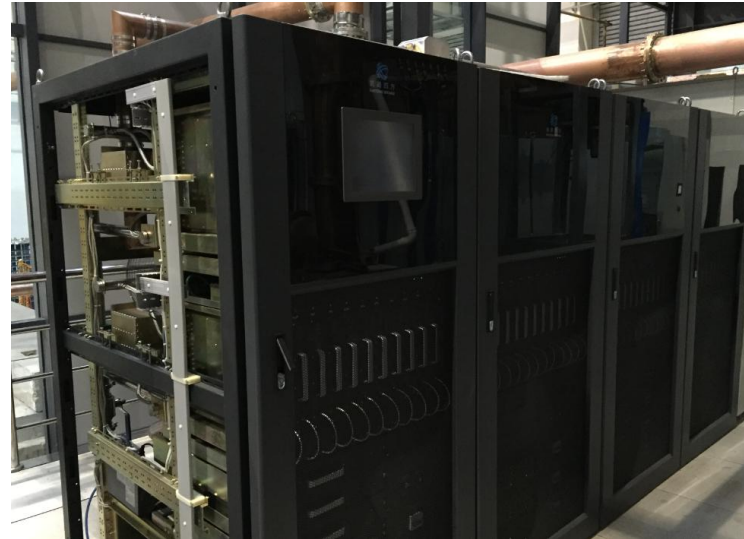
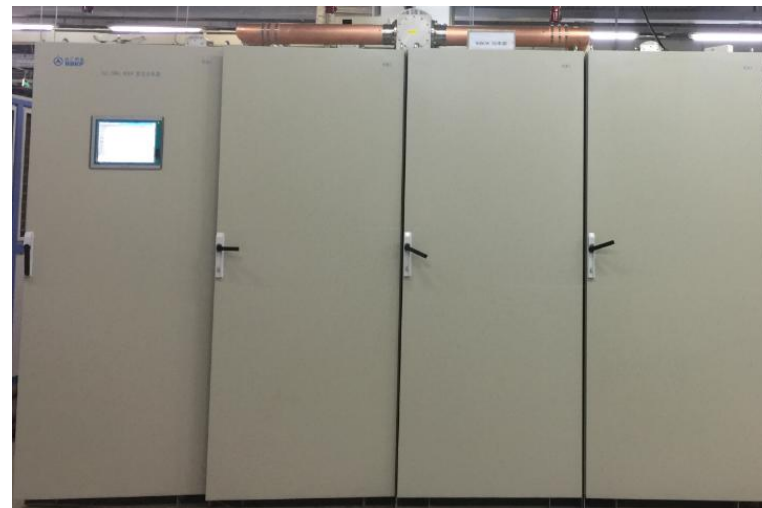
Two 80kW 162.5 MHz amplifiers for RFQ

The RF system for RFQ cavity was two 80kW solid-state amplifiers with many small circulators inserted in power modules for feeding power to separate.

Two sets of SSAs both are consisted of four 20kW sections to integrate gradually for providing 50-60kW RF power for separate coupler at the same time, and due to the different output characteristics, LLRF has to adjust the offsets of output gain and phase in the beginning.

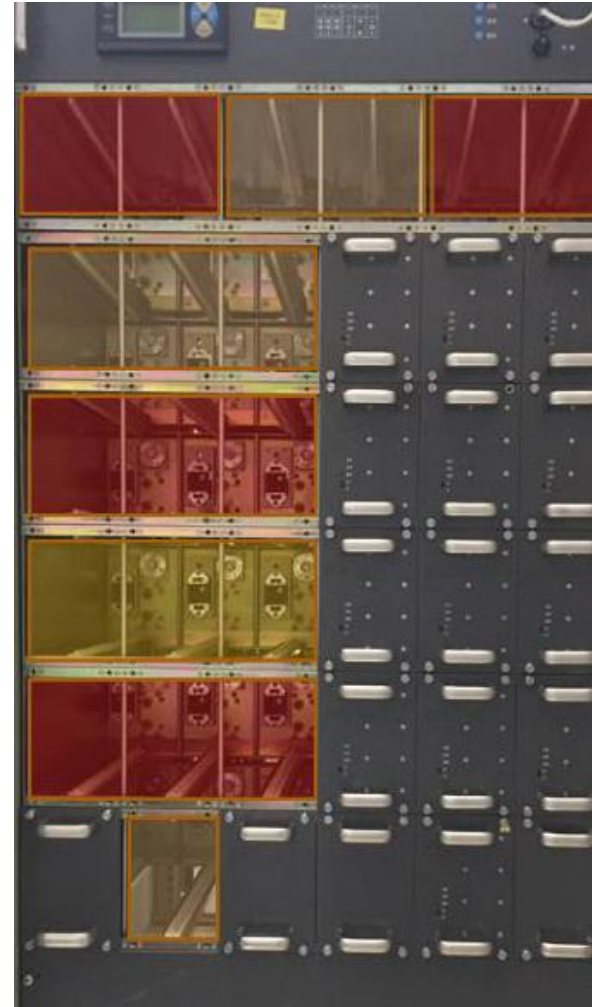
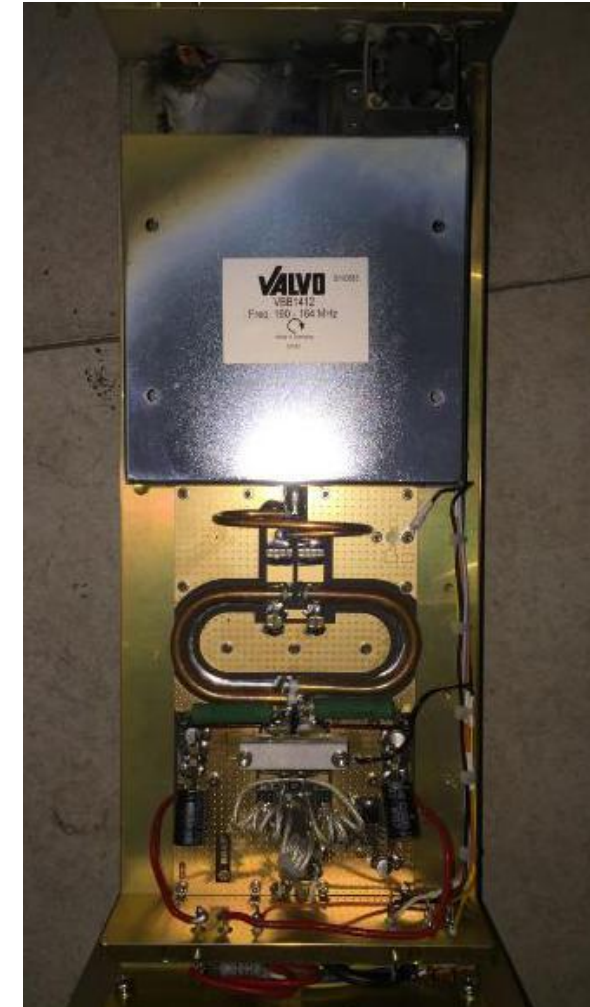
One section of 80kW 162.5 MHz amplifiers failure

One important reason for accident is too sensitive of driving signal interlock in 3# section. Since the output power of 3# section was shut down during operation, other three sections were influenced in the same time due to the connection from combines of whole system. Thus, all transistors and sink loads were burnt.

Two factors lead to this accident, one is too high driving power due to the close loop operation of LLRF, the other is shutting down of 3# section resulted from its own amplitude interlock of input power (too sensitive to operate stably). Now, the logic of interlock and LLRF are both modified according to the analysis as above, and the abnormal increase of reflected power has never observed again. The new function of power balance was added to prevent from the big difference between two 80 kW amplifiers output during operation.

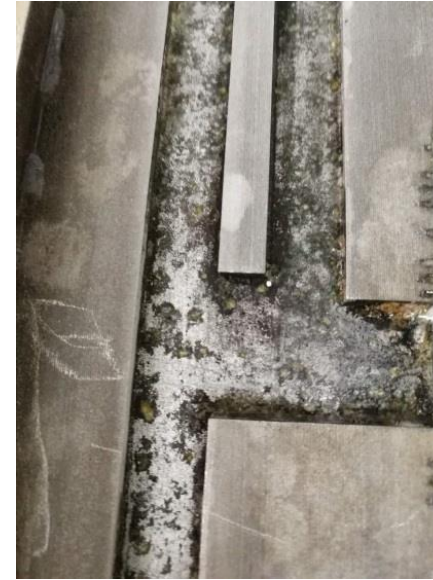
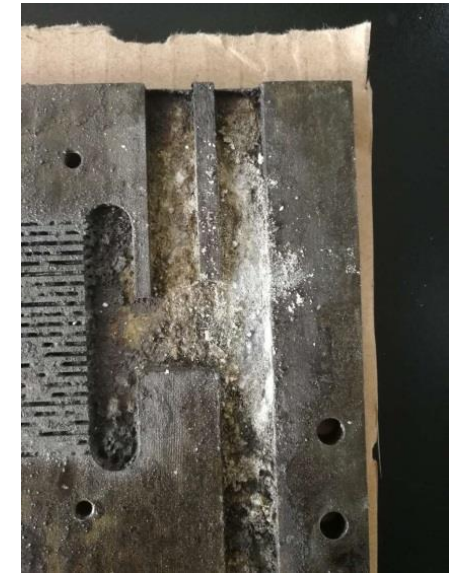
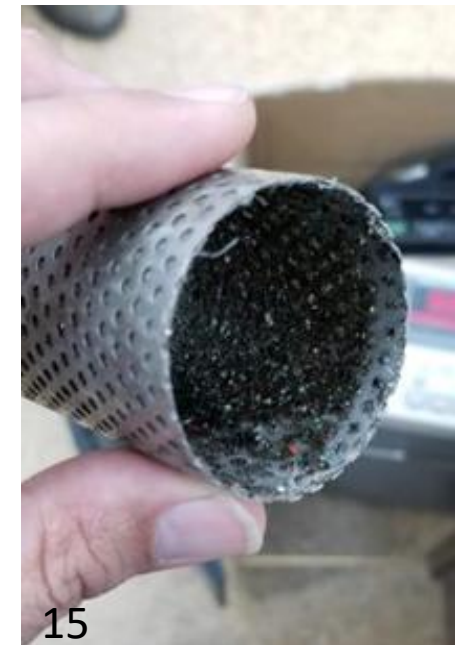
Cooling water problems

After a period of time of operation, the water flow decrease because of plug. Resin granule, solder, Al_2O_3 (Aluminum oxide), other impurities were found in the strainer.

Water flow decrease may cause a series of damages to the amplifier including the module and power supply.

Cooling water and Aluminum cold plate is the main reason.

Independent cooling water supply would be helpful to solve the problem.

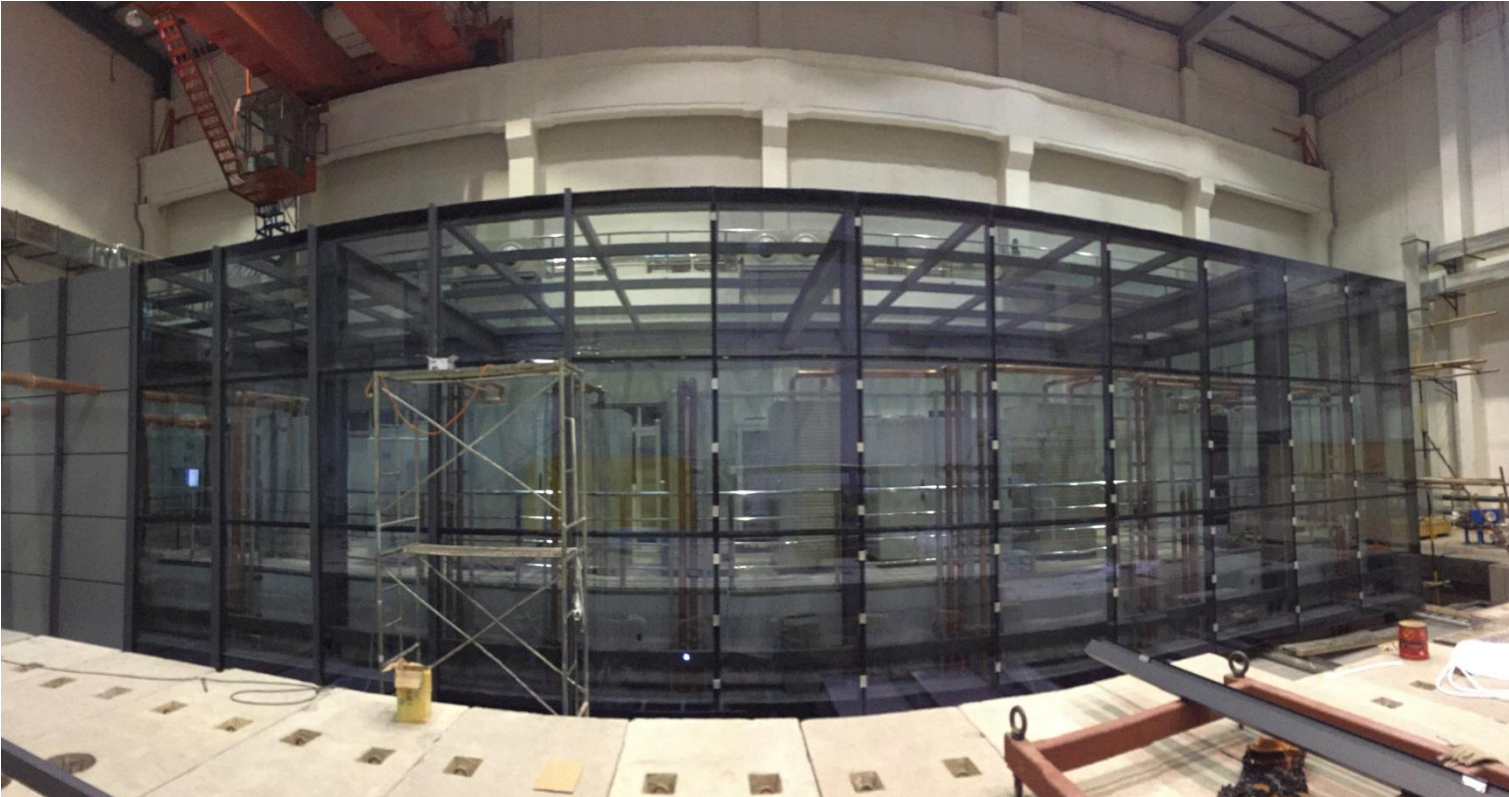
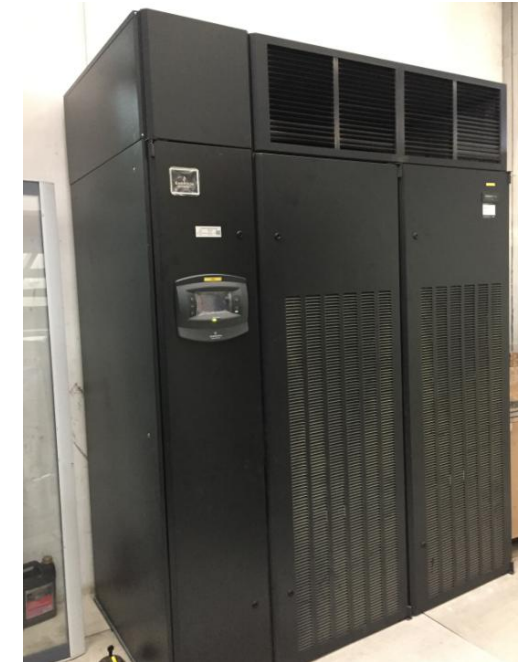
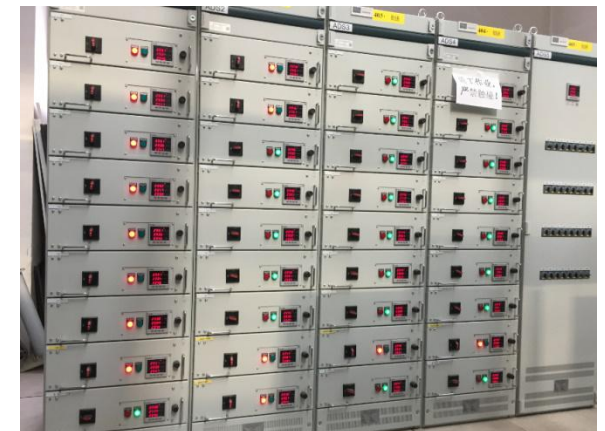
Experience: Build a glasshouse for SSA

A high power source room was built for amplifiers and power supply to provide clean environment. Precision air conditioning was also used to maintain constant temperature in the room. Each cabinet has independent power supply.
