Status and highlights of the NSLS-II and the

3rd RF system Upgrade and future plans

J. Rose, J. Cupolo, P. Davila, F. Gao, B. Holub, H. Ma, C. Marques, K. McDonald, J. Oliva, J. Papu, R. Sikora, C. Sorrentino, N. Towne*

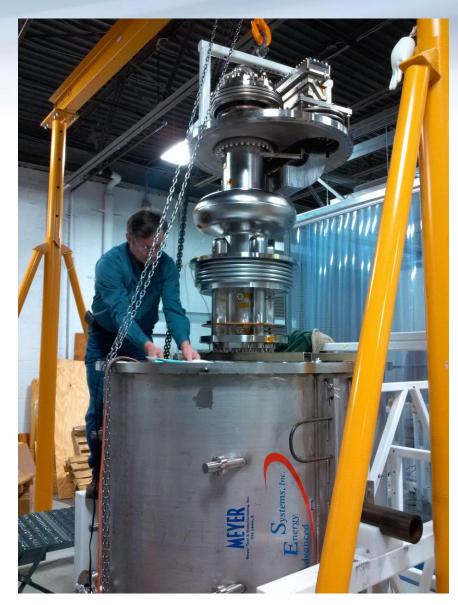
Storage Ring: Superconducting Cavity

- 2 (of 4) 500MHz Cornell type
 SRF cavities installed
- Redesigned coupling iris for Q_{ext}=79,000
- BNL assisted AES in assembly of first 2 cryomodules; complete knowledge base for refurbishing cryomodules

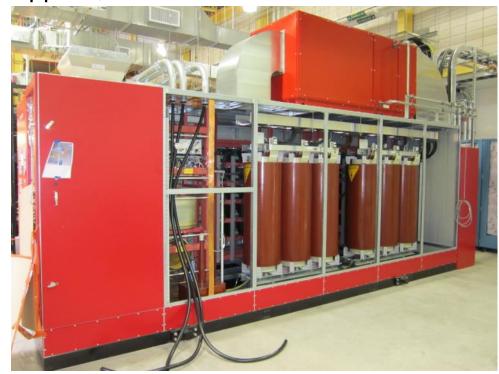
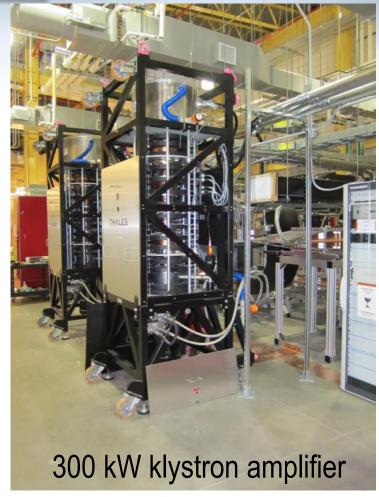
Storage Ring Transmitter

540 kVA klystron solid state switching power supply with mod-anode, filament supplies, interlocks and controls

Operating since 2012, only four failures: 1x PLC I/O module failed, 2 x HV capacitor in output filter, 1 x secondary winding in HV transformer- this latter did not cause downtime due to redundant switching modules

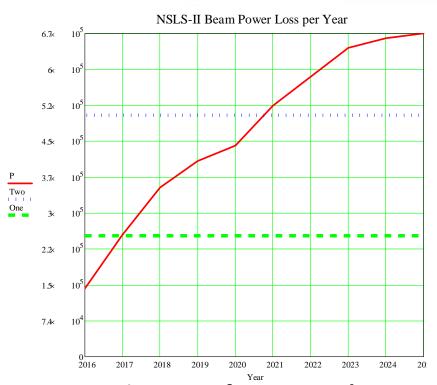
Motivation for Third RF System

Running out of RF power by 2021: Planned addition of SC wiggler puts us over the power limit of two systems

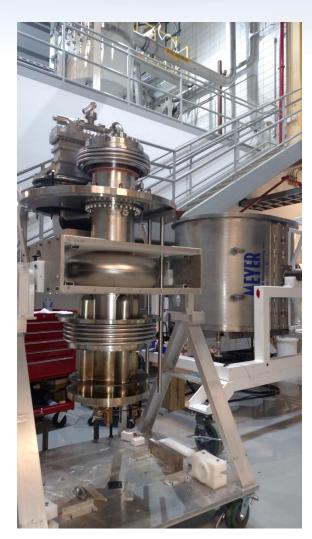
Third Cryomodule in final assembly at BNL/NSLS-II

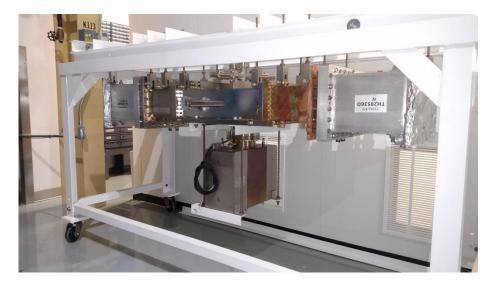
HOM built by industry
