Status and highlights of the NSLS-II and the 3rd RF system Upgrade and future plans

J. Rose, J. Cupolo, P. Davila, F. Gao, B. Holub, H. Ma, C. Marques,
K. McDonald, J. Oliva, J. Papu, R. Sikora, C. Sorrentino, N. Towne*

Overview

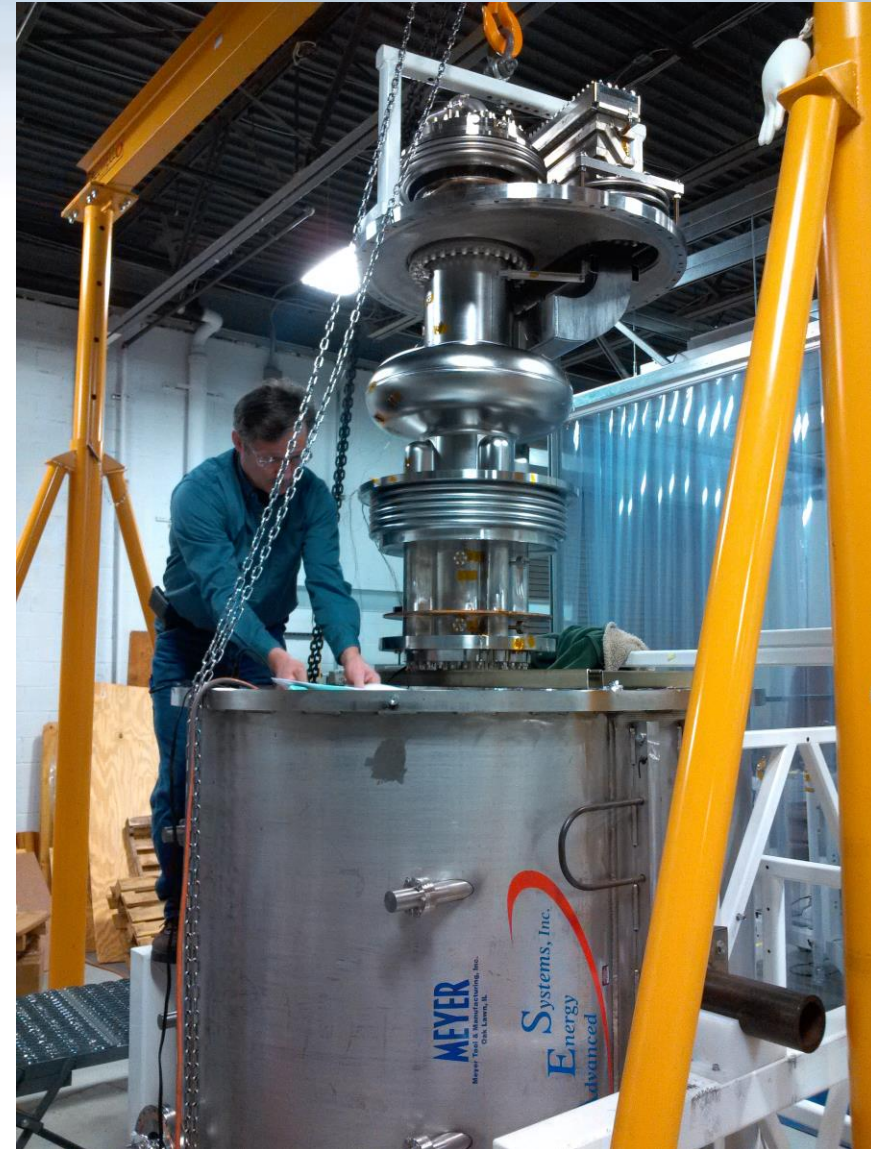
Storage Ring: Superconducting Cavity

- 2 (of 4) 500MHz Cornell type SRF cavities installed
- Redesigned coupling iris for $Q_{\text{ext}}=79,000$ (from 200,000)
- BNL assisted AES in assembly of first 2 cryomodules; complete knowledge base for refurbishing cryomodules

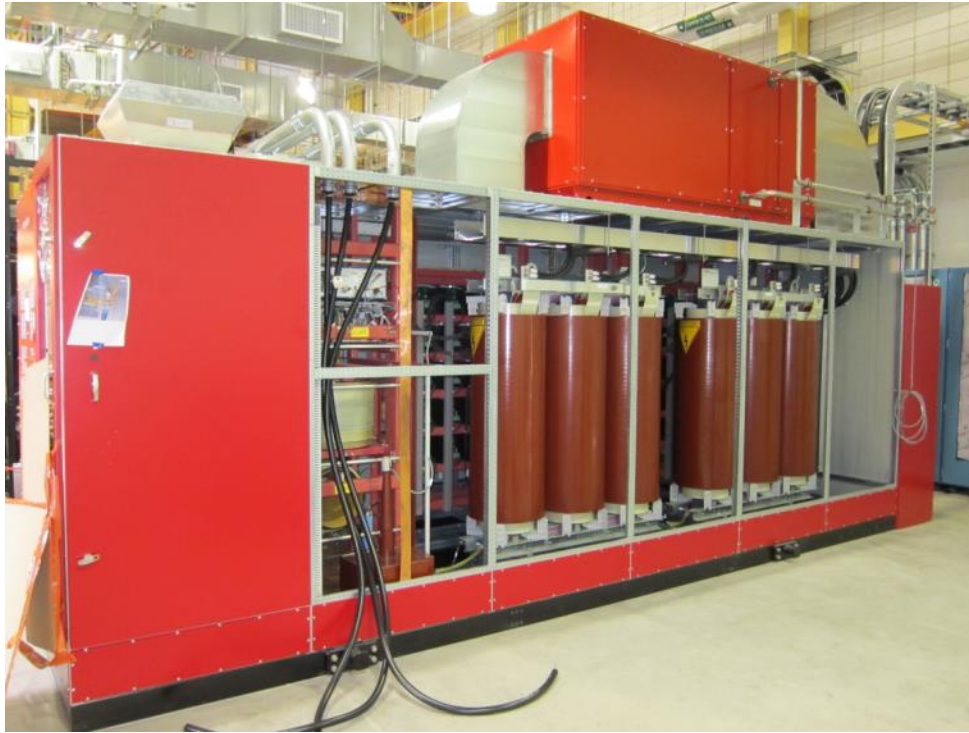
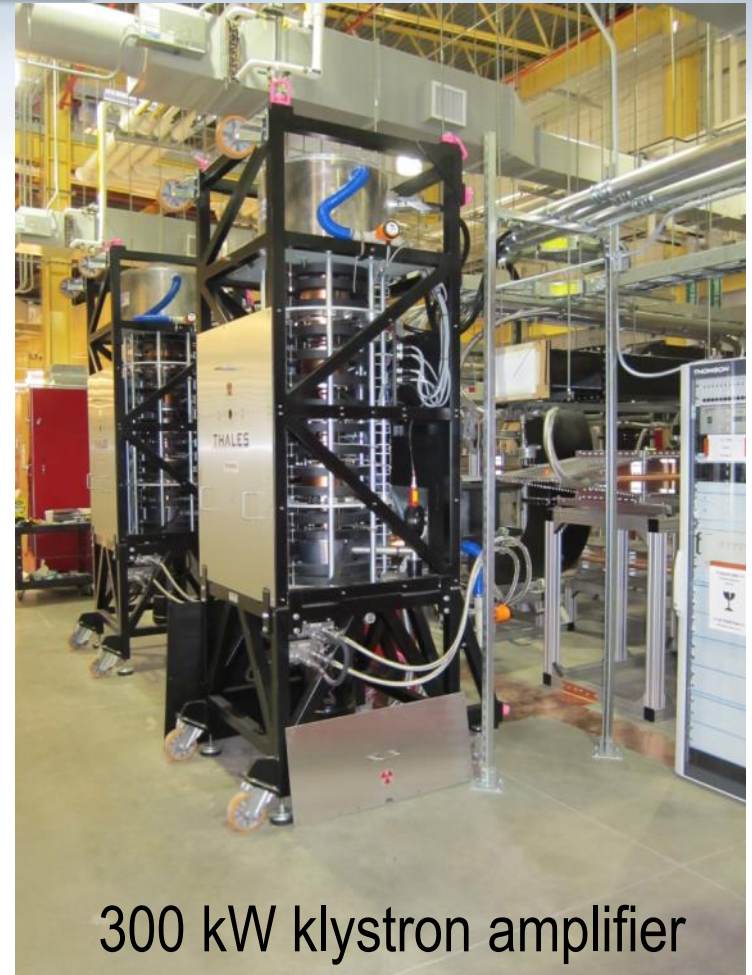
Storage Ring Transmitter

540 kVA klystron solid state switching power supply with mod-anode, filament supplies, interlocks and controls

300 kW klystron amplifier

Operating since 2012, only four failures: 1x PLC I/O module failed, 2 x HV capacitor in output filter, 1 x secondary winding in HV transformer- this latter did not cause downtime due to redundant switching modules

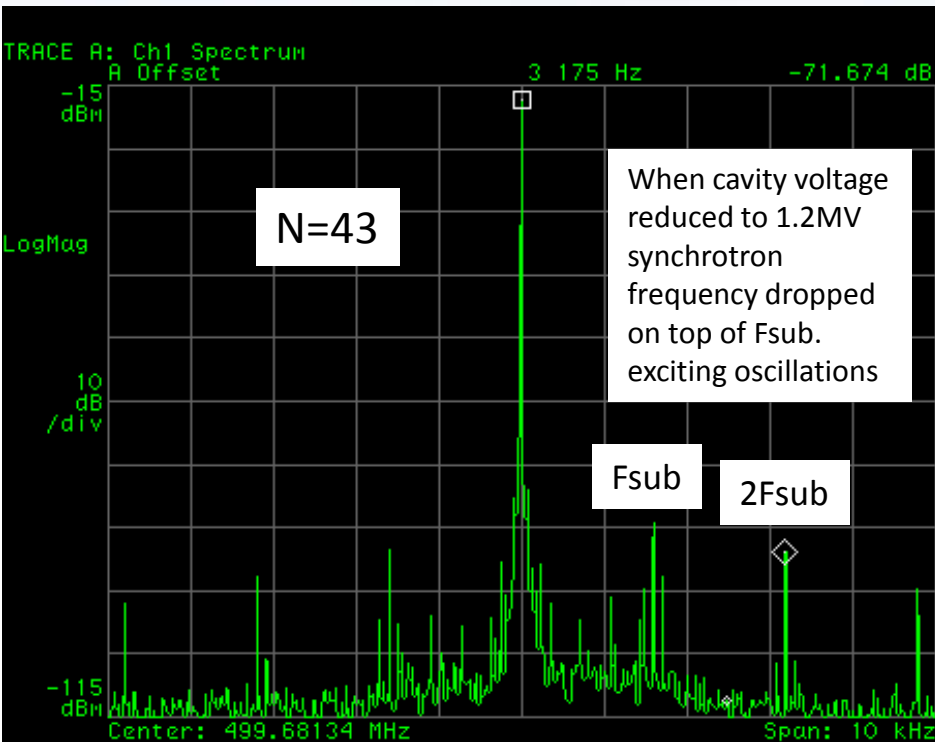
Klystron HVPS Switching Frequency

The klystron High Voltage PS is a switching PS with 86 switch modules. The switching frequency is programmable as N times 3.125 kHz, and is typically run at values of N between 30 and 120 for switching frequencies of 93.75kHz to 375 kHz. There is a subharmonic at the switching frequency divided by the number of modules which places the subharmonic in the vicinity of the synchrotron frequency- we occasionally have to change the switching frequency as RF voltage is raised and the beam potentially driven by the switching sub-harmonic.

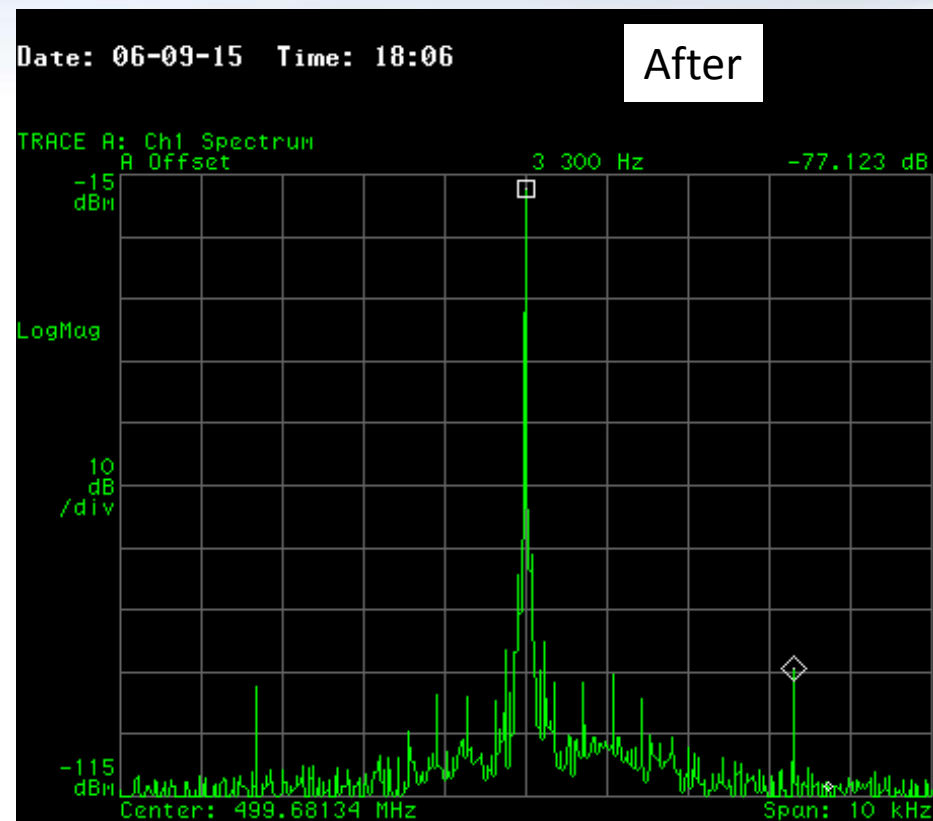
Transmitter HVPS AC Mains compensation

The klystron HVPS is a switching power supply with 86 switch modules, 82 typically active at any time- with 4 redundant spares. An algorithm for switching sequence allows us to select weights for reducing the amplitude of the AC power harmonics: 60, 120, 180, 240, 360 and 720 Hz. This can be performed “live” with beam.

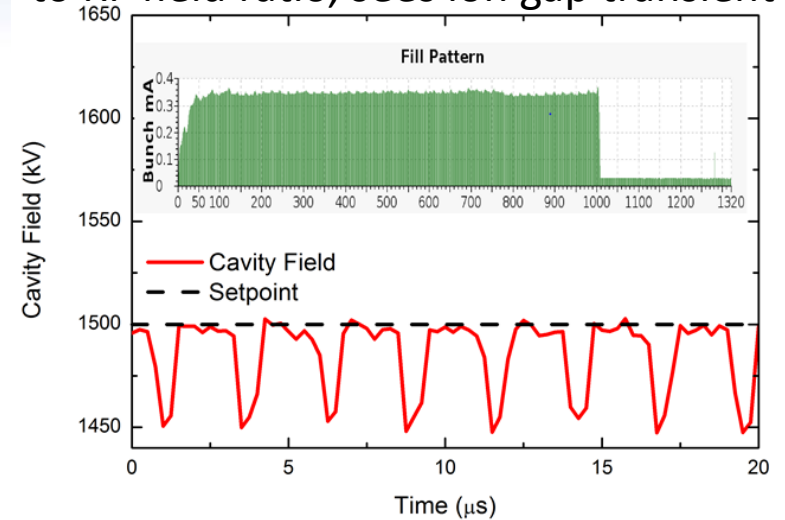
Field Probe failed, backup has high beam to RF field ratio, sees ion gap transient

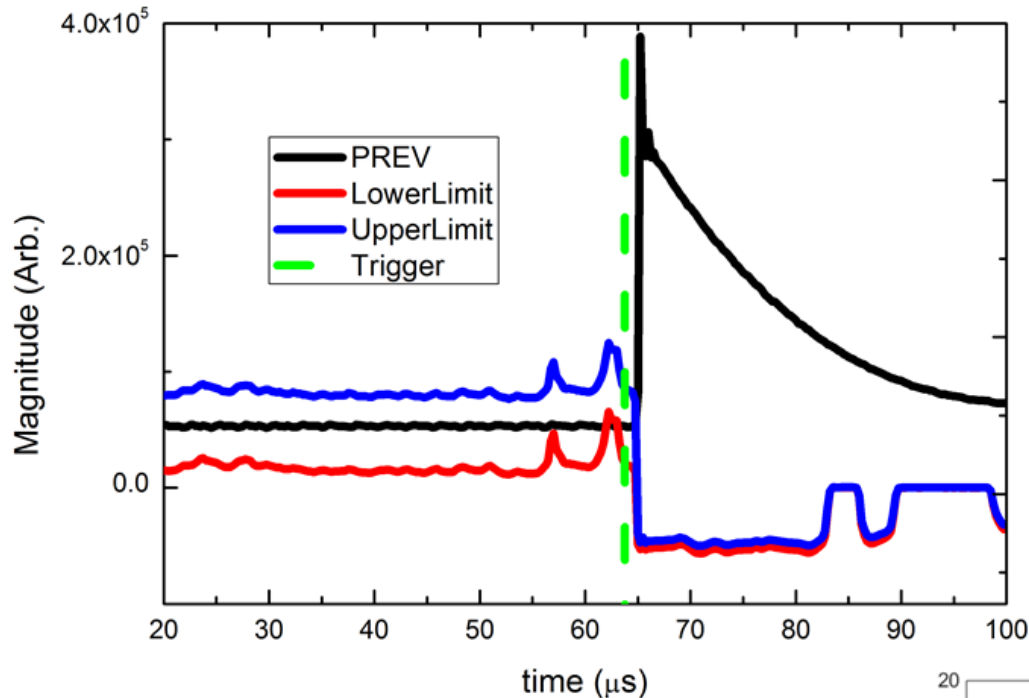
Equench: detect “lost” rf power, trip RF

EQuench event during conditioning the superconducting cavities. The recovery of the RF systems from an EQuench trip is dramatically easier since the cryoplant does not need to be recovered, only the RF power.

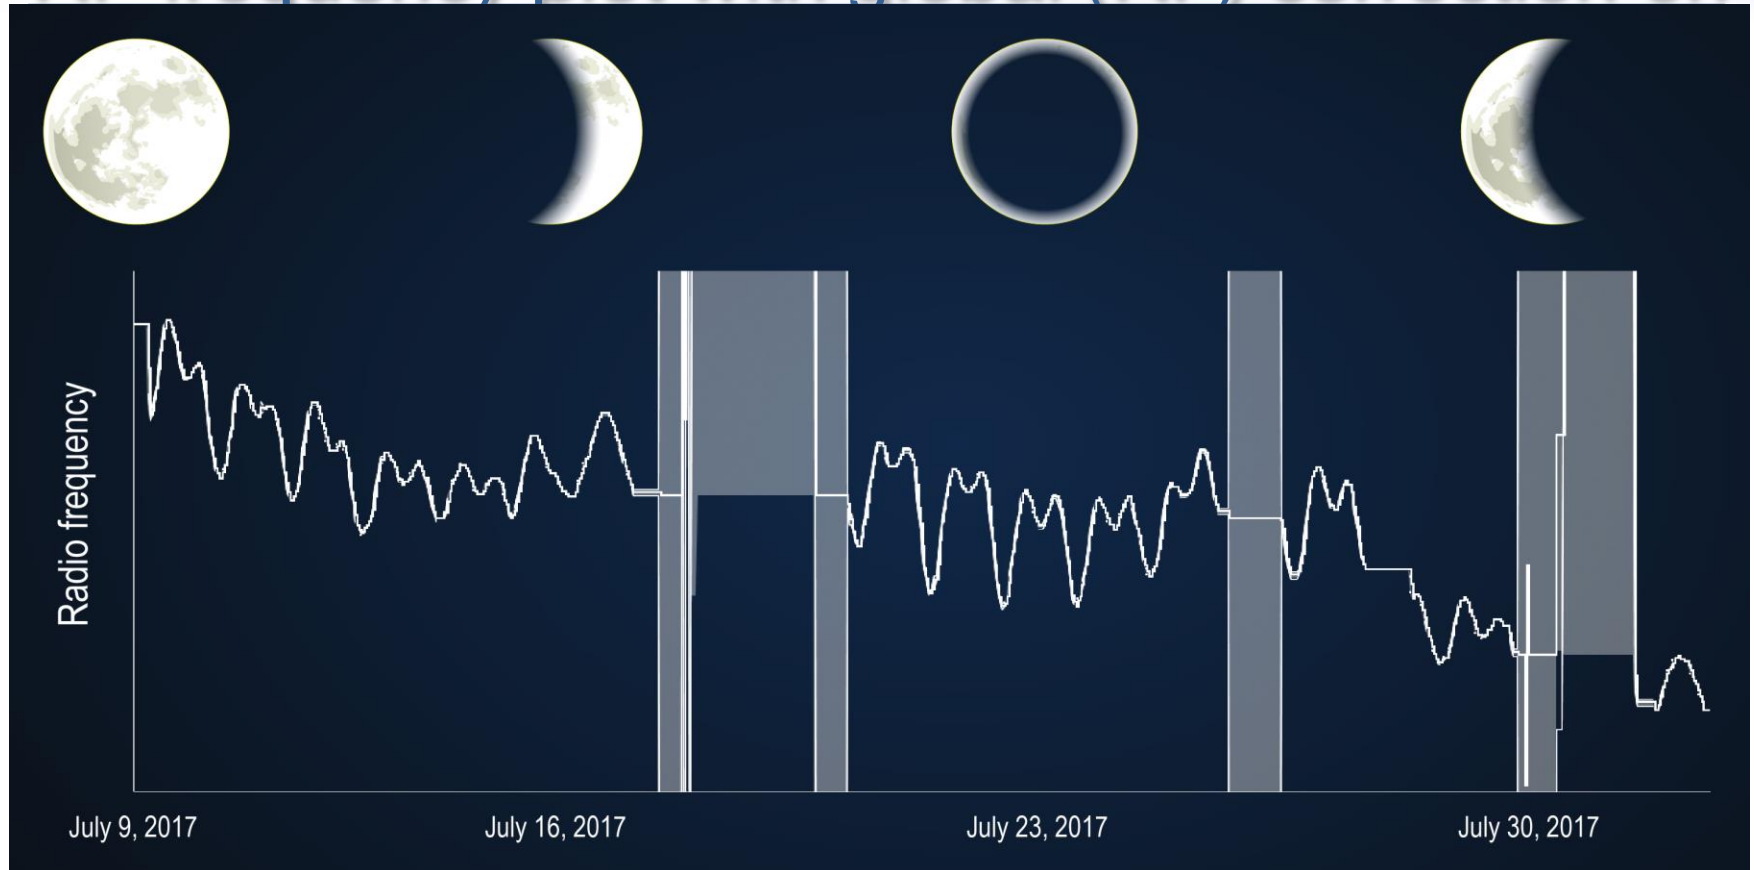
RF frequency plot with global (RF) correction on

Very slow orbit (circumference) feedback with RF frequency adjustment is correlated to the phase of the moon due to tidal forces

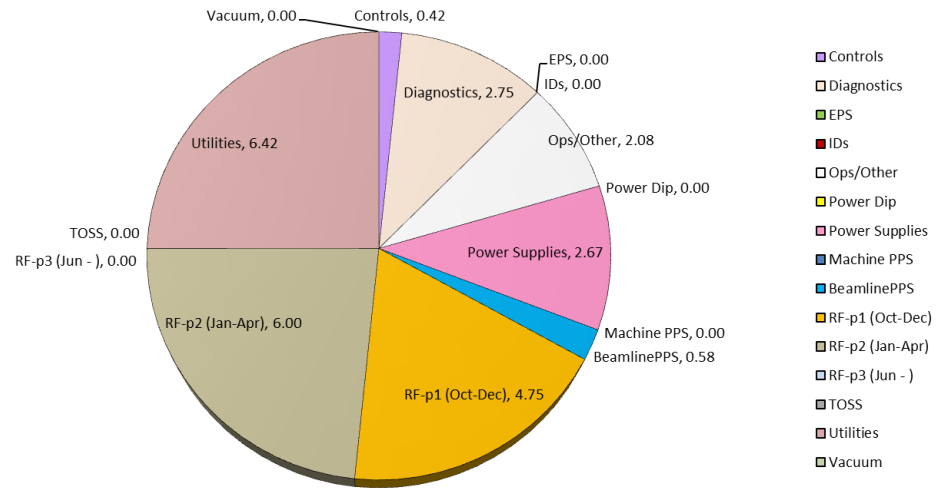
FY18 Downtime

Reliability: Up until very recently the cavity vacuum trips dominated machine downtime. A real failure in one of the RF systems would mean reducing operations beam current.

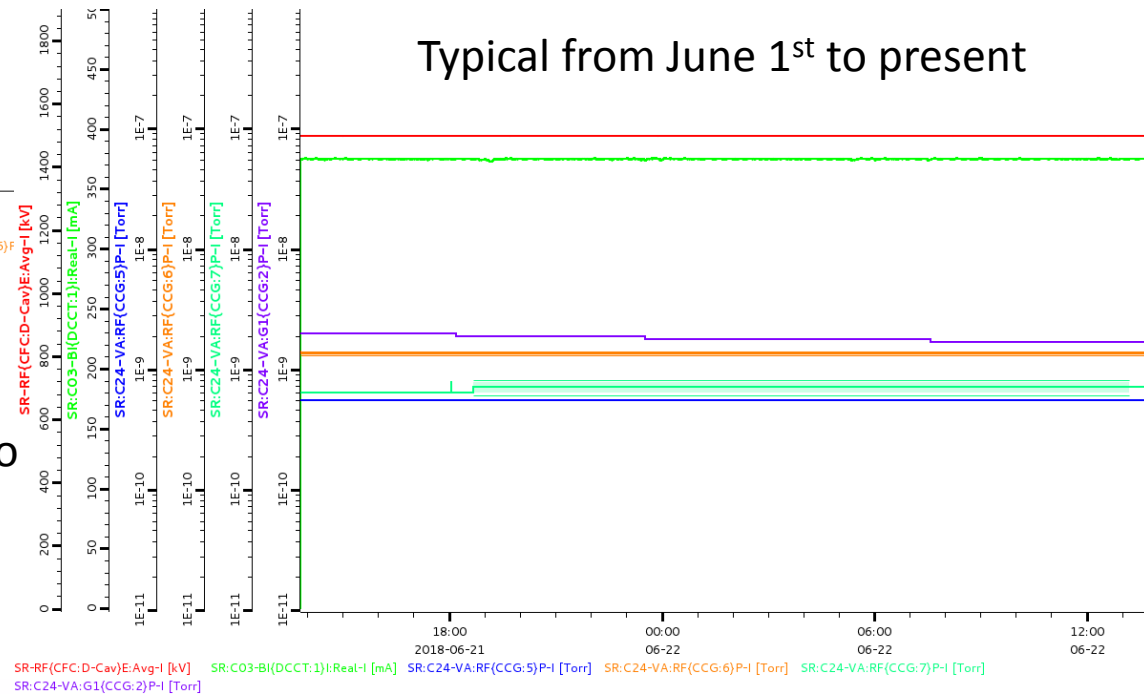
Typical from June 1st to present

After full warmup during May shutdown, Cavity D conditioned to 1800kV, runs reliably at optimum voltage of 1500kV

Full warm-up of cavity, replacement of pump-out box ion pump+ elbow, downstream shielded bellows and cleaning of BPM assembly during May shutdown has fixed the problem

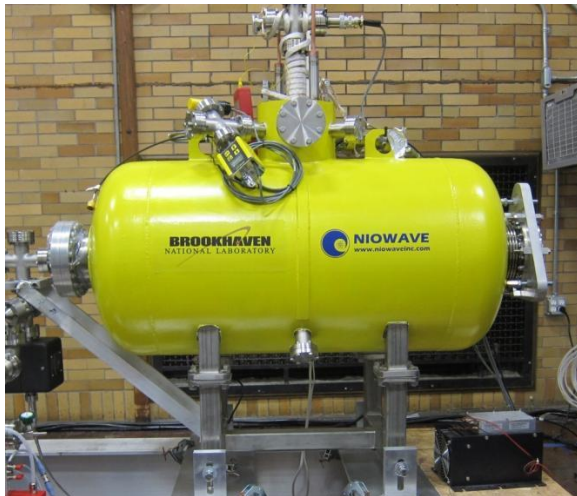
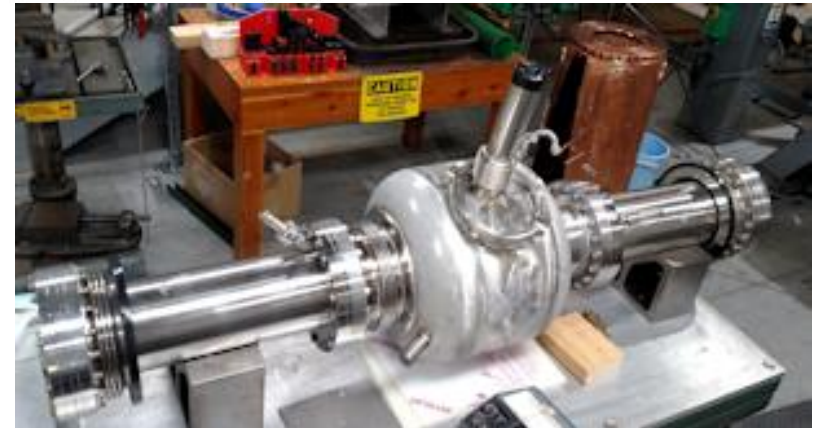
Landau Cavity

First horizontal cold test complete completely validates $0-\pi$ mode tuning over 1 MHz bandwidth. Low Q loaded ($6e7$ vs. $2e8$) explained by trapped TE mode when tested without dampers.

Need to design and fabricate new vacuum jacket, instrumentation, ferrite dampers, tuner mechanism
