A Review of Klystron History and Performance at CEBAF

Richard Nelson - 6/27/18

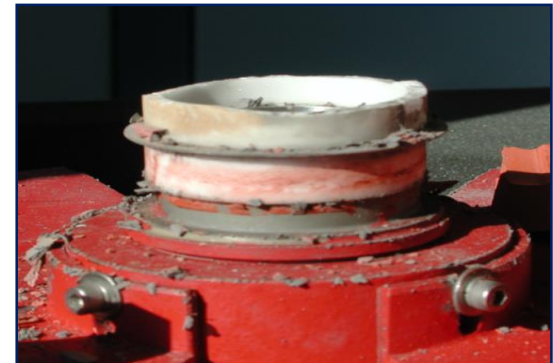
- Based on requested 20k hour life
 - Anticipated failures was 100 failures/year based on operating hours
- Repair contracts to date: 3
- Most early failures were catastrophic
 - MA ceramic leakage & heating
 - Internal on mod anode ceramic
- Thermal runaway without limiters
- Leakage still most common failure
 - Still usable with reduced output
 - Of 340 installed, >50 are limited

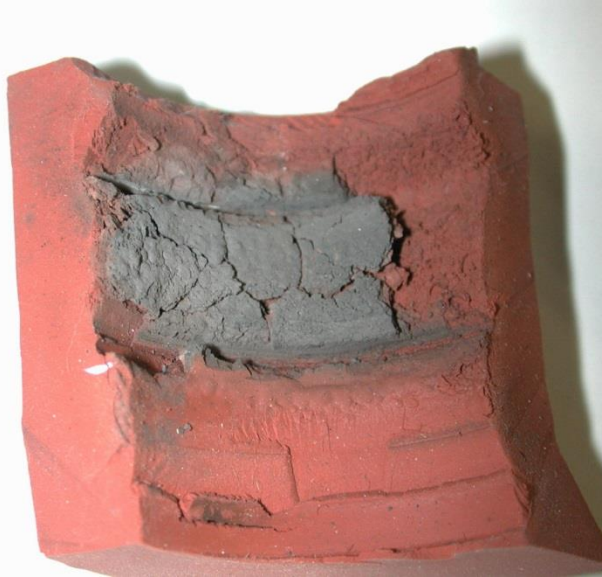
Degraded Potting

Potting degradation due to high ceramic temperature

- Degraded potting the result of?
 - Temperature?
 - Curing process?
 - Material itself?
 - Considered running with no potting on gun
 - First repair contract switch materials
 - Better thermal characteristics
 - All removed and repotted -- still failures
 - MA current monitoring **not** continuous (or easy)
 - Added live monitoring & later active controls

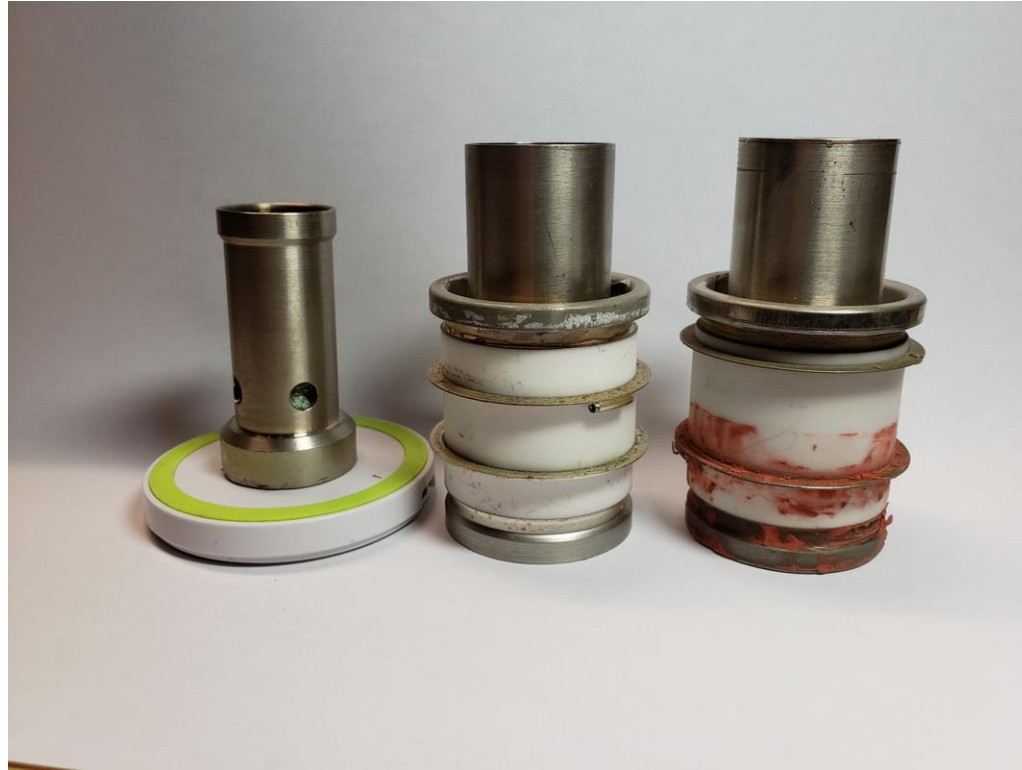
Gun Stalk & Ceramic Changes

- Problem due to barium deposits on ceramic interior
- Gun revise to try and minimize deposition
- Internal vents relocated
- Ceramic length rearranged to increase path length on critical surface
