10th CWRF

**Recent RF operation experience
&
RF upgrade for the new ESRF-EBS storage ring**

Jörn Jacob, Alessandro D'Elia, Georges Gautier, Michel Langlois,
Jean-Maurice Mercier, Vincent Serrière

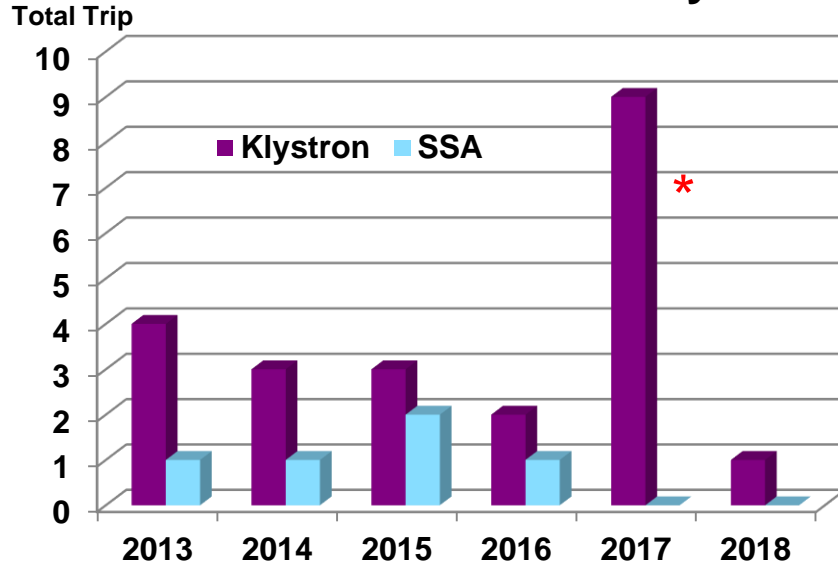
Beamloss : SSA vs Klystron

KLYSTRON average failure: **4** trips / year

SSA average failure: **0.9** trips/ year

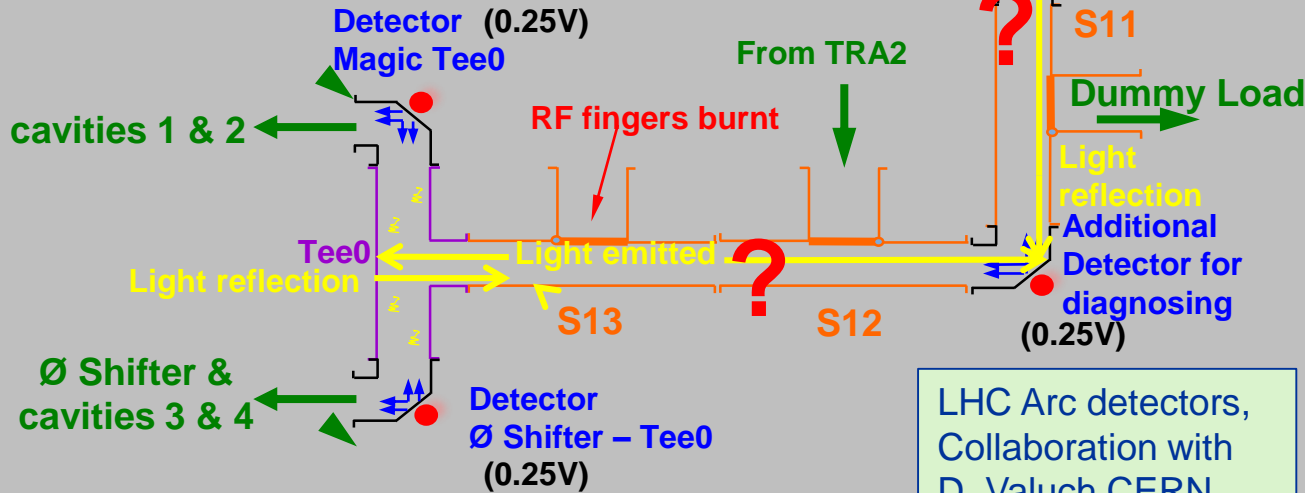
WHY ARC DETECTORS AT HIGH POWER ?

Interlock Threshold:

- Step1 – 0.25V
- Step2 – 0.50V
- Step3 – 1.00V

LHC Arc detectors, Collaboration with D. Valuch CERN

1. Interlock Threshold back to 250 mV
2. Additional detector to be connected with TRA1 fast interlock system
3. When the first arc detection occurs, the entire high power waveguide run must be conscientiously inspected
4. A detector upgrade to better identify which photodiode triggered (and not only how many)

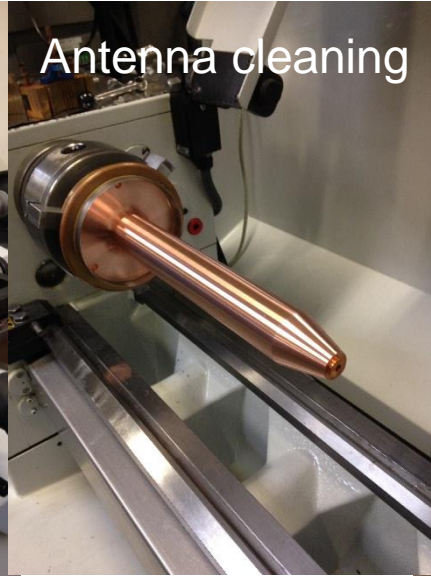
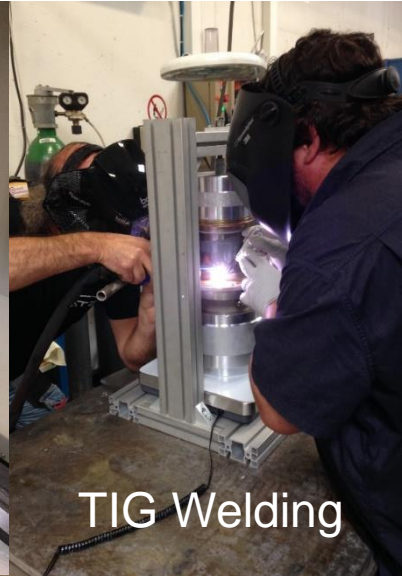
IN HOUSE REPAIR OF POWER COUPLER: CERAMIC WINDOW REPLACEMENT

- Disassembly revealed bad initial assembly with uncomplete contact between window face and body
- Repaired coupler installed on new EBS Cavity#12
- **Successful power test during RF conditioning to 750 kV**

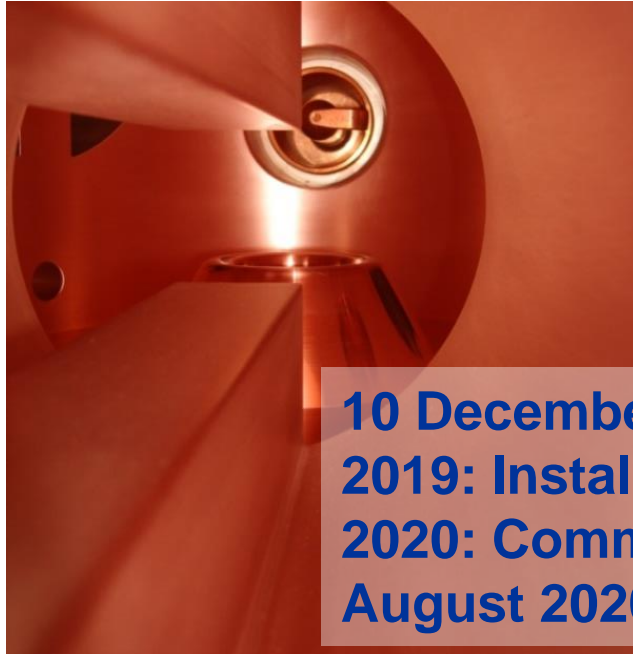
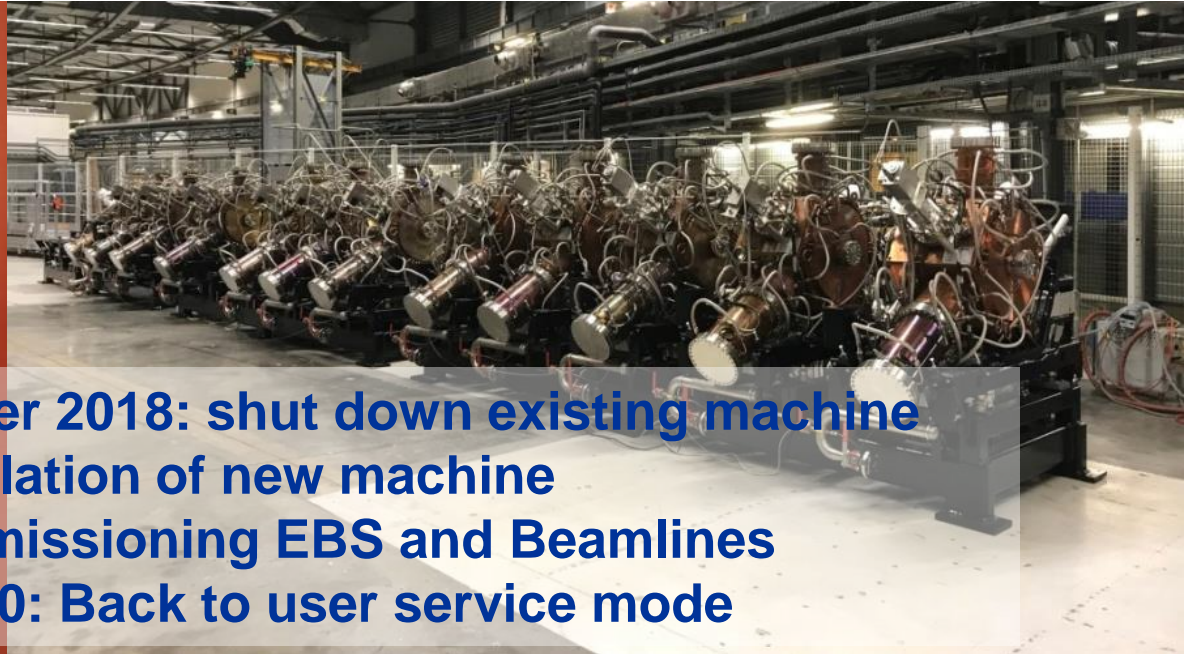
Extremely Brilliant Source: ϵ_x : 4 nm \rightarrow 134 pm

**10 December 2018: shut down existing machine
2019: Installation of new machine
2020: Commissioning EBS and Beamlines
August 2020: Back to user service mode**

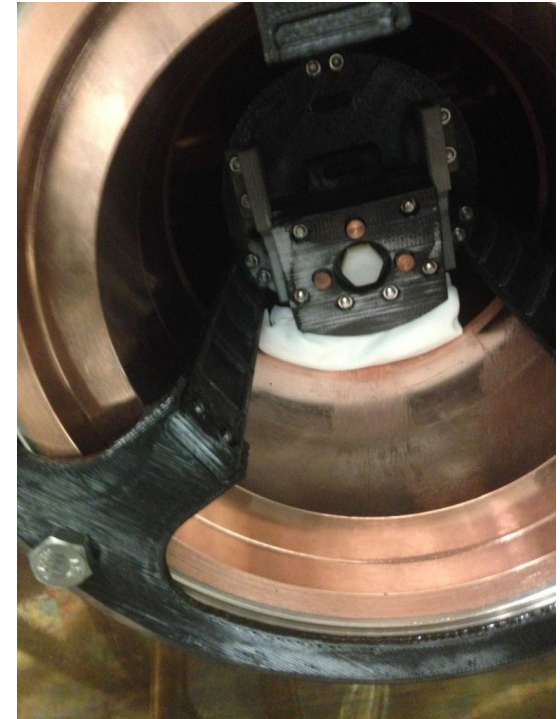
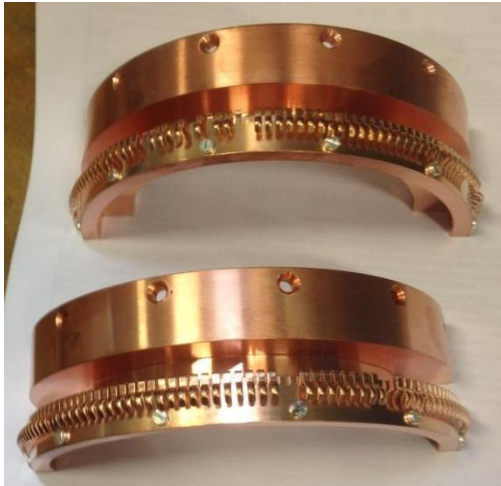
INDEED: PROBLEM WITH TUNER ON CAVITY RI #9

Cavity #9: tuner port

Tuner piston: off axis by 1.2 mm

Tuner **scratched** the cavity port

← **Some RF fingers broken**
Fortunately not fallen into cavity !

Special tool to repair the port:

- 3D printed in house
- Holds rag wetted with alcohol
- Avoids Cu particles falling into the cavity

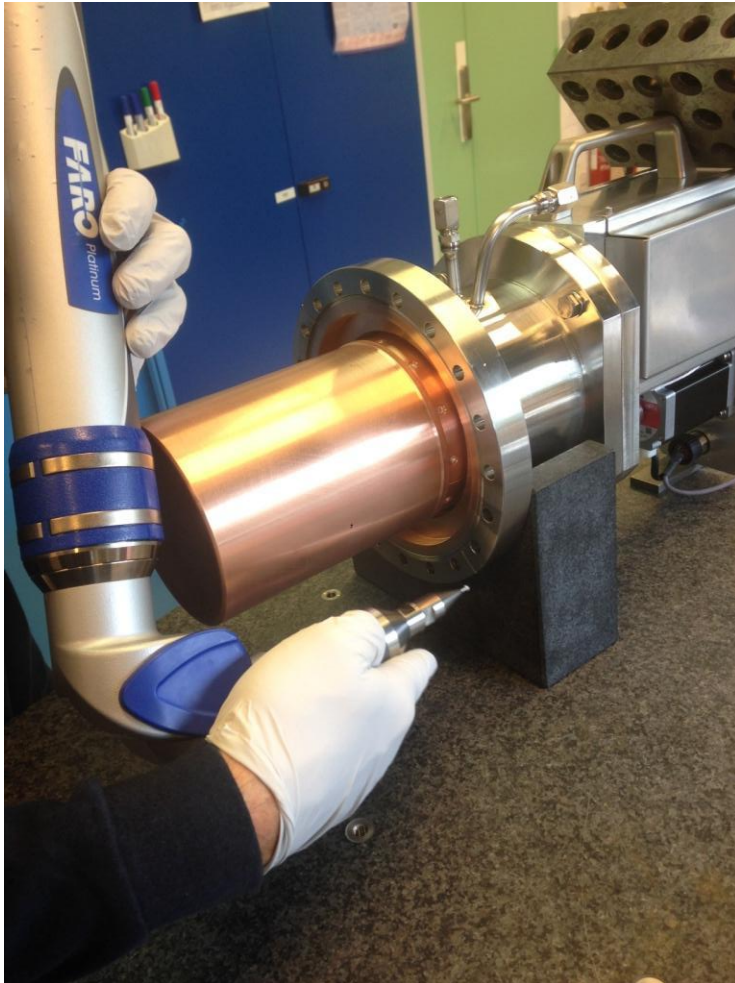
COMPLETE CHECK UP OF ALL NEW TUNERS

All Tuners produced for the EBS have been re-machined:

Cavity ports: Diam = 120 mm

Tuner pistons: Diam = 118 mm → re- machined to 116 mm

Concentricity: a few 0.01 mm

Sag: 0.1 to 0.25 mm

⇒ 1 piston face bulged out: tuner was badly brazed !
(production prototype, not repairable)

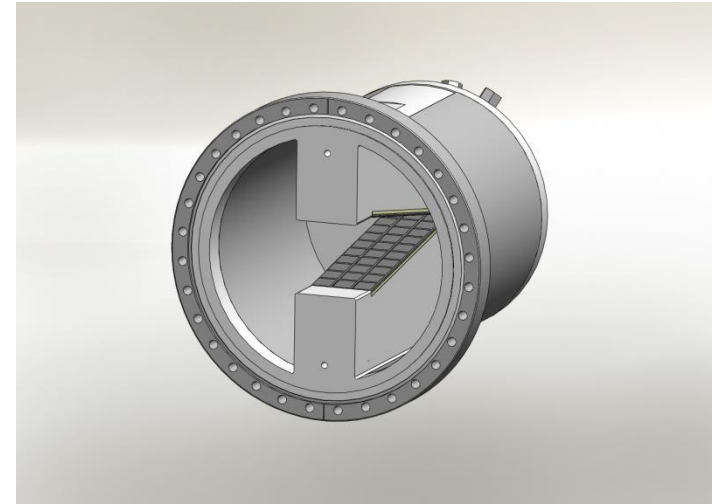
Ferrite tiles brazed on stainless steel wedges to form an absorbing taper for all Higher Order Modes.

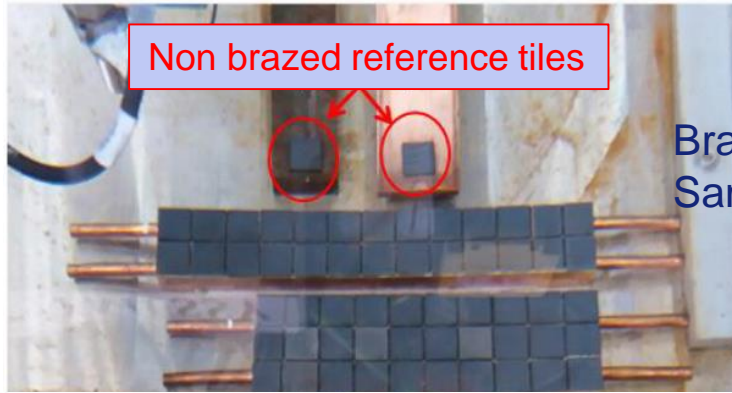
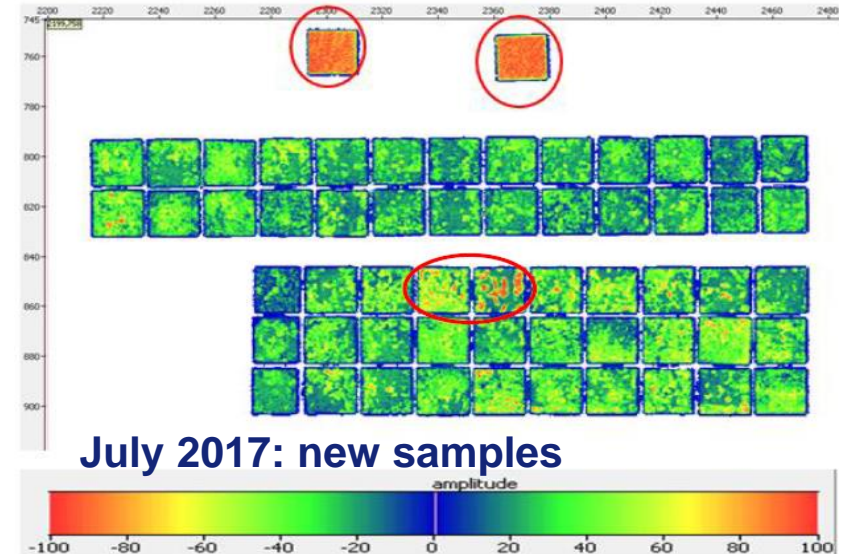
HOM ABSORBERS – ULTRASONIC TESTS BY INSTITUT DE SOUDURE

Brazing definitely improved, also looks mechanically very sound

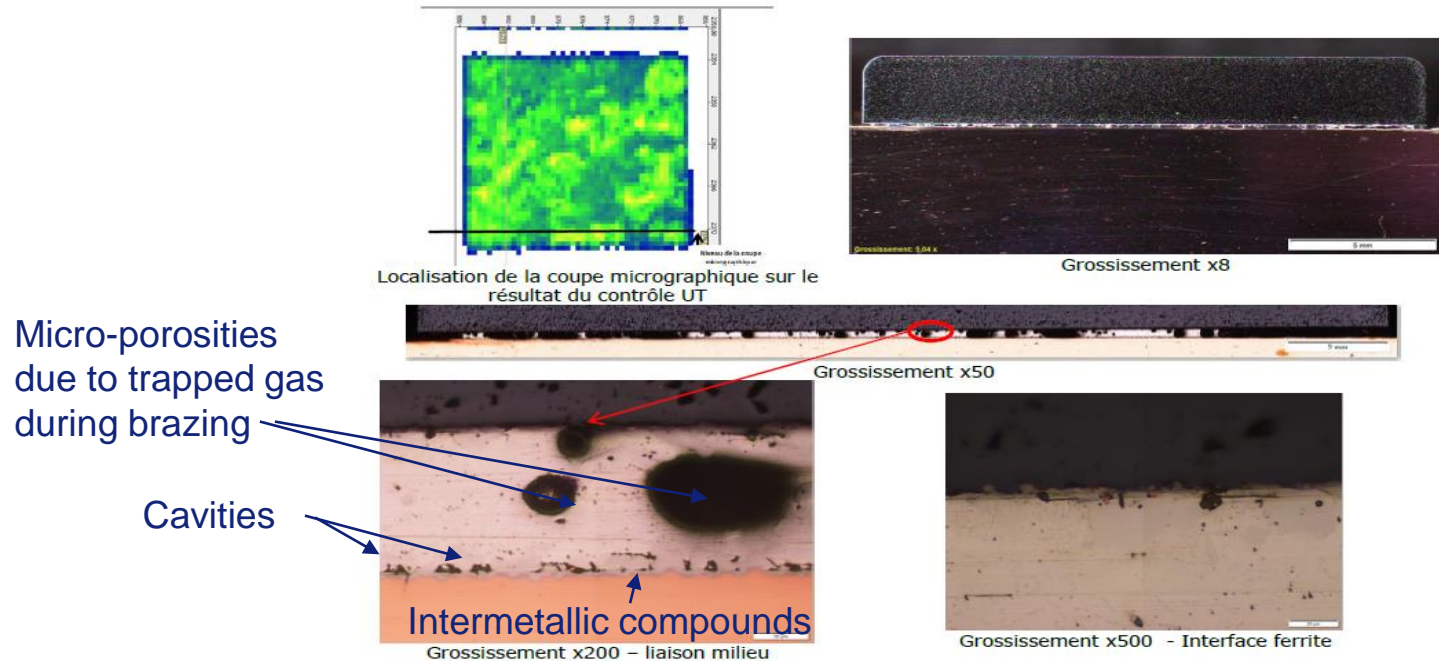
MICROSCOPIC CUT ANALYSIS

Still defects:

- Copper / brazing interface looks not very homogeneous
- Wetting of copper looks fine
- Ferrite / brazing interface looks better

- Defects make brazed interface fragile
- In principle no guarantee for good adhesion in time
- ⇒ **Fatigue/ageing test required [Y. Dabin, ESRF]**

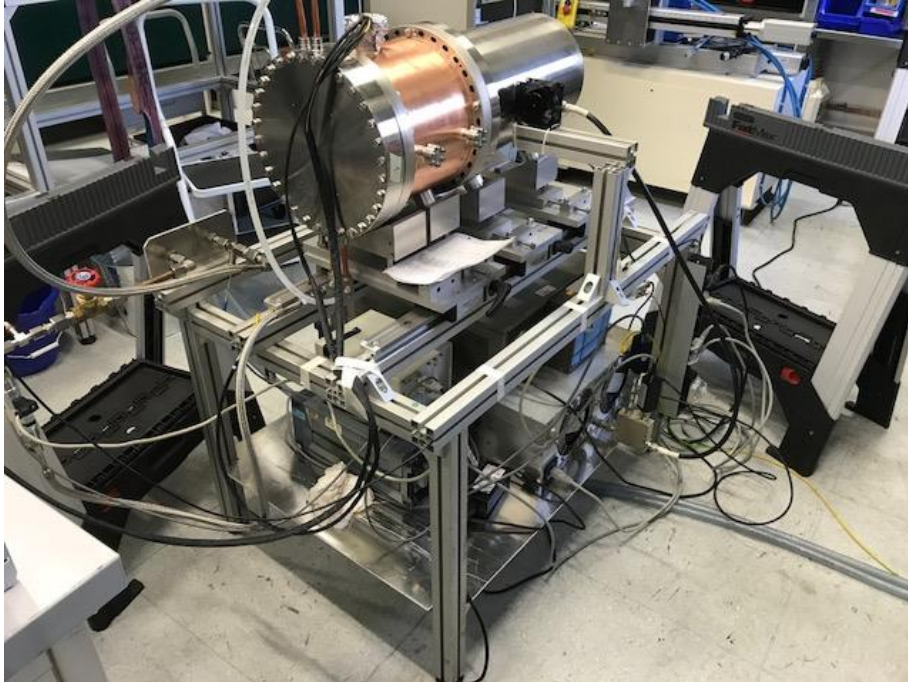
- 570 cycles RF power (15 min ON / 15 min OFF) → at least 5 years of 16 bunches (with 1 beam loss/day)
- 1/3 of the cycles at 360W (max dissipated power measured in the dampers in cell 23), 2/3 at 500W
- Monitoring temperature on several ferrite tiles:
 - No evolution of temperature profiles and thermal time constants observed
- No measurable difference of ultrasonic cartographies before and after RF cycles:
 - ⇒ No degradation of the brazing junction
 - ⇒ Brazing samples accepted and series fabrication of HOM absorbers launched

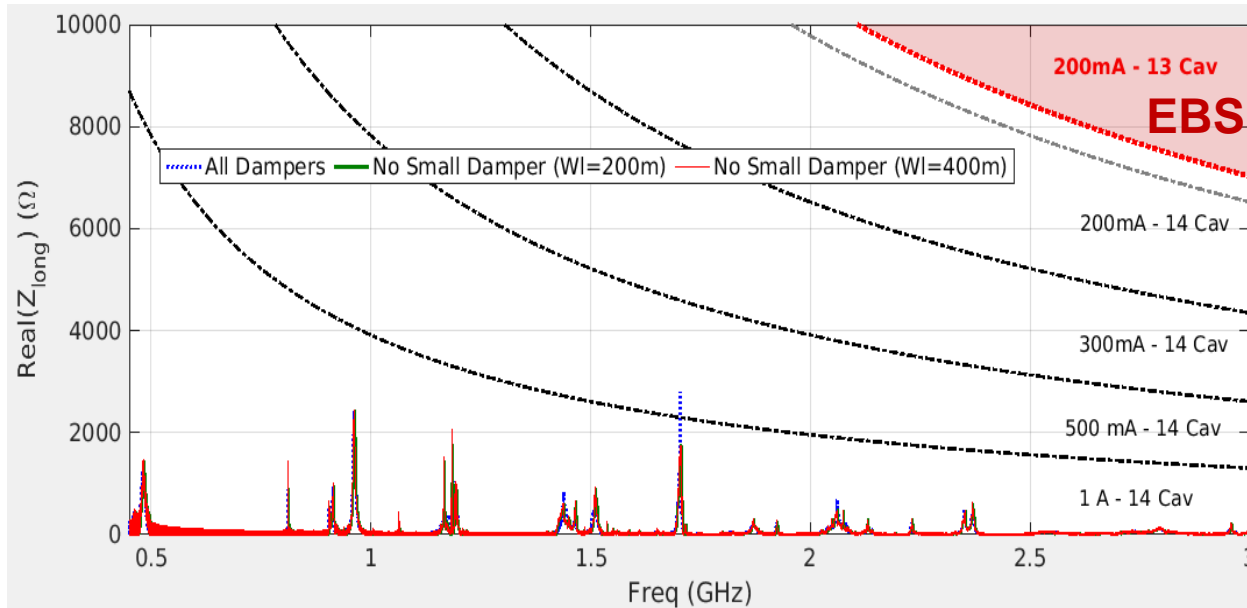
FURTHER RISK REDUCTION: SUPPRESSION OF SMALL HOM ABSORBER ON TOP

- Uncertainty of simulation codes 10 years ago: safer with 3rd small HOM damper on top of the cavity against a few HOMs above 1 GHz
- Today's improved codes, confirmed by bead pull measurements:
→ no need for small HOM damper
- DECISION: small HOM absorber replaced by special flange for good electrical contact with HOM ridge waveguide in place

⇒ Avoids any residual risk of a ferrite tile falling into the cavity

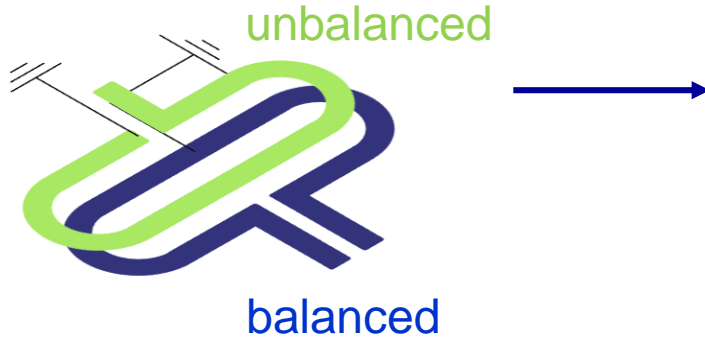
ESRF fully planer design:

- Printed circuit baluns
- RF drain chokes replaced with “quarter wave” transmission lines.
- Very few components left, all of them SMD and prone to **automated manufacturing**

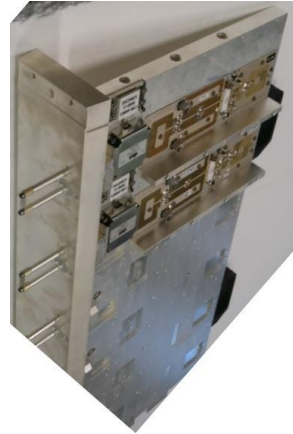
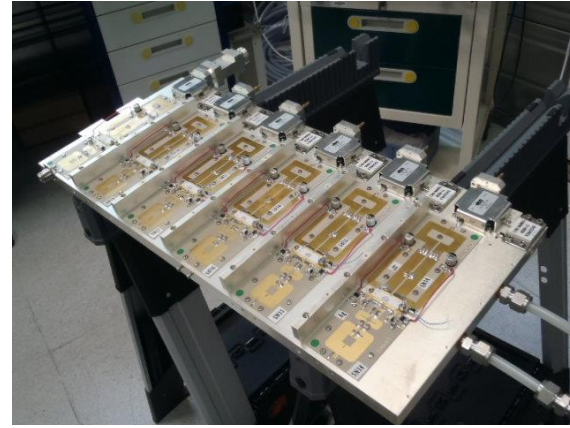
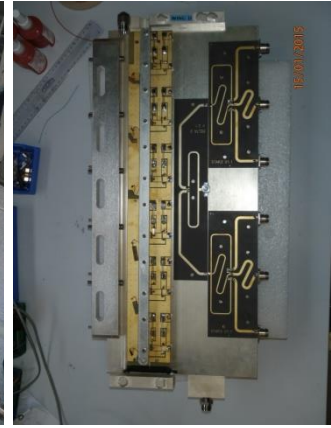
Direct coupling of RF modules to the cavity combiner:

- No coaxial RF power line
- Very few, sound connections
- 6 RF modules are supported by a water cooled “wing”
- The end plate of the wing is part of the cavity wall with built on coupling loops
- One collective shielding per wing
- Less than half the size of a 75 kW tower with coaxial combiner tree

$\eta_{RF/DC} = 62\%$ at $P_{nom} = 85\text{ kW}$

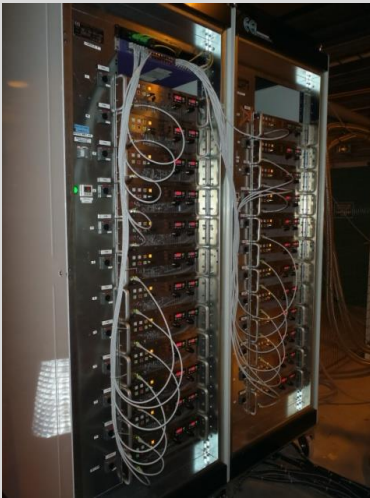
ESRF 352 MHz - 85 kW SSPA:

- Direct 400 Vac / 50 Vdc converters from EEI
 - ⇒ Higher **efficiency** than 2 stages
 - OK for CW, but antiflicker capacitances for pulsed operation 6x higher at 50 Vdc
- One 160 A / **8 kW** PS per wing = 6 RF modules
 - ⇒ **Redundancy**: can tolerate 1 PS failure at P_{nom} without tripping the SSPA
