Overview and Progress of RFT-30 High Power RF Amplifier

Advanced Radiation Technology Institute, Korea Atomic Energy Research Institute

2018.06.28

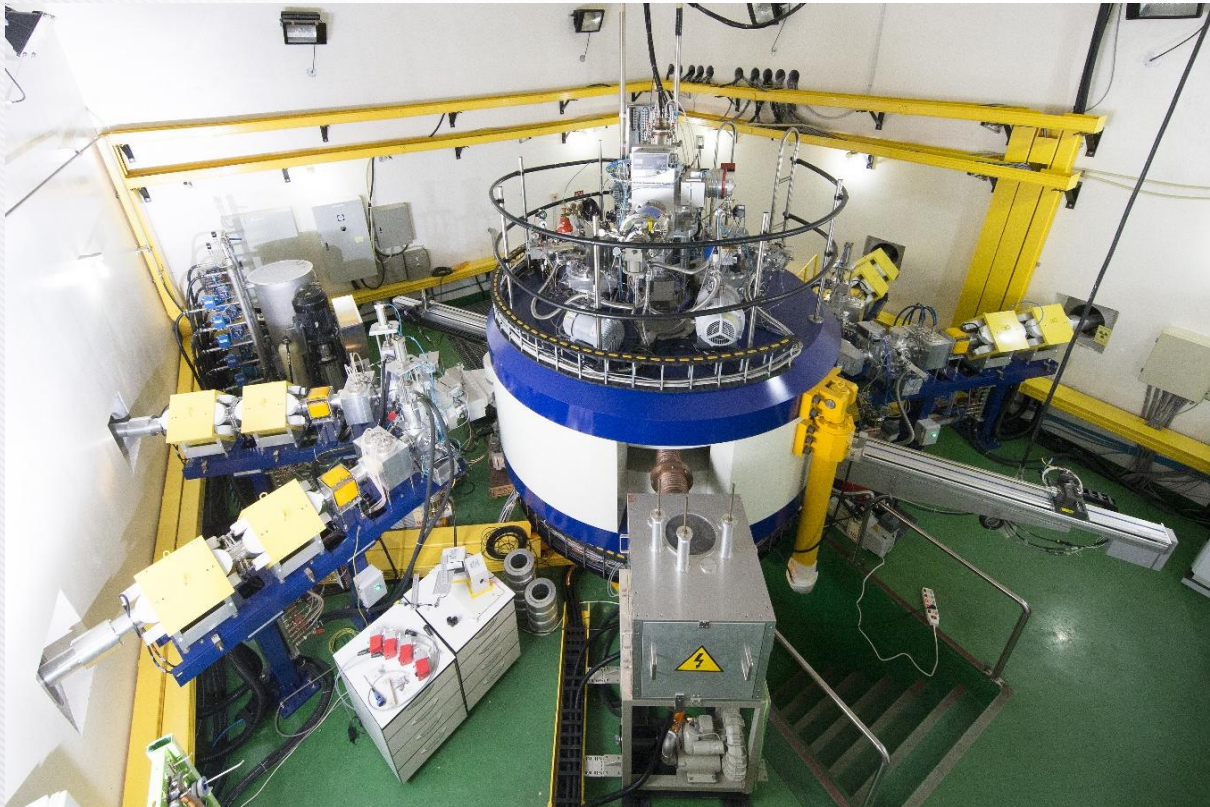
» RFT-30 cyclotron (Prototype)

RFT-30 (30 MeV cyclotron)

Design specifications	
Type of accelerated ions	Negative hydrogen
Extraction method	Stripper carbon foil
Beam energy (proton)	15 ~ 30 MeV
Beam current (proton)	Max. 300 uA
Number of beam lines	4
Dee voltage	58 kV
Resonant frequency	63.96 MHz

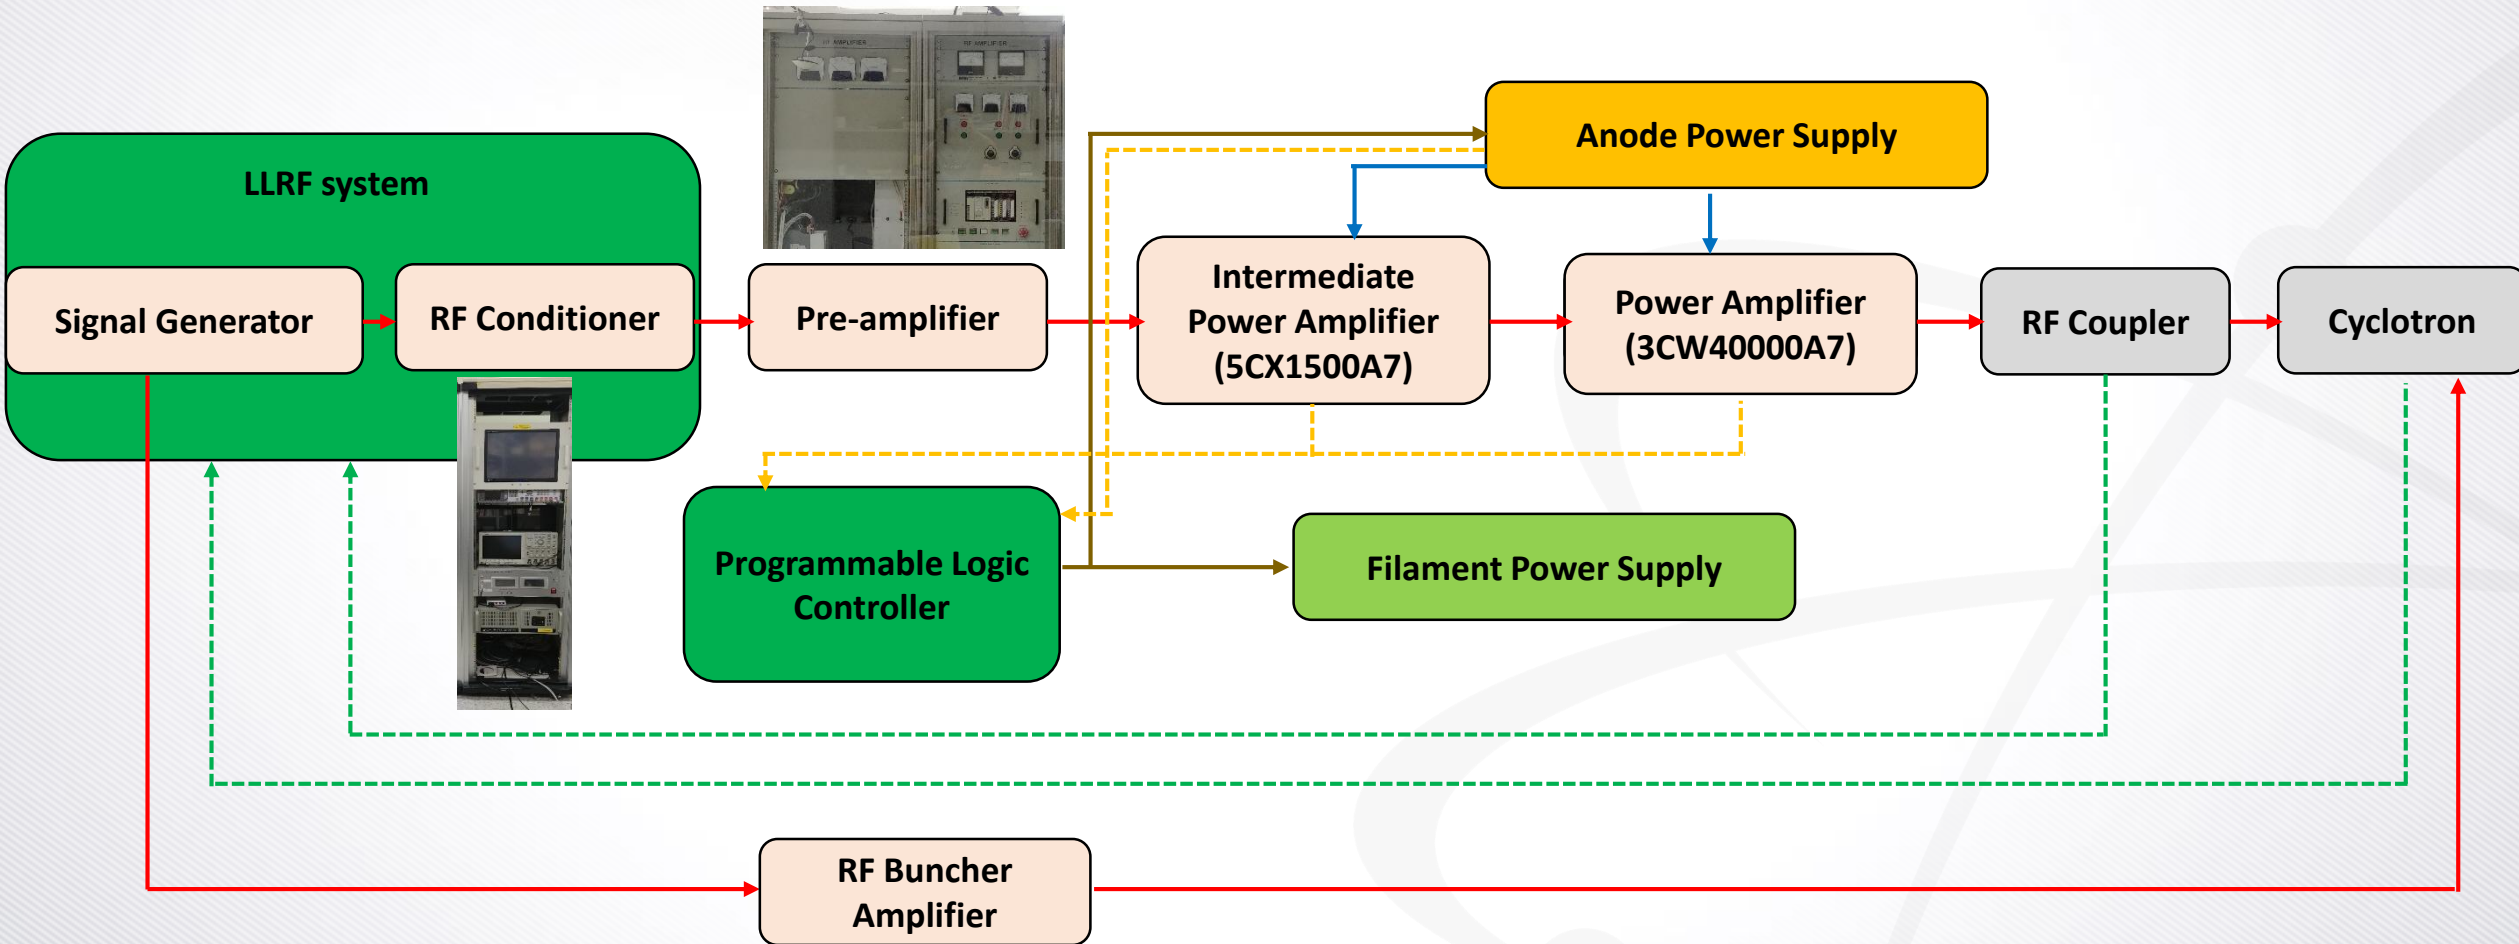
» RF amplifier architecture

- 50 kW RF amp. made by Converttech

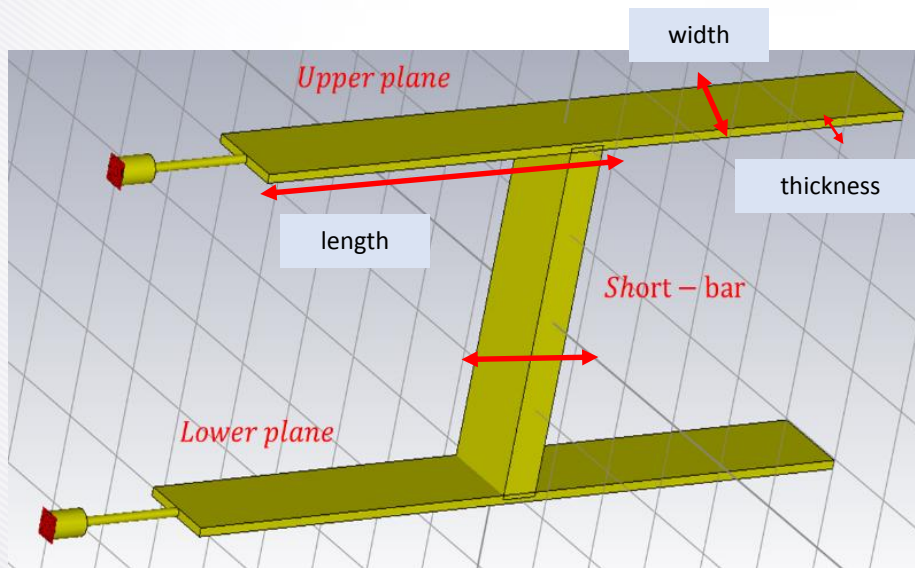
» Impedance matching box

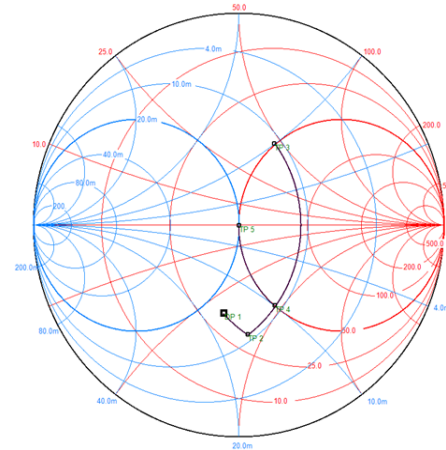
Stub-line inductor

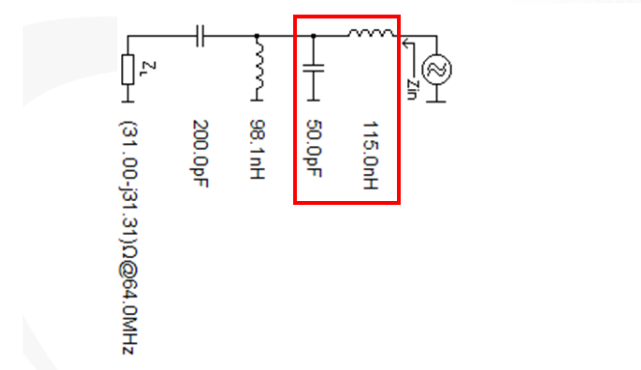
Smith Chart: Impedance matching box

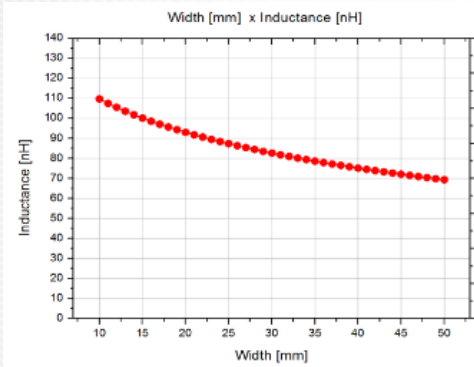
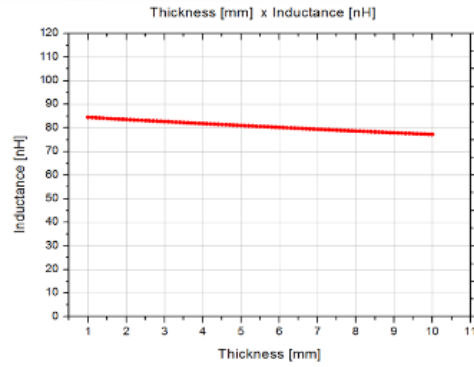
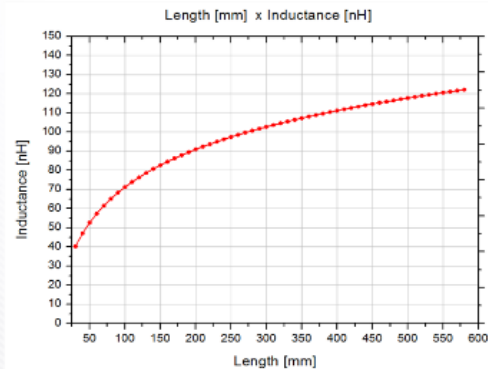
Stub-line inductor simulation (width, thickness, and length)

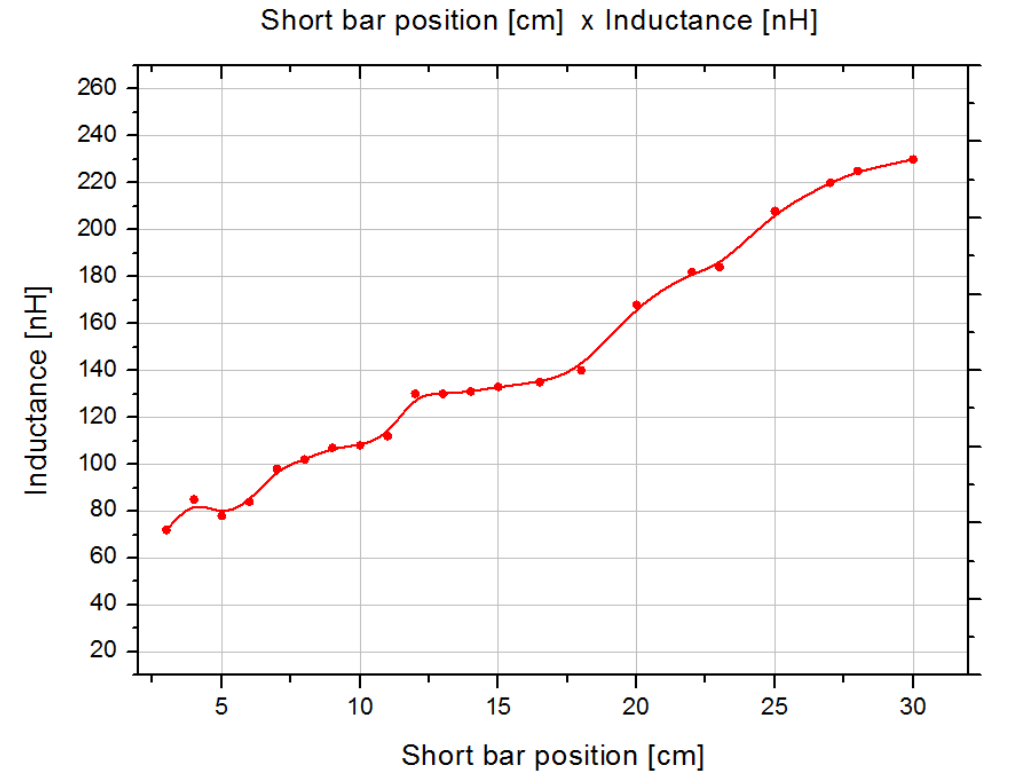
Measurement of inductance of stub-line inductor

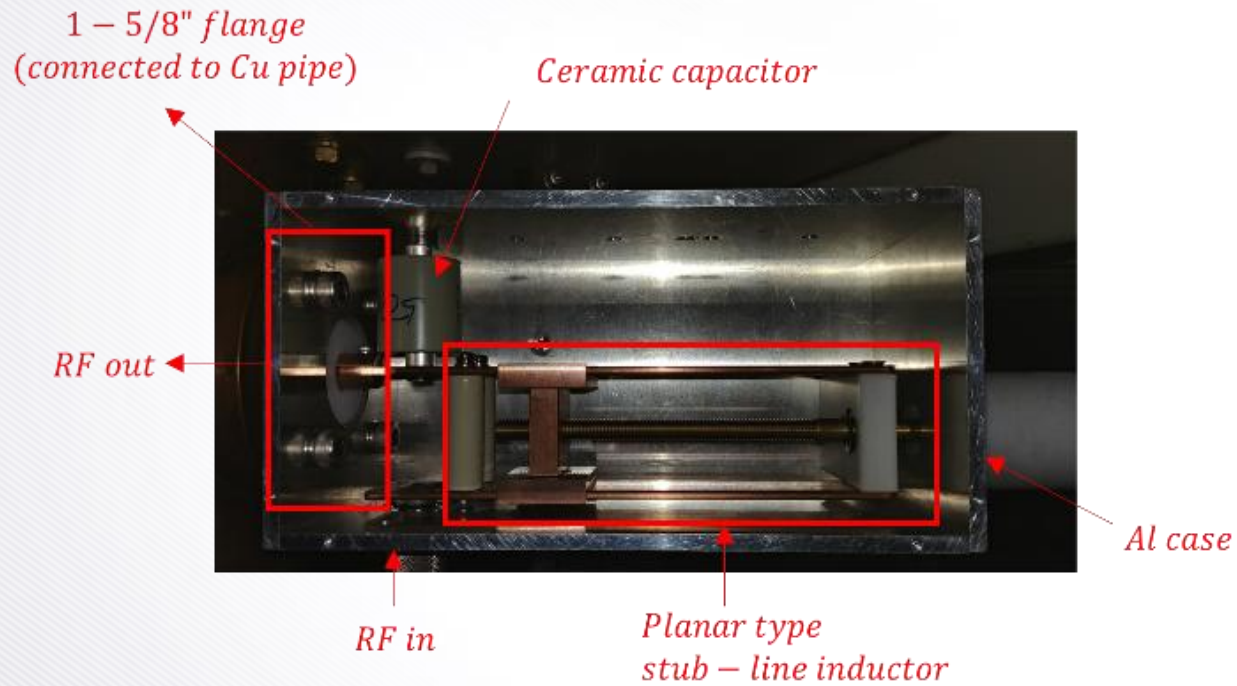
Impedance matching box structure

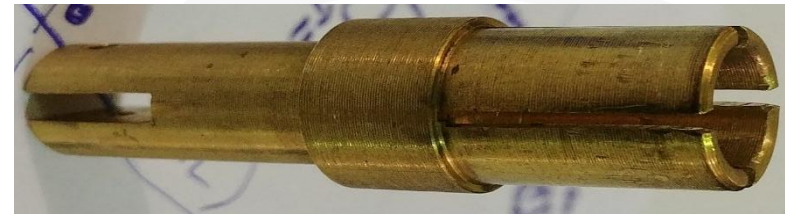
Output connector (Brass)

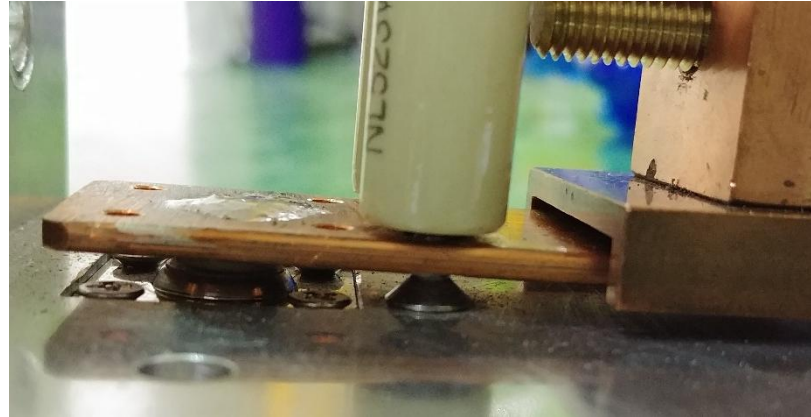
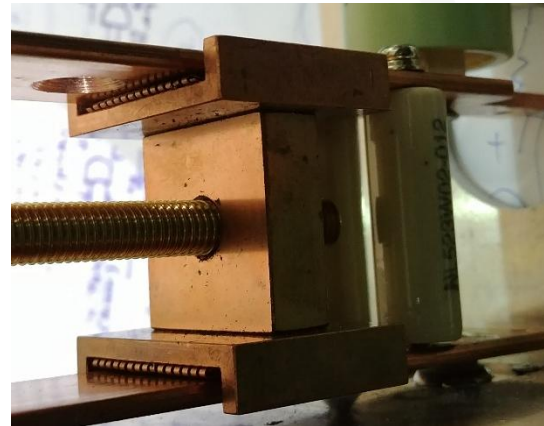
Problems:

- Stub-line inductor is not tightly fixed
→ the structure is tilted to one side
- Output connector material: brass
→ low conductivity, possibility of oxidation
- Input connector part is not well manufactured
- Others

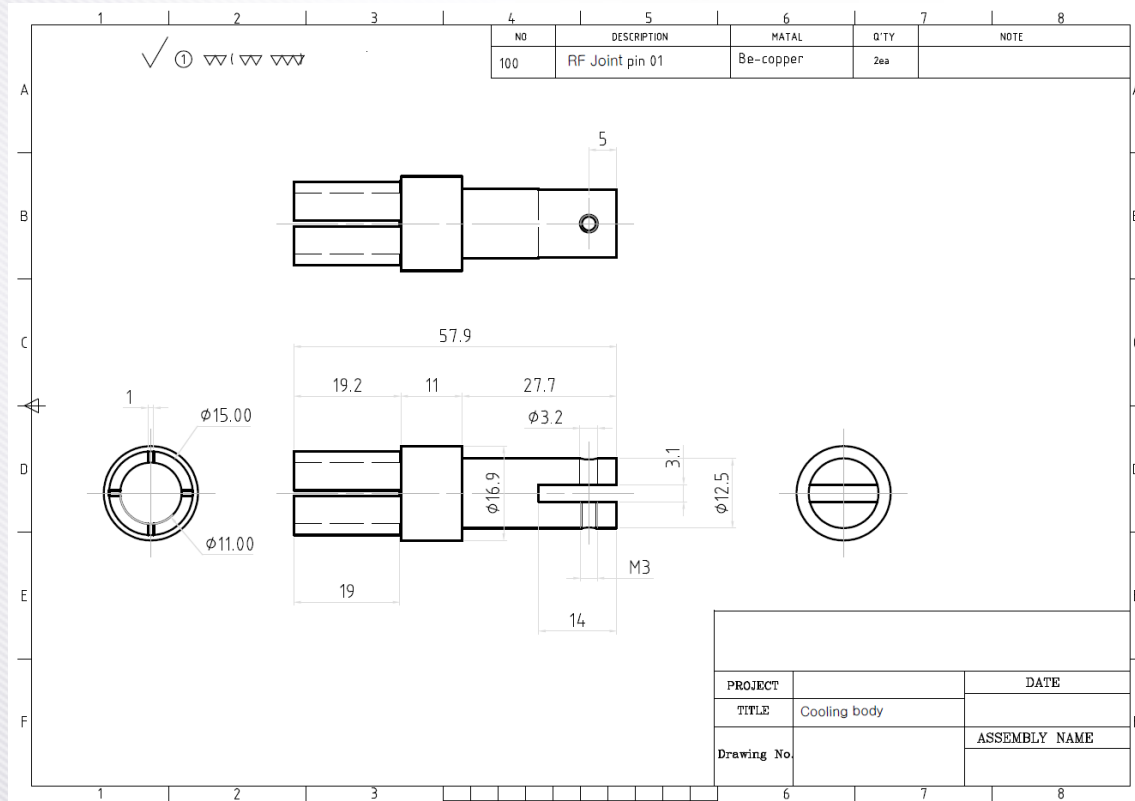
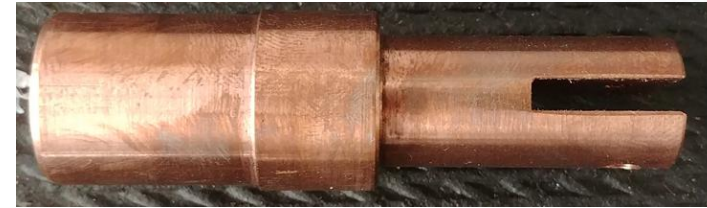
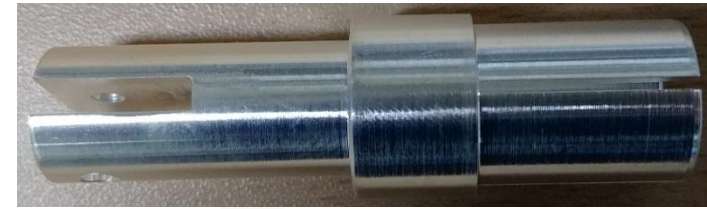
- Connector material: BeCu, BeCu+Ag plated

SG Condition: 950 mVpp, duty: 20 %

-> forward power increased by 10 % (1.6 kW -> 1.8 kW)

-> Clear RF pick-up signal

More performance expected using BeCu+Ag plated connector

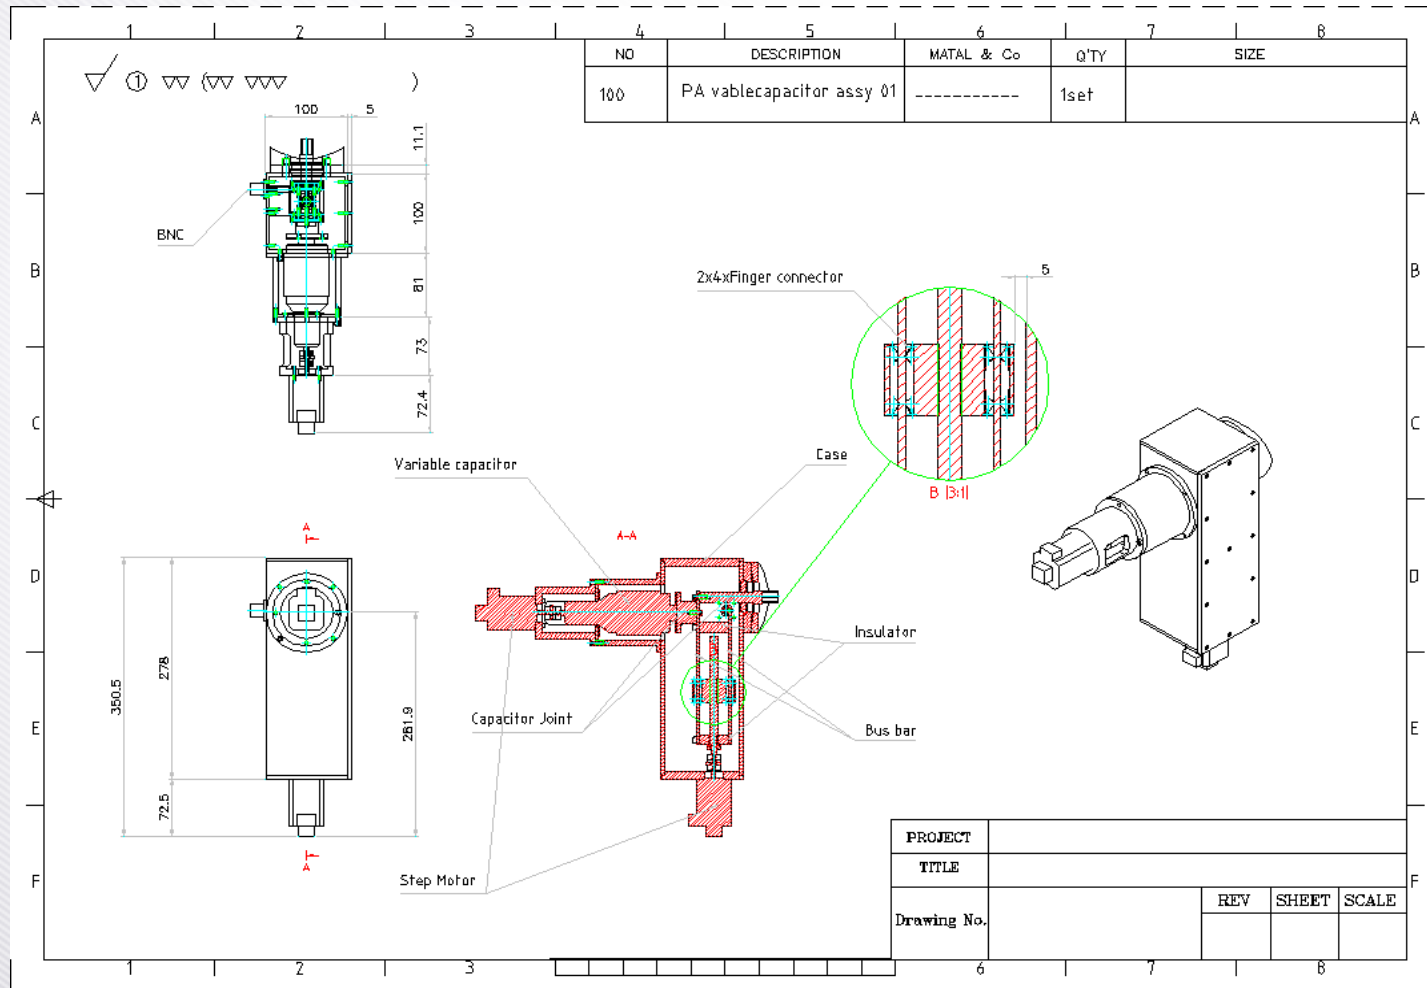
✂ Manufacturing on progress

Try to improve RF characteristics as well as mechanical and electrical properties

Features:

- VVC (Vacuum Variable Capacitor)
- Real-time motor control (position, direction)
- Control program

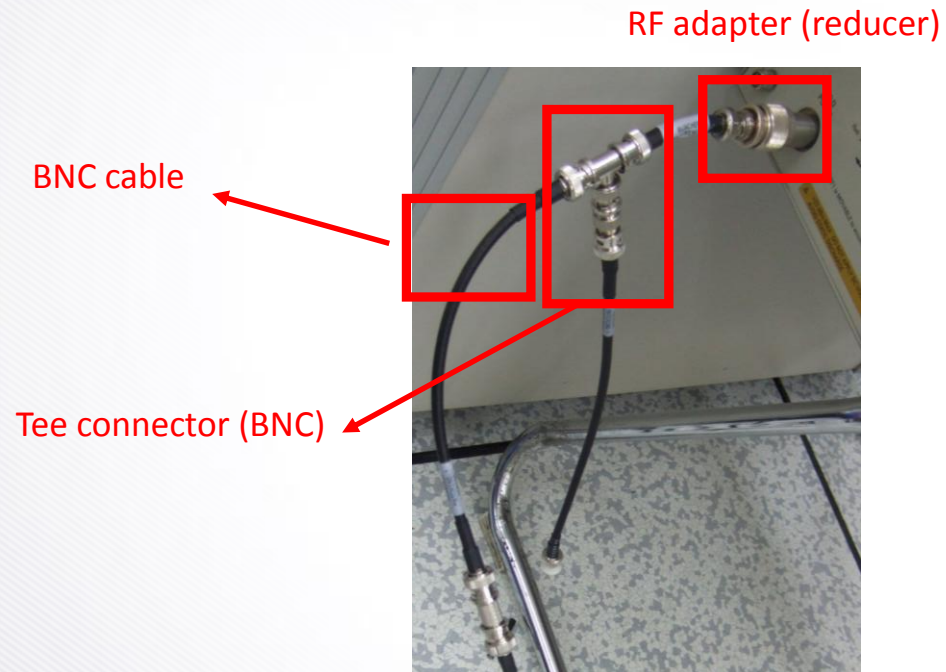
Problems:

- Not enough cable length margin (from buncher amplifier to RF buncher)
- Mechanical tension gives higher resistivity, higher cable loss
- Unnecessary RF adapters (reducer, cables)
- Thermal loss at tee connector and BNC cable (50°C), when operating 2-3 hours

* Optimization of impedance matching appropriate use of cable is required

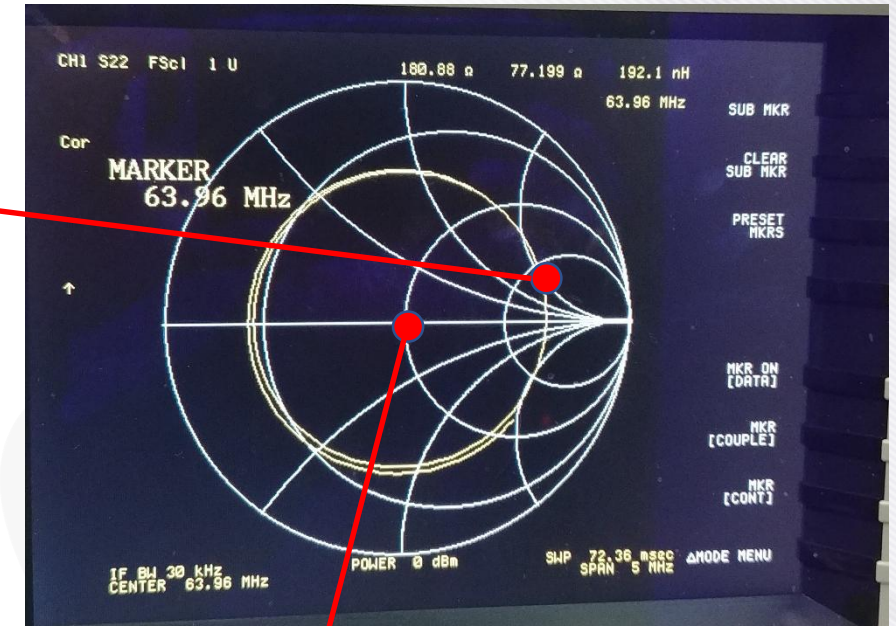
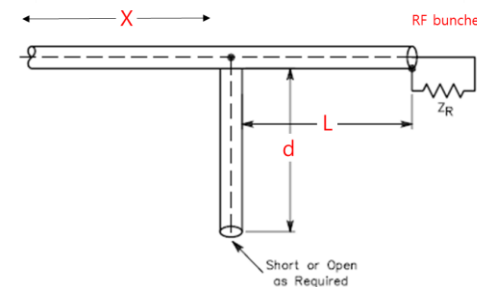
Reference point (load impedance, 4.6m)

Ref VF (RG-213) = 66 %
 Measured VF (RG-213) \approx 61.89 %
 $\lambda = 2.896 \text{ m}$
 $S_{21} \approx -0.5 \text{ dB}$ (10 % loss)

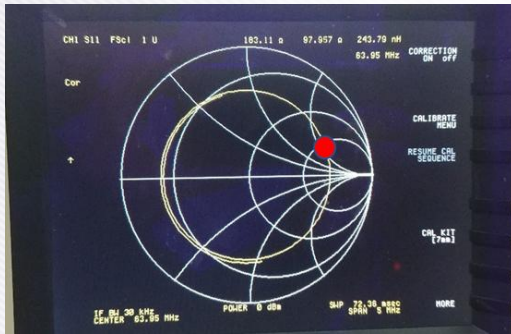
Reference point: existing cable + 4.6 m RF cable

Load impedance

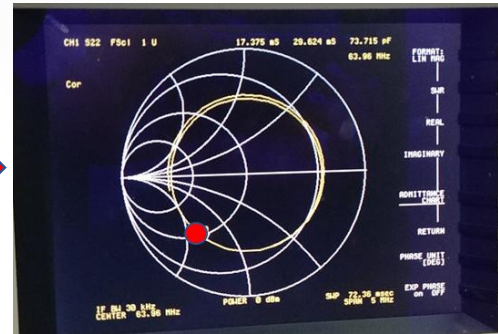
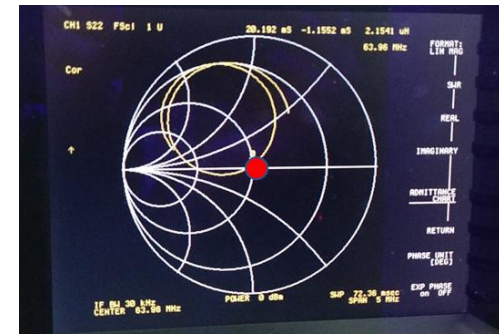
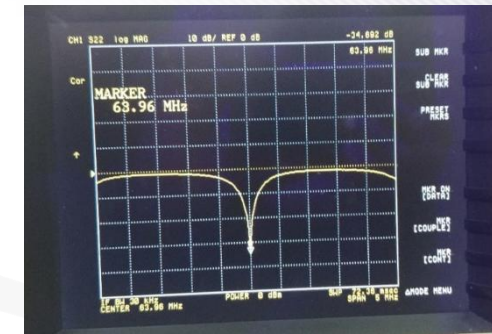
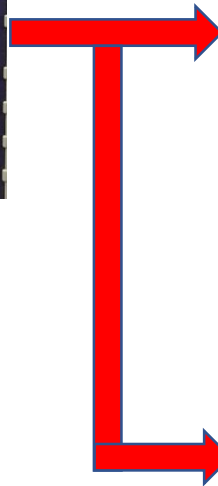
Solution 1)

Sol 1): $L = 61$ cm, $d = 108$ cm

Sol 1) $L = 57.1$ cm, $d = 99.3$ cm

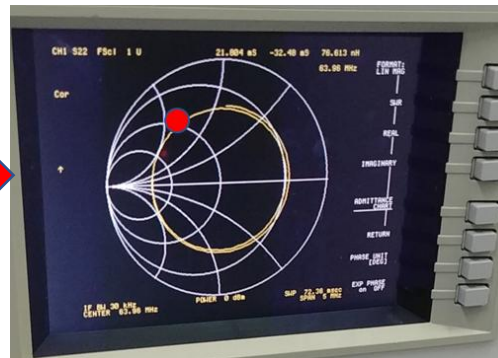
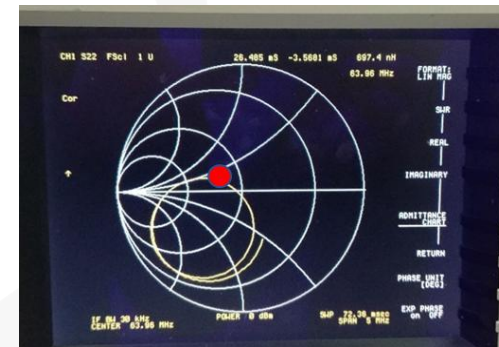
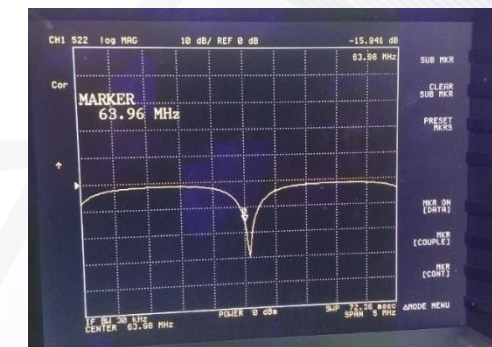
Solution 2)

Sol 2): $L = 102.5$ cm, $d = 54.5$ cm

Sol 2) $L = 99$ cm, $d = 45.6$ cm

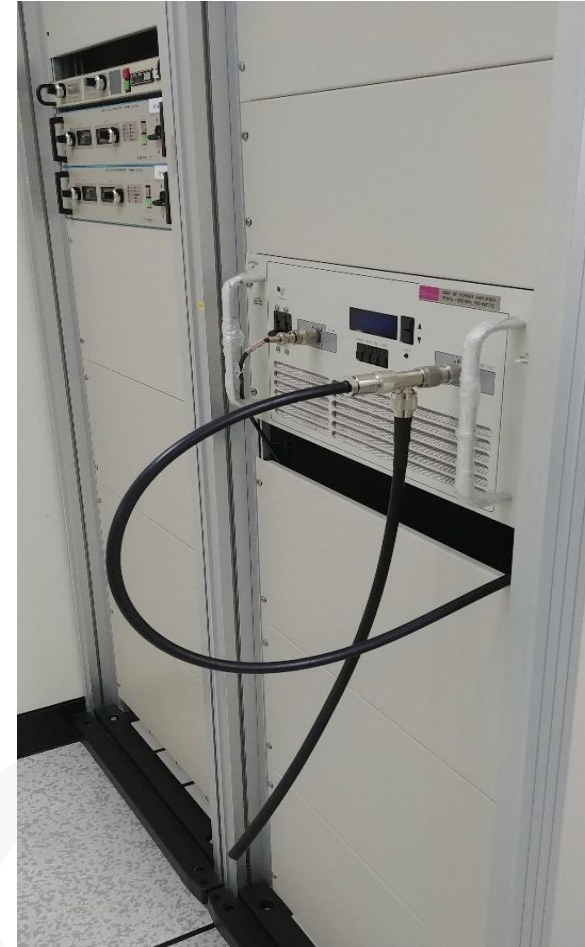
- Cable: RG-58 -> RG-213
- Connector: BNC type Tee connector -> N type Tee connector
- Choose 2nd solution with open-stub

Network analyzer measurement

S11: -25 dB @ 63.96 MHz

L: approx. 101 cm, d: 49.6 cm

RF test (Over 3 hour beam irradiation)

Less heat generated (around 30 degree on surface)

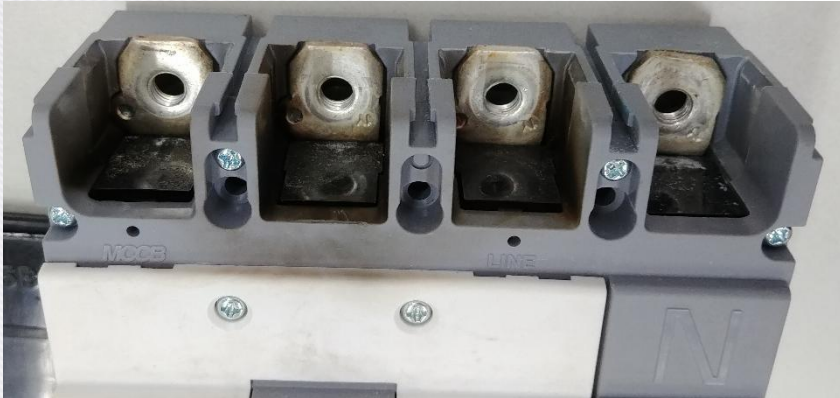
MCCB malfunction

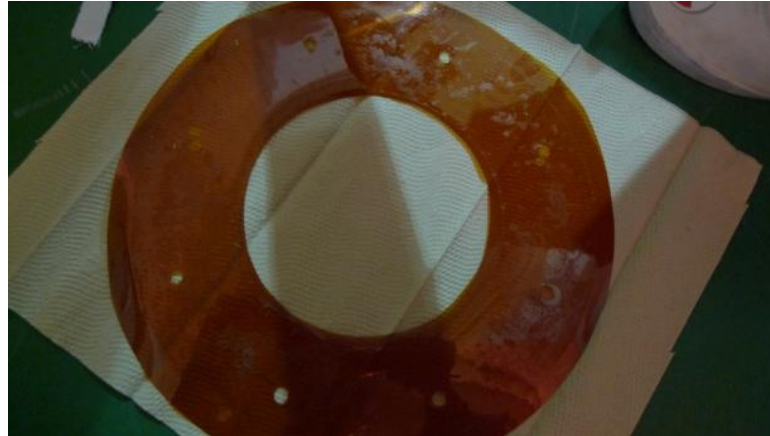
Kapton film

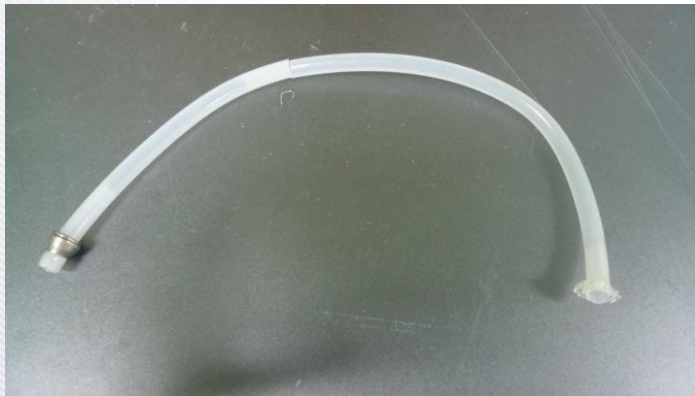
Cooling hose

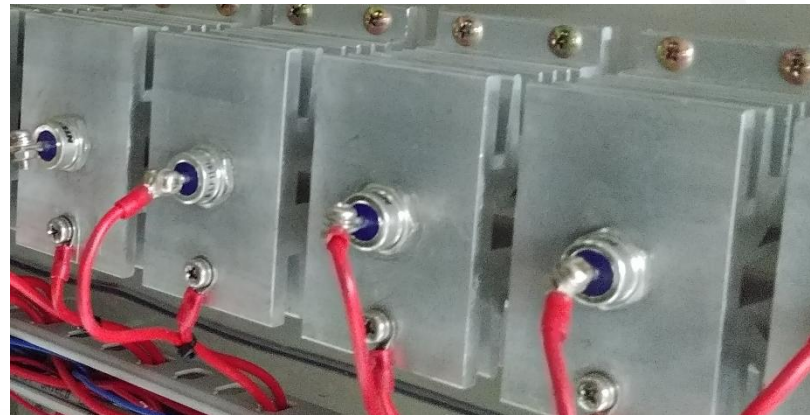
Zener diode

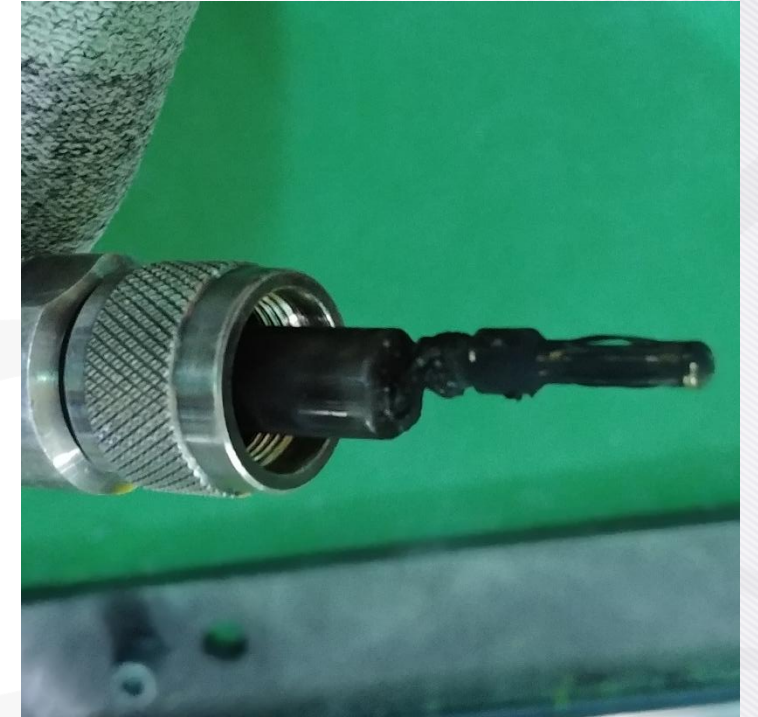
HV connector
