Irradiation aging of the electronics of the ATLAS Transition Radiation Tracker

Bijan Haney, on behalf of the TRT Group
Radiation Effects Workshop - April 23, 2018

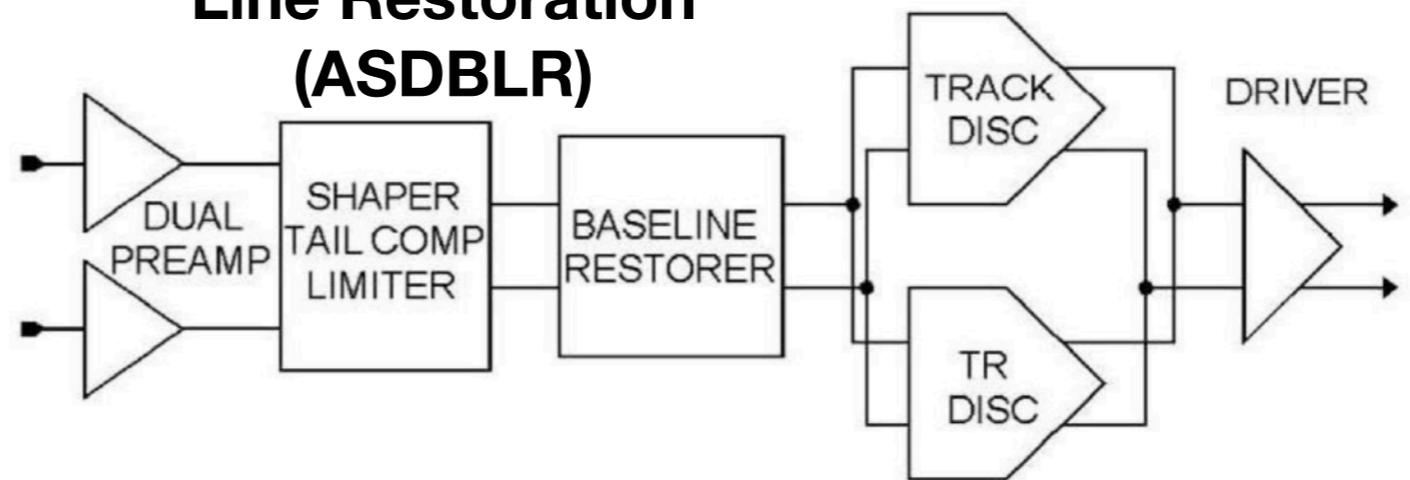
Figure 2. Block Diagram of one channel of the ASDBLR

Amplification, Shaping, Discrimination, and Base-Line Restoration (ASDBLR)

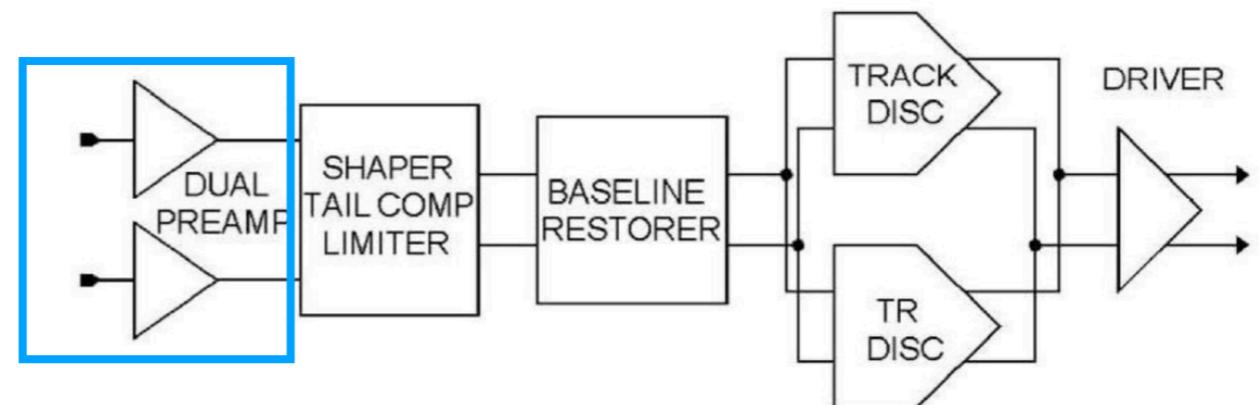
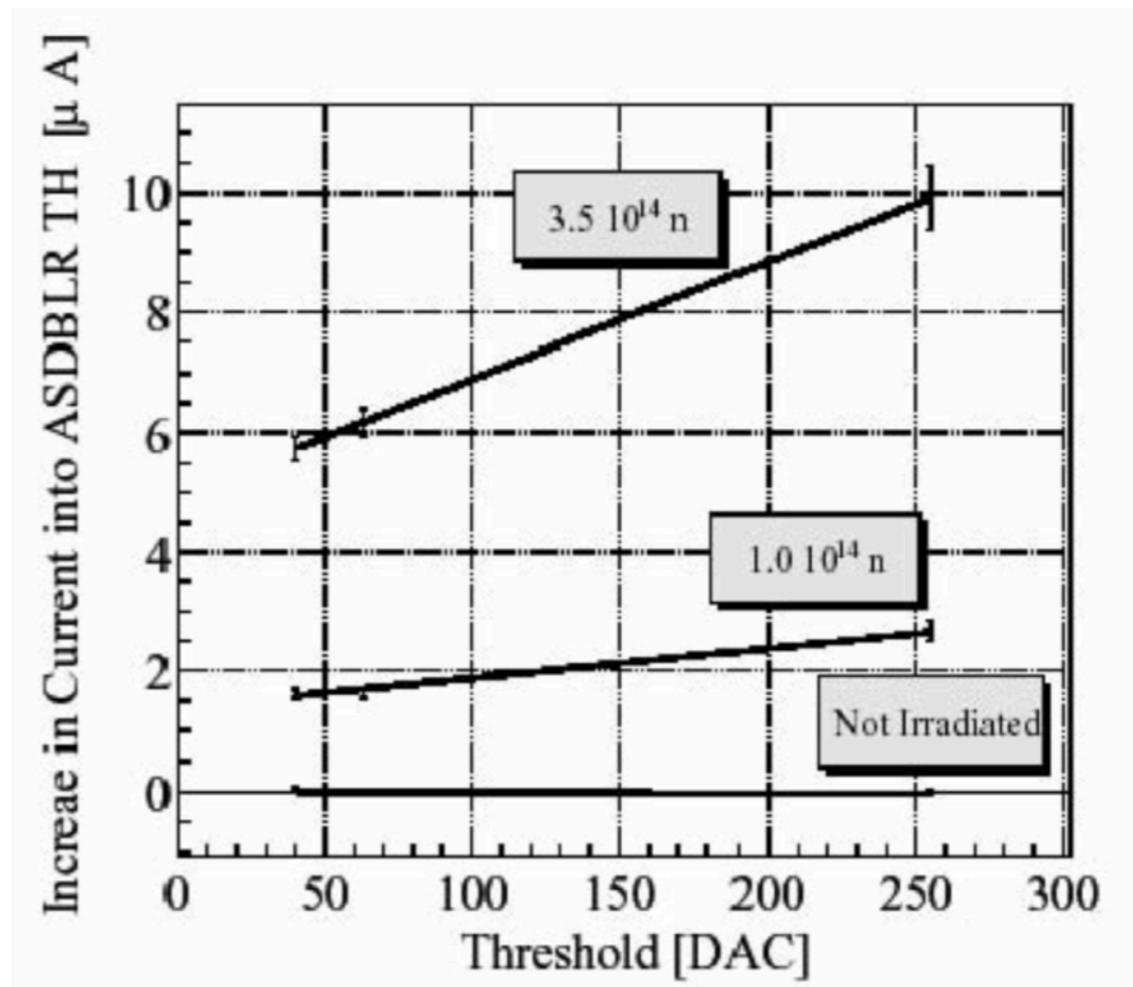
- Significant attention was given to the protection of the preamp on the ASDBLR since the input is directly attached to the straw anode wire.
- The preamp is the part of the circuit most affected by radiation damage, as the transistor is sensitive to displacement damage from neutrons and protons.
- This causes an increase in current at the base of the transistor of the preamp, which will lower the gain (β).
- Plot shows base current change as a function of different neutron irradiation levels. The threshold input (x-axis) is wired directly to the base of the transistor.

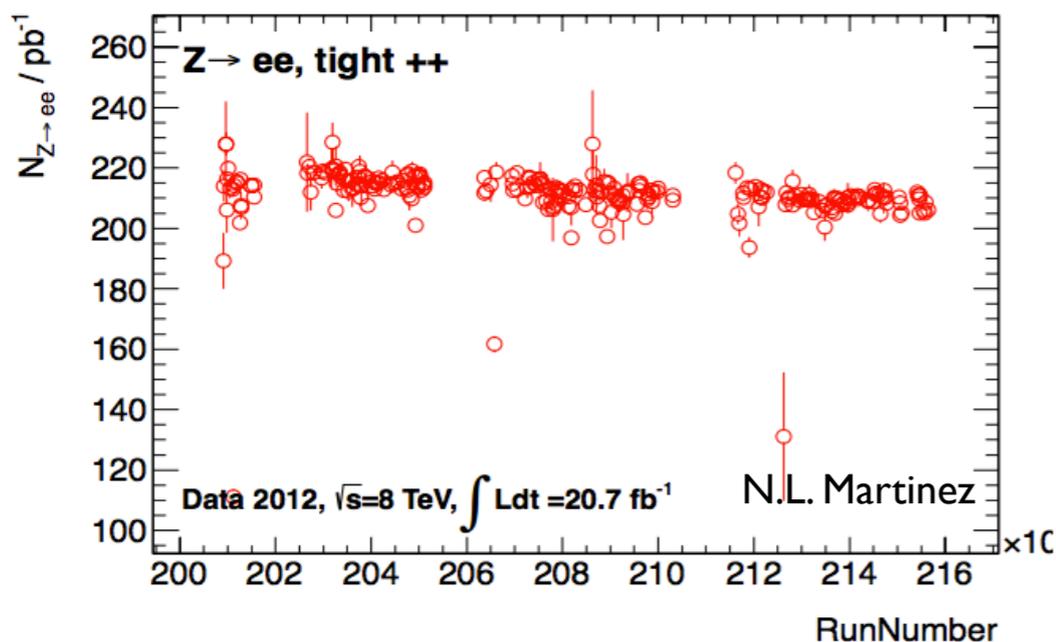
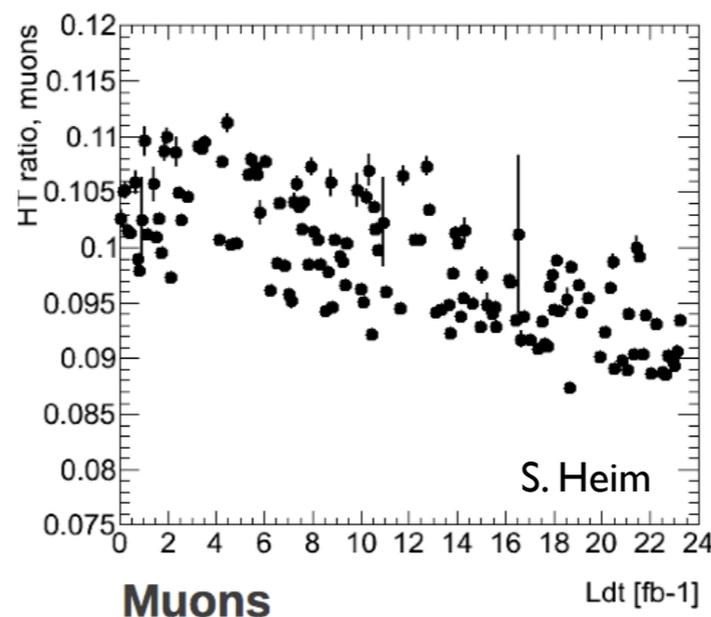
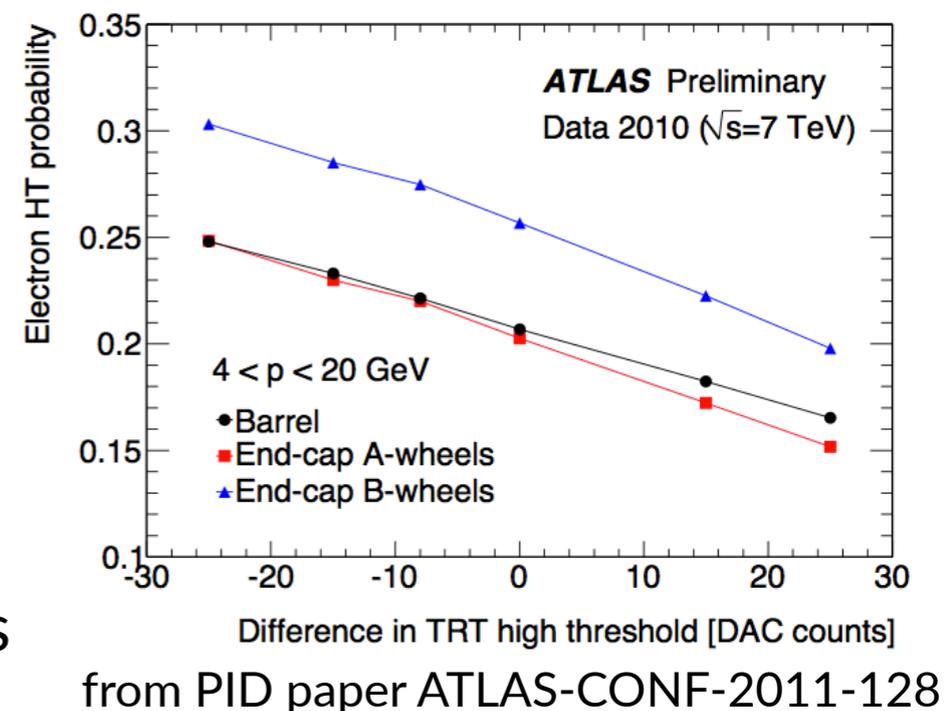
Electron Efficiency in High Threshold

- Loss of gain caused by radiation damage to the ASDBLR will mean less tracks will pass the high threshold for electron identification.
- At the end of Run 1, we saw a decrease in the $Z \rightarrow ee$ efficiency.
- The high thresholds had not been changed since the beginning of run 1. A decrease in electron efficiency is an effective increase in the TRT high threshold.

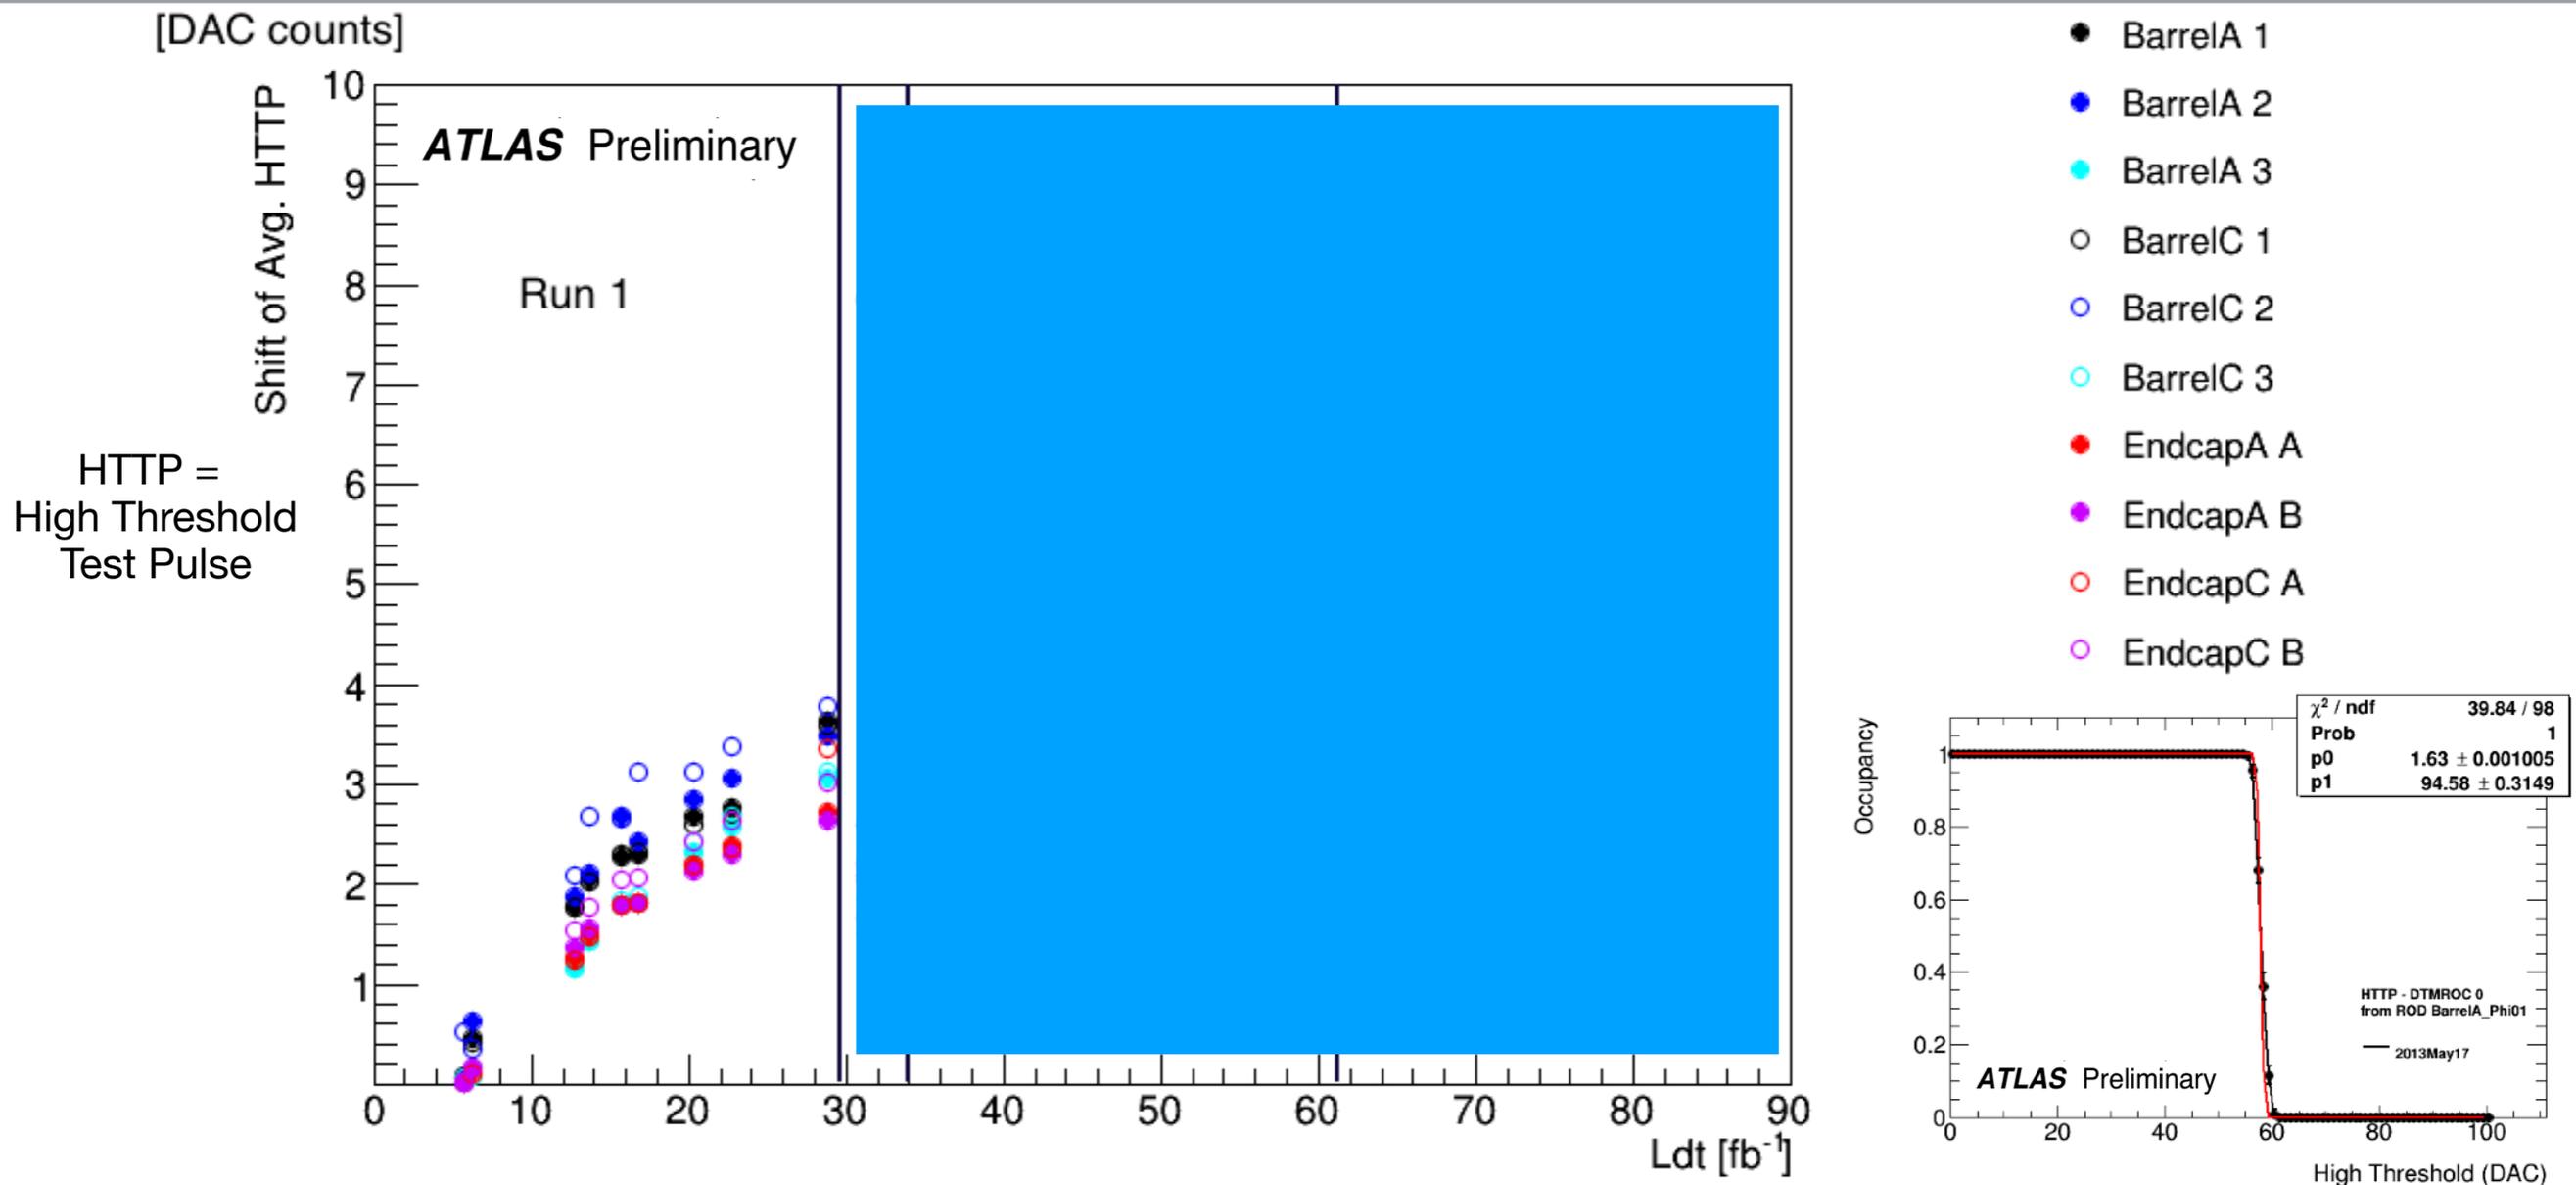
High Threshold Drift in Run 1

- Plot of TRT high threshold calibration scans as a function of integrated luminosity over run 1. Calibration scans inject a 63 DAC test-pulse from the DTMROC into the ASDBLR.
- The y-axis shows how the 50% occupancy threshold has drifted over time for a constant injected test pulse from the DTMROC. (change is *-1 on the plot).

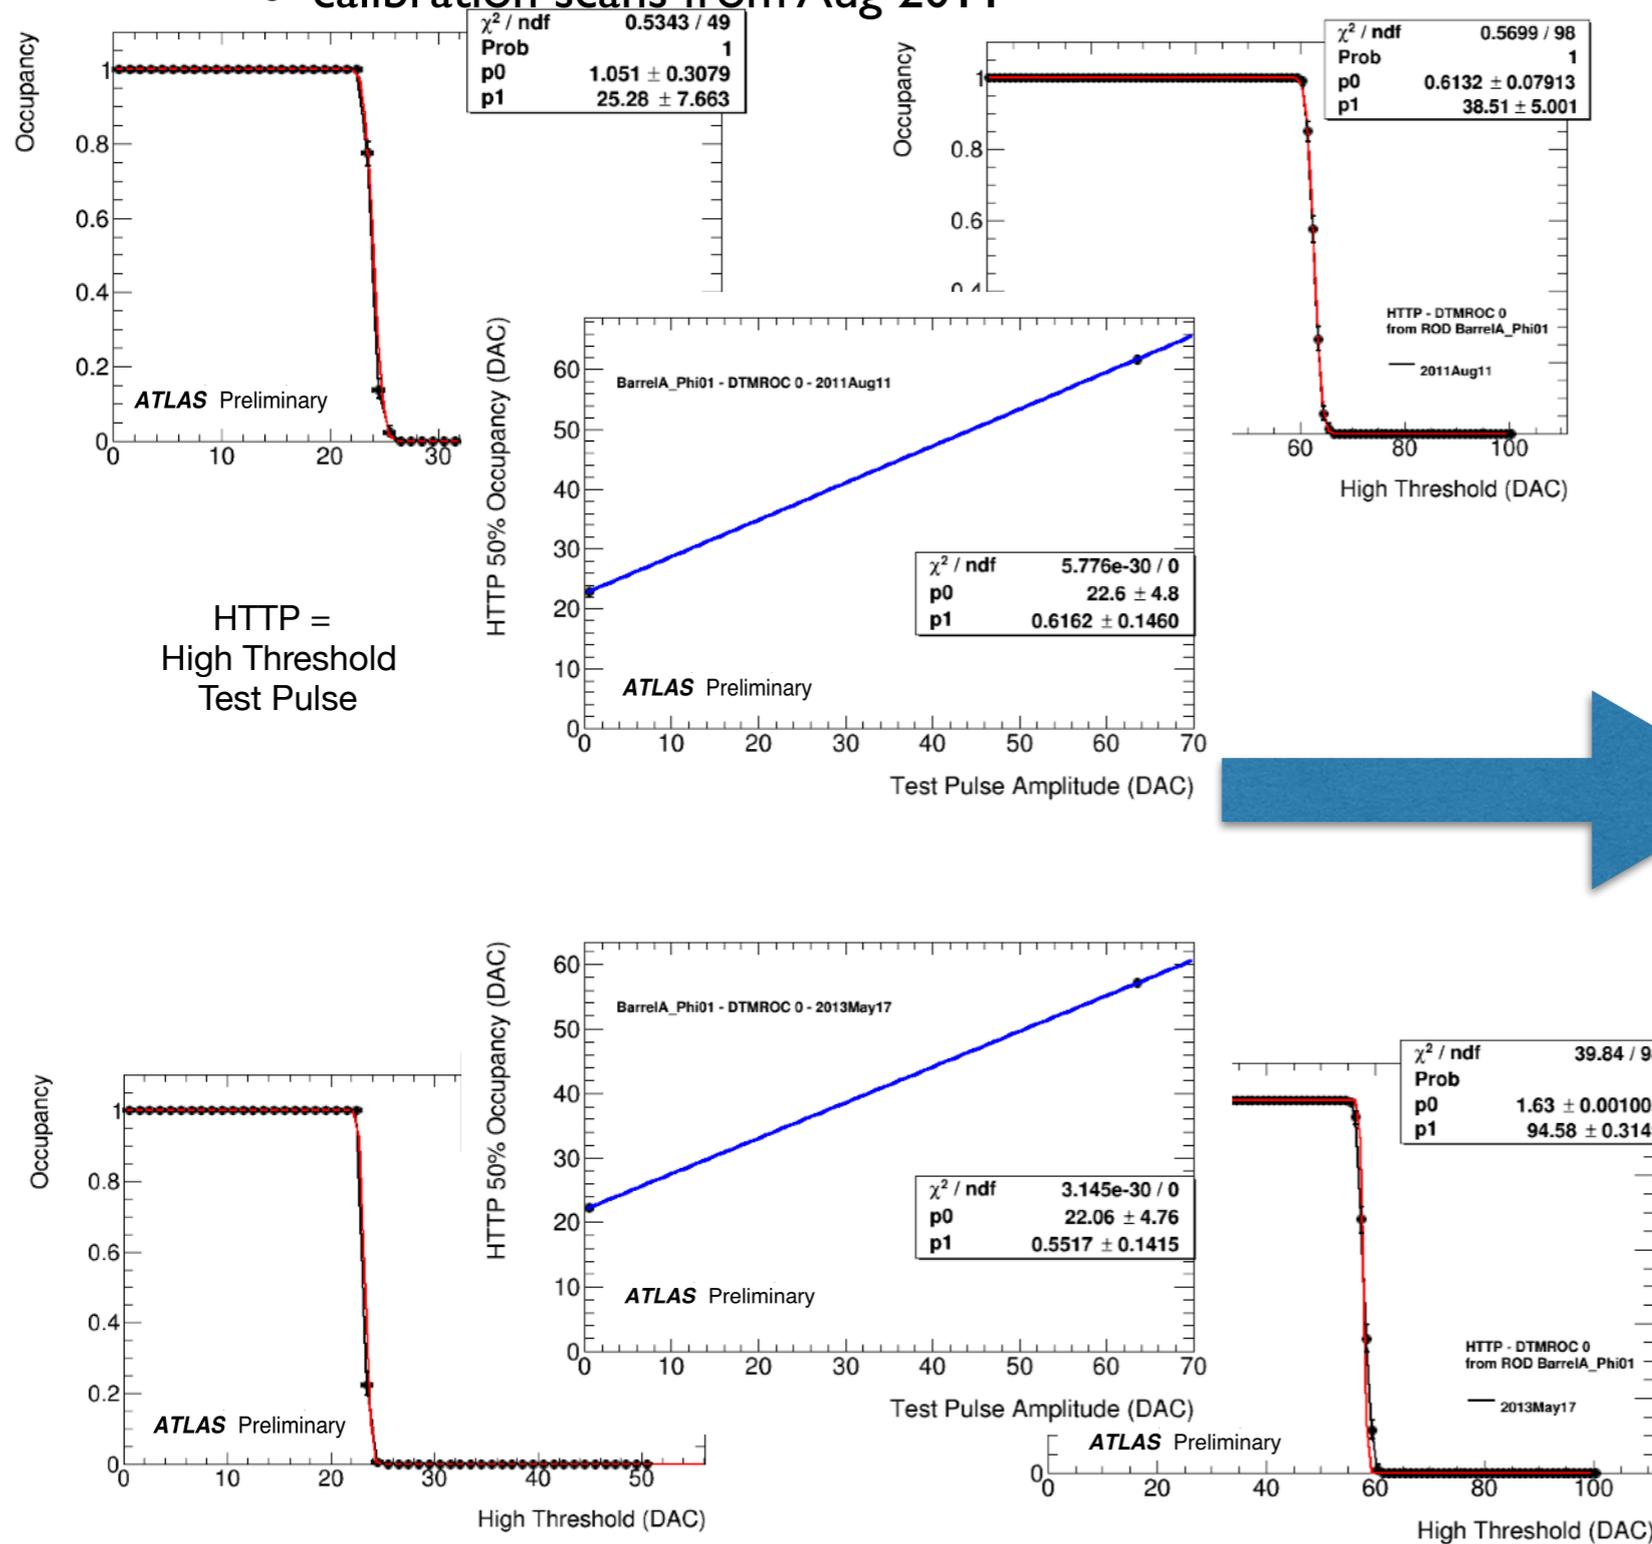
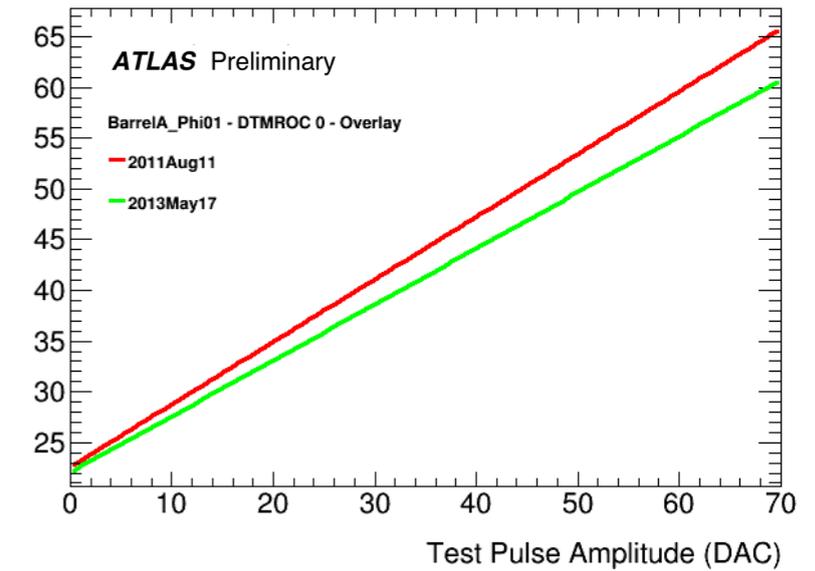
Change in Gain on TRT over Run 1

- calibration scans from Aug 2011

HTTP =
High Threshold
Test Pulse

HTTP 50% Occupancy (DAC)

- calibration scans from May 2013

- You can see gain change in threshold response from the calibrations scans using a injected test-pulse into the ASDBLR over run 1.

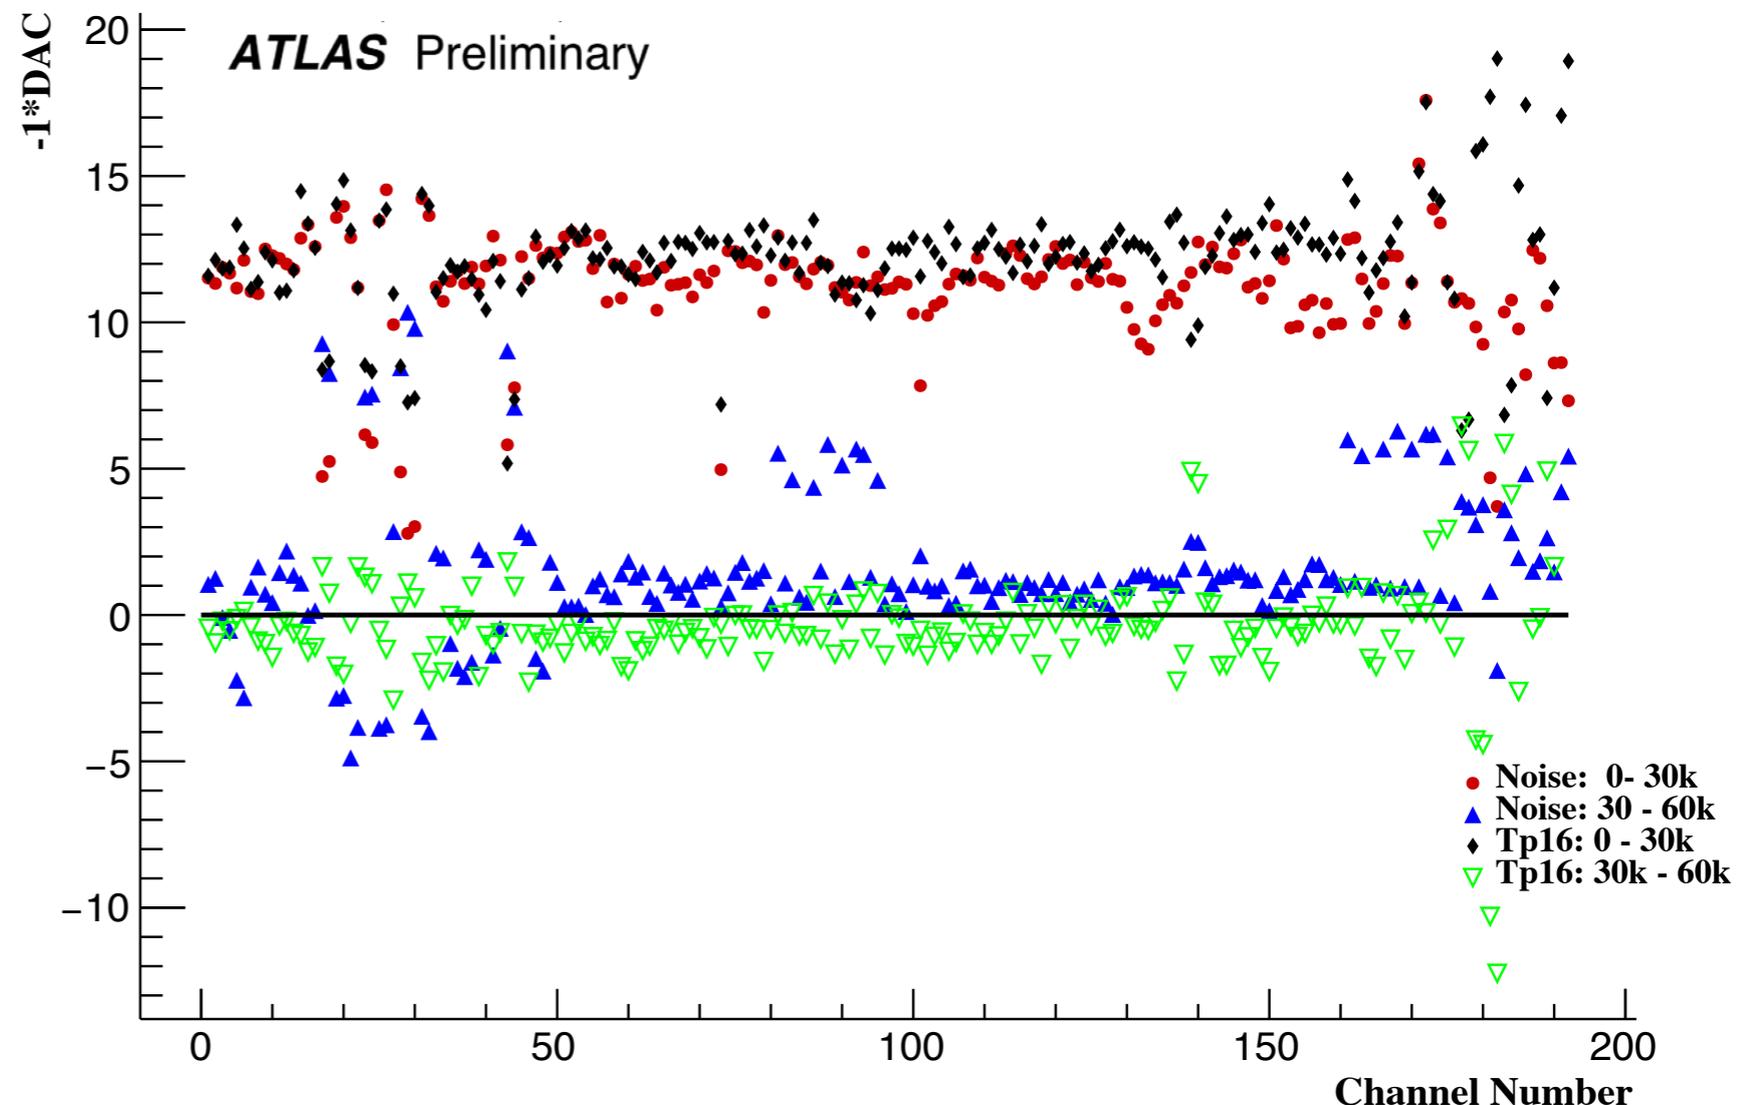
DAC Change: Set1, 60kRad

- Front-end ASDBLR boards were sent to Brookhaven lab to be irradiated by a Co60 source, first to 30 kRad, and then to 60 kRad.
- Using the test pulse on the DTMROC, a test-pulse at 63 DAC was injected into the ASDBLR at 0 kRad, 30 kRad, and 60 kRad to see shift in threshold.
- Threshold drift was observed from 0 to 30 kRad, but no drift was observed from 30 to 60.
- 30 kRad is about the amount of integrated radiation for run 1.

- This shows that the radiation damage saturates after 30 kRad.

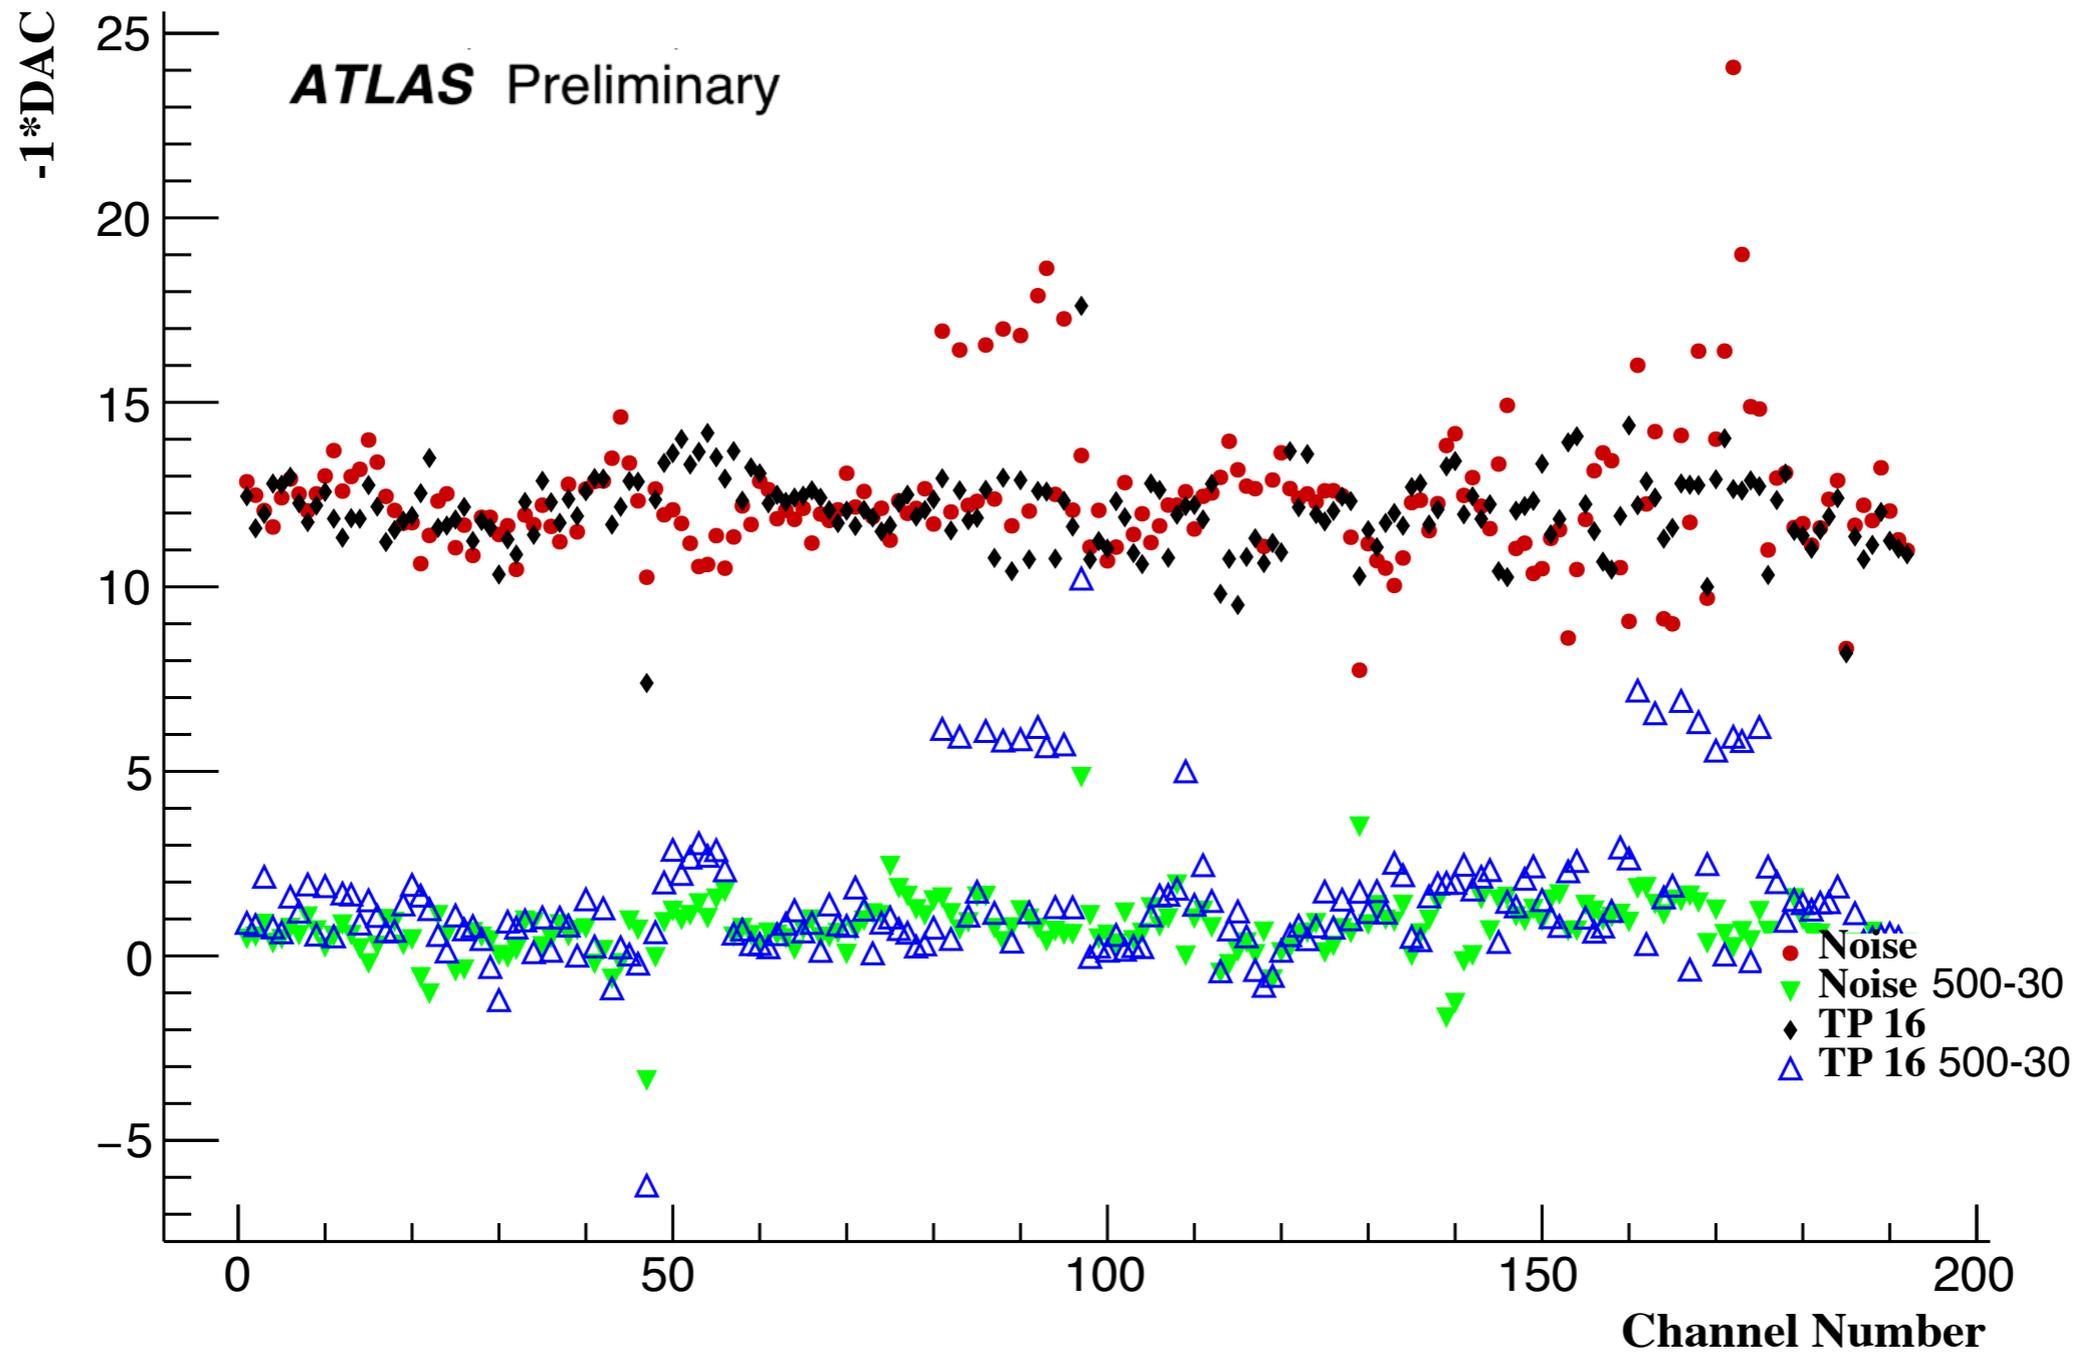
DAC Change: Set4, 500kRads

- Same plot as before, but from 30 to 500 kRad.
- Threshold drift effect seems to saturate after 30 kRad.

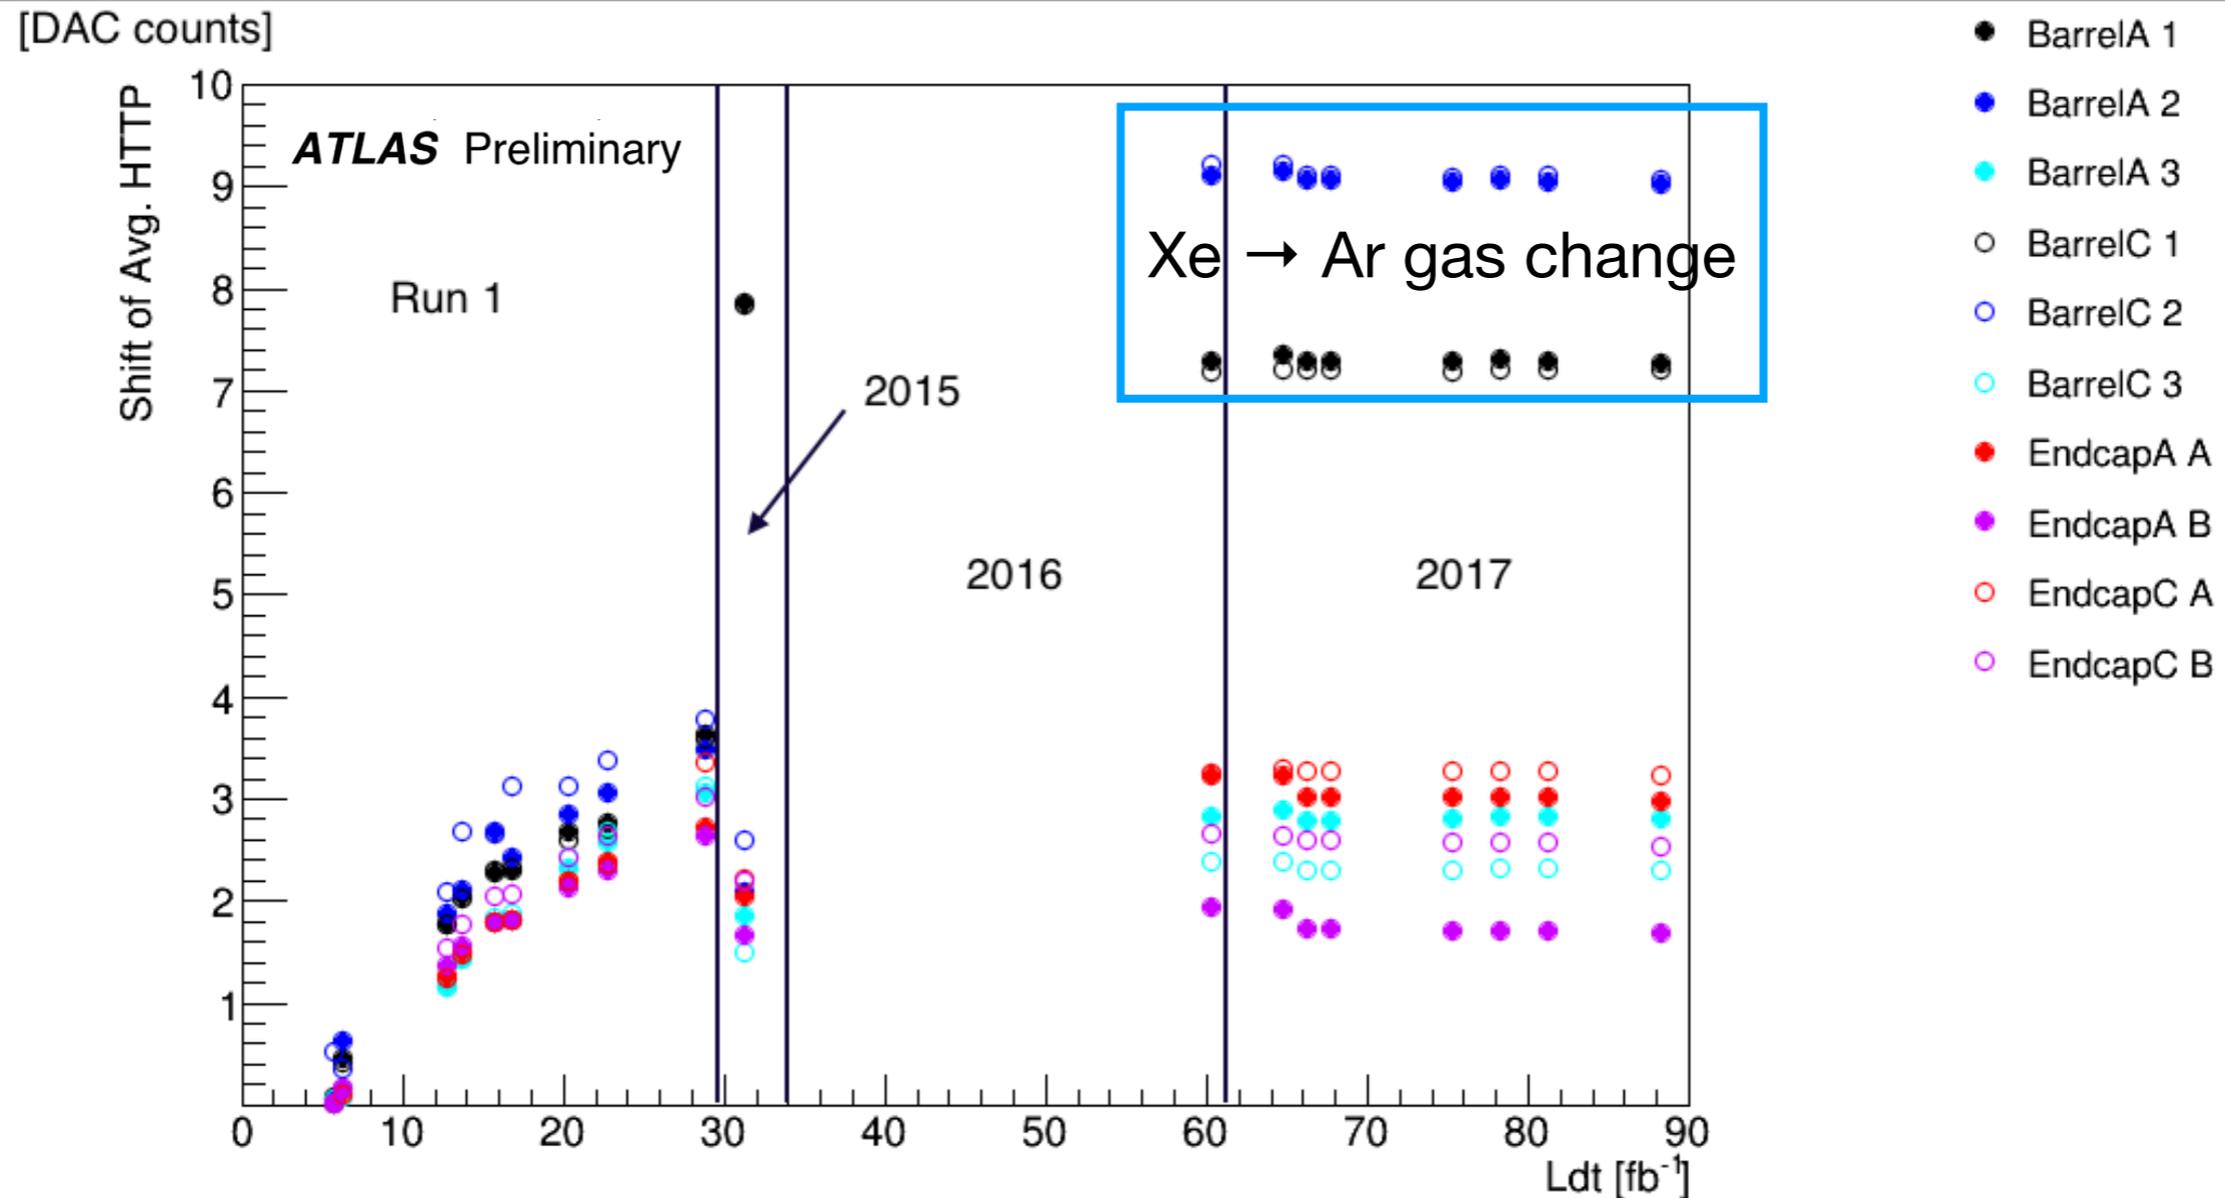
High Threshold Drift in Run 2

- Plot of TRT high threshold calibration scans as a function of integrated luminosity over run 1 and run 2. Just as seen in the tests, threshold drift has saturated after run 1.
- Large jumps in 2016 and 2017 are caused by change of gas configuration and not radiation damage.

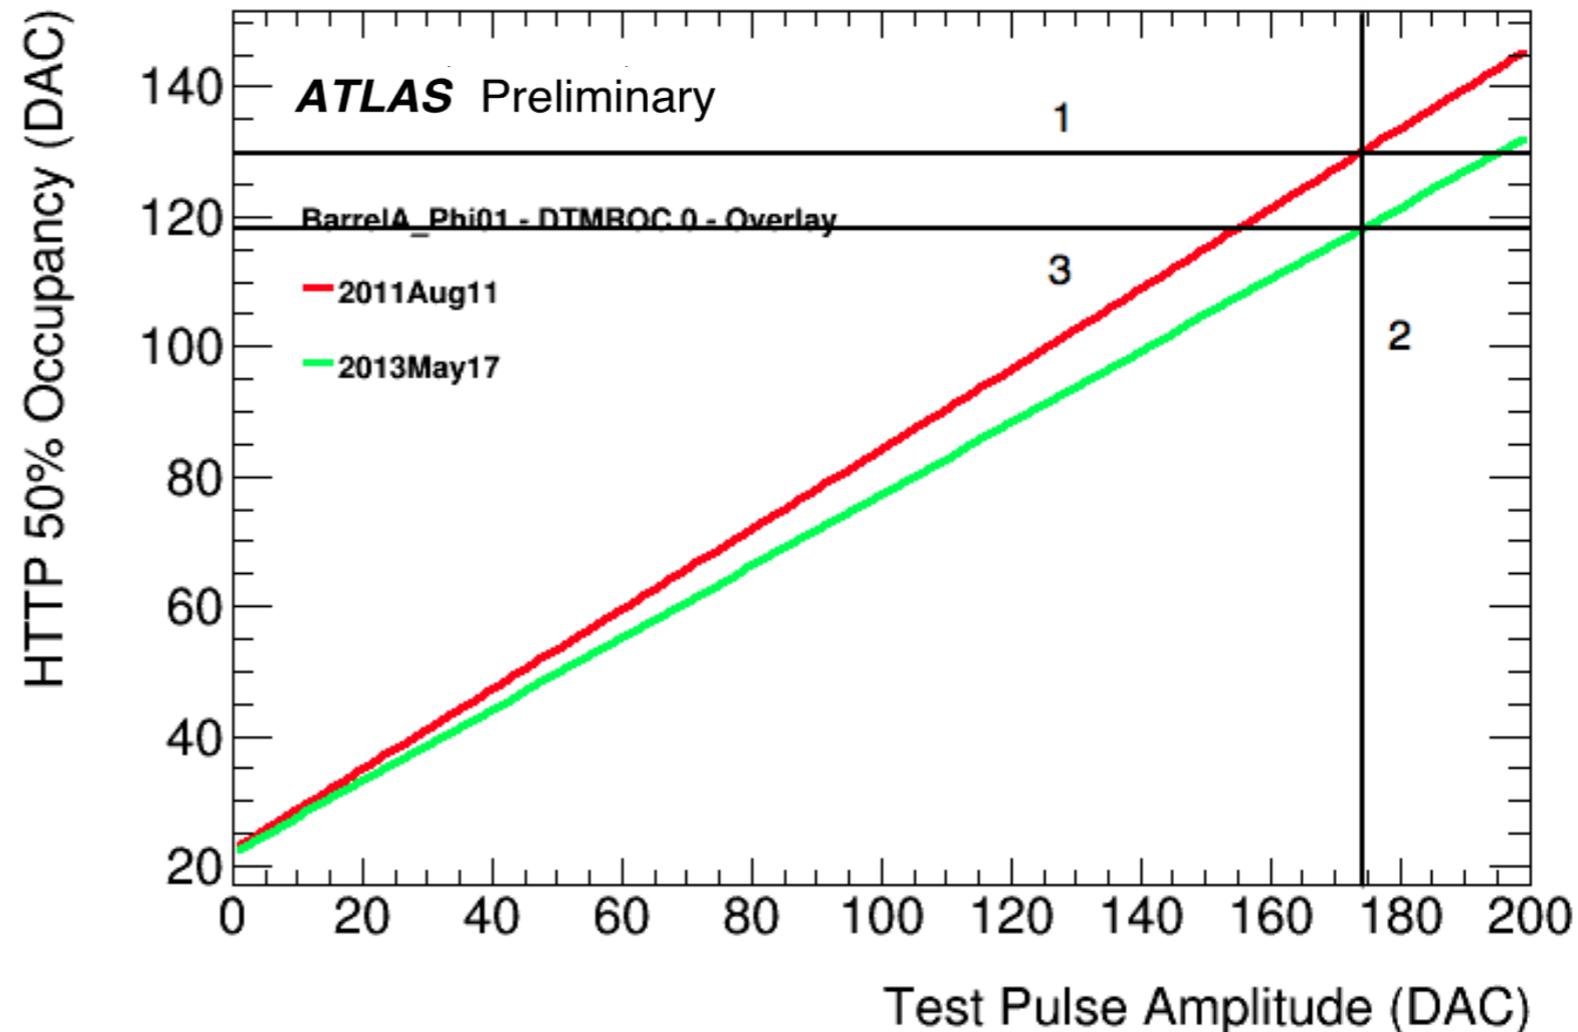
- A method for correcting the high thresholds was developed using the test-pulse on the DTMROC.
- Essentially, the high thresholds have to be lowered to compensate for the change in gain.
- (1) Use the original high thresholds in the TRT (e.g. 130) to find the test pulse amplitude that would create that 50% occupancy response.
- (2) Use that test-pulse amplitude to see what new threshold would be needed to create a 50% occ. response at the time after irradiation.
- (3) Use the found threshold value (e.g 119) as the new high threshold in the TRT.

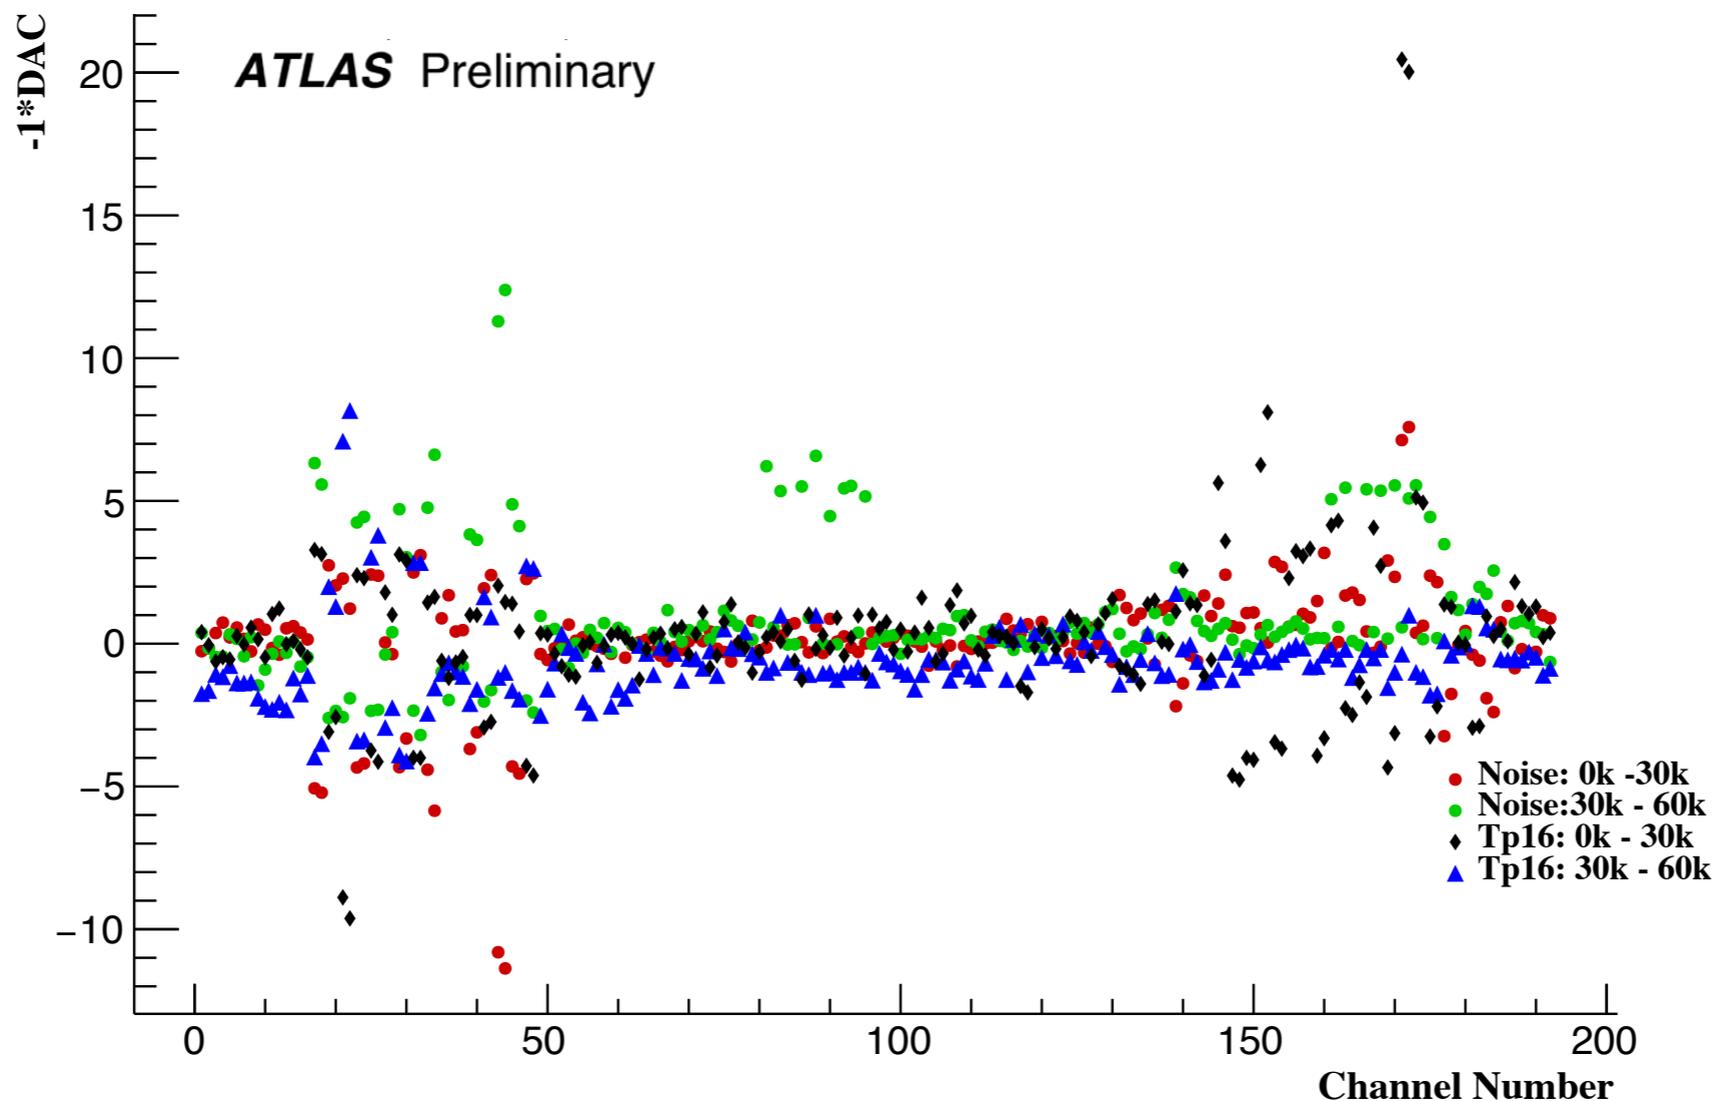
DAC Change: Control

Unused front-end ASDBLR boards were sent to Brookhaven lab to be irradiated, first to 30 kRad, and then to 60 kRad. These boards are a control sample, that were not placed in front of the Cobalt-60 source.
